## DAILY REPORT #32 – DORIS NORTH INFRASTRUCTURE/ NORTH DAM

Prepared by:	Murray McGregor / Megan Miller	Date:	2012.02.06
Reviewed by:		Project #:	1CH008.058.0320
Role	Company	Personnel – Position	On Site
Client	Hope Bay Mining Limited (HBML)	Angela Holzapfel – ESR Compliance Manager David Vokey – ESR Coordinator Don Ethelston – HSLP Advisor Dean Wold - Safety Jill Turk – ESR Coordinator Katsky Venter – ESR Manger Michelle Tanquay – ESR Site Manager Stirling Kelly – HSLP Advisor	No No No No Yes Yes No Yes
	JDS	Lloyd Jackson – Mechanical Superintendent Doug Fielding – Construction Manager Ishan Fechter – Construction Coordinator Jerry Graham – Construction Manager Kevin Whieldon – Project Coordinator Mark Valeriote – Construction Manager	Yes No No Yes Yes Yes
Engineering Design Consultants	SRK Consulting (Canada) Inc.	John Kurylo – Site Engineer Megan Miller – Site Engineer Lawrence Borowski – Site Engineer Murray McGregor – Site Engineer Iozsef Miskolczi – Site Engineer	Out Yes No Yes No

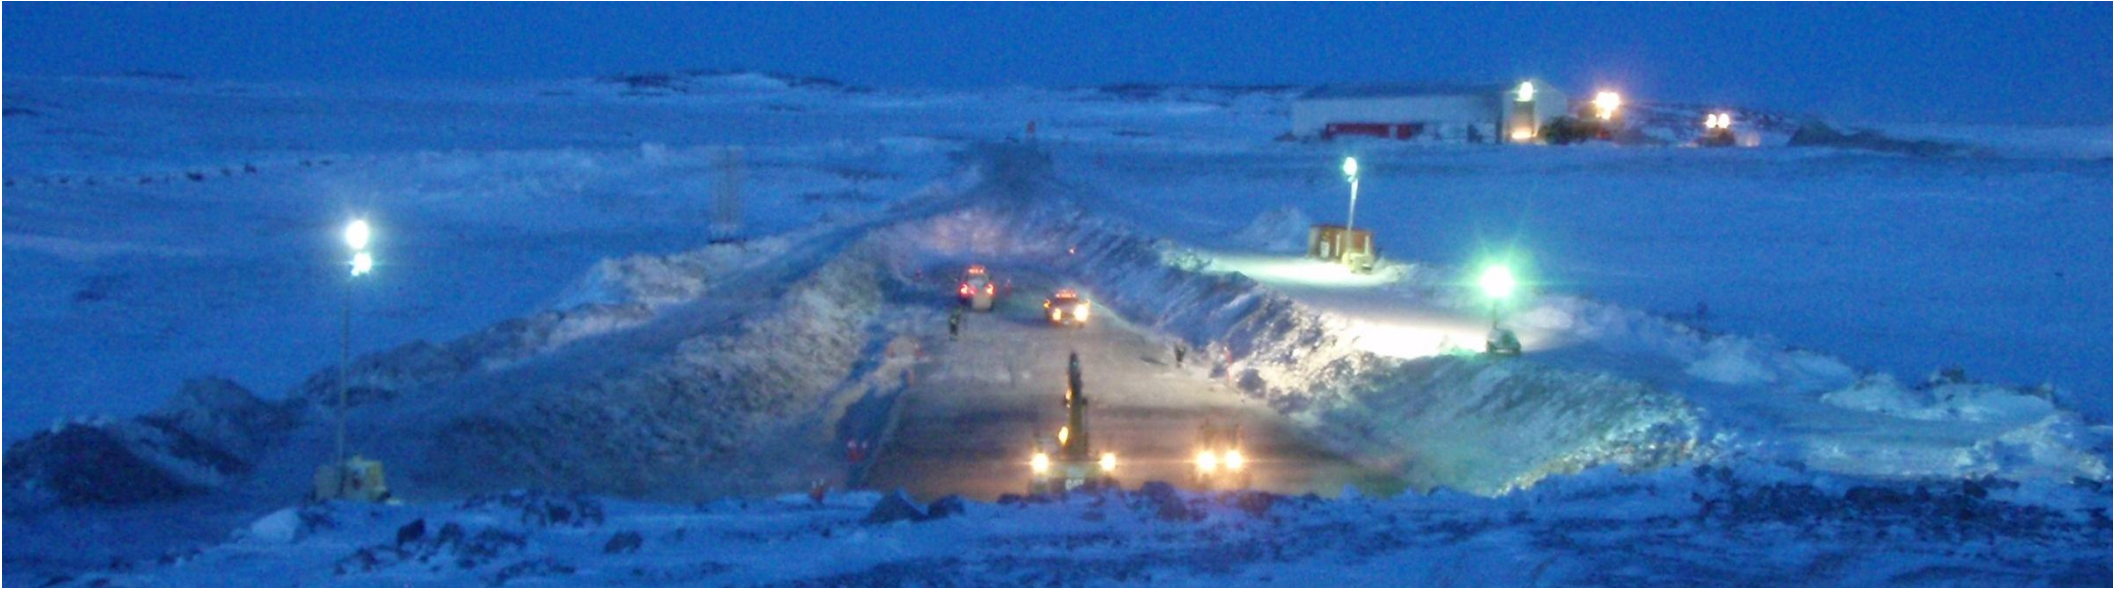
**Photo 1:** Progress photo of North Dam from photo point 3. ~NW view.

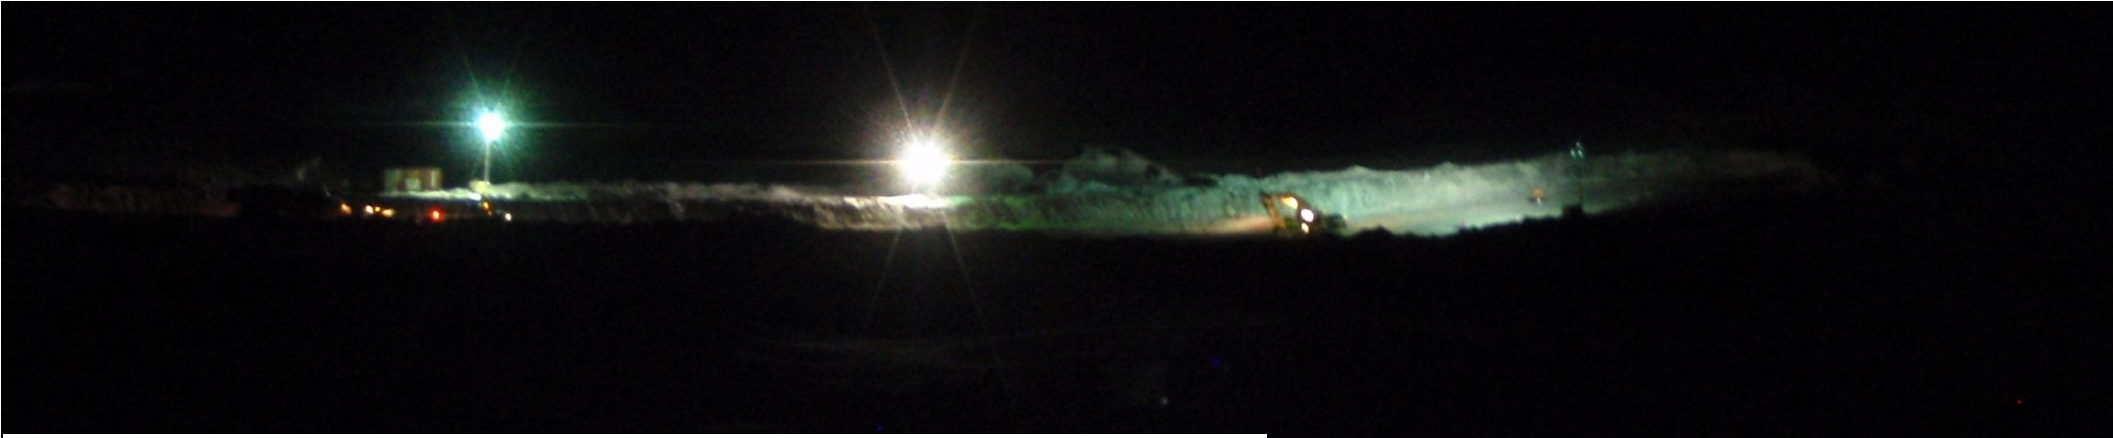
**Photo 2:** Progress photo of North Dam from photo point 1. ~SSE view.

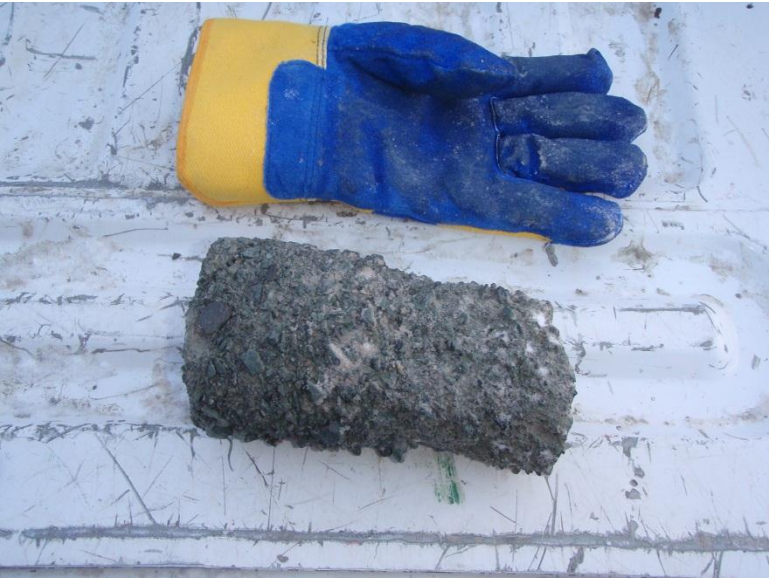
Drill cores HB12-ND-CORE-DC-24-QA-20120206 and HB12-ND-CORE-DC-24-QA- were taken at approximately 0+93 CL and 0+85 US respectively from core placed on February 4<sup>th</sup>, 2012.

**Photo 3:** Drill core HB12-ND-CORE-DC24-QA-20120206.  
Coring stopped after grinding noises were heard.

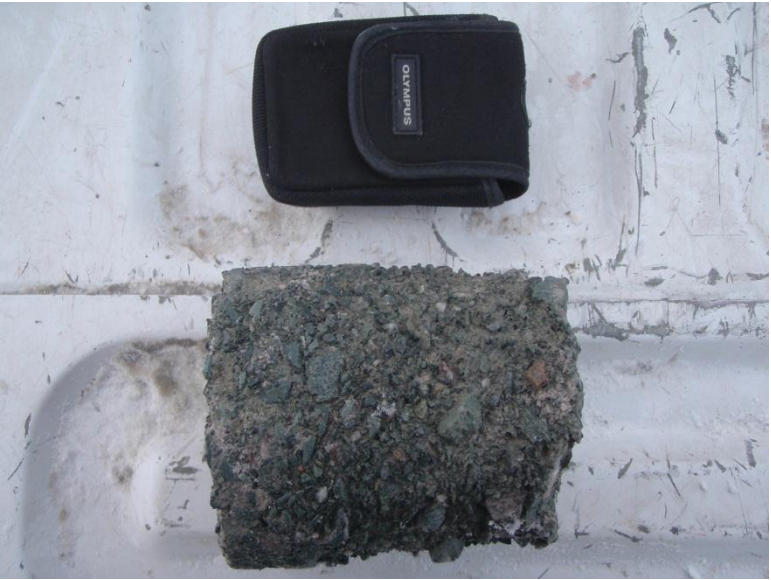
**Photo 4:** Drill core HB12-ND-CORE-DC25-QA-20120206.  
Poor quality due to lost circulation and loosened gravel.

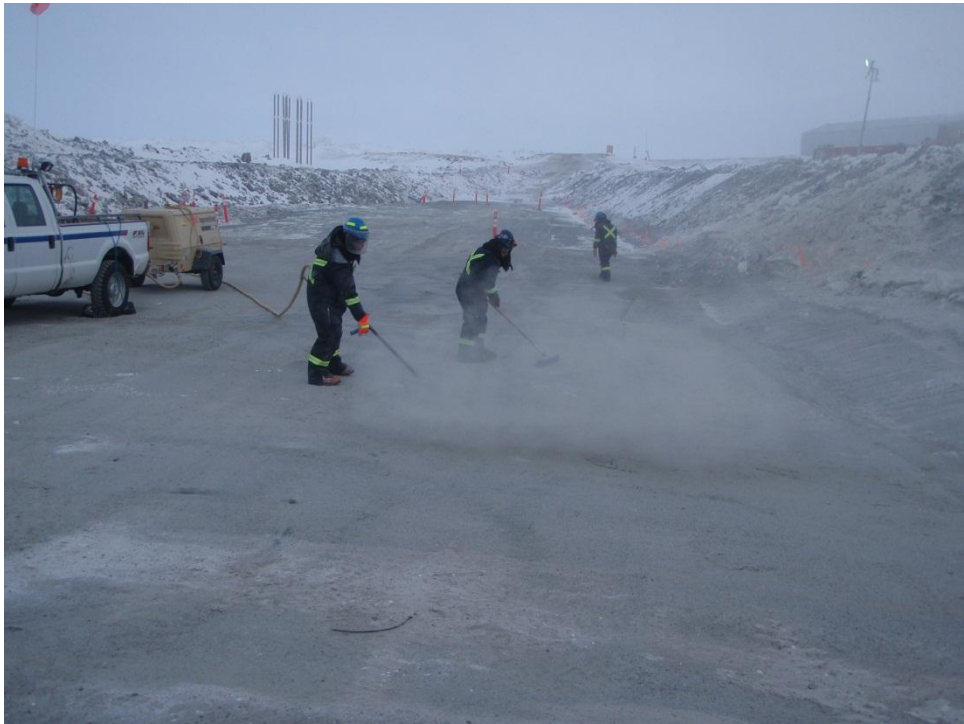
**Photo 5:** Labourers clearing debris with brooms and the air compressor in the morning.

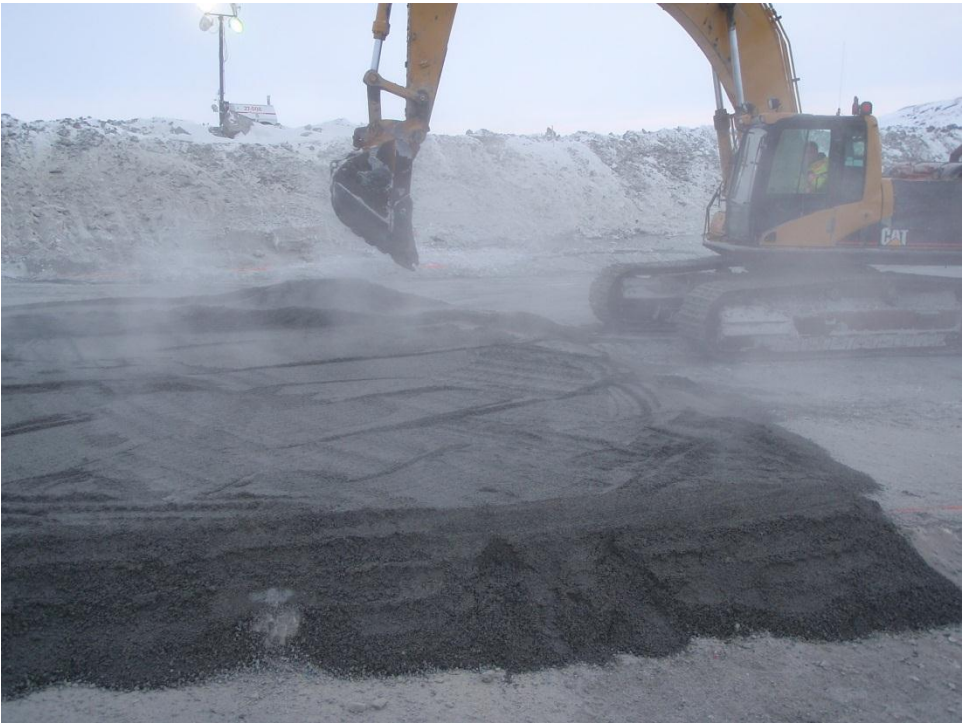
**Photo 6:** The first few lifts of FCM. Note the overbuild in the foreground to ensure design lines are met.

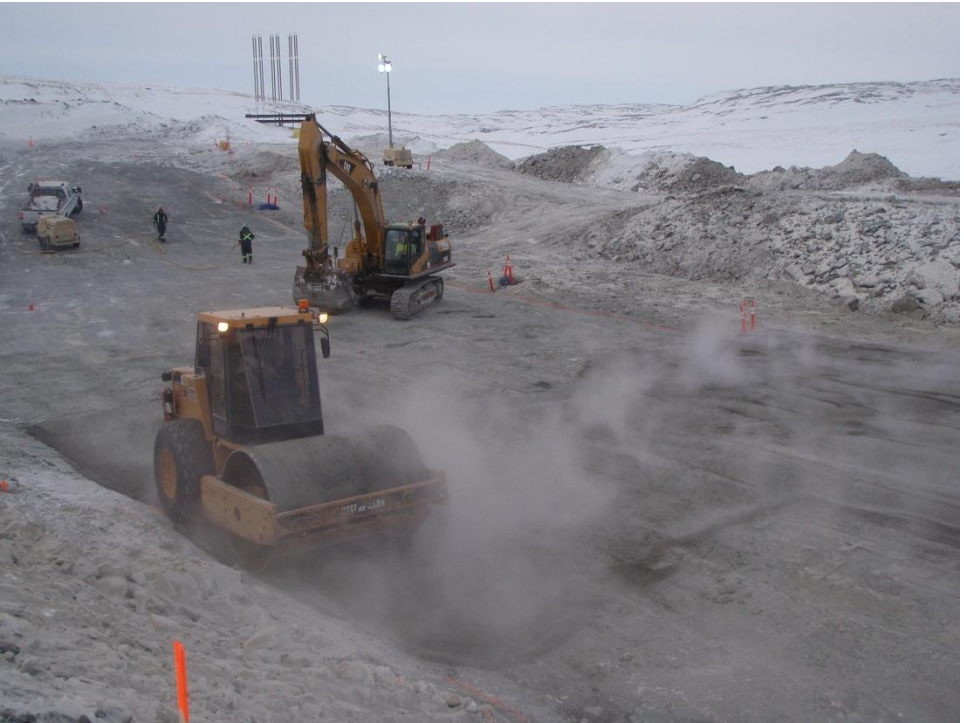
**Photo 7:** Vibratory packer passing four times with static rolling, two times with the vibrator on.

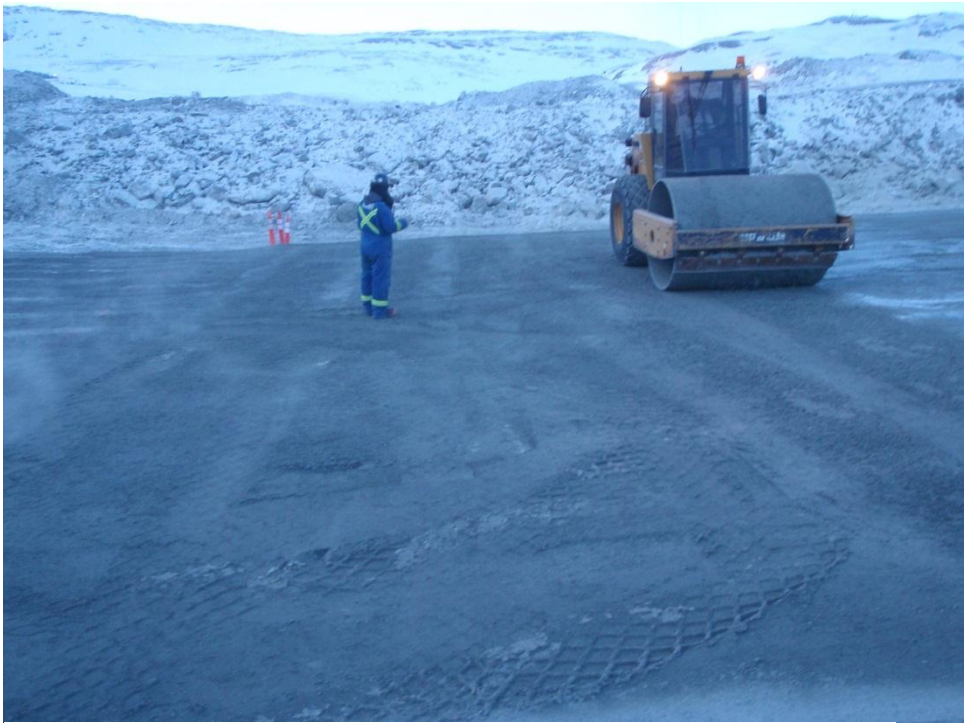
**Photo 5:** Area where saturation was low after initial compaction. Vibratory packer completed several extra passes to bring this area to passing specifications.

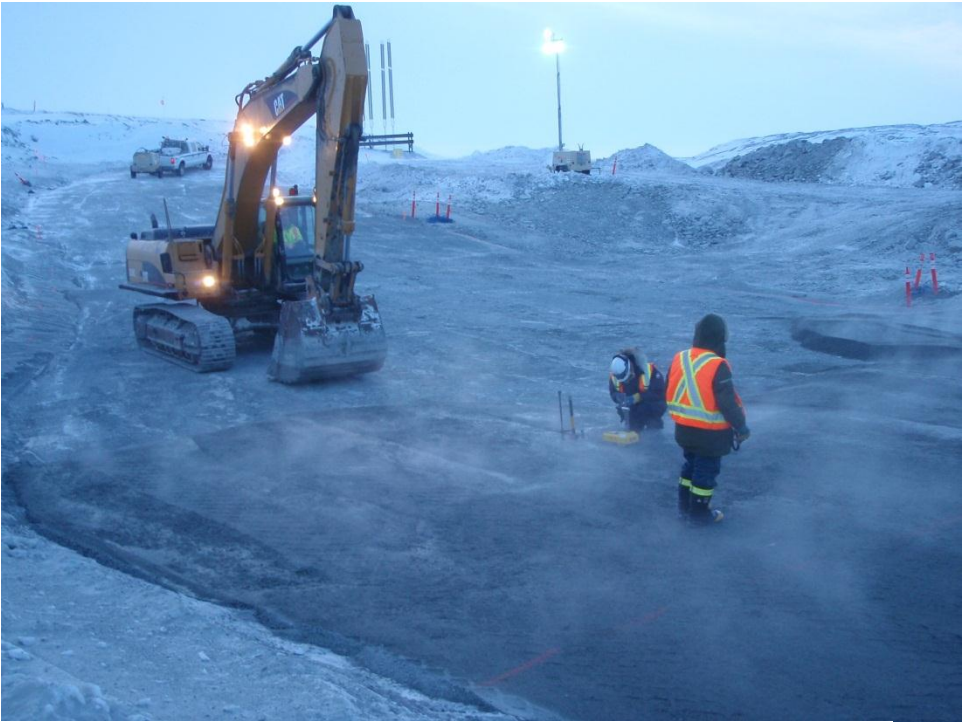
**Photo 5:** Midday placement of FCM. Nuclear density testing continued throughout placement.

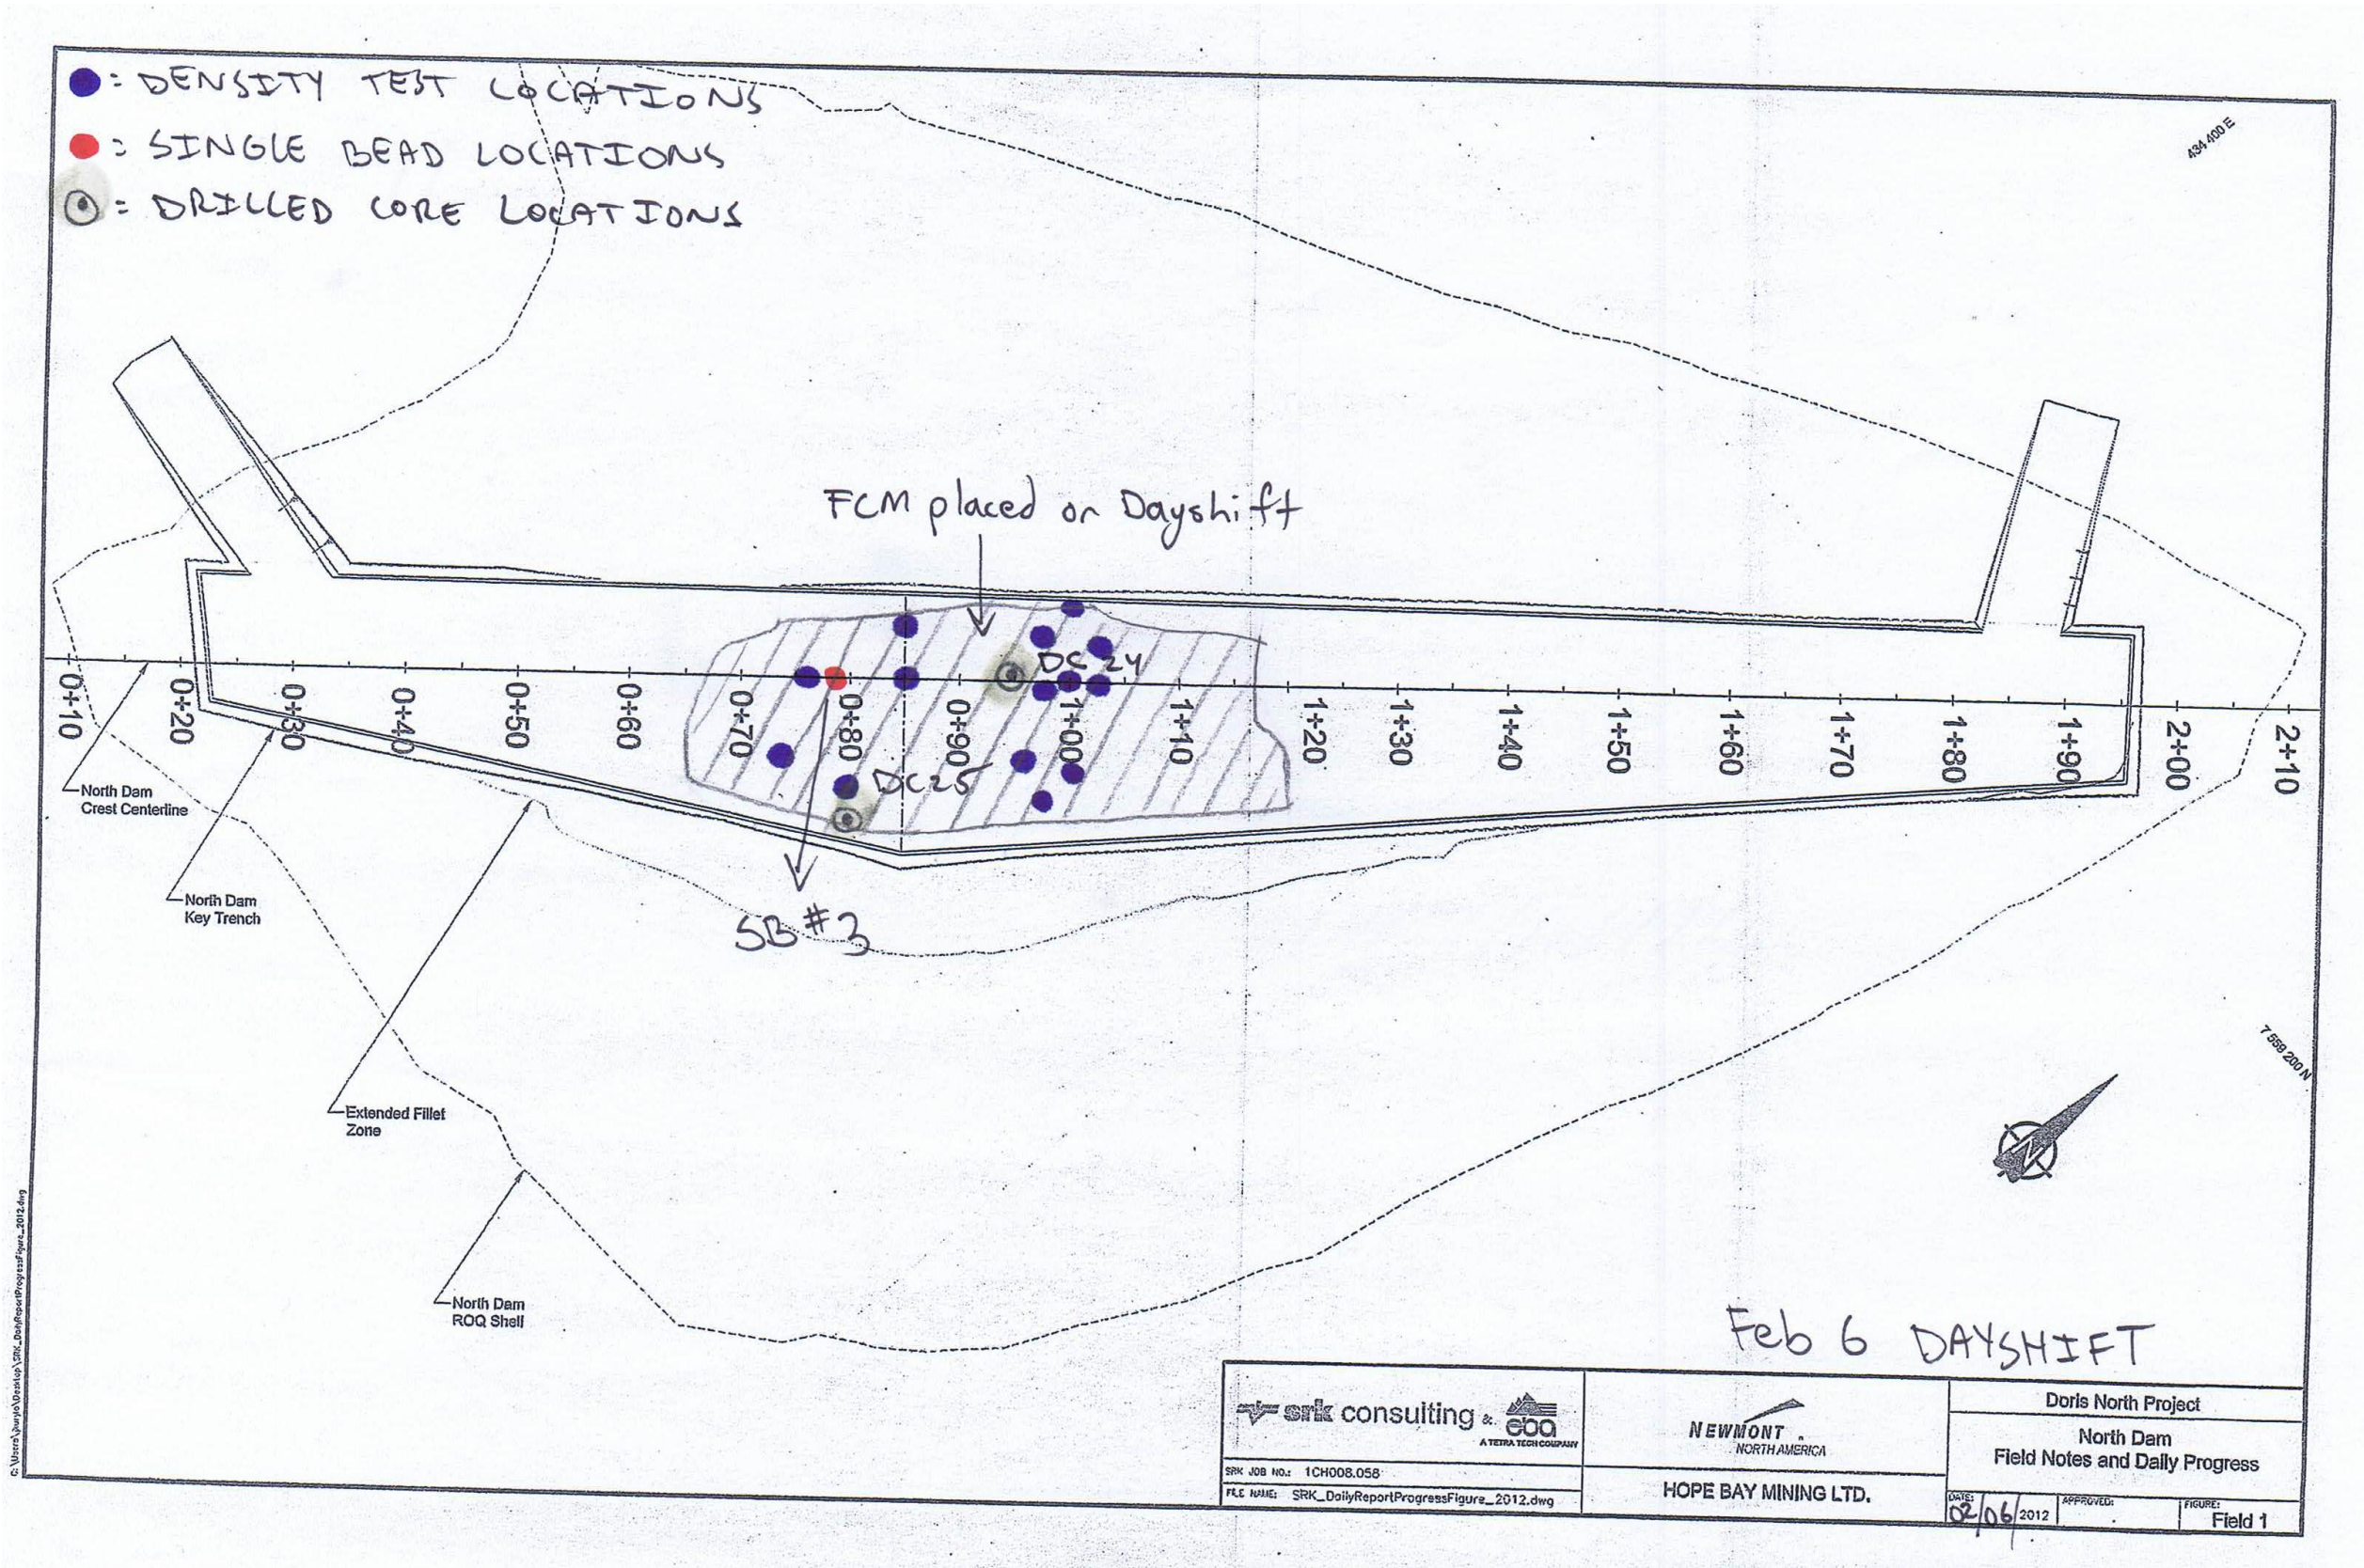
**FIGURES:**  
Figure 1 – North Dam Progress – February 6<sup>th</sup> DAYSHIFT

- FCM was placed from chainage 1+20 to 0+75.
- Some material was slightly dry, but saturation was reached due to extra vibratory packing.
- Minor bleeding of water was noted across most other areas; good compaction was indicated on all material placed on dayshift.

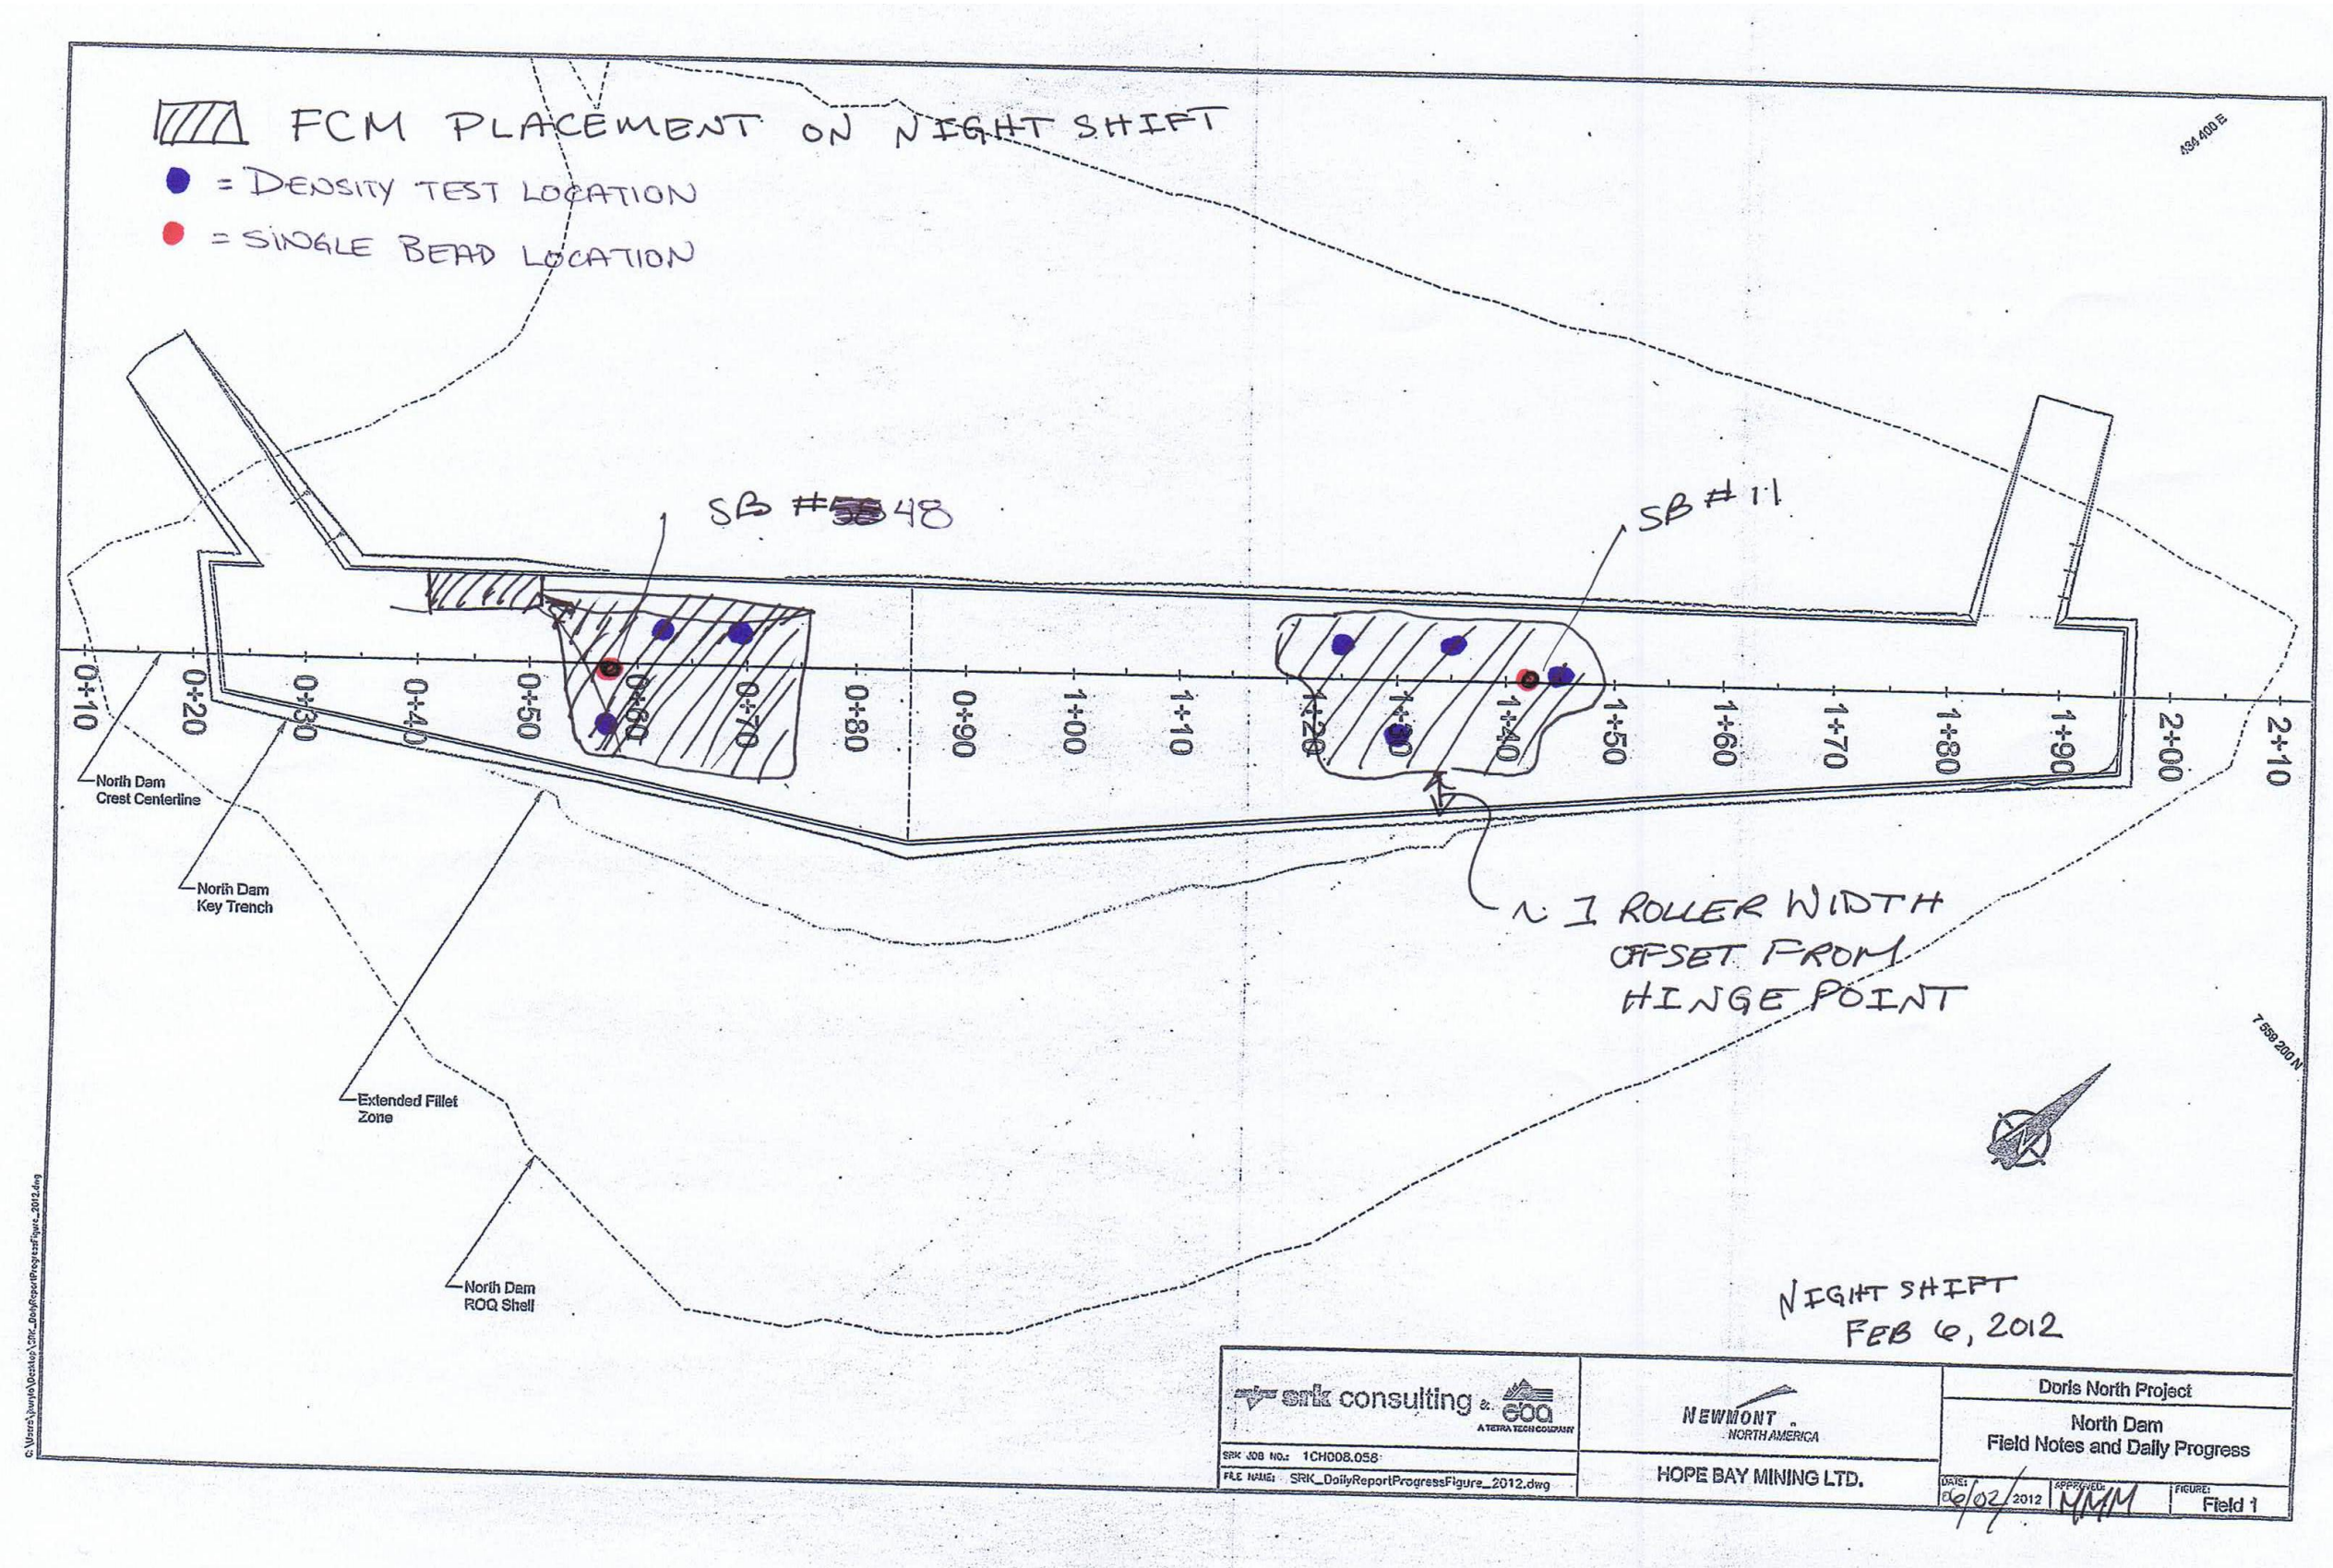
Figure 2 – North Dam Progress – February 6<sup>th</sup> NIGHTSHIFT

- FCM material was placed along the width of the key trench from ~ 0+80 to 0+55, and in the low spot on the downstream side from ~0+55 to 0+40.
  - The first approximately 3 loads of the FCM material were very wet and squishy to the step. Several additional passes with the vibratory compactor were used to compact these loads. Though some areas met the compaction specification of 90% there were other areas where even after additional compaction a maximum compaction of 87 to 89% was measured. As the saturation for this area was high (mid to high 90's). A one-time variance was given and the material was left in place even though it did not meet the compaction specification.

- The temperature of the first load of material in the ground after compaction was 19°C.
  - At station 0+60 the previous lift of core material was within ~10 cm of the elevation of the next horizontal thermistor. This cable was going to be installed; however the first bead of the material was located on/near the cover on the hinge point. Discussions were had with the Nuna foreman and it was decided that installing the thermistor and leaving a bead uncover would make the GCL excavation difficult. It was decided that a trench would be left in the FCM to the level of the thermistor string and the thermistor string installed once the hinge point was uncovered.
