## DAILY REPORT #34 – DORIS NORTH INFRASTRUCTURE/ NORTH DAM

Prepared by:	Murray McGregor Megan Miller	Date:	2012.02.08
Reviewed by:		Project #:	1CH008.058.0320
Role	Company	Personnel – Position	On Site
Client	Hope Bay Mining Limited (HBML)	Angela Holzapfel – ESR Compliance Manager David Vokey – ESR Coordinator Don Ethelston – HSLP Advisor Dean Wold - Safety Jill Turk – ESR Coordinator Katsky Venter – ESR Manger Michelle Tanquay – ESR Site Manager Stirling Kelly – HSLP Advisor	No No No No Yes Yes No Yes
	JDS	Lloyd Jackson – Mechanical Superintendent Doug Fielding – Construction Manager Ishan Fechter – Construction Coordinator Jerry Graham – Construction Manager Kevin Whieldon – Project Coordinator Mark Valeriote – Construction Manager	Yes No No Yes Yes Yes
Engineering Design Consultants	SRK Consulting (Canada) Inc.	John Kurylo – Site Engineer Megan Miller – Site Engineer Lawrence Borowski – Site Engineer Murray McGregor – Site Engineer Iozsef Miskolczi – Site Engineer	No Yes No Yes No

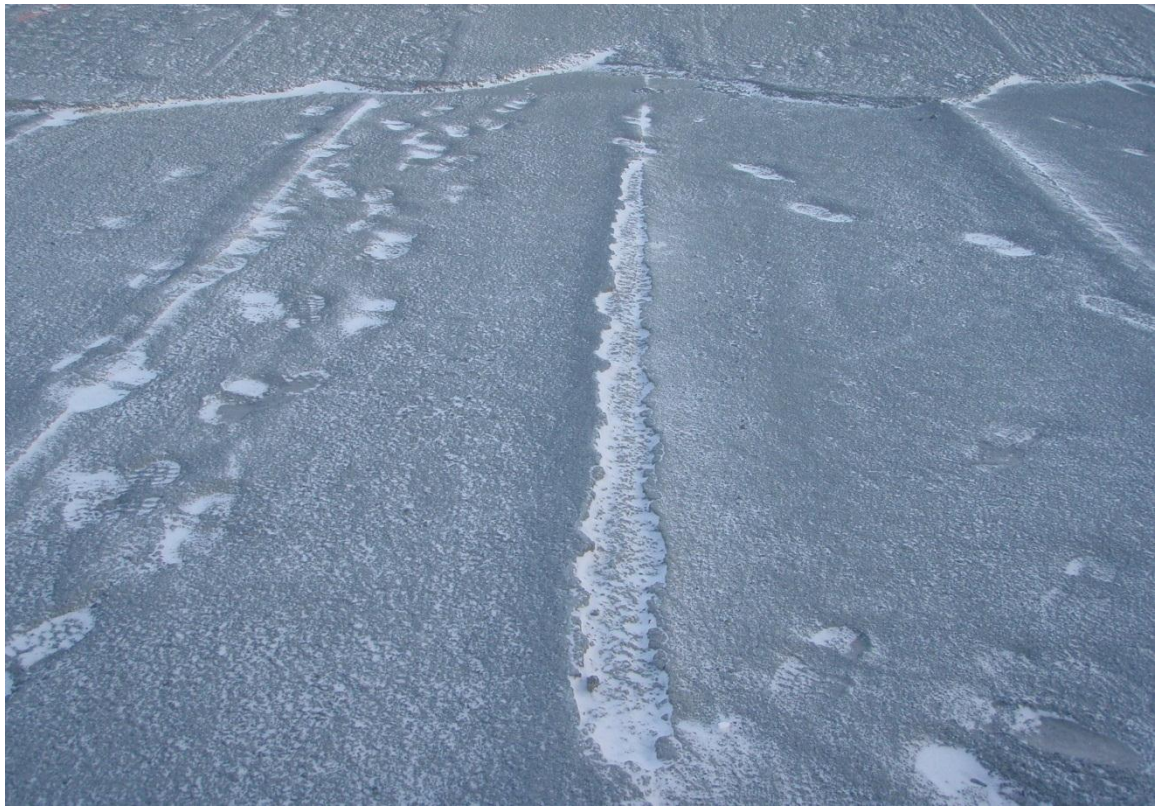
- SRK and EBA worked quickly in order to complete three cores on the previous lift before placement began.
- Skid steer with broom attachment swept core in preparation for placement.
- Some chipping at cracked material was necessary to eliminate air voids.
- SRK approved a surface for placement from 1+20 to 0+80 for immediate placement and 0+80 to 0+55 if cleaning is continued ahead of placement; all approval conditional that continual cleaning to be

**Photo 6:** Some hand chipping was completed to eliminate air voids in the previously placed lift.

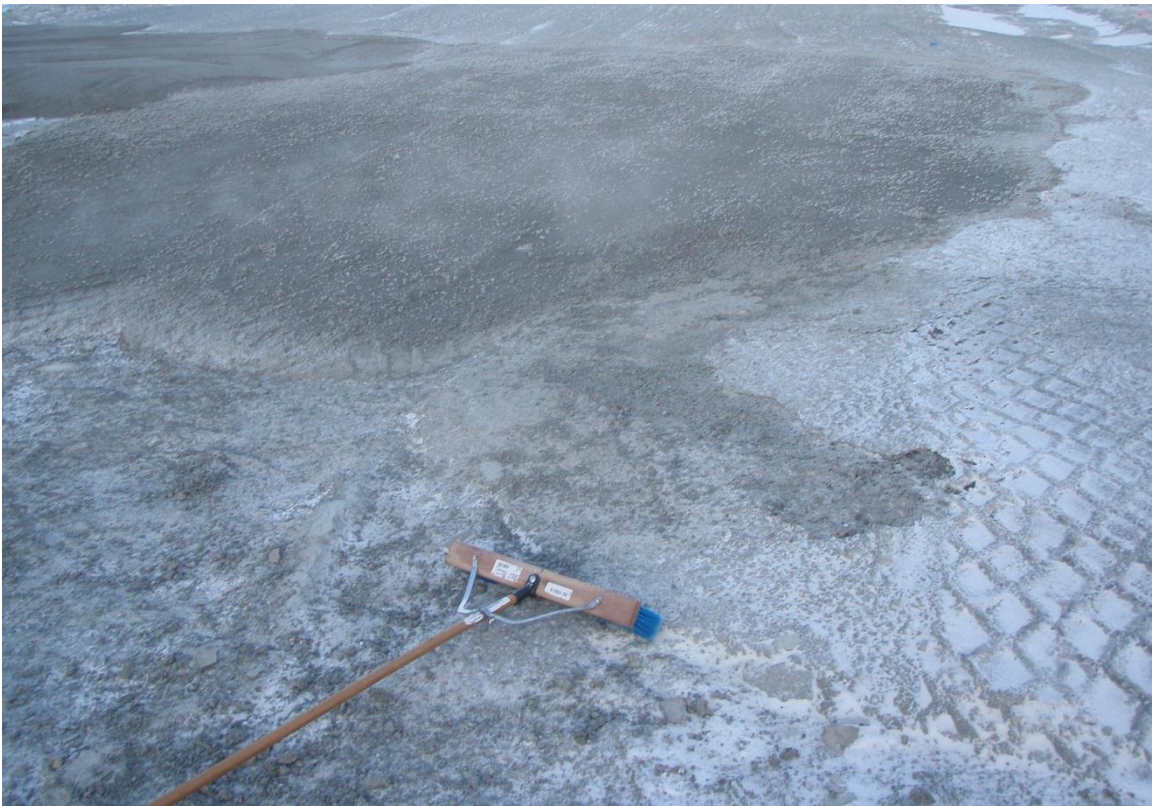
- There were a few breaks in material placement due to the issues at the plant.
    - The material in the ground was freezing quickly. In a few places the packer ran onto the placed material in front of the fresh load and cracked the crust of the partially frozen material.

**Photo 7:** Clean up completed after the packer drove over partially frozen ground. All loose pieces were pull out and the surface was swept before the next tie-in.

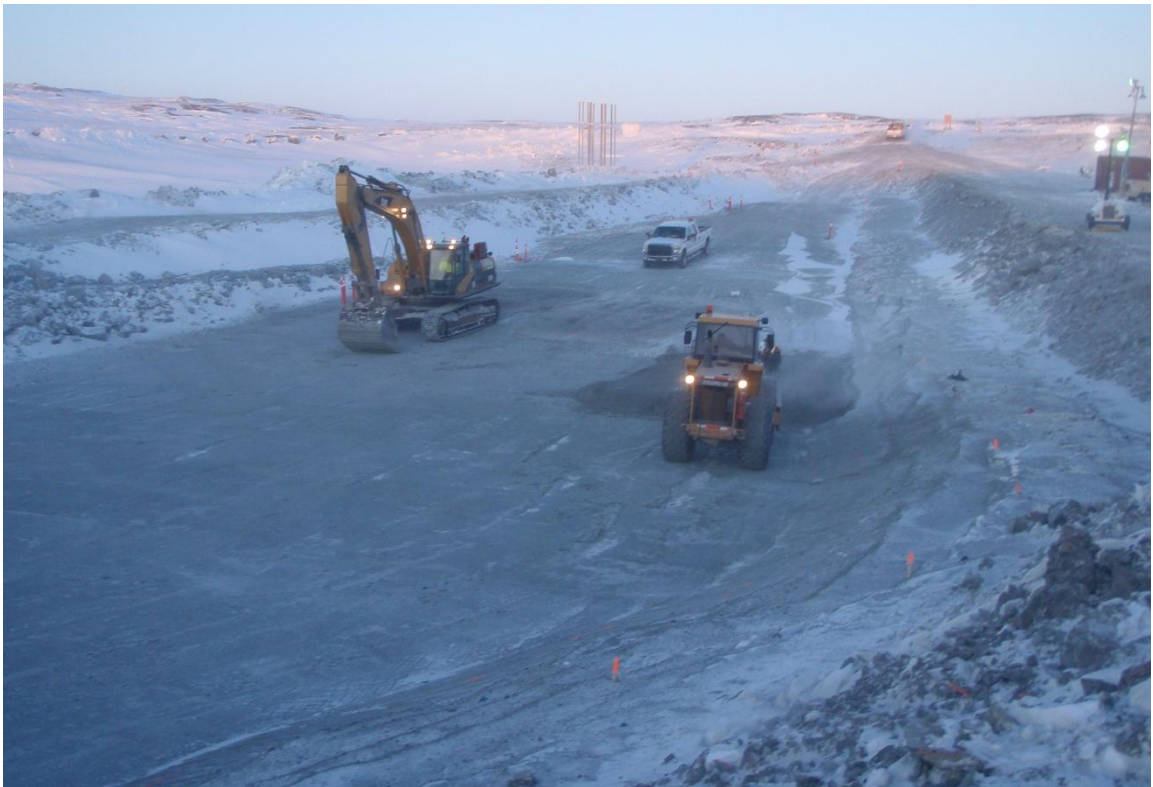
**Photo 9:** Pickup truck parked immediately before starting placement. Visible freeze back of surface crust was noted within a couple hours of placement.

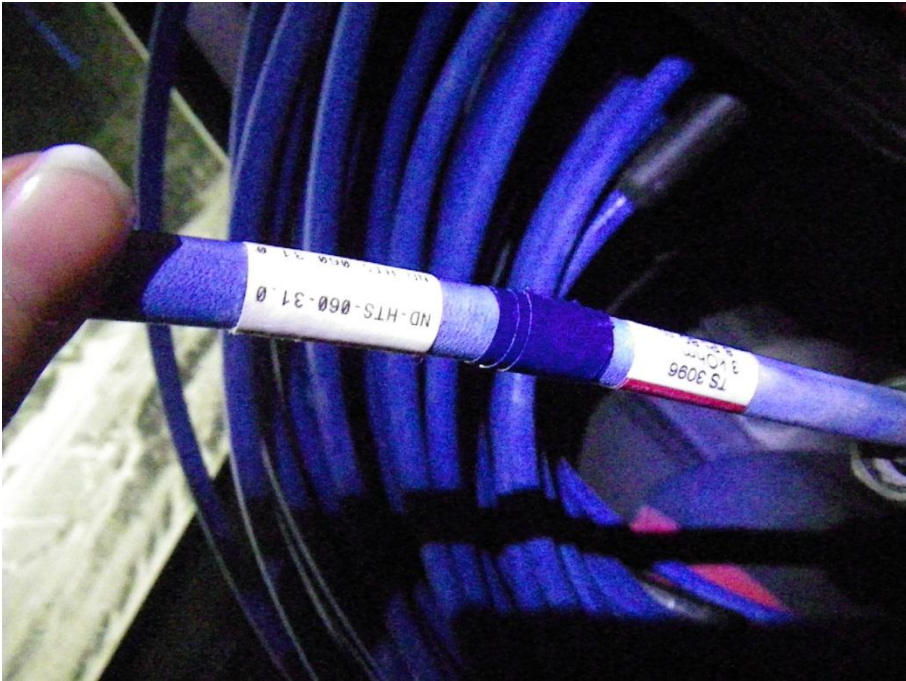
- Dark blue electrical tape was put around the thermistor as a secondary identifier. The dark blue tape indicates 'Middle Core' thermistor strings.

**Photo 12:** Identifiers for thermistor cable ND-HTS-060-31.1. Serial number TS 3096.

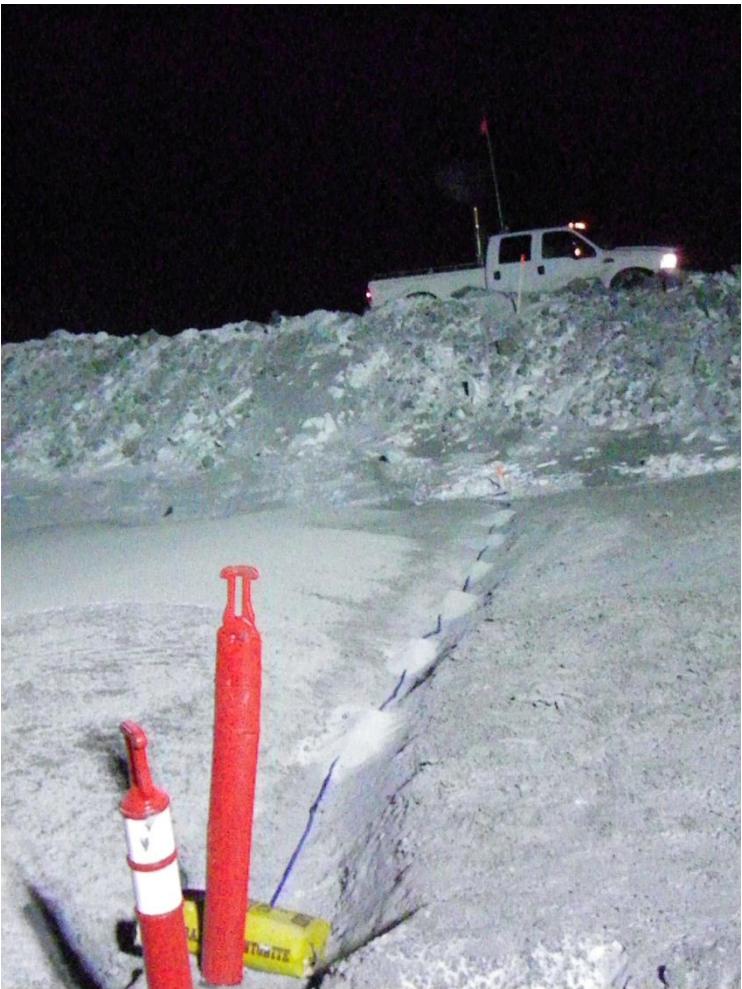
- The last two beads of this string were not covered by FCM, as the end of the string was located too close to the hinge point which is not yet been cleared of 5/8" material. A delineator was placed to mark the exposed end and survey was to flag off the area with stakes and survey tape.

- An initial reading was taken and recorded when the string was in place and the bentonite water stops were in place but before FCM was placed on top.

**Photo 13:** Thermistor cable ND-HTS-060-31.1 laid out with water stops in place ready to be covered with FCM.

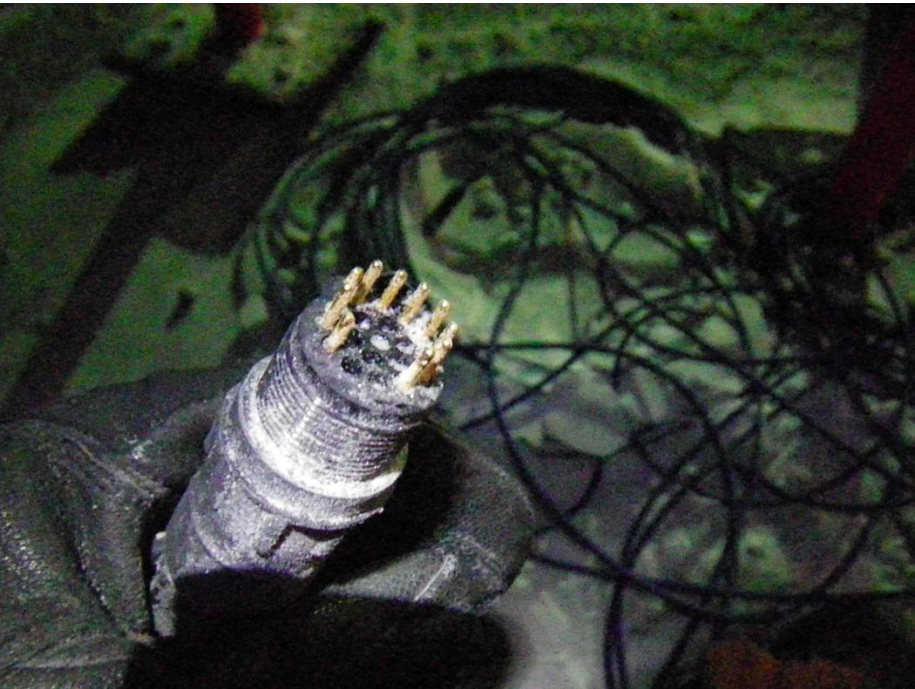
- Multi-bead thermistor readings were taken for most thermistors located within the key trench.
  - The plastic on the connector for ND-HTS-175-32.2 which protects the pins and aligns the pins in the readout box has been broken all the way around the connector. See photo below. It appears as though the pins are fine; however this was not checked with the readout box. It is likely that a new connector will be required.
  - One bead of ND-HTS-060-28.8 is not working.
  - All other read thermistors are in working order.

**Photo 14:** The plastic surrounding the pins on the connector of ND-HTS-175-32.5.
