DAILY REPORT #35 – DORIS NORTH INFRASTRUCTURE/ NORTH DAM

Prepared by:	Murray McGregor Megan Miller	Date:	2012.02.09
Reviewed by:		Project #:	1CH008.058.0320
Role	Company	Personnel – Position	On Site
Client	Hope Bay Mining Limited (HBML)	Angela Holzapfel – ESR Compliance Manager David Vokey – ESR Coordinator Don Ethelston – HSLP Advisor Dean Wold - Safety Jill Turk – ESR Coordinator Katsky Venter – ESR Manger Michelle Tanquay – ESR Site Manager Stirling Kelly – HSLP Advisor	No No No No Yes Yes No Yes
	JDS	Lloyd Jackson – Mechanical Superintendent Doug Fielding – Construction Manager Ishan Fechter – Construction Coordinator Jerry Graham – Construction Manager Kevin Whieldon – Project Coordinator Mark Valeriote – Construction Manager	Yes No In Yes Yes Yes
Engineering Design Consultants	SRK Consulting (Canada) Inc.	John Kurylo – Site Engineer Megan Miller – Site Engineer Lawrence Borowski – Site Engineer Murray McGregor – Site Engineer Iozsef Miskolczi – Site Engineer	No Yes No Yes No

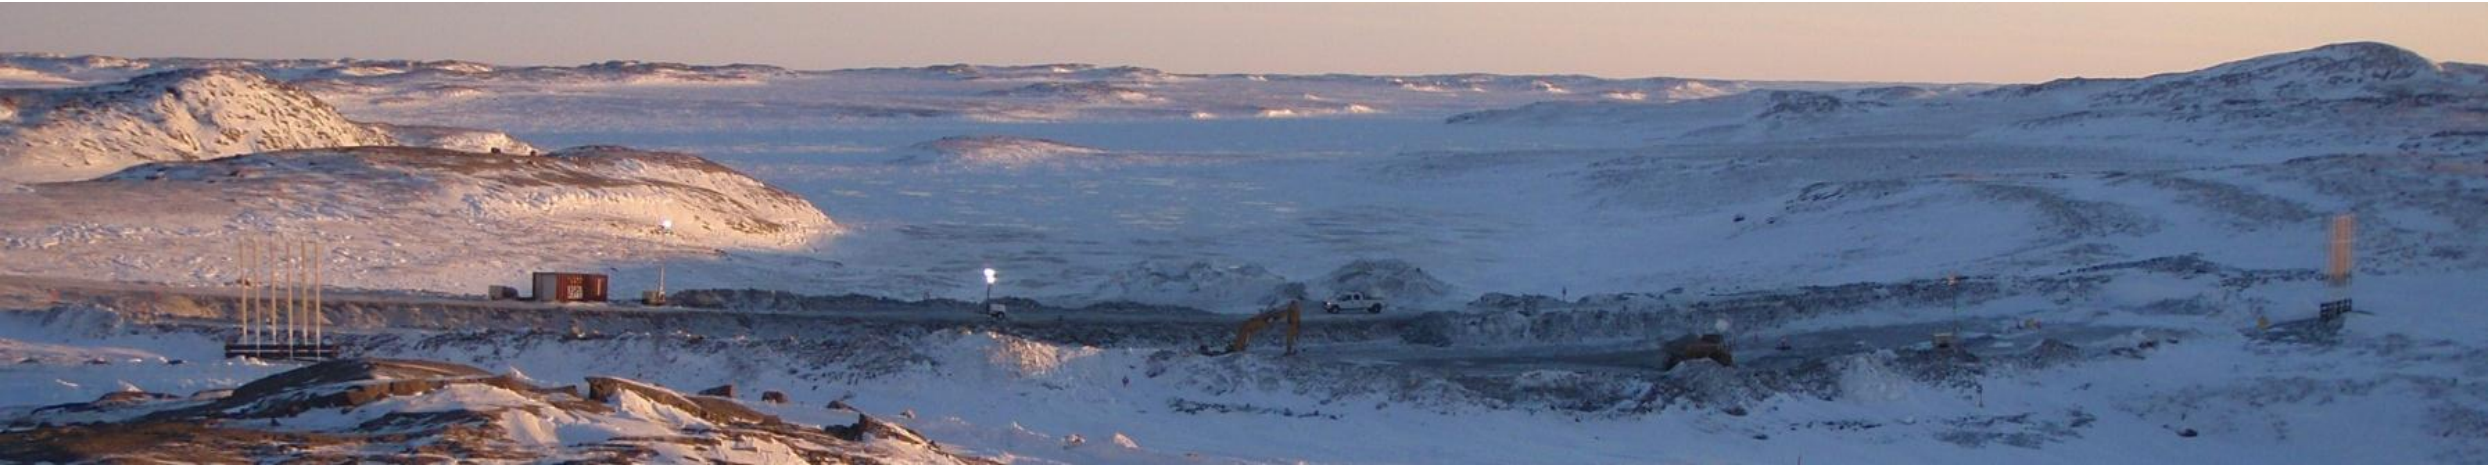
Photo 1: Progress photo of North Dam from photo point 1. ~SSE view.

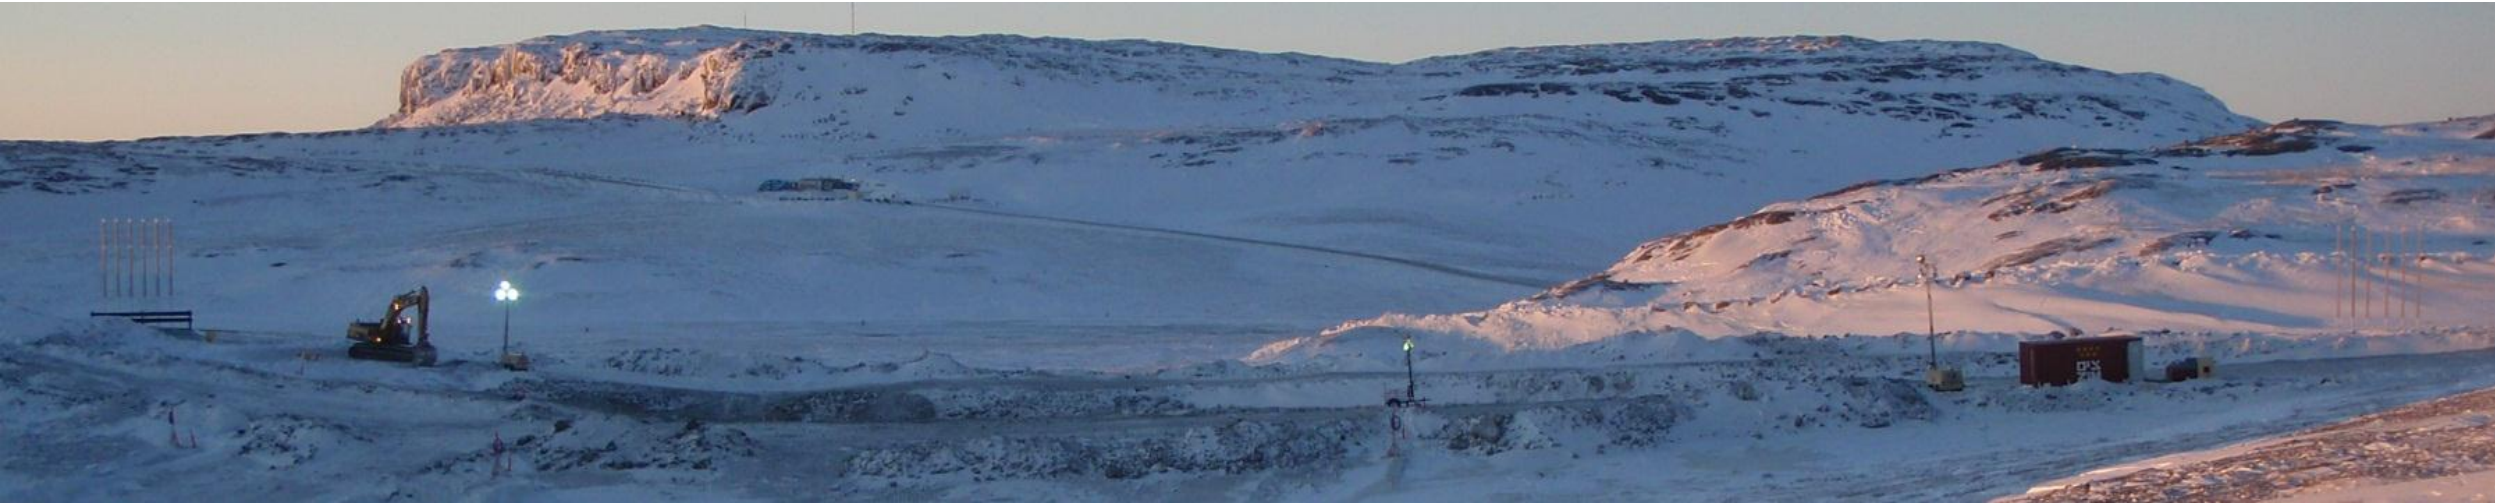
Photo 2: Progress photo of North Dam from photo point 2. ~NW view.

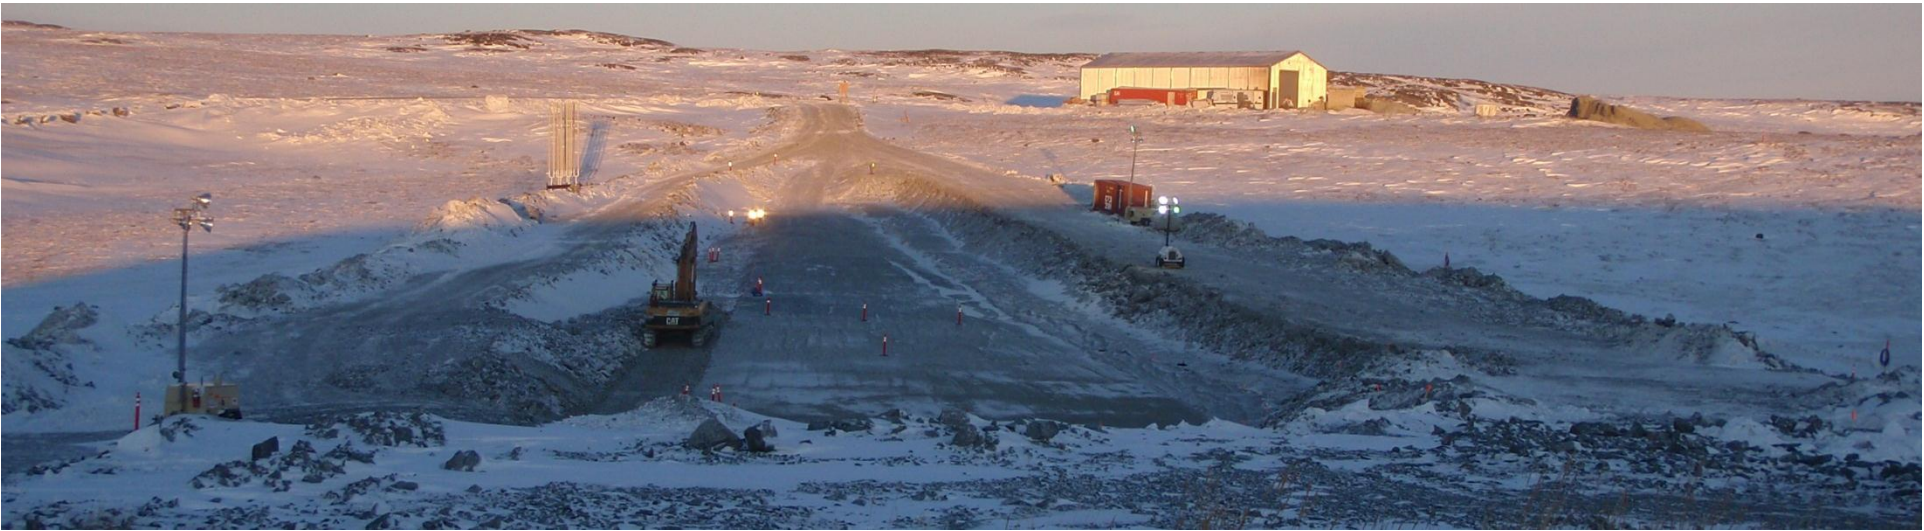
Photo 3: Progress photo of North Dam from photo point 3. ~NE view.

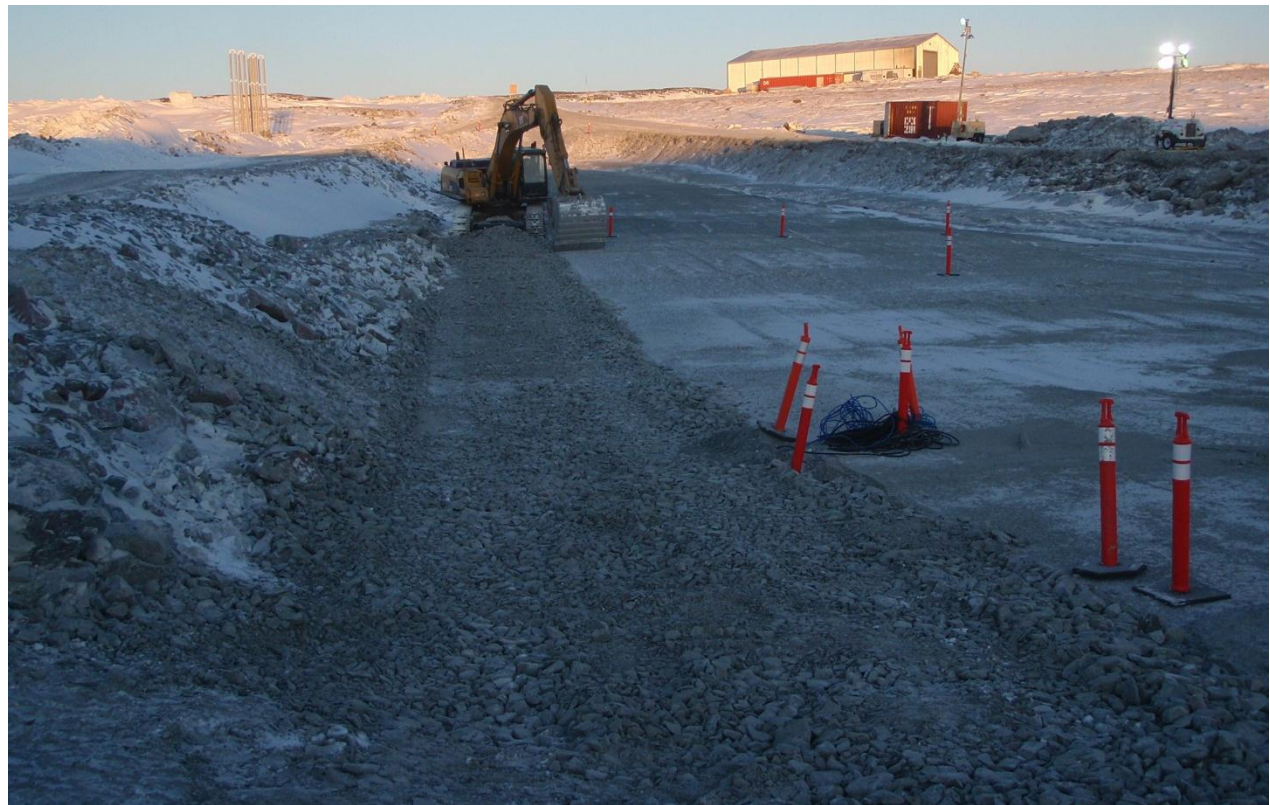
- Cat 330 Excavator peeled back 5/8 clear to within a height of 100 mm of the HDPE on the north end of the upstream portion of the dam.
- Transition material was added along the downstream side of the dam from chainage 0+60 to 1+40; no compaction was observed for this placement.

Photo 6: Transition material placed along the downstream side of the dam. Thermistor cables in foreground buried in a blanket of crush.

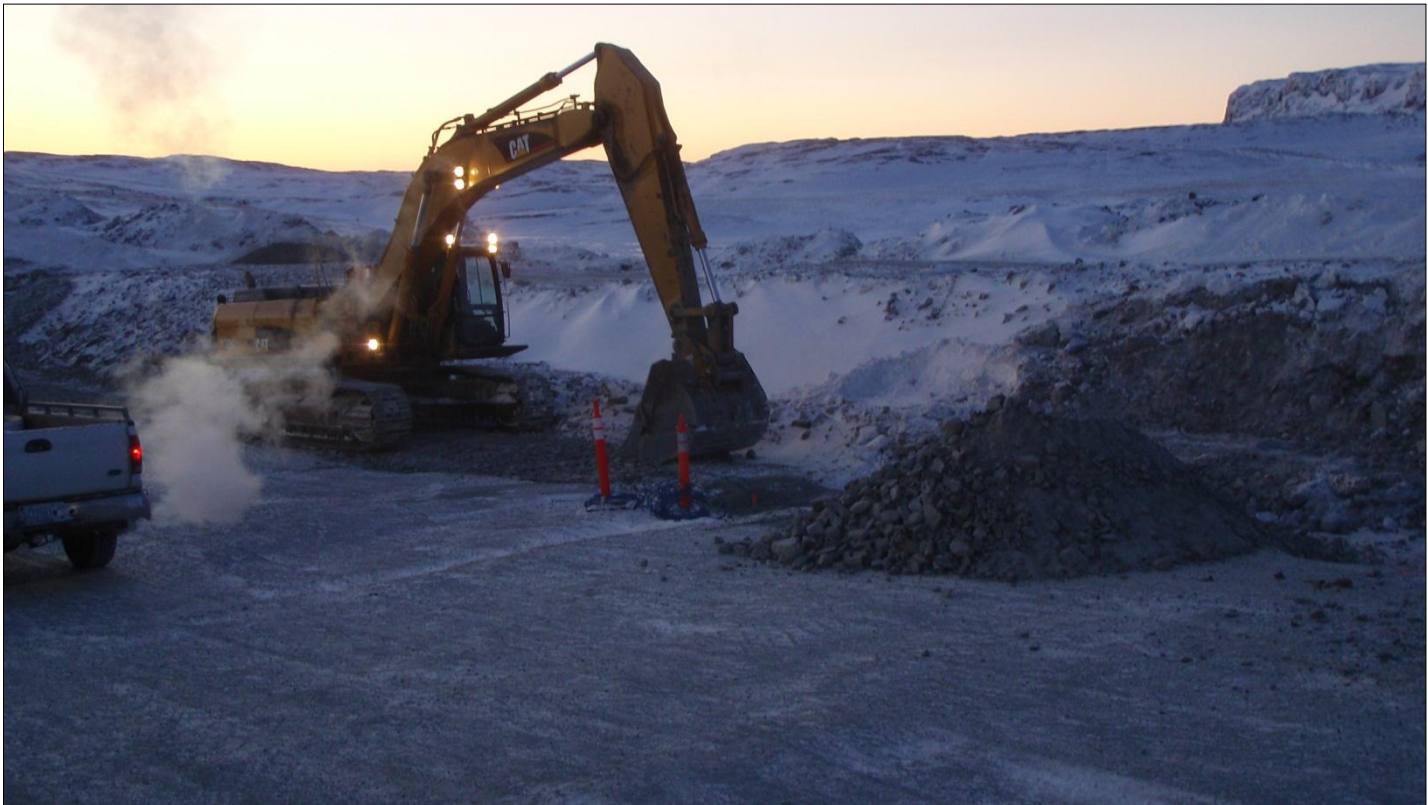
Photo 7: Cat 330 excavator tamping $\frac{3}{4}$ crush on top of thermistor cables at chainage 1+30.

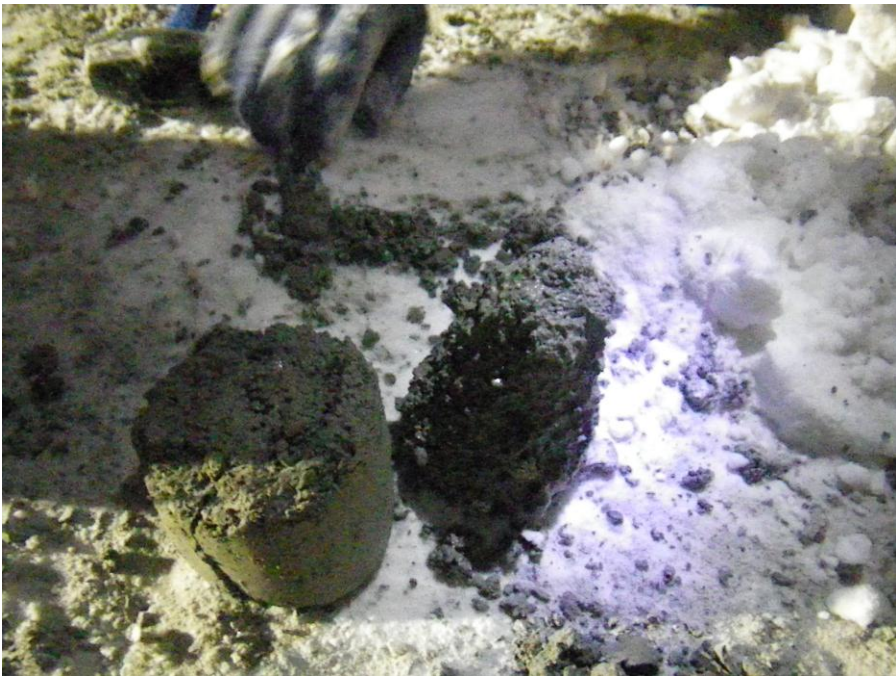
- The previously placed core material from approximately station 0+55 to 1+20 was cleaned in anticipation of core placement on dayshift.
 - The CAT 330 excavator scraped up loose material and broken crust from the surface that resulted from the packer running onto core material once a crust had formed.
 - Labourers used the air compressor to 'dental clean' the surface. The skid steer with broom attachment was not available as it was down with mechanical issues.
- A drilled core sample was collected from the lift placed 2012/02/08 near 1+00 centerline.
 - Four attempts were made at coring before a useable core could be obtained (see photos below). It is thought that the unsuitable cores were the result of insufficient glycol flow and/or operator

error. At least one of the cores was noted to be slightly steaming. The material in this area was at ~-14°C when the core was taken.

Photo 8: First attempt at core sampling. The core crumbled as it was removed from the drill bit.

- An additional core will be taken on dayshift to check.
- The shop-vac used to clean up after coring is no longer functioning. Spill pads and snow were used to clean up after coring. All dirty snow was scraped up and put in a bucket to be disposed of later.

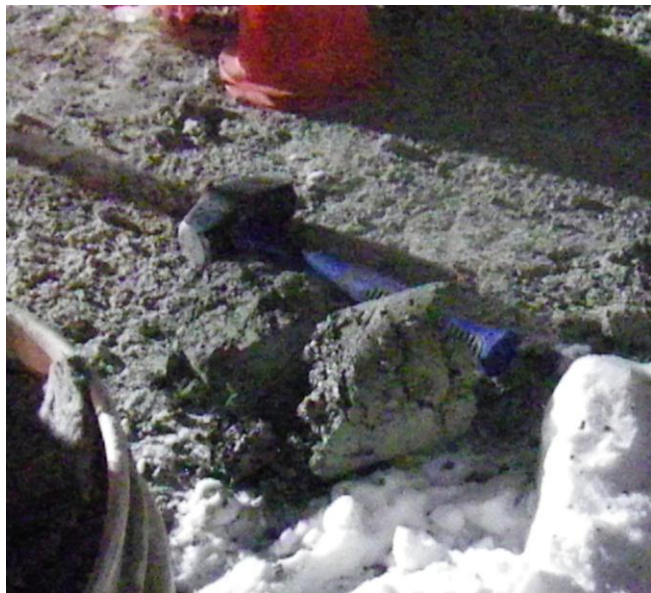
Photo 9: Second attempt at coring, insufficient glycol was used when coring this core.
