## DAILY REPORT #36 – DORIS NORTH INFRASTRUCTURE/ NORTH DAM

Prepared by:	Murray McGregor Megan Miller	Date:	2012.02.10
Reviewed by:		Project #:	1CH008.058.0320
Role	Company	Personnel – Position	On Site
Client	Hope Bay Mining Limited (HBML)	Angela Holzapfel – ESR Compliance Manager David Vokey – ESR Coordinator Don Ethelston – HSLP Advisor Dean Wold - Safety Jill Turk – ESR Coordinator Katsky Venter – ESR Manger Michelle Tanquay – ESR Site Manager Stirling Kelly – HSLP Advisor	No No No No Yes Yes No Yes
	JDS	Lloyd Jackson – Mechanical Superintendent Doug Fielding – Construction Manager Ishan Fechter – Construction Coordinator Jerry Graham – Construction Manager Kevin Whieldon – Project Coordinator Mark Valeriote – Construction Manager	Yes No Yes Yes No Yes
Engineering Design Consultants	SRK Consulting (Canada) Inc.	John Kurylo – Site Engineer Megan Miller – Site Engineer Lawrence Borowski – Site Engineer Murray McGregor – Site Engineer Iozsef Miskolczi – Site Engineer	No Yes No Yes No

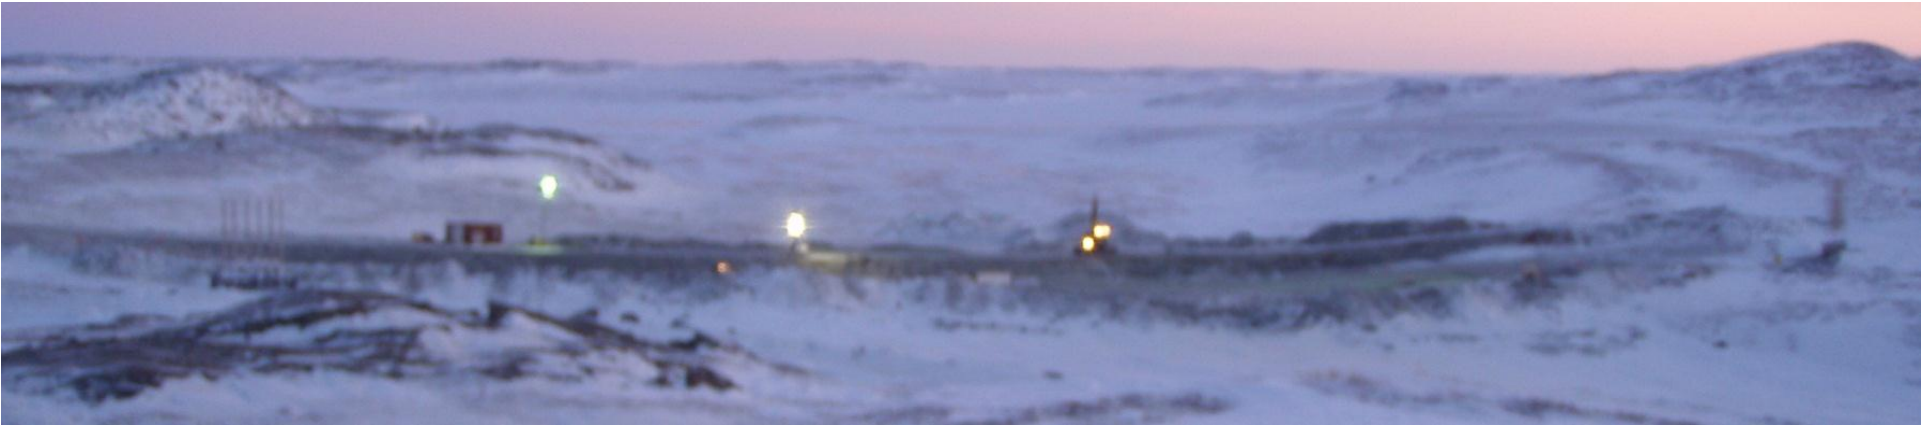
**Photo 1:** Progress photo of North Dam from photo point 1. ~SSE view.

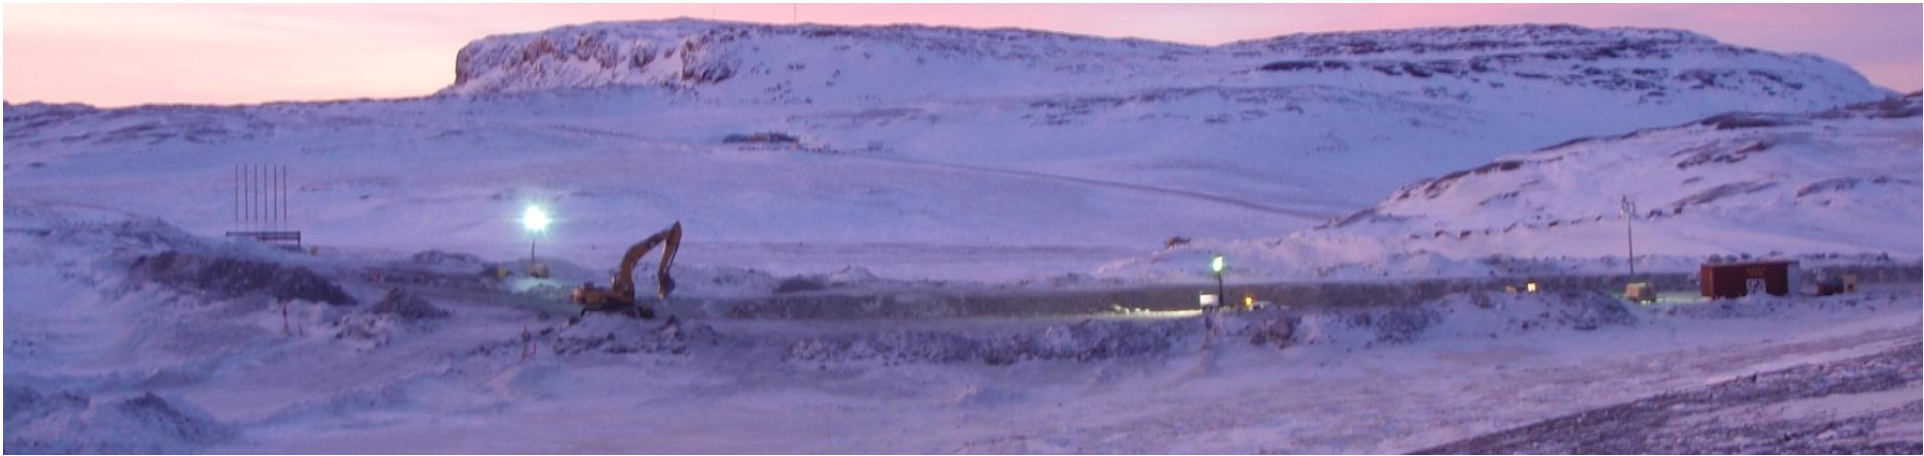
**Photo 2:** Progress photo of North Dam from photo point 2. ~NW view.

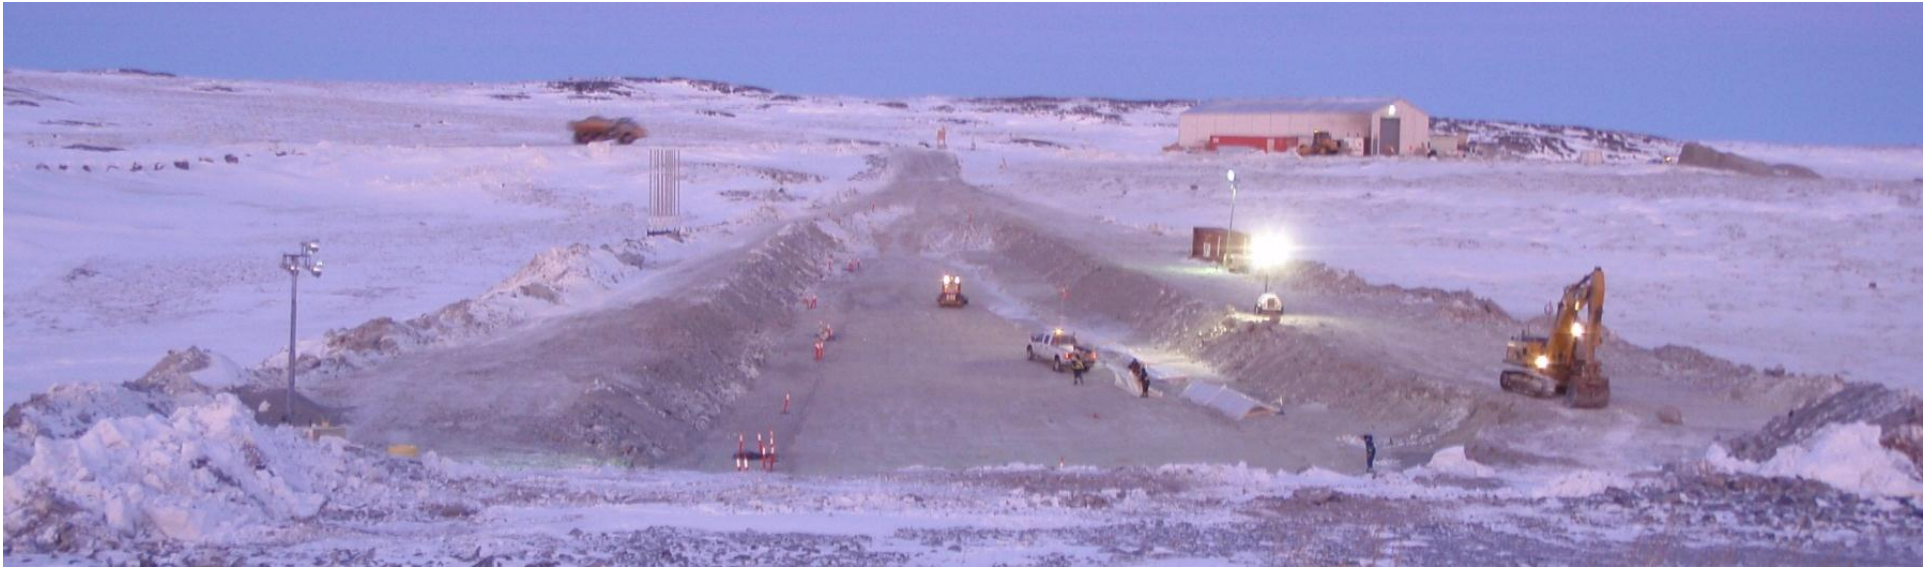
**Photo 3:** Progress photo of North Dam from photo point 3. ~NE view.

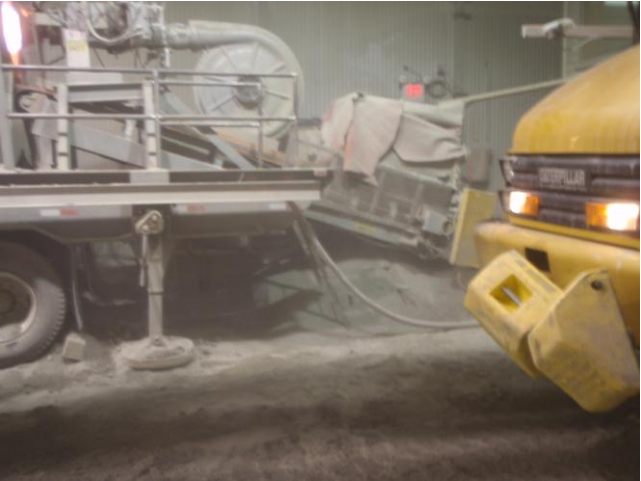
- Frozen core plant started at roughly 10:00AM; problem with water and feed caused material to flow down the belt and over the guards.
- Hopper was jammed around 10:30, which took labourers half an hour to clear.
- After starting back up, the moisture and feed were still inconsistent; the plant was shut down and underwent further repairs.
- At 11:15, the plant was up and running and material was coming through consistently.
- Just when material was within spec, a belt blew just below the tower and material started piling on the ground.
- FCP operator and crew spent the remainder of the day taking the belt out and replacing it.

**Photo 4:** Material escaping from the feed belt at the frozen core plant

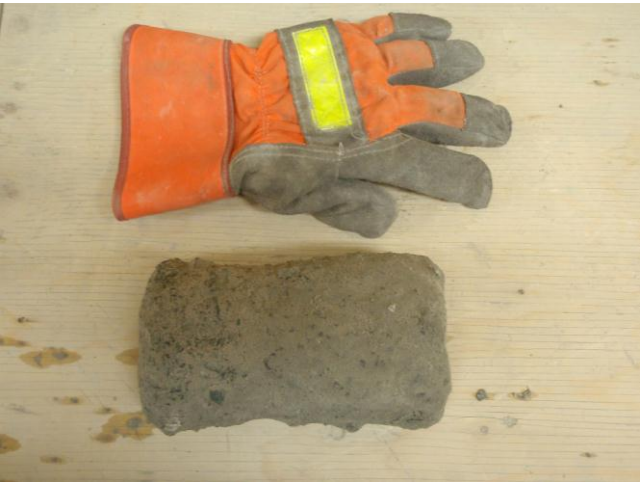
**Photo 5:** Drilled core HB12-ND-CORE-DC30-QA-201202010. Some drill chatter wore on the sides of the sample.

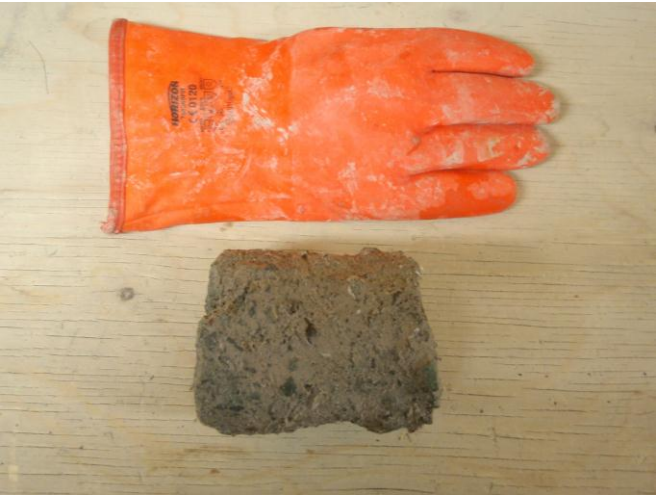
**Photo 6:** Drilled core HB12-ND-CORE-DC31-QA-201202010. Some gravel stuck in the annulus prompted a premature removal of this core.

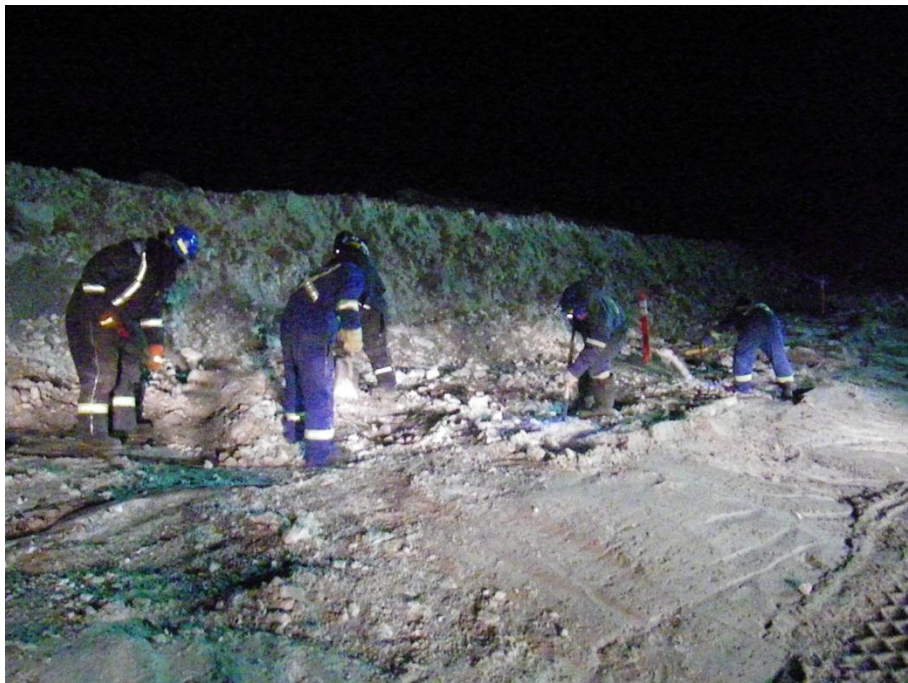
**Photo 7:** Labourers shoveling 5/8" core material from the HDPE liner on the upstream side.

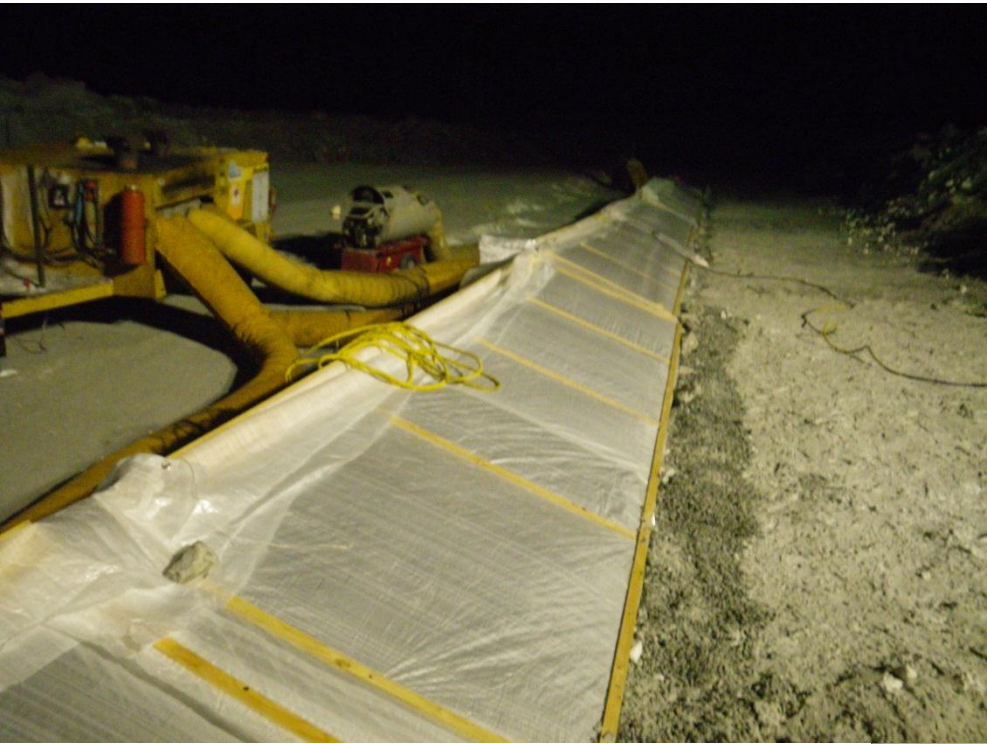
**Photo 8 (Left):** Looking at Herman Nelson heaters and hotbox heating liner hinge area. Photo looking north east along trench.

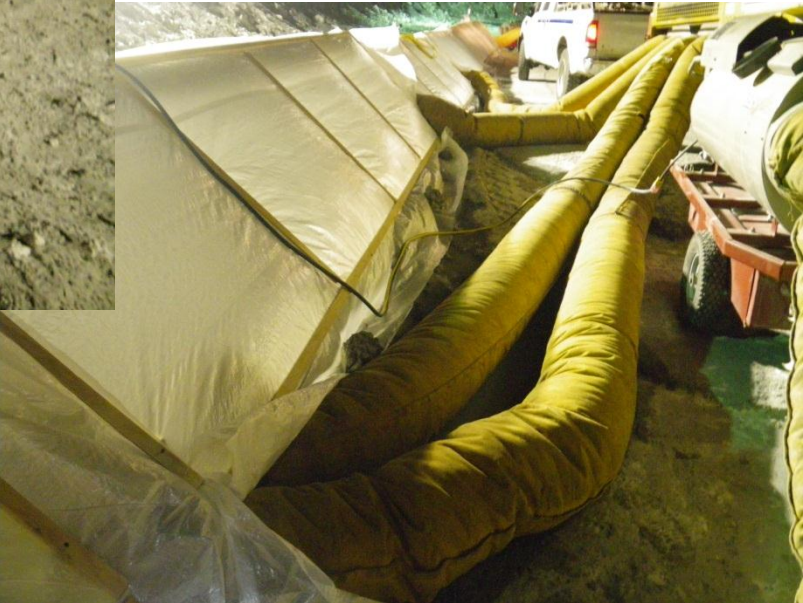
**Photo 9 (Below):** Some melting of the core material was observed where the trunks for the heaters rested on the ground. Rocks were used to bring the trunks off the ground.

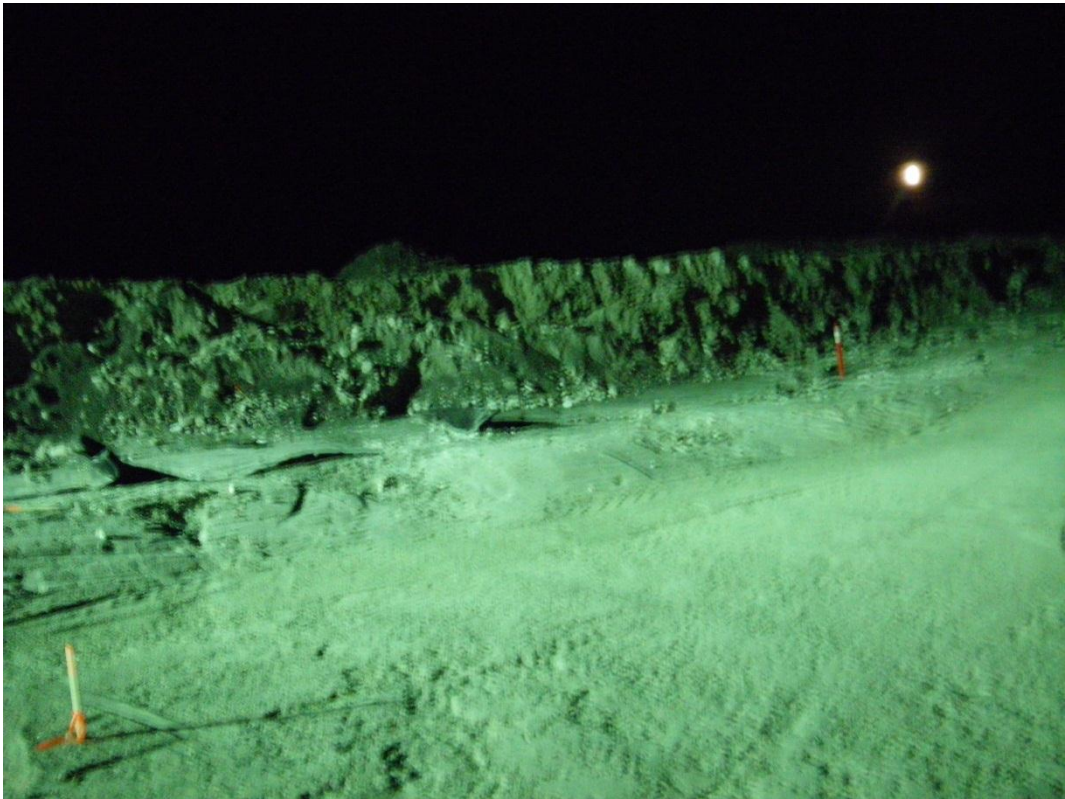
**Photo 10:** View of exposed HDPE liner which covers the GCL liner on the upstream side.

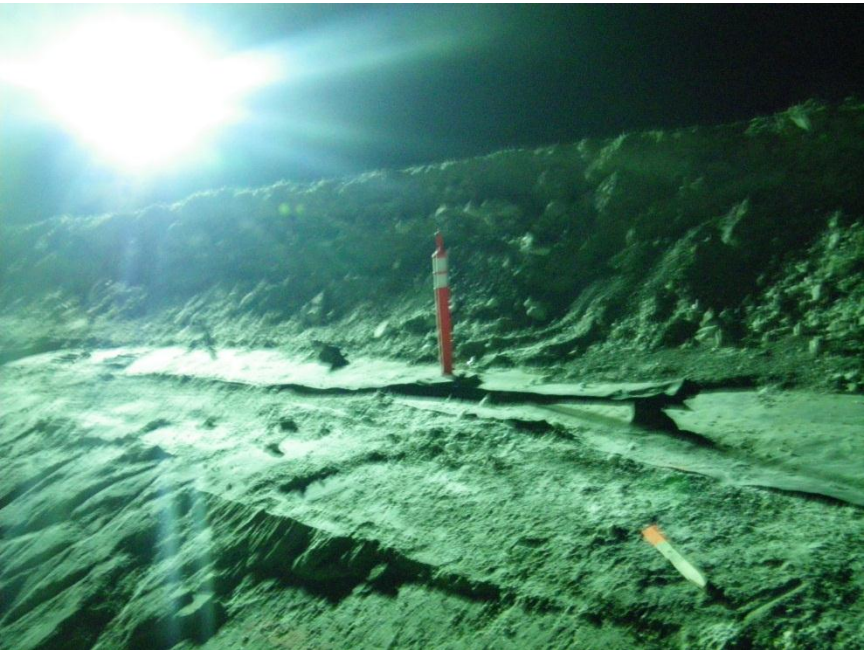
**Photo 11:** A closer look at the exposed HDPE.

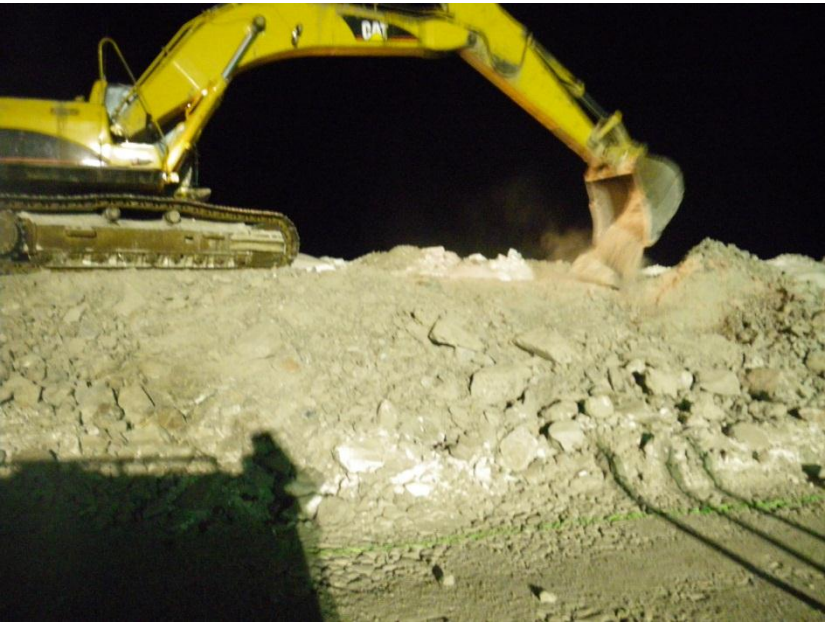
**Photo 12:** CAT 330 excavator placing ROQ material on downstream side of the dam.
