DAILY REPORT #38 – DORIS NORTH INFRASTRUCTURE/ NORTH DAM

| Prepared by: | Murray McGregor Megan Miller | Date: | 2012.02.12 |
| Reviewed by: | | Project #: | 1CH008.058.0320 |

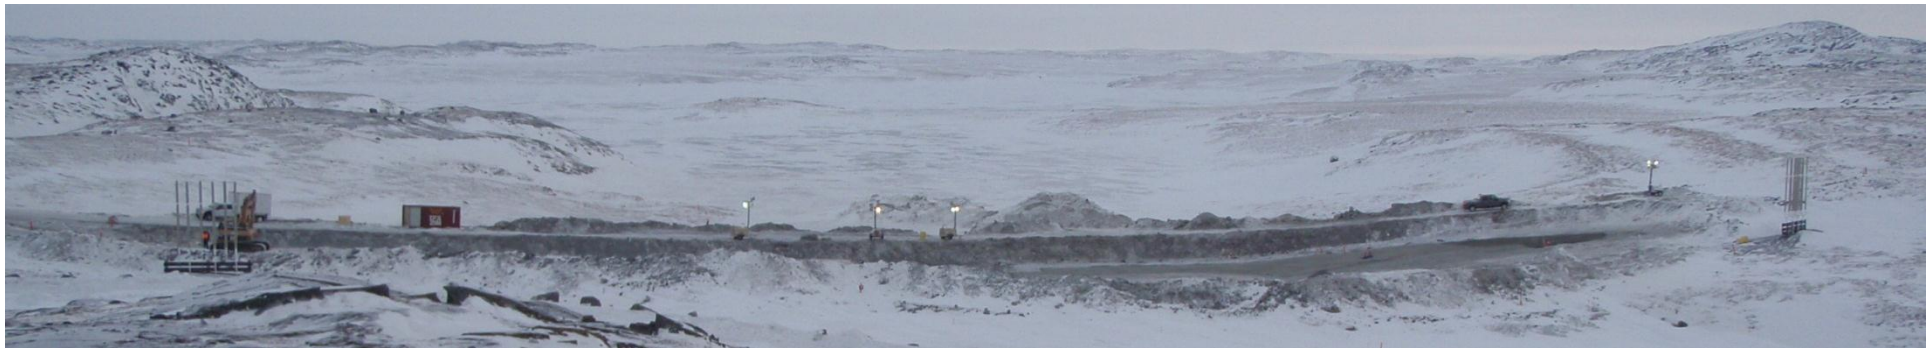
Photo 1: Progress photo of North Dam from photo point 1. ~SSE view.

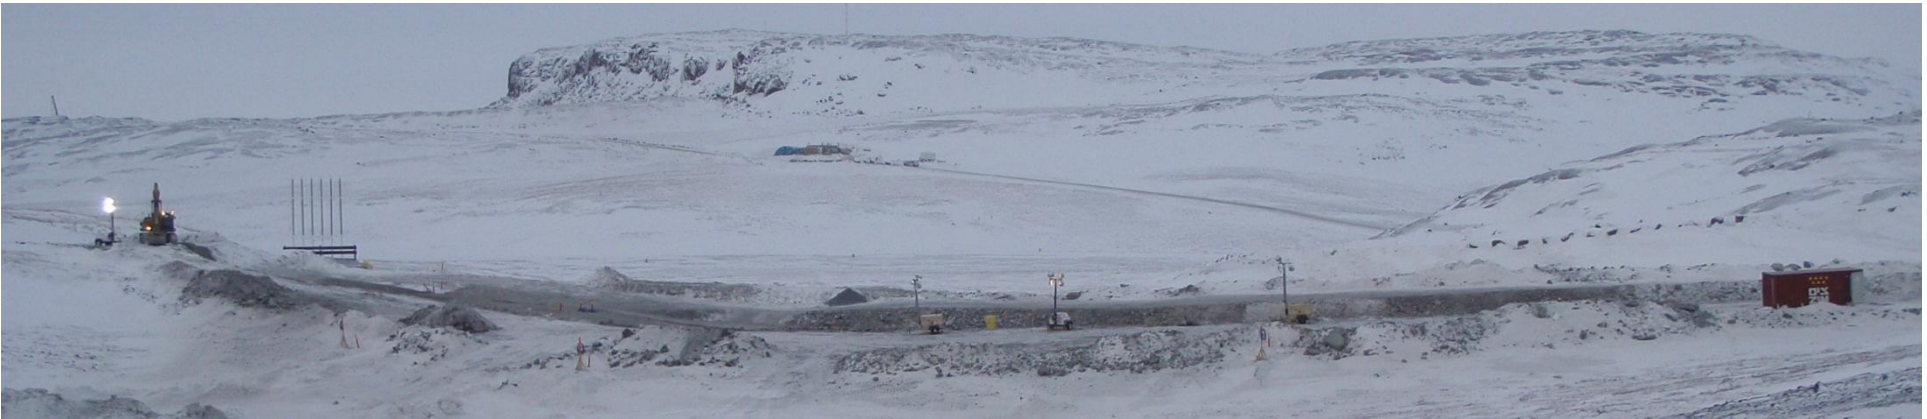
Photo 2: Progress photo of North Dam from photo point 2. ~NW view.

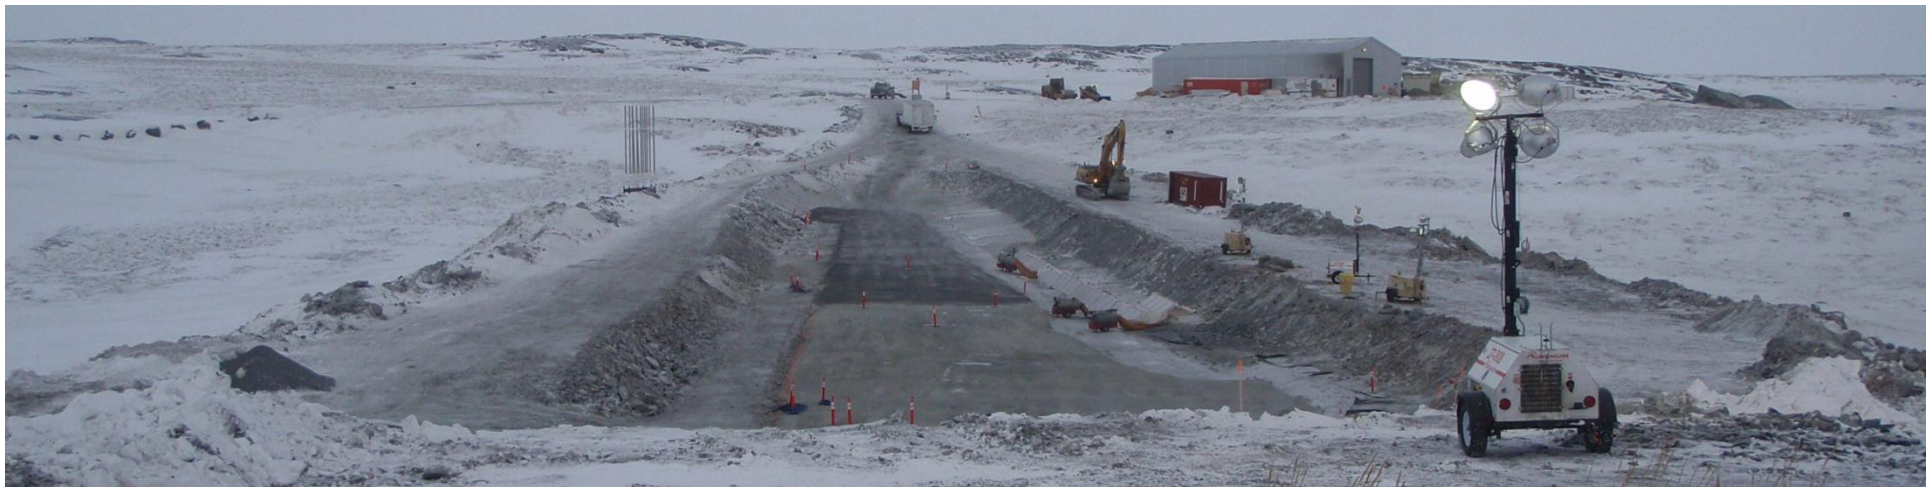
Photo 3: Progress photo of North Dam from photo point 3. ~NE view.

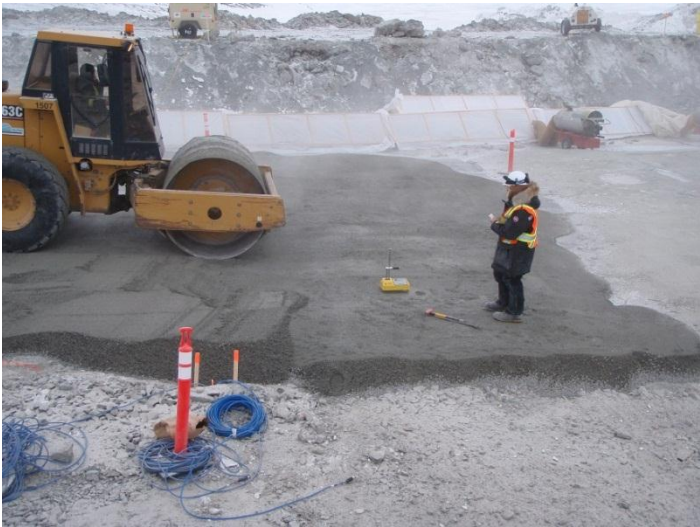
Photo 4: FCM placement over top thermistor cable DN-HTS-130-31.0; only static compaction was used directly above the cable.

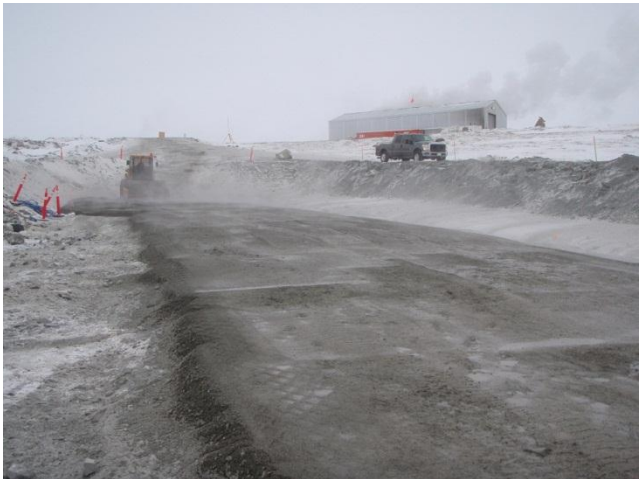
Photo 5: View facing NE of FCM placement, roughly 1+25 to 1+85.

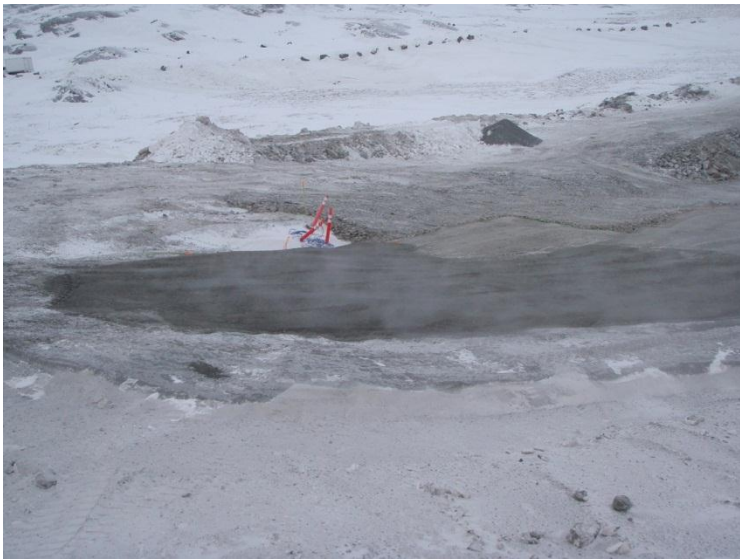
Photo 6: Small additional patch of FCM placement at the southwest end of the dam.

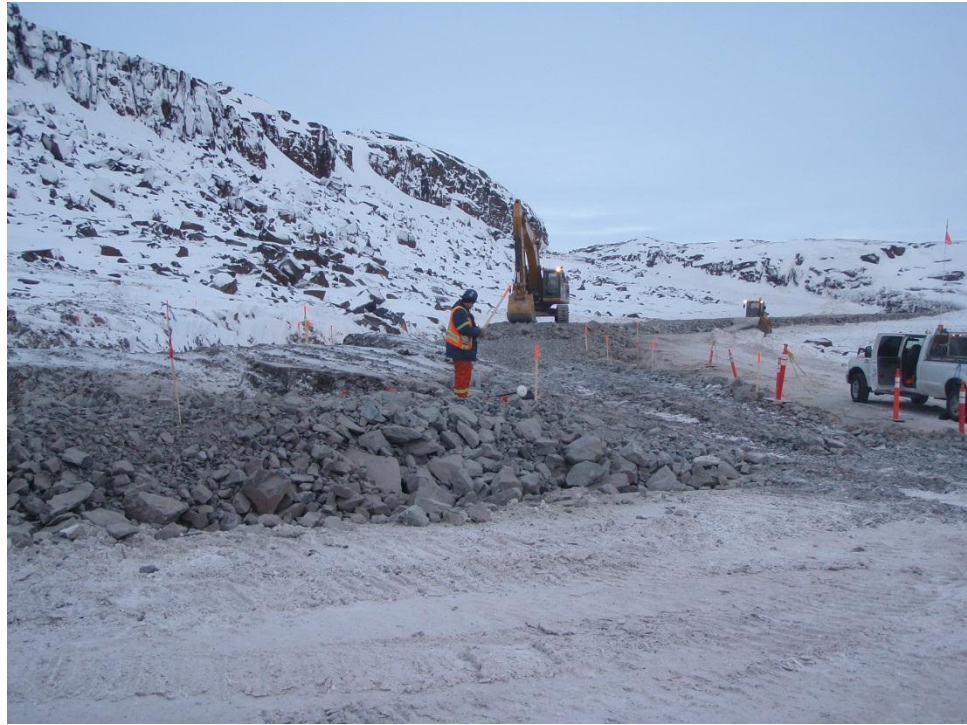
Photo 7: ROQ placement at the Doris North Diversion Berm. Note the packer (in the background) has been mobilized to compact ROQ between lifts.

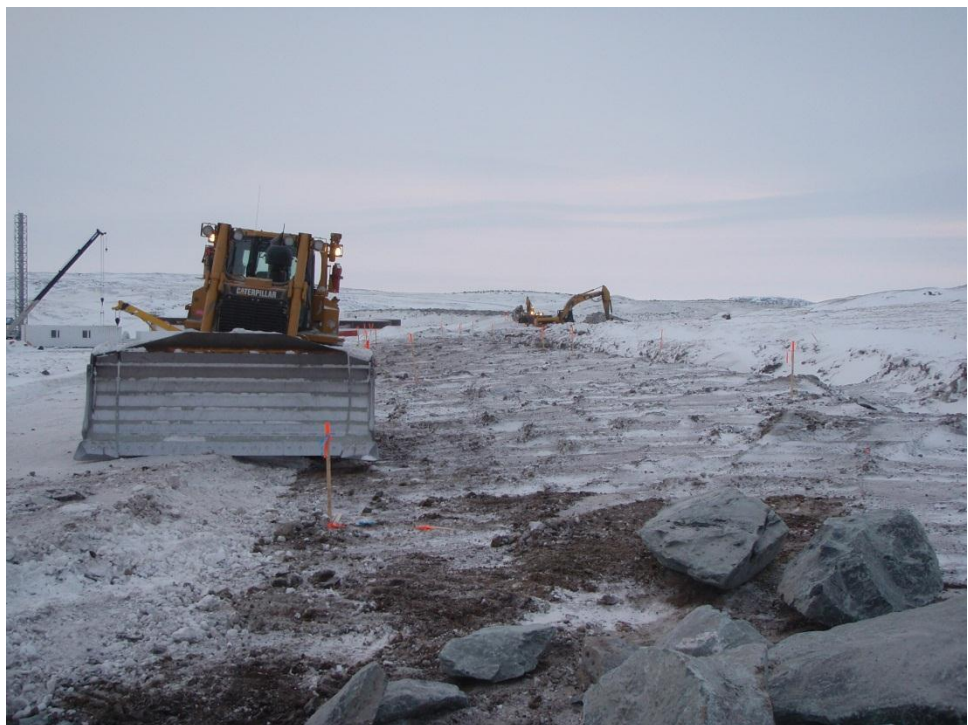
| DORIS NORTH CAMP: <ul style="list-style-type: none"> SRK met with Nuna's site engineer and again with Nuna's foreman to reiterate the importance of preserving vegetation while clearing snow for ROQ placement. Small blasts occurred throughout the day at the Doris North Diversion Berm. Cat 345 excavator continued mucking out the blast and moving blast mats. ROQ placement continued up to the bedrock outcrop. Multiple lifts were observed. Nuna had one of the vibratory packers present to compact areas with multiple lifts. Some areas of the key-trench quite steep, beyond appropriate angles to install liner systems. These areas will need to be sloped/ripped to create a proper working surface. | | |

Photo 8: View looking west along the Doris North Diversion Berm. Some vegetation has been stripped in this area while snow clearing.

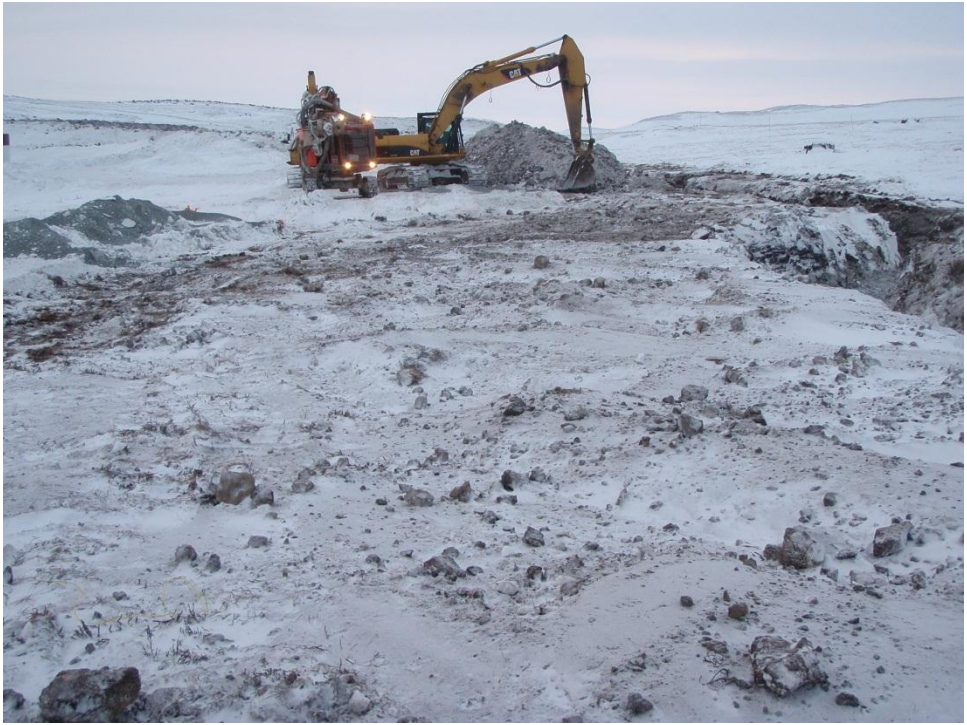
Photo 9: Recent snow clearing near the Doris North Diversion Berm key-trench excavation. Much better preservation of vegetation was observed after recent discussions with Nuna foreman.

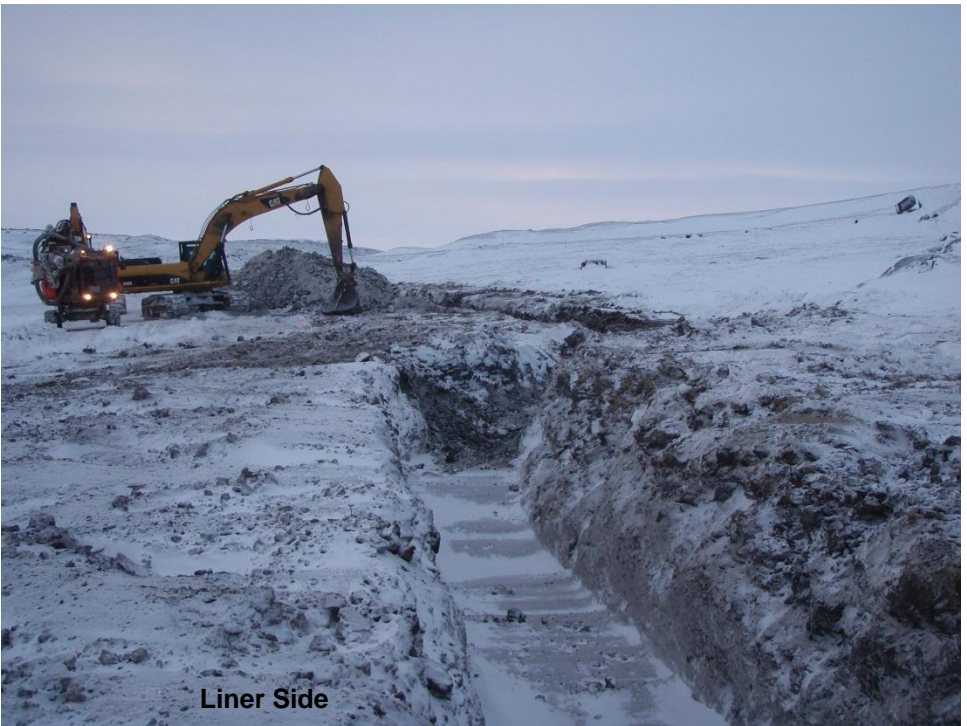
Photo 10: Doris North Diversion Berm. In some areas, the key-trench requires significant cutting to achieve a slope acceptable for liner placement. Photo looking west towards Quarry 2.

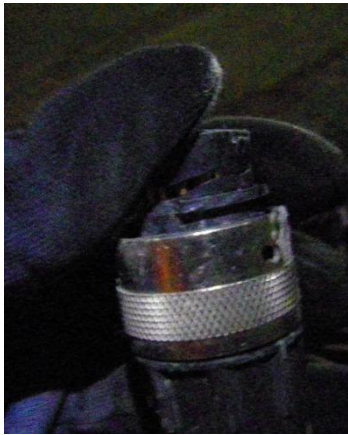
- Readings were taken for all multi-bead thermistors with the exception of ND-VTS-085-DS and ND-HTS-175-32.5.
- A reading was attempted at ND-HTS-175-32.5, however two beads showed no reading and the beads that worked showed readings lower than expected (-30°C vs. -20°C). The plastic around the pins on this connector is broken off; therefore it is likely that the pins were improperly aligned in the readout device.
- Damage was noticed on the connector to ND-HTS-085-25.3. The plastic around the pins is cracked and looks like it may break off soon. See photo below.
- One bead of ND-HTS-060-28.8 is not working.
- Thermistor cable ND-HTS-130-31.0 was installed and covered with 250 mm-300 mm of FCM. Only static rolling was performed to compact the material covering the thermistor cable. The last two beads of this thermistor string remain uncovered.

Photo 12: Cracked plastic on connector of thermistor cable ND-HTS-085-25.3

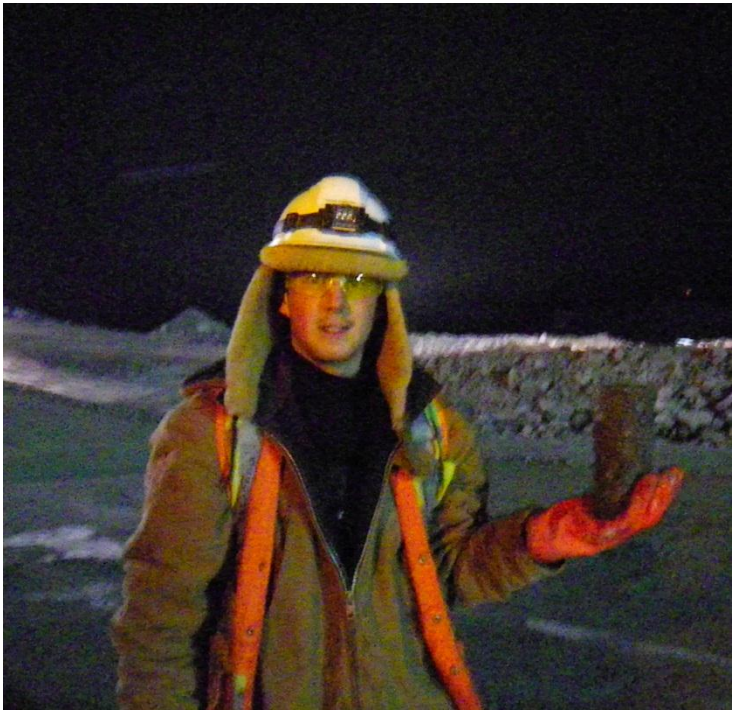
- The lift of material placed dayshift February 11, 2012 froze back midway through the shift. Three drilled core samples of this material were collected.

- Two of the cores were collected within 0.5-2 m of locations where compaction testing during placement occurred.
 - All cores were of good quality.
- Labourers used shovels and a small jackhammer to remove 5/8" material from the HDPE liner covering the GCL on the upstream side.

Photo 13: Success full coring expedition on nightshift!

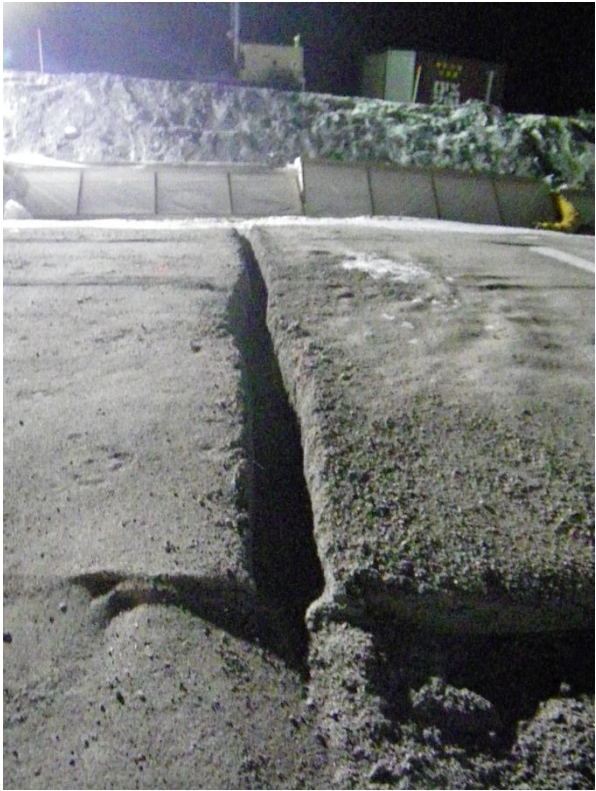
- No FCM placement.
- Prior to FCM placement on dayshift the FCM at station 1+75 was on grade for the next horizontal thermistor string. This forgotten on dayshift, and a lift was placed over the area. While the material was still warm a trench was hand shoveled in the placed material to the appropriate grade.

Photo 14: Trench cut in FCM at 1+75 to allow for installation of the next horizontal thermistor at the correct elevation.
