## DAILY REPORT #39 – DORIS NORTH INFRASTRUCTURE/ NORTH DAM

Prepared by:	Murray McGregor Iozsef Miskolczi	Date:	2012.02.13
Reviewed by:		Project #:	1CH008.058.0320
Role	Company	Personnel – Position	On Site
Client	Hope Bay Mining Limited (HBML)	Angela Holzapfel – ESR Compliance Manager David Vokey – ESR Coordinator Don Ethelston – HSLP Advisor Dean Wold - Safety Jill Turk – ESR Coordinator Katsky Venter – ESR Manger Michelle Tanquay – ESR Site Manager Stirling Kelly – HSLP Advisor	No No No No Yes No Yes Yes
	JDS	Lloyd Jackson – Mechanical Superintendent Doug Fielding – Construction Manager Ishan Fechter – Construction Coordinator Jerry Graham – Construction Manager Kevin Whieldon – Project Coordinator Mark Valeriote – Construction Manager	Yes No Yes Yes No Yes
Engineering Design Consultants	SRK Consulting (Canada) Inc.	John Kurylo – Site Engineer Megan Miller – Site Engineer Lawrence Borowski – Site Engineer Murray McGregor – Site Engineer Iozsef Miskolczi – Site Engineer	No Out No Yes In

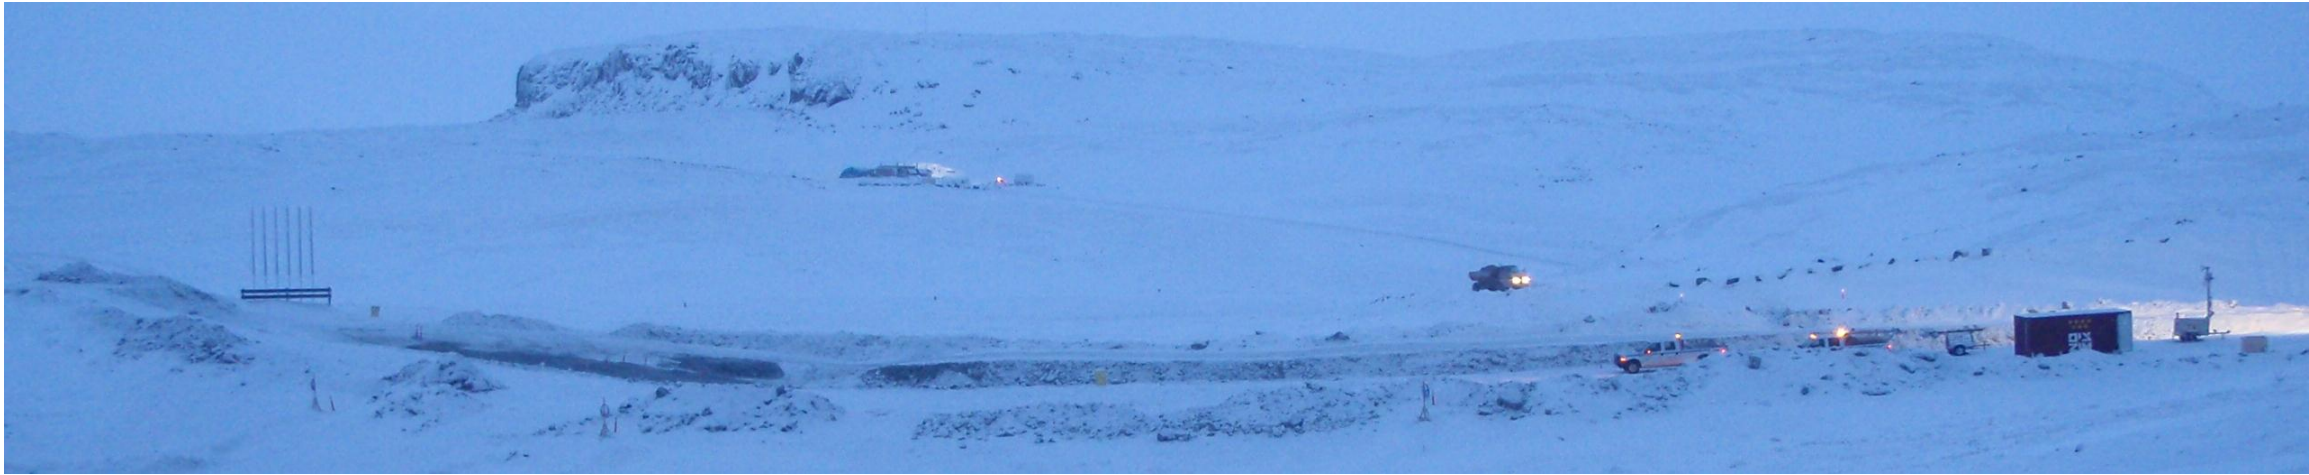
**Photo 2:** Progress photo of North Dam from photo point 2. ~NW view.

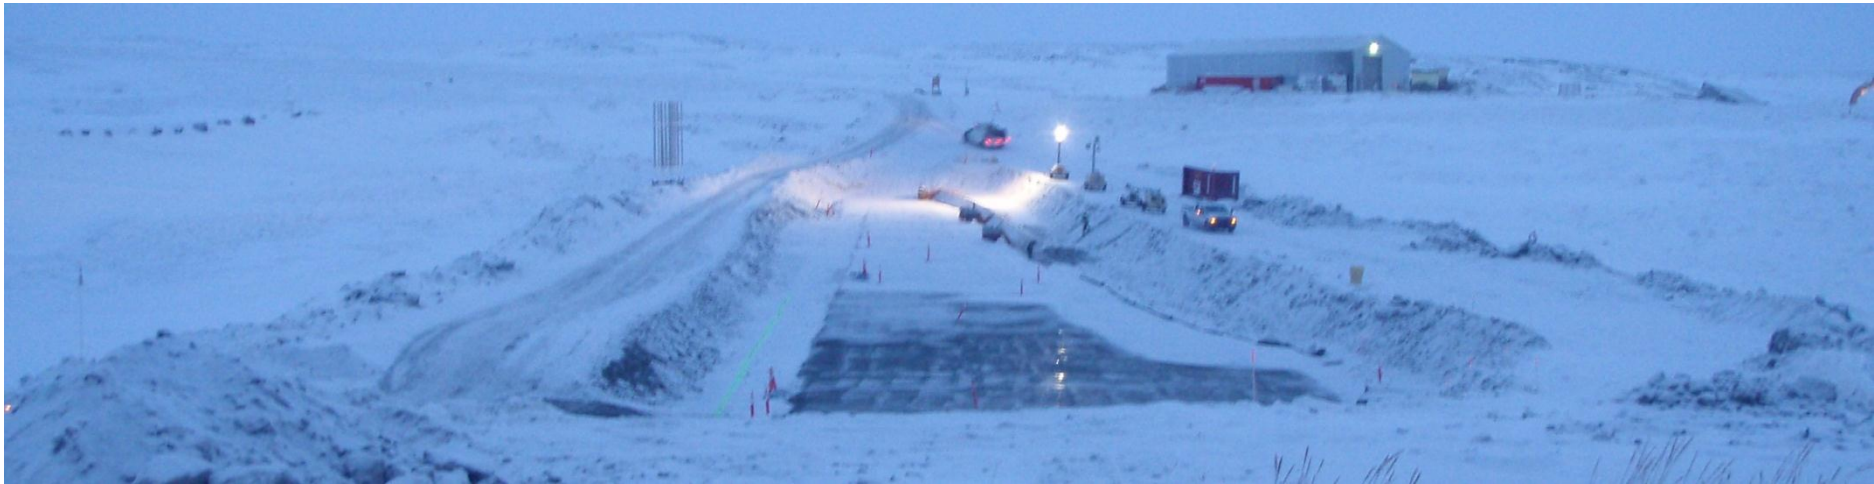
**Photo 2:** Progress photo of North Dam from photo point 3. ~NE view.

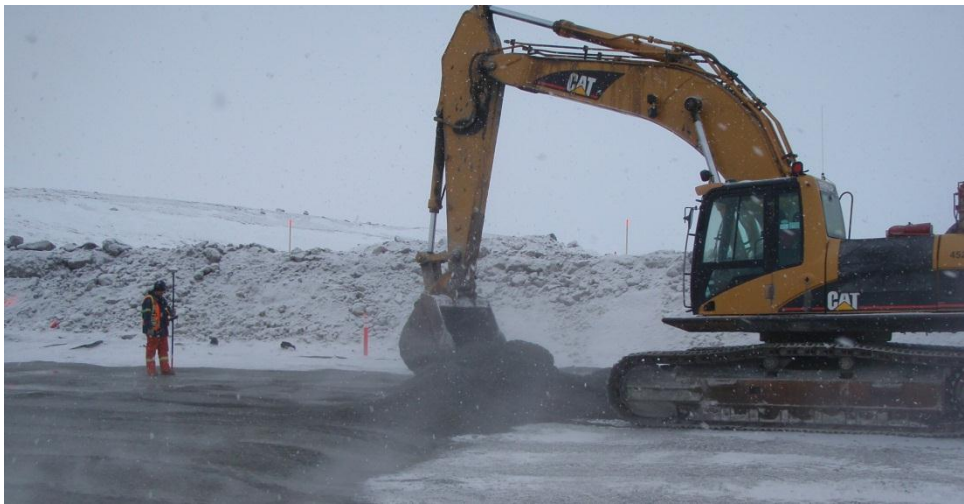
**Photo 3:** Survey working with excavator to ensure placement is at or below liner grade.

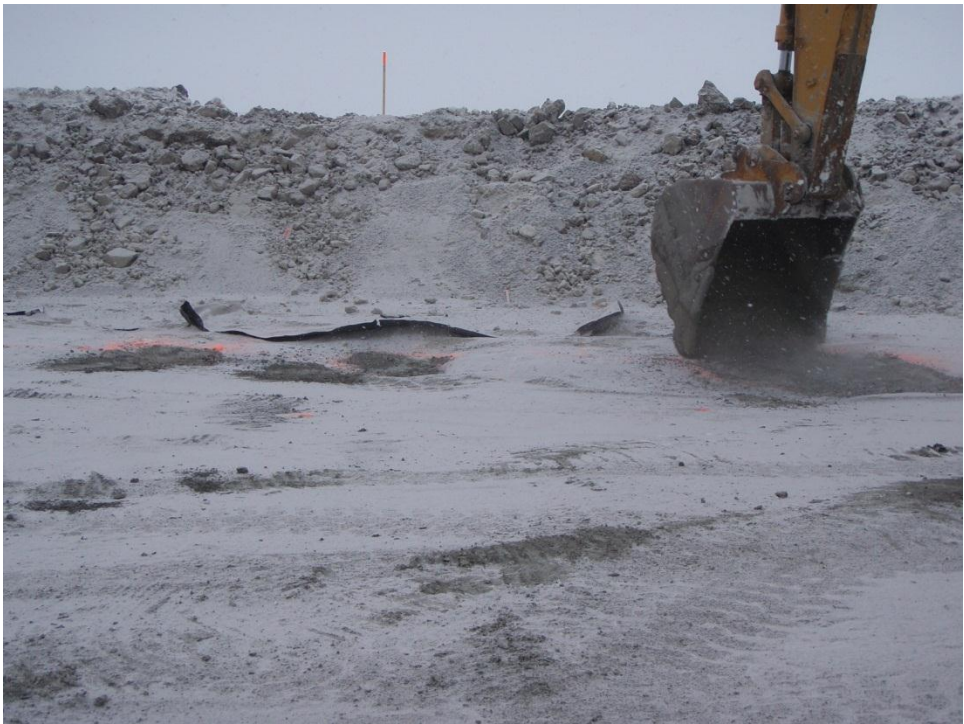
- Transition material was tied into the edge of the placed core material. The next lift of core material should toe out onto this transition material.
- Labourers continued removing 5/8" material from a small portion of the HDPE liner covering the GCL on the upstream side, using hand shovels and a jack hammer. After disassembly of the hoarding tents, the 330 excavator was used to remove as much of the thawed 5/8 crush as possible. About one truckload of crush was removed. The hoarding was subsequently rebuilt and heat was applied for further thawing.

**Photo 3:** Cat 330 excavator scratching areas of frozen 5/8 clear to be removed prior to placement.

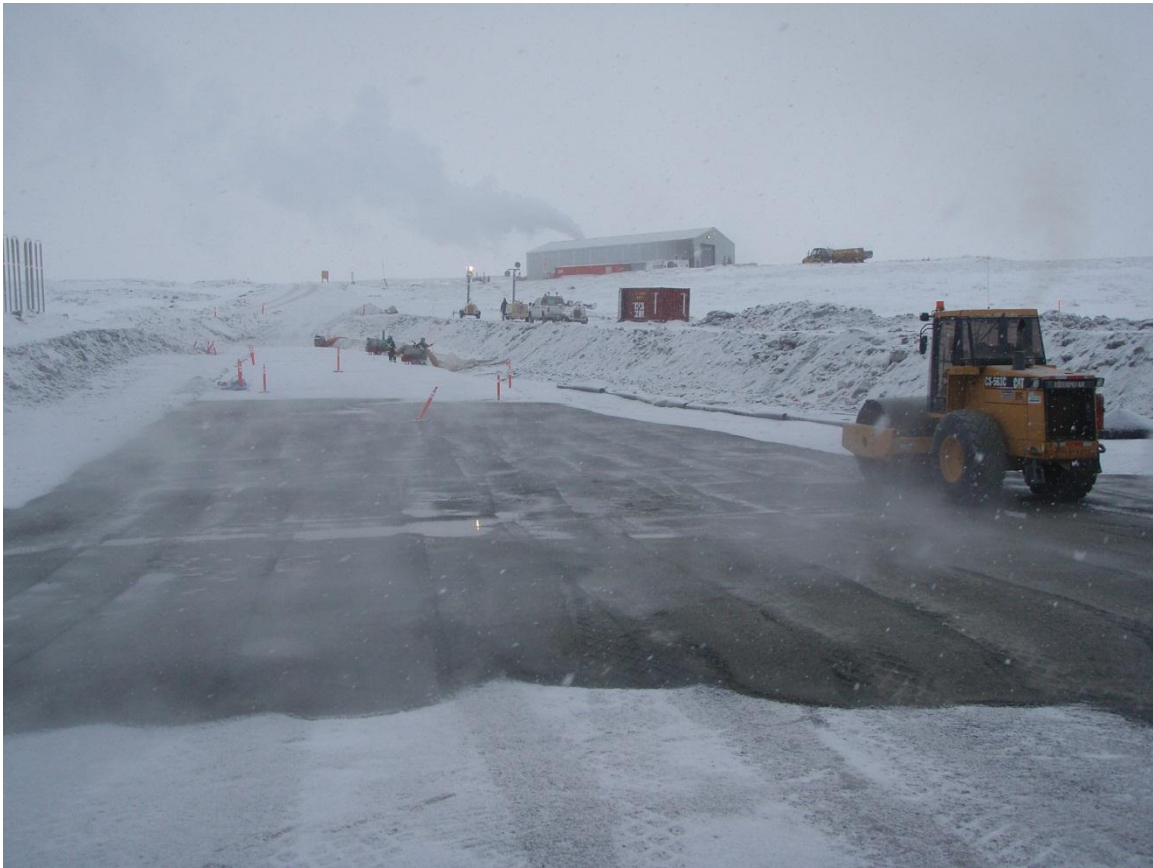
- Placement was started from 1+25 and continued until 0+55.
- Material looked excellent when first placed; over time some water bled out to form puddles.
- Almost all compaction and saturation tests were above targets.
- The last two truckloads were wet, resulting in proctors as low as 89% in a localized area.
- One single bead thermistor was installed at either end of today's placement.

**Photo 5:** FCM placement. Some water bled out of the material over time.

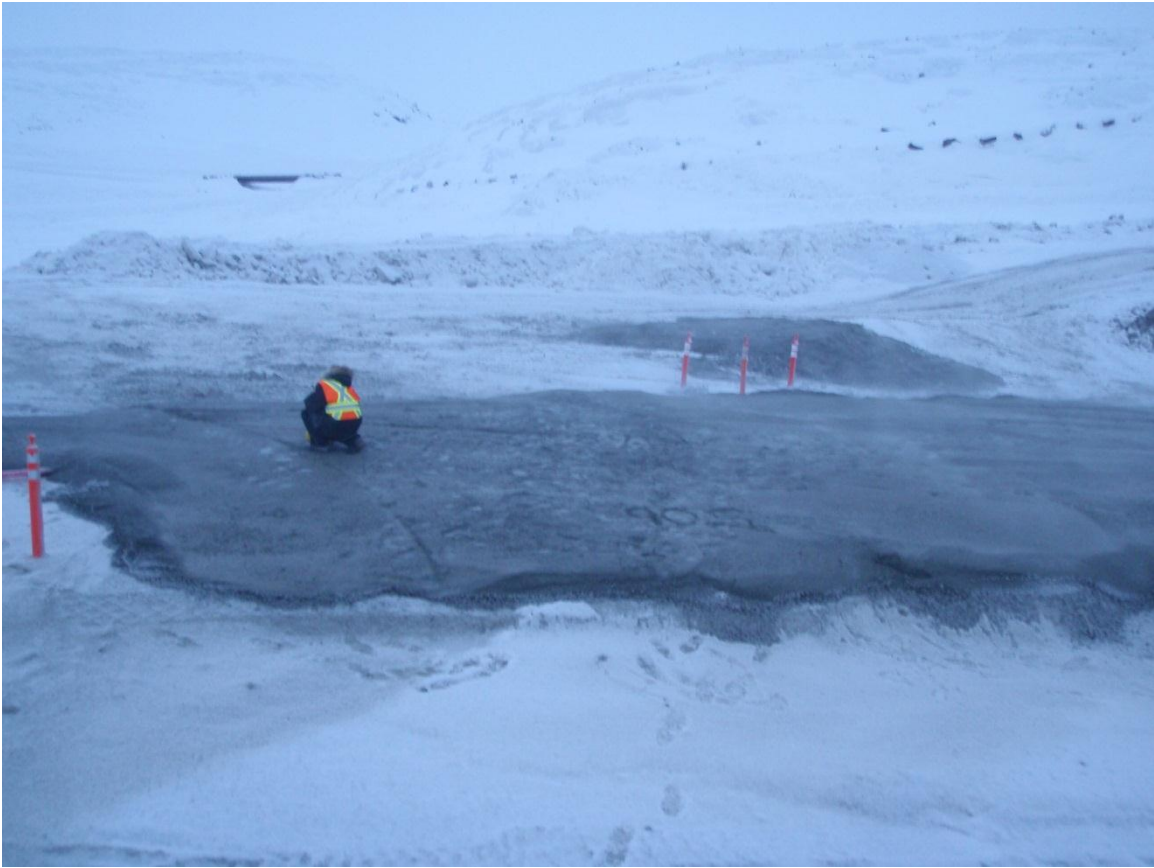
**Photo 6:** Placement near the south end of the dam. Compaction results were slightly (1%) low in one localized area.

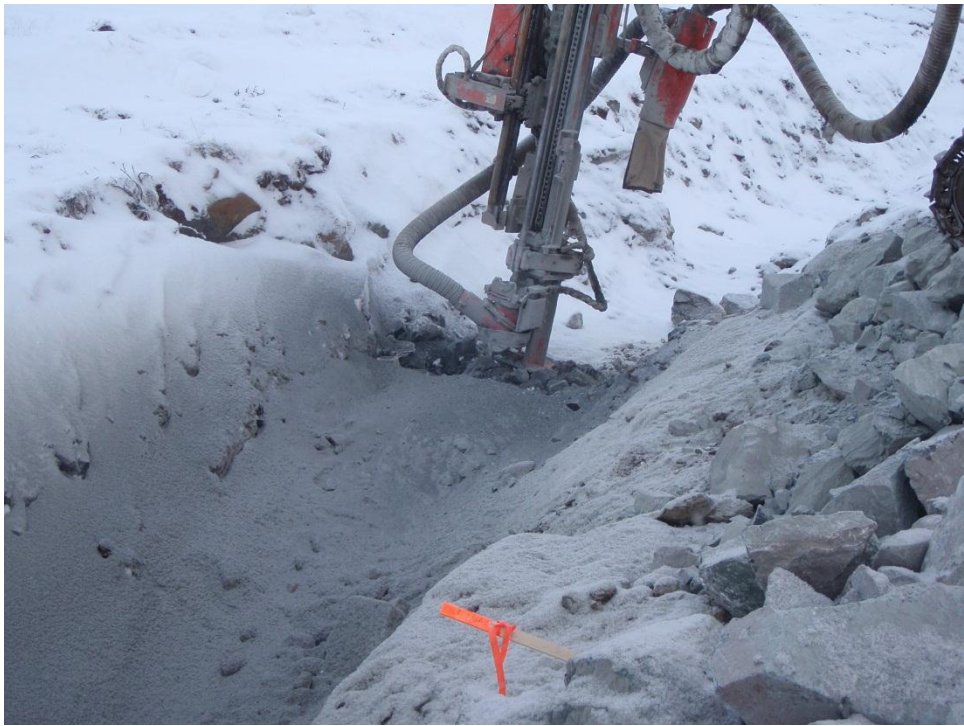
**Photo 10:** Chipping to obtain grade at the Doris North Diversion Berm.

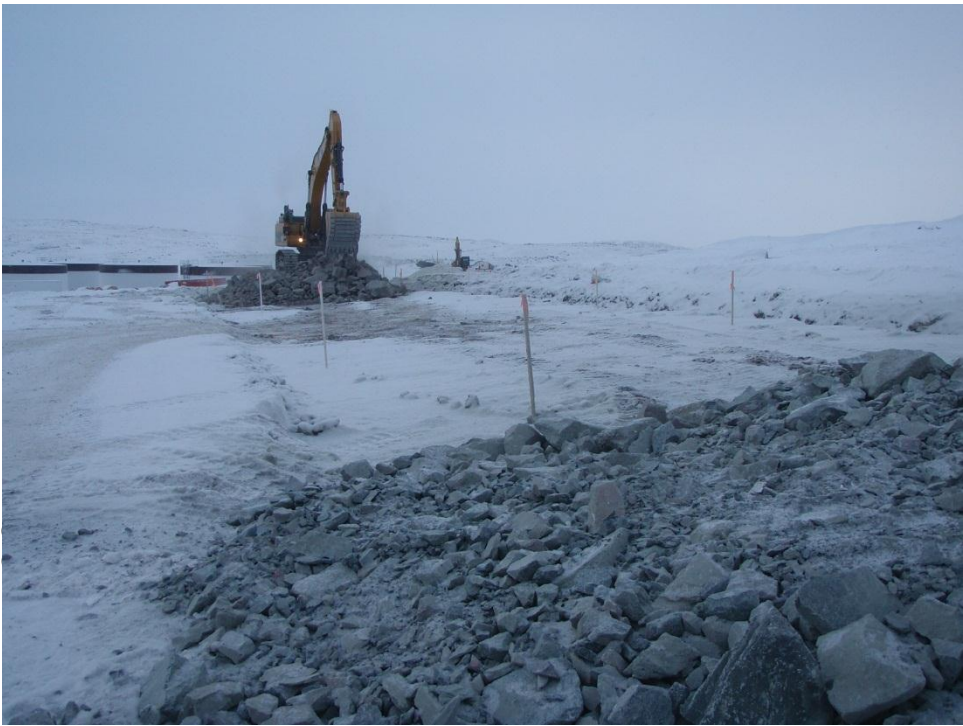
**Photo 13:** ROQ placement at the Doris North Diversion Berm.

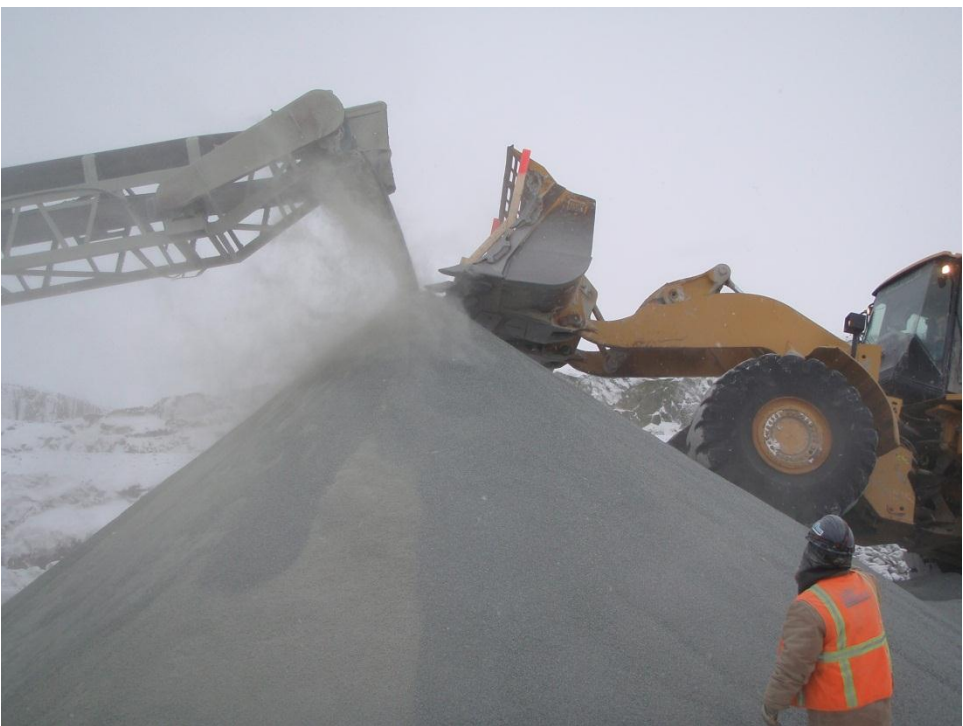
- Crusher operator started the crusher after overseeing the FCP start-up.
- Material was produced from noon until shift end.
- There was an issue taking samples off the belt because of the volumes of material sitting on the screens; if the crusher were stopped, it would require hours of cleaning to start it again.
- Four samples were taken off the end of the belt using a plywood box held up by the loader; the loader carries the box through the stream and back again.
- All soil in the sampling box is loaded into pails and reconstituted in the EBA soils lab for sieve and moisture tests.

**Photo 14:** Sampling at the crusher using a plywood box in the loader bucket.

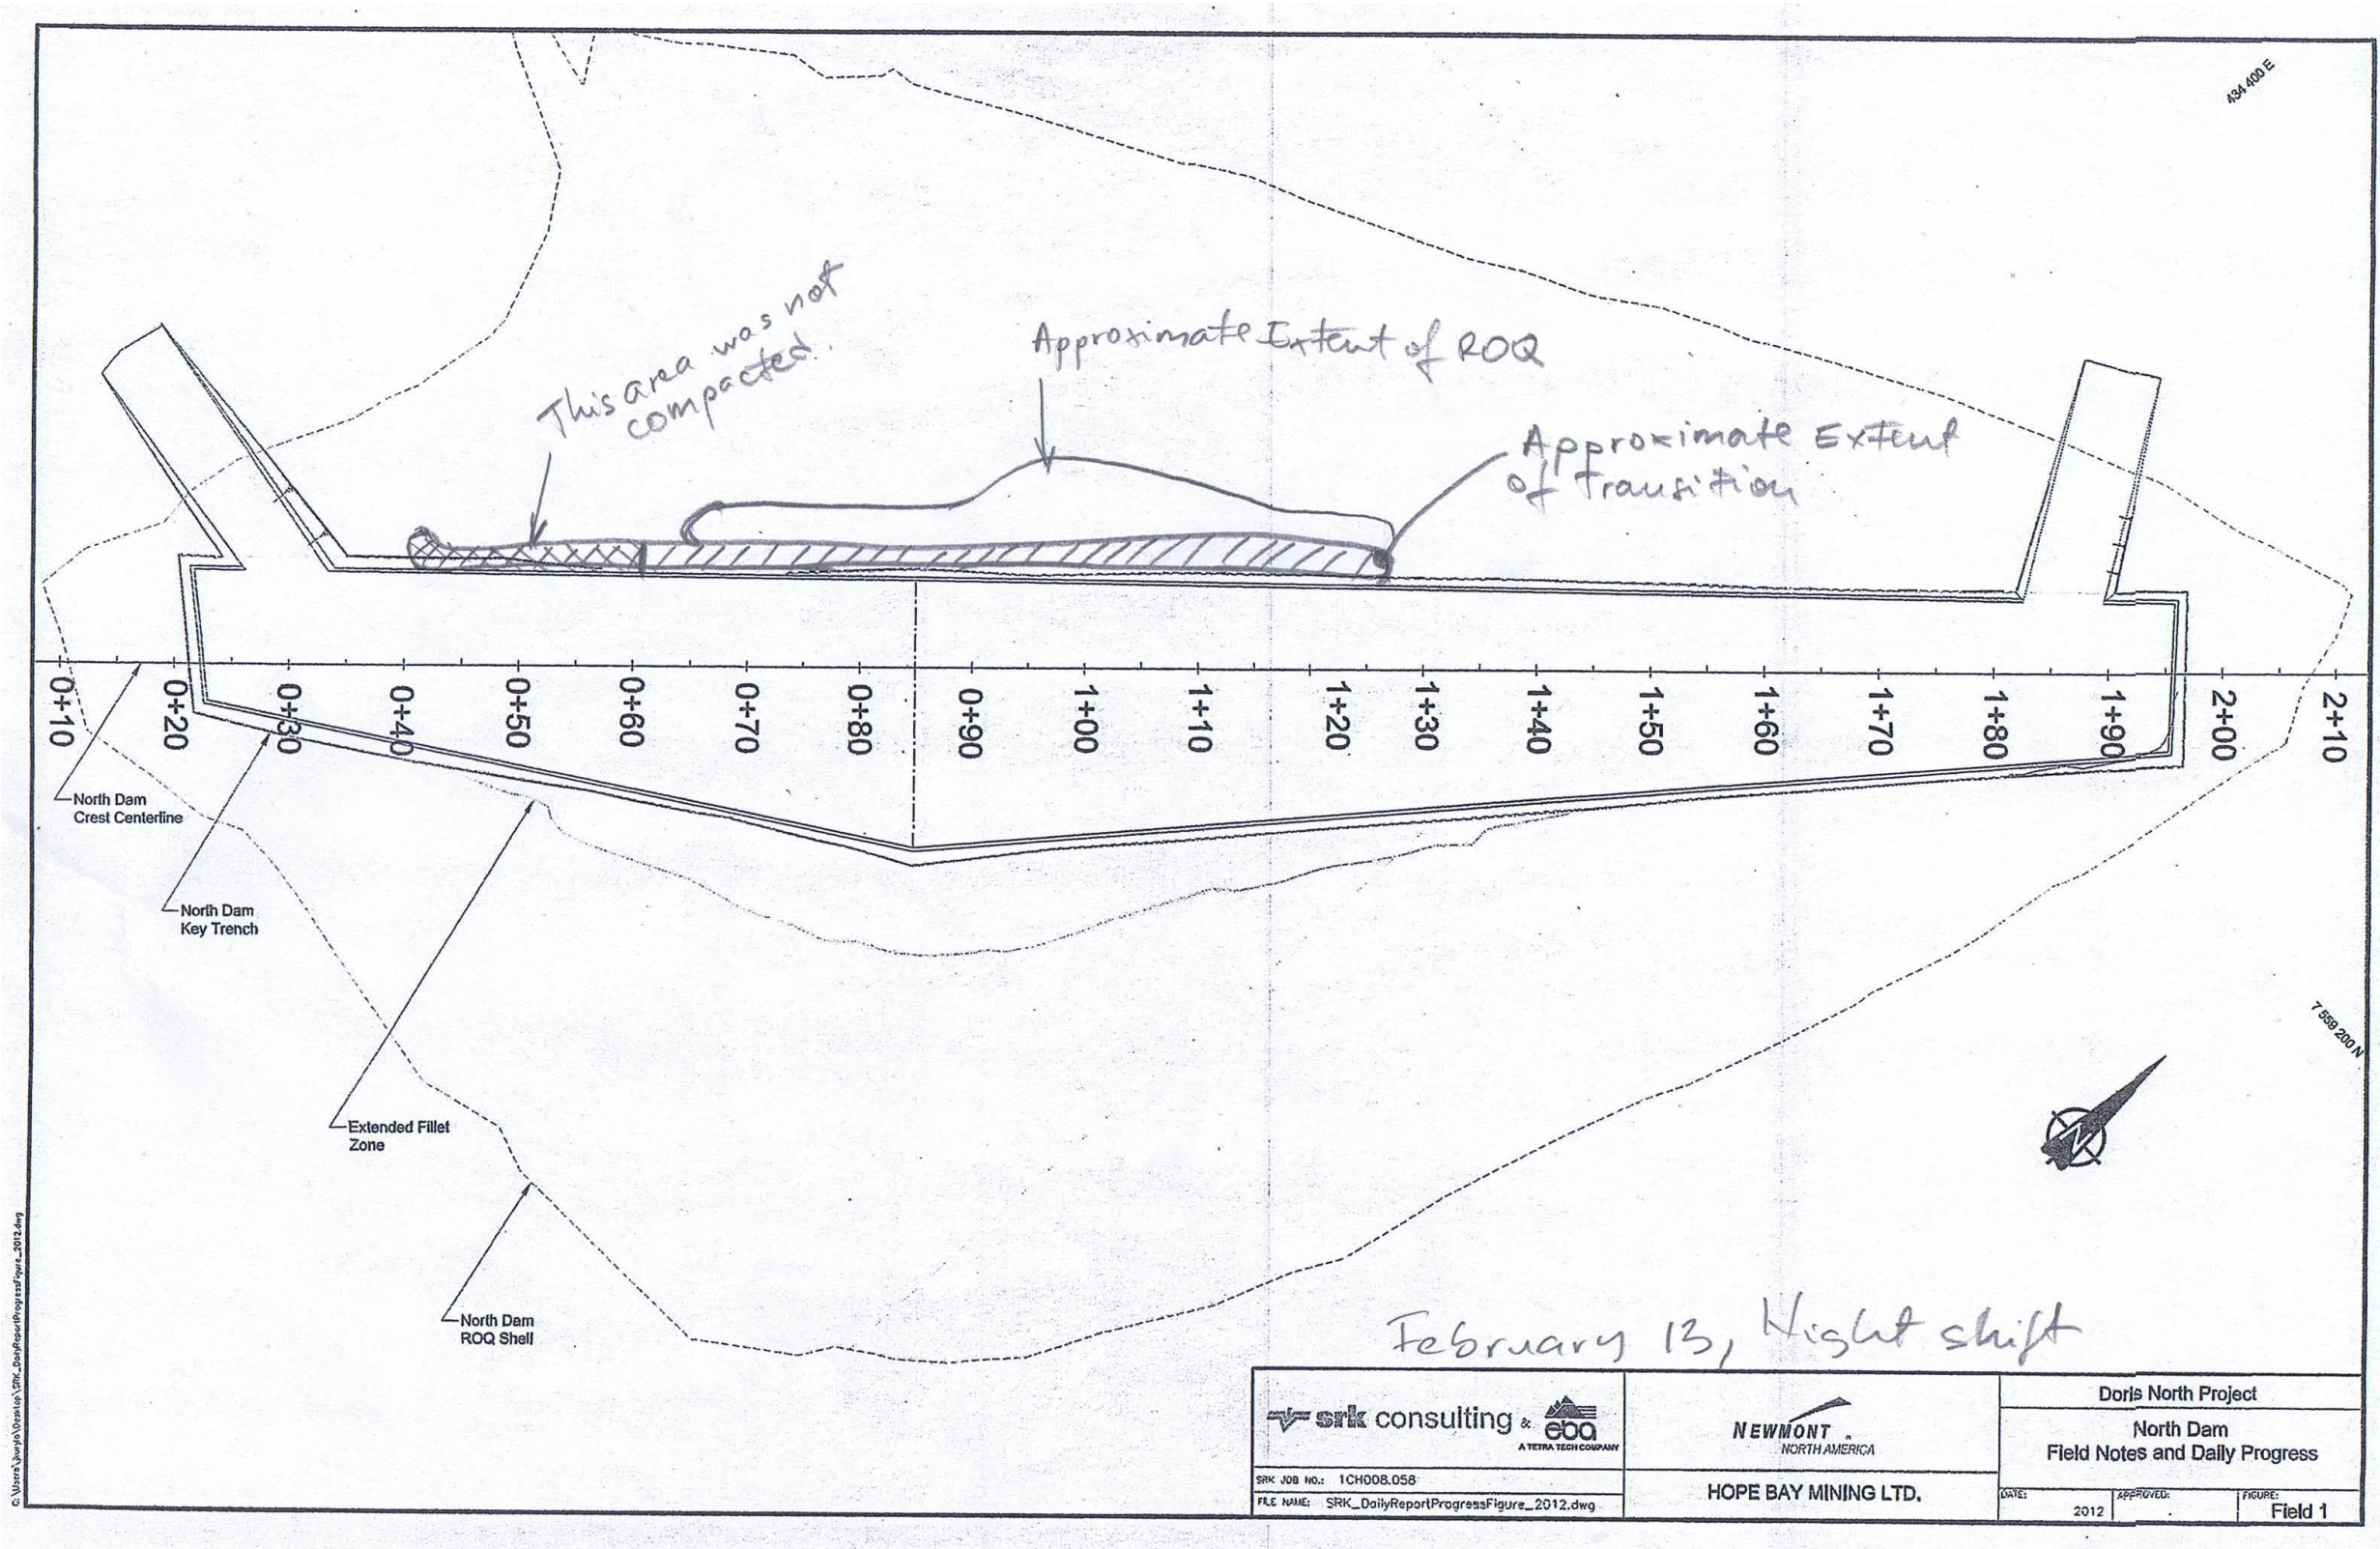
Figure 2 – North Dam Progress – February 13<sup>th</sup> Nightshift

- Transition and some ROQ material were placed along the downstream side of the core material. This material was placed with the CAT 330 excavator and compacted with the vibratory packer.
  - Transition material was obtained from the stockpile near the crusher.
  - Some of the ROQ stockpiled on the downstream side was placed in a lift approx. 50 cm thick to match the transition material elevation.
  - The thin layer (1 to 2 cm) of powder snow accumulated during the evening was left in place and covered with transition/ROQ material.
- Transition material was stockpiled at the Frozen Core Plant.
