DAILY REPORT #40 – DORIS NORTH INFRASTRUCTURE/ NORTH DAM

Prepared by:	Murray McGregor Iozsef Miskolczi	Date:	2012.02.14
Reviewed by:		Project #:	1CH008.058.0320
Role	Company	Personnel – Position	On Site
Client	Hope Bay Mining Limited (HBML)	Angela Holzapfel – ESR Compliance Manager David Vokey – ESR Coordinator Don Ethelston – HSLP Advisor Dean Wold - Safety Jill Turk – ESR Coordinator Katsky Venter – ESR Manger Michelle Tanquay – ESR Site Manager Stirling Kelly – HSLP Advisor	No No No No Yes No Yes Yes
	JDS	Lloyd Jackson – Mechanical Superintendent Doug Fielding – Construction Manager Ishan Fechter – Construction Coordinator Jerry Graham – Construction Manager Kevin Whieldon – Project Coordinator Mark Valeriote – Construction Manager	Yes No Yes Yes No Yes
Engineering Design Consultants	SRK Consulting (Canada) Inc.	John Kurylo – Site Engineer Megan Miller – Site Engineer Lawrence Borowski – Site Engineer Murray McGregor – Site Engineer Iozsef Miskolczi – Site Engineer	No No No Yes Yes

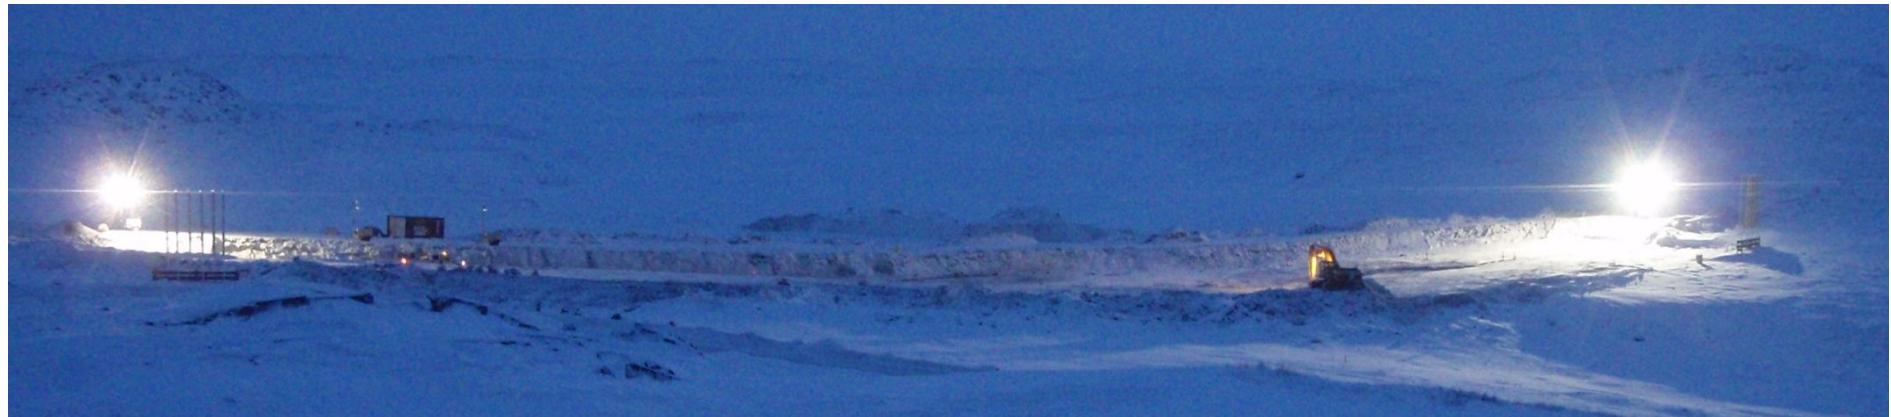
Photo 1: Progress photo of North Dam from photo point 1. ~SSE view.

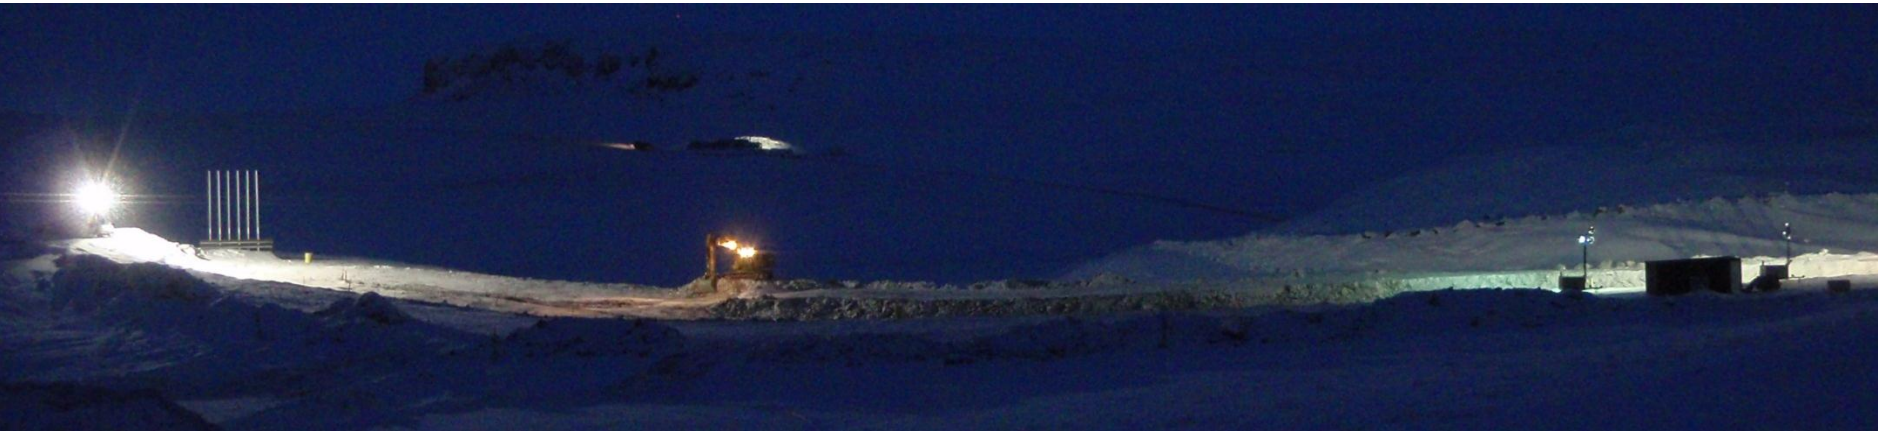
Photo 2: Progress photo of North Dam from photo point 2. ~NW view.

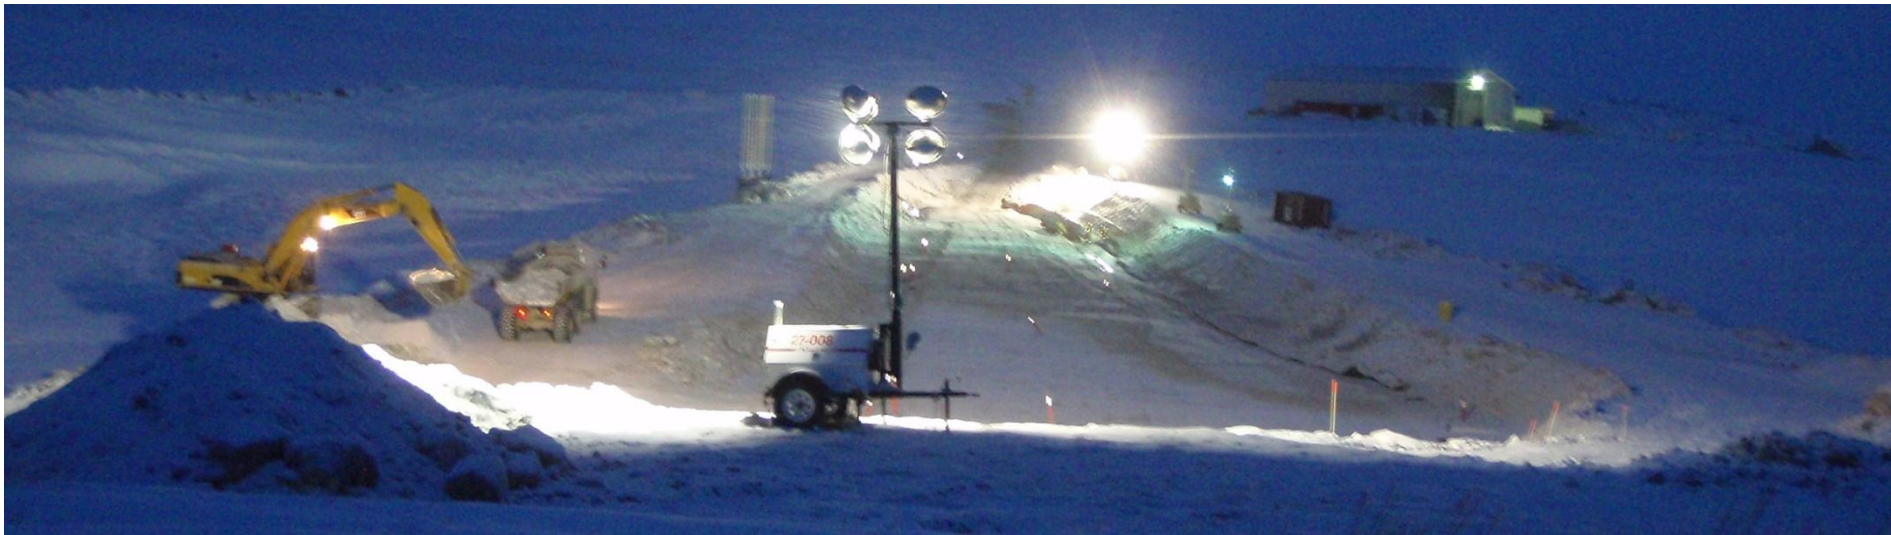
Photo 3: Progress photo of North Dam from photo point 3. ~NE view.

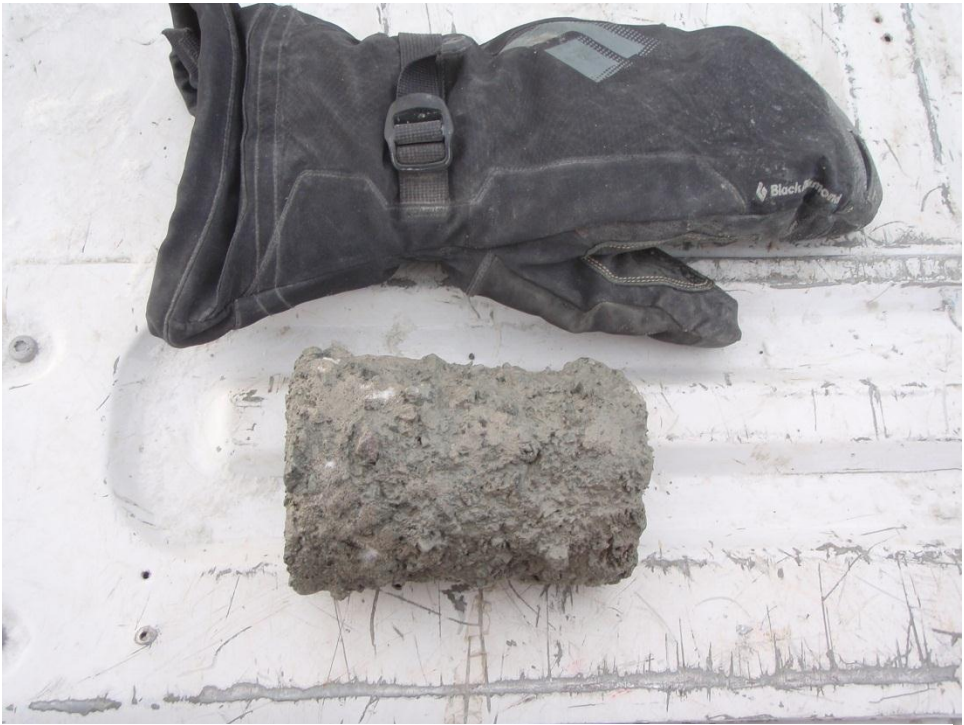
Photo 4: Drilled Core HB12-ND-CORE-DC35-20120214. Some degradation due to spinning gravel.

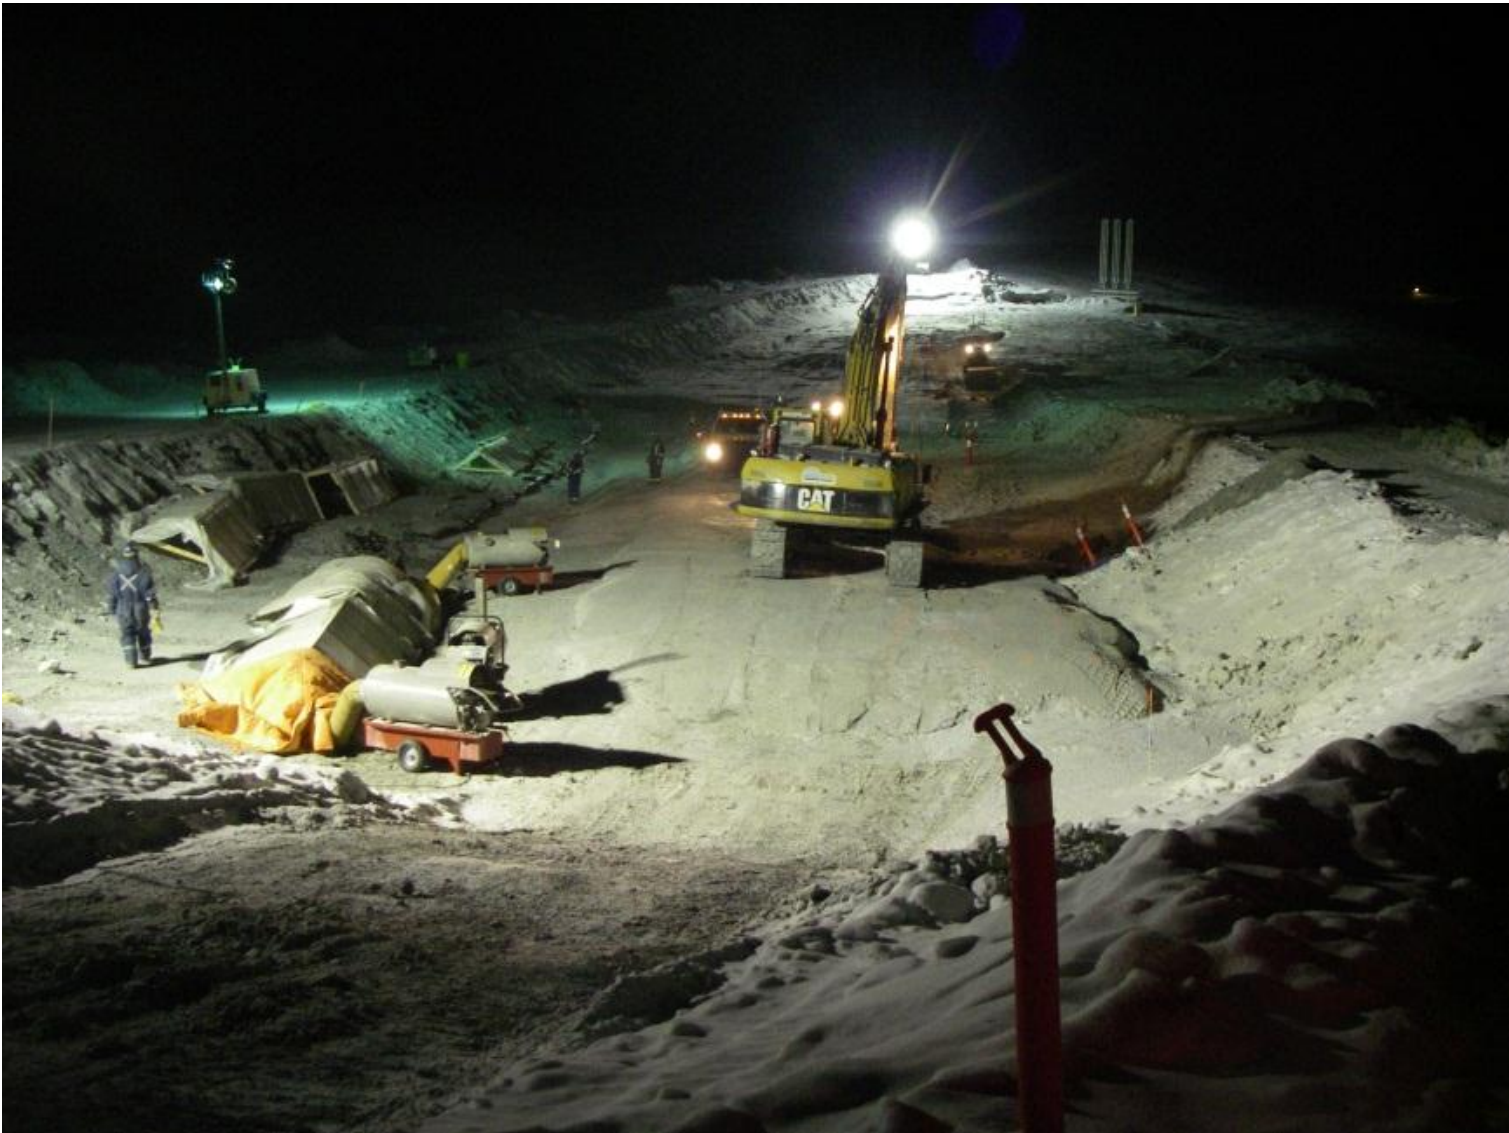
- The excavated area was cleaned with compressed air. A few areas require further cleaning to remove all crush.
- Removal of the frozen 5/8 crush from above the HDPE liner continued. Holes in the GCL caused by the jackhammer punching through the frozen crush and the HDPE liner were noted.
- The single bead thermistors were monitored throughout the night for freeze-back. At the end of the night shift SB5 was indicating that freeze-back was achieved, while SB12 was measuring around -1°C.

Photo 7: Cleanup of the frozen core placed on Feb. 12. On the left side of the photo laborers are removing 5/8 crush from the GCL liner.

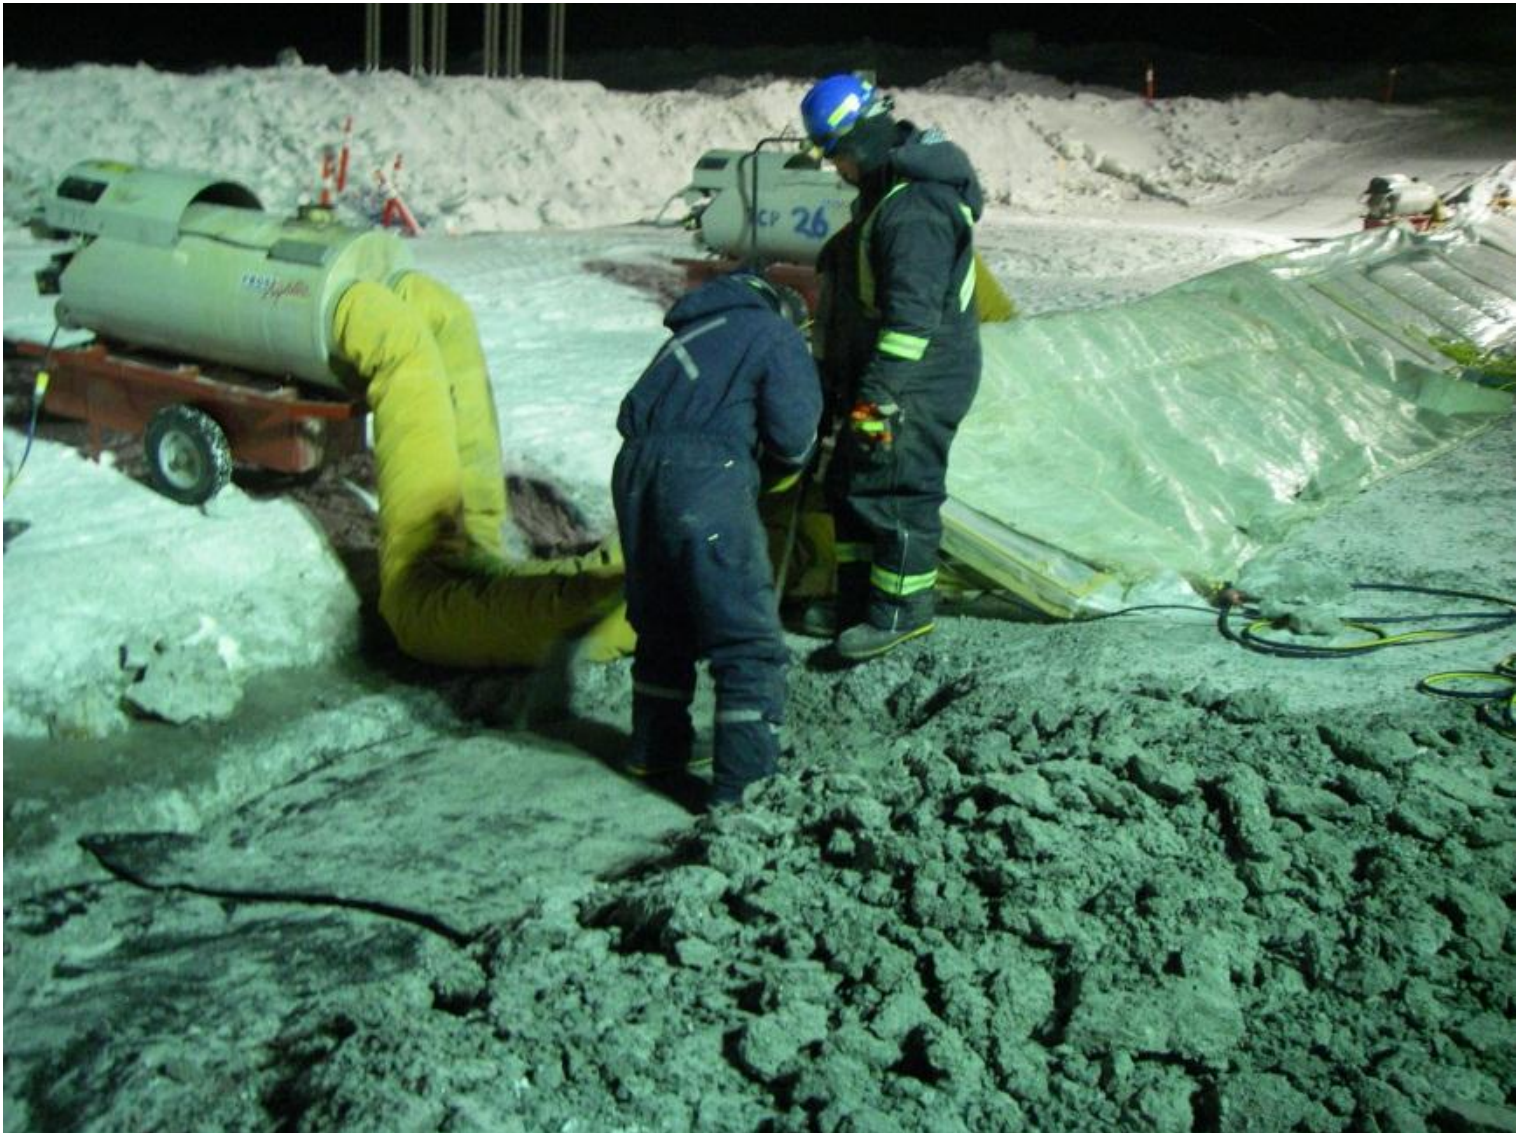
Photo 6: Laborers breaking up the frozen 5/8 crush using a jack hammer.
