DAILY REPORT #47 – DORIS NORTH INFRASTRUCTURE/ NORTH DAM

Prepared by:	Murray McGregor Iozsef Miskolczi	Date:	2012.02.21
Reviewed by:		Project #:	1CH008.058.0320
Role	Company	Personnel – Position	On Site
Client	Hope Bay Mining Limited (HBML)	Angela Holzapfel – ESR Compliance Manager David Vokey – ESR Coordinator Don Ethelston – HSLP Advisor Dean Wold - Safety Jill Turk – ESR Coordinator Katsky Venter – ESR Manger Michelle Tanquay – ESR Site Manager Stirling Kelly – HSLP Advisor	No No No No Yes No Yes No
	JDS	Lloyd Jackson – Mechanical Superintendent Doug Fielding – Construction Manager Ishan Fechter – Construction Coordinator Jerry Graham – Construction Manager Kevin Whieldon – Project Coordinator Mark Valeriote – Construction Manager	Yes Yes Yes No No Yes
Engineering Design Consultants	SRK Consulting (Canada) Inc.	John Kurylo – Site Engineer Megan Miller – Site Engineer Lawrence Borowski – Site Engineer Murray McGregor – Site Engineer Iozsef Miskolczi – Site Engineer	No No No Yes Yes

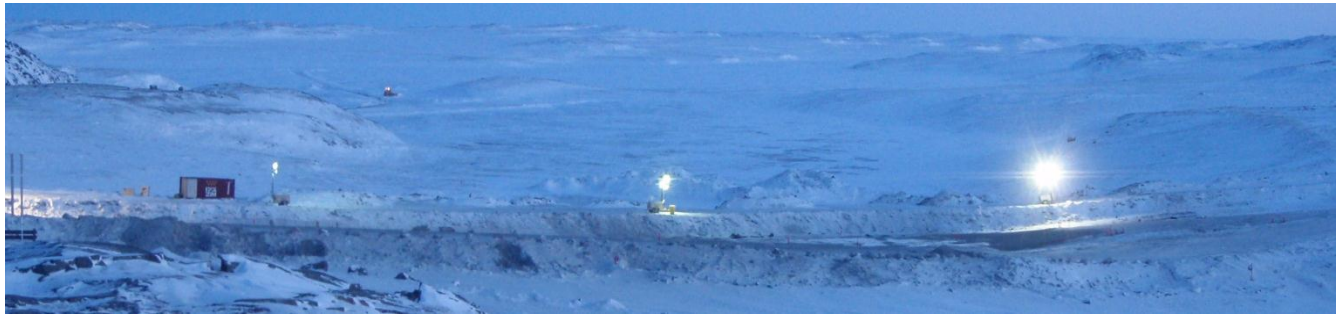
Photo 1: Progress photo of North Dam from photo point 1. ~SSE view

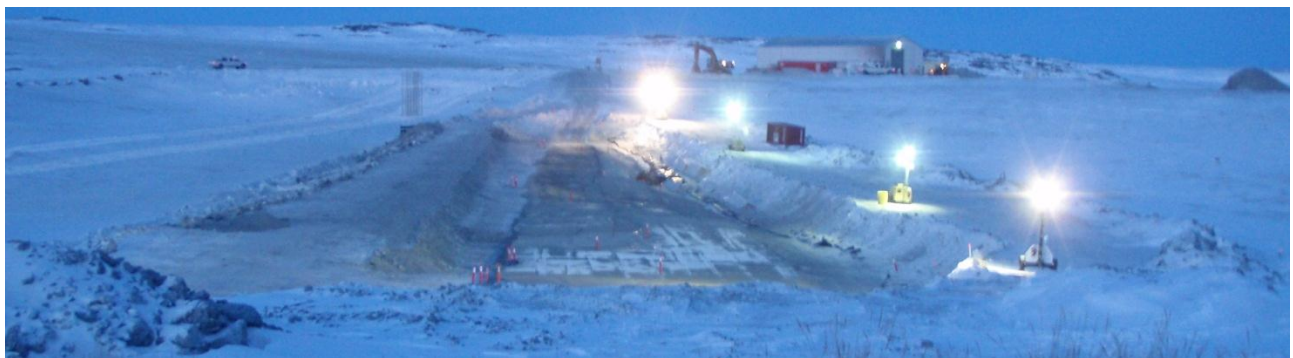
Photo 2: Progress photo of North Dam from photo point 3. ~NE view

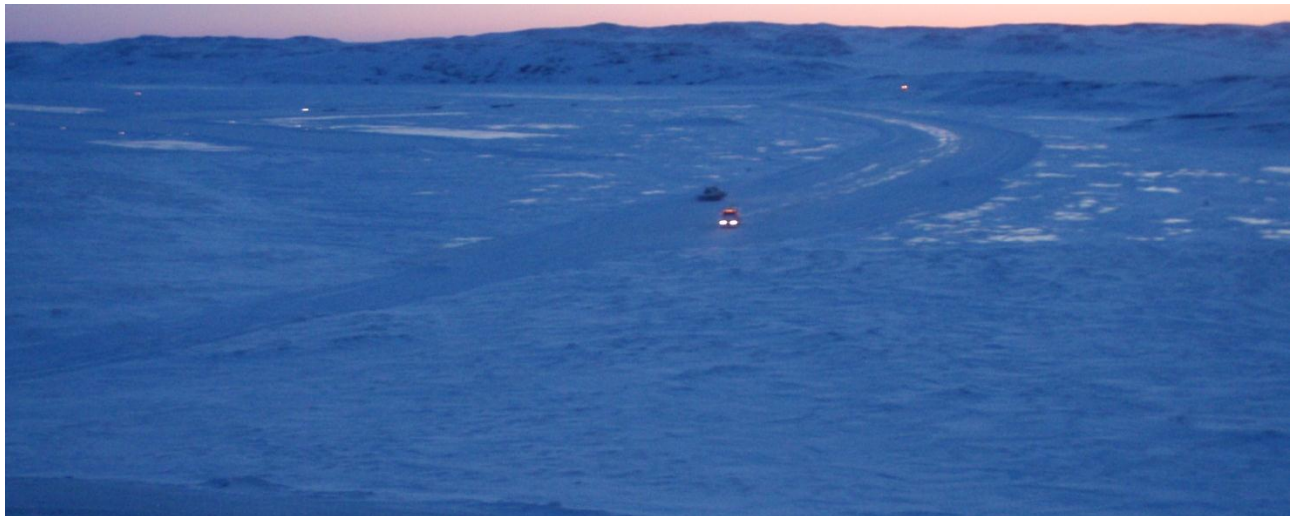
- Nuna electricians repaired the cable for the EBA coring drill.
- One SnowCat was pushing snow along the alignment of the short-haul route across Doris Lake. The snow at the end of the ice road near the dam was graded and watered.

Photo 3: Snow cat pushing snow across Doris Lake for the snow road to the north dam

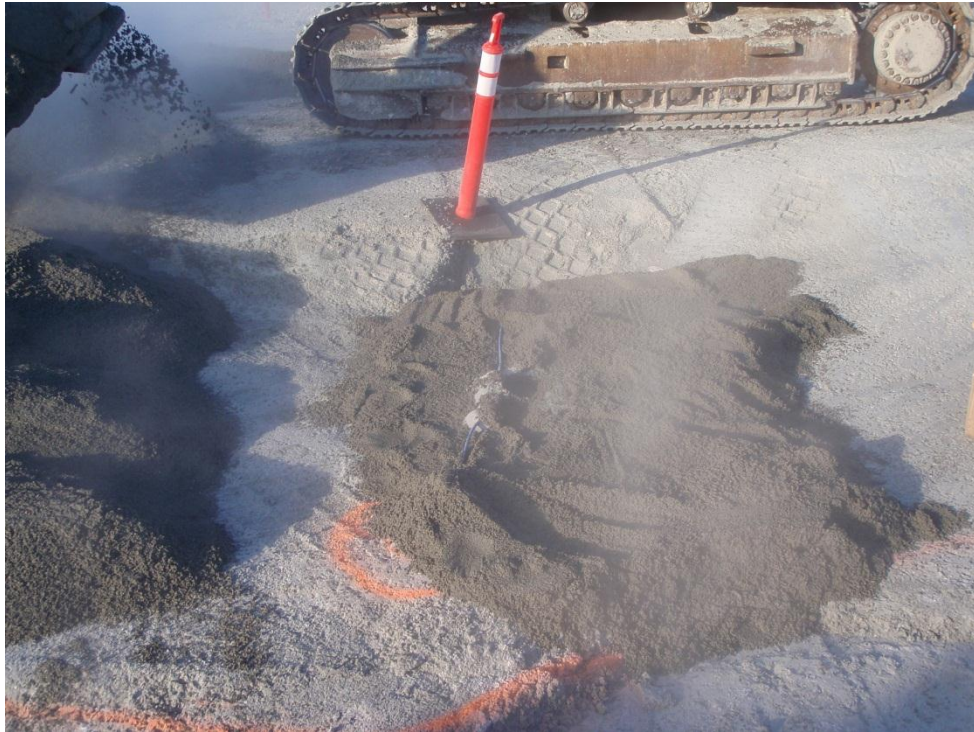
Photo 4: Placement of the last two beads of a horizontal thermistor cable at chainage 1+30

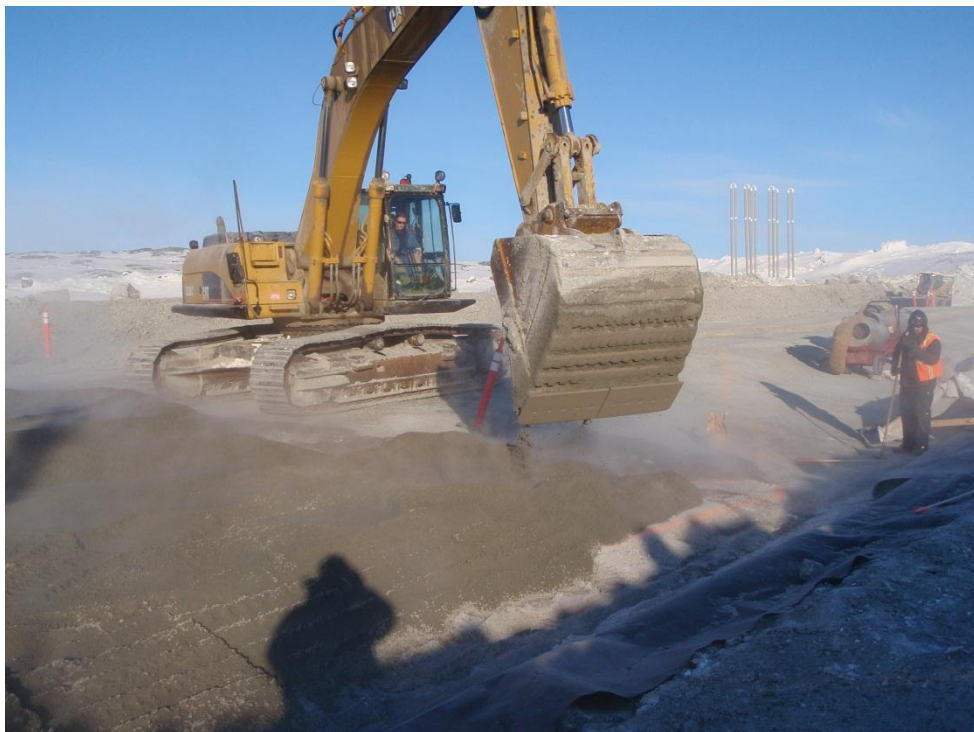
Photo 5: Covering thermistor cable at chainage 1+30

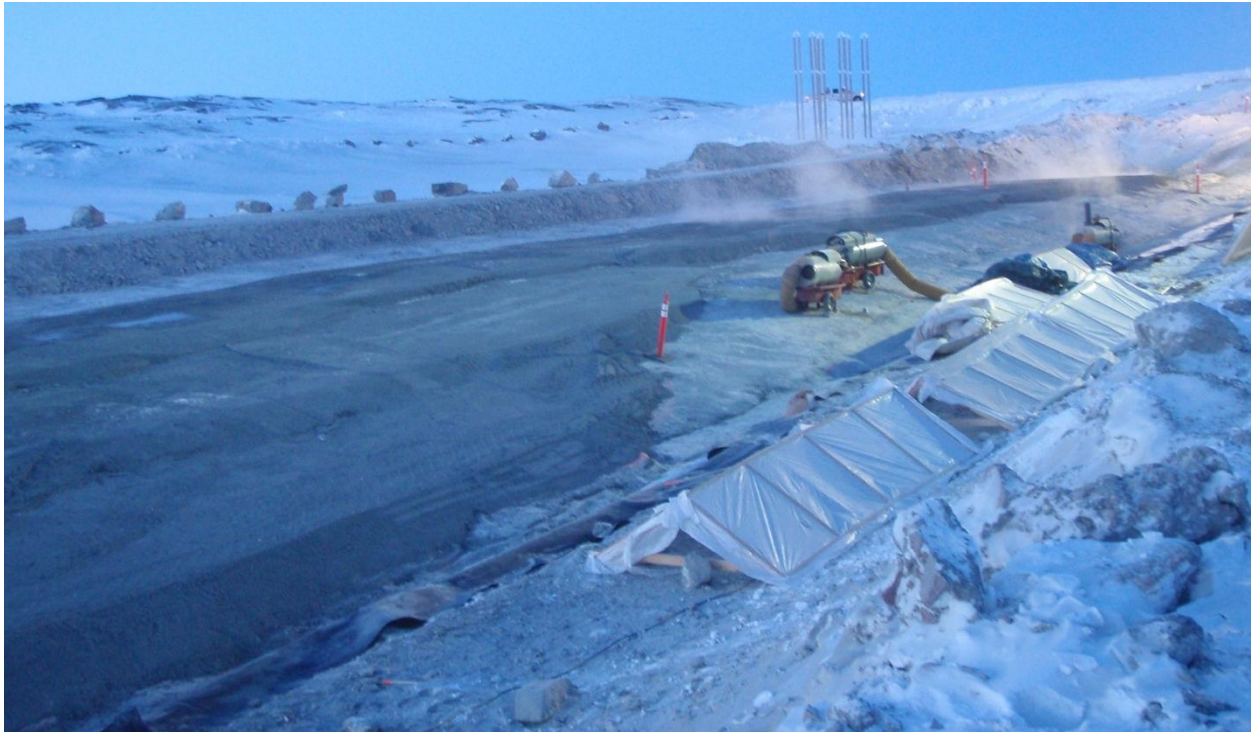
- An area from 1+25 to 0+60 was cleaned for placement; the area had an odd shape dictated by last day's placement.
- Some additional spot cleaning was required near ledges before approval for placement was given.
- Material placed was drier than yesterday, but still had a noticeable sheen in most areas.
- Diligent compaction was observed resulting in smoother finished surfaces.
- All Troxler measurements indicated acceptable saturation and compaction.

Photo 6: Photo of today's FCM placement

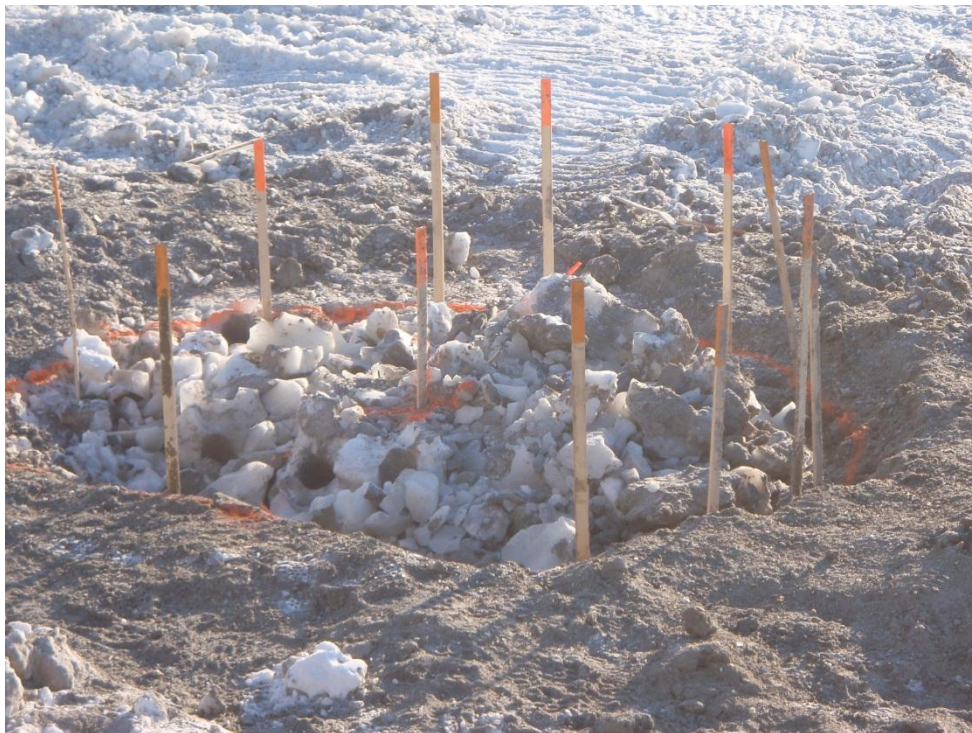
- Cat 330 excavator with ripper tooth started excavations at Sump #1.

Photo 7: Honeycombed drill pattern at Sump #1; orange survey line represents extends of required excavation

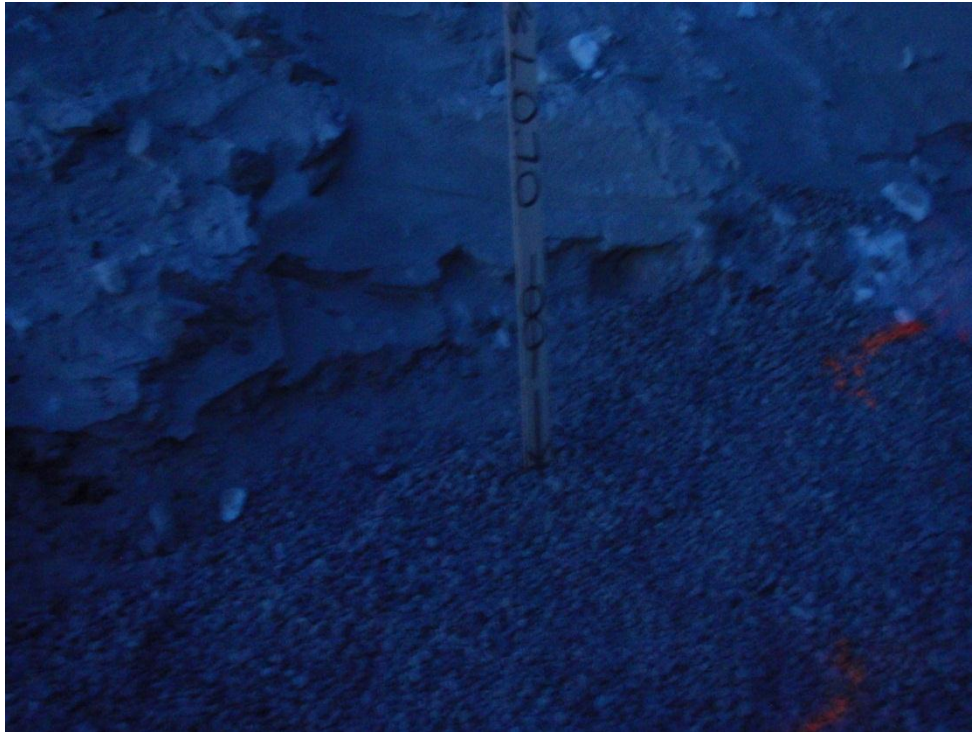
- Cat 325 excavator hoisted bentonite chip bags into the key-trench.
- Labourers continued cleaning the upstream wall for bentonite tie-in; then bentonite was spread in a 100mm lift across the bottom of the key-trench.
- Two 730 haul trucks hauled ROQ to the central berm area; Cat 345 excavator spread ROQ for the berm.
- Survey was present throughout key Diversion Berm activities.

Photo 8: Photo of bentonite tie-in at the base of the Doris North Diversion Berm key-trench

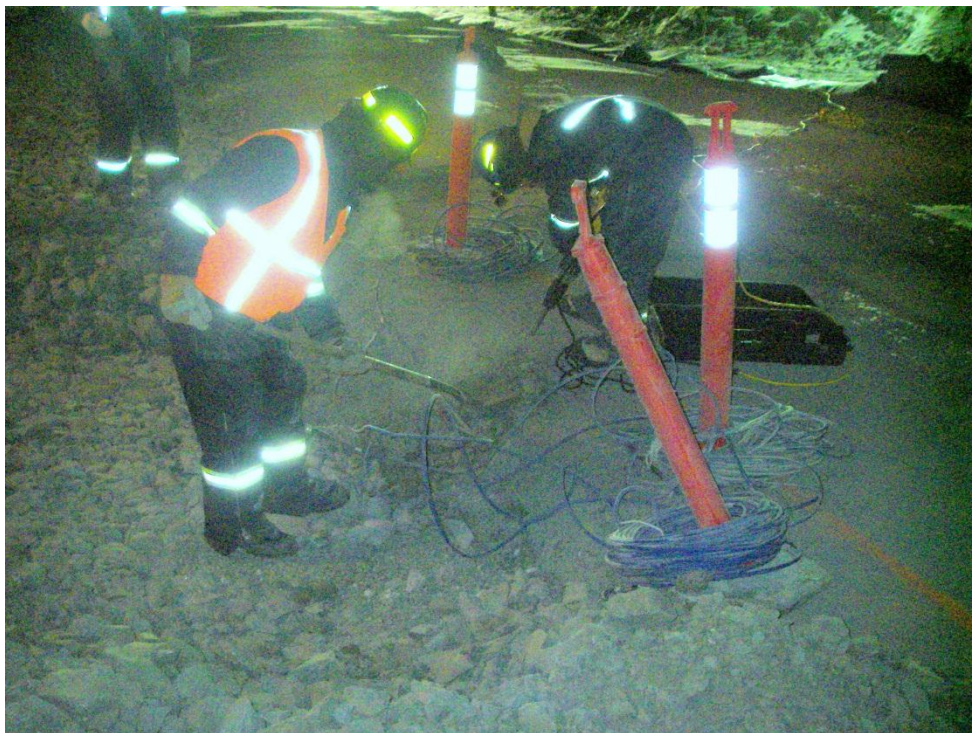
- The overbuilt section at Sta. 1+35 resulted in the encasement on the thermistor cables in the frozen core. The nightshift foreman was notified; workers used a jackhammer to break up the frozen core to get the cables loose.

Photo 9: Workers breaking up the frozen core around the thermistor cables at Sta. 1+30.

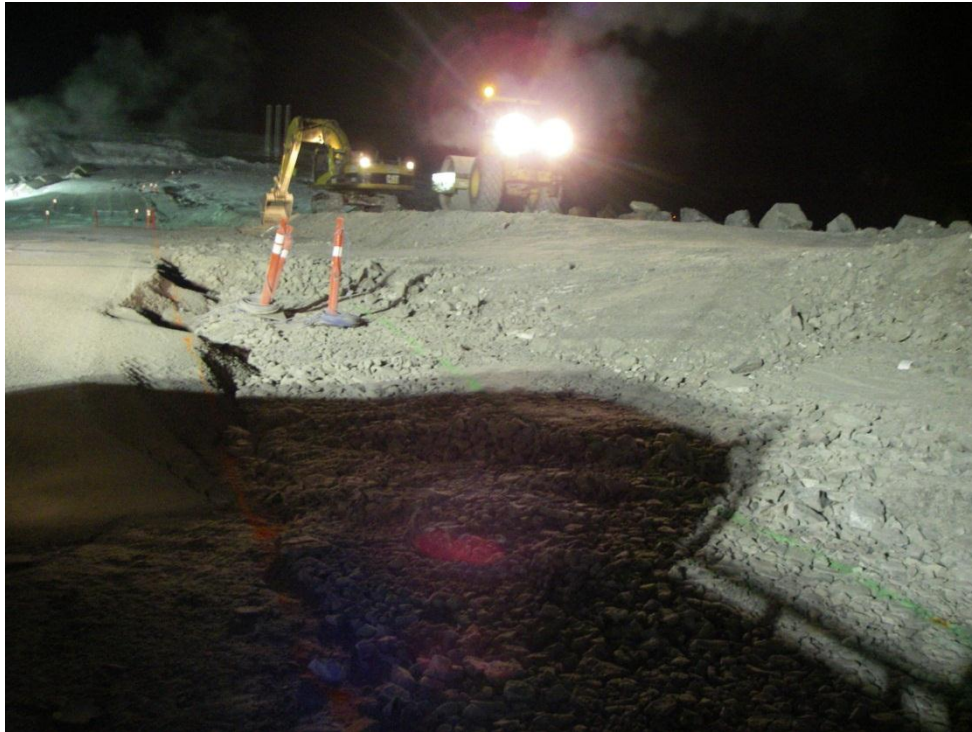
- Transition material was placed and compacted from Sta. 0+60 to Sta 1+10.
- ROQ and Transition material was placed along the core placed on day shift from Sta. 1+10 to Sta. 1+85.
- A new access point into the key trench was created at Sta. 1+70 on the downstream side, by filling a ramp from the ROQ level onto the transition material.

- The FCM placed on Feb. 19 was cleaned with the mechanical broom in preparation for placement on day shift.
- The FCM placed on day shift was overbuilt by as much as 1 m between Sta. 1+30 and 1+50, and slightly underbuilt in one spot around Sta. 1+75.

Photo 10: Access point created at Sta1+70. Note the red line along the frozen core marking the crest of the new lift. The core was slightly underbuilt around Sta. 1+75.
