DAILY REPORT #48 – DORIS NORTH INFRASTRUCTURE/ NORTH DAM

Prepared by:	Murray McGregor Iozsef Miskolczi	Date:	2012.02.22
Reviewed by:		Project #:	1CH008.058.0320
Role	Company	Personnel – Position	On Site
Client	Hope Bay Mining Limited (HBML)	Angela Holzapfel – ESR Compliance Manager David Vokey – ESR Coordinator Don Ethelston – HSLP Advisor Dean Wold - Safety Jill Turk – ESR Coordinator Katsky Venter – ESR Manger Michelle Tanquay – ESR Site Manager Stirling Kelly – HSLP Advisor	No No No No Yes No Yes No
	JDS	Lloyd Jackson – Mechanical Superintendent Doug Fielding – Construction Manager Ishan Fechter – Construction Coordinator Jerry Graham – Construction Manager Kevin Whieldon – Project Coordinator Mark Valeriote – Construction Manager	Yes Yes Yes No No Yes
Engineering Design Consultants	SRK Consulting (Canada) Inc.	John Kurylo – Site Engineer Megan Miller – Site Engineer Lawrence Borowski – Site Engineer Murray McGregor – Site Engineer Iozsef Miskolczi – Site Engineer	No No No Yes Yes

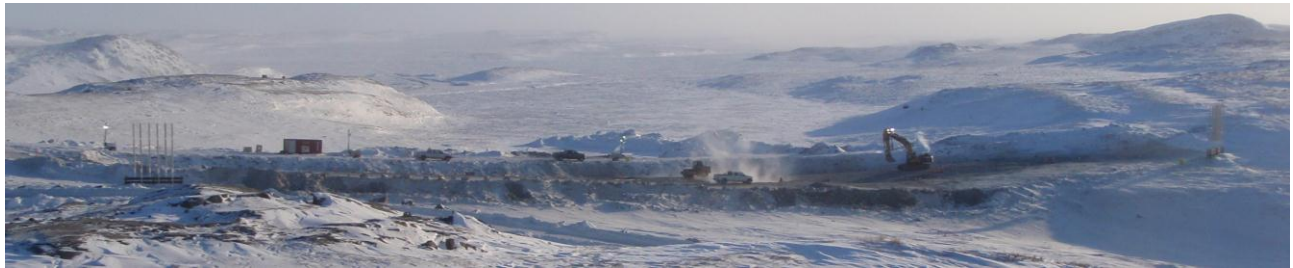
Photo 1: Progress photo of North Dam from photo point 1. ~SSE view

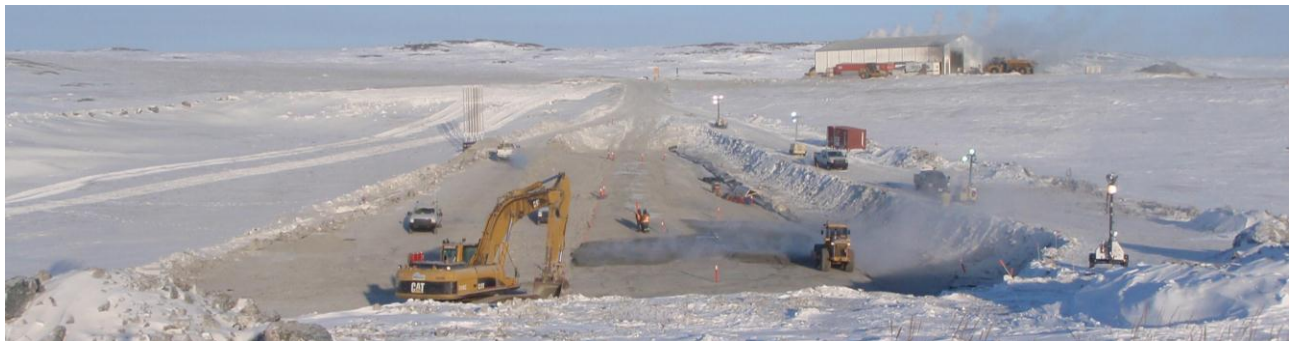
Photo 2: Progress photo of North Dam from photo point 3. ~NE view

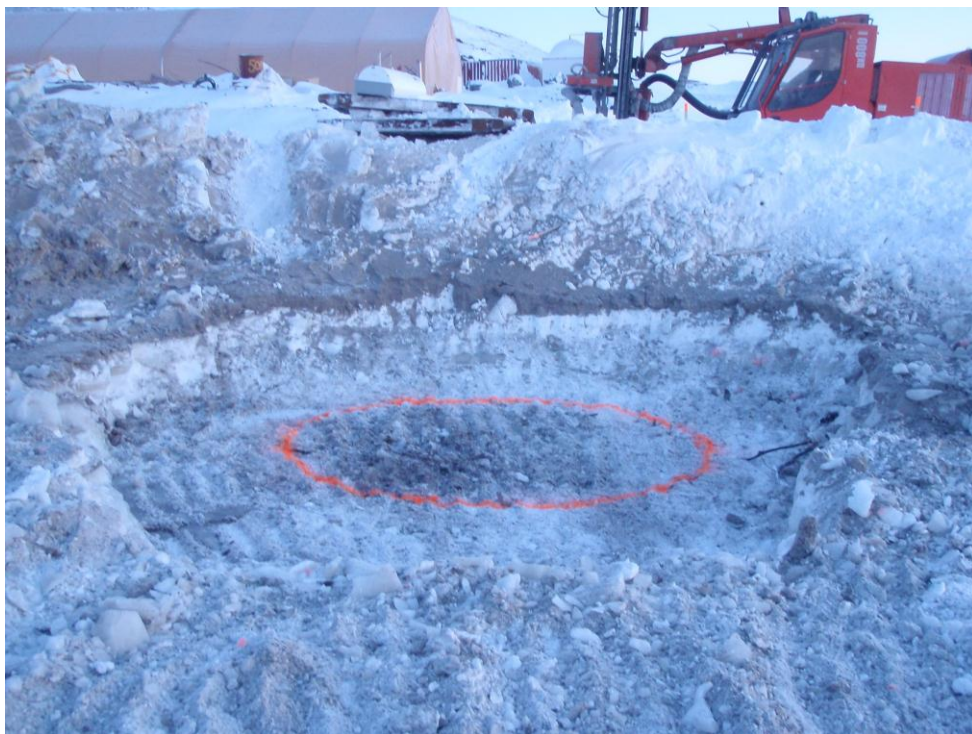
Photo 3: Snow clearing at Sump #1

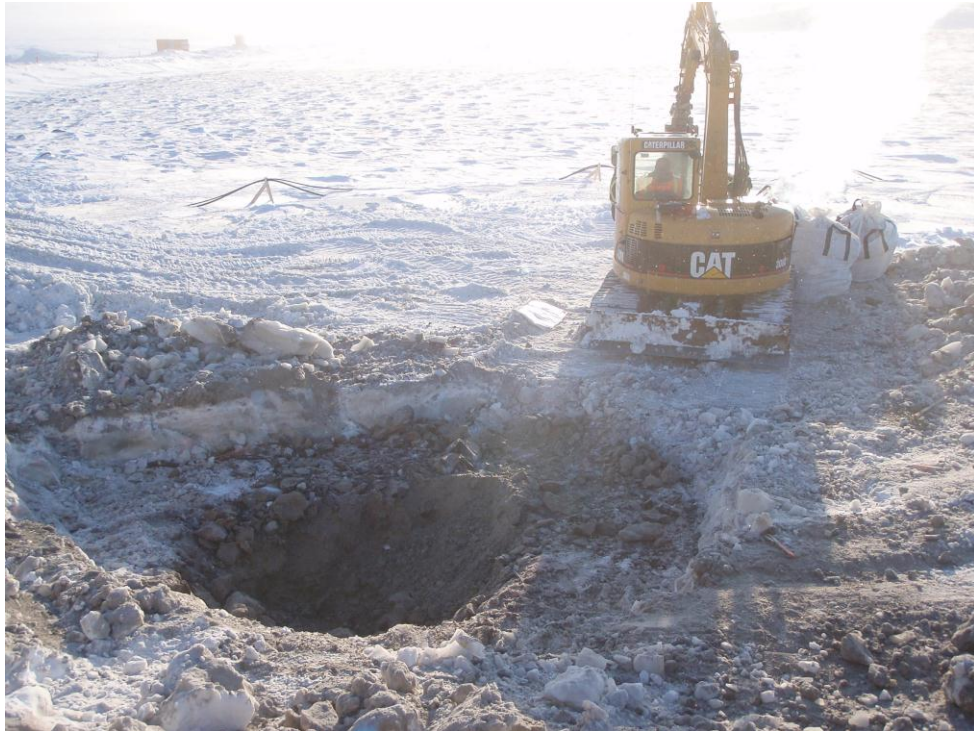
Photo 4: Initial excavation at Sump #1 at 11:00

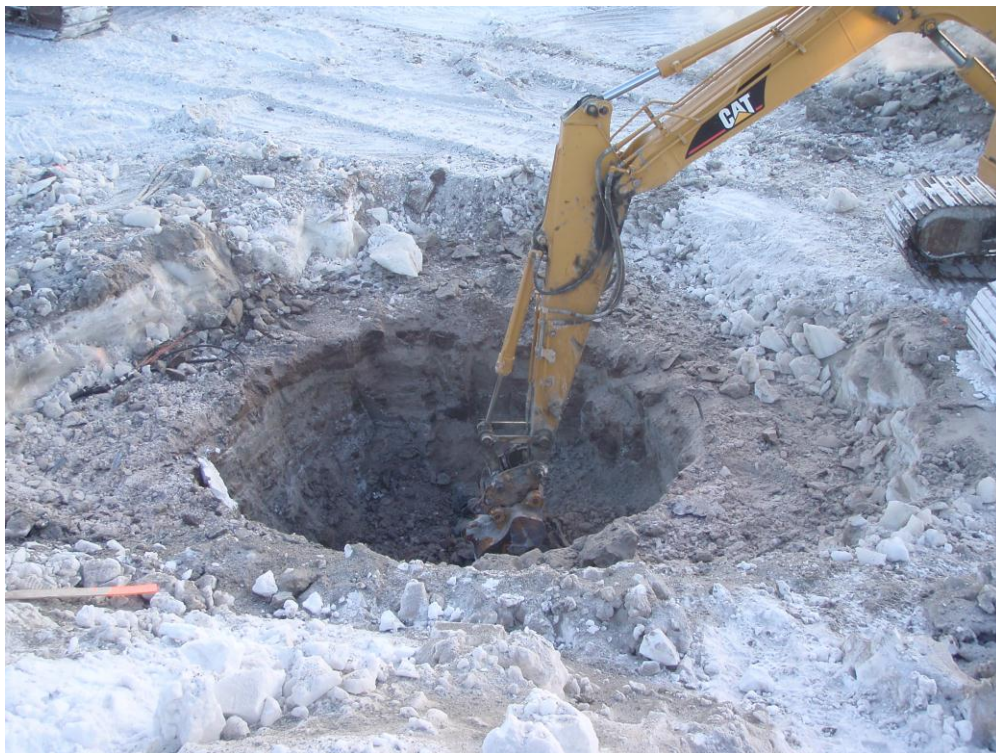
Photo 5: Photo of Sump #1 in the afternoon

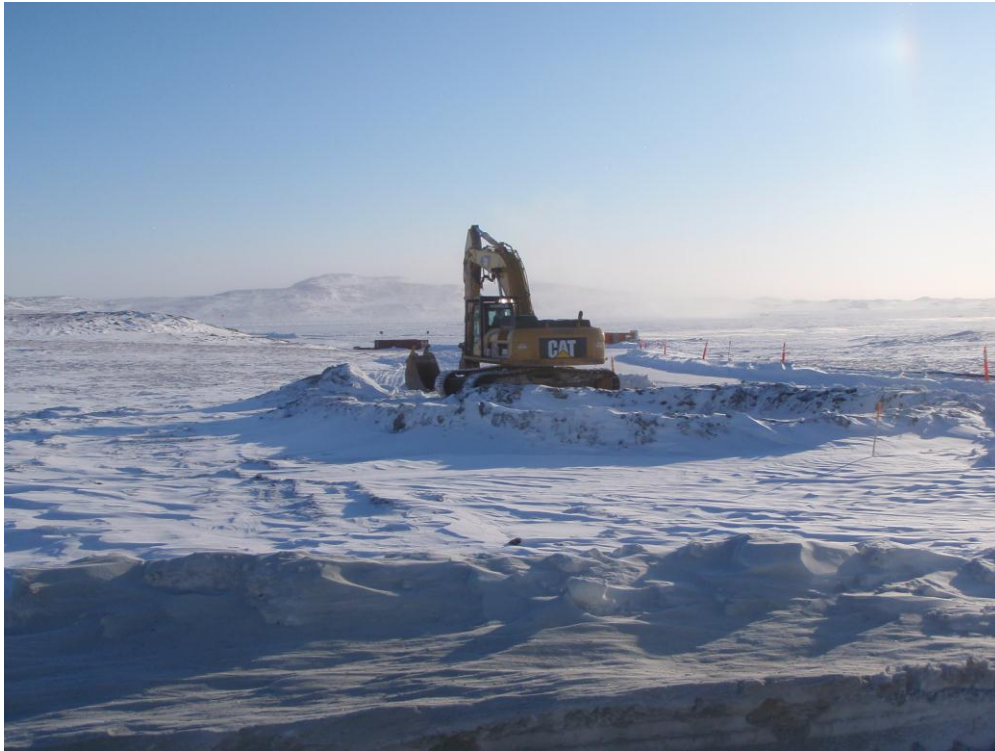
Photo 6: No activity at Sump #2

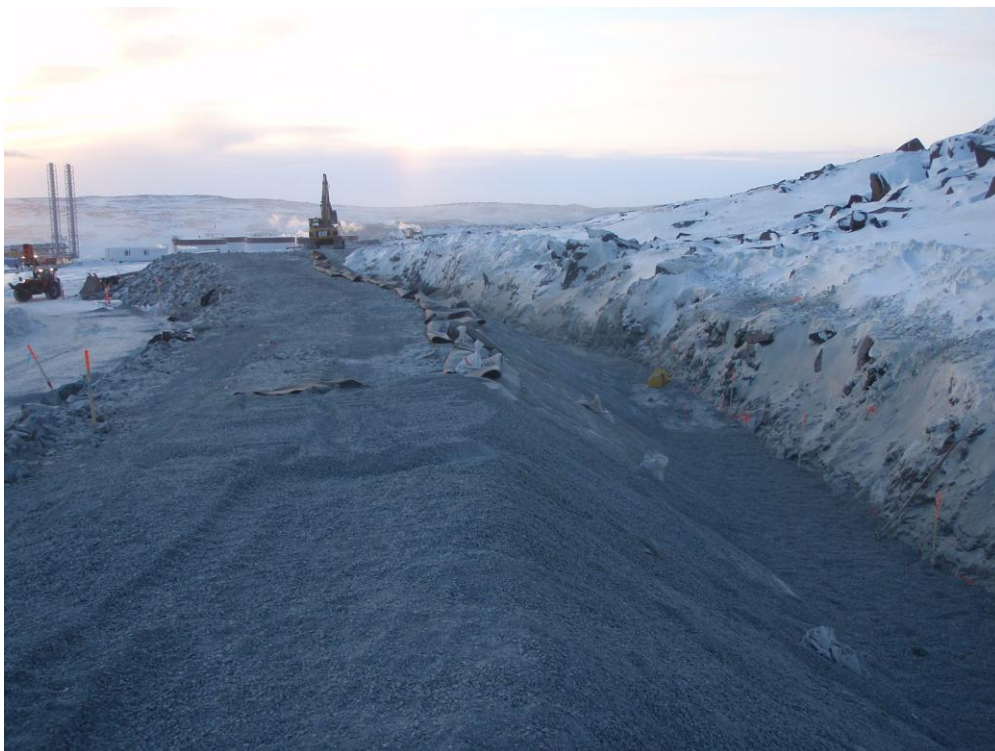
Photo 7: Crush placed atop the lower geotextile at the Doris North Diversion Berm

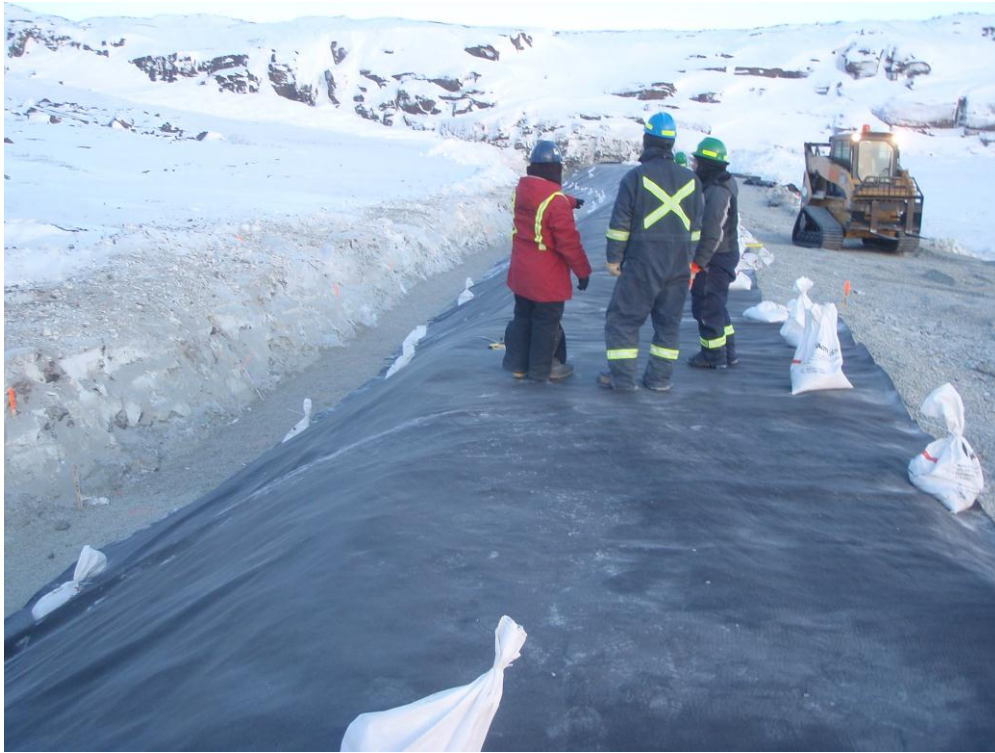
Photo 8: Layfield gathering atop the geotextile under liner

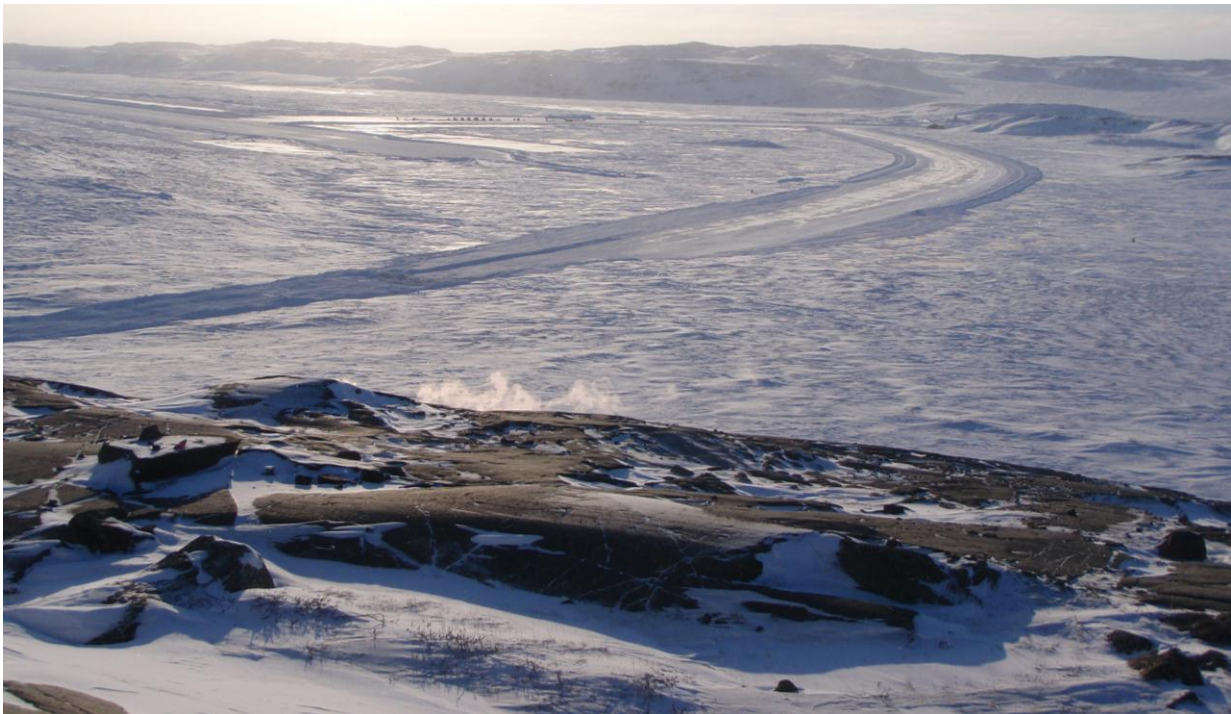
Photo 9: Photo looking west from photo point 1 across the Doris Lake snow road

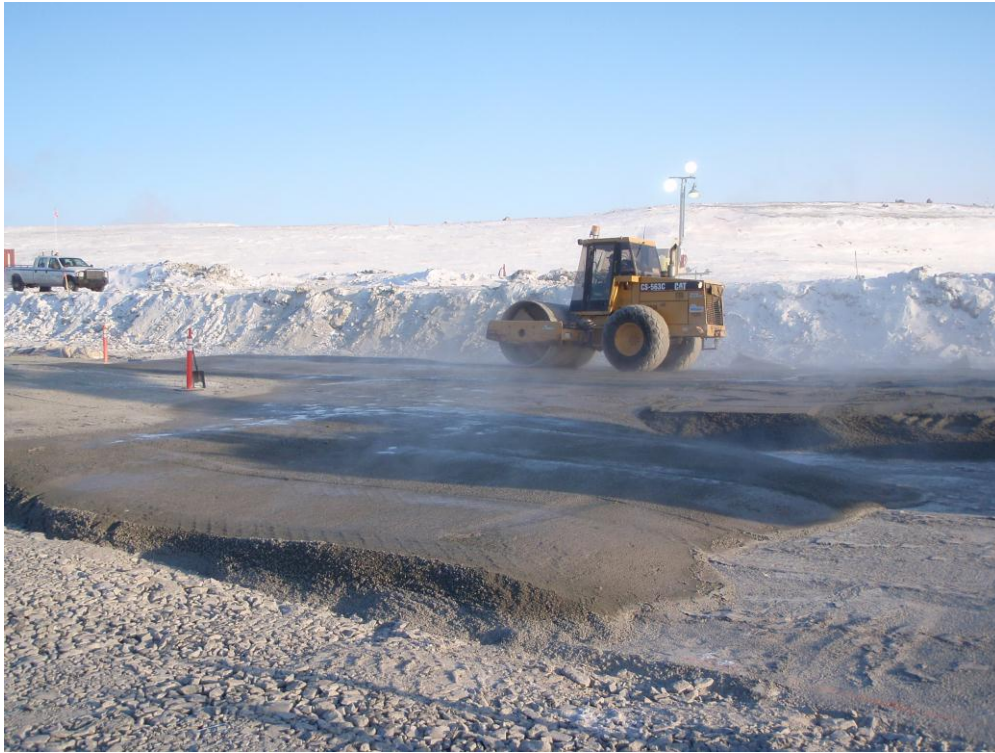
Photo 10: Placement at the north dam; photo taken at 14:00

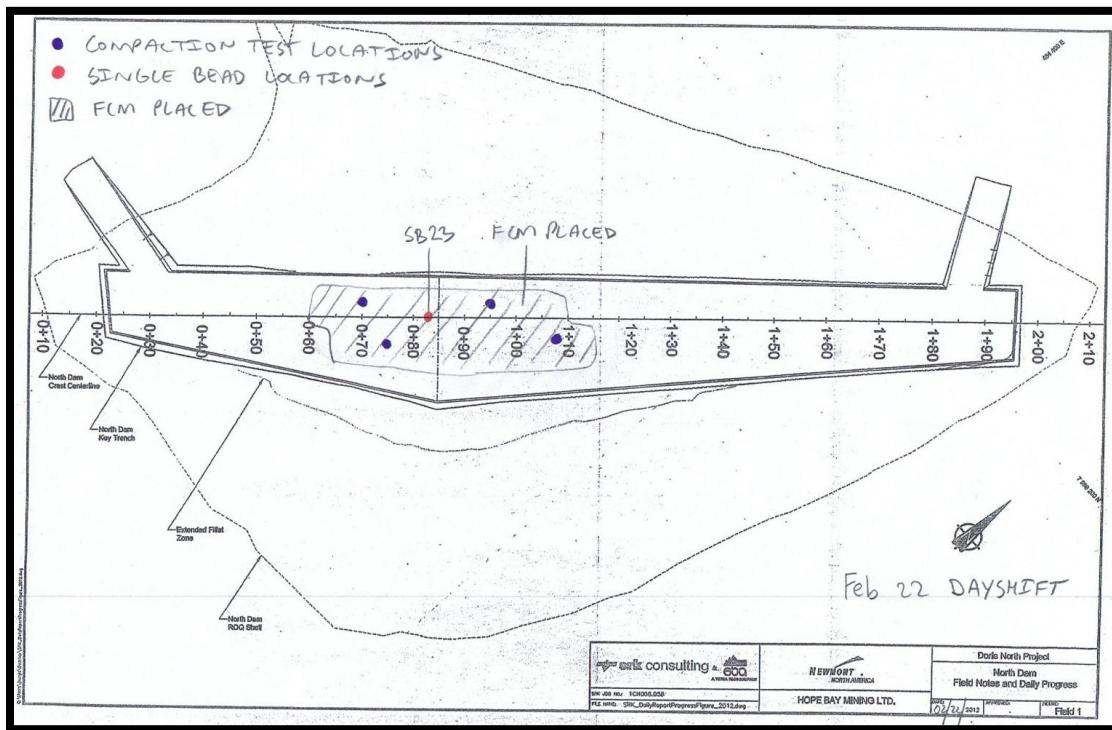
FIGURES:**Figure 1 – North Dam Progress – Dayshift**

- An area from 1+25 to 0+55 was cleaned for placement.
- Material placed had a noticeable sheen; some puddles formed in the low point across the core.
- Diligent compaction was observed on finished surfaces; some extra compaction was needed at the end of shift when material became slightly drier for the last couple loads.
- Cables were unburied by hand at the end of shift to ensure the cables will not freeze into placement.
- All Troxler measurements indicated acceptable saturation and compaction.

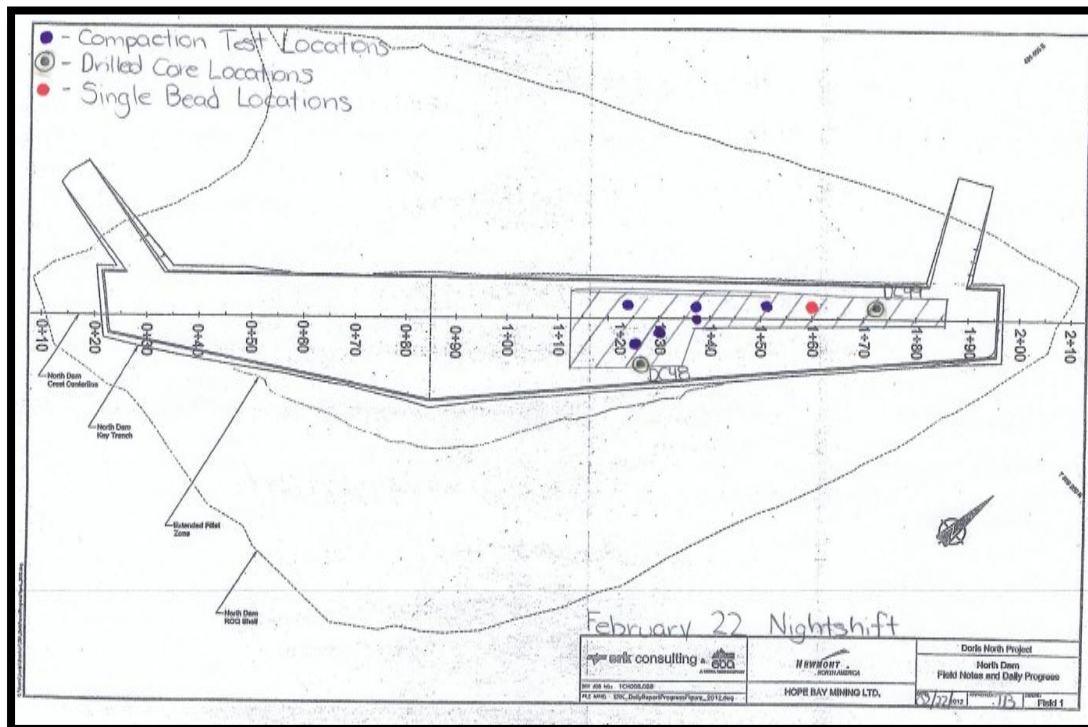
**Figure 2 – North Dam Progress – Nightshift**

- Transition material was placed from Sta. 0+50 to Sta1+10 against the core placed on the previous dayshift.

- A total of 18 loads of core mix were placed from Sta. 1+15 to Sta 1+90.
- No core was placed within 30 cm of the exposed GCL liner edge.
- One single bead thermistor was installed around Sta. 1+60, near the center of the poured strip.
- Good compaction was observed.
- All Troxler measurements indicated acceptable saturation and compaction.
-
