## DAILY REPORT #49 – DORIS NORTH INFRASTRUCTURE/ NORTH DAM

Prepared by:	Murray McGregor Iozsef Miskolczi	Date:	2012.02.23
Reviewed by:		Project #:	1CH008.058.0320
Role	Company	Personnel – Position	On Site
Client	Hope Bay Mining Limited (HBML)	Angela Holzapfel – ESR Compliance Manager David Vokey – ESR Coordinator Don Ethelston – HSLP Advisor Dean Wold - Safety Jill Turk – ESR Coordinator Katsky Venter – ESR Manger Michelle Tanquay – ESR Site Manager Stirling Kelly – HSLP Advisor	No No In No Out No Yes No
	JDS	Lloyd Jackson – Mechanical Superintendent Doug Fielding – Construction Manager Ishan Fechter – Construction Coordinator Jerry Graham – Construction Manager Kevin Whieldon – Project Coordinator Mark Valeriote – Construction Manager	Yes Yes Out No In Out
Engineering Design Consultants	SRK Consulting (Canada) Inc.	John Kurylo – Site Engineer Megan Miller – Site Engineer Lawrence Borowski – Site Engineer Murray McGregor – Site Engineer Iozsef Miskolczi – Site Engineer	No No In Yes Yes

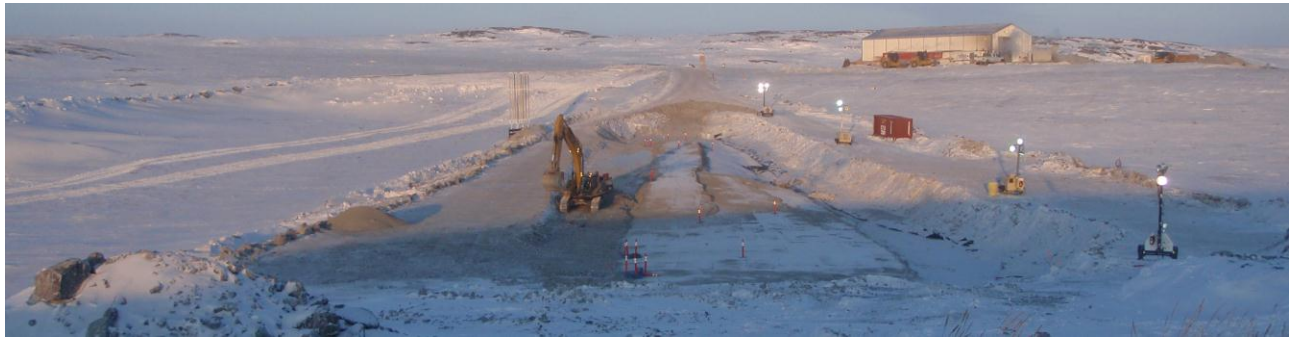
**Photo 1:** Progress photo of North Dam from photo point 3. ~NE view

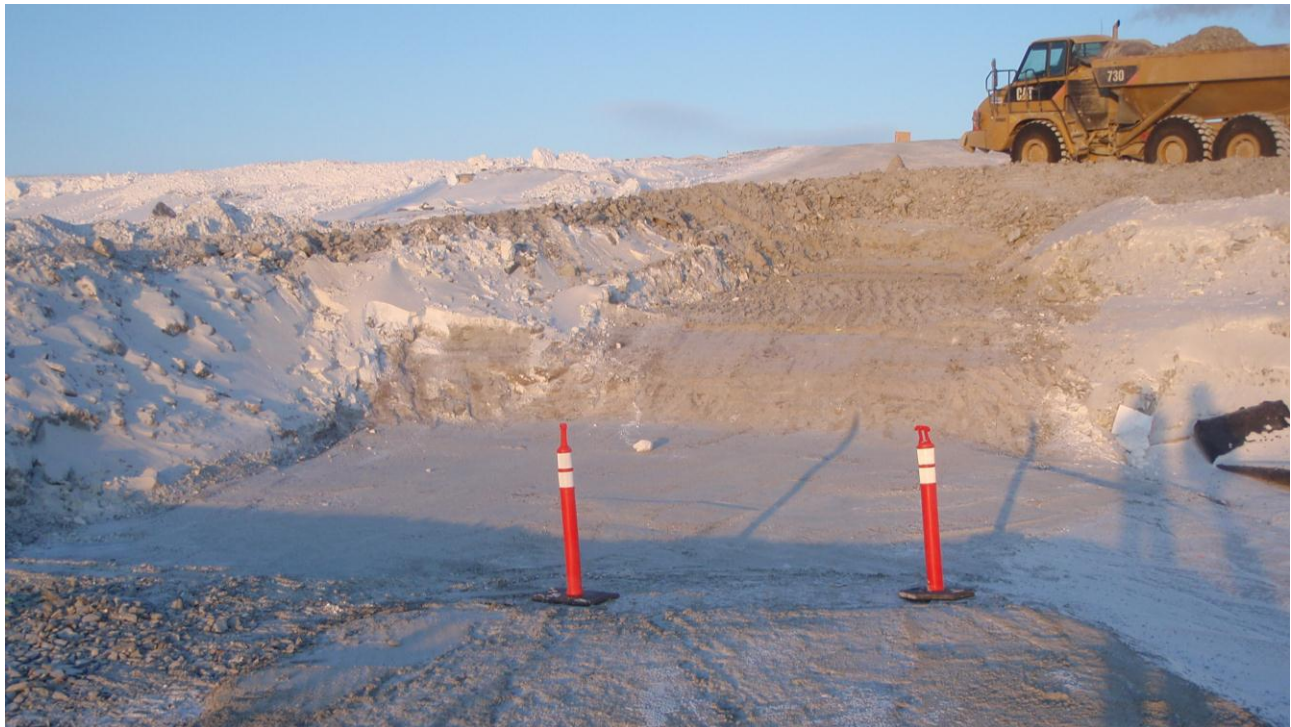
- Excavator, broom and labourers cleaned down to core at the northern tie-in.

**Photo 2:** Removal of debris where the northern core ties in to original ground; this area will no longer be used as access.

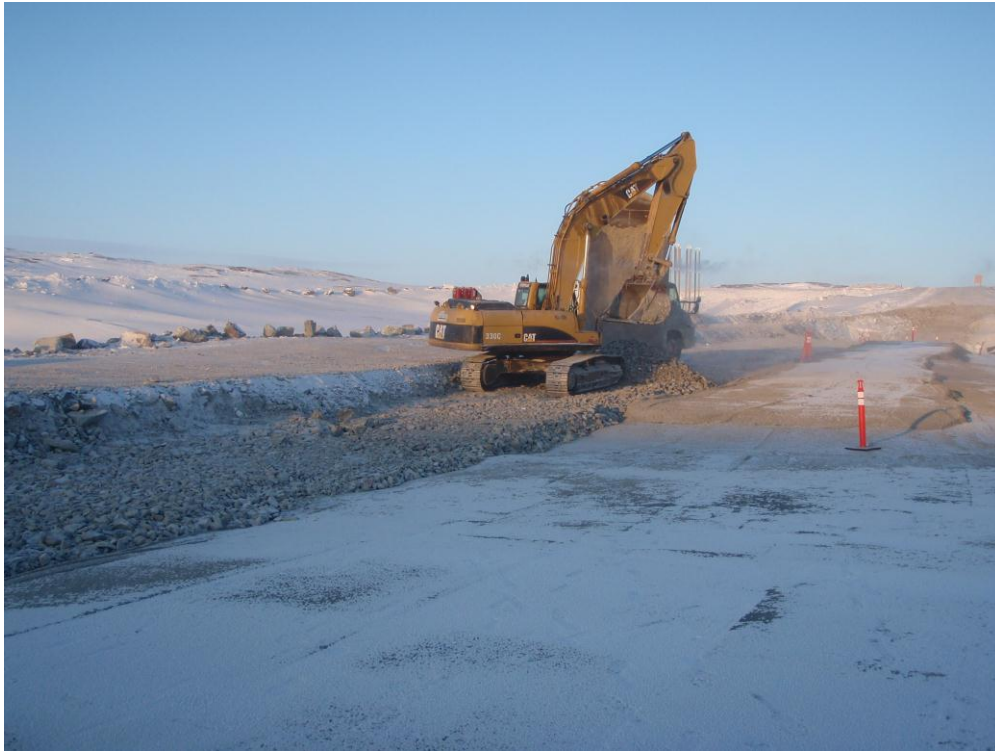
- Transition was placed along the downstream edge from 0+65 to 1+10.
- Crush was placed where thermistor cables daylight.

**Photo 3:** Excavator placing transition material along the downstream side of the dam.

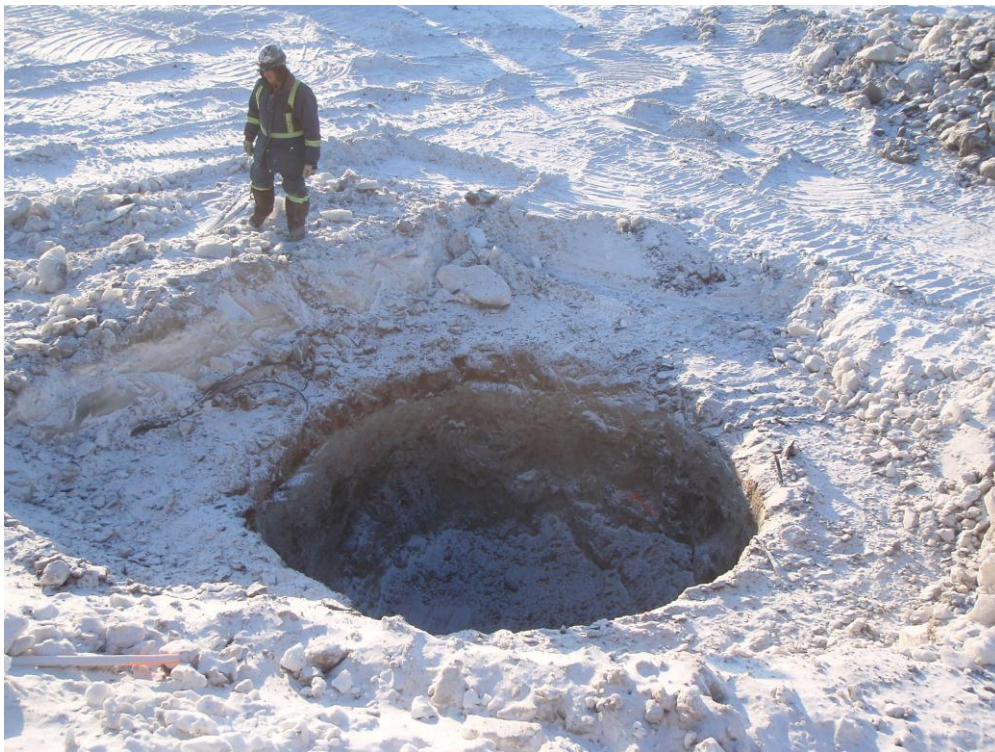
- Cat 308 excavator continued excavations at Sump #1; the excavation is nearly complete.

**Photo 4:** Daily photo of Sump #1 at 10:30, excavation nearly complete.

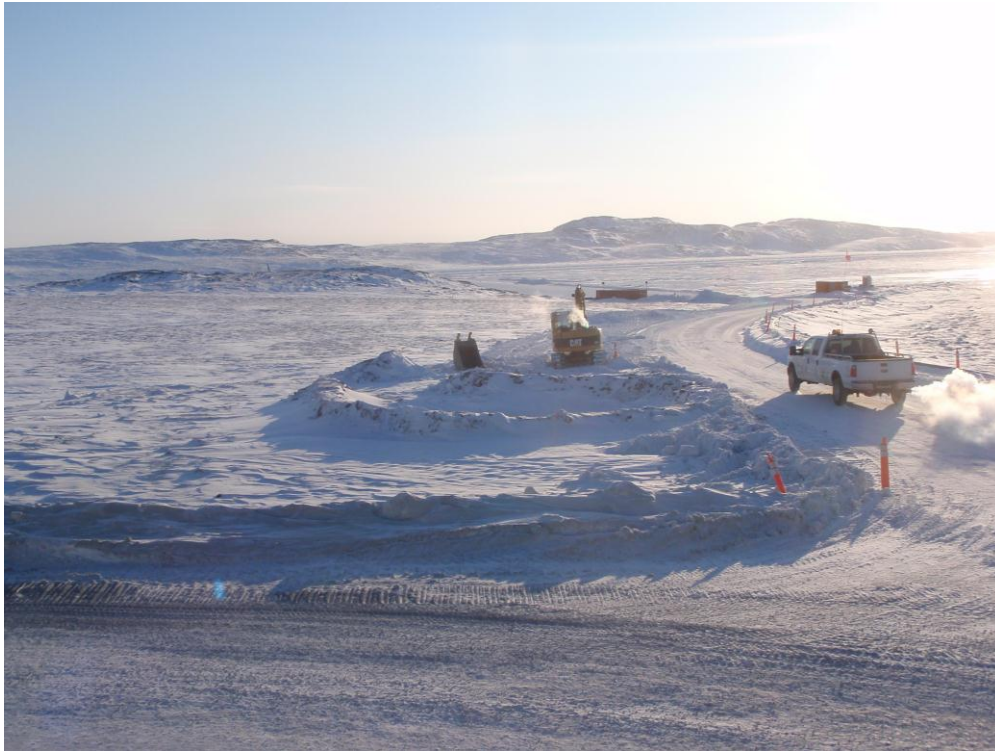
**Photo 5:** Daily photo of Sump #2; no activity in the past several days.

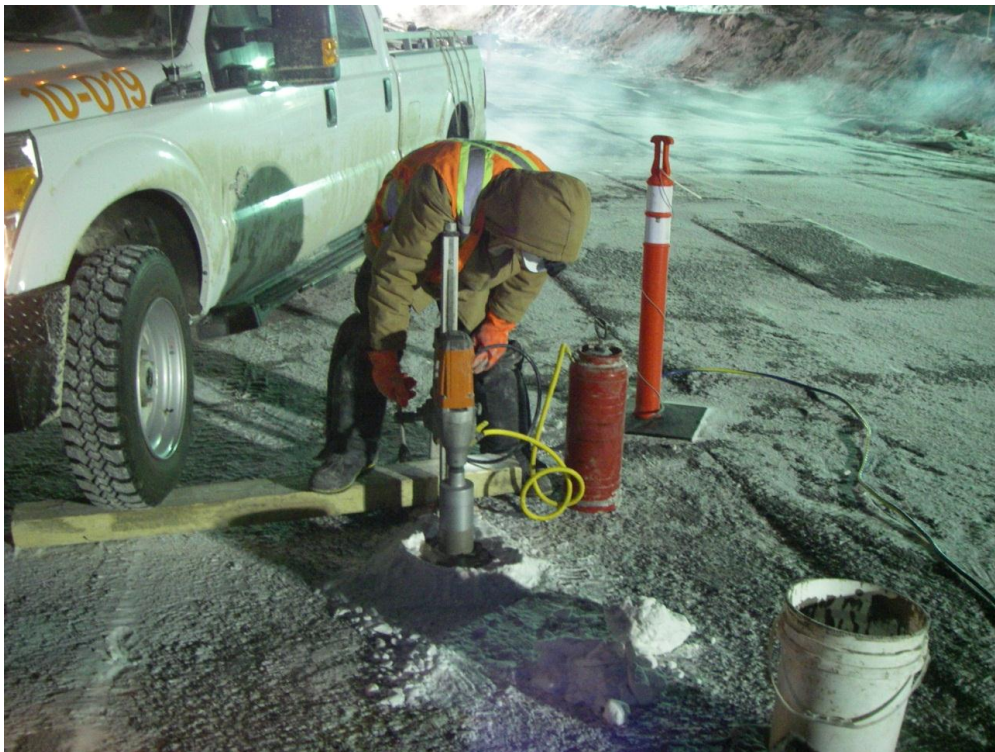
**Photo 6:** Collecting a core sample using the concrete coring machine. Photo looking east from around Sta.0+80.
