DAILY REPORT #50 – DORIS NORTH INFRASTRUCTURE/ NORTH DAM

Prepared by:	Murray McGregor Iozsef Miskolczi Lawrence Borowski	Date:	2012.02.24
Reviewed by:		Project #:	1CH008.058.0320
Role	Company	Personnel – Position	On Site
Client	Hope Bay Mining Limited (HBML)	Angela Holzapfel – ESR Compliance Manager David Vokey – ESR Coordinator Don Ethelston – HSLP Advisor Dean Wold - Safety Jill Turk – ESR Coordinator Katsky Venter – ESR Manger Michelle Tanquay – ESR Site Manager Stirling Kelly – HSLP Advisor	No No Yes No No No Yes No
	JDS	Lloyd Jackson – Mechanical Superintendent Doug Fielding – Construction Manager Ishan Fechter – Construction Coordinator Jerry Graham – Construction Manager Kevin Whieldon – Project Coordinator Mark Valeriote – Construction Manager	Yes Yes No No Yes No
Engineering Design Consultants	SRK Consulting (Canada) Inc.	John Kurylo – Site Engineer Megan Miller – Site Engineer Lawrence Borowski – Site Engineer Murray McGregor – Site Engineer Iozsef Miskolczi – Site Engineer	No No Yes Yes Yes

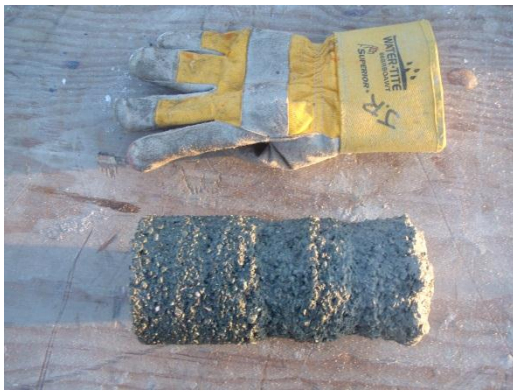
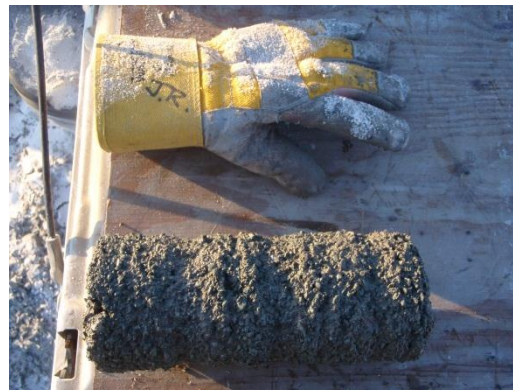
Photos 7&8: Drill core ND-CORE-DC52-20120224 and drill core ND-CORE-DC53-20120224 respectively.

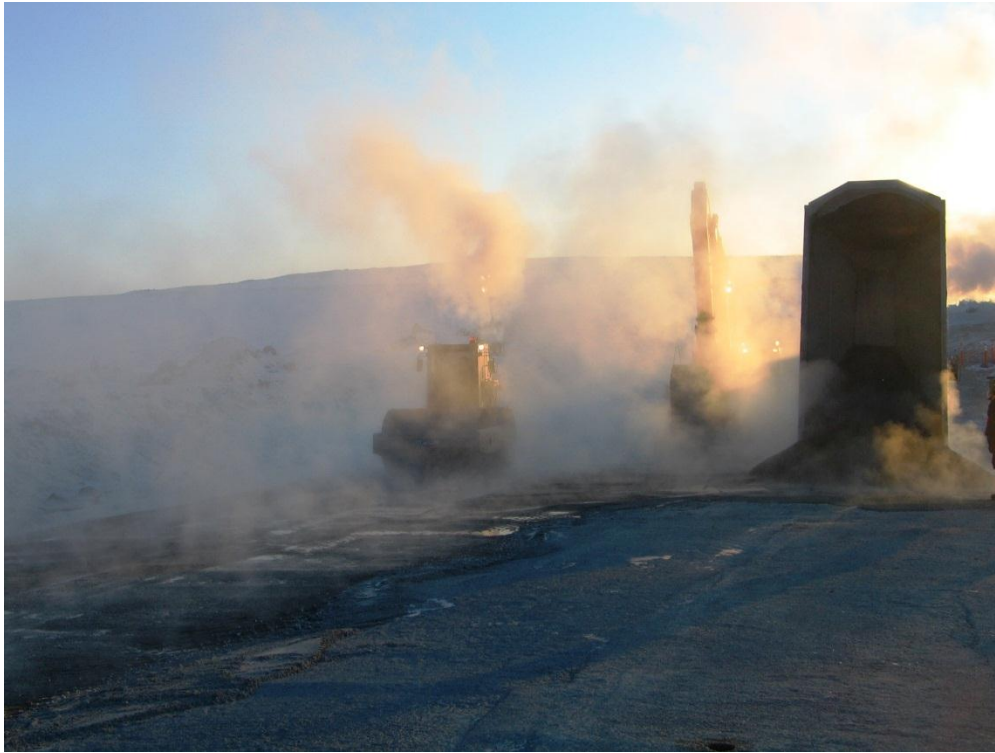
- Placement started from 1+30 upstream, and then fanned out over the entire dam to 0+80.
- Some placement was thicker than the optimal 250mm.
- One single bead was added at 0+85 chainage.
- Minor bleeding was observed on most of the FCM placed.

Photo 10: Today's frozen core placement. A sheen was consistently present on the surface. Steam caused poor visibility from the excavator cab.

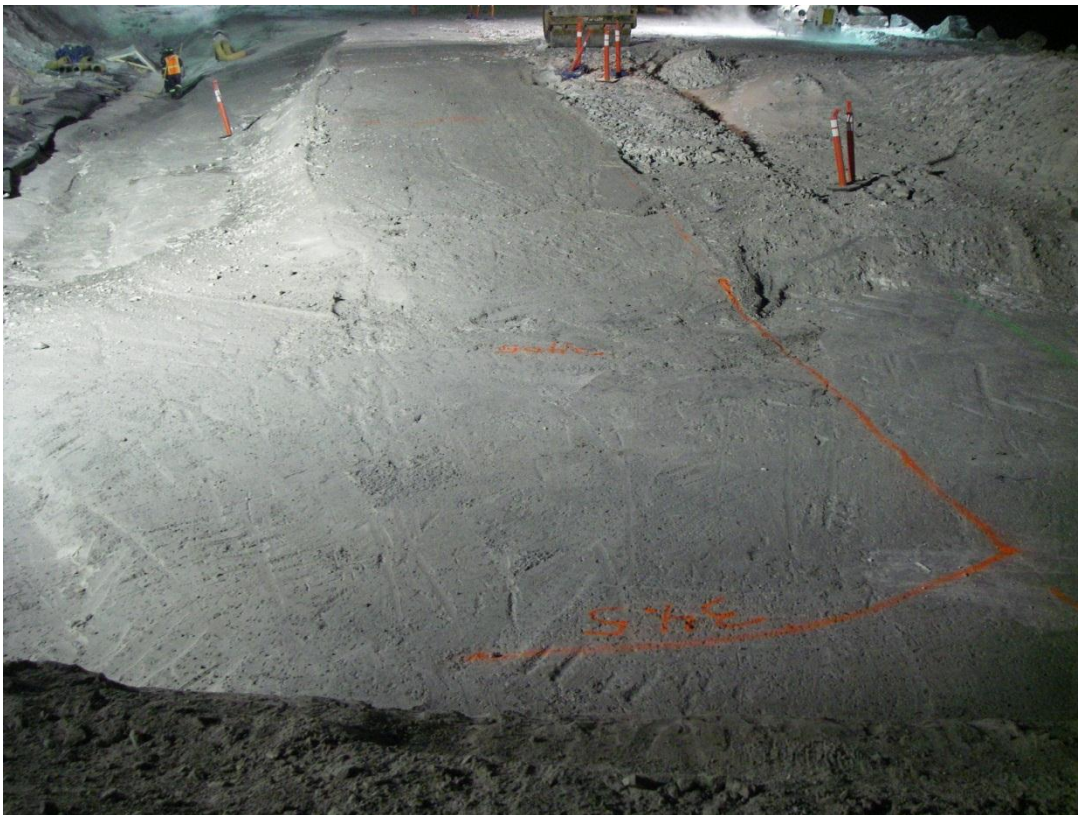
Photo 11: Photo of the north-east end of the frozen core. The surveyor marked up the current elevation of the core (34.5 m).

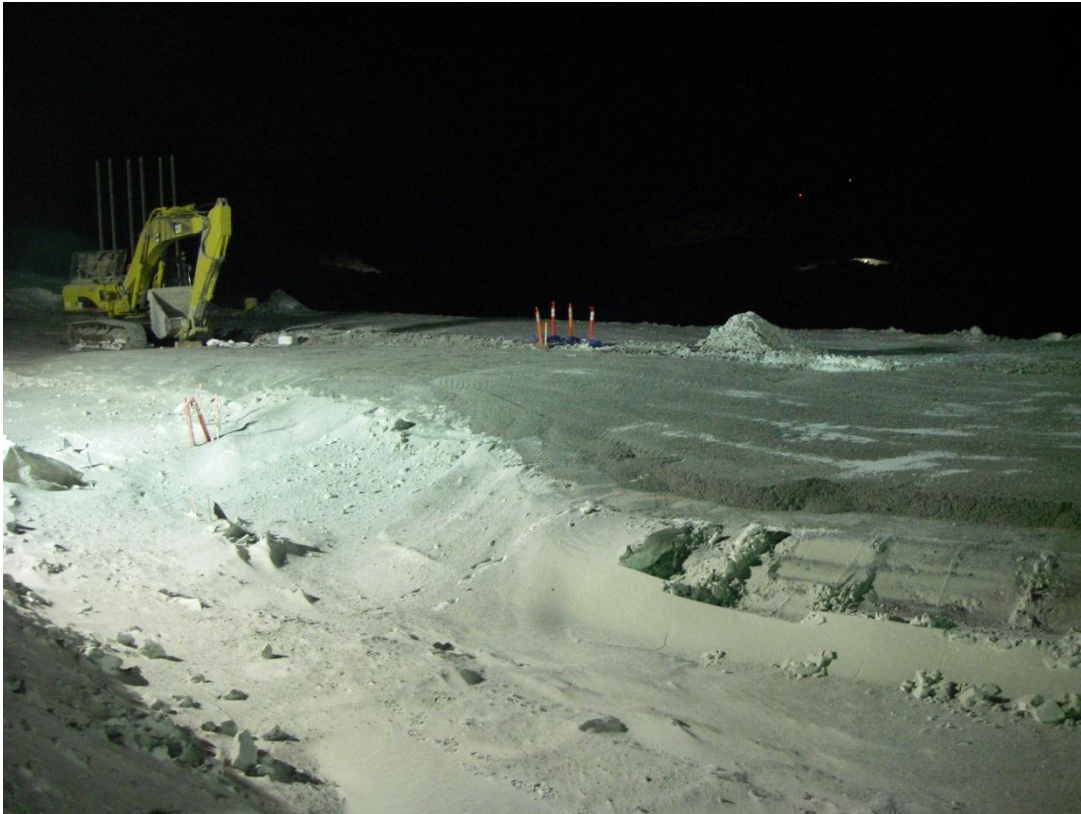
- Core placement continued from dayshift, with a hot shift change. Core placement stopped around 7PM when the CAT 330 excavator broke down on the placement area. Mechanics were working on disengaging the drive cogs to move the excavator off the frozen core, but by the end of the nightshift the excavator was still parked in the same spot. No further placements occurred on nightshift.
- The extreme south end of the key-trench was cleared of snow and the excess 5/8 was excavated to the edge of the liner. Spot checks of the elevation were done by the surveyor and SRK and it was found that essentially all the 5/8 crush was removed. The area was approved for dental cleaning before core placement.

Photo 12: Photo of the southern extent of the frozen core placed on dayshift. The CAT 330 excavator broke down in the work area and could not be moved.

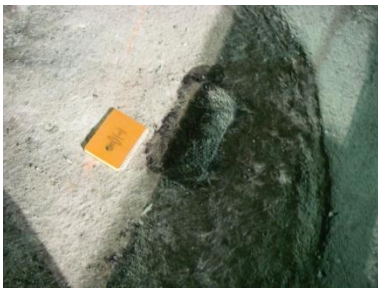
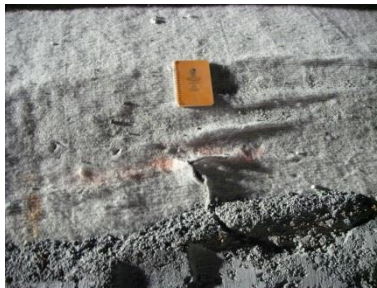
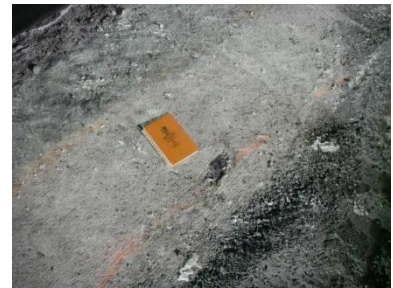
Photo 13: Examples of tears in the GCL liner between Sta. 1+50 and 1+85. Note the field book (12 cm x18 cm) for size reference.

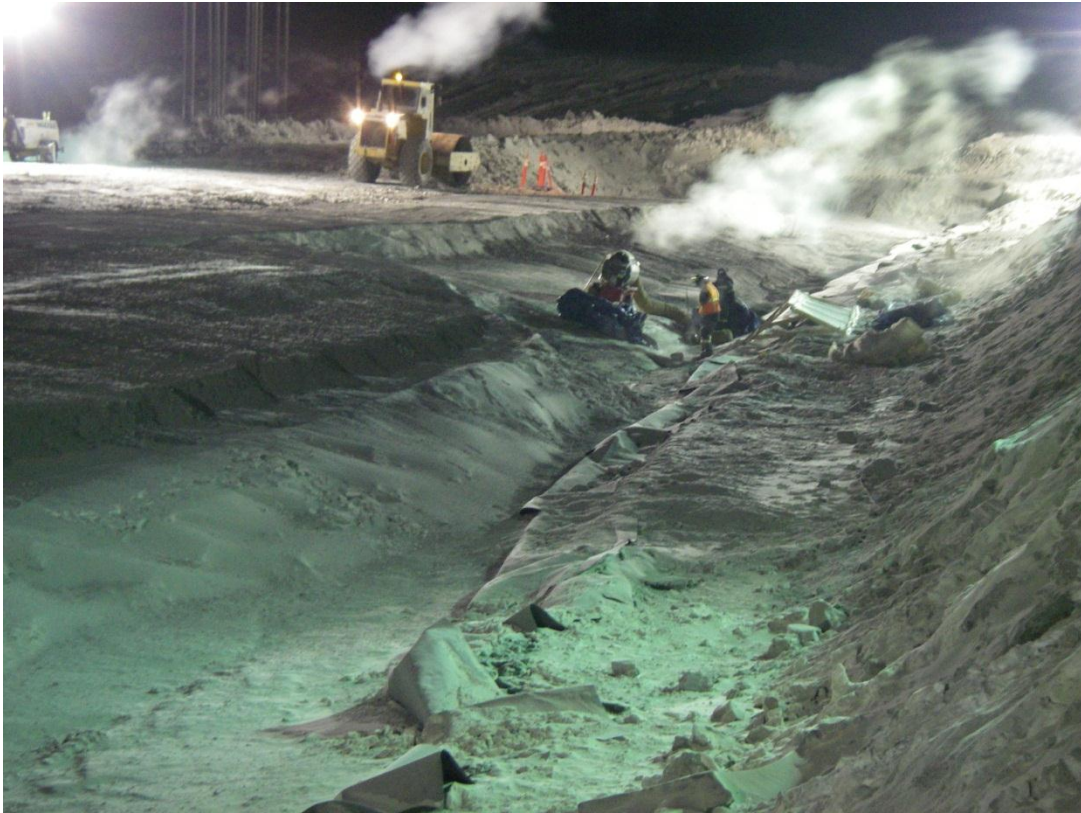
Photo 9: Workers cleaning the frozen core and the GCL liner near Sta. 1+40. Photo looking north from Sta. 1+00.
