DAILY REPORT #51 – DORIS NORTH INFRASTRUCTURE/ NORTH DAM

Prepared by:	Murray McGregor Iozsef Miskolczi Lawrence Borowski	Date:	2012.02.25
Reviewed by:		Project #:	1CH008.058.0320
Role	Company	Personnel – Position	On Site
Client	Hope Bay Mining Limited (HBML)	Angela Holzapfel – ESR Compliance Manager David Vokey – ESR Coordinator Don Ethelston – HSLP Advisor Dean Wold - Safety Jill Turk – ESR Coordinator Katsky Venter – ESR Manger Michelle Tanquay – ESR Site Manager Stirling Kelly – HSLP Advisor	No No Yes No No No Yes No
	JDS	Lloyd Jackson – Mechanical Superintendent Doug Fielding – Construction Manager Ishan Fechter – Construction Coordinator Jerry Graham – Construction Manager Kevin Whieldon – Project Coordinator Mark Valeriote – Construction Manager	Yes Yes No No Yes No
Engineering Design Consultants	SRK Consulting (Canada) Inc.	John Kurylo – Site Engineer Megan Miller – Site Engineer Lawrence Borowski – Site Engineer Murray McGregor – Site Engineer Iozsef Miskolczi – Site Engineer	No No Yes Yes Yes

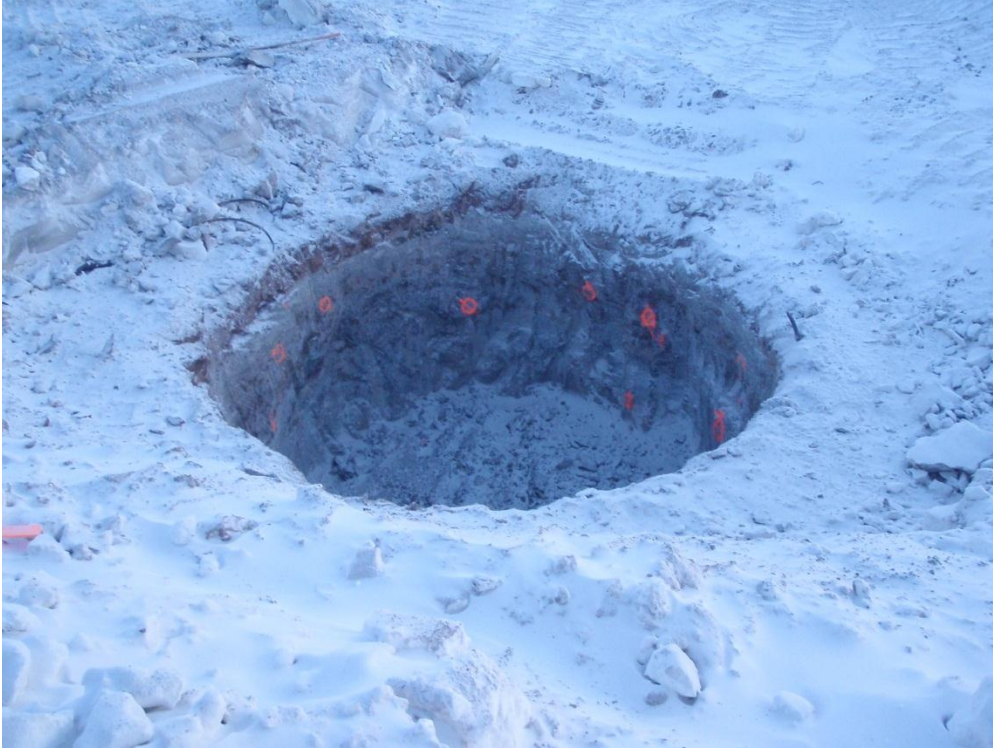
Photo 1: Daily progress photo of Sump #1.

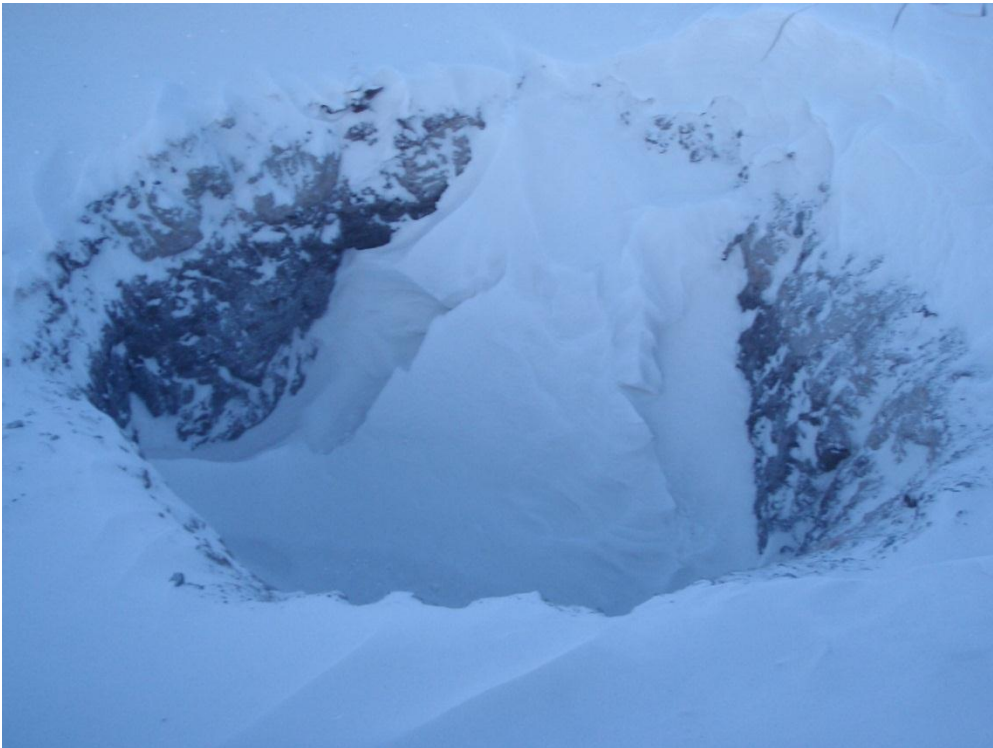
Photo 2: Daily progress photo of Sump #2.

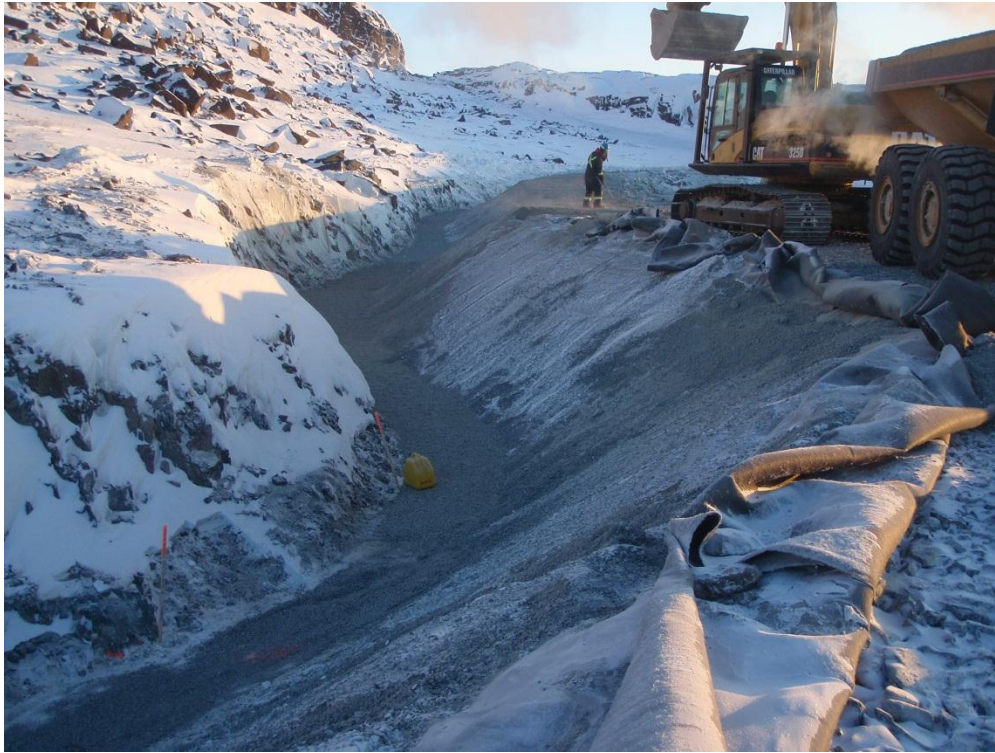
- Layfield continued to lay geotextile above the lower crush layer with the zoom boom
- Cat 325 excavator removed debris from the key-trench in the morning; then placed old FCM in the key-trench in the afternoon.
- Two labourers assisted with plate tamper compaction, raking crush and installing liner.

Photos 3: Photo of the Doris North Diversion Berm; excavator placing crush along the crest. Bentonite chips along the base of the key-trench extend up to the jerry-can.

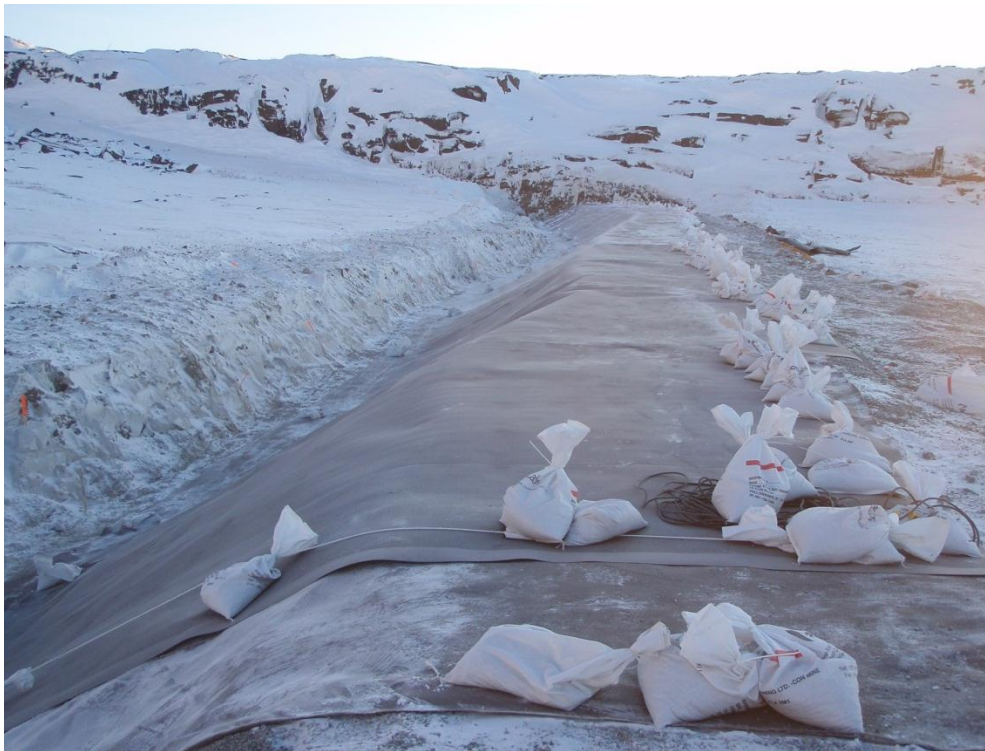
Photos 4: Extent of current HDPE placement; approximately 100m of placement to date.

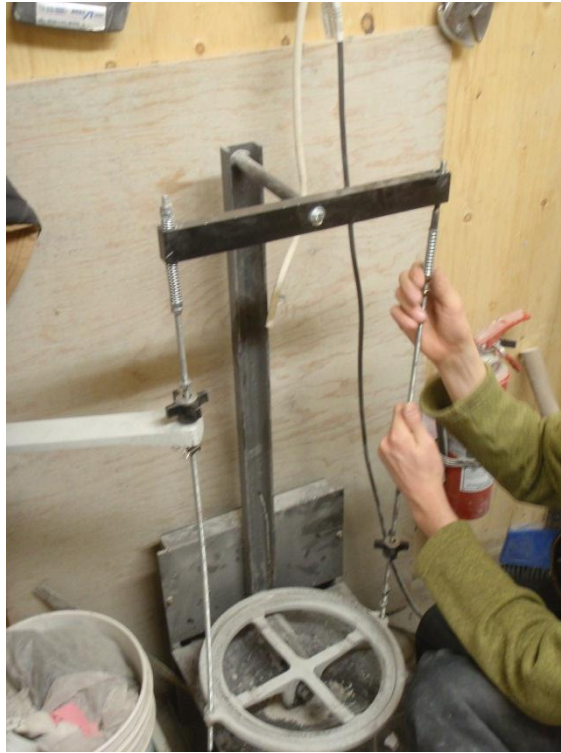
Photo 5: Repairing the sieve shaker in the geotechnical lab.

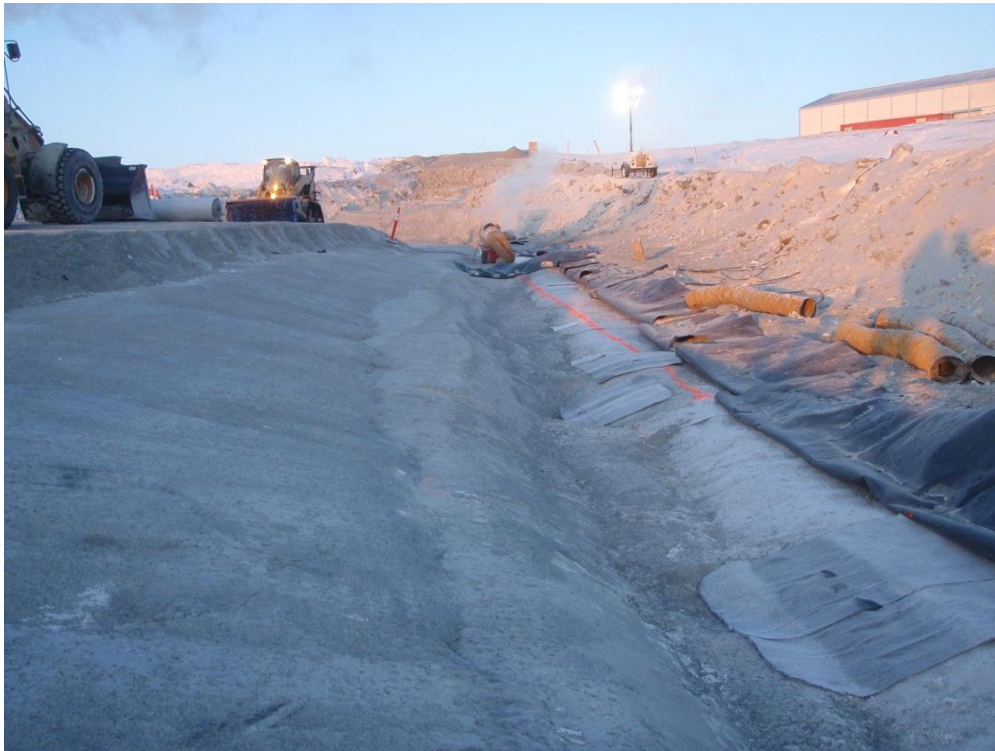
- Mechanics had difficulty removing the Cat 330 excavator with a blown engine; a dozer was used to assist its decent down the hill onto the low-bed.
- Labourers exposed more liner and cut GCL patches for torn sections from chainage 1+90 to 1+50; good dental cleaning was observed.
- Patches have not yet been sealed with bentonite powder.
- No material was placed during dayshift.

Photo 6: Dental cleaning from chainage 1+50 to 1+90 at the dam. Patches were cut and placed over tears; no bentonite has been applied at this point.

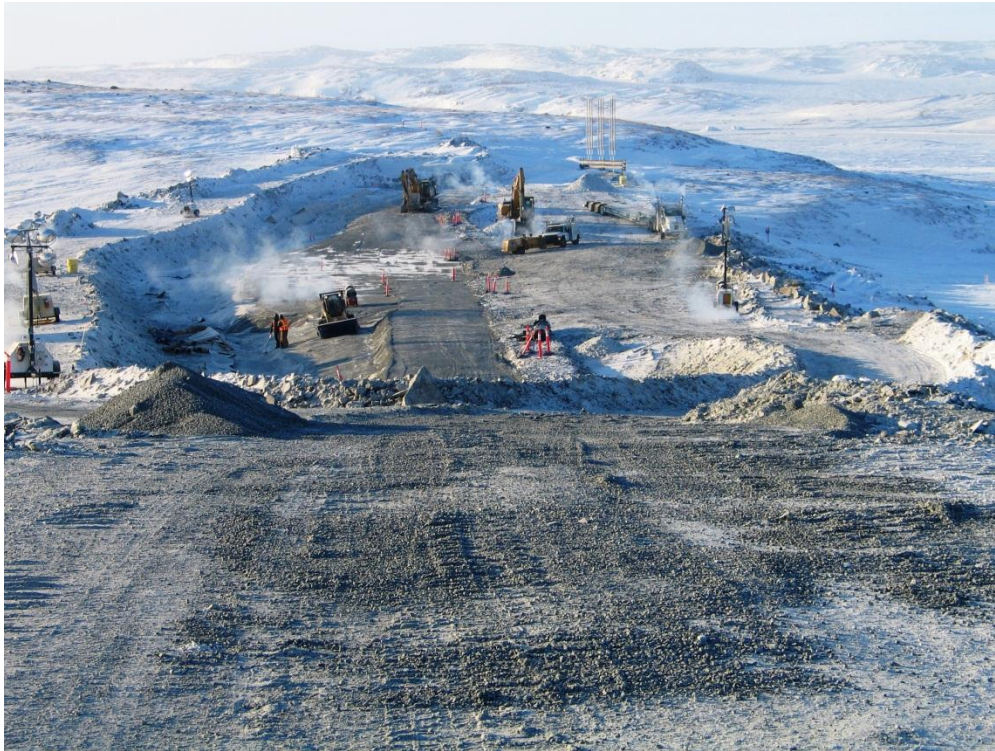
Photo 7: Photo of dam activities during the day, view SW.

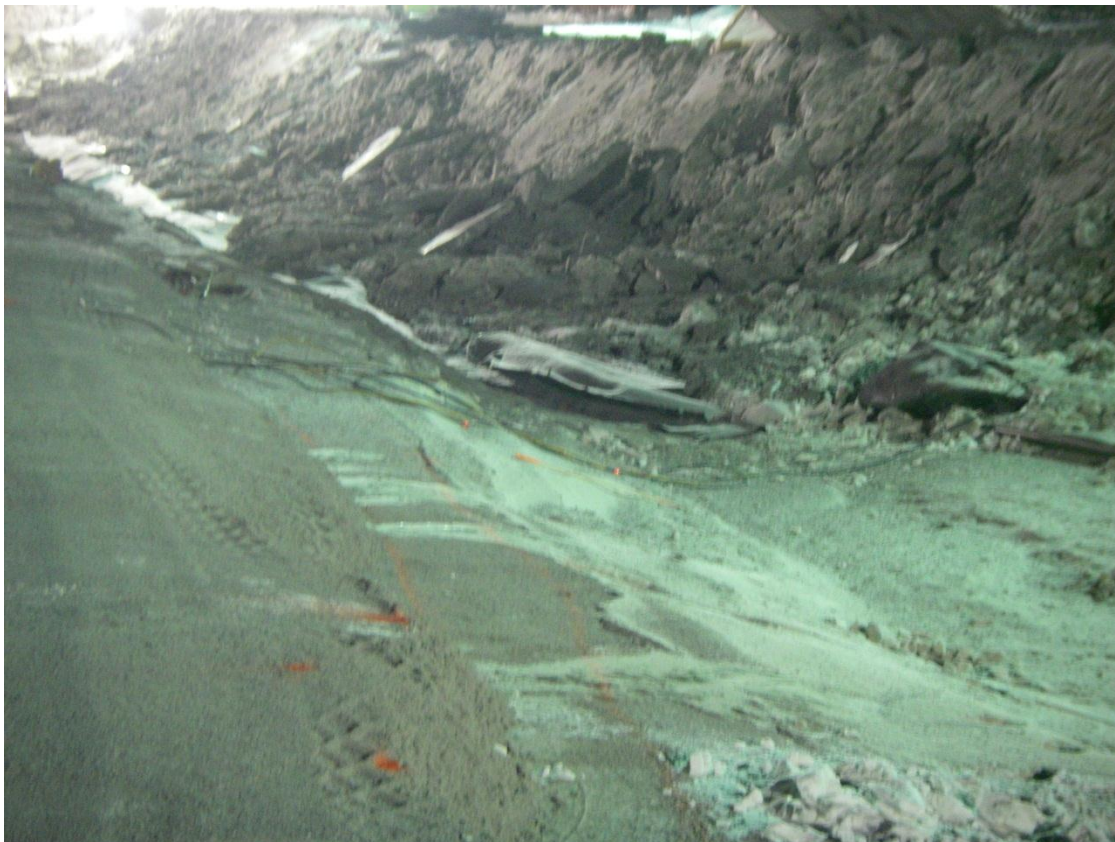
- The 5/8 crush covering the HDPE liner past the exposed GCL was ripped with the Cat 345 excavator. The material broke up in large blocks, at it appeared to not be sticking to the HDEP liner.

Photo 8: The 5/8 crush protecting the liner broken up. Photo looking east from Sta. 1+35.
