## DAILY REPORT #52 – DORIS NORTH INFRASTRUCTURE/ NORTH DAM

<b>Prepared by:</b>	Ioşef Miskolczi Lawrence Borowski	<b>Date:</b>	2012.02.26
<b>Reviewed by:</b>		<b>Project #:</b>	1CH008.058.0320
<b>Role</b>	<b>Company</b>	<b>Personnel – Position</b>	<b>On Site</b>
Client	Hope Bay Mining Limited (HBML)	Angela Holzapfel – ESR Compliance Manager David Vokey – ESR Coordinator Don Ethelston – HSLP Advisor Dean Wold - Safety Jill Turk – ESR Coordinator Katsky Venter – ESR Manger Michelle Tanquay – ESR Site Manager Stirling Kelly – HSLP Advisor	No No Yes No No No Yes No
	JDS	Lloyd Jackson – Mechanical Superintendent Doug Fielding – Construction Manager Ishan Fechter – Construction Coordinator Jerry Graham – Construction Manager Kevin Whieldon – Project Coordinator Mark Valeriote – Construction Manager	Yes Yes No No Yes No
Engineering Design Consultants	SRK Consulting (Canada) Inc.	John Kurylo – Site Engineer Megan Miller – Site Engineer Lawrence Borowski – Site Engineer Murray McGregor – Site Engineer Ioşef Miskolczi – Site Engineer	No No Yes Yes Yes

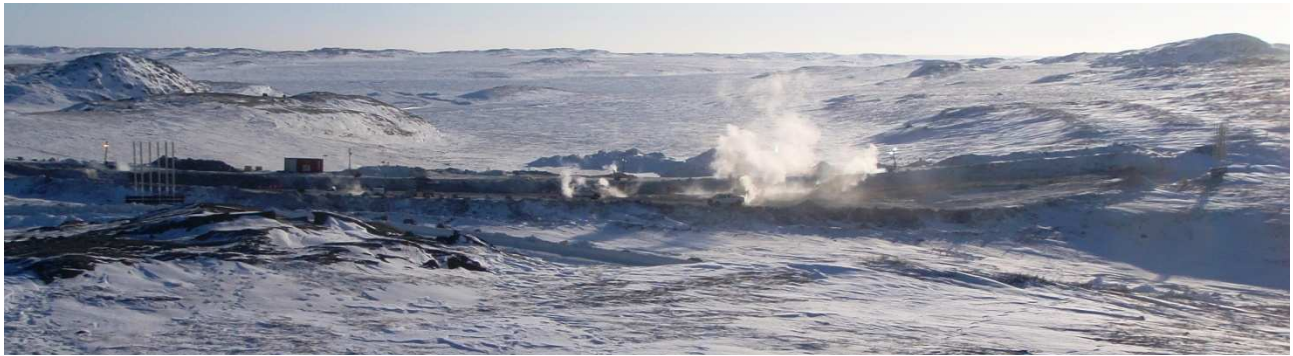
**Photo 1:** Progress photo of North Dam from photo point 1. ~SSE view

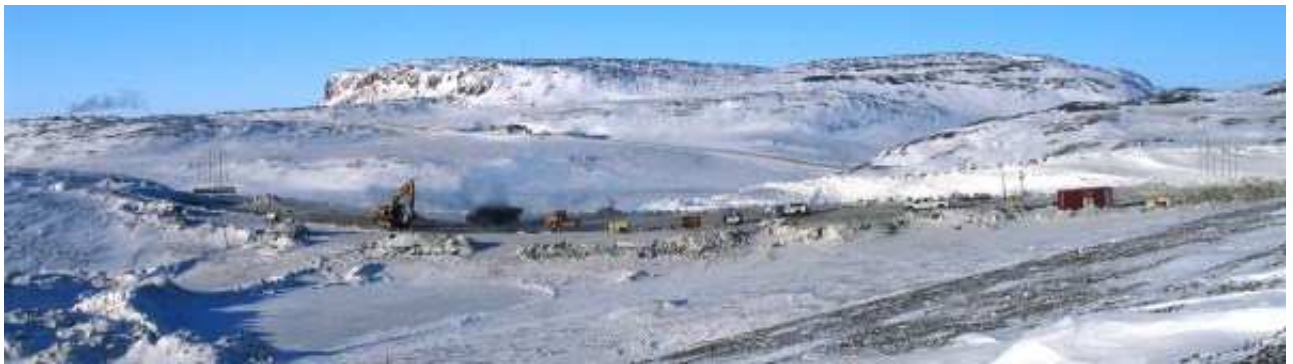
**Photo 2:** Progress photo of North Dam from photo point 2. ~NW view

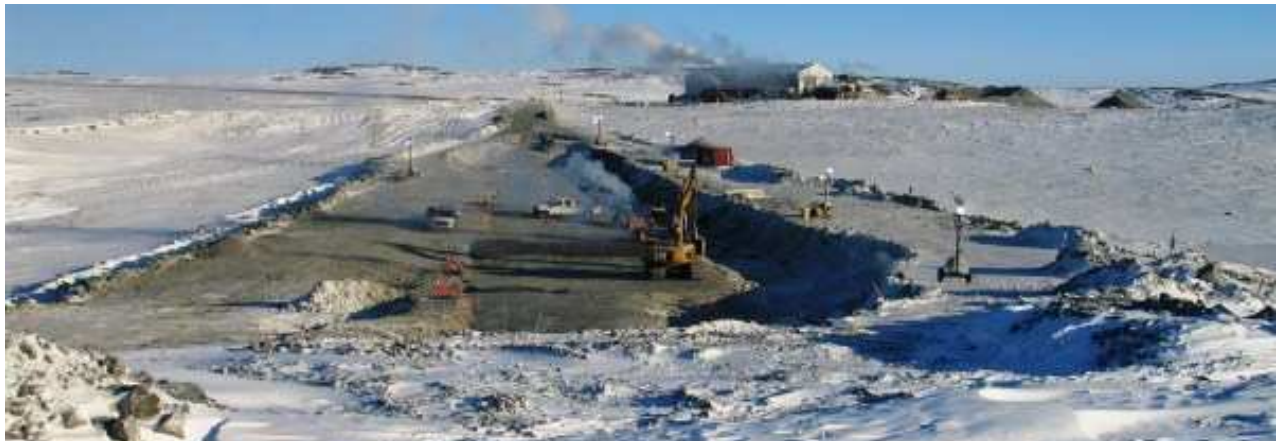
**Photo 3:** Progress photo of North Dam from photo point 3. ~NE view

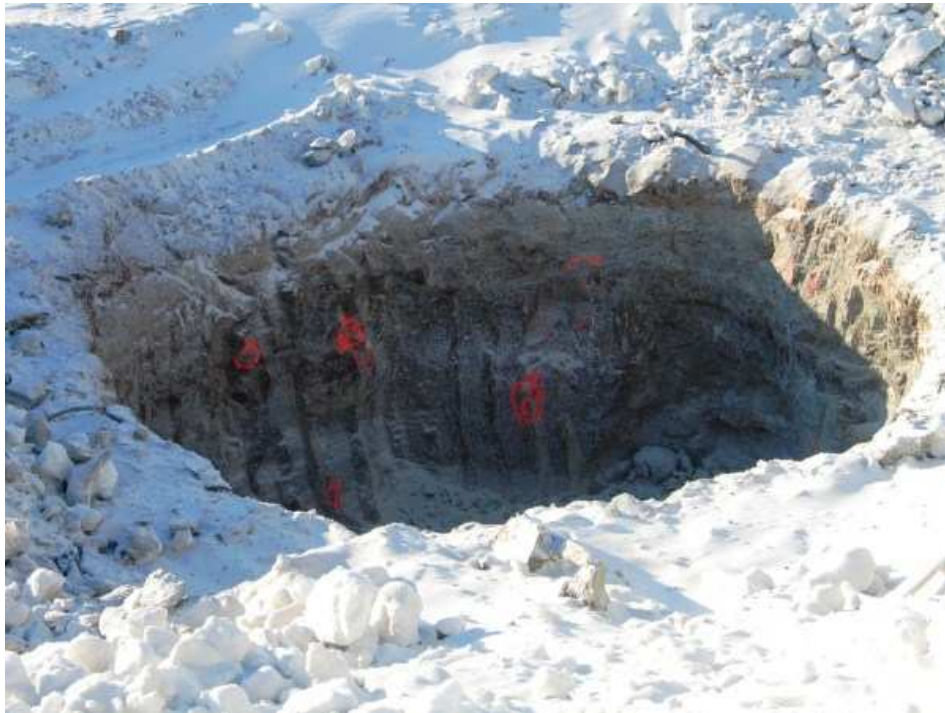
**Photo 4:** Daily progress photo of Sump #1.

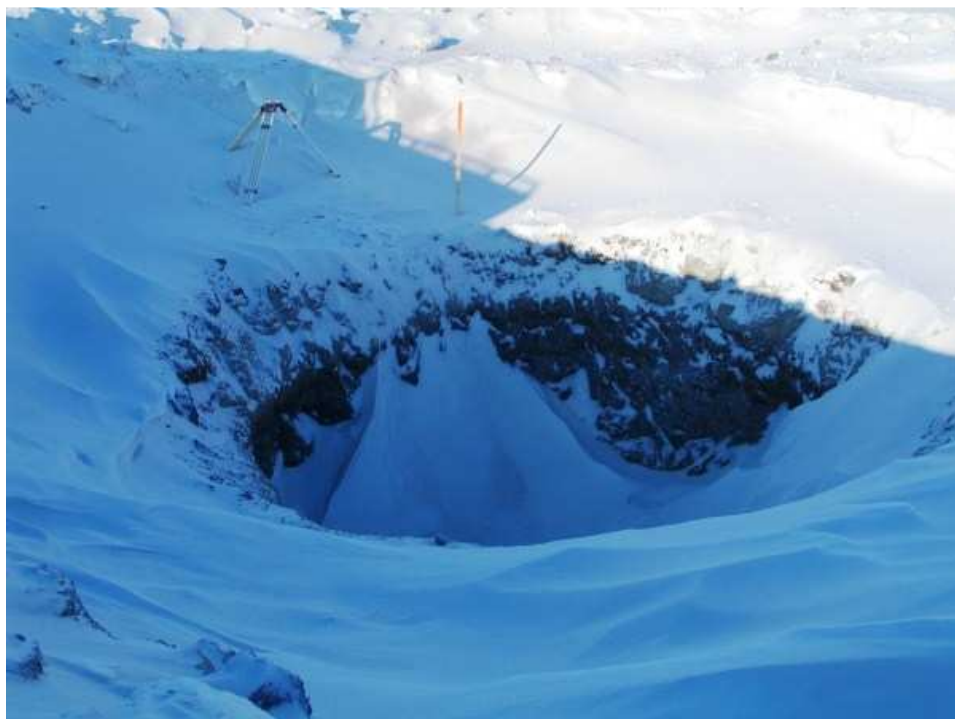
**Photo 5:** Daily progress photo of Sump #2.

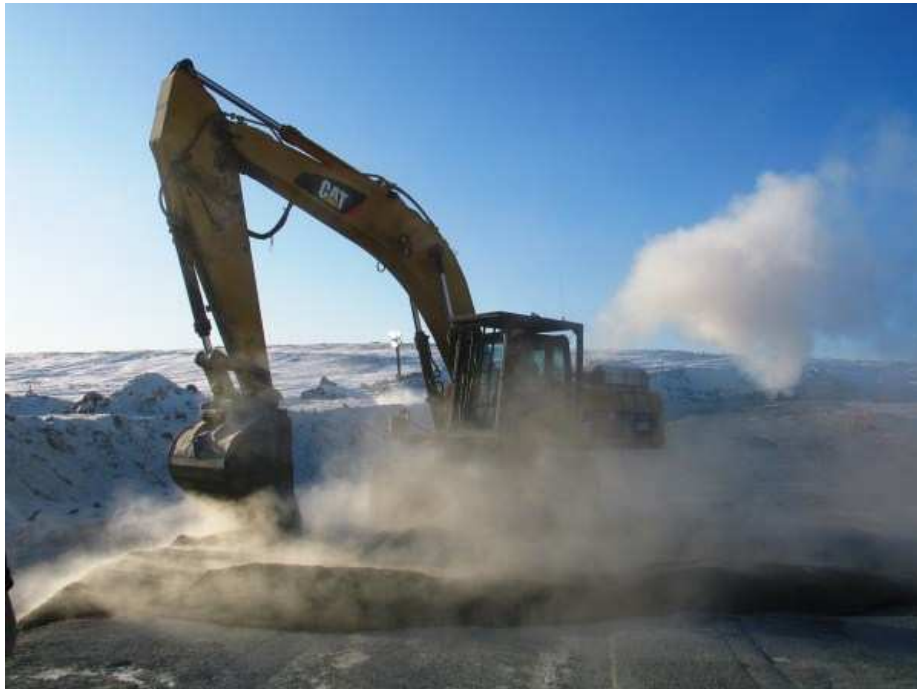
**Photos 6:** Placing frozen core material at Station 0+100

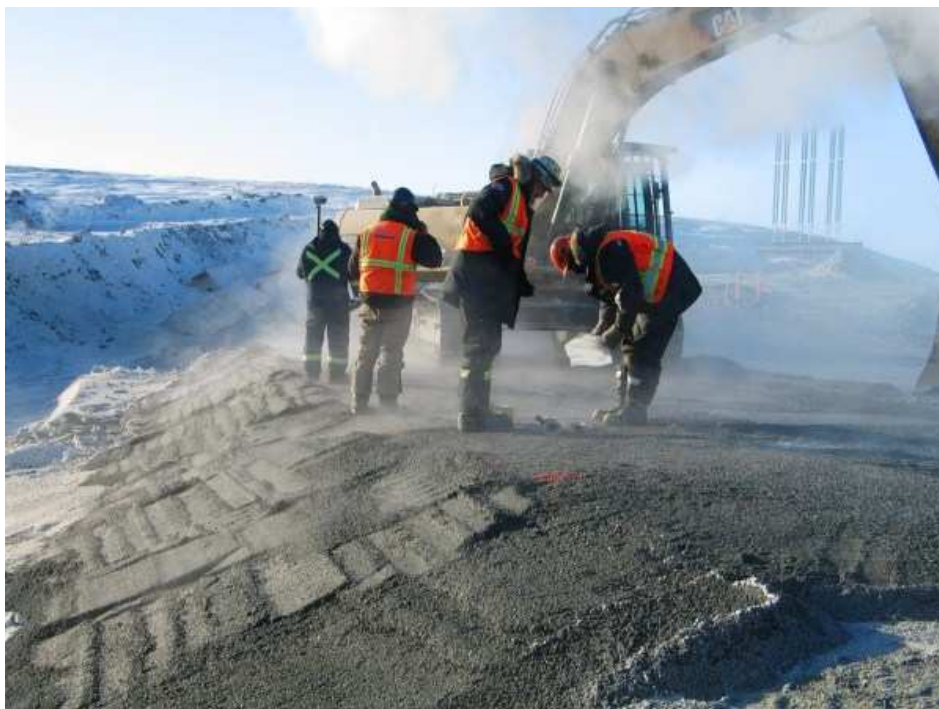
**Photo 7:** Initial placement of core material on slopes. Station 0+100 facing south

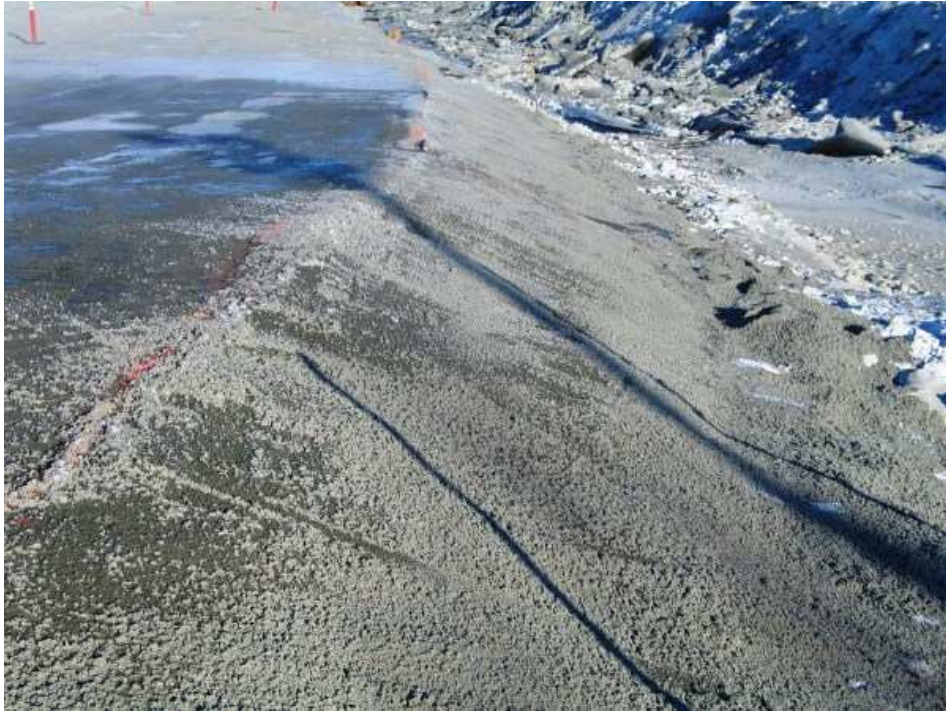
- Placement started from 1 +03 upstream, and then fanned out over the entire dam to 0+73.
- Backslopes were placed and graded to the required 2.5H:1V
- In accordance with plan to bring up low area systematically, today's grade elevation was 31.35.
- Minor bleeding was observed on most of the FCM placed.
- Work on section 1+03 to 0+73 was completed by early afternoon.
- Net section where FCM was placed was from section 0+70 to 0+40. This was a test section 150 mm thick with the objective of determining length of time for freezeup on a thinner section.
- Two single bead thermistors were installed.
- After FCM core material placement was finished for the day, crew continued with removal of ROQ from the HDPE liner at the north end of the dam.
- Densities and saturation all met specifications.

**Photo 8:** Hand raked backslope Sta 0+73 facing north

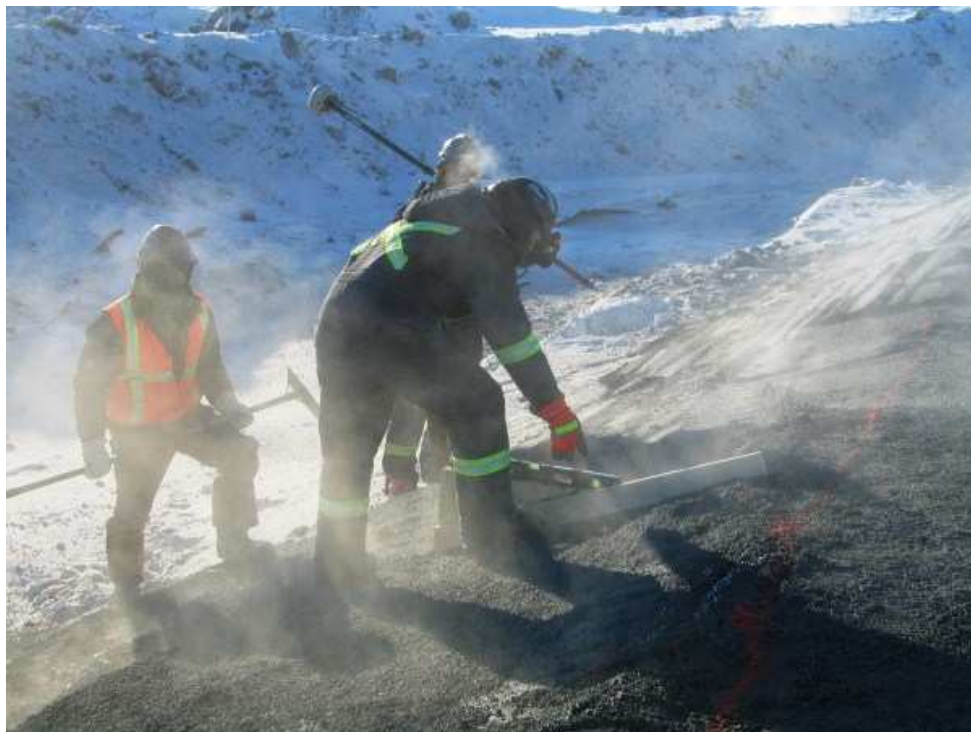
**Photo 9:** Hand raking. Note device being used to establish angle

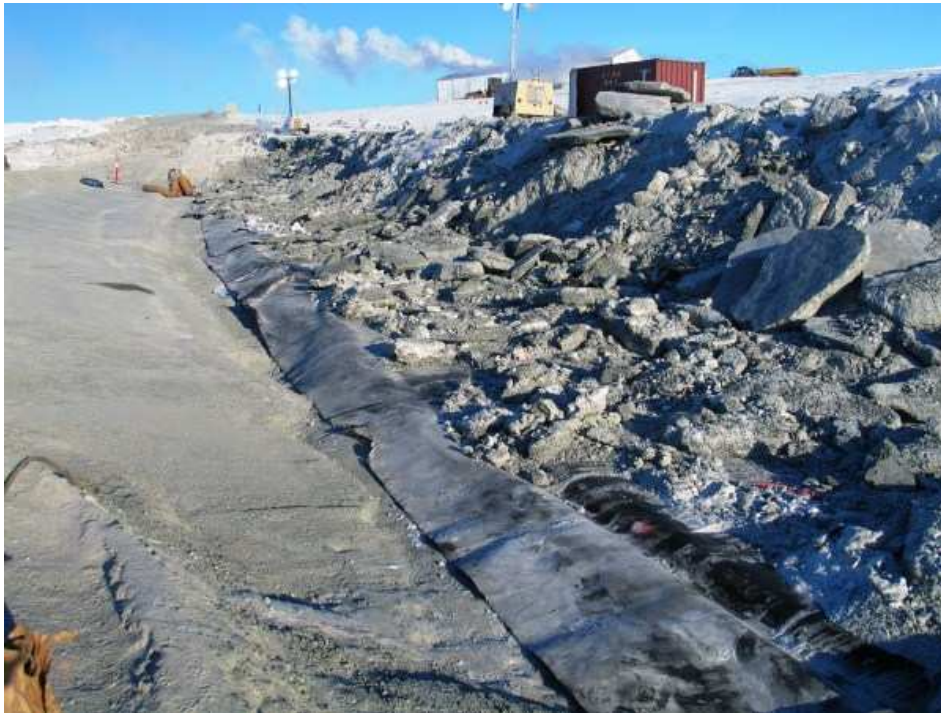
**Photo 10:** ROQ removal over HDPE Station 1+30 facing north

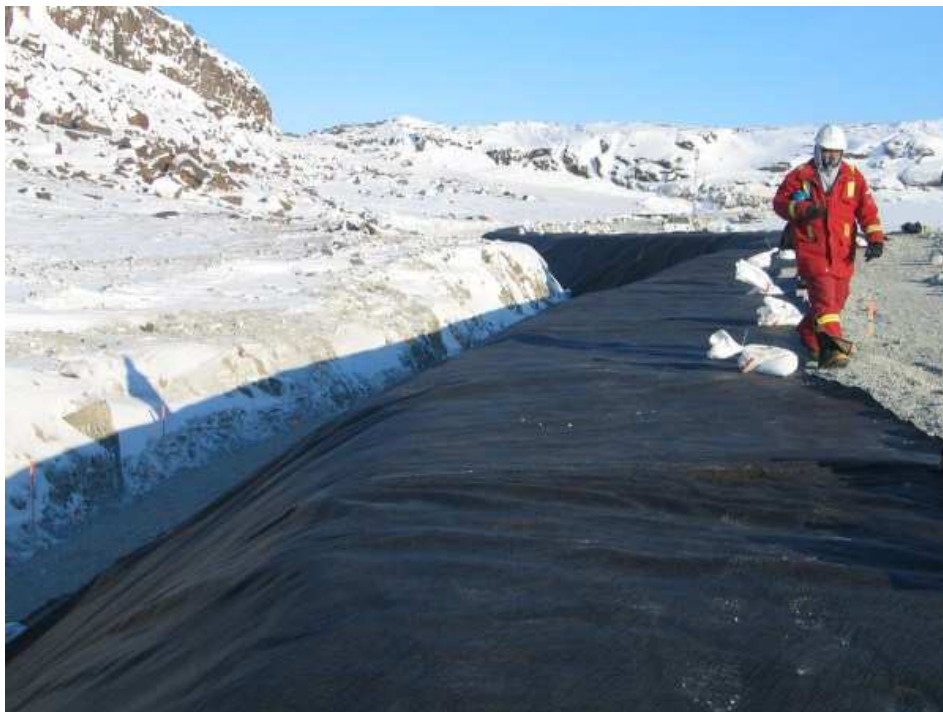
- Excavators working at ~ Sta 0+300 preparing key-trench
- Layfield continued placing geotextile to Sta. 0+445.
- Survey continued to pick up as-builts for liner, crush, key-trench and bentonite fill.

**Photo 11:** Geotextile placed to Sta 0+445 facing east,

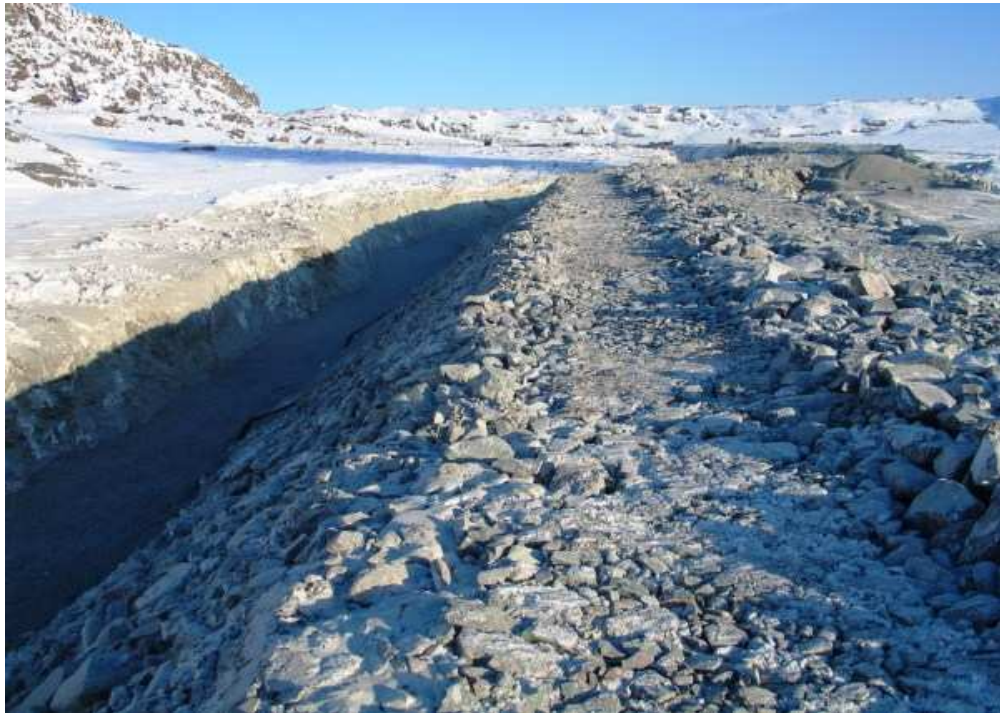
**Photo 12:** Crush levelling course ~ Sta 0+300

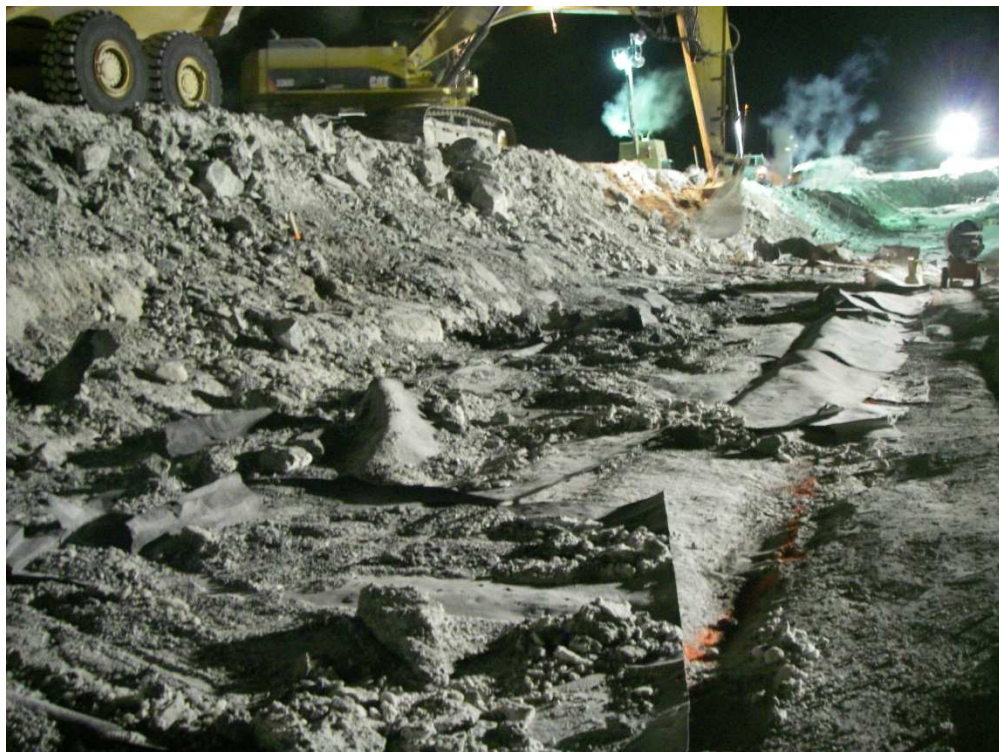
- Removal of the 5/8 clear crush continued along the upstream side of the keytrench.
- The exposed sections of GCL were blown clean using the air compressor.
- The single bead thermistors were monitored for freeze-back. In the 150 mm thick section freeze-back

**Photo 13:** CAT 345 excavator loading out 5/8 crush from above the HDPE liner.

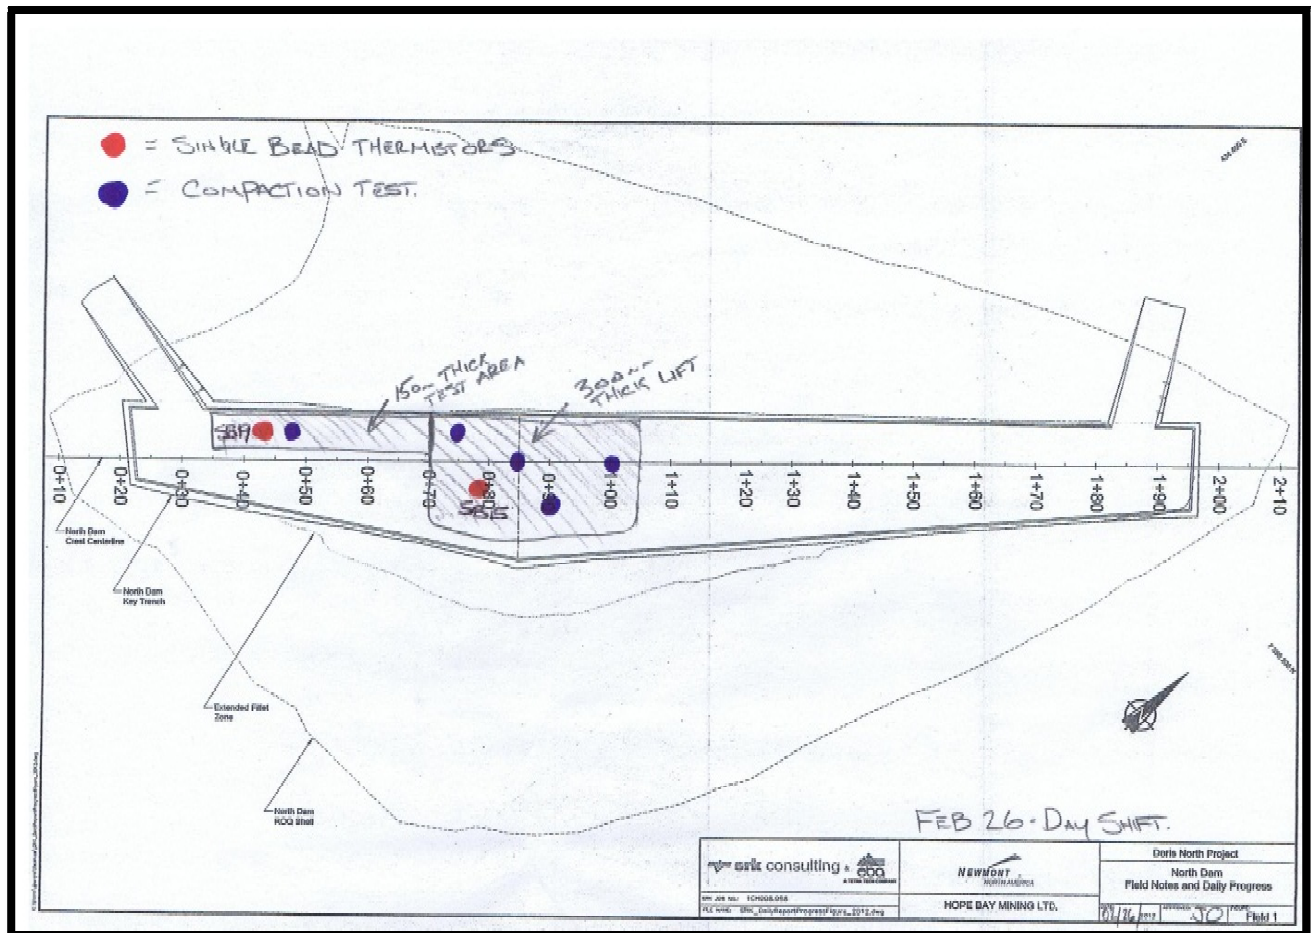
Figure 2 – North Dam Progress – Nightshift

was noted around midnight. The thicker section reached zero degrees around 5 AM.

- One core sample was collected from the 150 mm thin lift. The core broke off clean at the interface between the previous lift and the test lift, indicating that bonding between the lifts is inadequate.
