## DAILY REPORT #53 – DORIS NORTH INFRASTRUCTURE/ NORTH DAM

<b>Prepared by:</b>	Iozsef Miskolczi Lawrence Borowski	<b>Date:</b>	2012.02.27
<b>Reviewed by:</b>		<b>Project #:</b>	1CH008.058.0320
<b>Role</b>	<b>Company</b>	<b>Personnel – Position</b>	<b>On Site</b>
Client	Hope Bay Mining Limited (HBML)	Angela Holzapfel – ESR Compliance Manager David Vokey – ESR Coordinator Don Ethelston – HSLP Advisor Dean Wold - Safety Jill Turk – ESR Coordinator Katsky Venter – ESR Manger Michelle Tanquay – ESR Site Manager Stirling Kelly – HSLP Advisor	No In Yes No No In Yes No
	JDS	Lloyd Jackson – Mechanical Superintendent Doug Fielding – Construction Manager Ishan Fechter – Construction Coordinator Jerry Graham – Construction Manager Kevin Whieldon – Project Coordinator Mark Valeriote – Construction Manager	Yes Yes No No Yes In
Engineering Design Consultants	SRK Consulting (Canada) Inc.	John Kurylo – Site Engineer Megan Miller – Site Engineer Lawrence Borowski – Site Engineer Murray McGregor – Site Engineer Iozsef Miskolczi – Site Engineer Lowell Wade	No No Yes Out Yes In

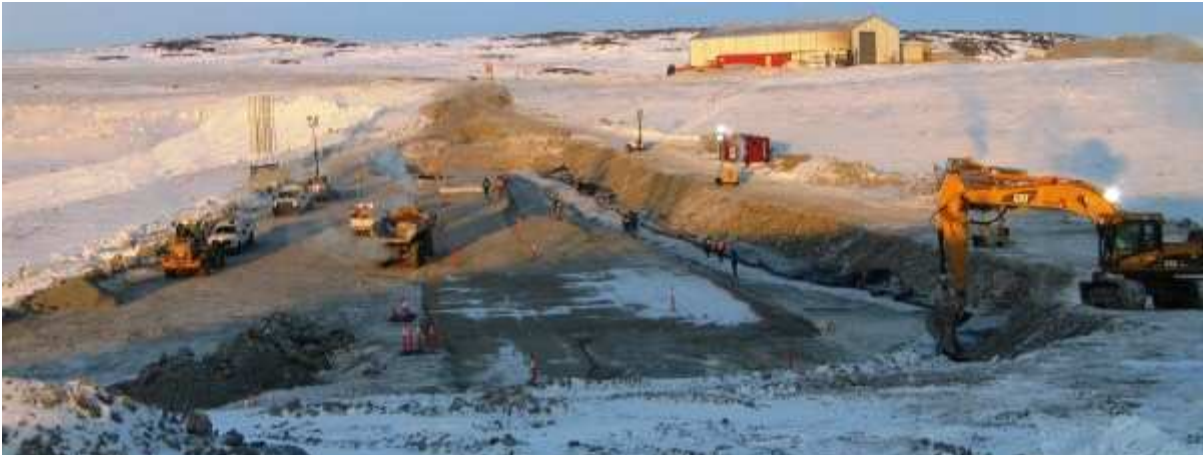
**Photo 1:** Progress photo of North Dam from photo point 3. ~NE view

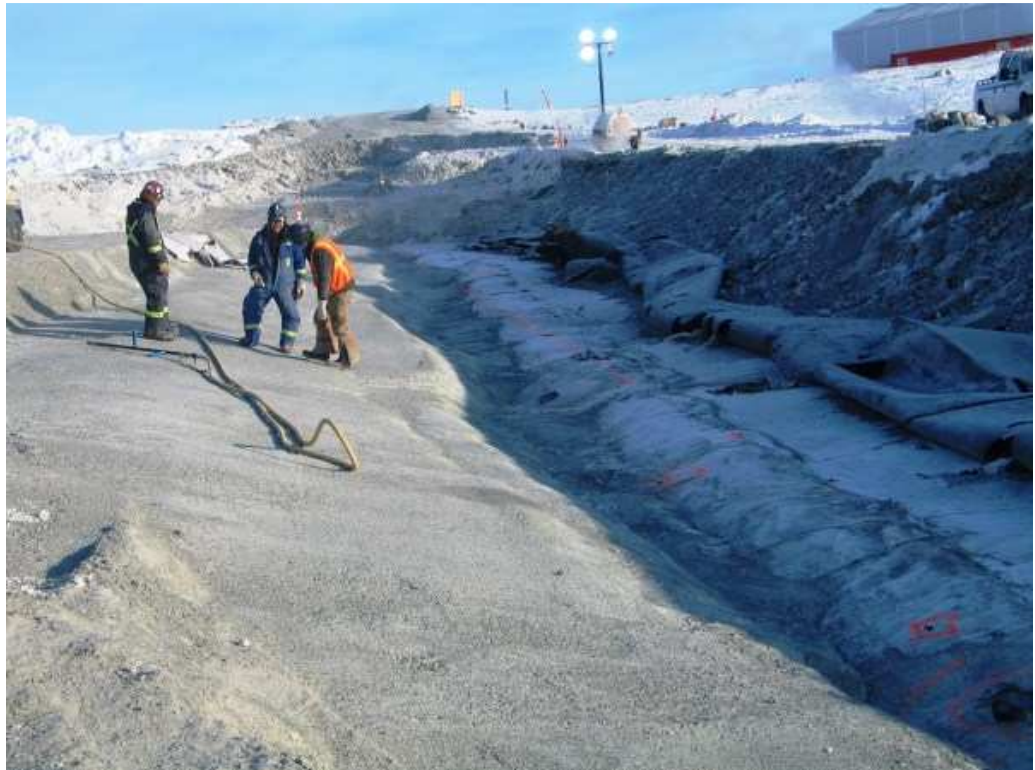
**Photo 2:** North east corner after cleaning with air compressor.

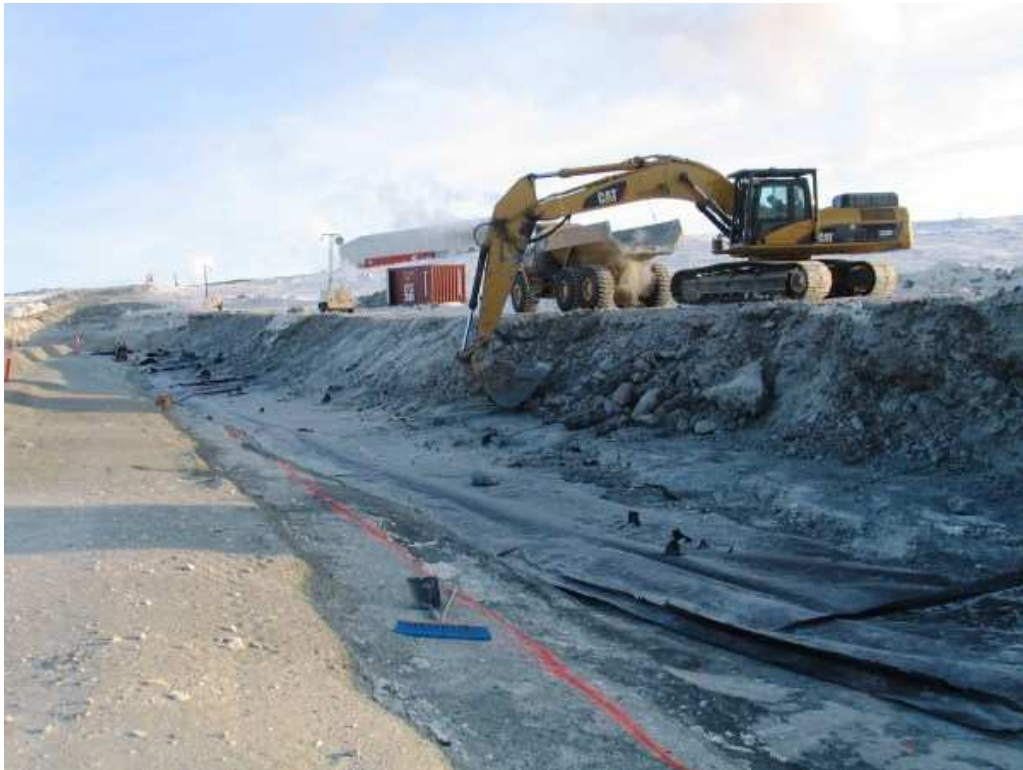
**Photo 3:** Excavator reshaping ROQ slopes and cleaning above GCL at north end.

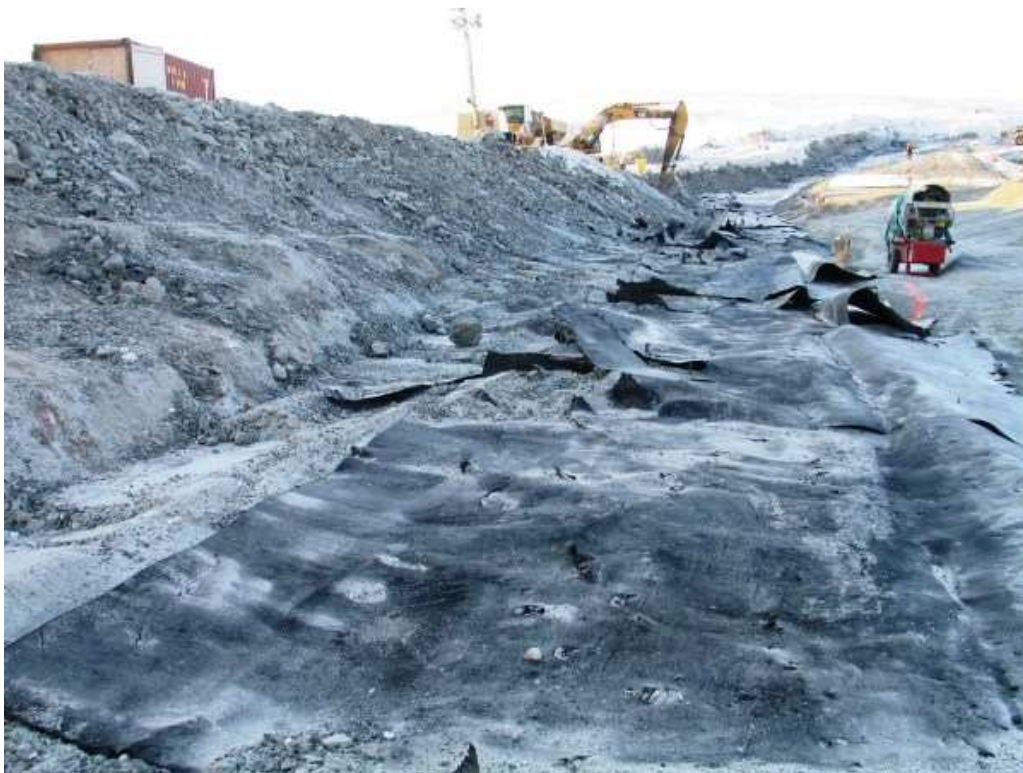
**Photos 4:** ROQ removed from top of HDPE facing south (morning view)

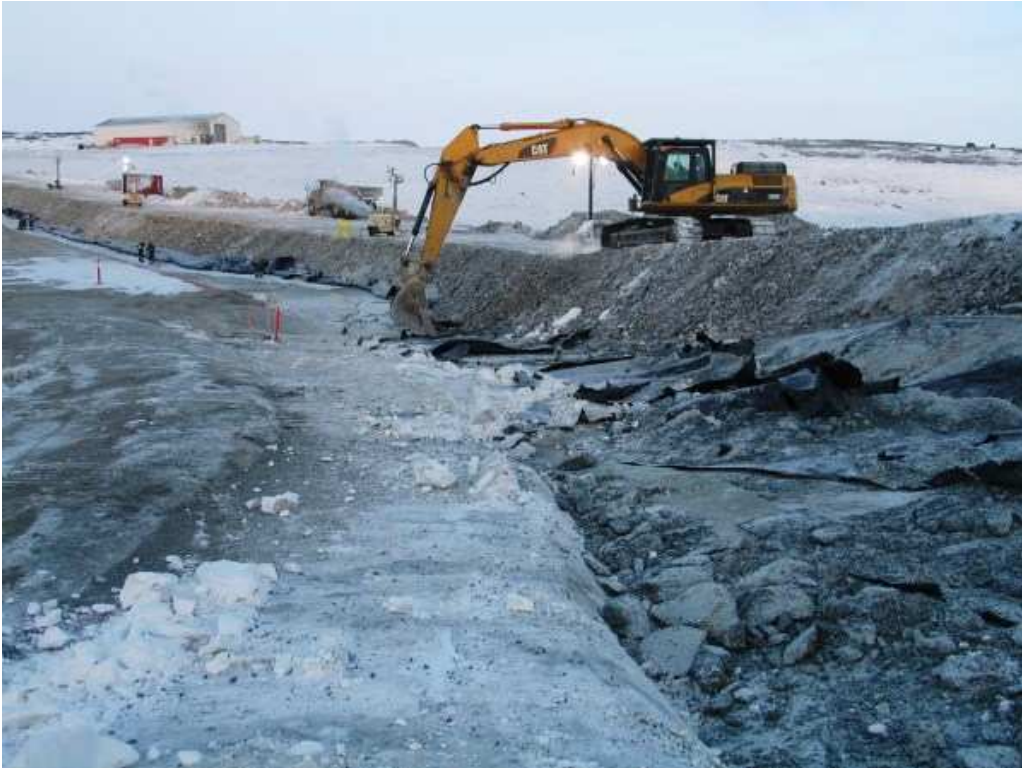
**Photo 5:** Excavator cleaning banks facing north-afternoon view.

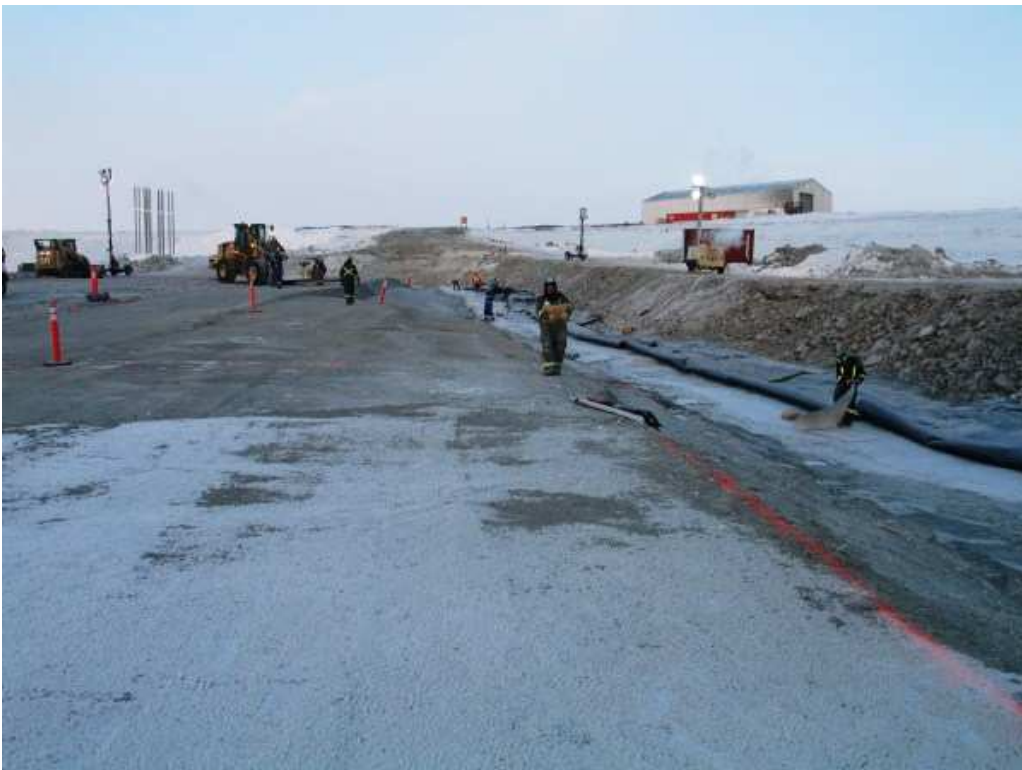
**Photo 6:** labourers patching GCL north end.

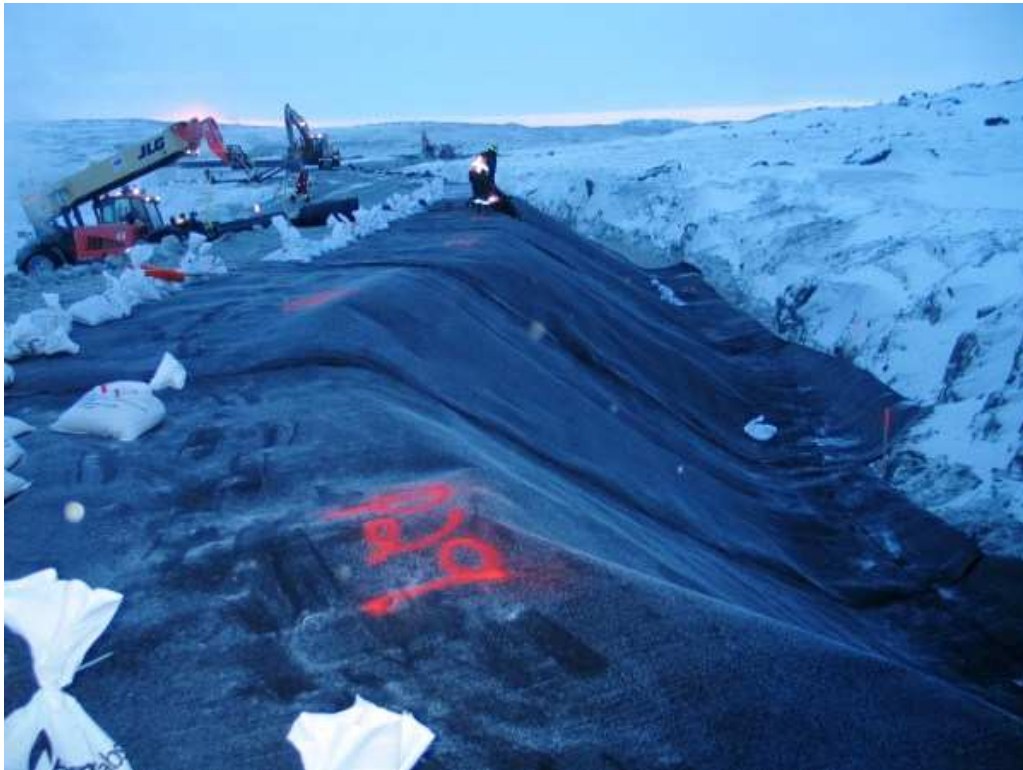
**Photo 9:** HDPE liner placement

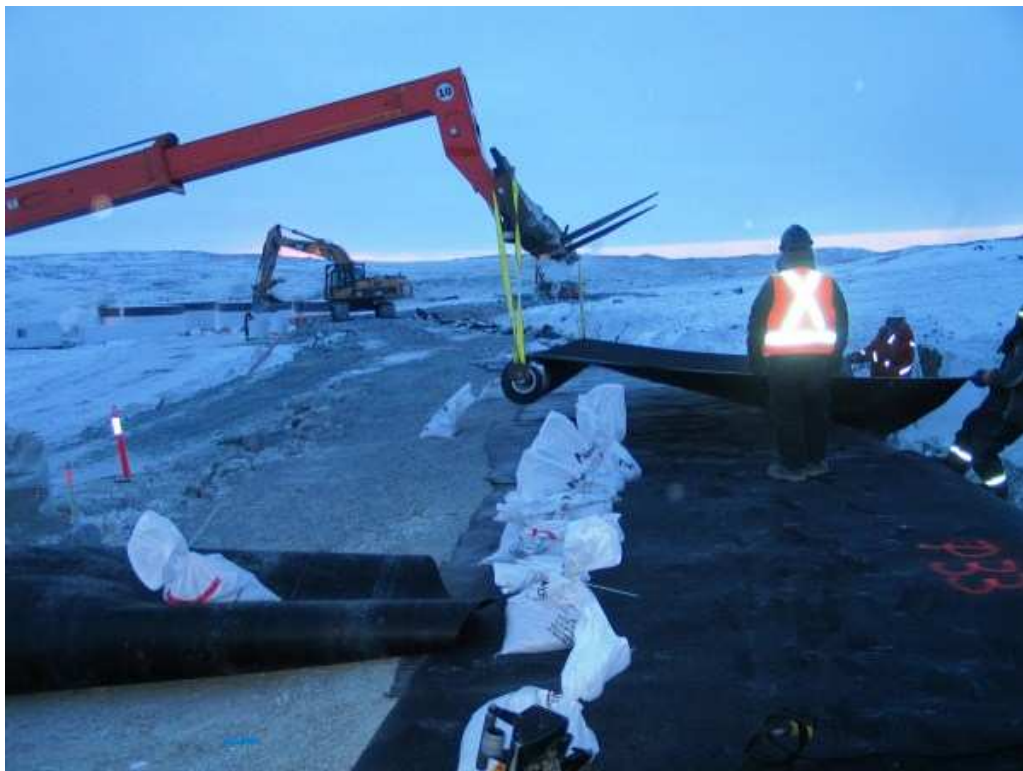
**Photo 10:** Layfield placing HDPE

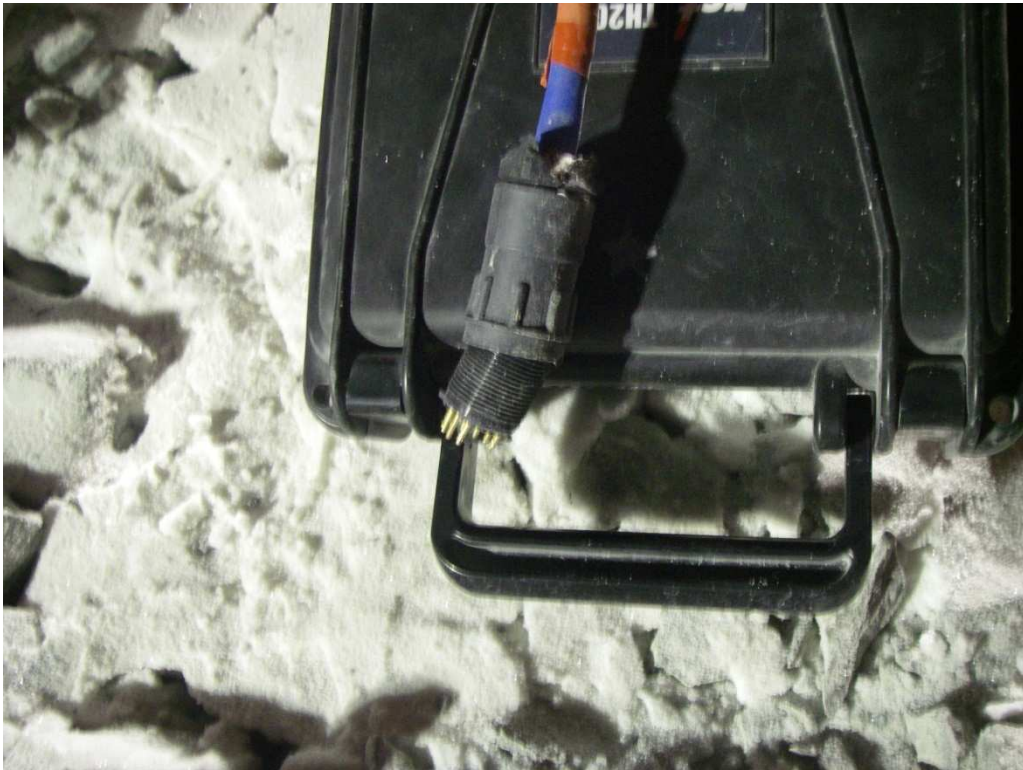
- Thermistor strings at Sta. 1+75 and 1+60 were downloaded. All strings are working as intended.
- One thermistor connector is severely broken and will need to be changed, although readings could still be taken with some effort to match the pins.

**Photo 11:** Broken thermistor connector.

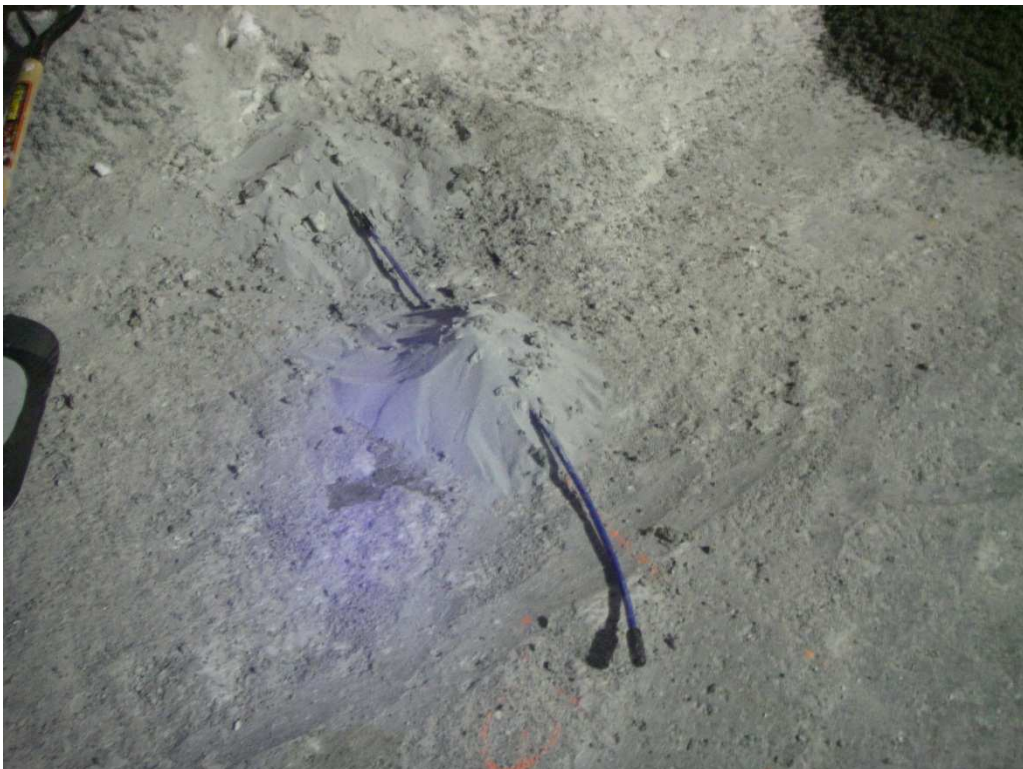
- The last two beads of thermistor string ND-HTS-175-33.5 were buried. The bentonite water stop was placed on the cable, and the beads were surveyed before being covered. The last bead moved about 5 cm in south direction due to the core material being pushed rather than dropped over the cable.

**Photo 12:** Last 2 beads of ND-HTS-175-33.5 before being buried in frozen core material.

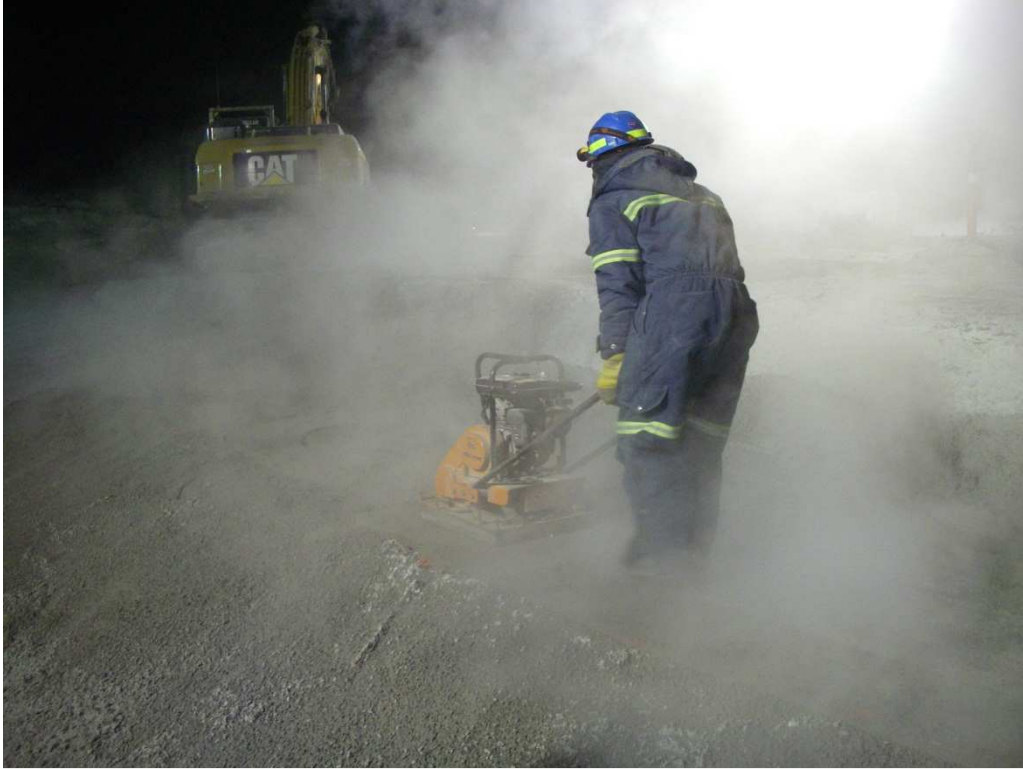
- First the Diesel compactor was used, but it sunk in the wet core material. The smaller gasoline

powered compactor was used subsequently, with good results.

**Photo 13:** Small compactor being used on the core material.

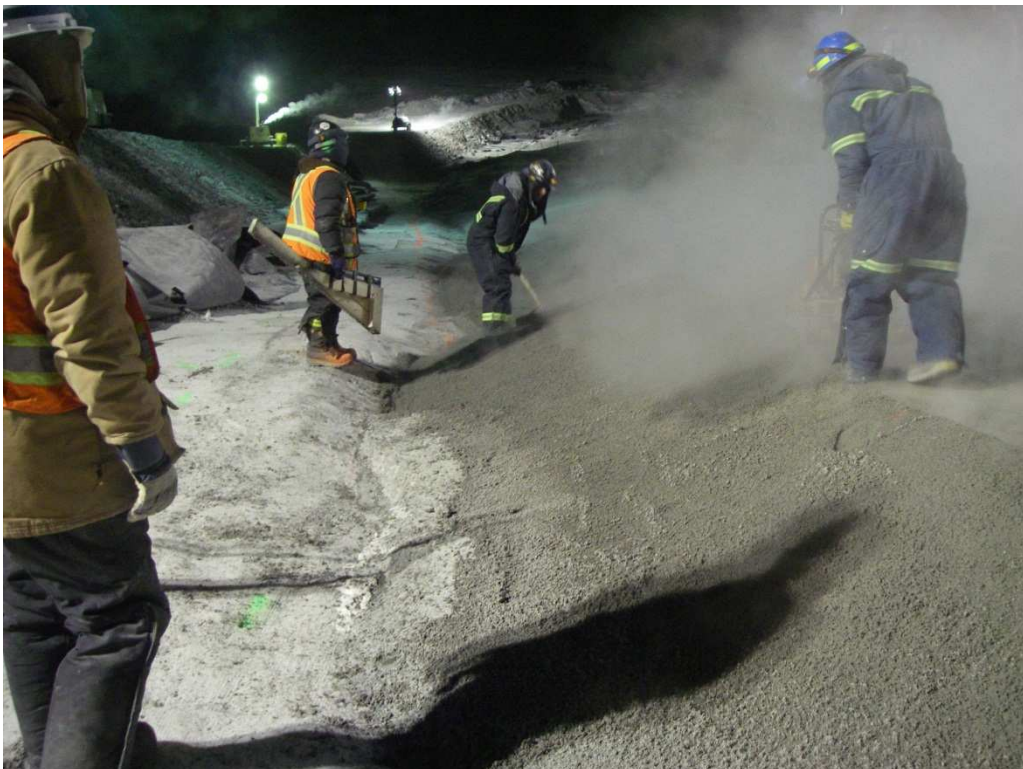
- A full lift of 250 mm was placed in the inflection point tapered off at the edges.
  - The 2.5H:1V upstream slope was created using the jig with the builder's level. Material was spread and shaped by manual labor, using shovels and rakes.
  - The core material was a bit wet, and water was pooling on the surface following compaction.
  - All compaction tests were acceptable.
- Two single bead thermistors were installed, one in the strip along the GCL around Sta. 1+74 and the second one at Sta. 0+91, near centerline.
-

**Photo 14:** The 2.5H:1V slope being finished using rakes and shovels.

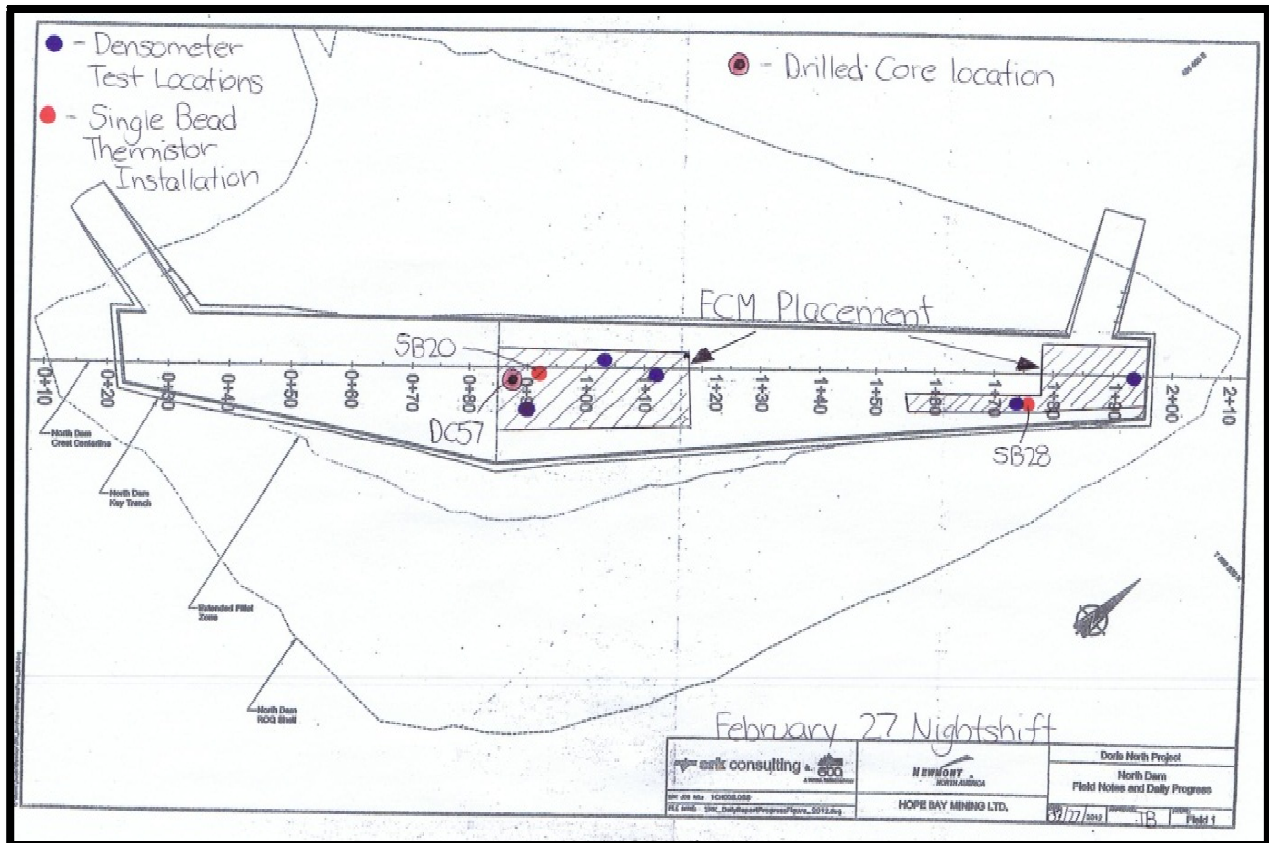
Figure 2 – North Dam Progress – Nightshift

- The plant was started up around 9PM and ran until 12:30 when the north area of placement (see Figure 2) was completed.
- The plant was restarted at 2 AM, once freezeback was observed in the inflection line area, and run until the end of the nightshift.
- Production ran smoothly throughout the night.
- The south bay door got stuck open towards morning, but it did not hinder production. Core material temperature was slightly increased to compensate for the low ambient temperature in the plant.
- Hot change was made between nightshift and dayshift.
