## DAILY REPORT #54 – DORIS NORTH INFRASTRUCTURE/ NORTH DAM

Prepared by:	Ioşef Miskolczi Lawrence Borowski	Date:	2012.02.28
Reviewed by:		Project #:	1CH008.058.0320
Role	Company	Personnel – Position	On Site
Client	Hope Bay Mining Limited (HBML)	Angela Holzapfel – ESR Compliance Manager David Vokey – ESR Coordinator Don Ethelston – HSLP Advisor Dean Wold - Safety Jill Turk – ESR Coordinator Katsky Venter – ESR Manger Michelle Tanquay – ESR Site Manager Stirling Kelly – HSLP Advisor	No Yes Yes No No Yes Yes No
	JDS	Lloyd Jackson – Mechanical Superintendent Doug Fielding – Construction Manager Ishan Fechter – Construction Coordinator Jerry Graham – Construction Manager Kevin Whieldon – Project Coordinator Mark Valeriote – Construction Manager	Yes Yes No No Yes Yes
Engineering Design Consultants	SRK Consulting (Canada) Inc.	John Kurylo – Site Engineer Megan Miller – Site Engineer Lawrence Borowski – Site Engineer Murray McGregor – Site Engineer Ioşef Miskolczi – Site Engineer Lowell Wade	No No Yes Out Yes yes

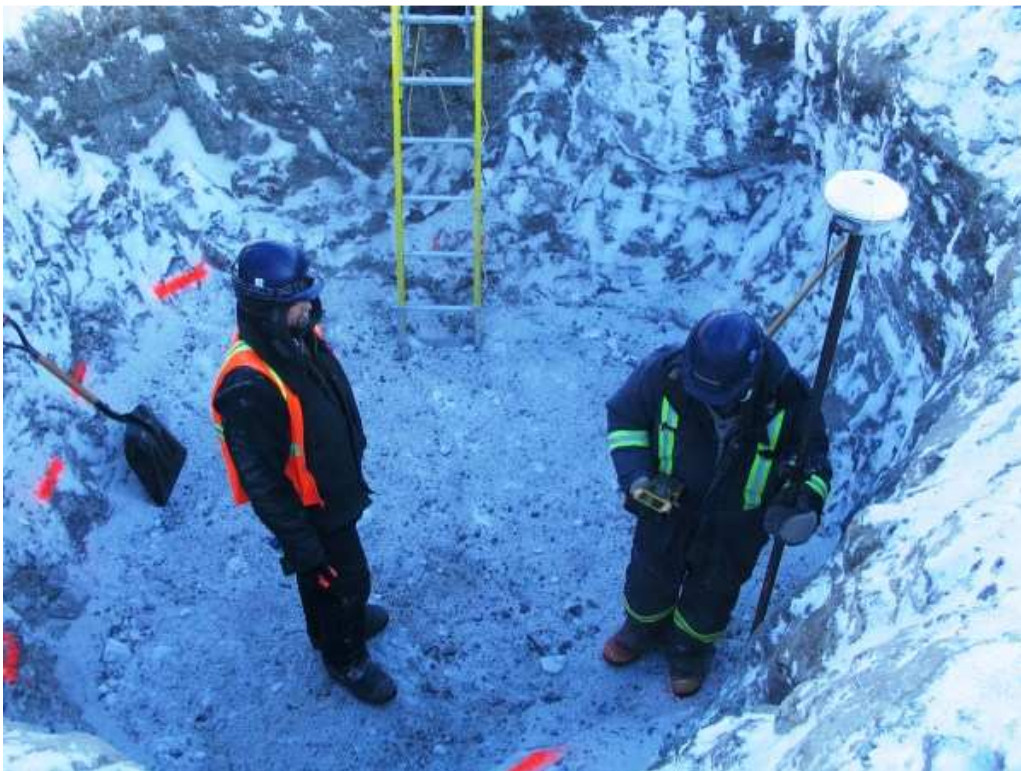
- Snow removed from Sump 2.
- Excavation surveyed. Paint sprayed on walls to mark height of 5/8" clear material.

**Photo 4:** Sump 2 with snow removed. Surveyor marking 5/8 clear levels.

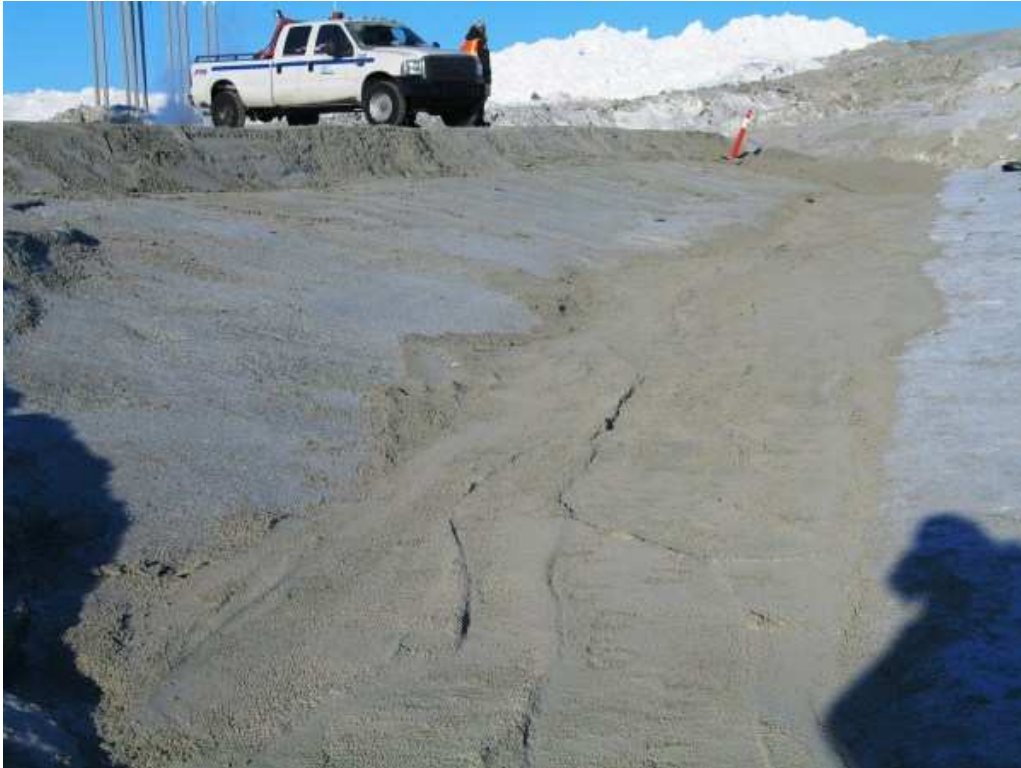
- Core material was placed in the wide square in the extreme north end of the keytrench (from Sta. 1+85 to Sta. 1+97) and the upstream strip (from Sta 1+30 to Sta 1+85) respectively.

**Photo 5:** Ditch sta 1+30 (facing north) filled by night shift.

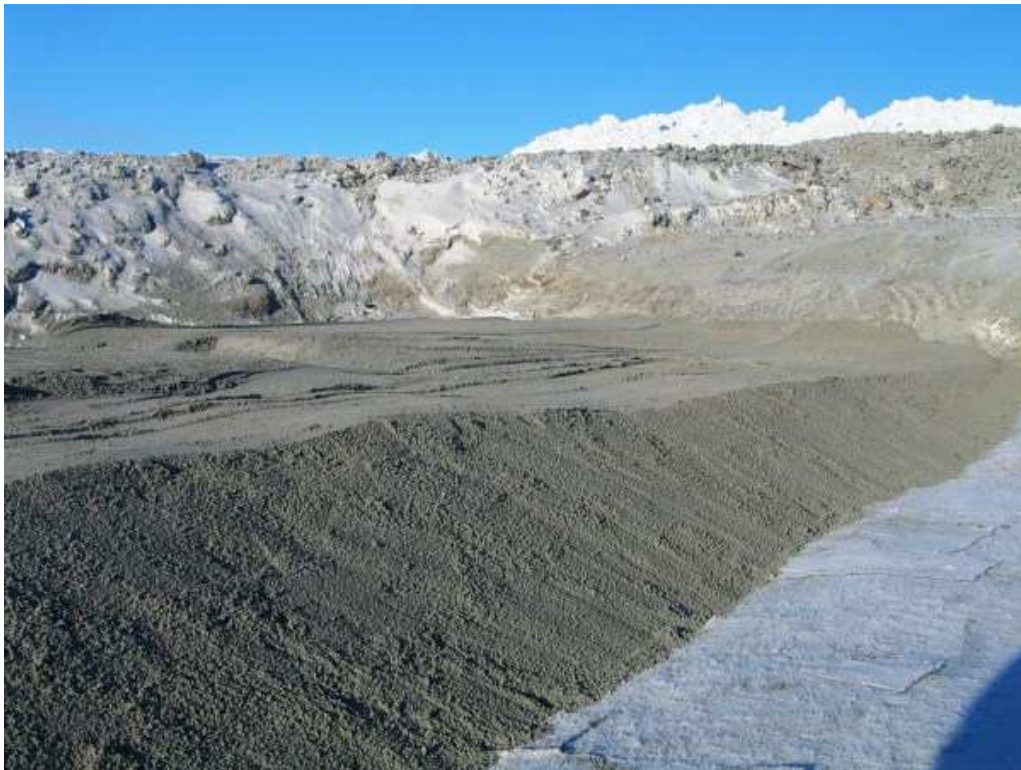
**Photo 6:** North end with sides sloped to design grade.

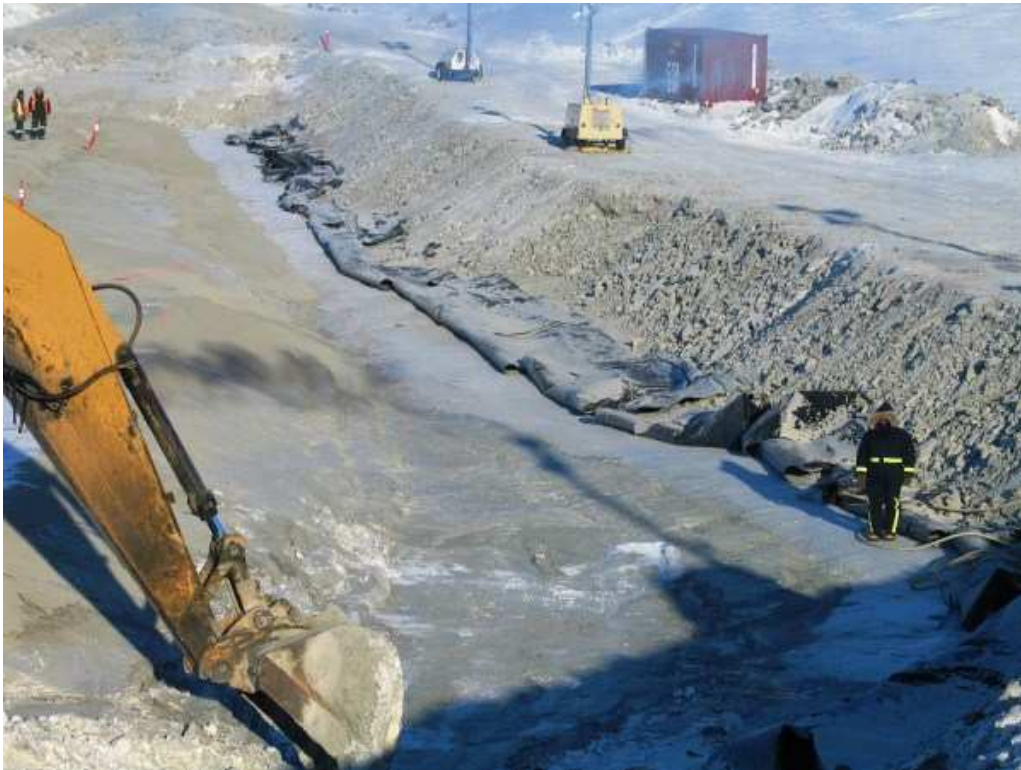
**Photo 7:** Excavator cleaning at extended fillet area.

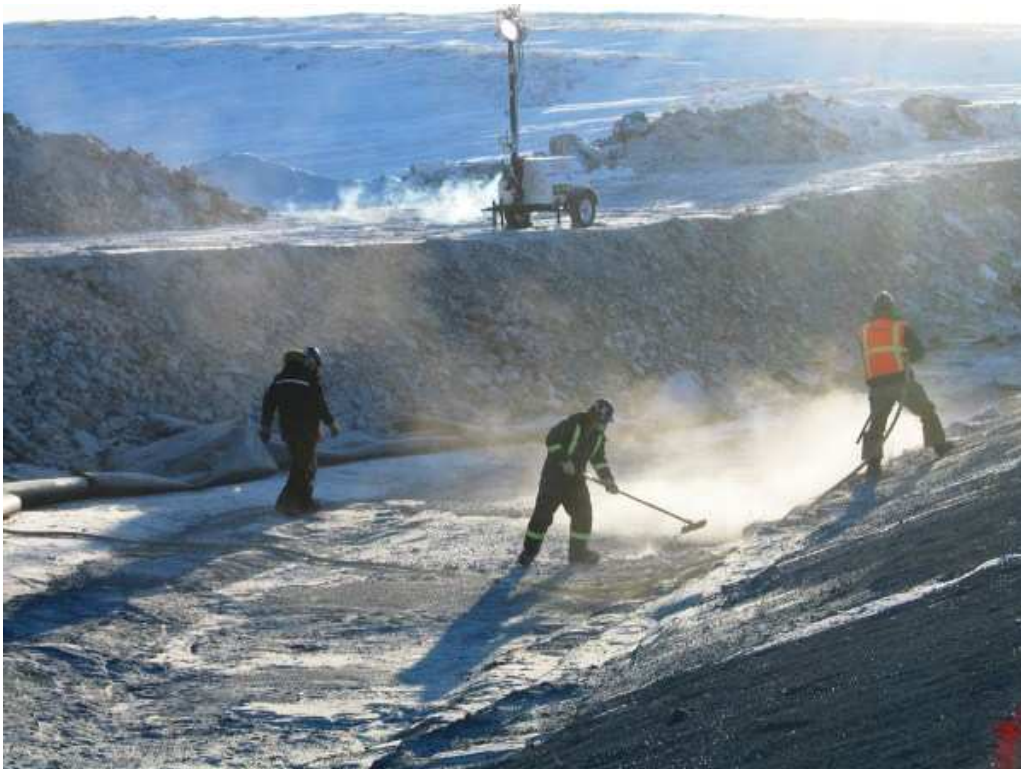
- Removal of the 5/8 clear crush continued along the upstream side of the key trench.
- HDPE liner was rolled back to expose the GCL. Exposed areas of GCL were blown clear with the air compressor.
- Single bead thermistor was monitored for freeze back all day. Freezeback did not occur during the day shift.

**Photo 8:** Cleaning in the extended fillet area with air compressor.

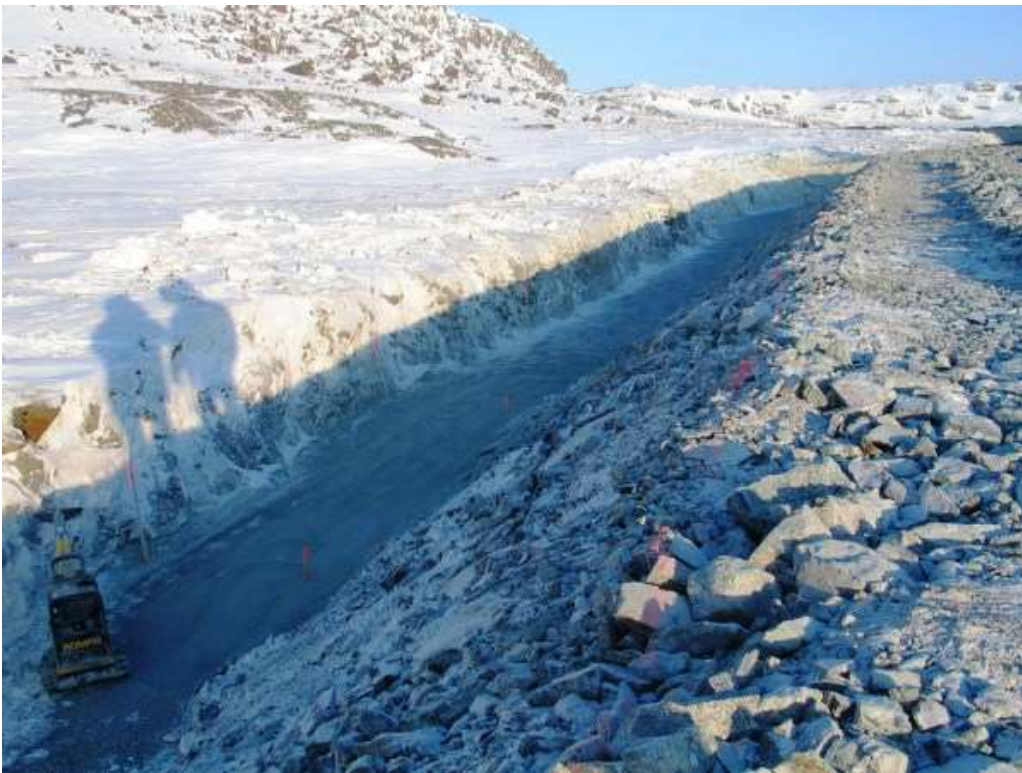
**Photo 10:** Bentonite placed to Sta 0+300 at diversion berm

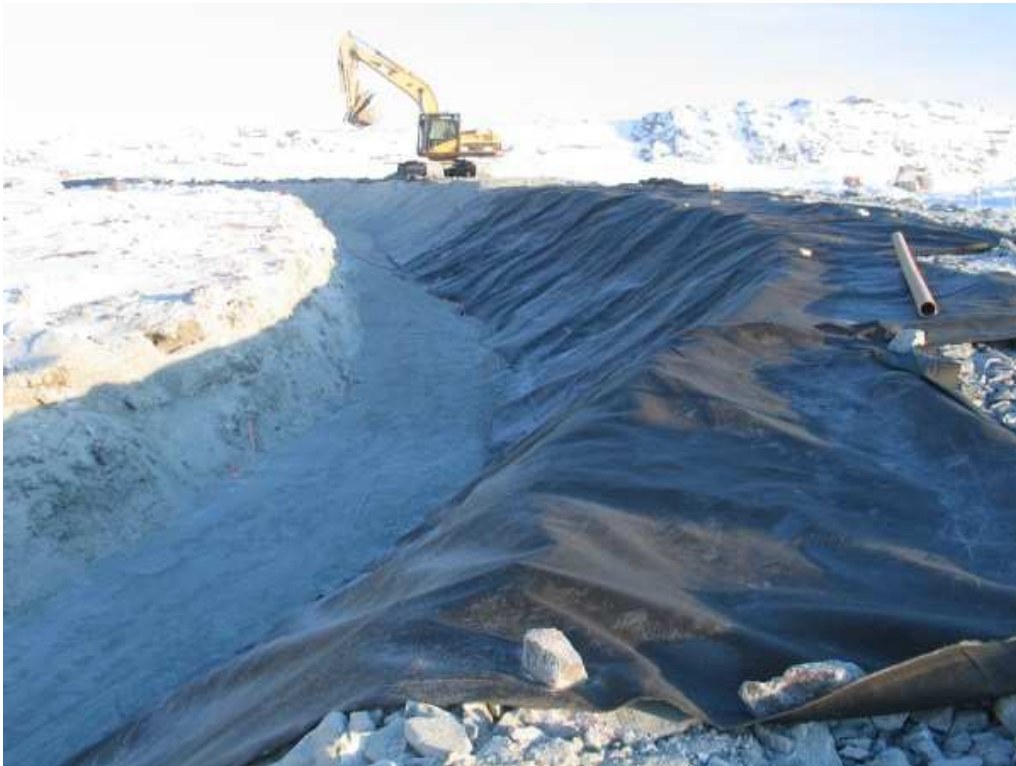
**Photo 11:** Underliner placed to Sta 0+340.

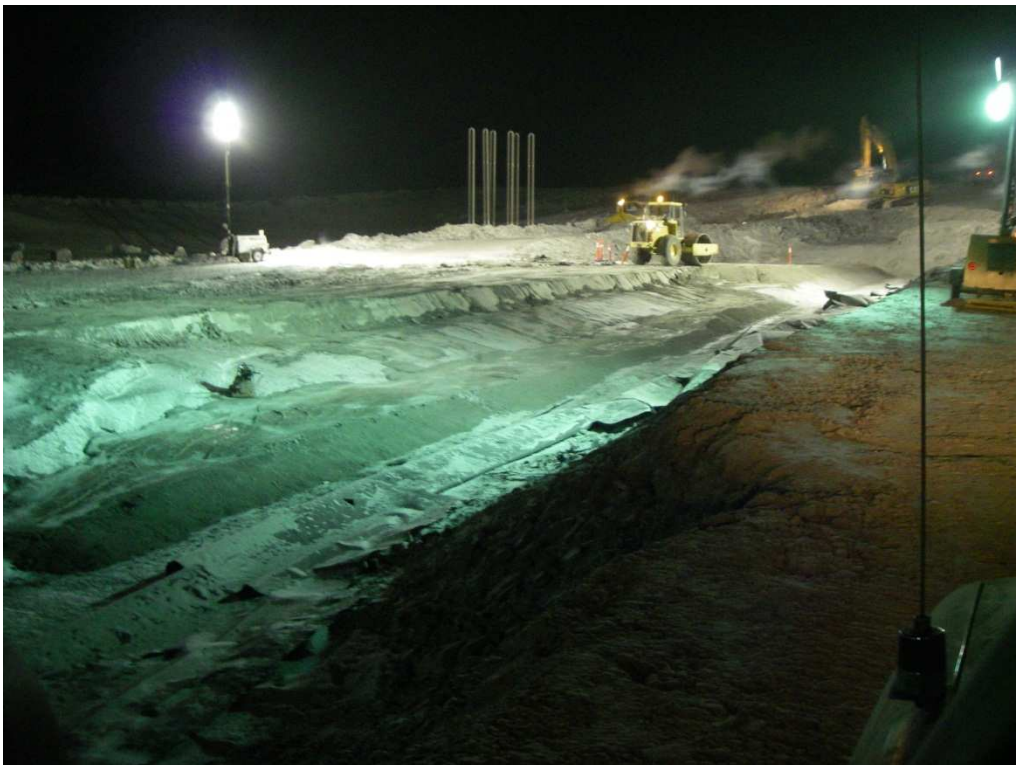
- Material quality was good. Temperature of material was increased to 43 °C to extend the time to freeze-up and allow proper finishing of the slopes by manual labor.

- Rakes and shovels were used to finish the 2.5H:1V slope along the upstream edge of the placed core material.
- All compaction tests were acceptable.
- Compaction in the north square was done with the 10 T compactor , while the small gasoline powered compactor was used along the crest of the square and along the strip.

**Photo 12:** View of the lift of material placed along the upstream edge of the core. The compactor is parked at the edge of material placed in the north square. Photo taken from Sta. 1+20 looking north.
