DAILY REPORT #56 – DORIS NORTH INFRASTRUCTURE/ NORTH DAM

Prepared by:	Iozsef Miskolczi Lawrence Borowski	Date:	2012.03.01
Reviewed by:		Project #:	1CH008.058.0320
Role	Company	Personnel – Position	On Site
Client	Hope Bay Mining Limited (HBML)	Angela Holzapfel – ESR Compliance Manager David Vokey – ESR Coordinator Don Ethelston – HSLP Advisor Dean Wold - Safety Jill Turk – ESR Coordinator Katsky Venter – ESR Manger Michelle Tanquay – ESR Site Manager Stirling Kelly – HSLP Advisor	No Yes Out In No Yes Yes No
	JDS	Lloyd Jackson – Mechanical Superintendent Doug Fielding – Construction Manager Ishan Fechter – Construction Coordinator Jerry Graham – Construction Manager Kevin Whieldon – Project Coordinator Mark Valeriotte – Construction Manager	Yes Out No In Yes Yes
Engineering Design Consultants	SRK Consulting (Canada) Inc.	John Kurylo – Site Engineer Megan Miller – Site Engineer Lawrence Borowski – Site Engineer Murray McGregor – Site Engineer Iozsef Miskolczi – Site Engineer Lowell Wade – Senior Engineer	No No Yes No Yes Out

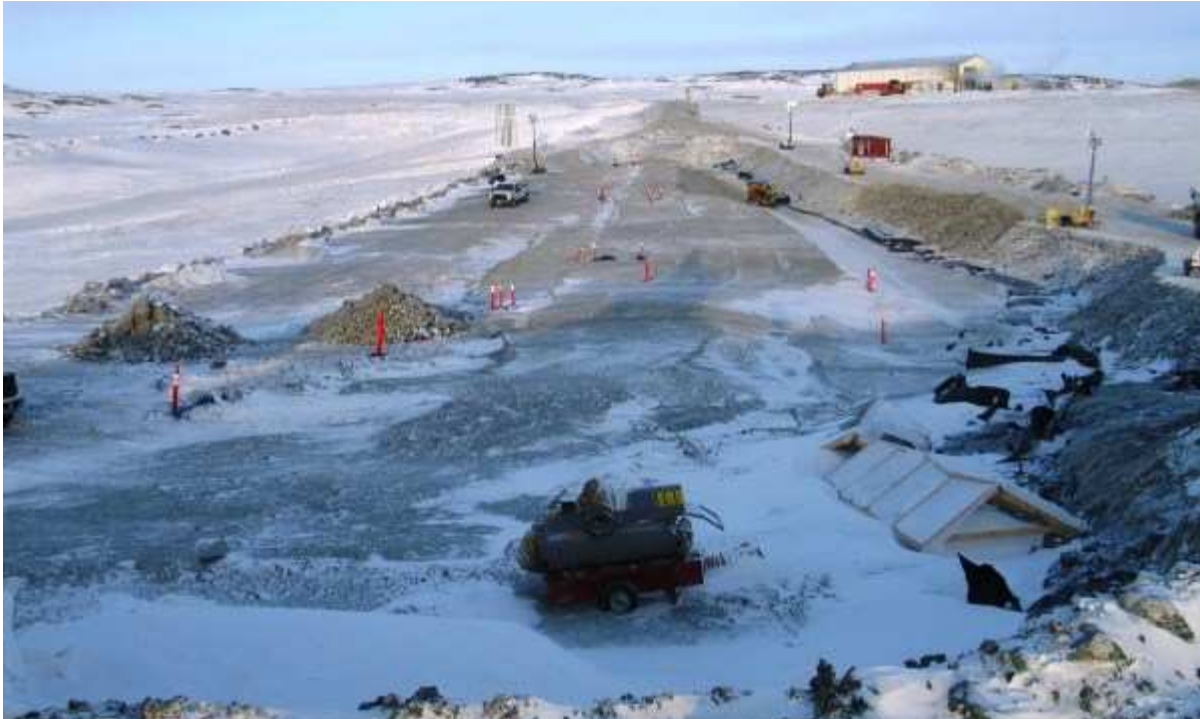
Photo 1: Key trench from point 3 facing north east in mid afternoon. The only work being done was some cleanup at the NE corner.

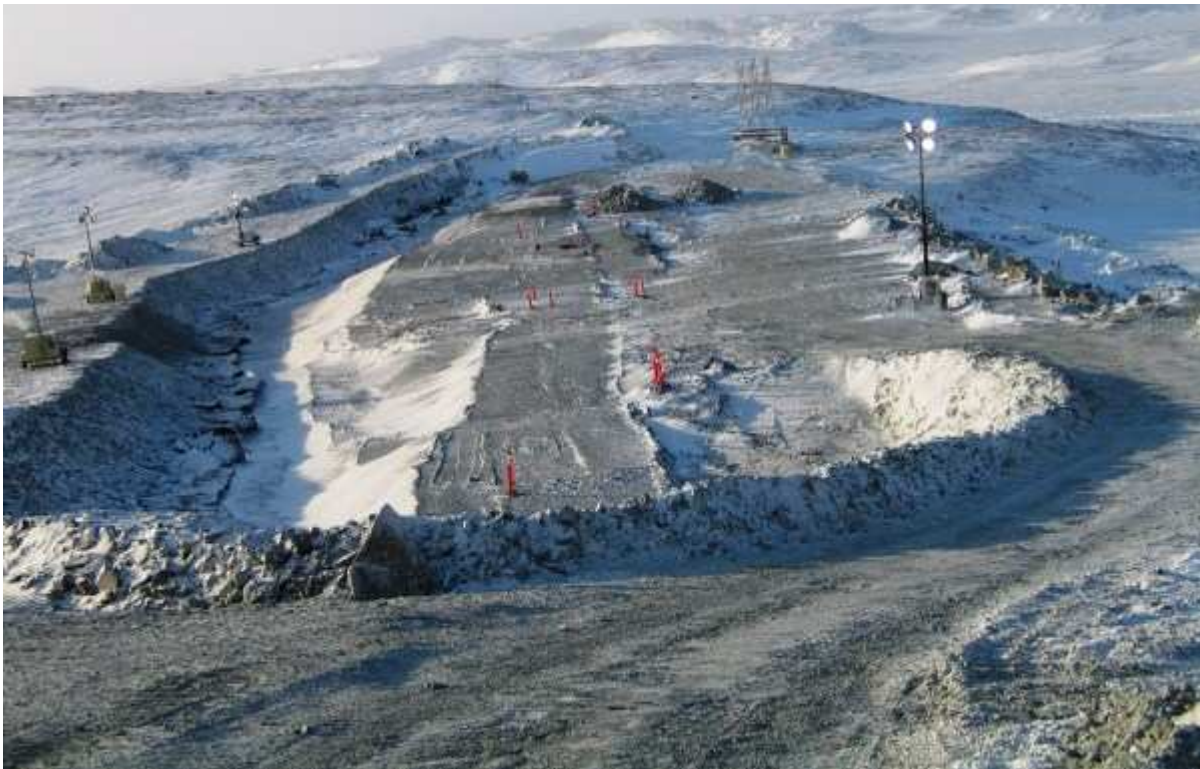
Photo 2: Key trench facing SW. No work being done. Mid morning photo.

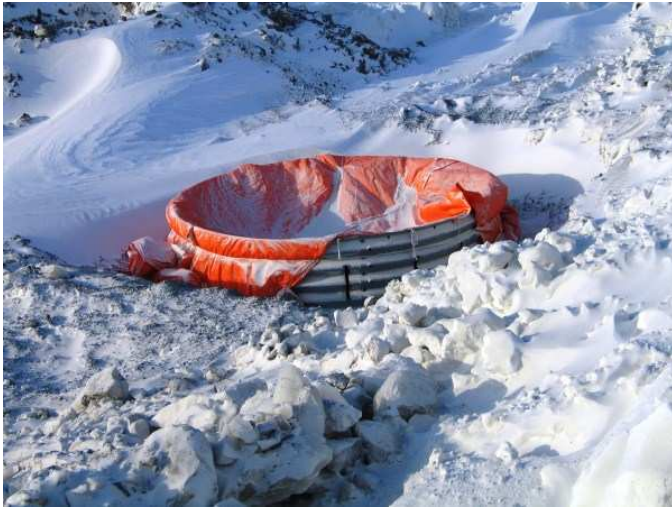
Photo 3: Sump 1 with tarp.

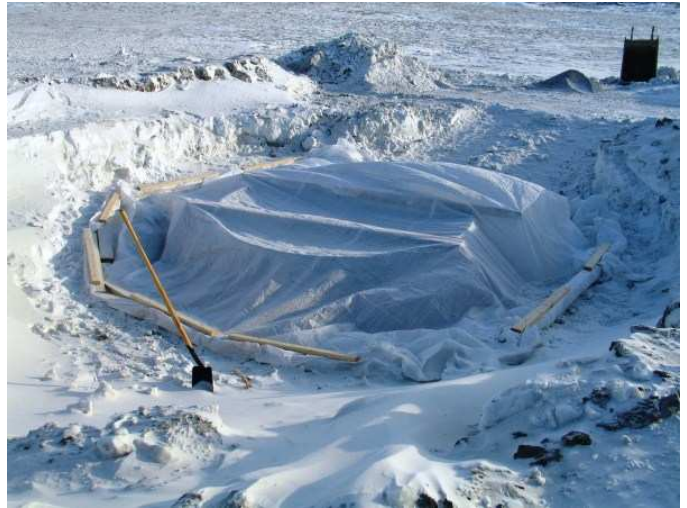
Photo 4: Sump 2 with tarp.

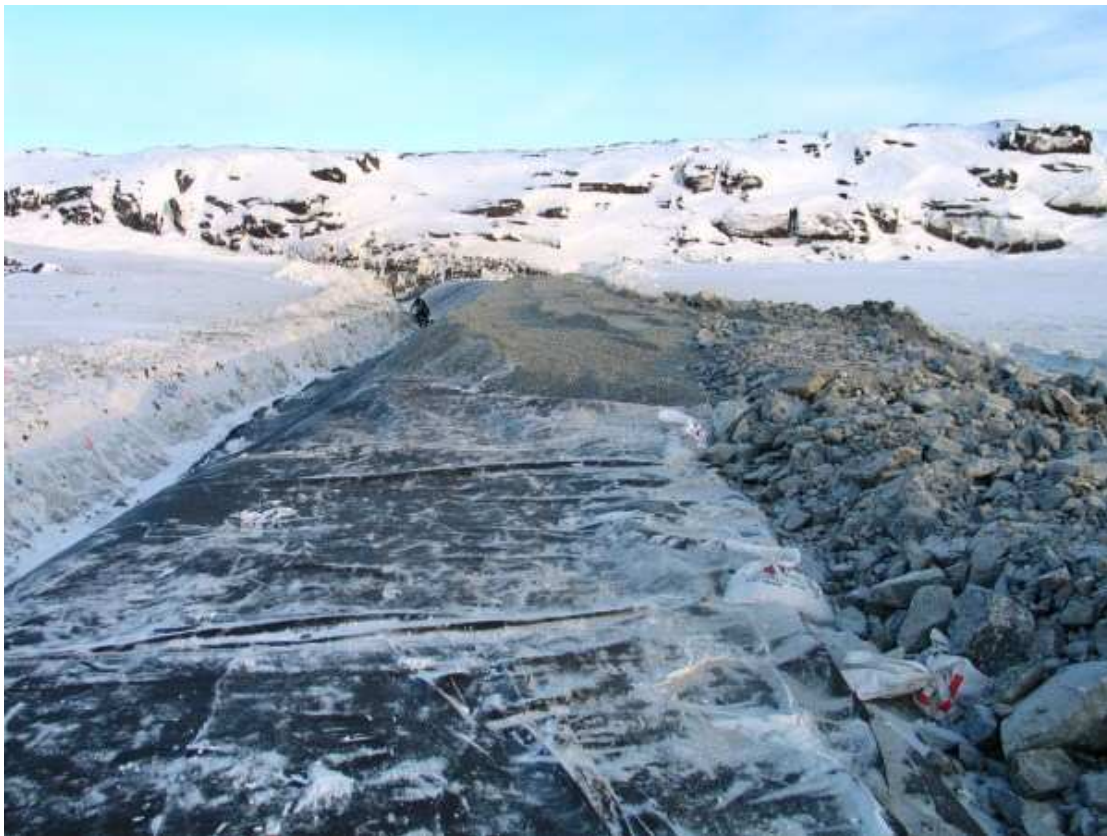
Photo 5: Start of modifications to the surface of the berm to permit equipment access. Sta. 580

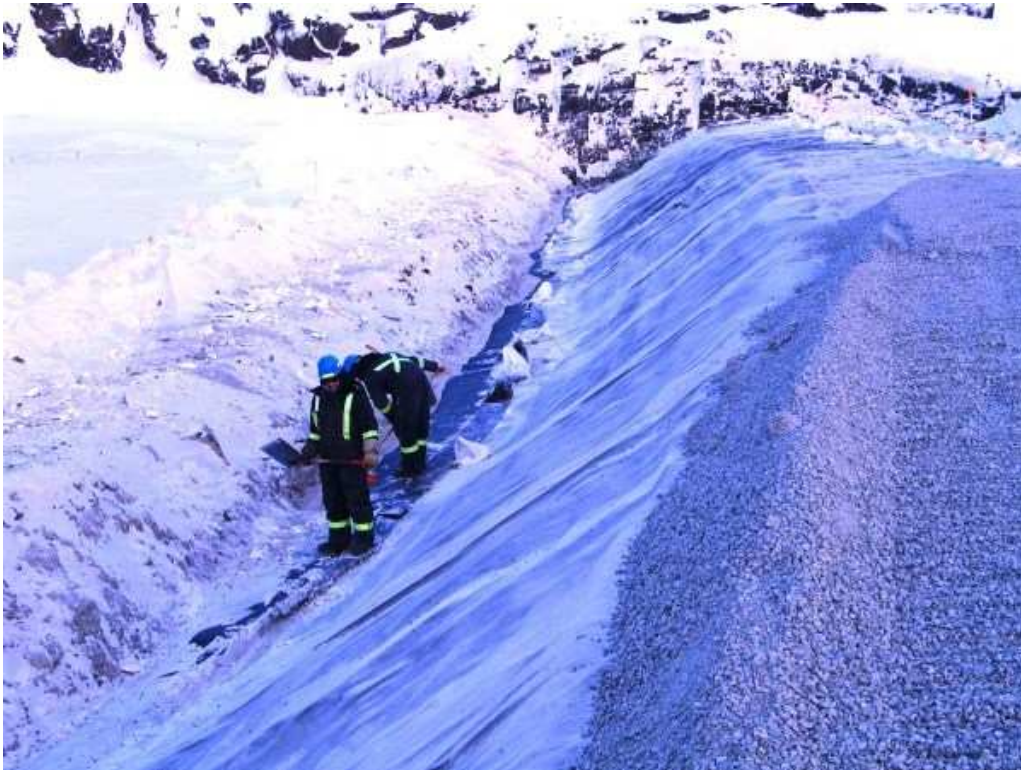
Photo 6: Labourers removing snow in key trench.

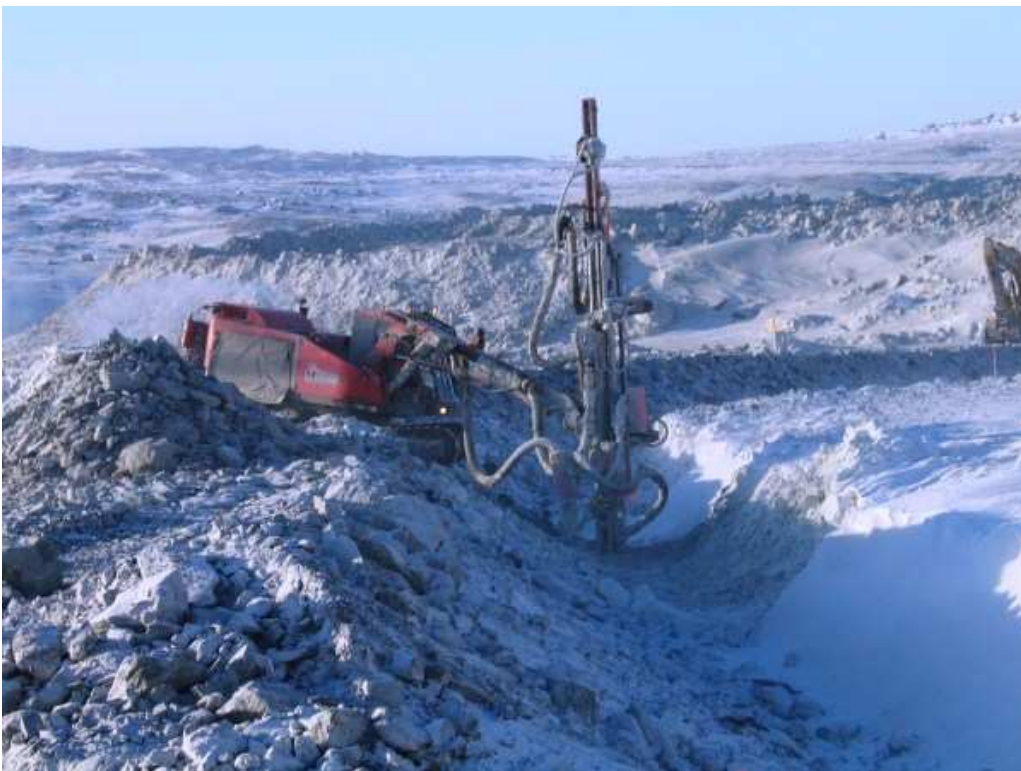
Photo 7: Drill working in key trench

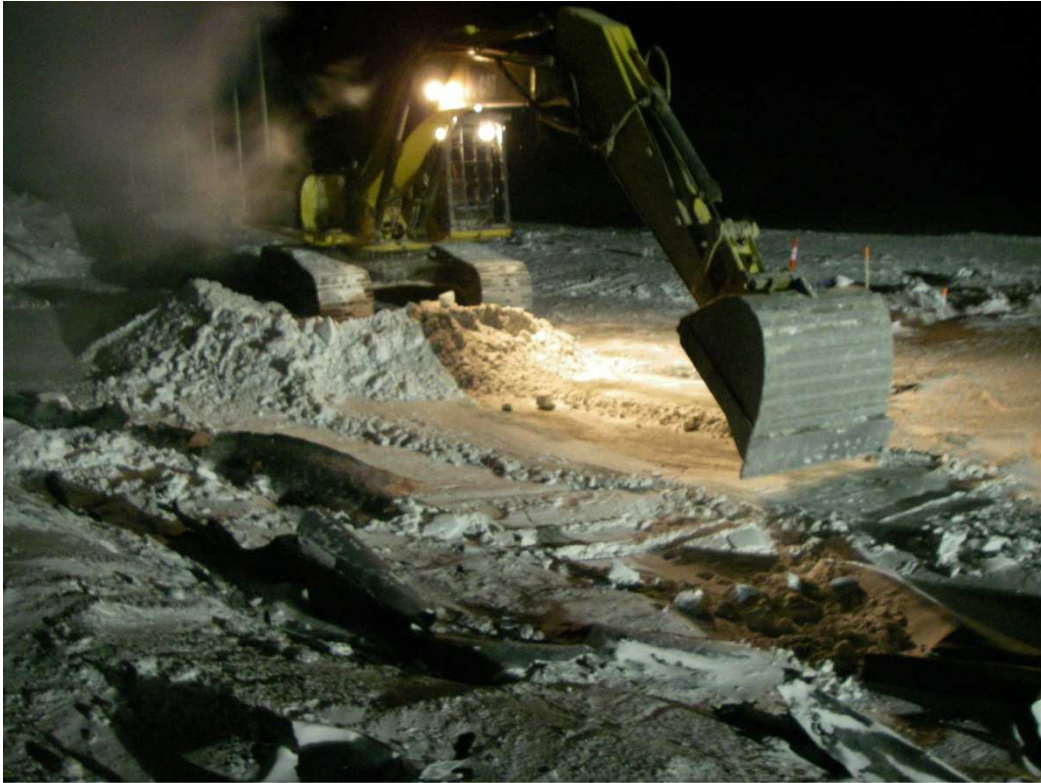
Photo 8: Removing snow from the south end of the dam, on the upstream side.

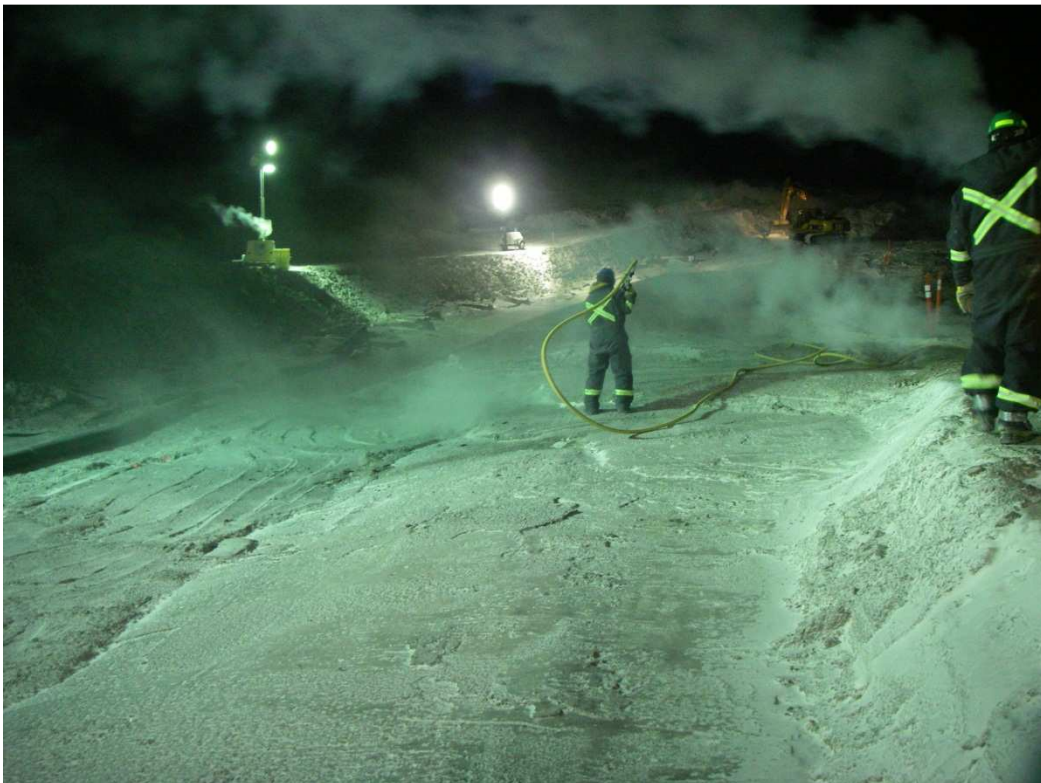
Photo 9: Worker cleaning the frozen core in preparation for placement on night shift.

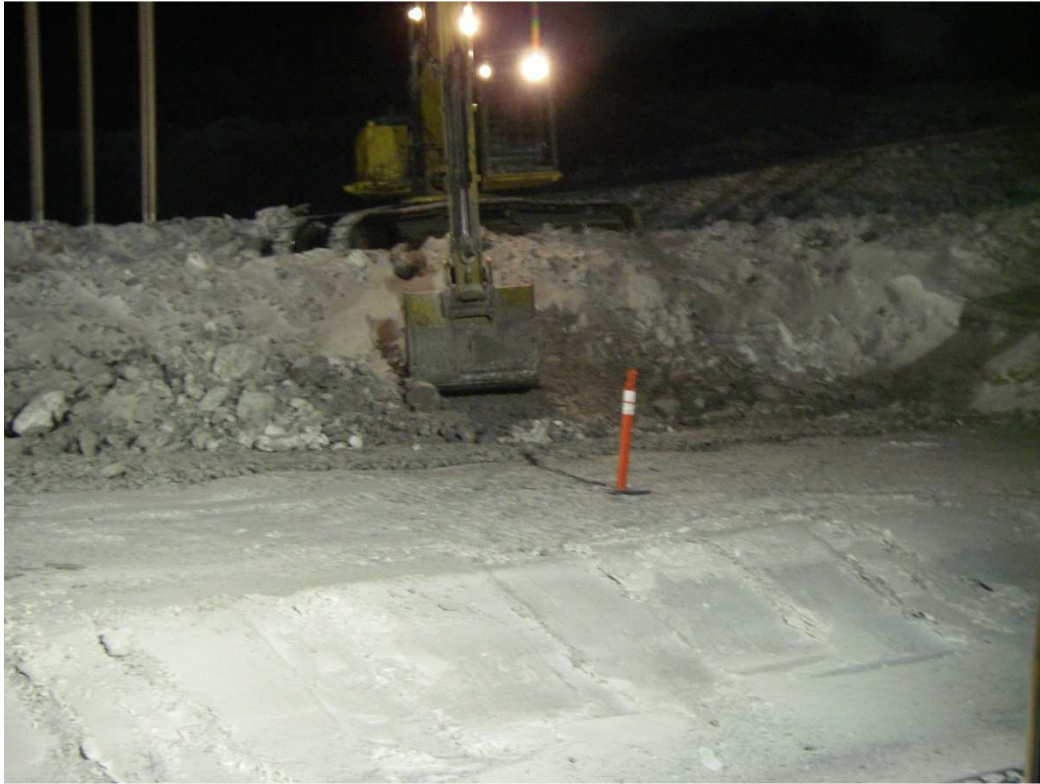
Photo 10: Excavator placing ROQ around Sta. 1+90, downstream of the core.
