## DAILY REPORT #57 – DORIS NORTH INFRASTRUCTURE/ NORTH DAM

<b>Prepared by:</b>	Iozsef Miskolczi Lawrence Borowski	<b>Date:</b>	2012.03.02
<b>Reviewed by:</b>		<b>Project #:</b>	1CH008.058.0320
<b>Role</b>	<b>Company</b>	<b>Personnel – Position</b>	<b>On Site</b>
Client	Hope Bay Mining Limited (HBML)	Angela Holzapfel – ESR Compliance Manager David Vokey – ESR Coordinator Don Ethelston – HSLP Advisor Dean Wold - Safety Jill Turk – ESR Coordinator Katsky Venter – ESR Manger Michelle Tanquay – ESR Site Manager Stirling Kelly – HSLP Advisor	No Yes No Yes No Yes Yes No
	JDS	Lloyd Jackson – Mechanical Superintendent Doug Fielding – Construction Manager Ishan Fechter – Construction Coordinator Jerry Graham – Construction Manager Kevin Whieldon – Project Coordinator Mark Valeriote – Construction Manager	Yes No No Yes Yes Yes
Engineering Design Consultants	SRK Consulting (Canada) Inc.	John Kurylo – Site Engineer Megan Miller – Site Engineer Lawrence Borowski – Site Engineer Murray McGregor – Site Engineer Iozsef Miskolczi – Site Engineer Lowell Wade – Senior Engineer	No No Yes No Yes No

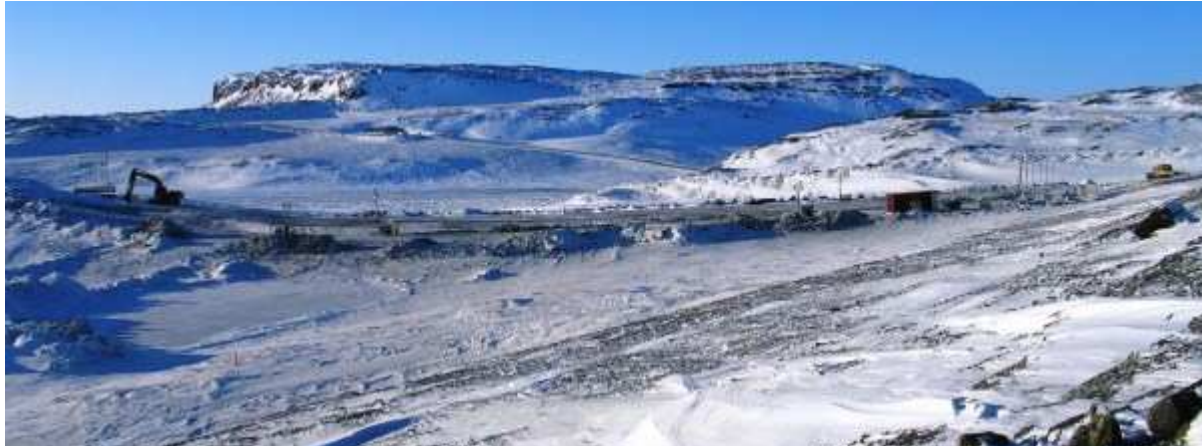
**Photo 1:** Progress photo from photo point 2, facing NW.

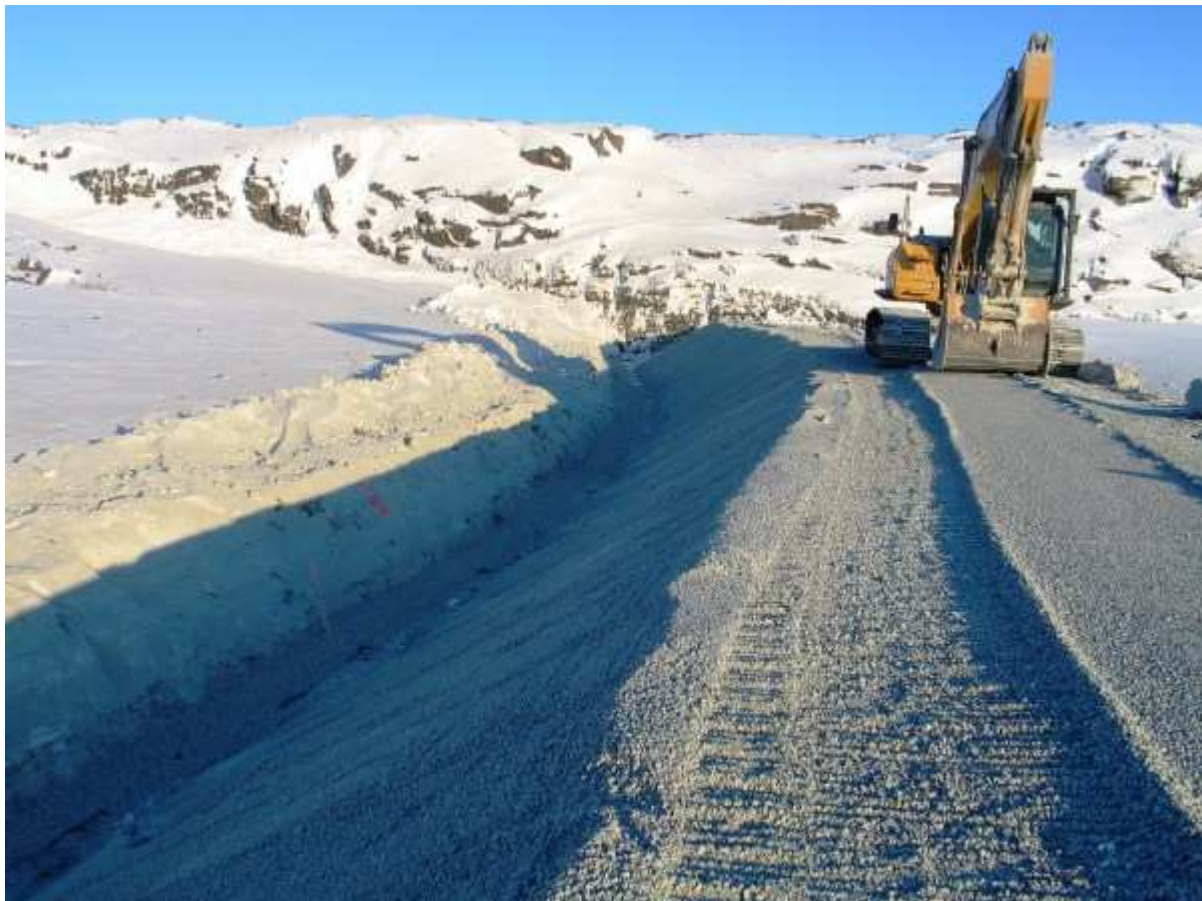
- Key trench was inspected by SRK. SRK pointed out areas where HDPE was too close to the Bank and needed to be cut back. HDPE was cut back by the foreman.
- Hauling crush. Placing crush on the banks. Working between stations 0+580 and 0+687.
- Hauling ROQ
- Tie in between berm and rock wall at the end completed. A bentonite seal .1m x .4m (min.) placed at the wall.
- Started placing final bentonite over HDPE in the key trench.
- Bentonite placed between Sta 0+580 and Sta 0+678

**Photo 2:** Progress on the north diversion berm. Bentonite was placed over HPDE.  $\frac{3}{4}$ " crush placed on top of berm and slopes. Section from 0+585 to the end.

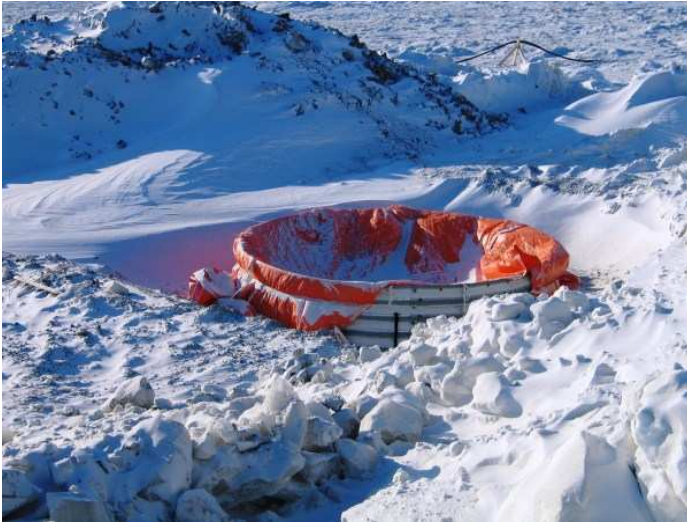
**Photo 3:** Sump 1 with tarp.

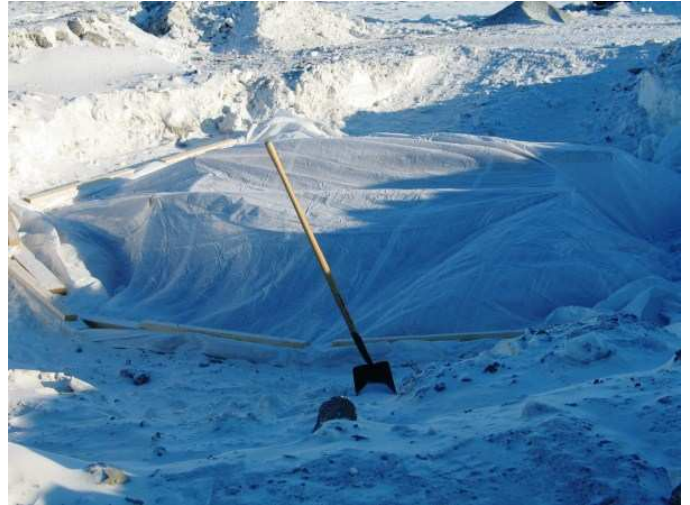
**Photo 4:** Sump 2 with tarp.

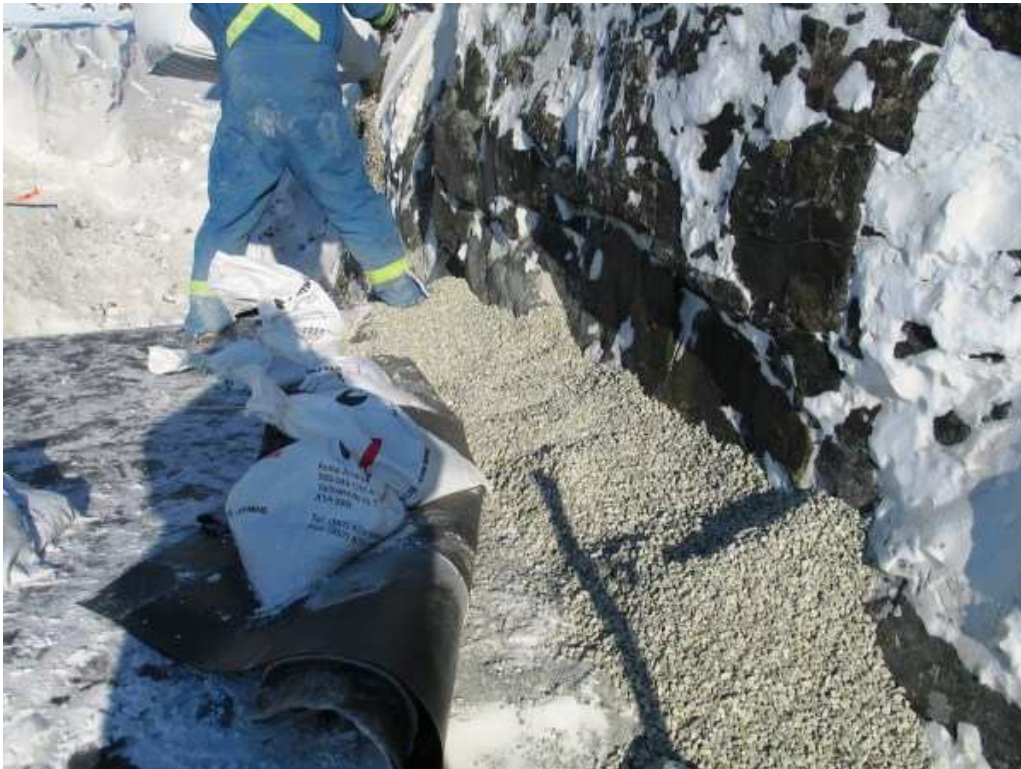
**Photo 5:** Bentonite seal placed at end of berm (tie in to rock face)

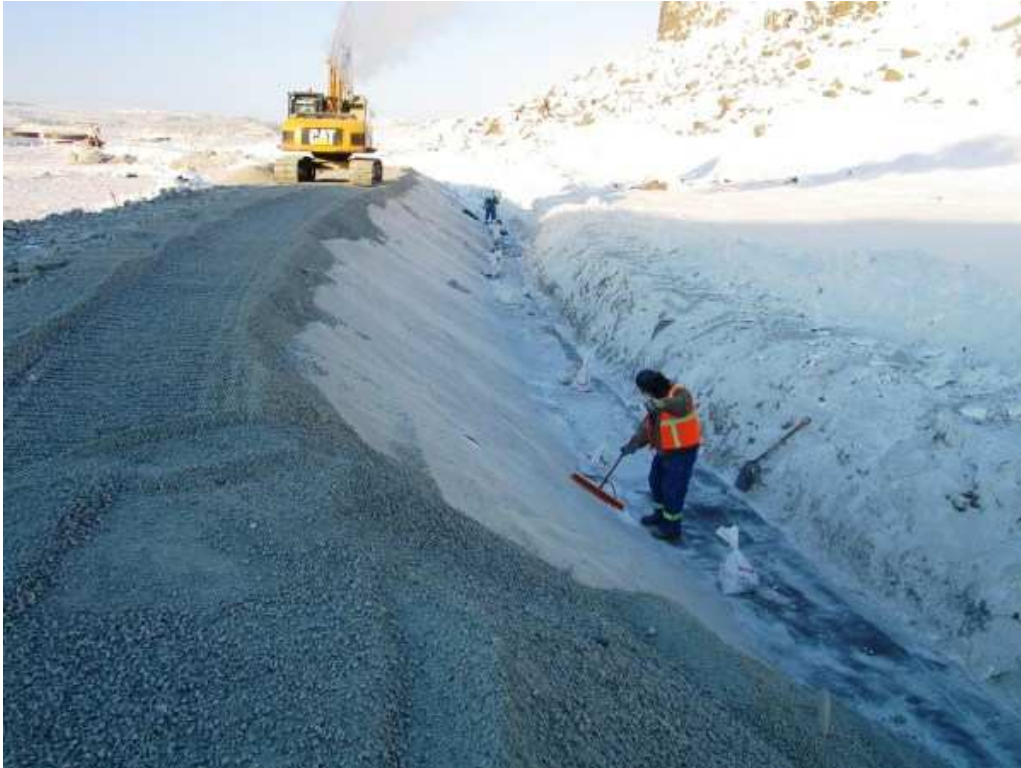
**Photo 6:** Labourers removing snow in key trench.

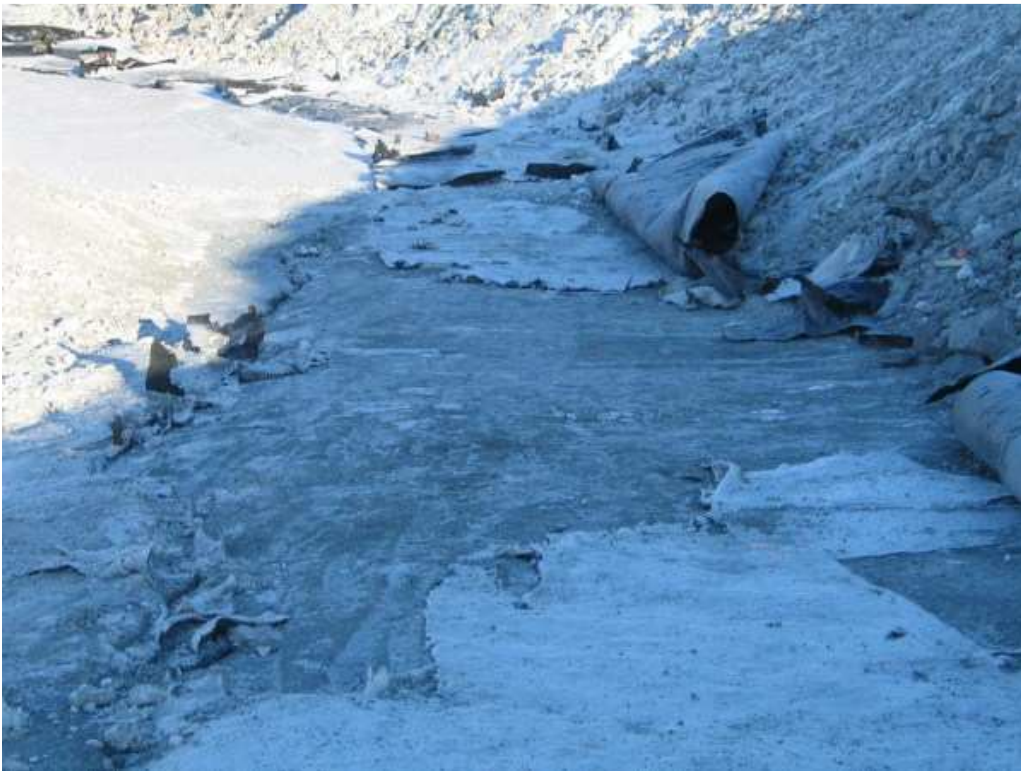
- Cleaning work areas for night shift.
- Some snow removed from extreme SE corner.
- GCL cleaned at the south end, and inspected.
- Workers moved light plant to the south end. Frost fighters set up to heat locations where GCL was ripped.
- Survey marked out hinge point and a 1 m offset.
- Single bead thermistor installed Feb 29<sup>th</sup> monitored all day.
- Two cores taken at the end of the day shift.

**Photo 7:** Cleaning at south end of berm. GCL was ripped and removed at this location

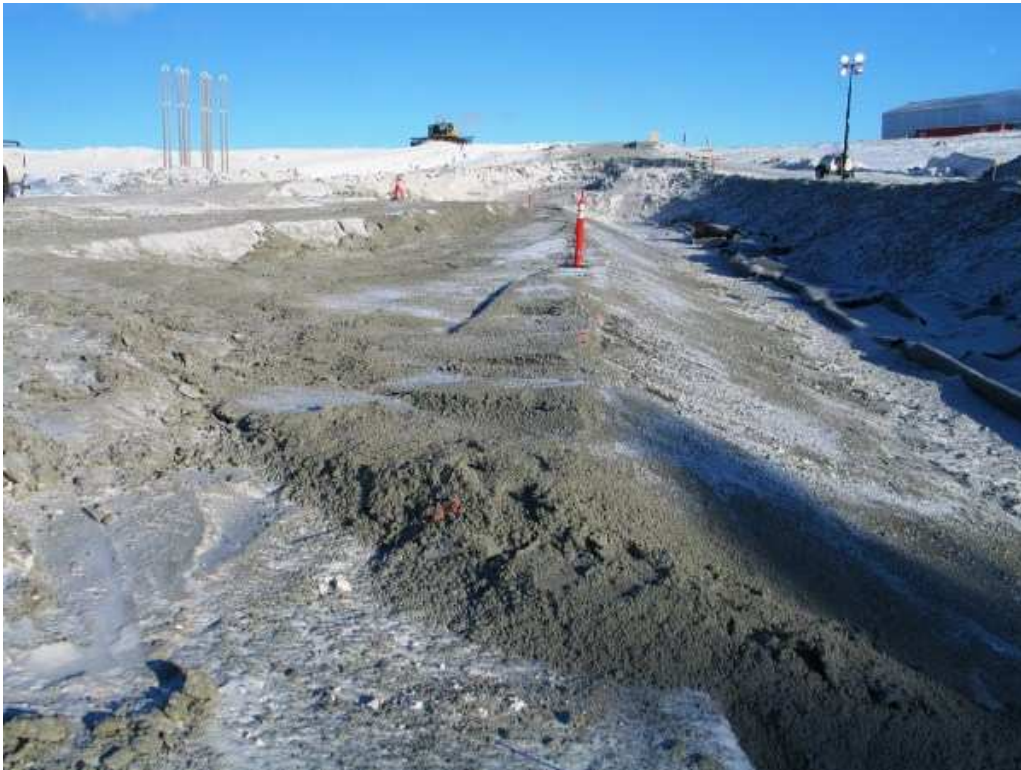
**Photo 8:** Slope at the north end, Sta 130. FCM placed March 1<sup>st</sup> nightshift.

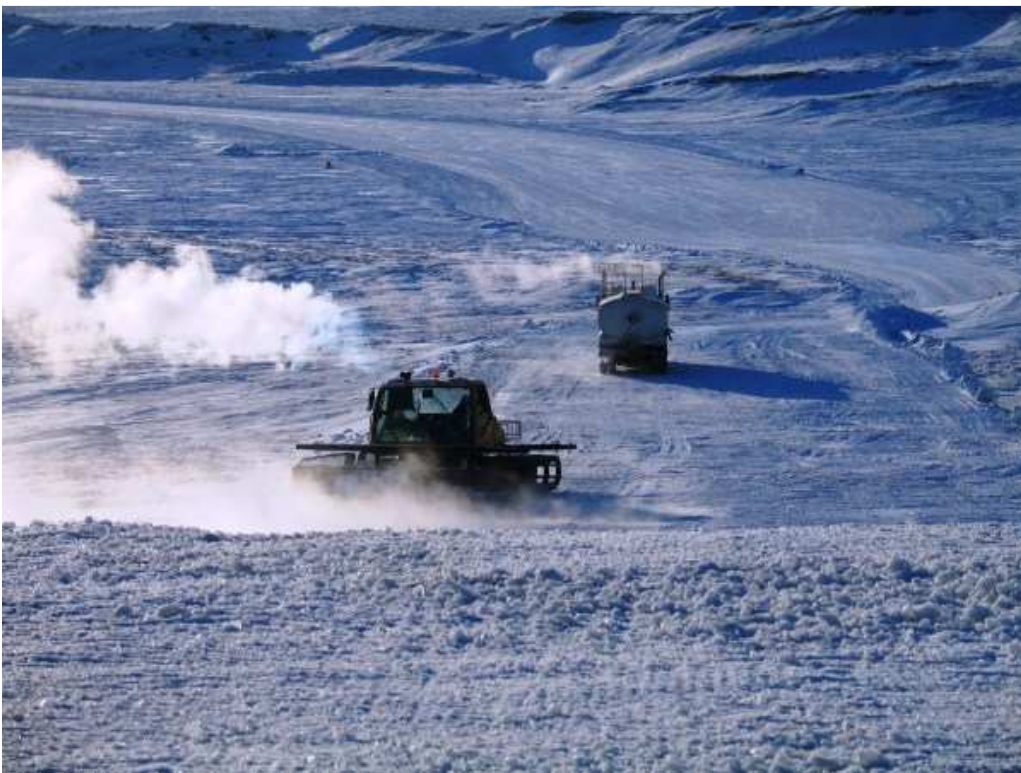
**Photo 9:** Final touches on the ice road. Road will open for traffic tomorrow (March 3<sup>rd</sup>).

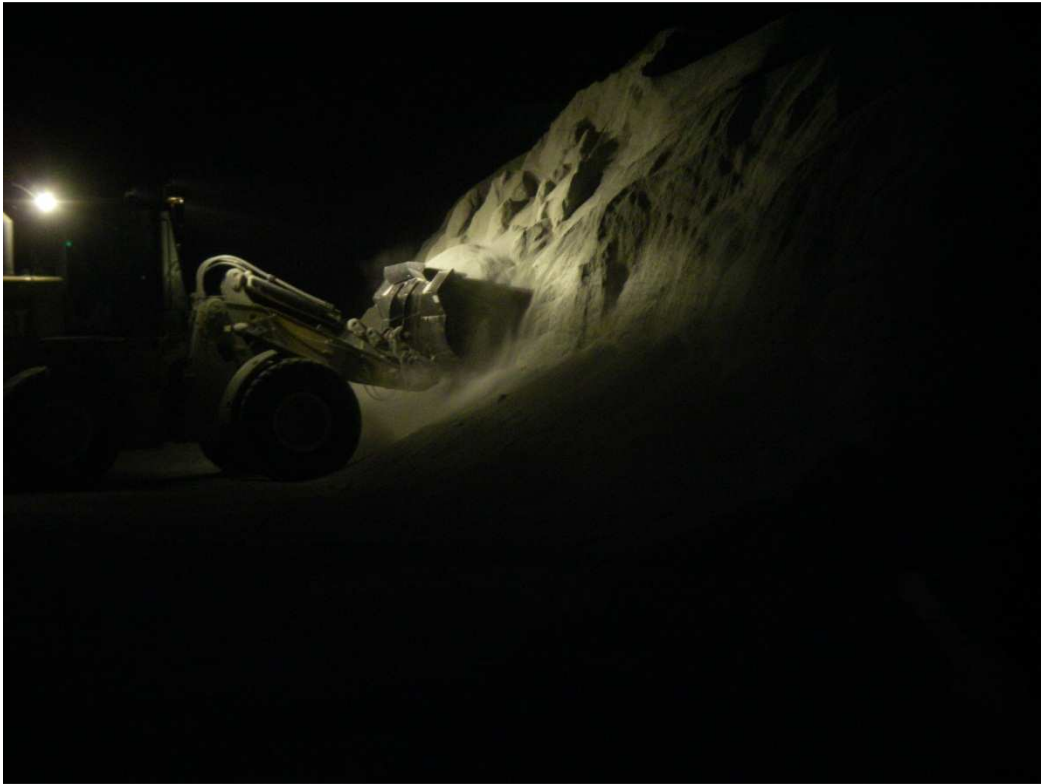
- Temperature of the core mix off the chute was 38 degrees at the beginning of the shift, decreasing to about 35 degrees towards the end of the shift.
- The matter of contradictory behaviour of the core mix was discussed with the plant operator, who mentioned seeing traces of snow in the mixer feed. The loader operator feeding the plant also mentioned that the nature of the FCM changed slightly, from a loose state in the beginning of the shift (recently hauled and stockpiled at the plant) to a state where the working front is standing up vertical, possibly indicating increased moisture content of the dry FCM. No interstitial ice or snow was apparent at the loading front, and when poked with a hand tool the vertical wall crumbled easily.

**Photo 10:** Loader scooping up FCM at the plant stockpile. Note the near vertical slope of the loading front.
