## DAILY REPORT #58 – DORIS NORTH INFRASTRUCTURE/ NORTH DAM

<b>Prepared by:</b>	Iozsef Miskolczi Lawrence Borowski	<b>Date:</b>	2012.03.03
<b>Reviewed by:</b>		<b>Project #:</b>	1CH008.058.0320
<b>Role</b>	<b>Company</b>	<b>Personnel – Position</b>	<b>On Site</b>
Client	Hope Bay Mining Limited (HBML)	Angela Holzapfel – ESR Compliance Manager David Vokey – ESR Coordinator Don Ethelston – HSLP Advisor Dean Wold - Safety Jill Turk – ESR Coordinator Katsky Venter – ESR Manger Michelle Tanquay – ESR Site Manager Stirling Kelly – HSLP Advisor	No Yes No Yes No Yes Yes No
	JDS	Lloyd Jackson – Mechanical Superintendent Doug Fielding – Construction Manager Ishan Fechter – Construction Coordinator Jerry Graham – Construction Manager Kevin Whieldon – Project Coordinator Mark Valeriote – Construction Manager	Yes No No Yes Yes Yes
Engineering Design Consultants	SRK Consulting (Canada) Inc.	John Kurylo – Site Engineer Megan Miller – Site Engineer Lawrence Borowski – Site Engineer Murray McGregor – Site Engineer Iozsef Miskolczi – Site Engineer Lowell Wade – Senior Engineer	No No Yes No Yes No

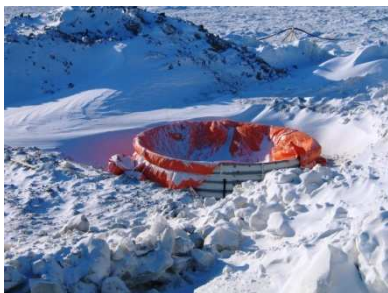
- No activity: sumps are covered with tarps

**Photo 4:** Sump 1

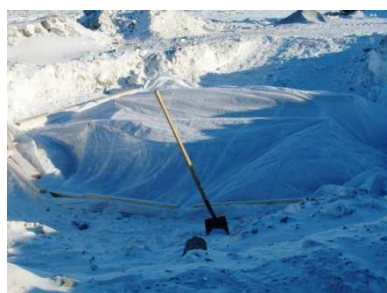
**Photo 5:** Sump 2

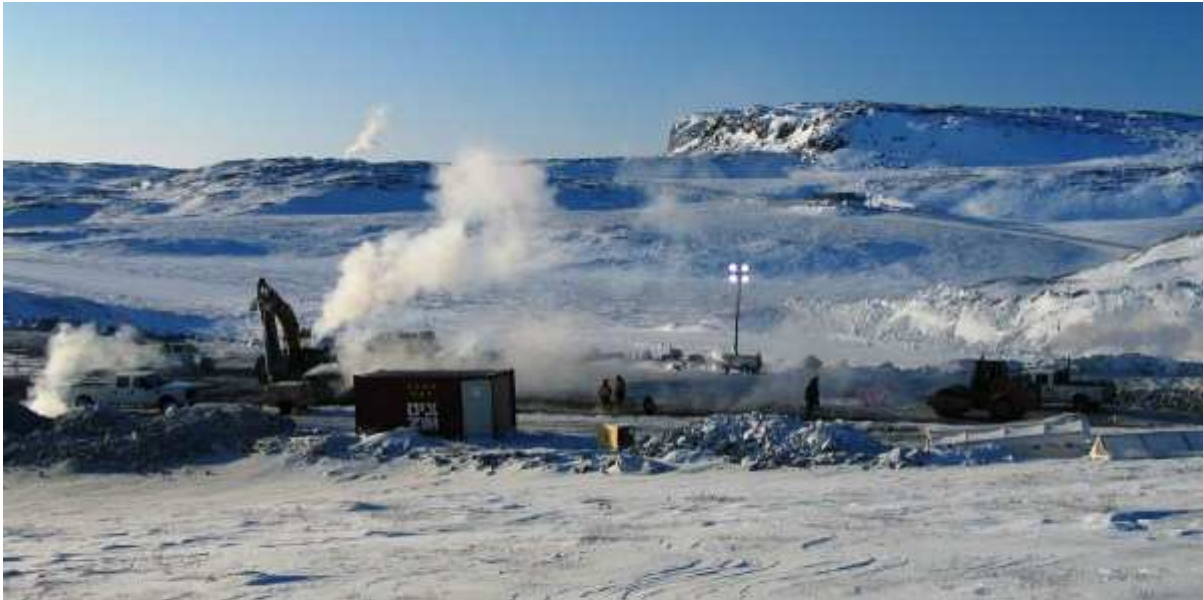
**Photo 6:** FCM work area, Sta 140 to Sta 180

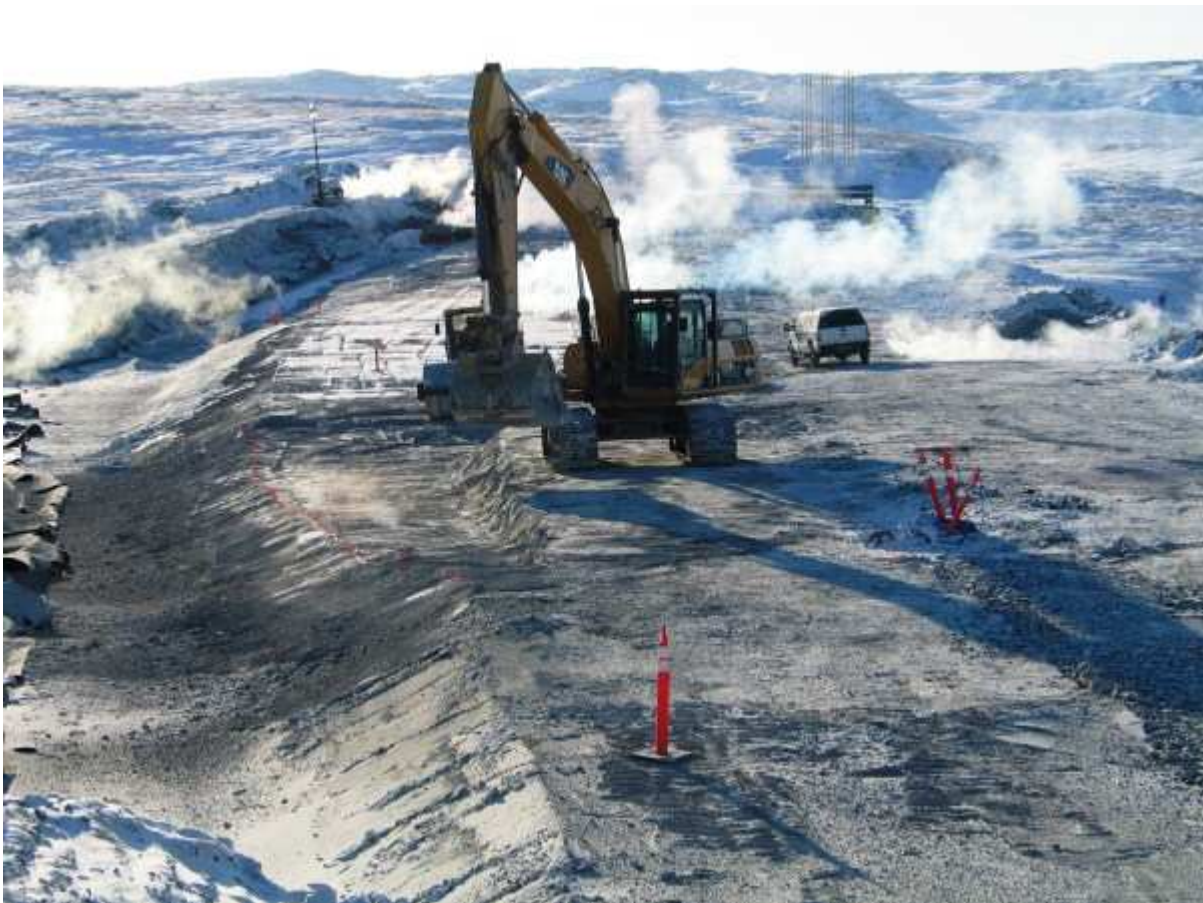
**Photo 7:** Work area cleaned prior to placing FCM.

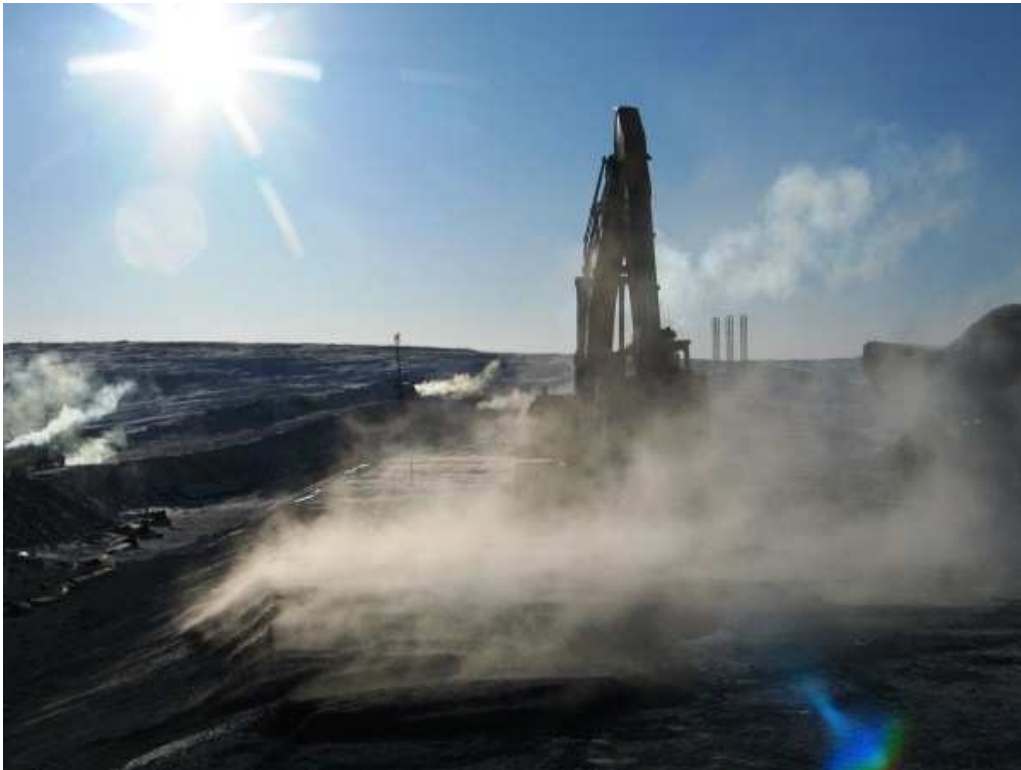
**Photo 8:** Placing FCM.

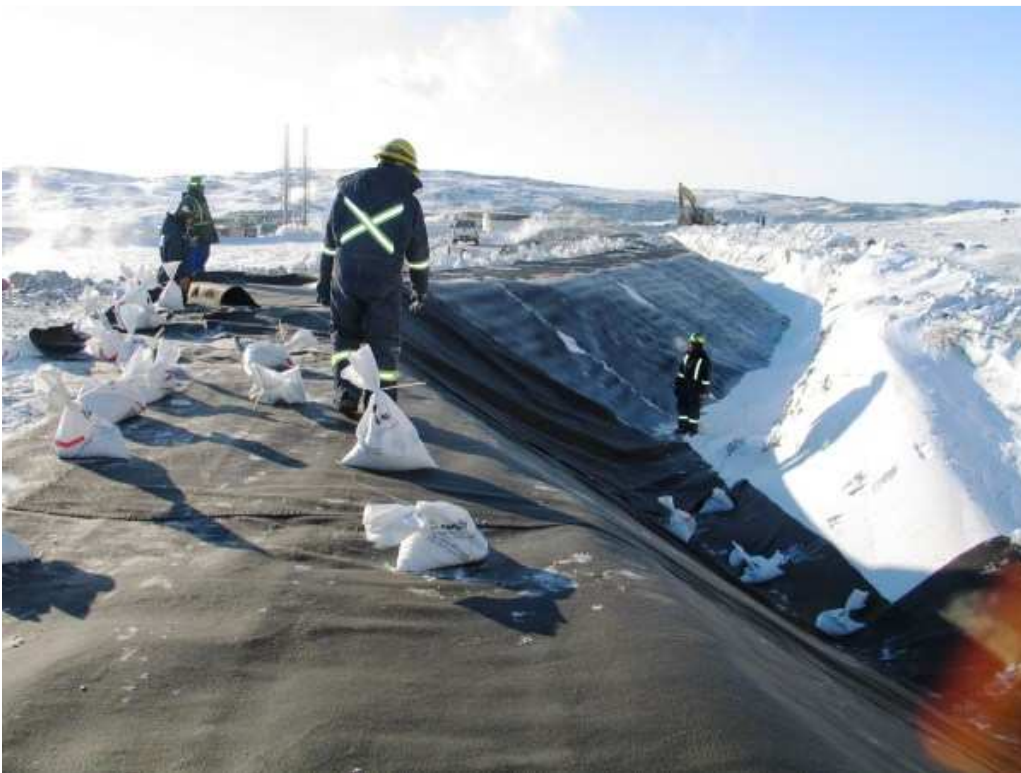
- Snow clearing in key trench continued.
- Completed placing crush over liners/bentonite in the key trench between stations 0+580 and 0+687.
- Crew placed geotextile over HDPE starting ~ Sta.560 and working west.
- Snow was not removed from the trench when the geotextile was placed. At present there is too much snow in the key trench to remove by hand. The plan now is to prepare a working surface over the berm sufficient for access by an excavator. The geotextile will be pulled back and the snow removed with the excavator.
- Seams were welded to the bottom of the slope.

**Photo 9:** Placing geotextile. Note snow in keytrench that will be removed.

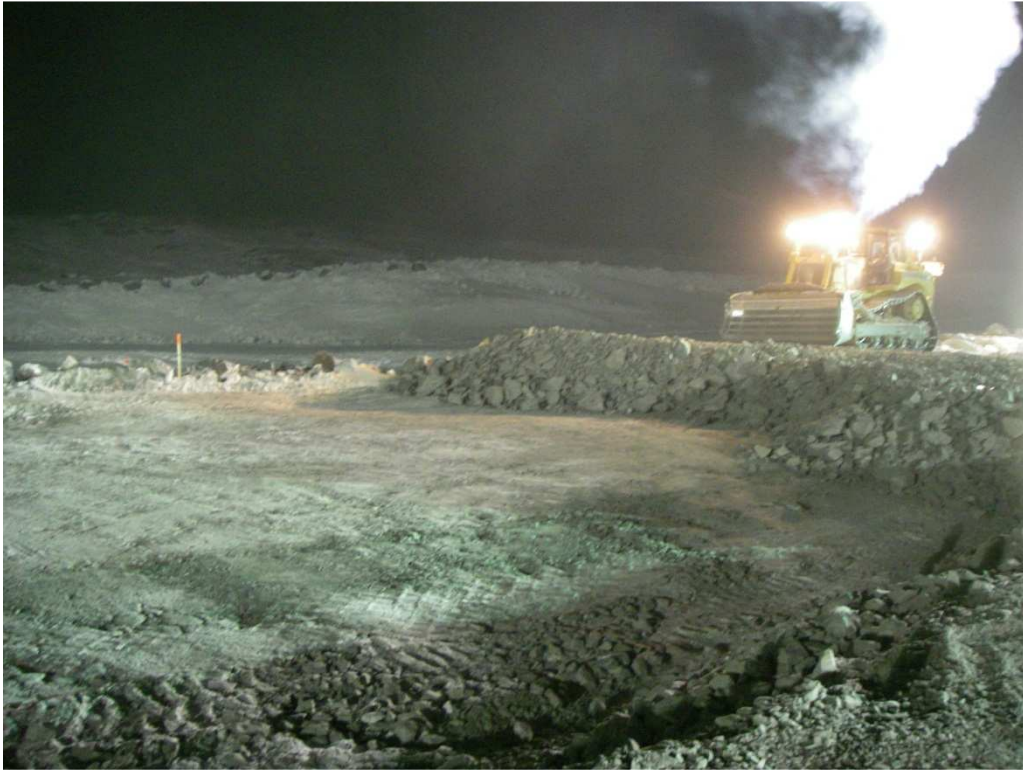
- ROQ was placed on the downstream side, in a lift close to 1 m thick, from Sta. 1+20 to Sta. 0+90. No compaction was observed.

**Photo 8:** CAT D8 dozer placing ROQ on the downstream of the dam.

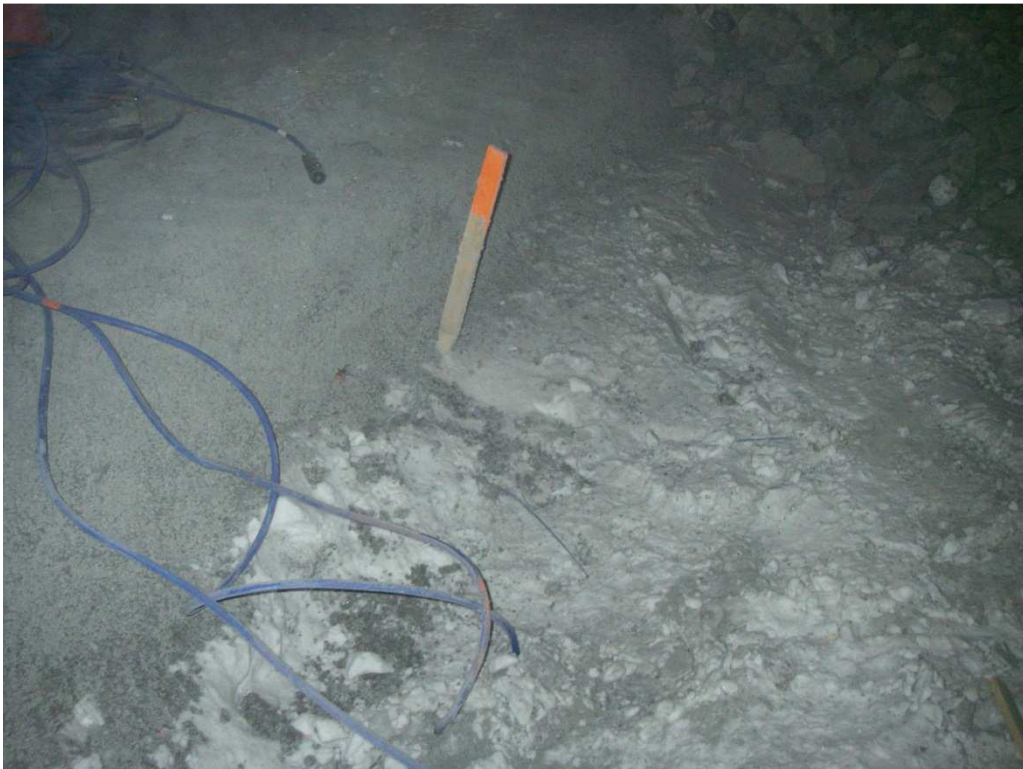
- A volume of packed snow was noted at Sta.0+60 lodged between the transition material and the frozen core. This snow will have to be removed by manual labor to eliminate the risk of damaging the thermistor cables.

**Photo 9:** Snow piled up against the core around Sta. 0+60. This snow will have to be removed before transition material can be placed.
