DAILY REPORT #59 – DORIS NORTH INFRASTRUCTURE/ NORTH DAM

Prepared by:	Iozsef Miskolczi Lawrence Borowski	Date:	2012.03.04
Reviewed by:		Project #:	1CH008.058.0320
Role	Company	Personnel – Position	On Site
Client	Hope Bay Mining Limited (HBML)	Angela Holzapfel – ESR Compliance Manager David Vokey – ESR Coordinator Don Ethelston – HSLP Advisor Dean Wold - Safety Jill Turk – ESR Coordinator Katsky Venter – ESR Manger Michelle Tanquay – ESR Site Manager Stirling Kelly – HSLP Advisor	No Yes No Yes No Yes Yes No
	JDS	Lloyd Jackson – Mechanical Superintendent Doug Fielding – Construction Manager Ishan Fechter – Construction Coordinator Jerry Graham – Construction Manager Kevin Whieldon – Project Coordinator Mark Valeriote – Construction Manager	Yes No No Yes Yes Yes
Engineering Design Consultants	SRK Consulting (Canada) Inc.	John Kurylo – Site Engineer Megan Miller – Site Engineer Lawrence Borowski – Site Engineer Murray McGregor – Site Engineer Iozsef Miskolczi – Site Engineer Lowell Wade – Senior Engineer	No No Yes No Yes No

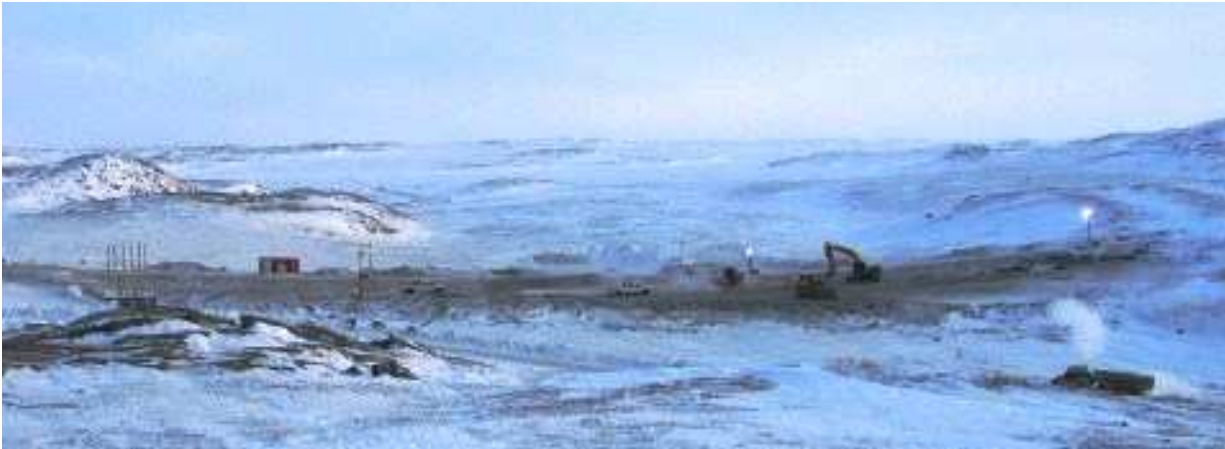
Photo 1: Progress photo from photo point 1, facing SSE

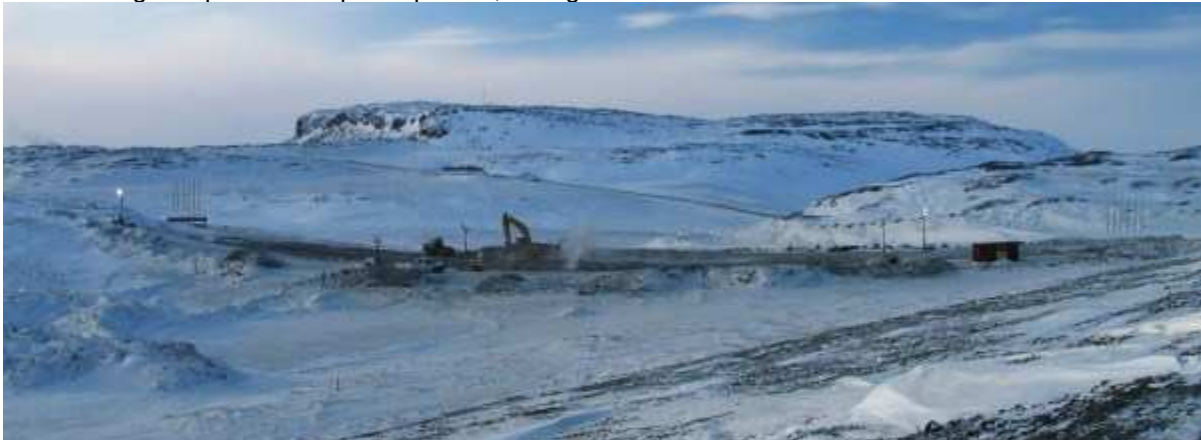
Photo 2: Progress photo from photo point 2, facing NNW

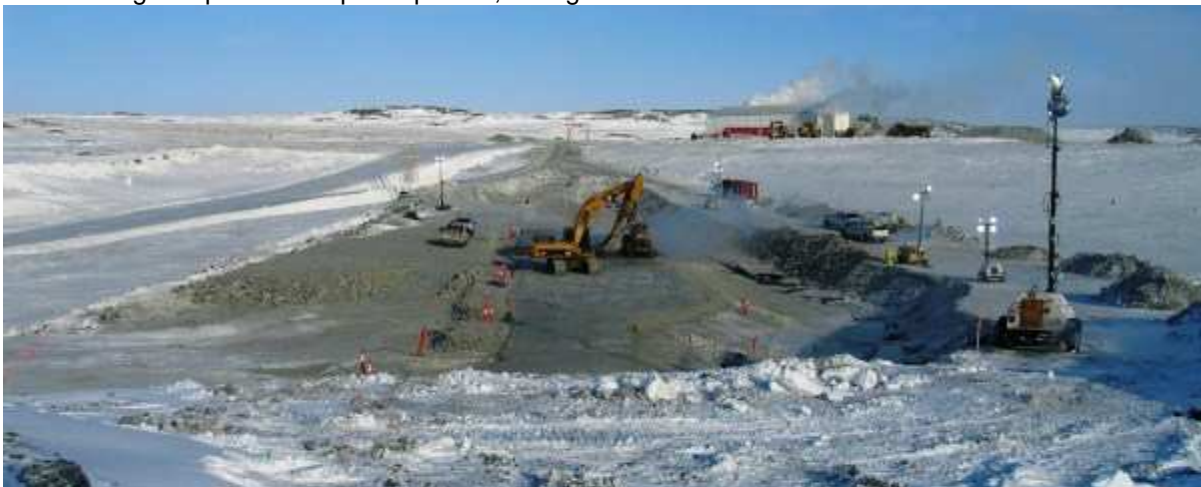
Photo 3: Progress photo from photo point 3, facing NNE

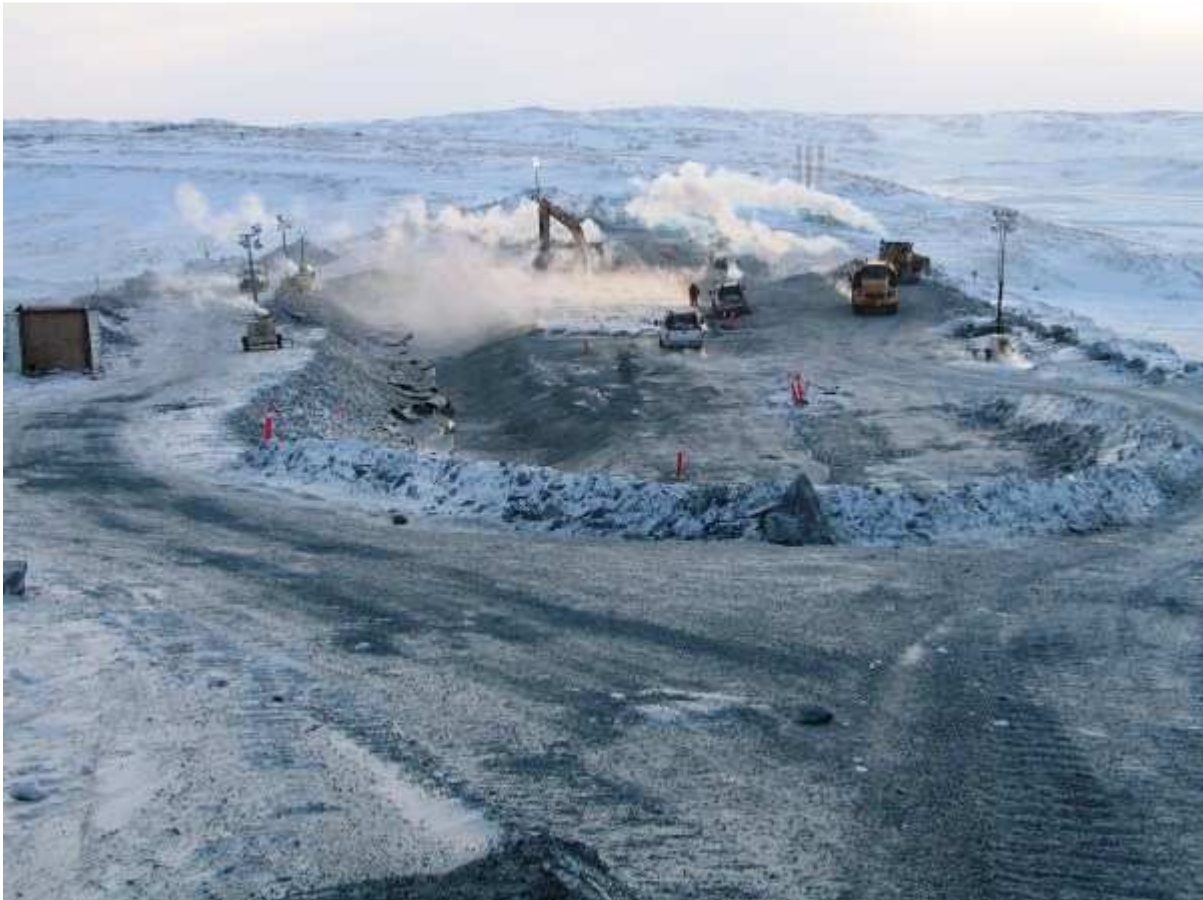
- Cleaned section from Sta 0+60 to 1+40
- FCM placed in a small wedge from Sta 1+40 to Sta 0+70
- Thickness varied to a maximum of 300 mm.
- Upstream slope was over built, packed, then cut with the excavator and raked. The resulting slope of 2.5:1 was achieved using a level mounted on a triangle with the correct slope.
- All test results were within specification limits.
- Water was pooling on the final surface after compaction.
- One single bead thermister installed.
- Labourers maintained hoarding on the upstream edge of the key trench, where two frost fighters were set up to melt ice and 5/8 crush over the GCL liner.

Photo 6: FCM work area facing south Sta 1+35 to Sta 0+70

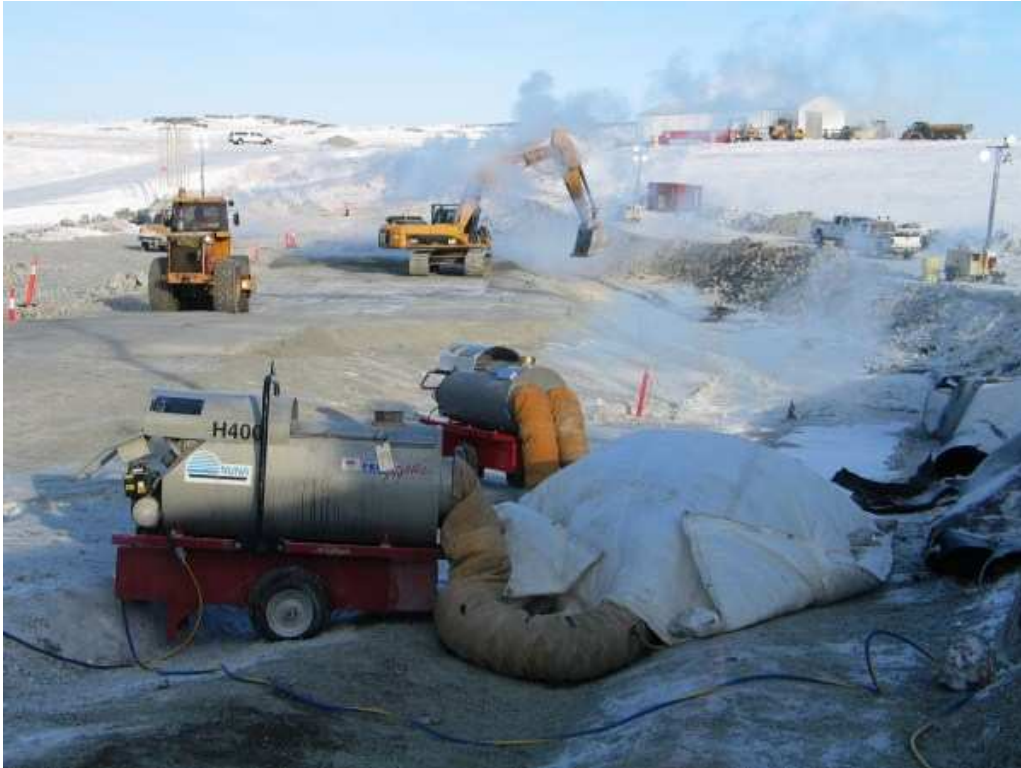
Photo 7: Frost fighters at the SE corner thawing ice over GCL.

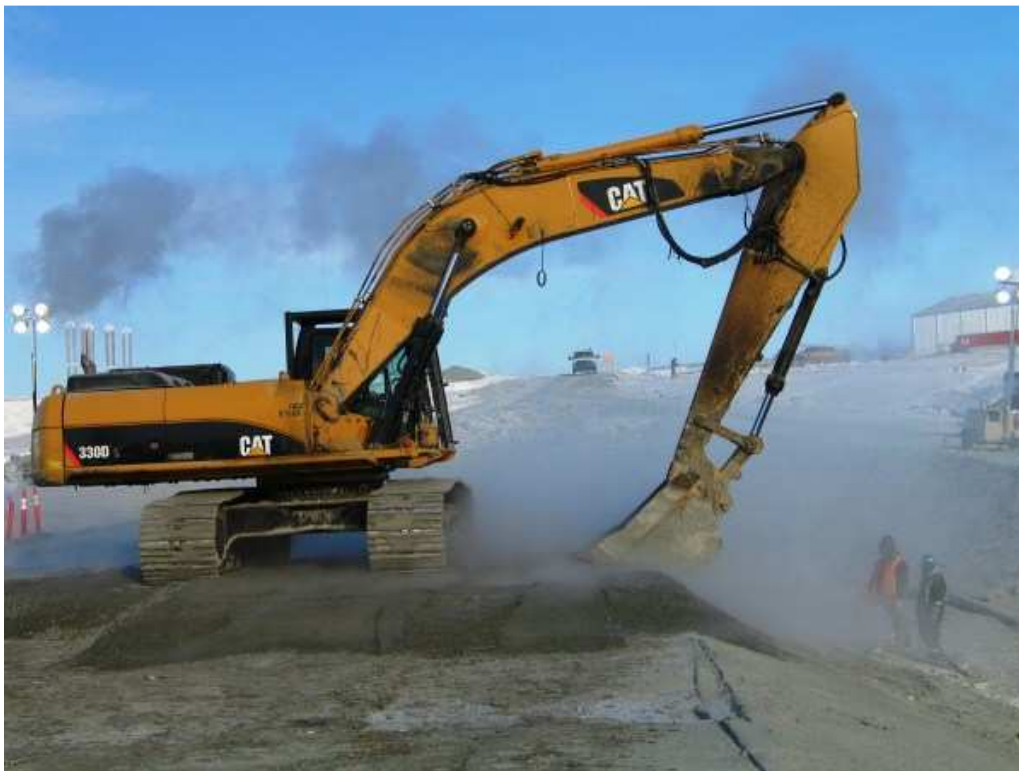
Photo 8: Placing FCM. Labourers to the right shape edges to achieve 2.5:1 slopes

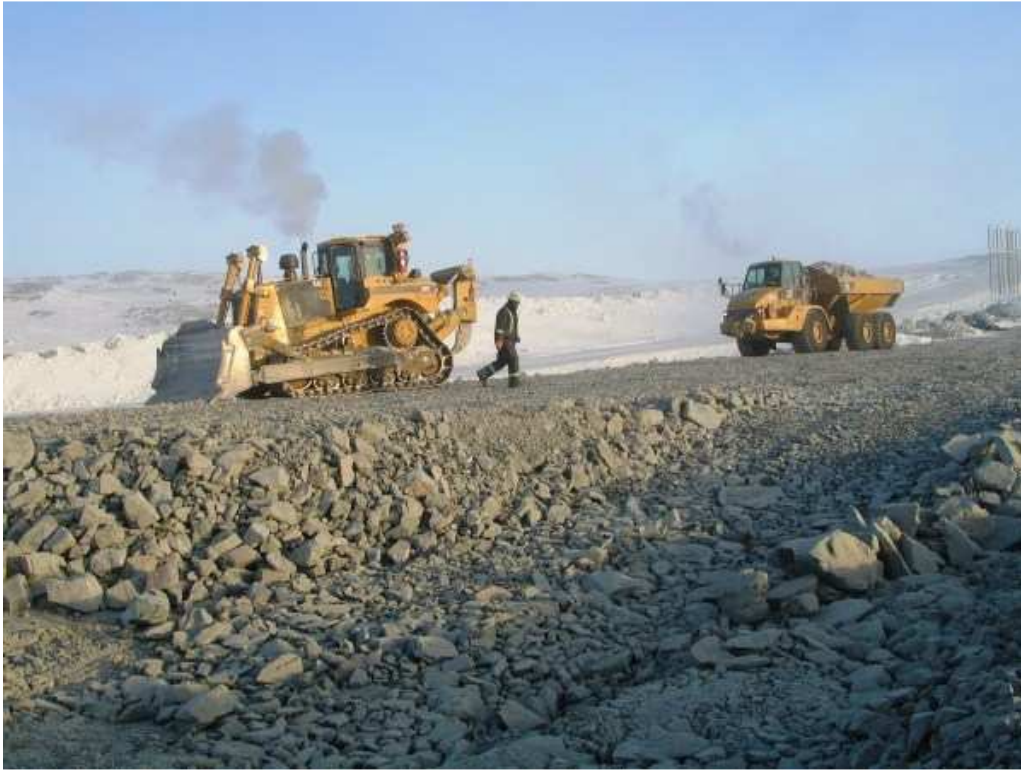
- Hauled ROQ to the downstream side until 11:00 am.
- Resumed hauling ROQ in the middle of the afternoon.
- Lift thickness was approaching 1.8 m. To be checked by surveys.

Photo 9: ROQ placement, downstream. ROQ is good quality.

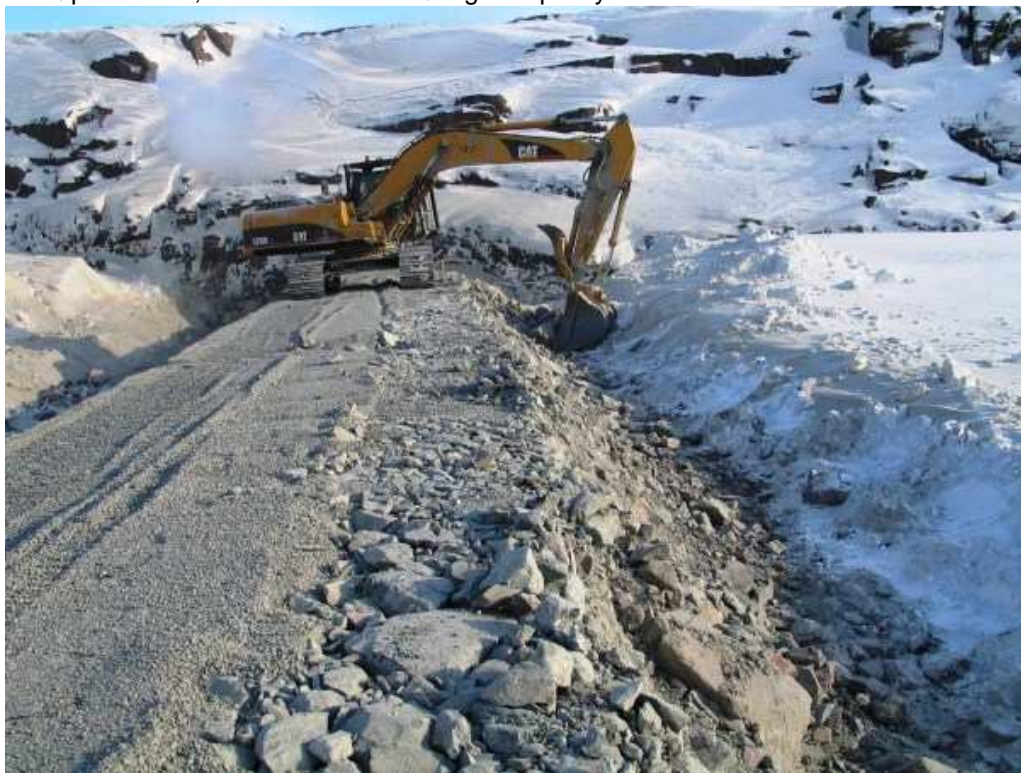
Photo 8: Reshaping the North Diversion Berm

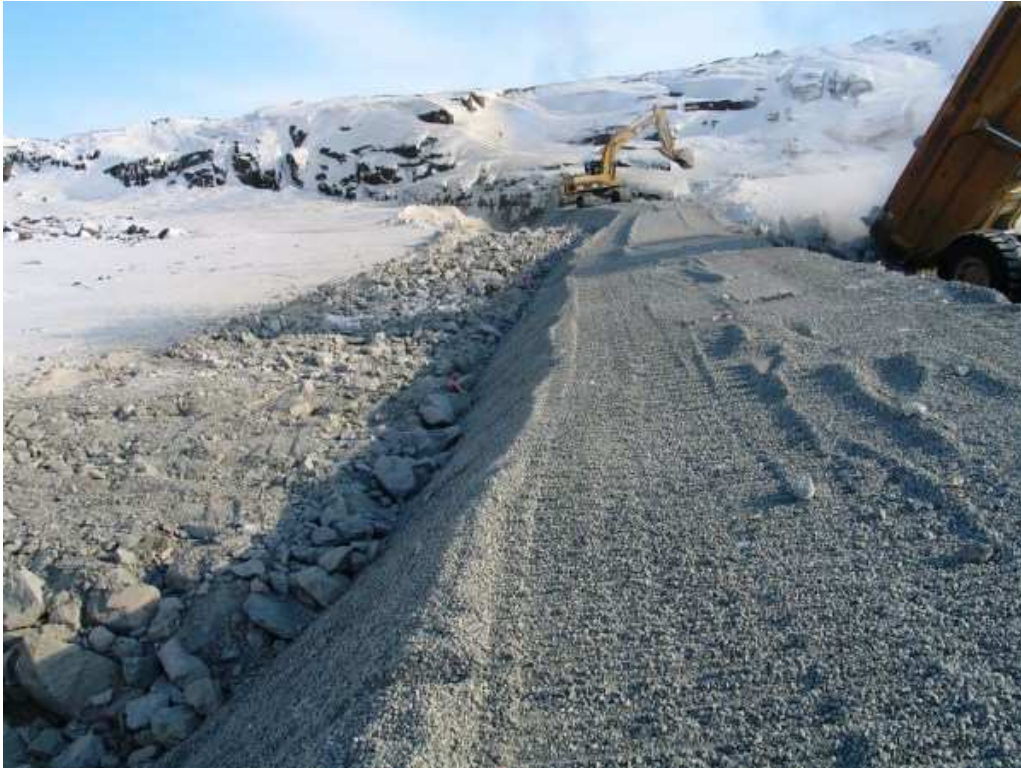
Photo 9 : Progress filling key trench.

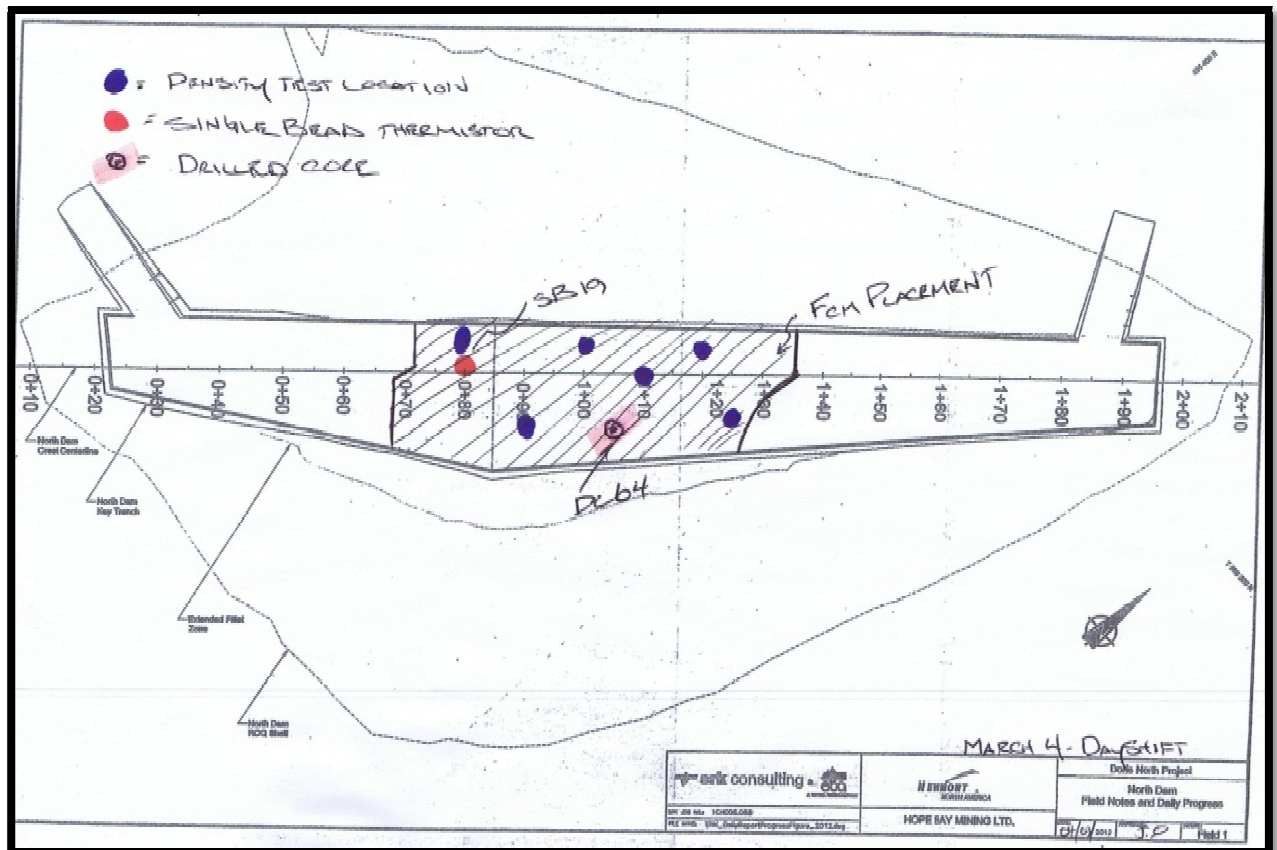
Figure 1 – North Dam Progress – Dayshift

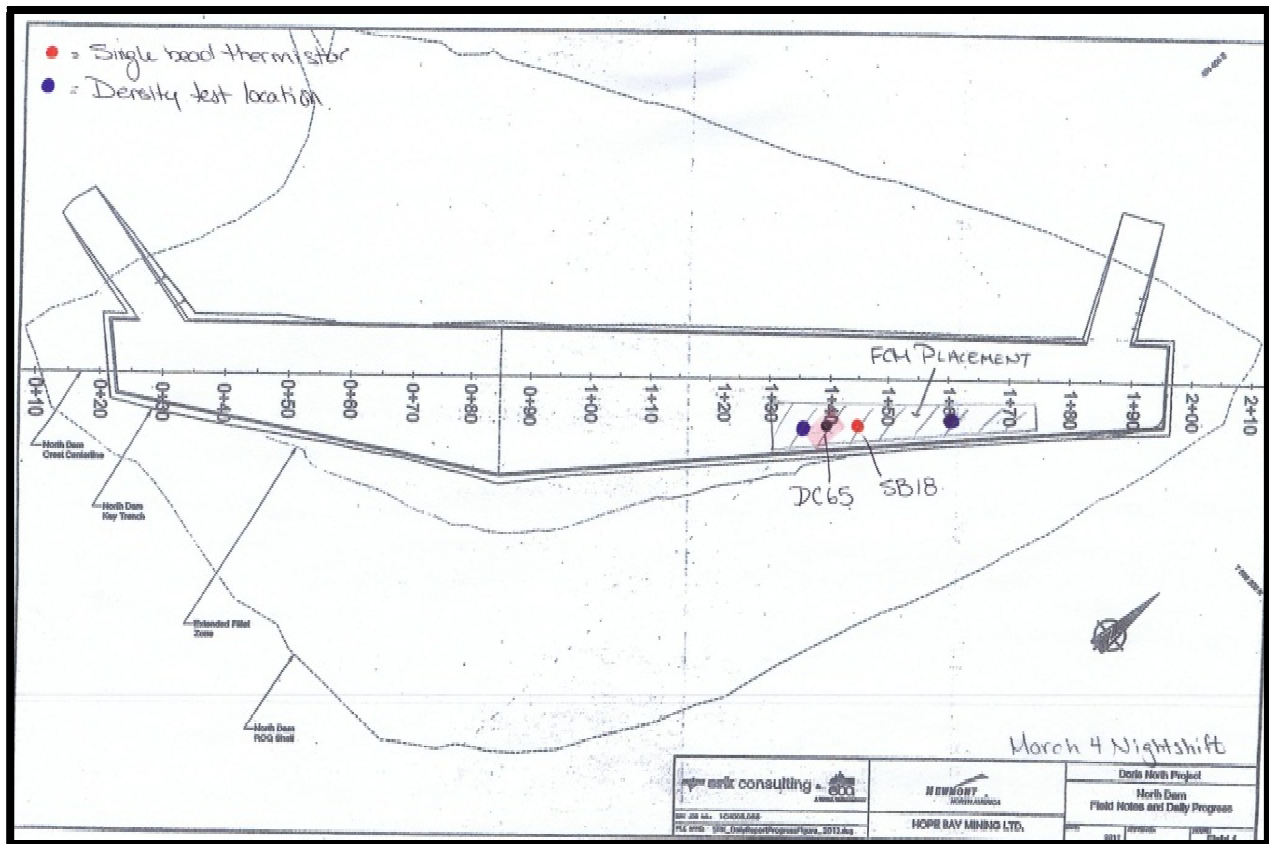
Figure 2 – North Dam Progress – Nightshift
