DAILY REPORT #60 – DORIS NORTH INFRASTRUCTURE/ NORTH DAM

Prepared by:	John Kurylo Lawrence Borowski	Date:	2012.03.05
Reviewed by:		Project #:	1CH008.058.0320
Role	Company	Personnel – Position	On Site
Client	Hope Bay Mining Limited (HBML)	Angela Holzapfel – ESR Compliance Manager David Vokey – ESR Coordinator Don Ethelston – HSLP Advisor Dean Wold - Safety Jill Turk – ESR Coordinator Katsky Venter – ESR Manger Michelle Tanquay – ESR Site Manager Stirling Kelly – HSLP Advisor	No Yes No Yes No Yes Yes No
	JDS	Lloyd Jackson – Mechanical Superintendent Doug Fielding – Construction Manager Ishan Fechter – Construction Coordinator Jerry Graham – Construction Manager Kevin Whieldon – Project Coordinator Mark Valeriote – Construction Manager	Yes No No Yes Yes Yes
Engineering Design Consultants	SRK Consulting (Canada) Inc.	John Kurylo – Site Engineer Megan Miller – Site Engineer Lawrence Borowski – Site Engineer Murray McGregor – Site Engineer Iozsef Miskolczi – Site Engineer Lowell Wade – Senior Engineer	In No Yes No Out No

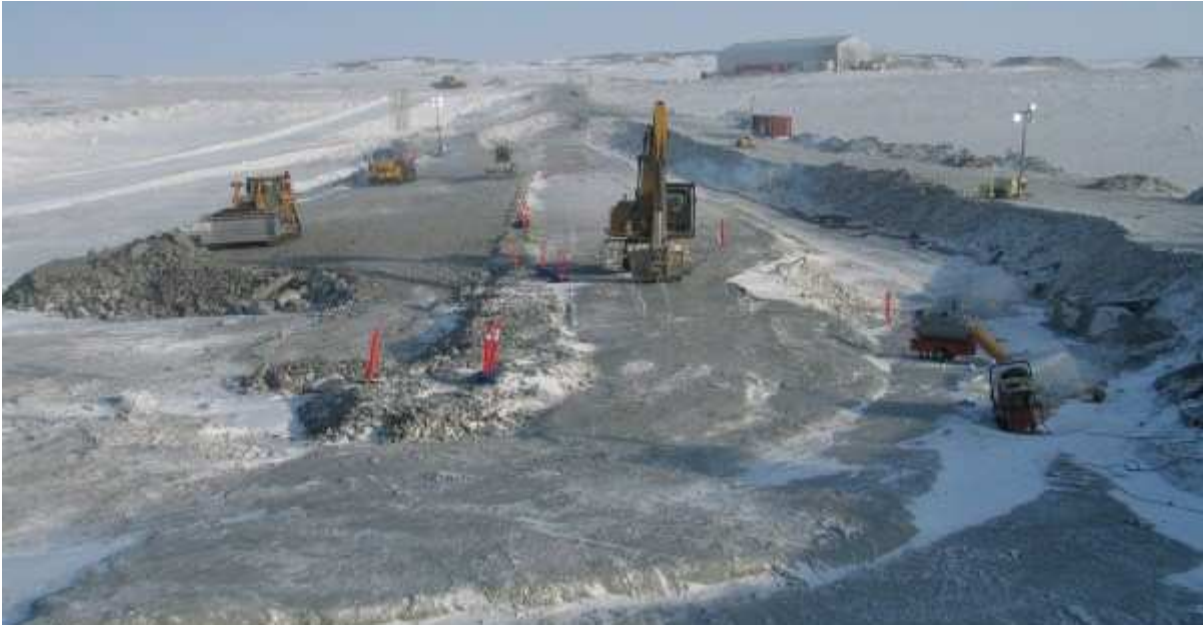
Photo 1: Progress photo from photo point 1, facing SSE

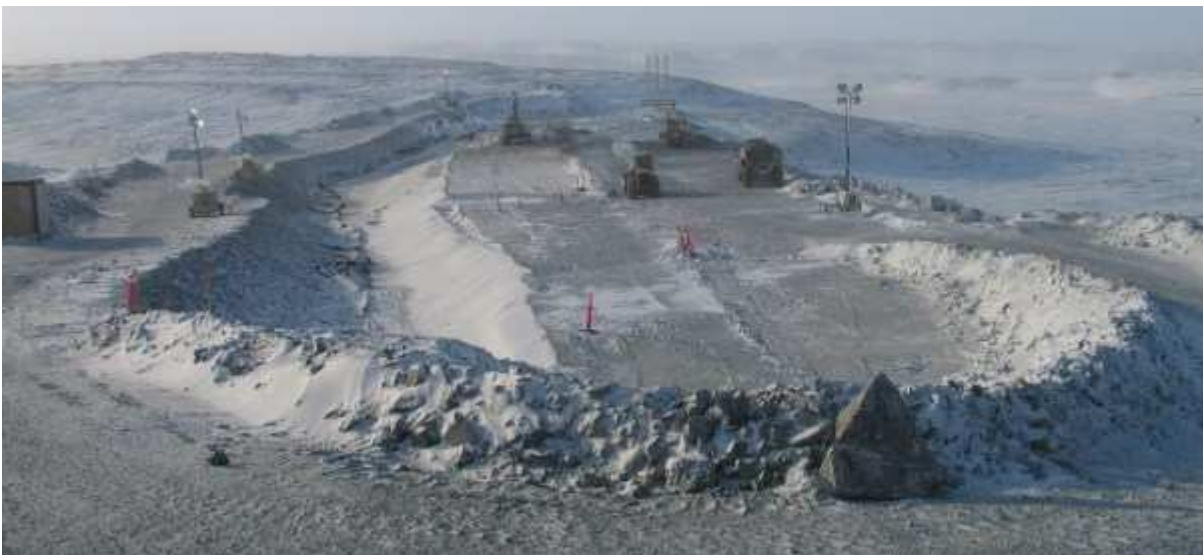
Photo 2: Progress photo facing SW

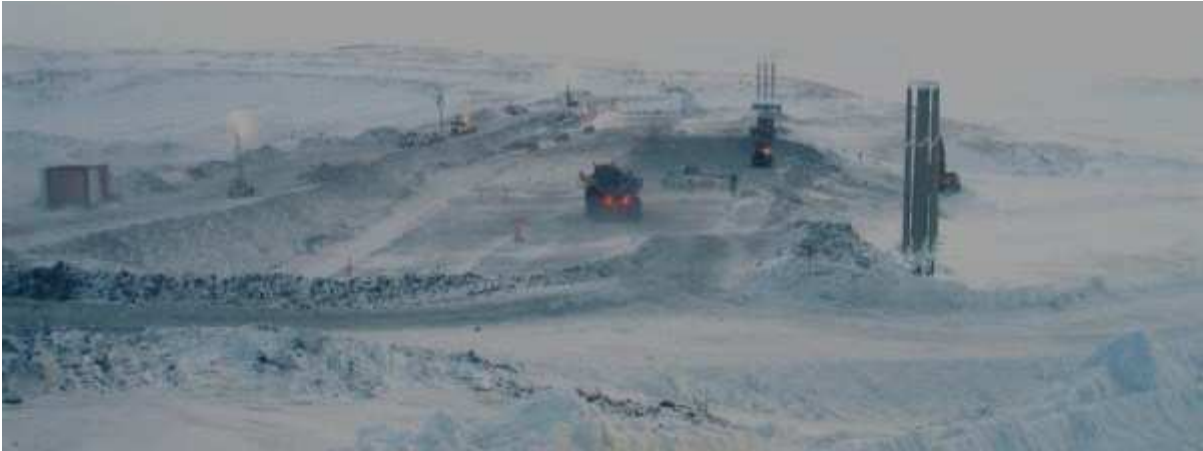
Photo 3: Progress photo Facing south late afternoon

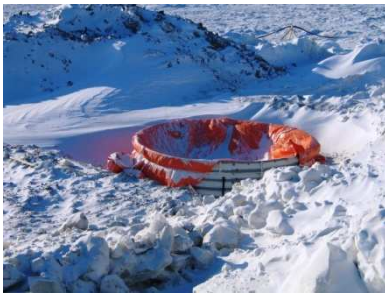
Photo 4: Sump 1

- No activity: sumps are covered with tarps
- Construction of the lids has not started.

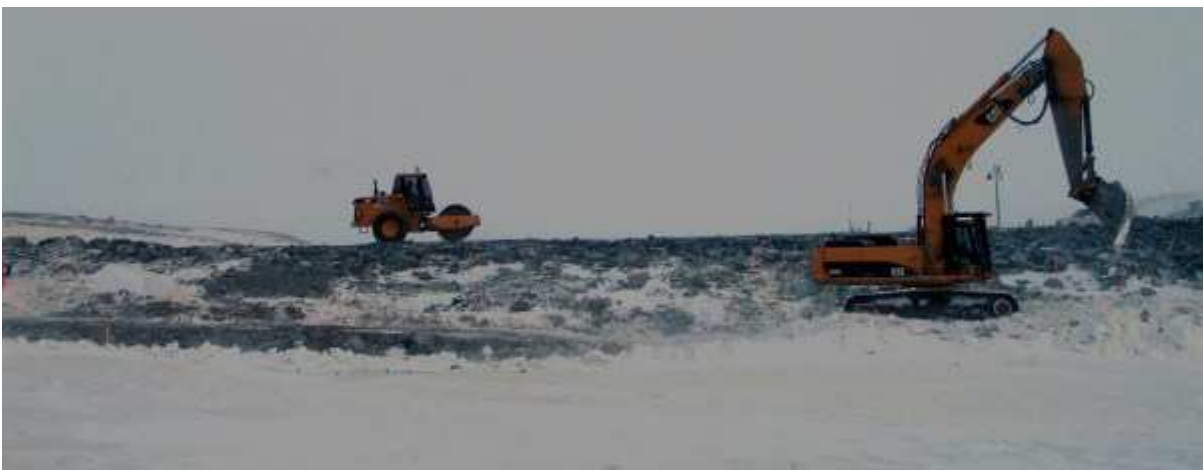
- Hauled ROQ to the downstream side all day.
- Compaction with the 10 ton packer during the day
- Quality of ROQ is good. Lift thicknesses are not exceeded.
- Ramp constructed on the side of the dam shell. Excavator working to backslope the dam shell.

Photo 7: Excavator sloping down stream ROQ

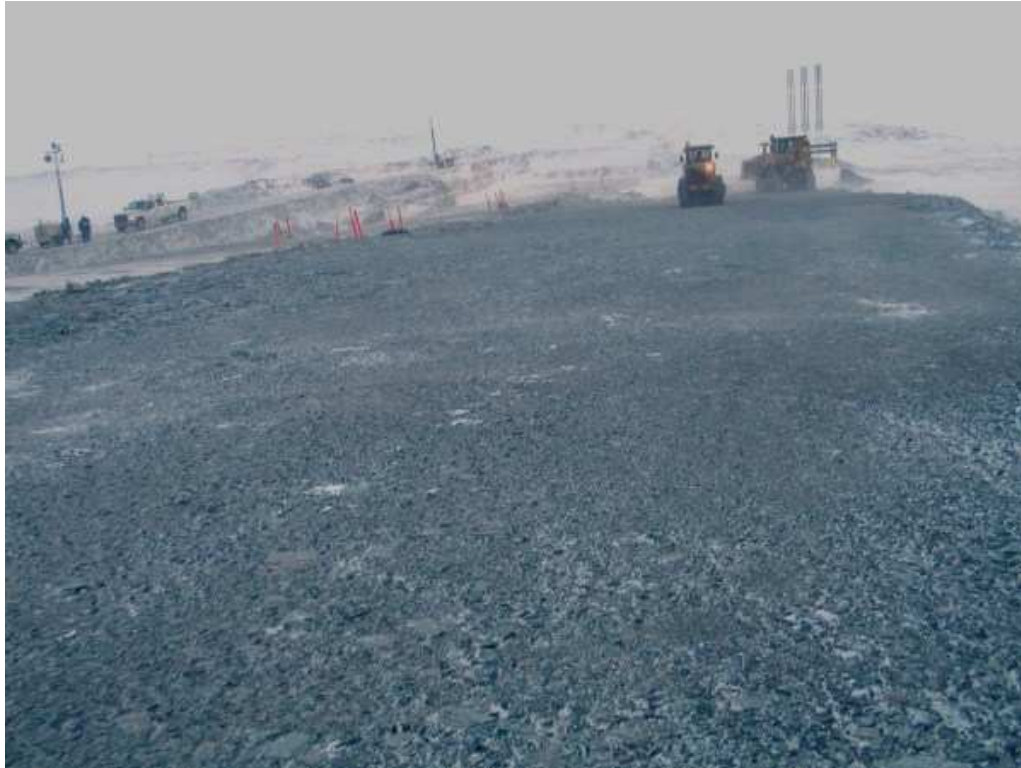
Photo 8: Dam shell construction. Vibratory packer worked most of the day.

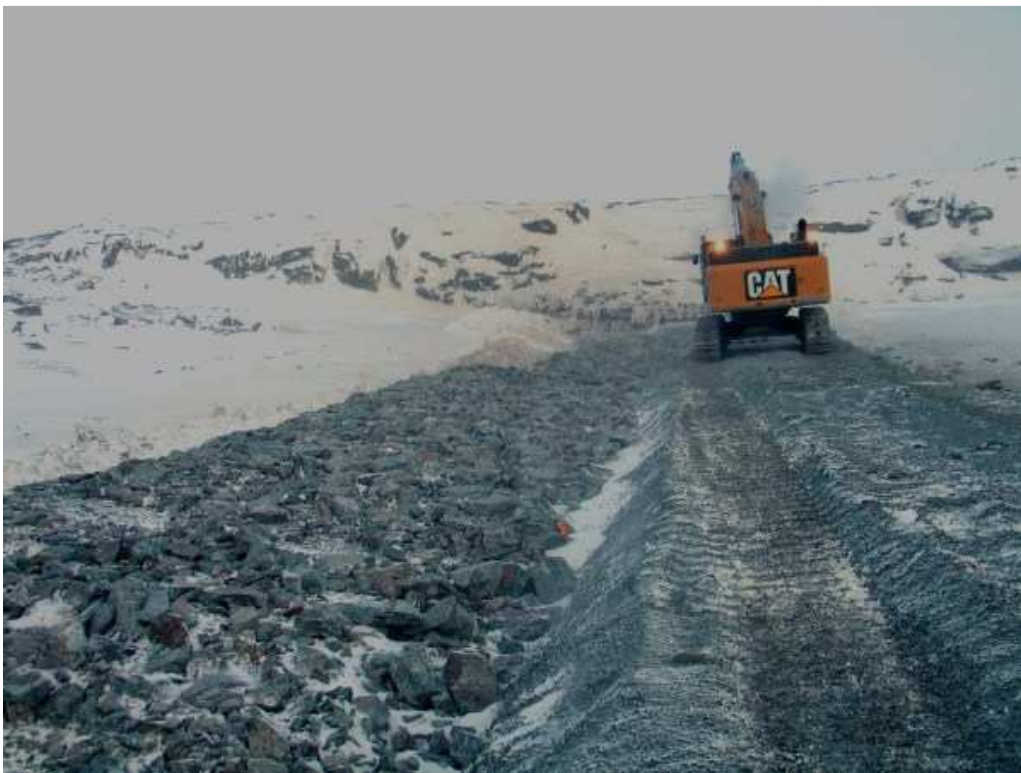
Photo 9: Progress filling key trench.

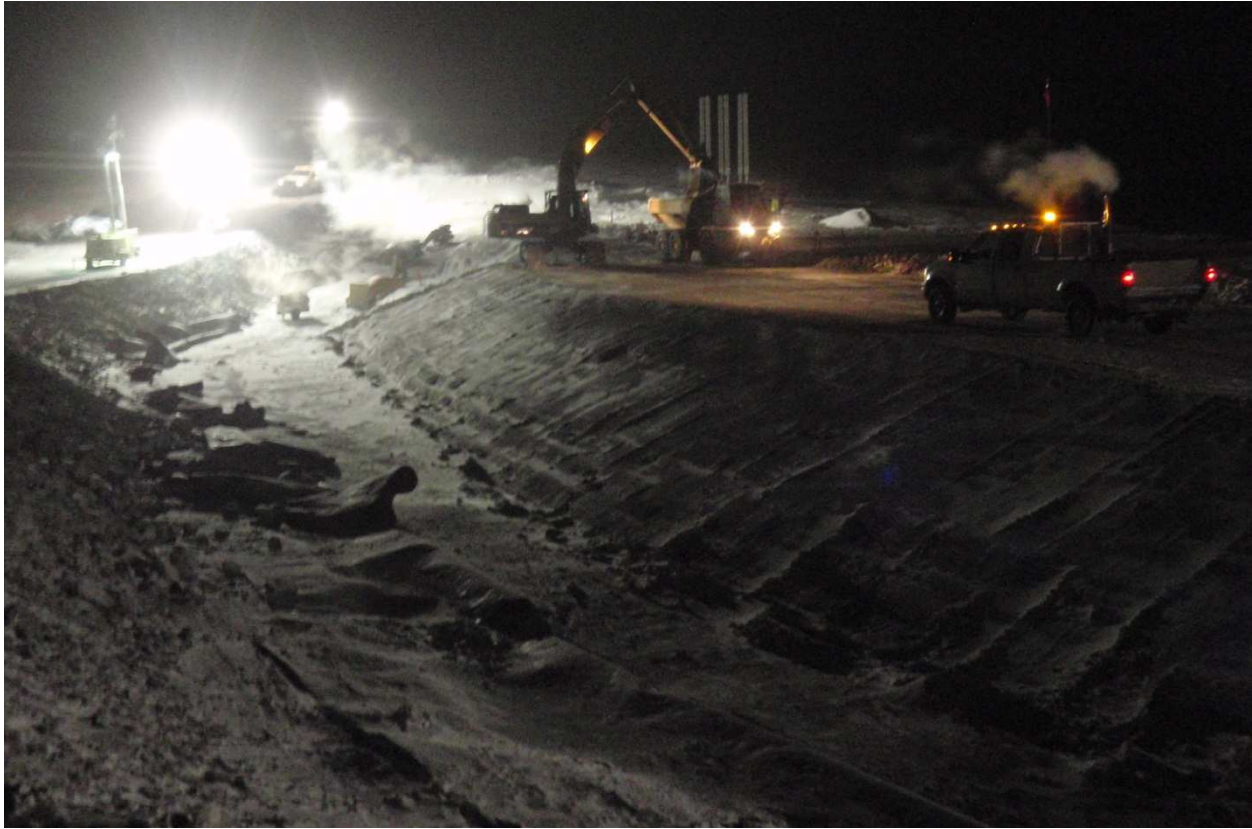
- No FCM was placed on nightshift.
- Freezeback of the previously placed FCM was achieved around 1:45 am.
- After freezeback was achieved the excavator switched over to clearing snow from the upstream slope. Snow clearing resulted on the upstream slope around 1+90 to ~1+75 and from ~ 1+30 to 0+70. The slightly overbuilt steps around the base of the 2.5H:1V upper GCL slope was slightly scraped back with the excavator bucket.

Photo 10 : Excavator working on clearing snow from upstream core slope, ~ WSW view.

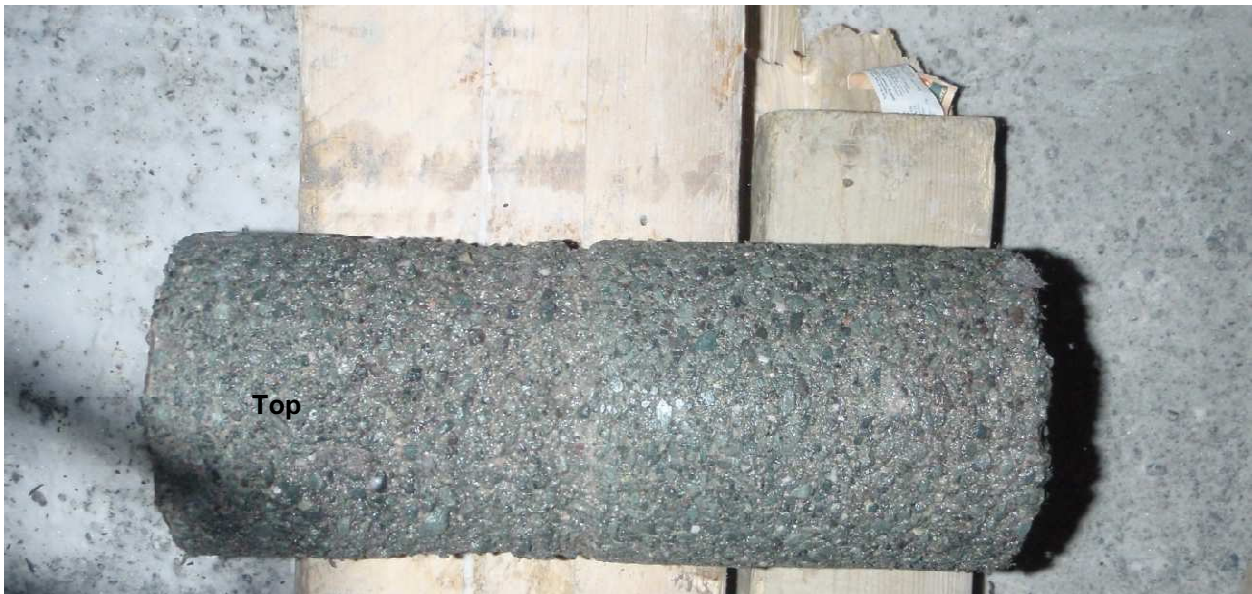
- Two cores were drilled on nightshift. Power was sourced from light plants for the drill and vacuum.
 - HB12-ND-CORE-DC66-20120305 was drilled around station 1+11 on the upstream;
 - Surveyed location: 7559146.04 North, 434380.14 East, 32.74m Elev
 - HB12-ND-CORE-DC67-20120305 was drilled around station 0+84 around the centerline.
 - Surveyed location: 7559124.67North, 434359.31East, 32.71m Elev

Photo 11 : Close up of drilled core 66, drilled around station 1+11 on the upstream. Note that less glycol was used when drilling the first half of this core.

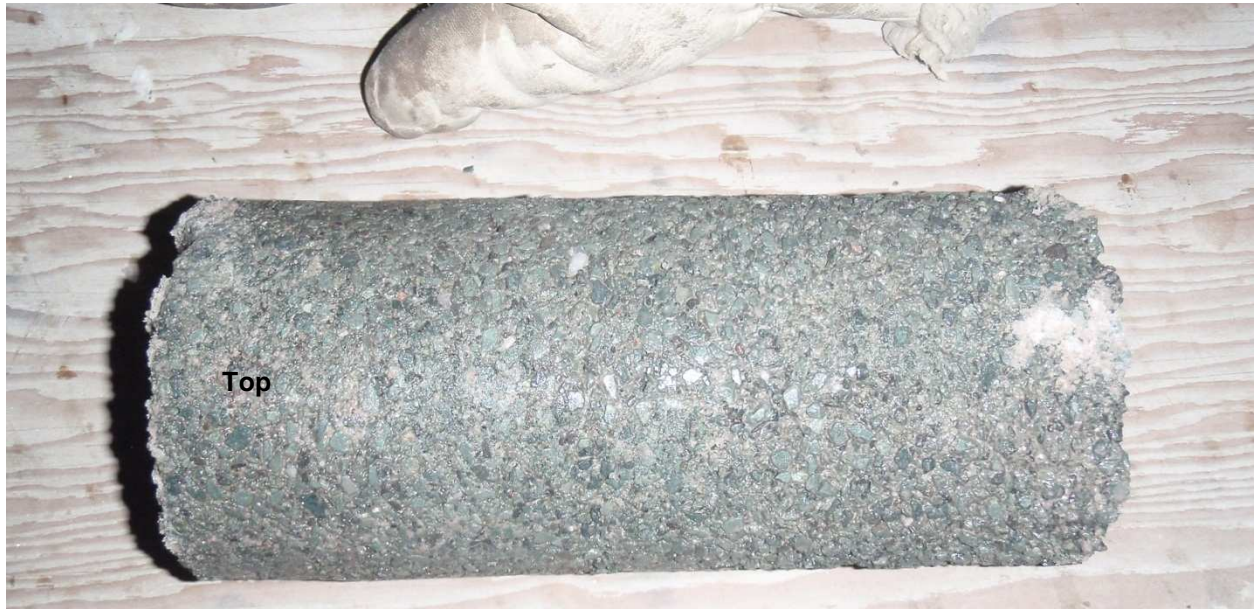
Photo 12 : Close up of drilled core 67, drilled around station 0+84 around the centerline.

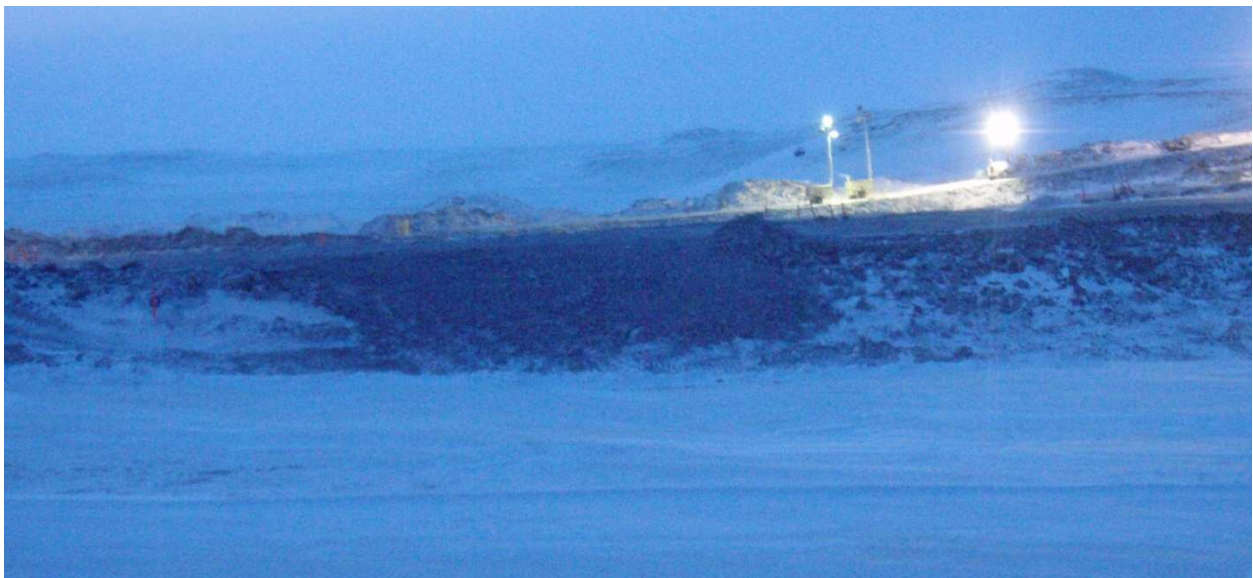
- Snow was cleared on the downstream dam shell from ~ station 0+60 to 1+30.
- ROQ was placed on the downstream side around station 0+90 to 1+20. Material was spread with a dozer. No compaction was observed on this material.
- Minor snow and snow with some rock was cleared from the upstream dam shell around 1+40 to 1+75.

Photo 13 : ~SSE view of nightshift ROQ placement, looking towards downstream dam shell.
