DAILY REPORT #61 – DORIS NORTH INFRASTRUCTURE/ NORTH DAM

Prepared by:	John Kurylo Lawrence Borowski	Date:	2012.03.06
Reviewed by:		Project #:	1CH008.058.0320
Role	Company	Personnel – Position	On Site
Client	Hope Bay Mining Limited (HBML)	Angela Holzapfel – ESR Compliance Manager David Vokey – ESR Coordinator Don Ethelston – HSLP Advisor Dean Wold - Safety Jill Turk – ESR Coordinator Katsky Venter – ESR Manger Michelle Tanquay – ESR Site Manager Stirling Kelly – HSLP Advisor	No Yes No Yes No Yes Yes No
	JDS	Lloyd Jackson – Mechanical Superintendent Doug Fielding – Construction Manager Ishan Fechter – Construction Coordinator Jerry Graham – Construction Manager Kevin Whieldon – Project Coordinator Mark Valeriote – Construction Manager	Yes No No Yes Yes Yes
Engineering Design Consultants	SRK Consulting (Canada) Inc.	John Kurylo – Site Engineer Megan Miller – Site Engineer Lawrence Borowski – Site Engineer Murray McGregor – Site Engineer Iozsef Miskolczi – Site Engineer Lowell Wade – Senior Engineer	Yes No Yes No No No

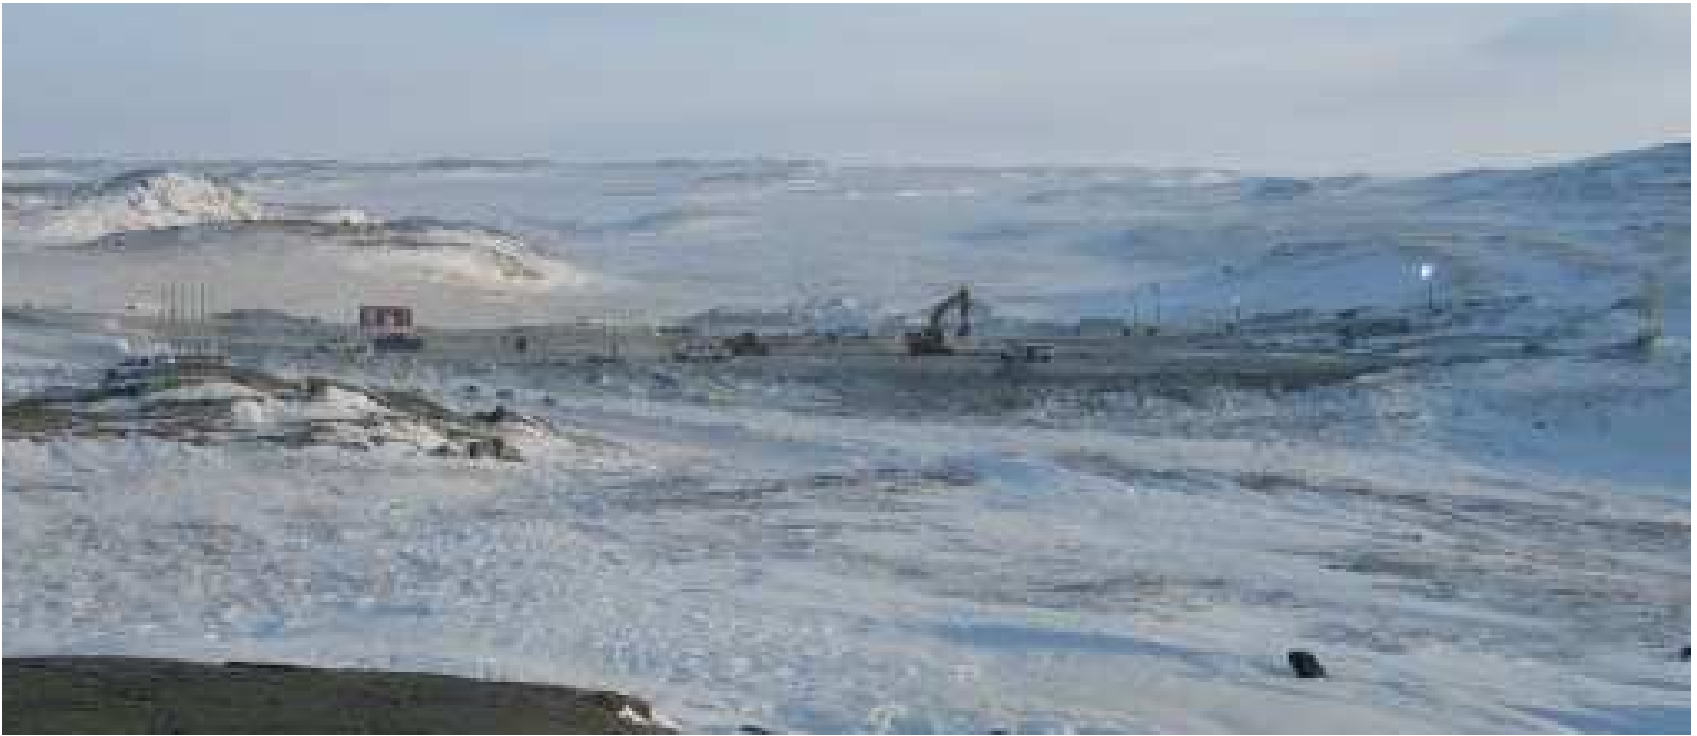
Photo 1: Progress photo from photo point 1, facing SSE

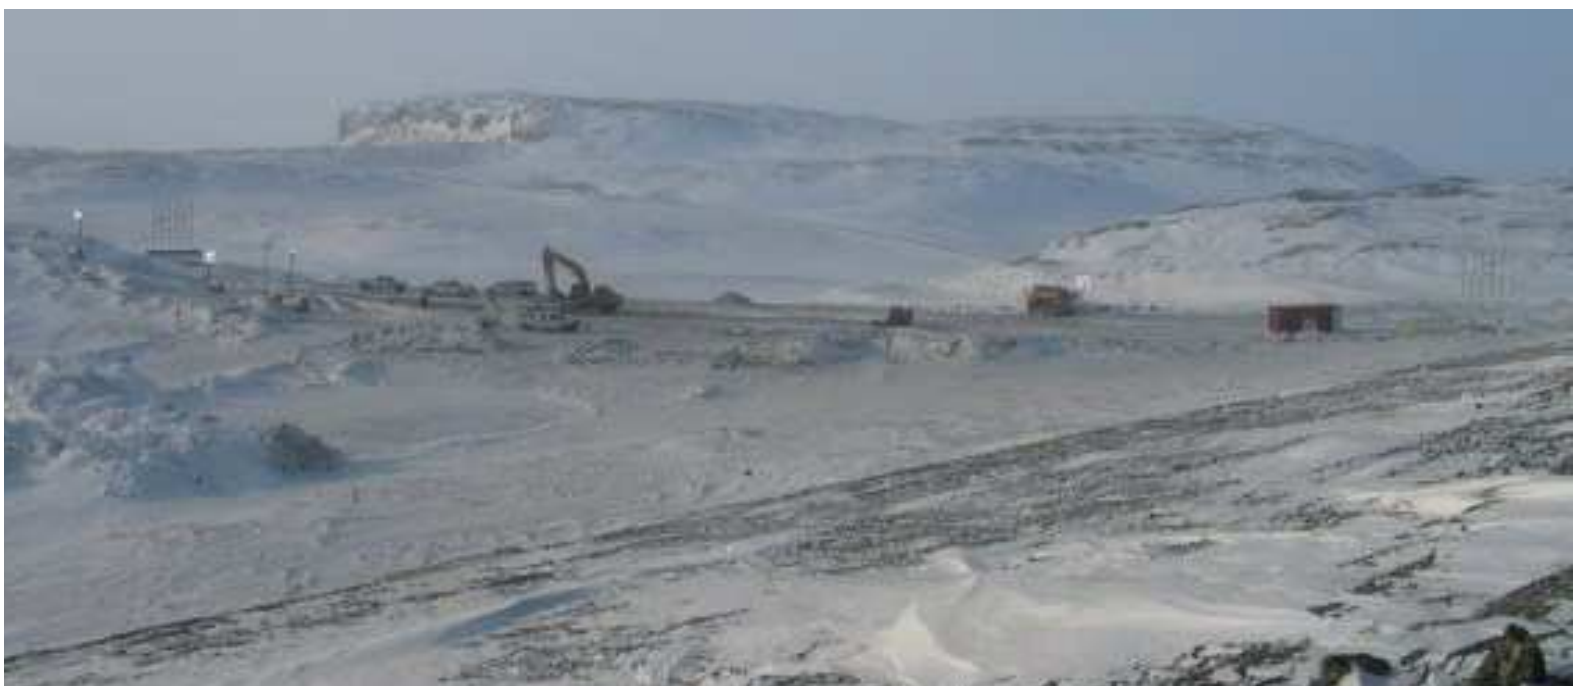
Photo 2: Progress photo from photo point 2, facing NNW.

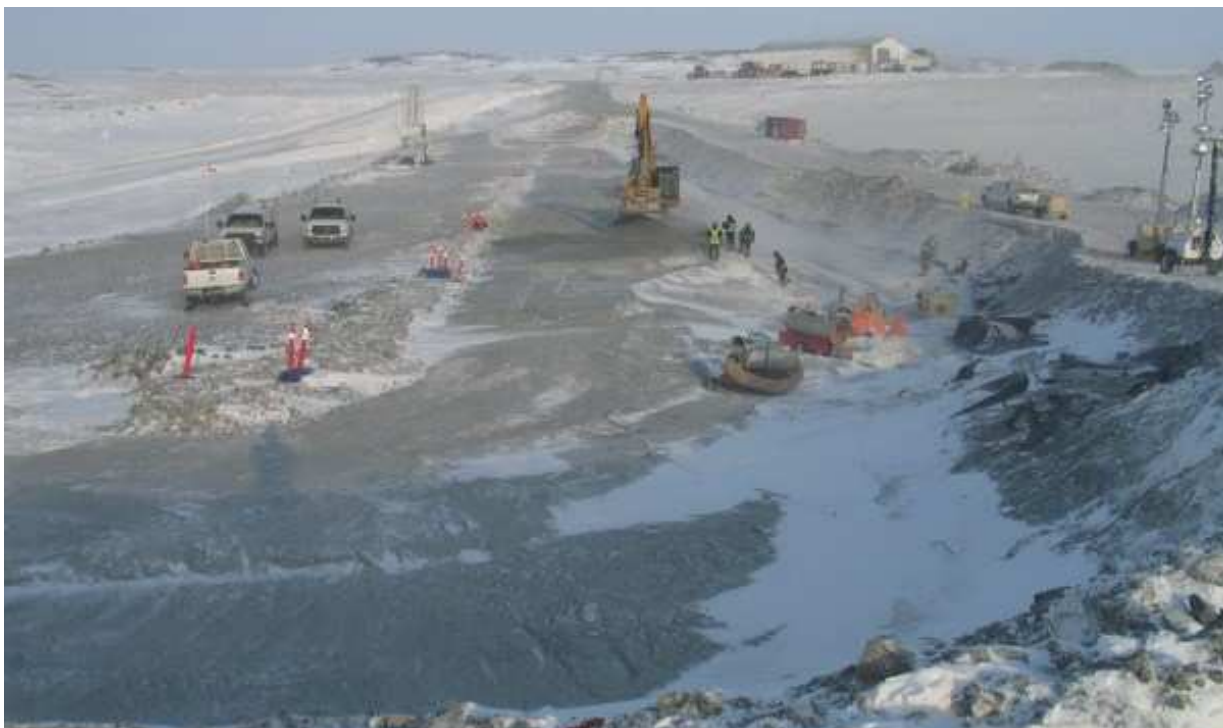
Photo 3: Progress photo from Photo Point 3, facing NW.

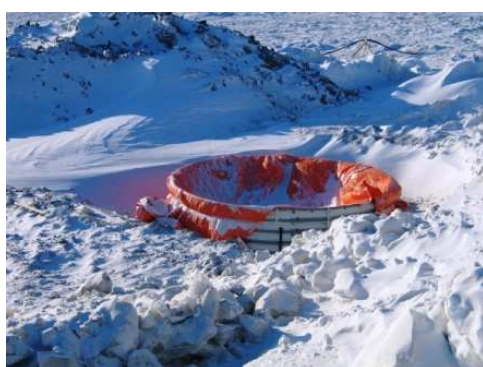
Photo 4: Sump 1 progress photo.

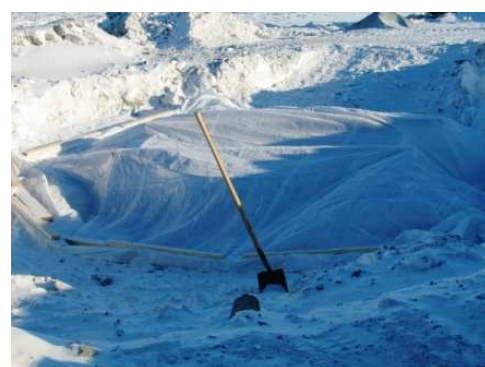
Photo 5: Sump 2 progress photo.

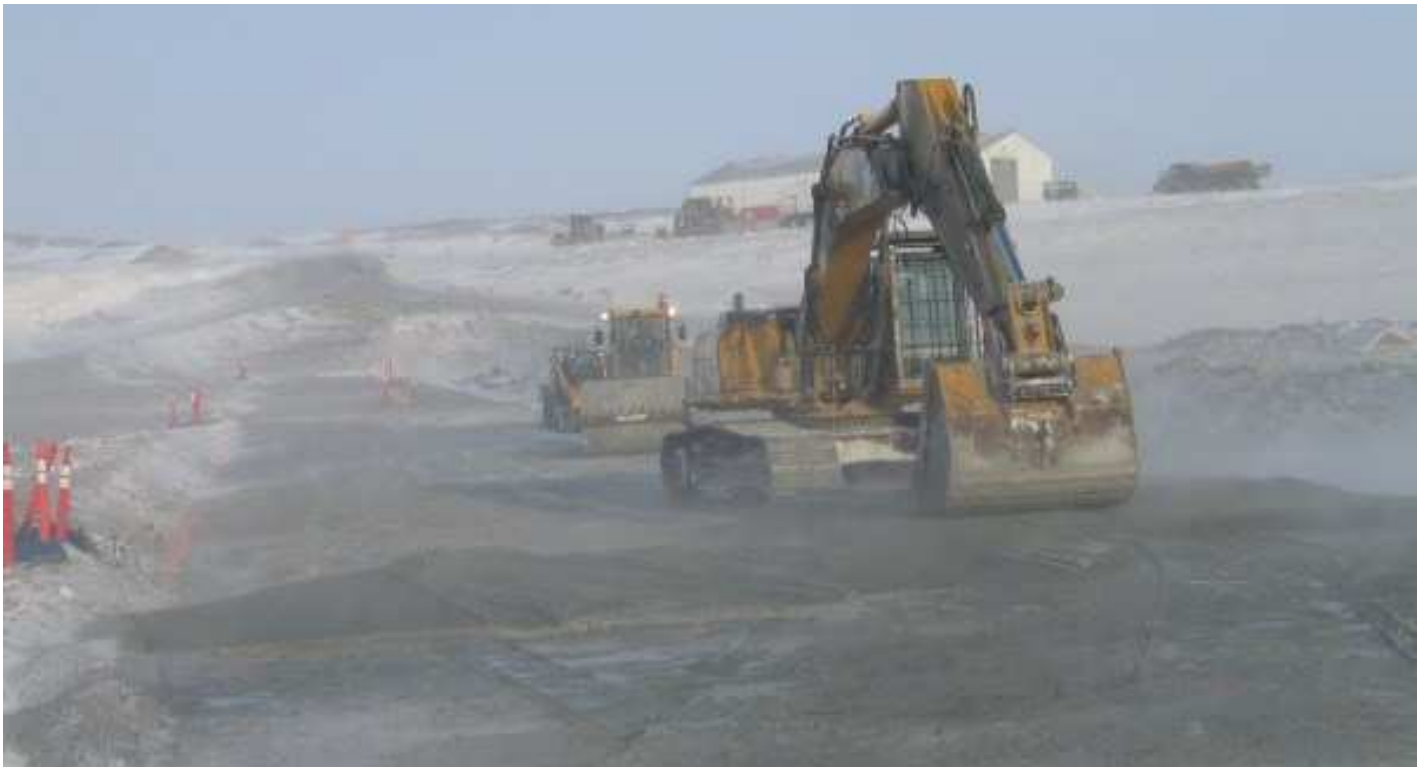
Photo 6: Placing ROQ ~ Sta.0+80

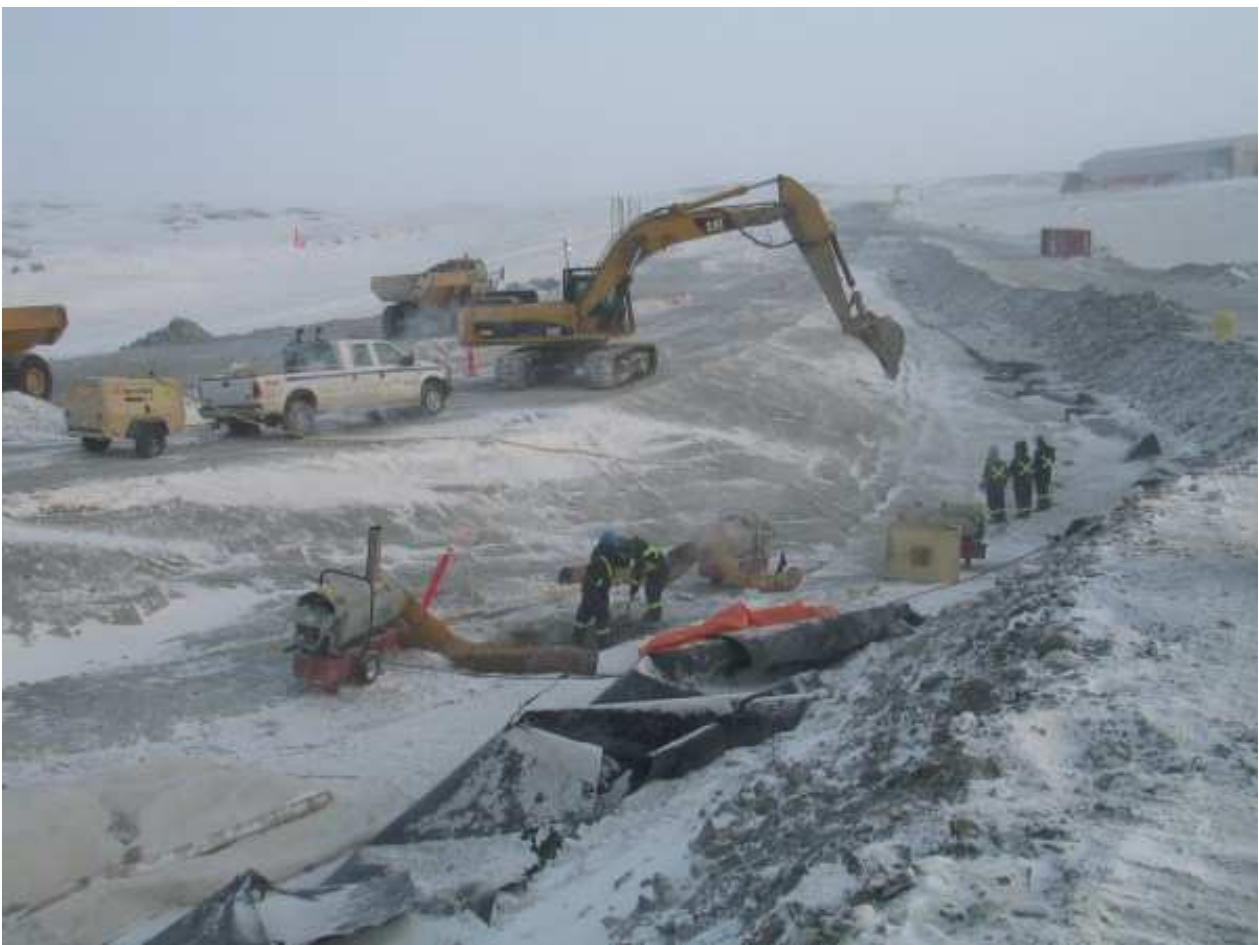
- Recent blowing snow had covered the stepped portion with snow.
- The excavator was used to remove the bulk of the snow. This was followed up with compressed air which yielded a satisfactory result.

Photo 7: Excavator clearing snow at bottom of core. Labourers ready to blow snow. Labourers in foreground working with frost fighters.

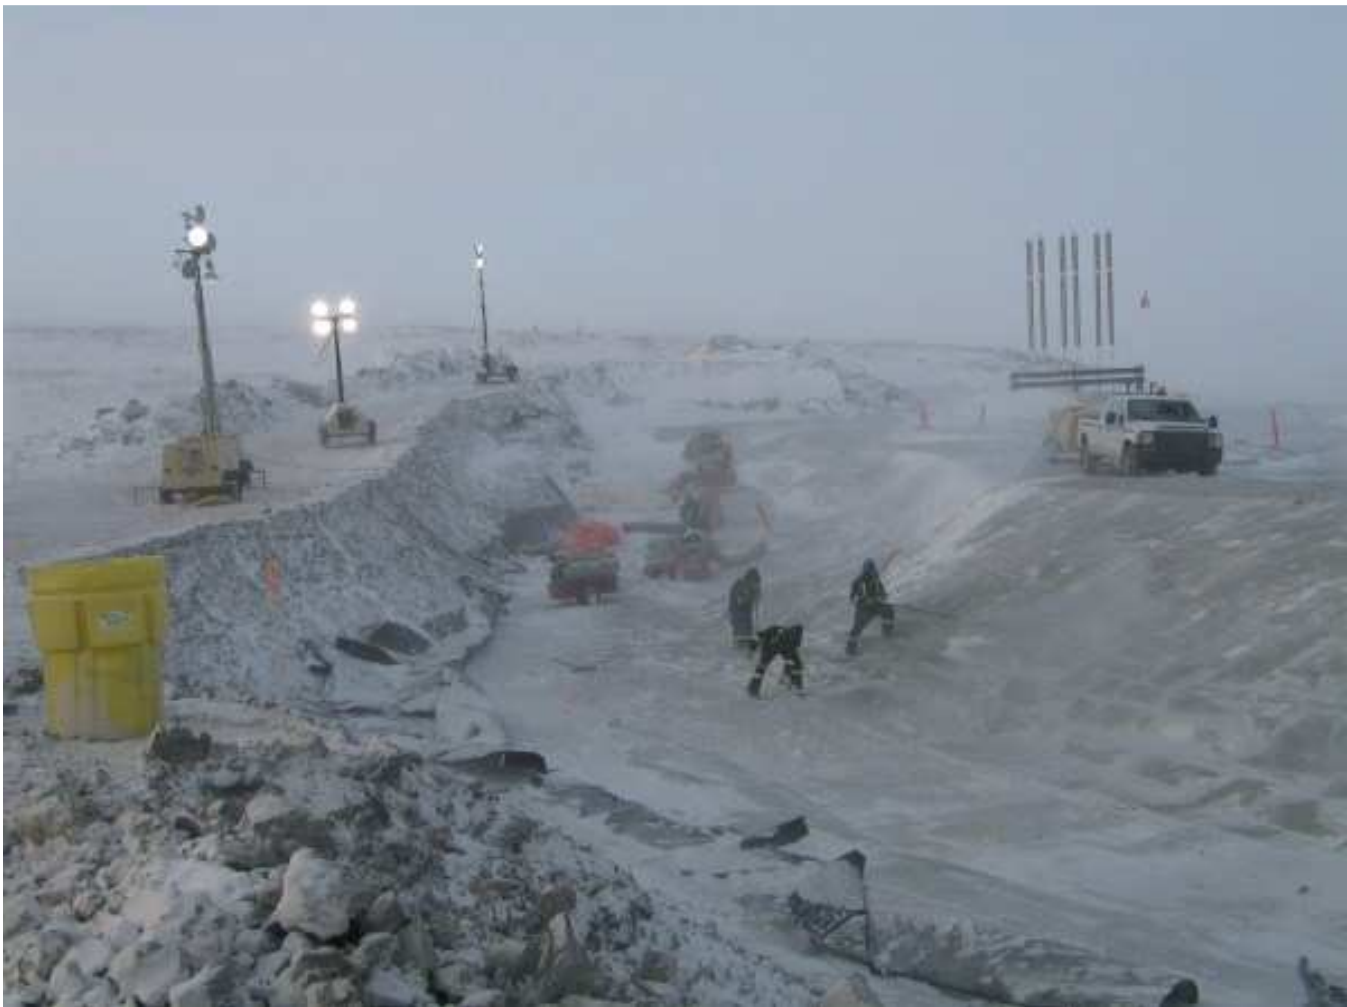
Photo 8: Dental cleaning with compressed air.

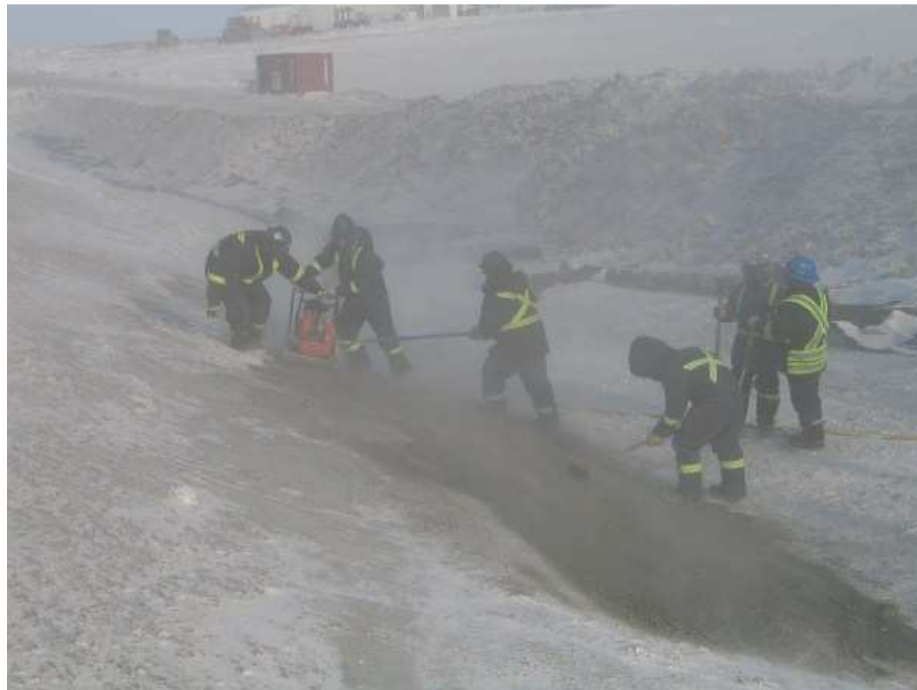
Photo 9: Raking and compaction at bottom of slope.

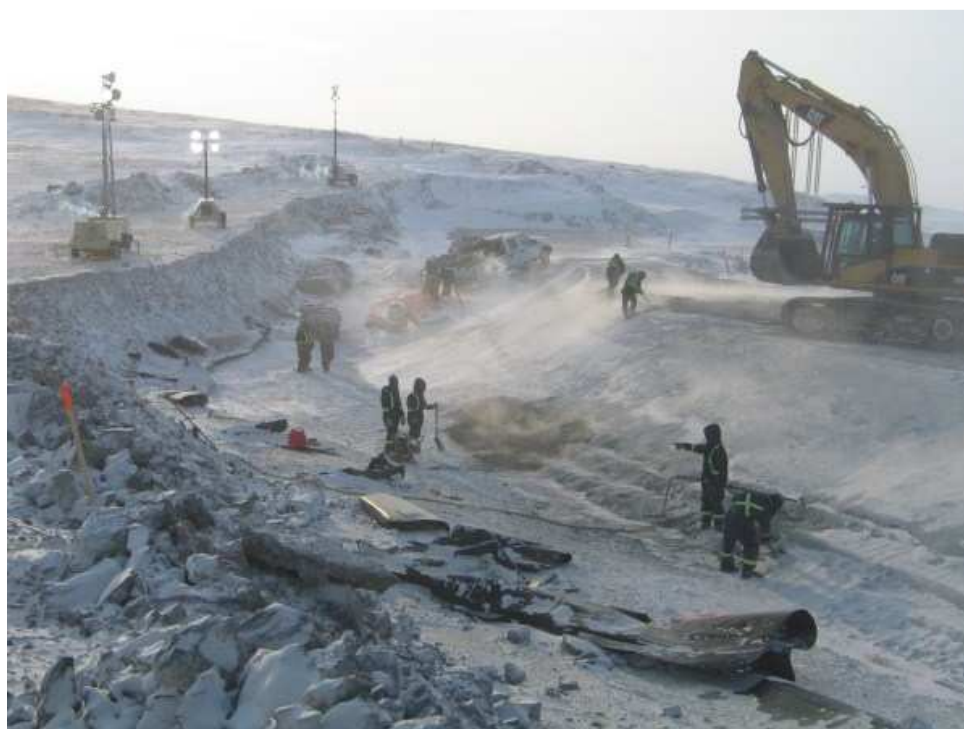
Photo 10: Labour crew at the dam

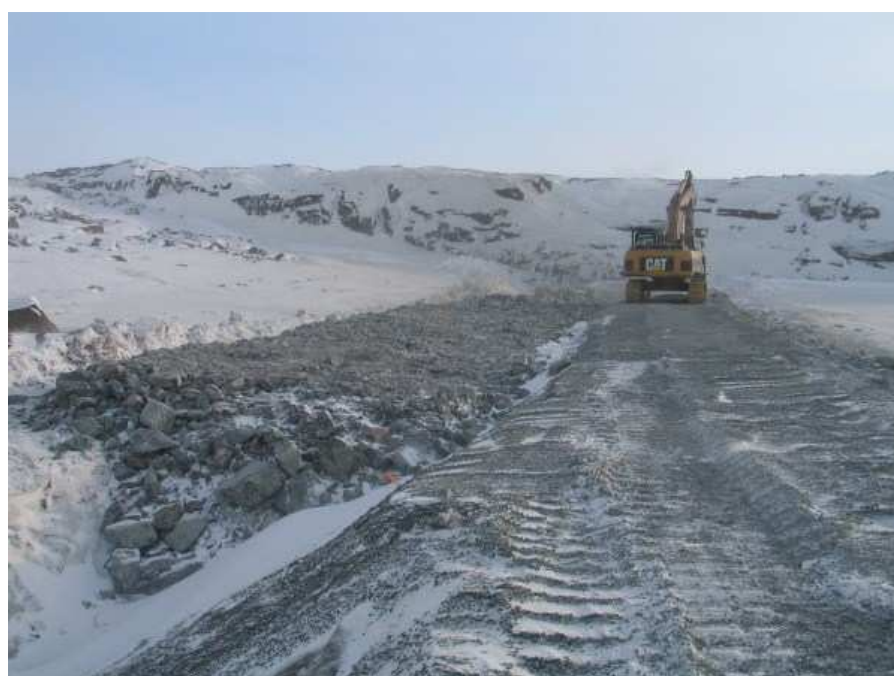
Photo 11: Excavator continuing with ROQ placement at the berm

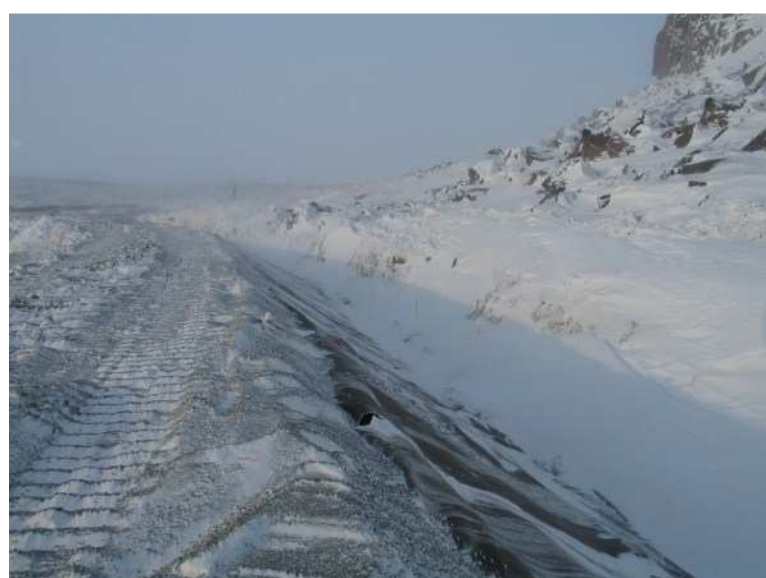
Photo 12: Snow in key trench that needs to be removed before any further work can be done.

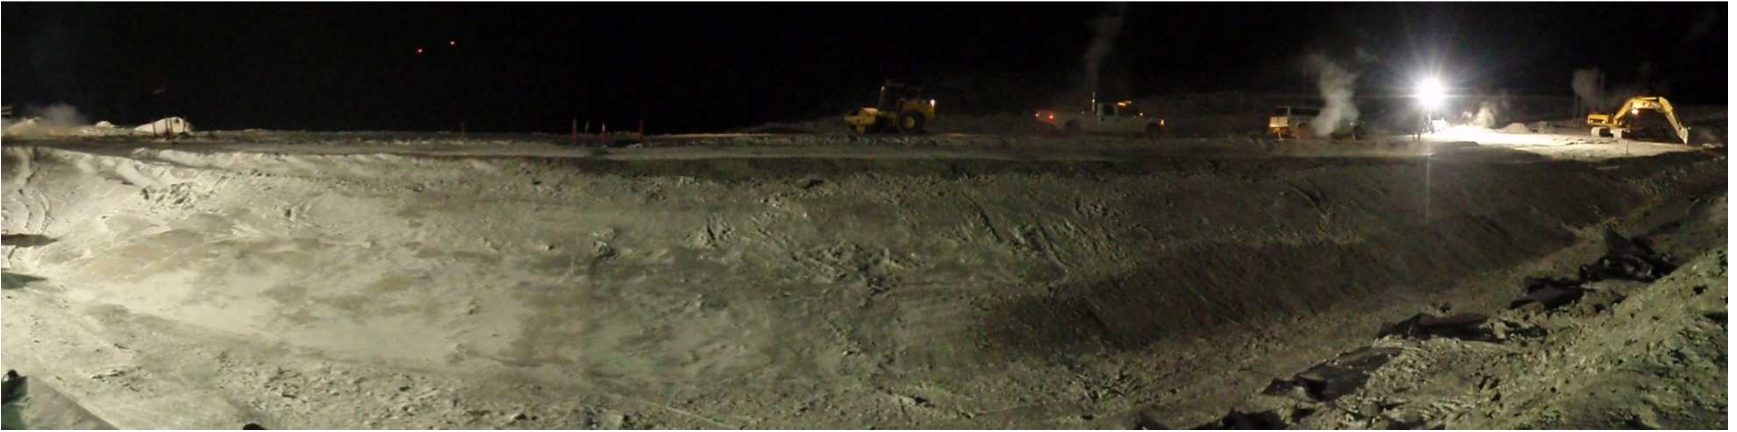
Photo 13: Stitched panoramic view of the upstream dam slope. Taking looking ~NNE from the dam shell around station 0+90. Note the dark patch in the bottom right of the picture that shows the area where dayshift placed FCM to remove the lower 'steps' in the upstream slope.

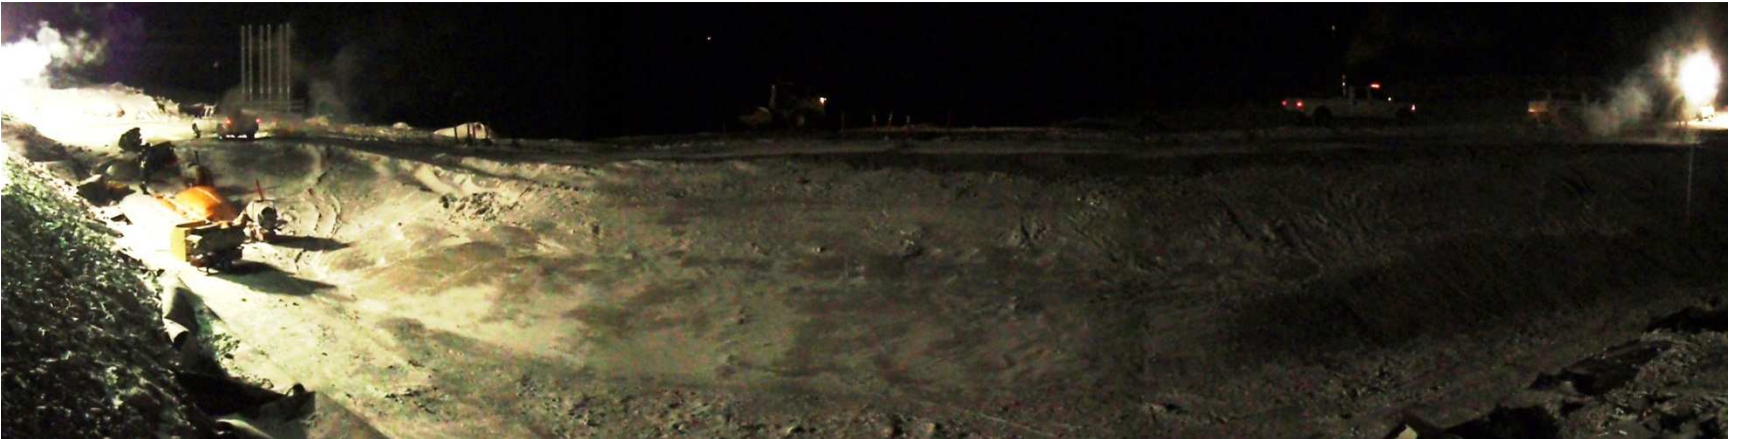
- Hording and heating with frost fighters continued over the GCL around station 0+50 area.
 - Some hand shovelling of frozen material over the GCL liner was completed at the beginning of the night.

Photo 14: Stitched panoramic view of the upstream dam slope. Taking looking ~ NWW from the dam shell around station 0+85. Note the severely underbuilt US slope from 0+60 westward and the heating and hording of the GCL taking place.

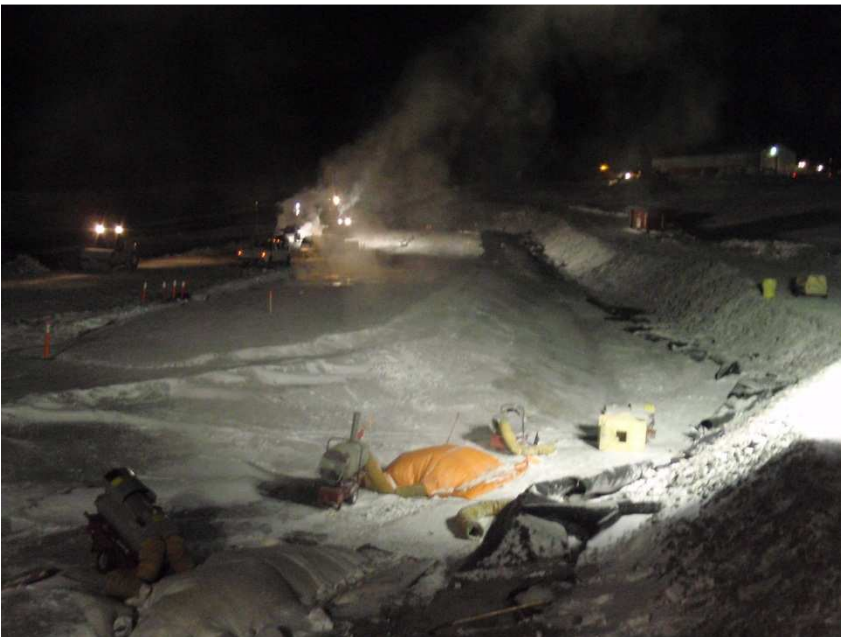
Photo 15: ~NE view looking down upstream dam slope.

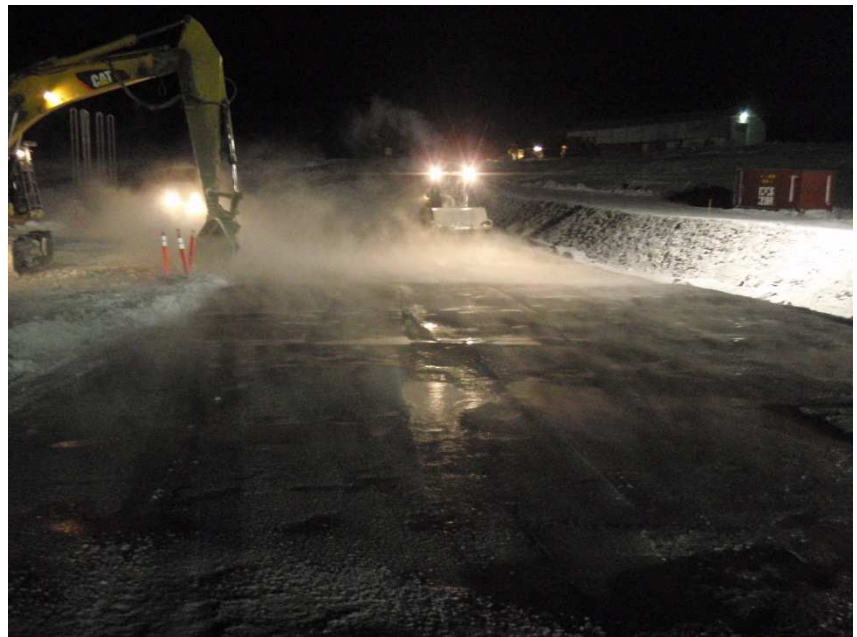
Photo 16: ~ NE view down core of nightshift placement.

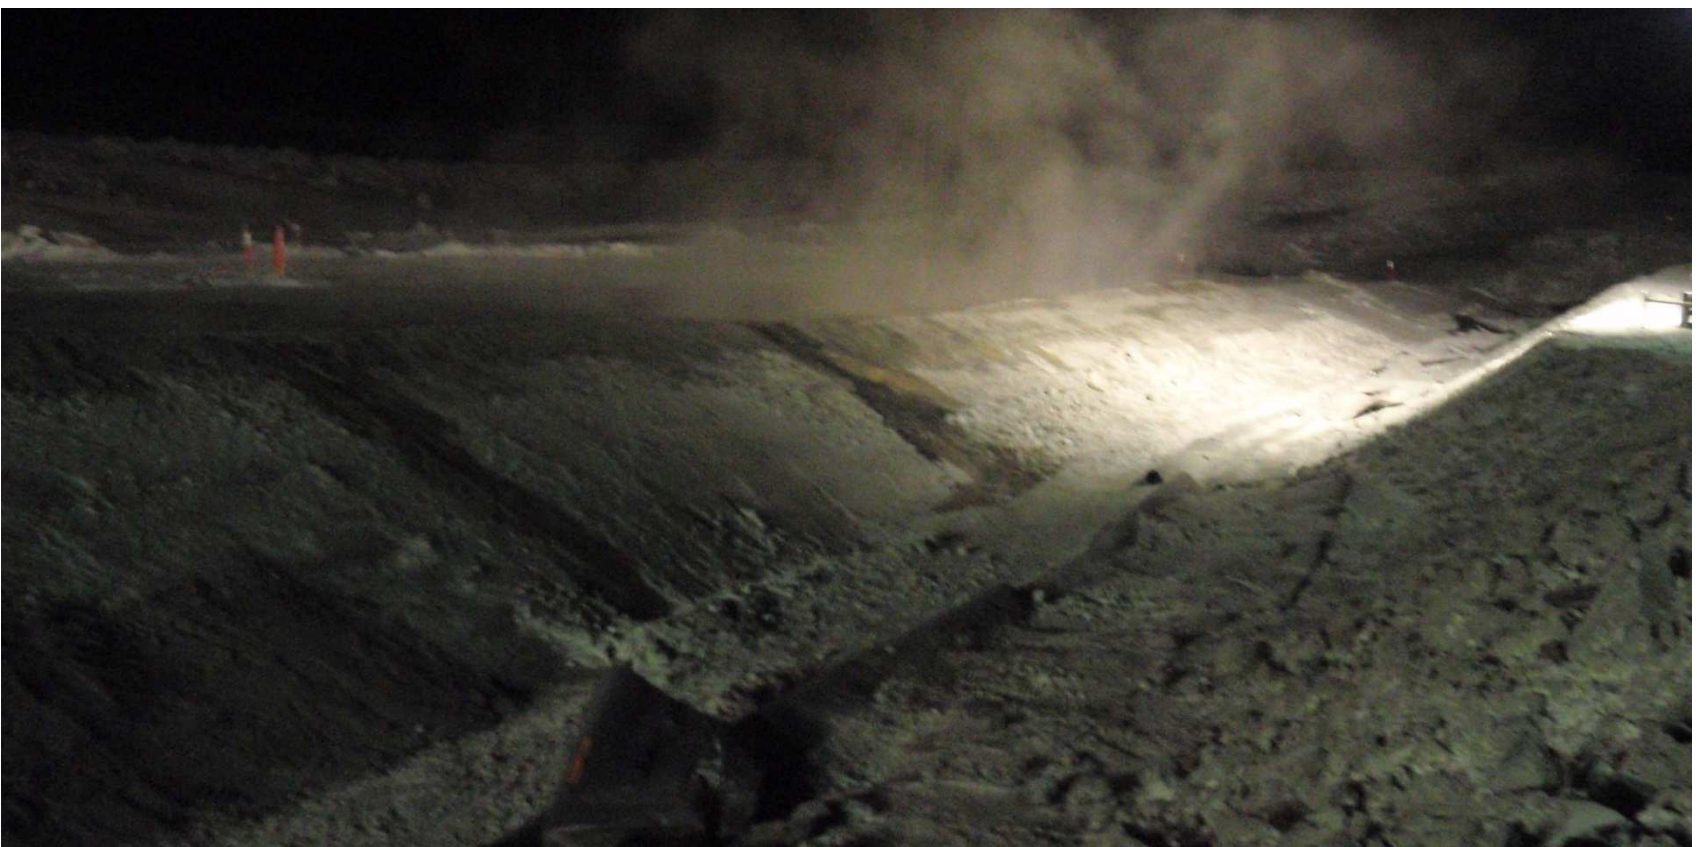
- Water was noted to be pooling in a few areas of the core. Based on the way the FCM was graded, see point above, the water was noted to preferentially flow to two low points around 1+25 and 1+30. Water was noted to be discharging down the slope in these areas. Some erosion along the top of the upstream crest and along the site was noted in these areas. Ice along the side slopes is expected to be required to be removed, after freeze back, and minor additional FCM is expected to be required to bring the eroded areas to grade.

Photo 16: ~N view of upstream core slope. Note areas where water ponded and seeped/ discharged down the upstream slope. The ice on the slope in these areas is expected to be scraped down along with the areas of minor water erosion. Some additional FCM is expected to be required near the upstream crest in these areas to bring the crest to the design lines / limit.

- Station 1+30 to be rechecked tomorrow. Near grade after last night's placement. Will require minor smoothing work due to undulating surface and noted ice and erosion closer to downstream edge.
- The dayshift single bead thermistor was monitored on nightshift. Around the end of nightshift this single bead was still slightly above 0C.
- **After tonight's placement a total of 8,525.5 m³ has been placed at the North Dam in 2012.**

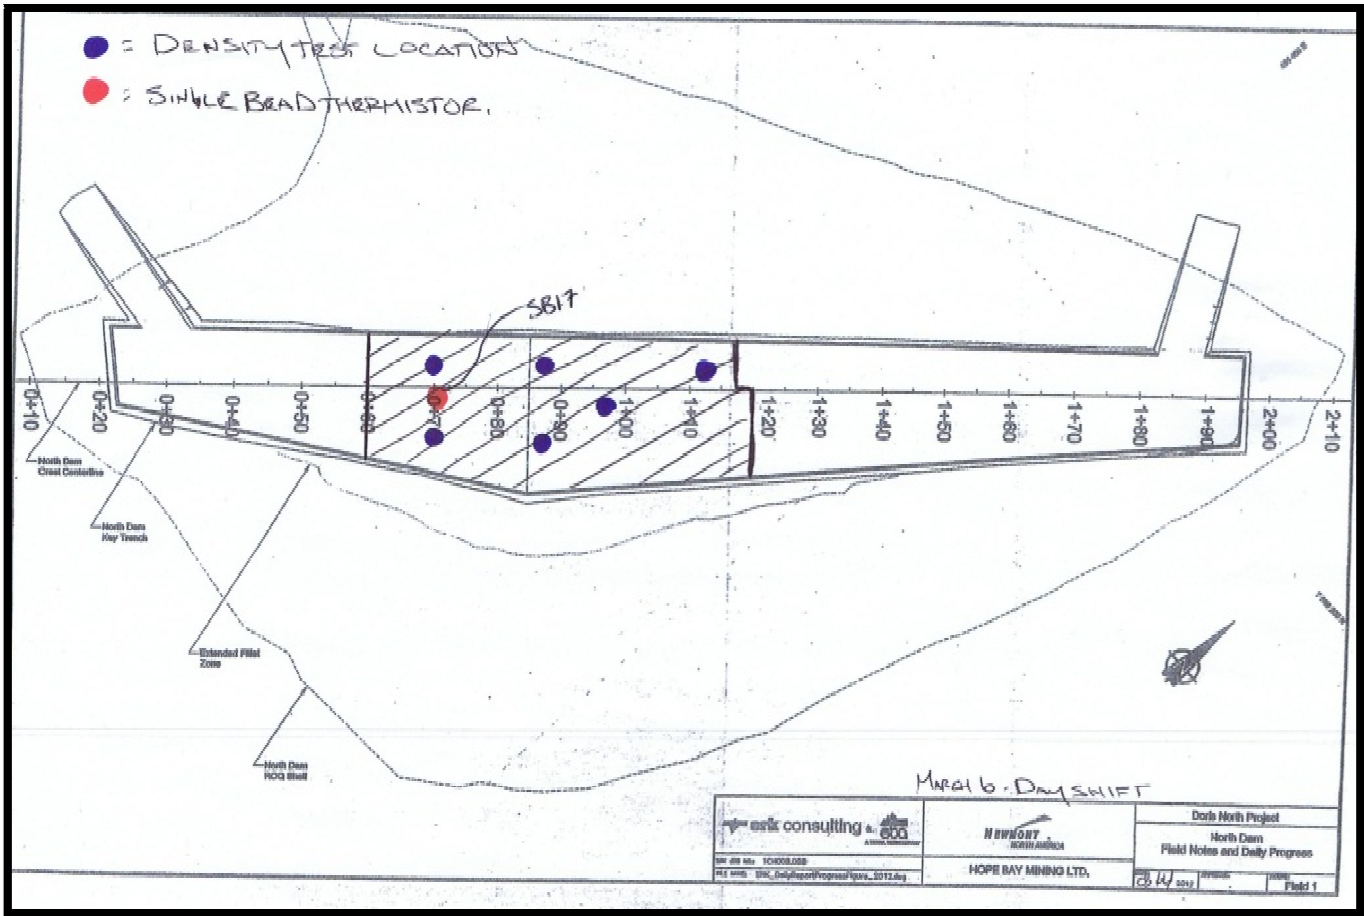
Figure 1 – North Dam Progress – Dayshift

- Production proceeded from noon until 5:00 pm. The area covered was from Sta 0+60 to Sta 1+15. As the FCM was crusting, temperature was raised to +40 C and the water content raised.

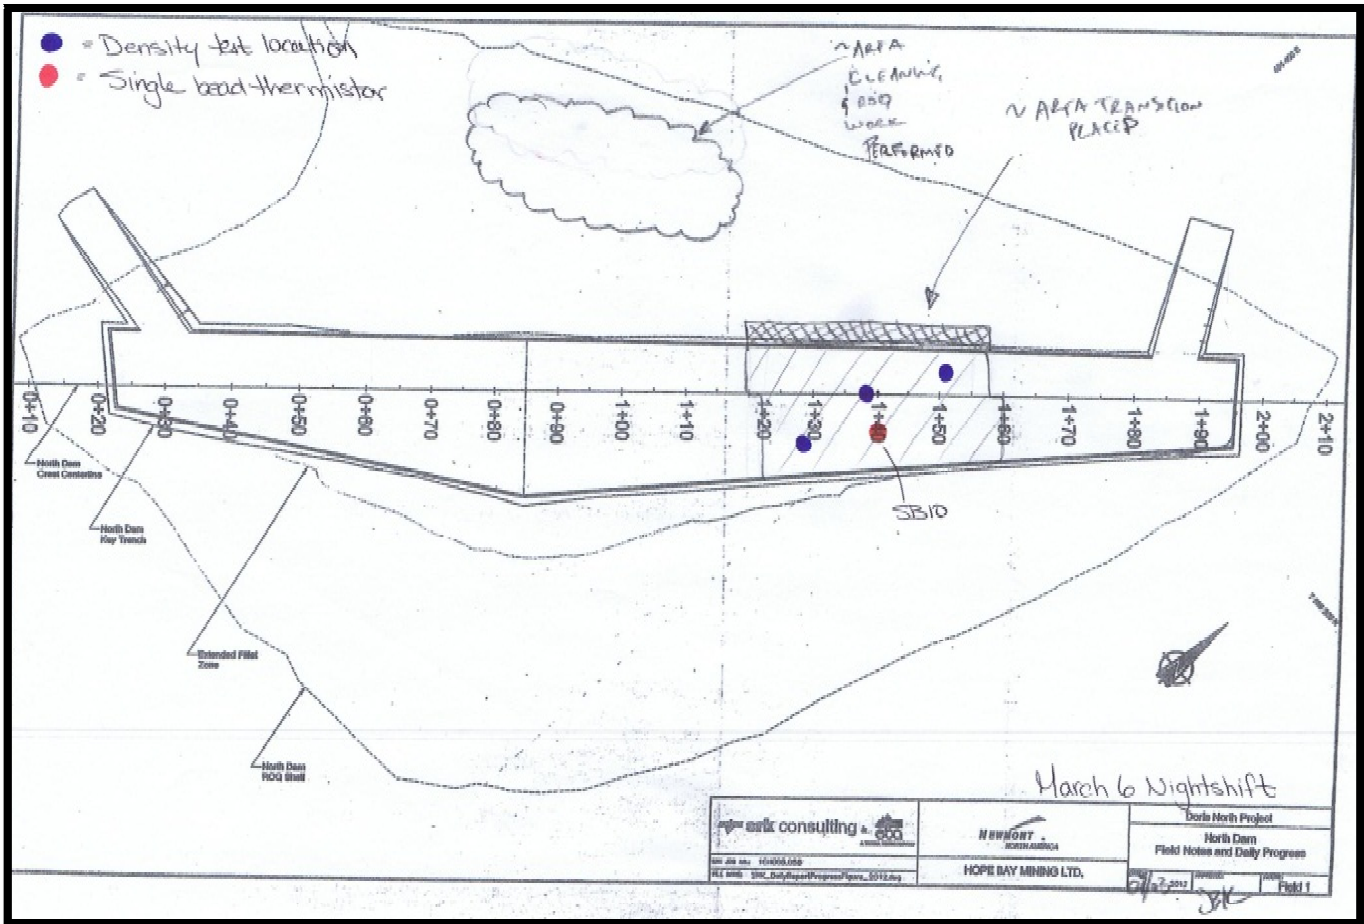
Figure 2 – North Dam Progress – Nightshift

- Cleaning, with the skid steer, resulted from ~ 1+20 to 1+70 and approved for placement.
- FCM was placed from ~1+20 to 1+60. Material was placed by the excavator and then packed.
