DAILY REPORT #62 – DORIS NORTH INFRASTRUCTURE/ NORTH DAM

Prepared by:	John Kurylo Lawrence Borowski	Date:	2012.03.07
Reviewed by:		Project #:	1CH008.058.0320
Role	Company	Personnel – Position	On Site
Client	Hope Bay Mining Limited (HBML)	Angela Holzapfel – ESR Compliance Manager David Vokey – ESR Coordinator Don Ethelston – HSLP Advisor Dean Wold - Safety Jill Turk – ESR Coordinator Katsky Venter – ESR Manger Michelle Tanquay – ESR Site Manager Stirling Kelly – HSLP Advisor	No Yes No Yes No Yes Yes No
	JDS	Lloyd Jackson – Mechanical Superintendent Doug Fielding – Construction Manager Ishan Fechter – Construction Coordinator Jerry Graham – Construction Manager Kevin Whieldon – Project Coordinator Mark Valeriote – Construction Manager	Yes No No Yes Yes Yes
Engineering Design Consultants	SRK Consulting (Canada) Inc.	John Kurylo – Site Engineer Megan Miller – Site Engineer Lawrence Borowski – Site Engineer Murray McGregor – Site Engineer Iozsef Miskolczi – Site Engineer Lowell Wade – Senior Engineer	Yes No Yes No No No

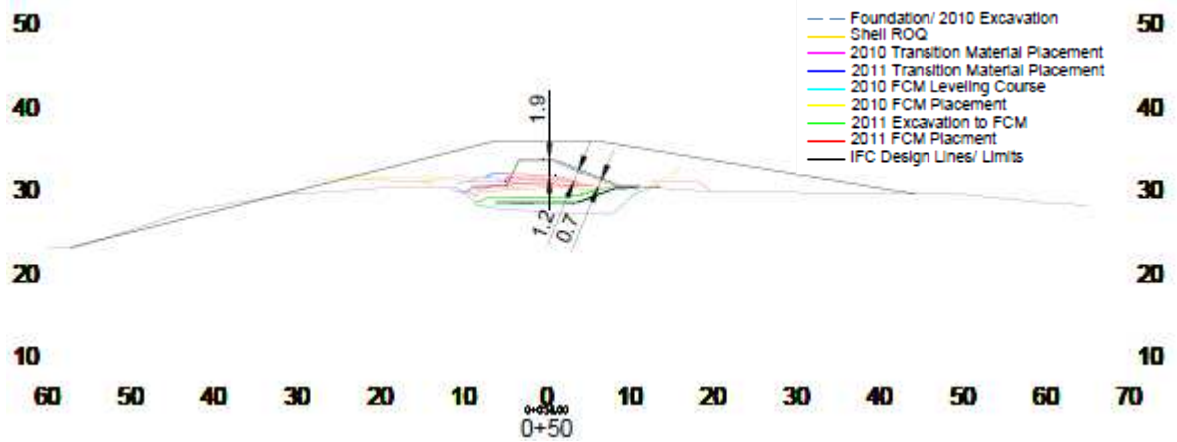
- Around station 0+50, approximately 1.9m of FCM is required to final core grade (i.e. fill over GCL or ~ 1.6m to GCL grade).

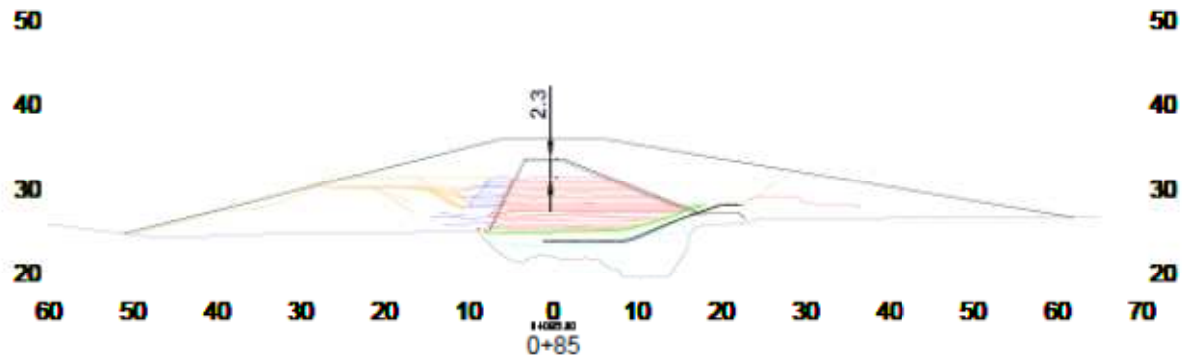
- Around the inflection point, at station 0+85, approximately 2.3m of FCM is required to final grade.

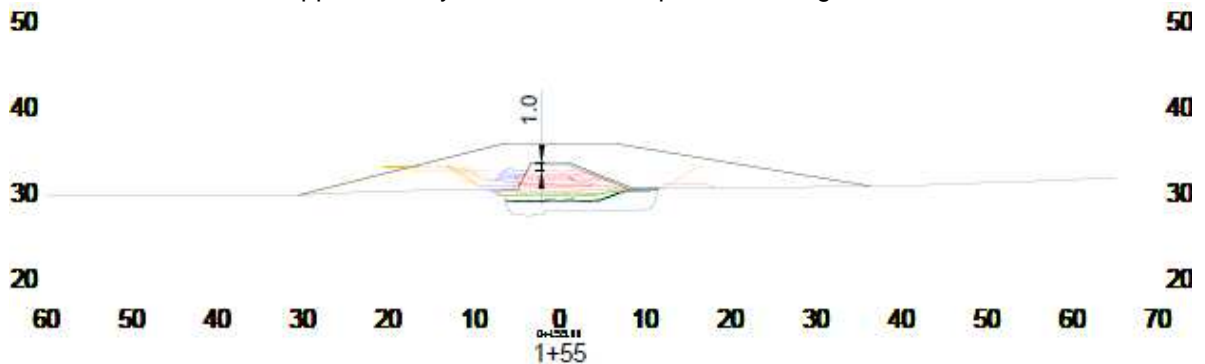
- Around station 1+55 approximately 1m of FCM is required to final grade.

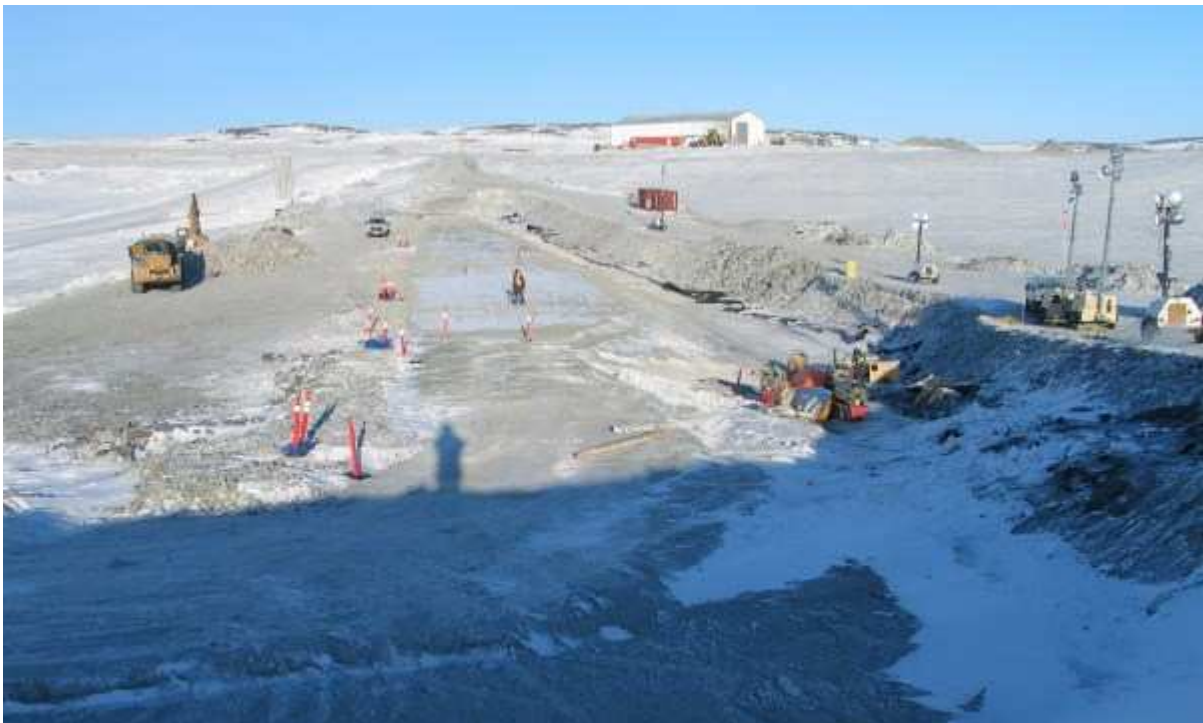
Photo 1: Progress photo from photo point 3, facing NNE

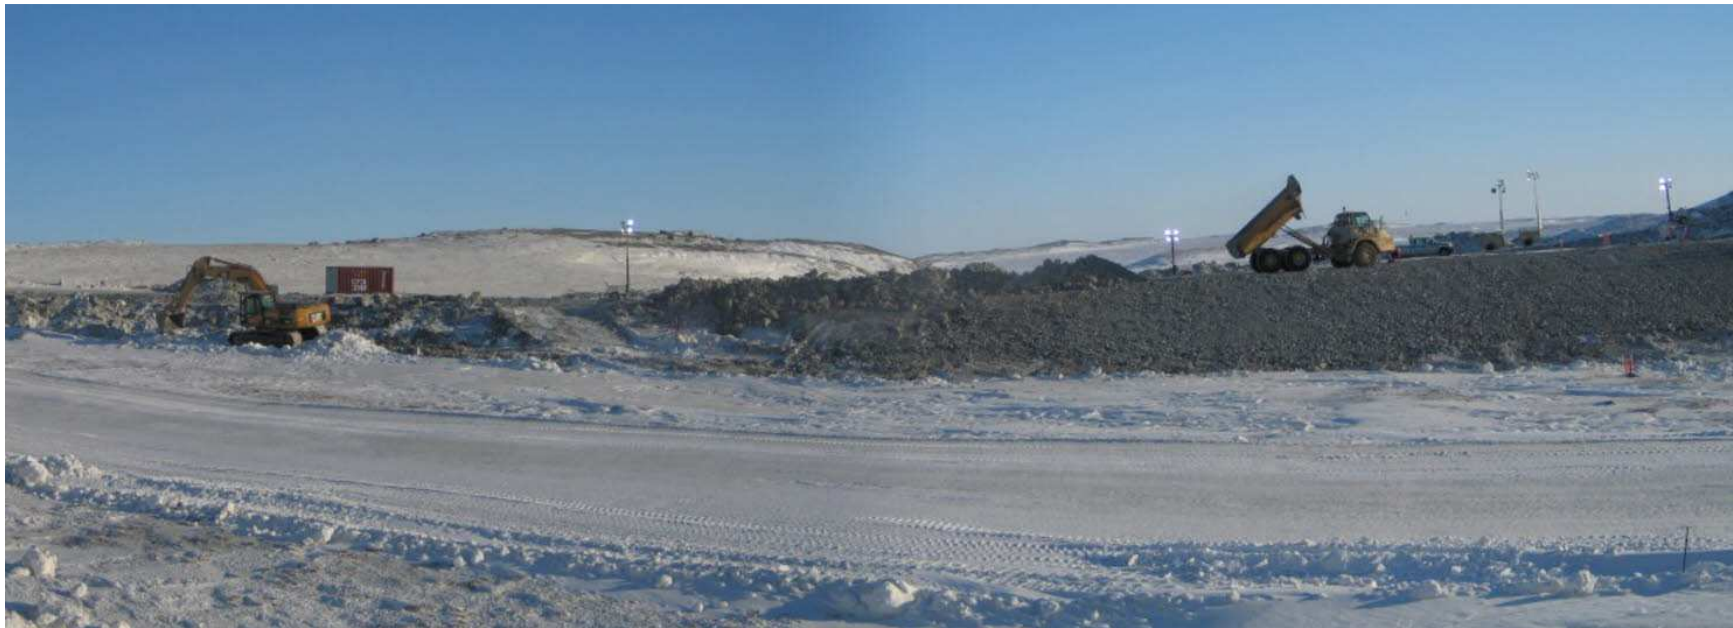
Photo 2: Panorama of downstream slope. Sloped and shaped section is between Sta 40 and Sta 1+30 Excavator is working towards north thermosyphons.

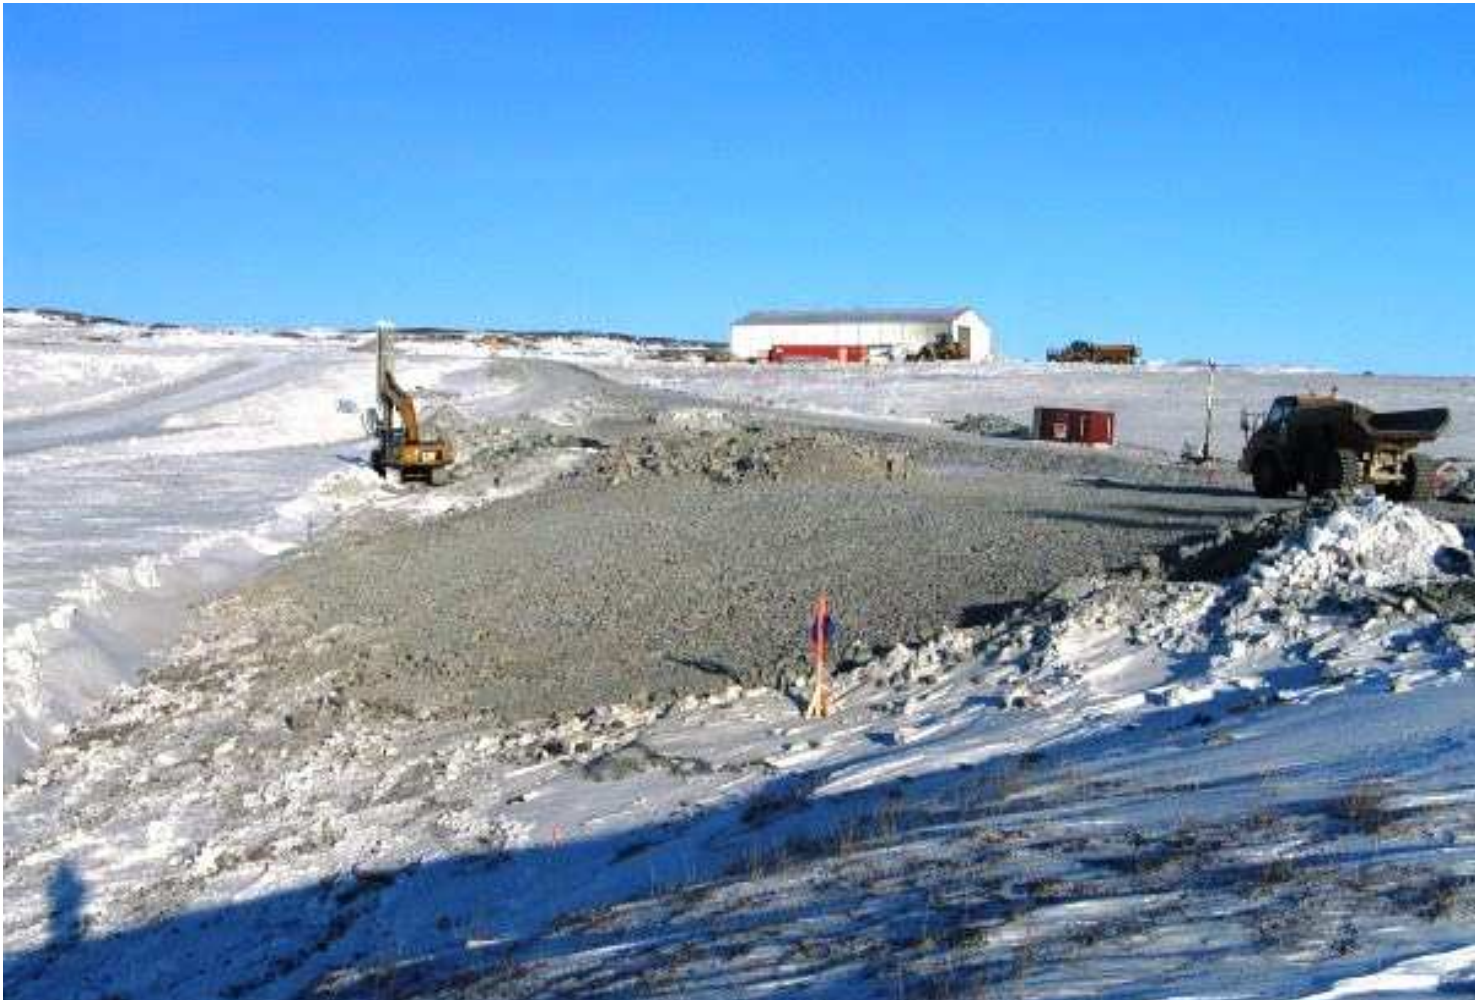
Photo 3: Sloping between Sta 0+40 and Sta 1+30.

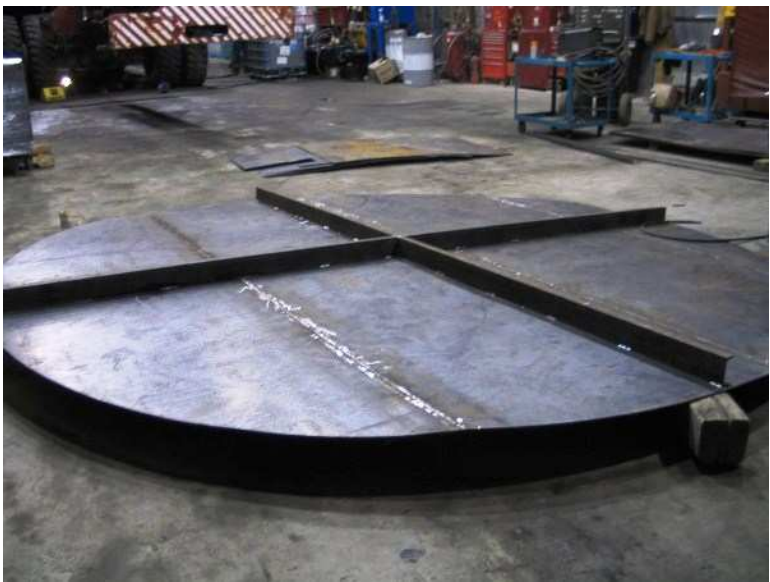
Photo 4: Lid for sump being constructed

- Lid for sump is being assembled today.
- Some discussion between the welder and Nuna, and later with SRK about the opening for the sump pump. Currently, drawings show the opening as one quarter panel. It was suggested that this opening far exceeds the opening for a sump pump and would be too large to open manually. Accordingly, a smaller opening is proposed. This will be cut unless the welder is instructed otherwise.

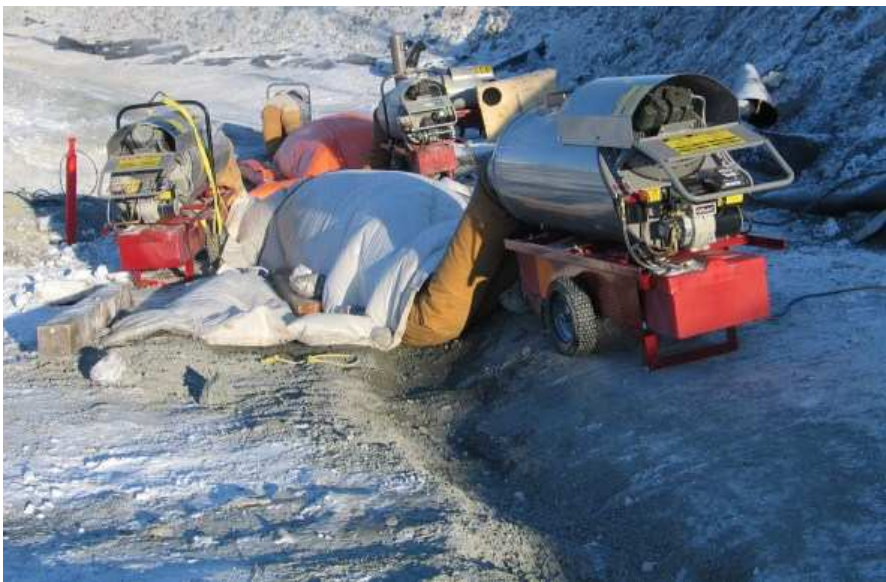
Photo 5: Frost fighters at south east corner of key

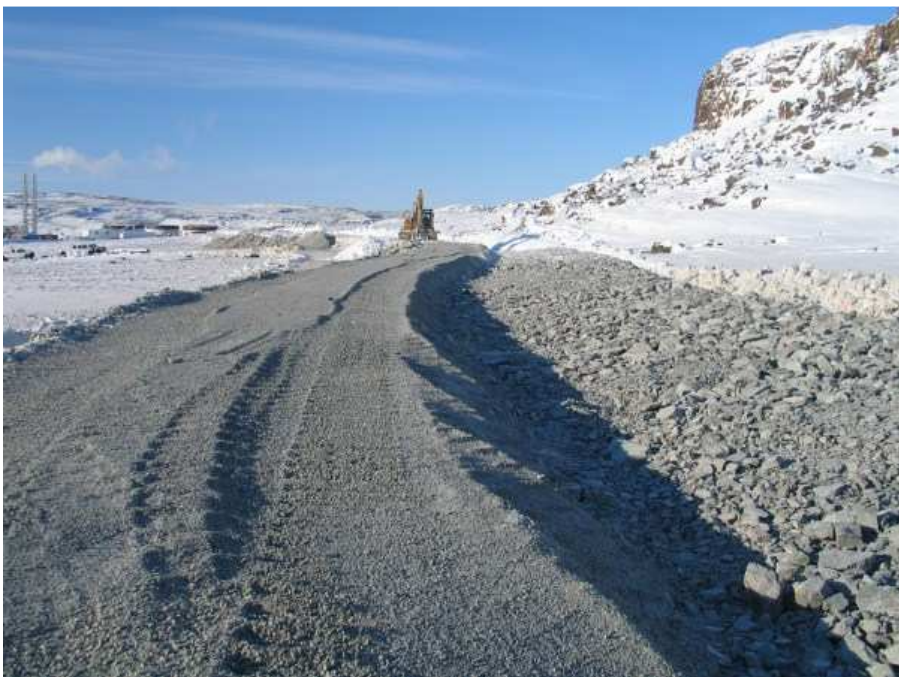
Photo 6: Finished portion of North Diversion Berm
Sta 5+80 to 6+78 facing west

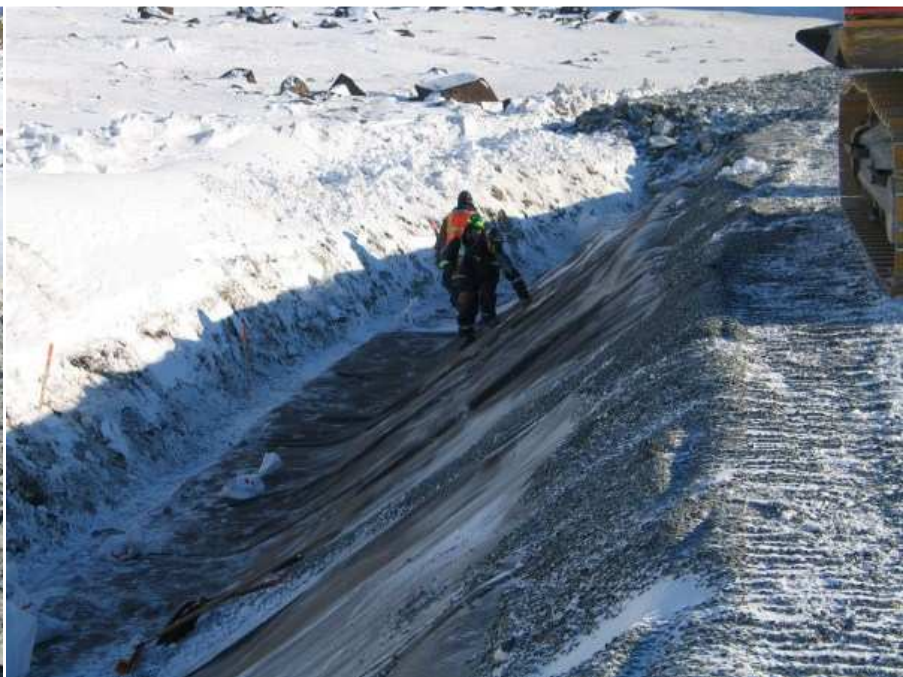
Photo 7: Labourers cleaning key trench prior to placing bentonite.

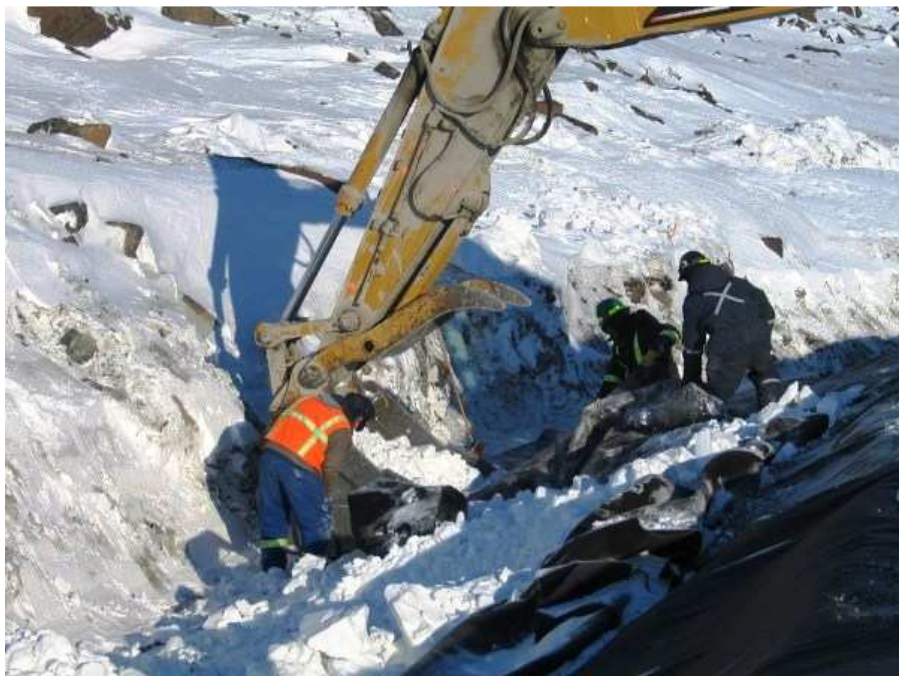
- Placement of ROQ in the key from ~ Sta 5+80 to 6+78 has been inspected and is complete.
- Excavator working with labourers clearing snow from key trench, working from Sta 5+80, west bound.
- Labour issues are making snow clearing in the key trench a slow process.
- Excavator was cleaning snow at ~Sta 5+50 when it was noted that a previous operator had snagged the HDPE liner and torn it. This will need to be repaired by Layfield.

Photo 8: Liners that were cut during snow clearing.

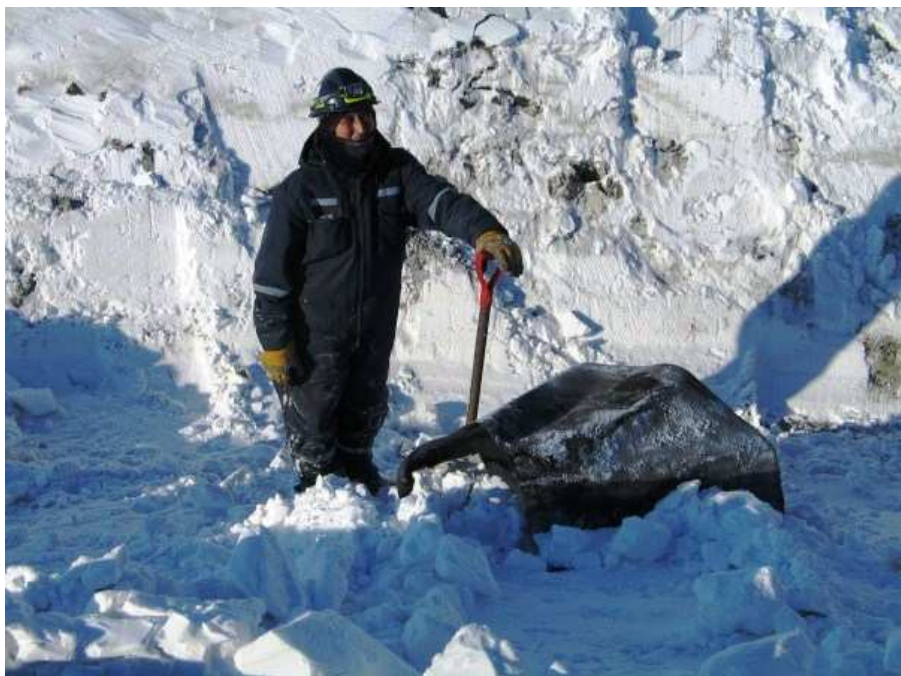
Photo 9: HDPE that was cut

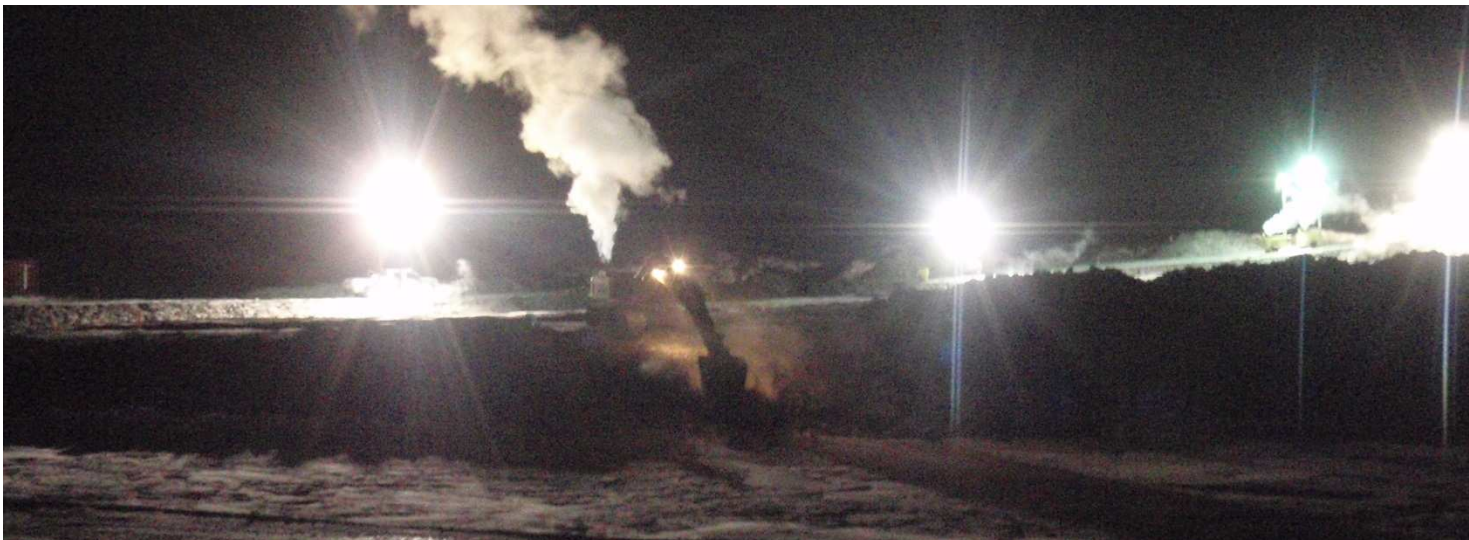
- Additional snow cleared on the downstream dam around station 1+60 to 1+30.
- Additional ROQ material was placed on the downstream side of the dam in spots around ~1+60 to 1+00. See Photo 10.
- No compaction effort has been observed on the recently placed downstream shell ROQ or Transition material. No packer operator was available on night shift.
- Additional ROQ was placed along the existing top edge of the downstream from ~ 0+60 to 1+60. See Photo 11.

Photo 10: ~S view of excavator spreading ROQ on downstream slope to 4H:1V.

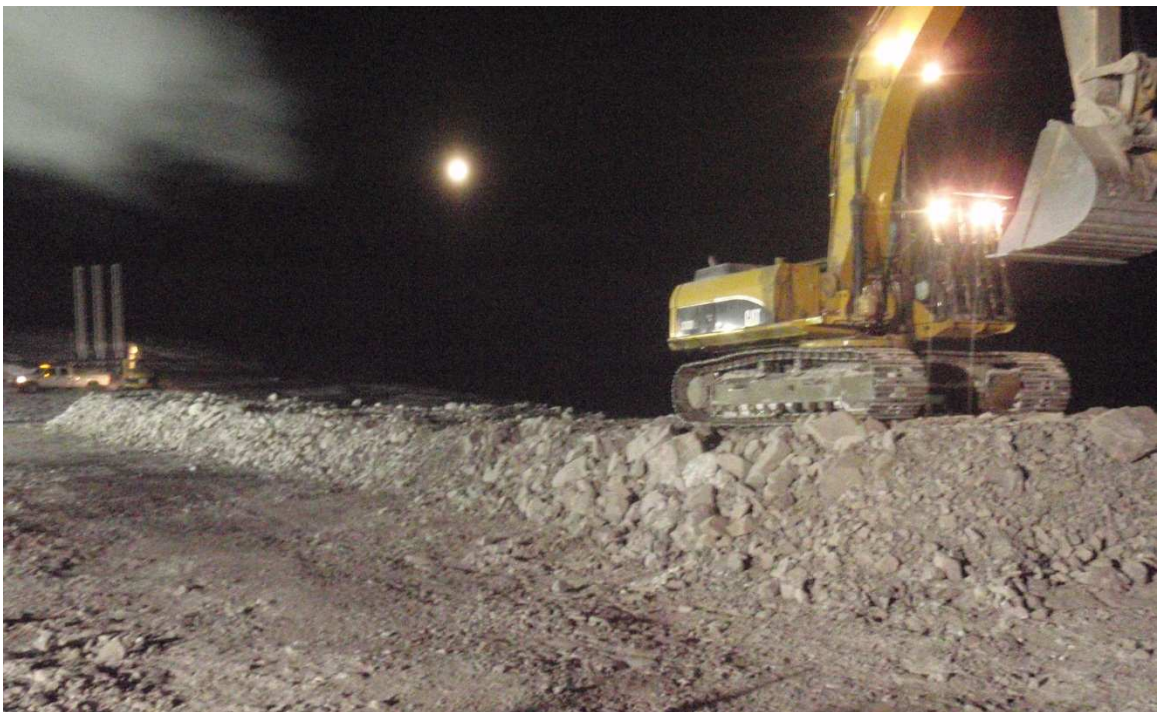
Photo 11: ~WSW view of ROQ placement along the downstream edge of the dam.

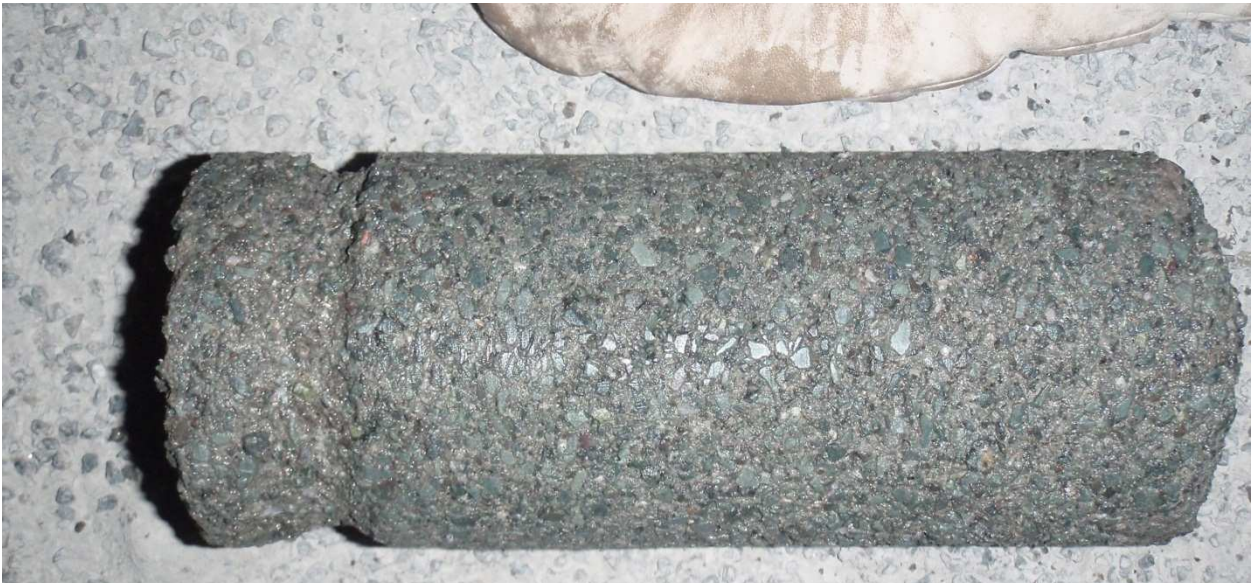
Photo 12: HB12-ND-CORE-DC68-20120307 was drilled around the centerline at station 1+31. Note that the top of the core is augmented in shape as this core was stopped short when the power on the light plant went out. A different light plant was sourced but the top portion of the core remained in glycol (as there was no way to draw it out) while another light plant was rigged up.

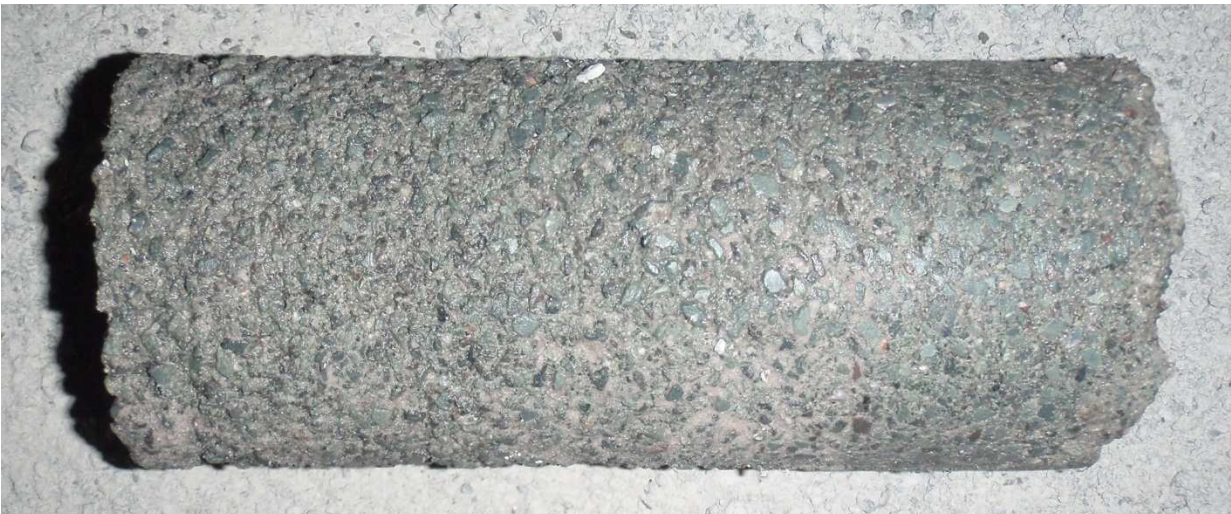
Photo 13: HB12-ND-CORE-DC69-20120307 was drilled around the centerline at station 0+86.

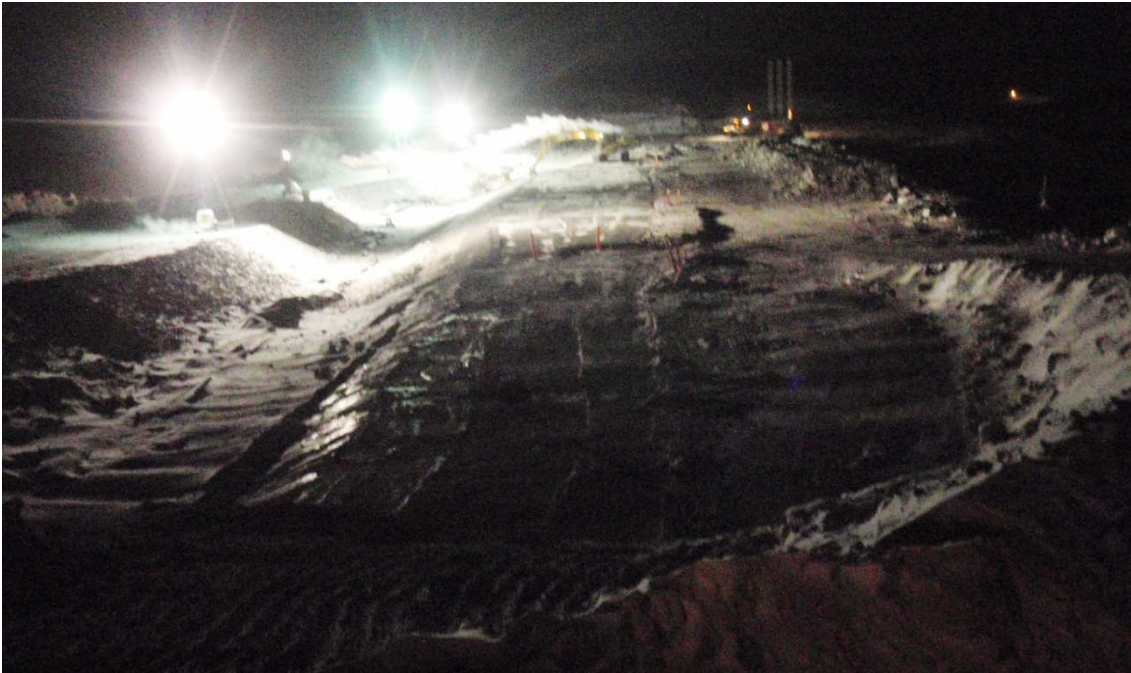
Photo 14: ~SW view down the dam center liner of construction progress. Note the excavator in the background assisting with cleaning material around station 0+50.
