## DAILY REPORT #63 – DORIS NORTH INFRASTRUCTURE/ NORTH DAM

| Prepared by: | John Kurylo<br>Lawrence Borowski | Date: | 2012.03.08 |
| Reviewed by: | | Project #: | 1CH008.058.0320 |

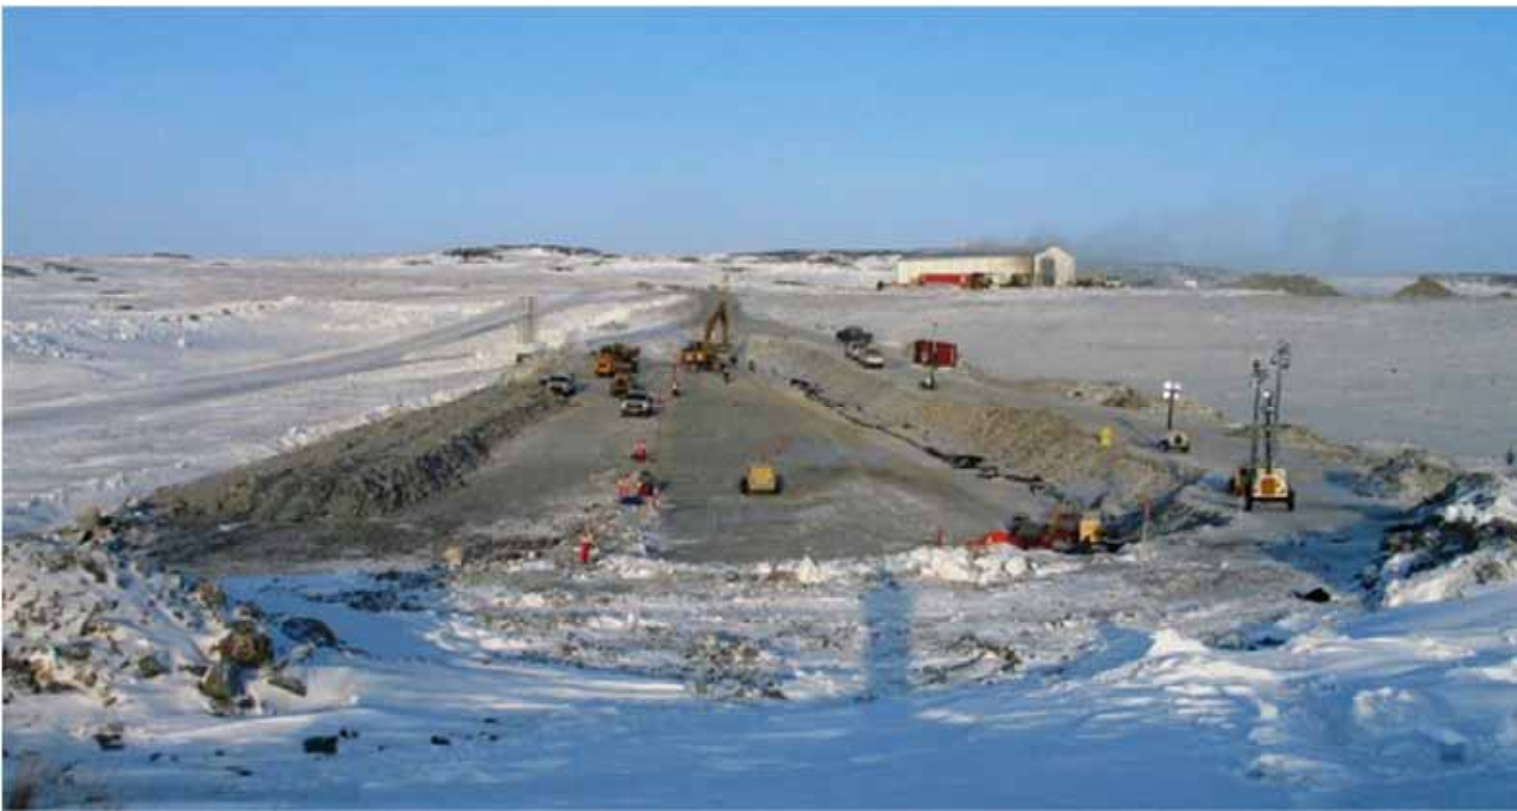
Photo 1: Progress photo from photo point 3, facing NNE

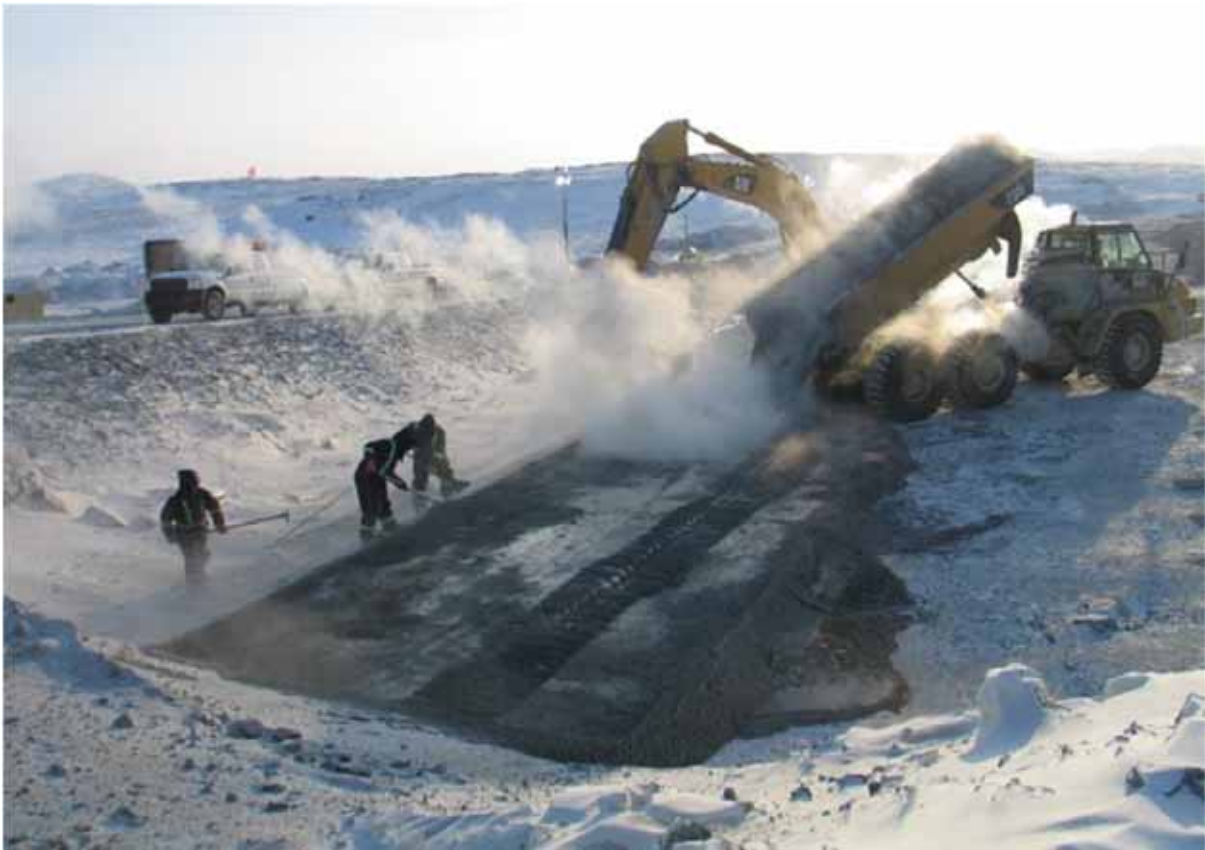
- Frost fighters still remain at about Sta 0+70. These were maintained all day.
- FCM was placed between Sta 1+45 and the end of the dam. The section from Sta 1+74 north is now at final grade.

Photo 2: Placing core material at extreme north end of the key trench. This section is now at final grade.

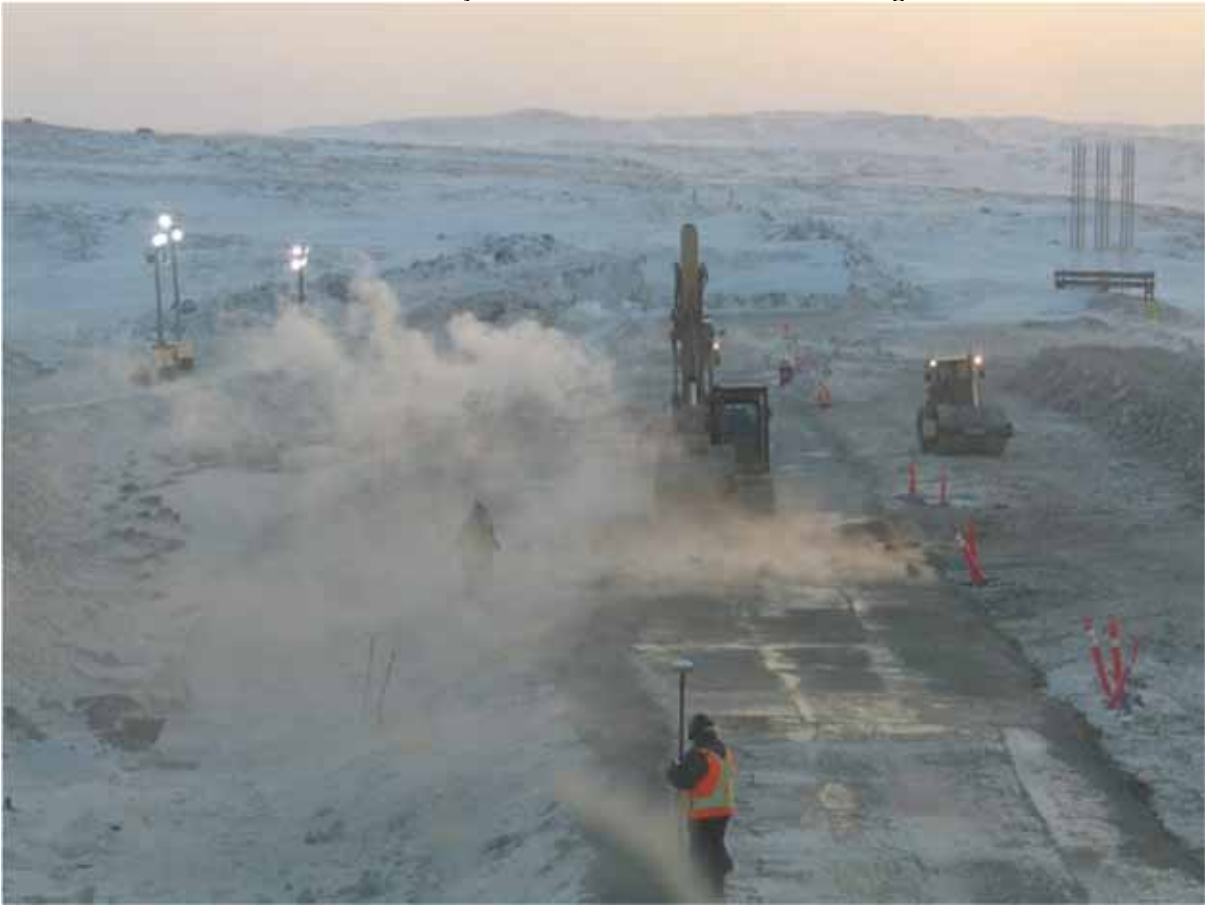
Photo 3: Surveyor taking as built measurements at the end of the shift

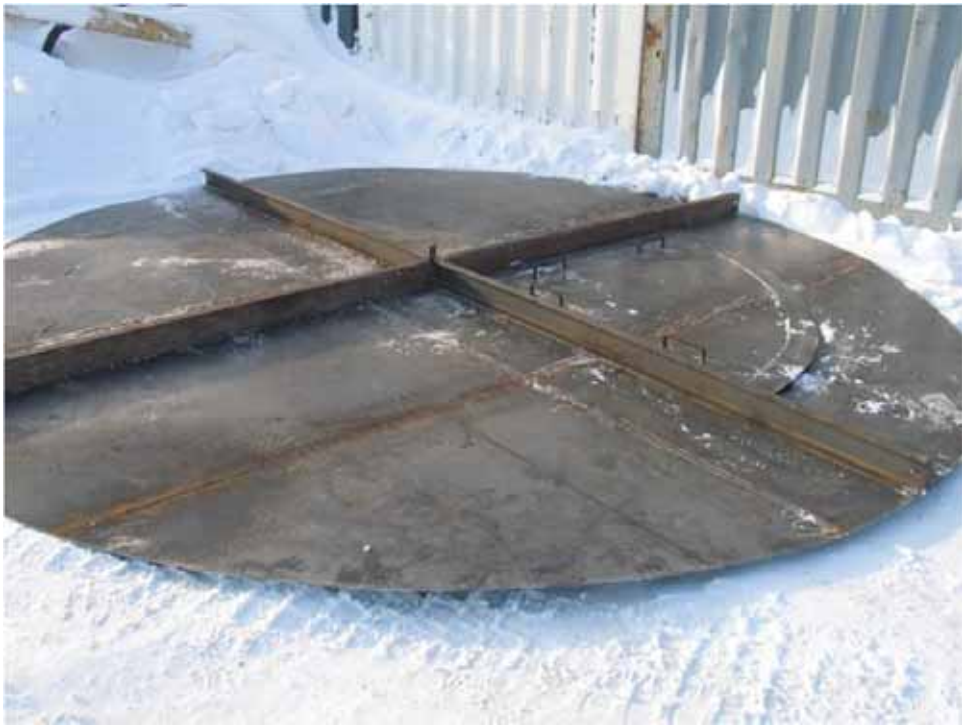
- Fabrication of the first lid complete. Still needs to be insulated.
- Discussed the proposed change to the lid with SRK. Change would reduce the size of opening to set the sump pumps.

Photo 4: Fabricated sump lid

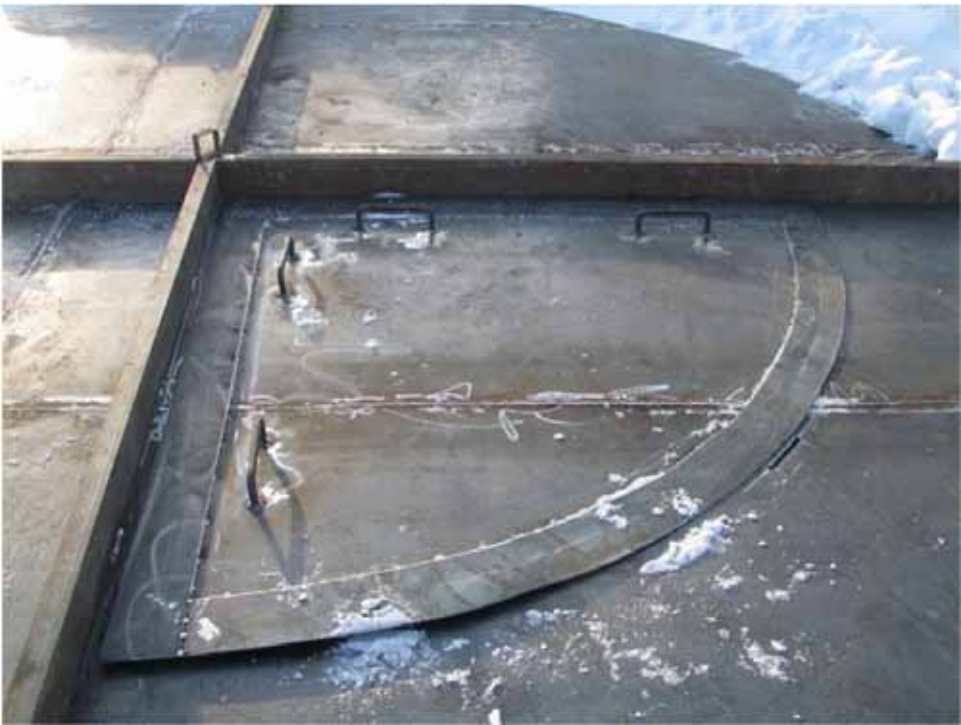
Photo 5: Section cut out to install sumps

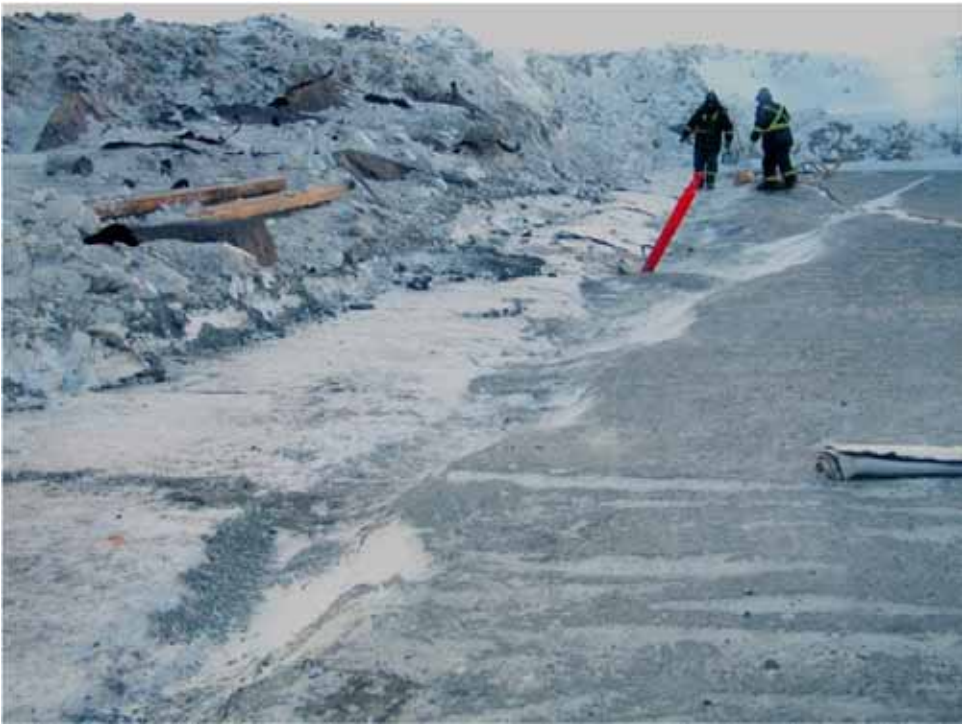
- As an operator for the excavator was not available, the foreman operated the excavator for part of the afternoon.
- Tli Cho was retained to clean at the inflection point at the south east corner. Following cleaning with an air compressor, holes in the GCL were patched with bentonite and GCL.

Photo 6: Cleaned inflection line

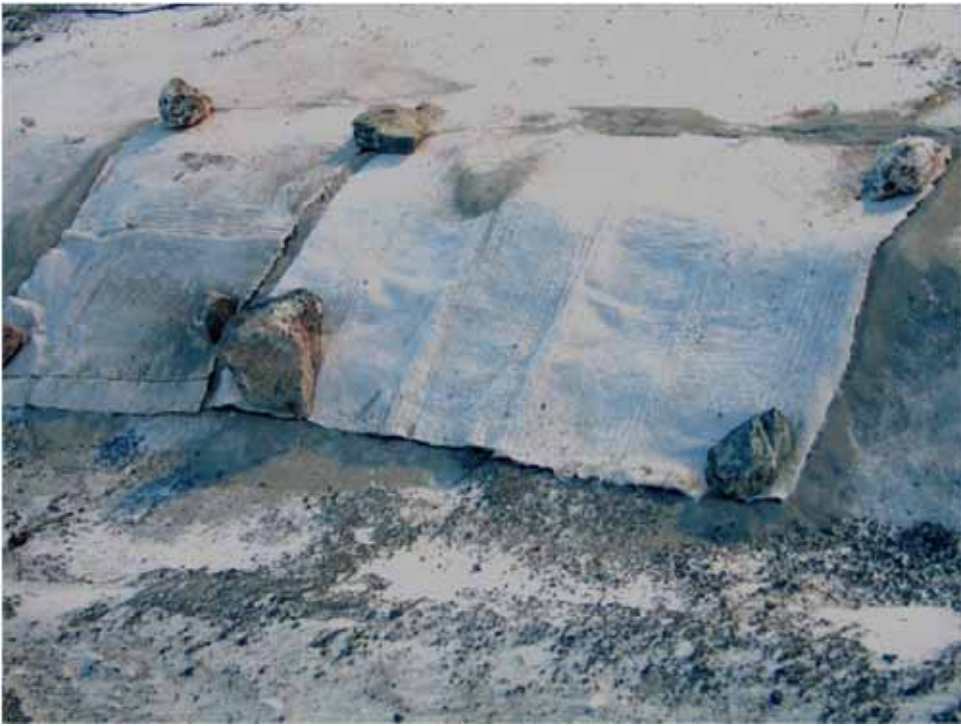
Photo 7: Patches to GCL

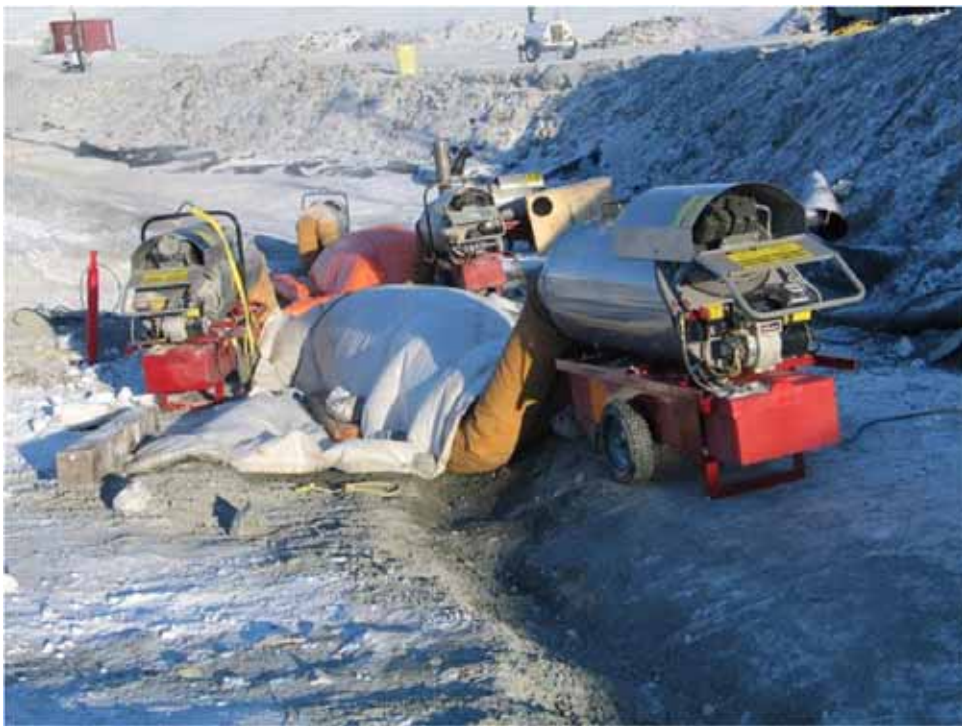
- Snow and ice continued to be cleaned from the SW upstream slope area from ~ 0+70 to 0+30. Hand shovelling and an air compressor was used.
- Hording and heating with frost fighters continued over the GCL around station 0+40 to 0+70 areas. No notable work was done beyond the heating

Photo 8: Frost fighters heating and hording around the fillet expansion around 0+70.

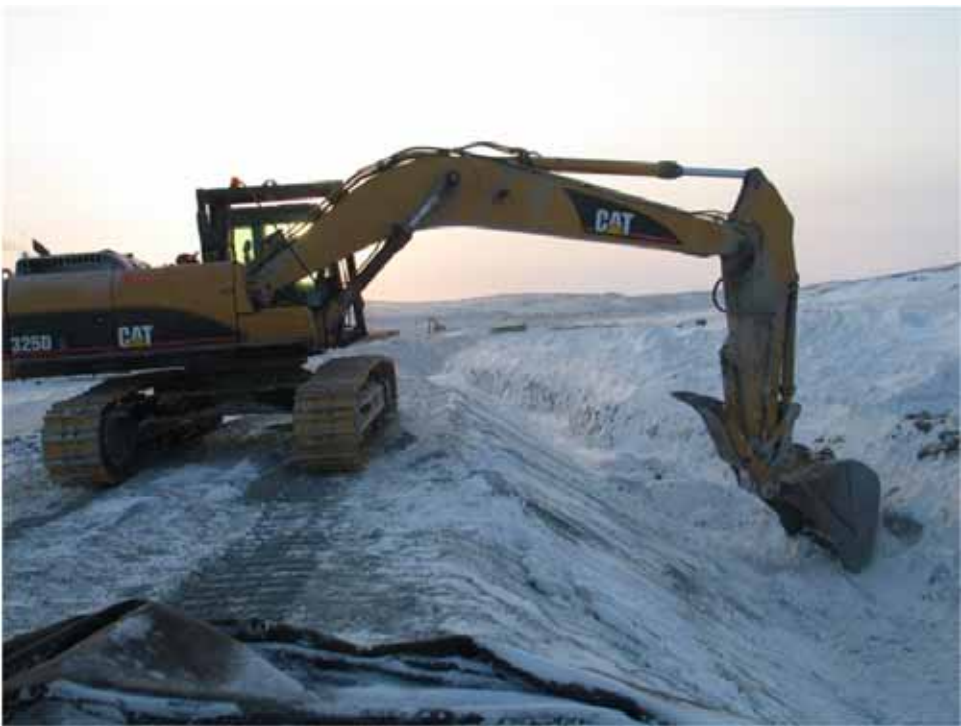
- Layfield arrived at site but were not at the berm today.
- A section of the key trench ~50 meters was cleared of snow and ready for the final bentonite layer yesterday. Snow blew in overnight and the key trench needs to be cleaned again.
- Excavator did some snow clearing in the afternoon.
- Foreman advises that they will no longer work long stretches. He plans to work in 10-20 meter stretches and finish before moving on, as too much time is being spent cleaning snow,

Photo 9: Excavator cleaning snow in berm key trench

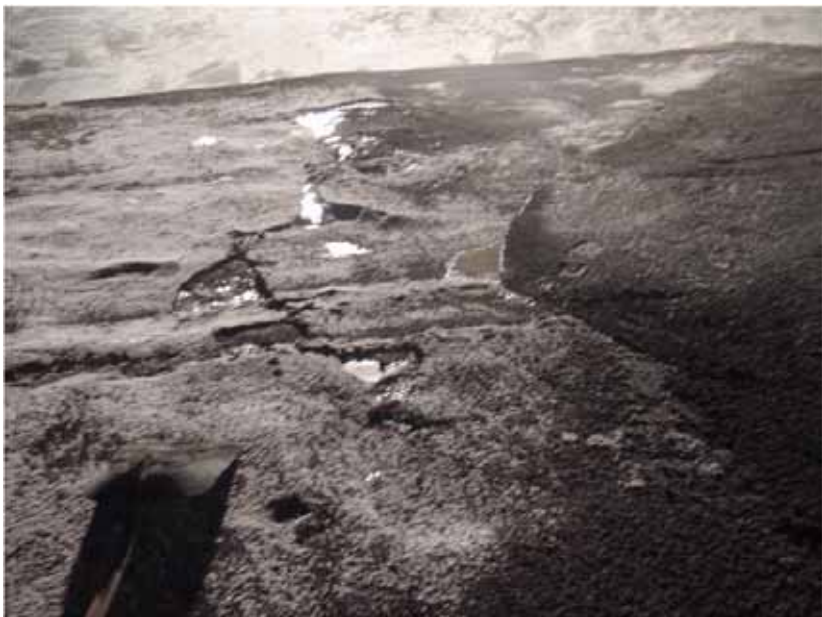
**Photo 10:** Slight cracking on top of dayshift placement near tie in. This area is planned to be revisited after freezeback.

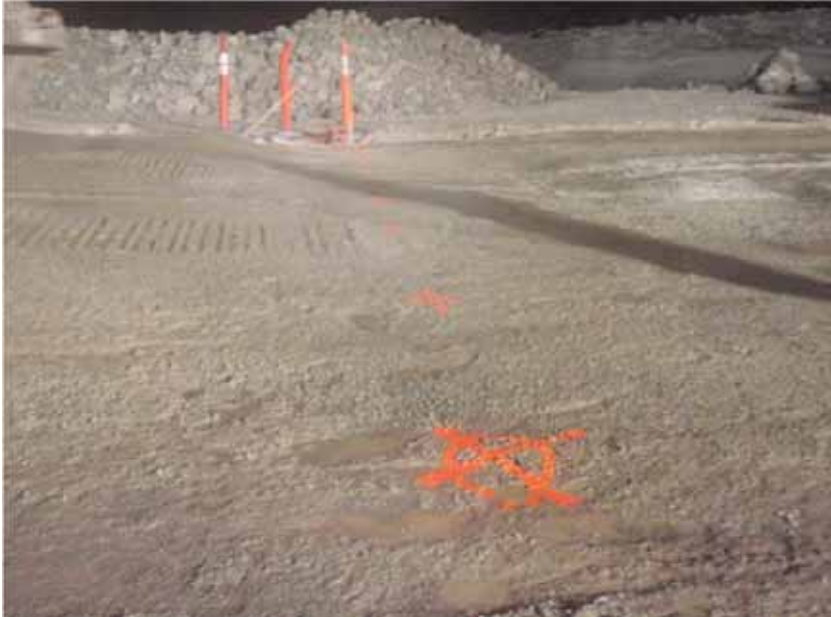
- A sheen of water was observed on the surface of the entire area where placement observed.
- The core elevation at 1+30 was graded to the elevation 33.5m or the elevation of the final multibead thermistor at this location. The elevations of the dam core at the four remaining multibead locations are outlined below

| Station | Current Top Elevation (m) | Install Elevation (m) | Comment |
|---|---|---|--|
| 1+30 | 33.50 | 33.50 | Graded to multibead elevation. Thermistor string to be installed when next lift placed over this area. |

**Photo 11:** ~NW view at station 1+30. Note station at next multibead elevation, elev 33.5m.

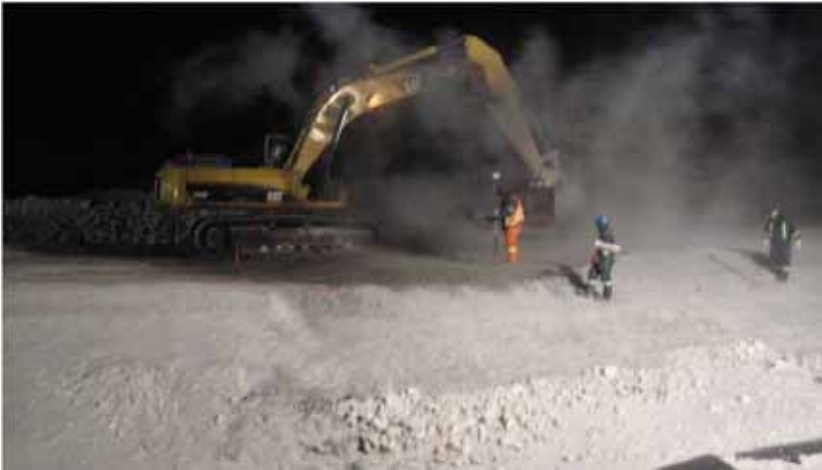
**Photo 12:** ~N view of construction crew working on sloping upstream of dam.

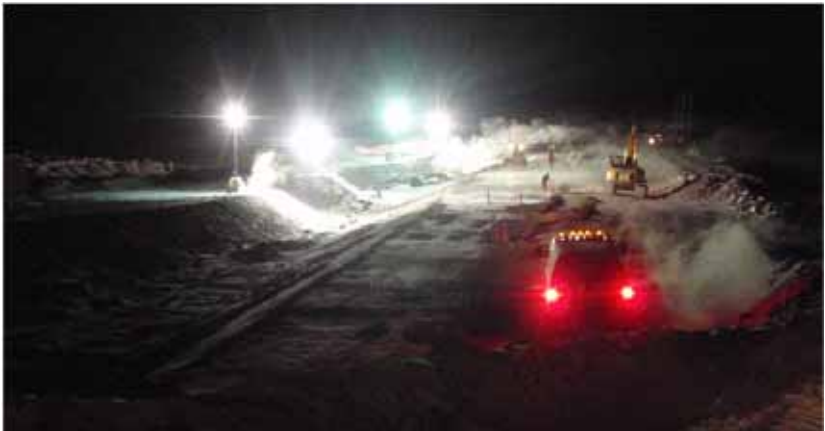
**Photo 13:** ~WSW view down core towards night construction activities.

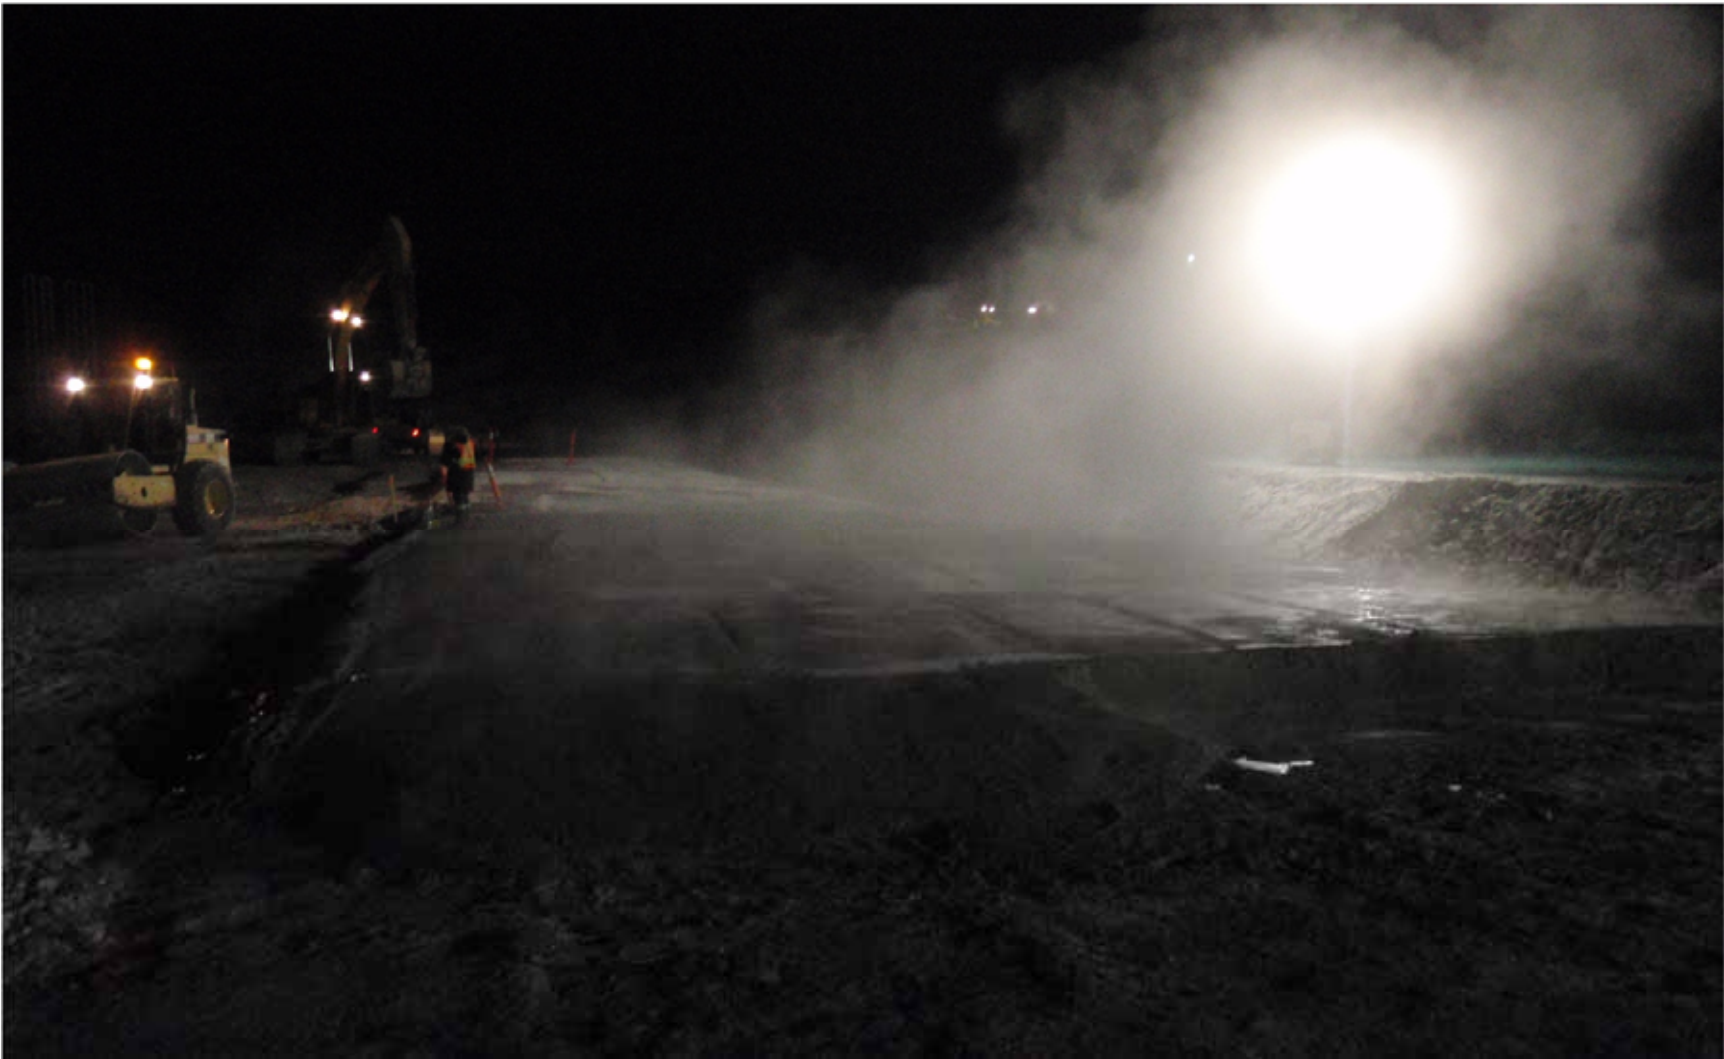
- FCM was placed from ~1+45 to 1+00.
  - Material looked of good quality for compaction and saturation.
  - Approximately 11 loads were placed on nightshift

- Some pooling was noted to be forming on the surface of the FCM after vibrator compaction. After a couple hours the large majority of the pooling water was noted to have gone. Some bubbles are noted during placement as air space gets replaced by water in the soil. Soil characteristics that appeared somewhat similar to traits of quickly dissipating capillary forces in sand were temporary observed in select area before pooling was noted.

**Photo 14:** ~NE view of nightshift FCM placement at the North Dam.

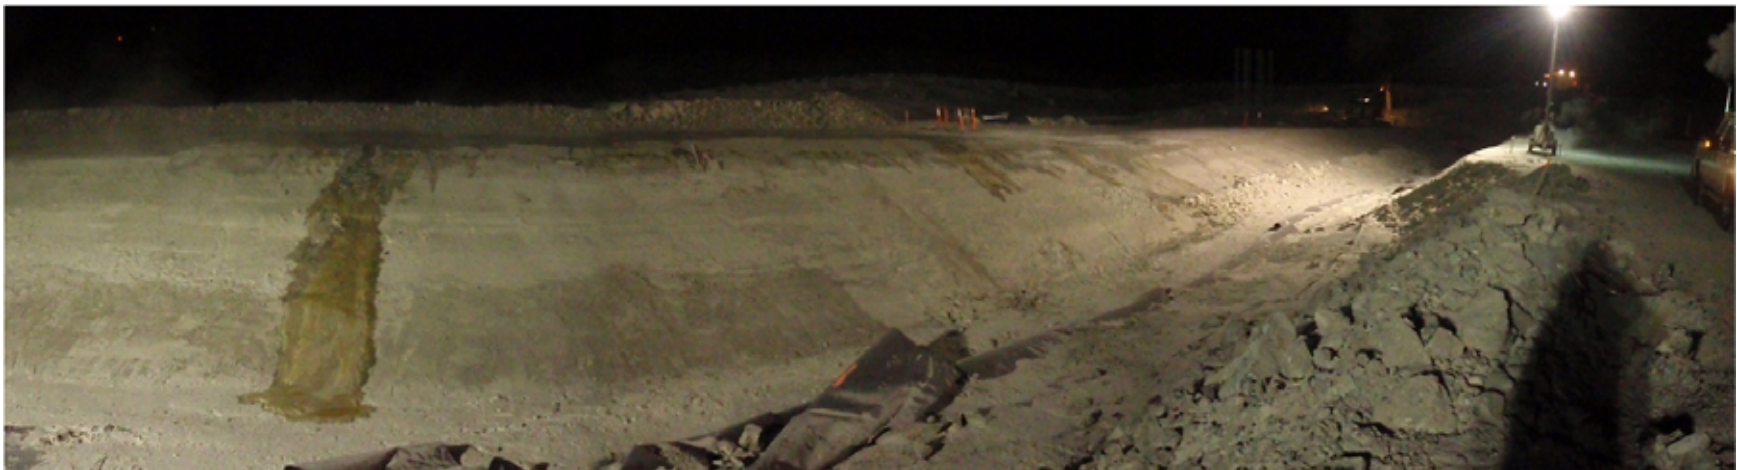
**Photo 14:** ~NNE stitched panoramic view of upstream dam slope. Taken from around 1+20 Note the ice on the slope around station 1+15 is expected to be scraped back when the next lift is placed in this area. Ice from water discharge down slope, due to water draining to a low graded point in the placement.

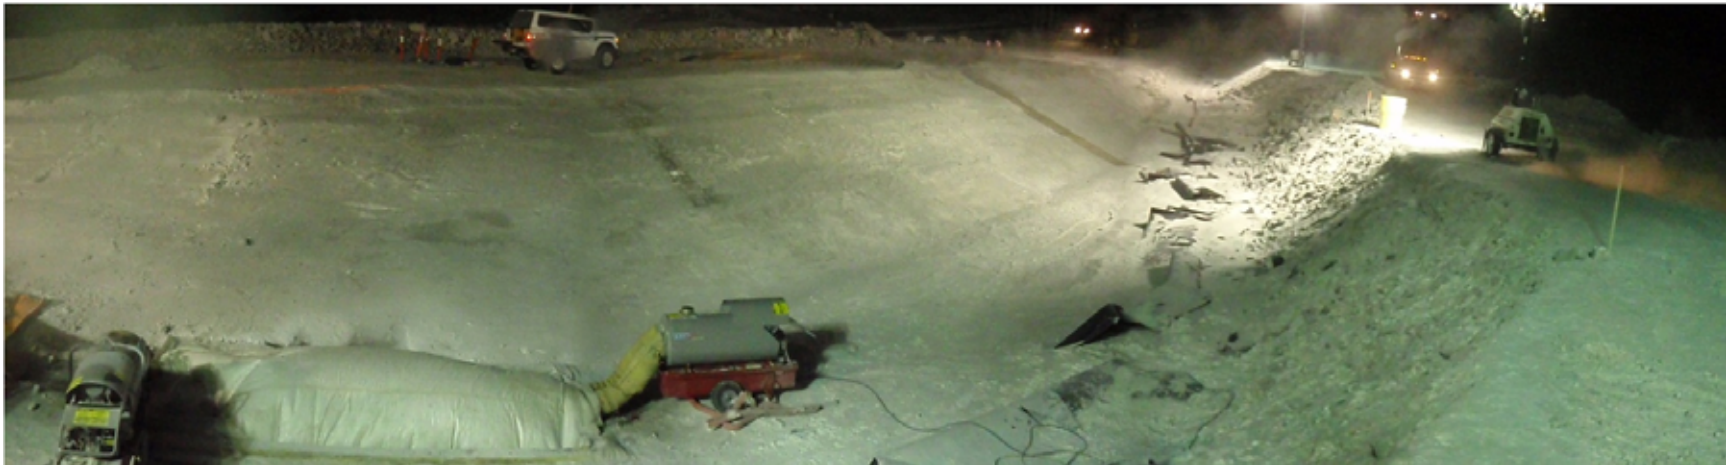
**Photo 14:** ~WNW view of the upstream dam slope. Taken from around station 0+75. Note the hording and heating being completed around 0+70 .

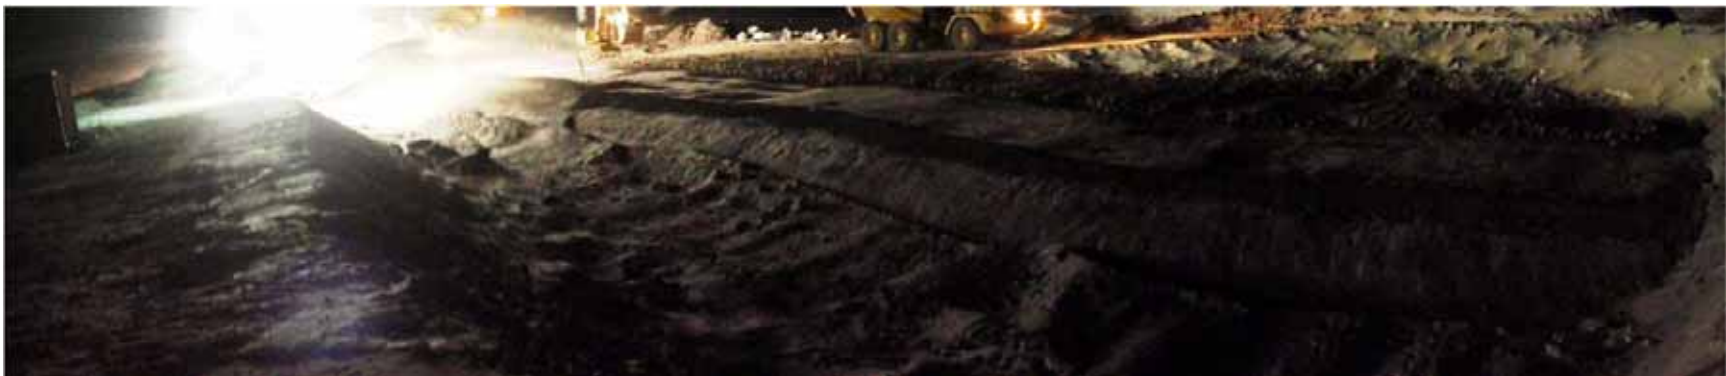
**Photo 14:** ~ESE view of north end of the Dam construction. Note that the area in the right of this photo is very close to design grade / lines.

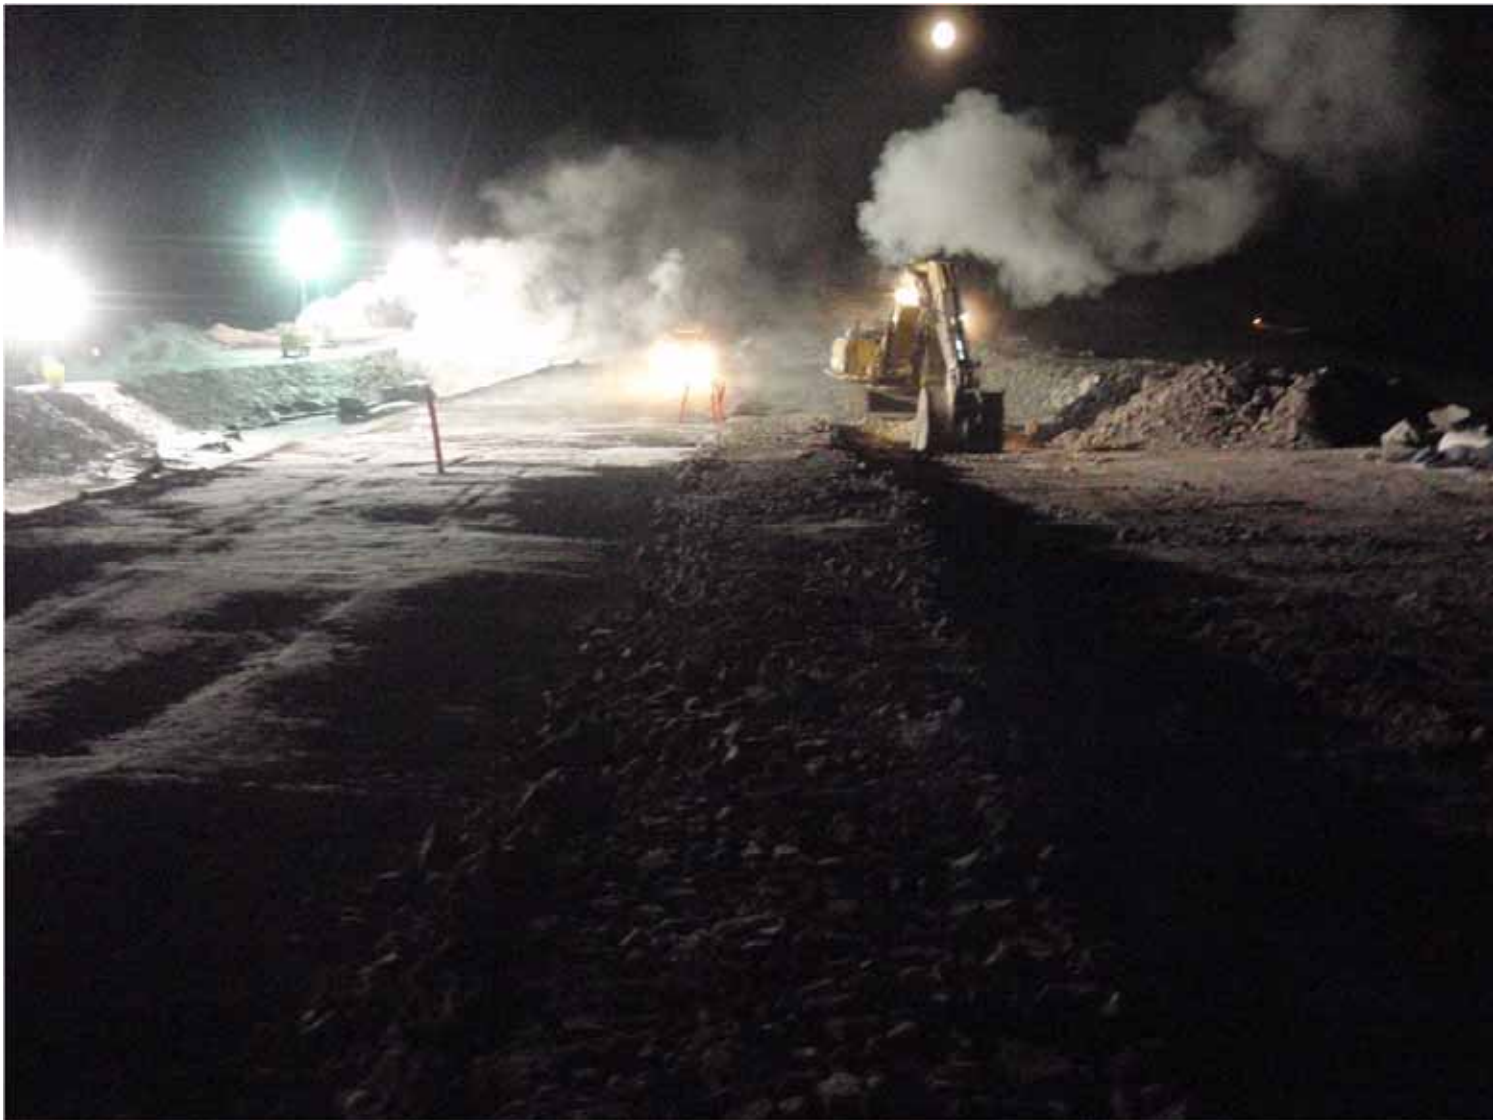
- Transition material was placed from ~ 1+95 to 1+00 on the upstream of the FCM placed today. Additional compaction is still required on this area before the next lift of Transition is placed.

**Photo 14:** ~330 Excavator placing Transition material along downstream edge of FCM placed today.
