## DAILY REPORT #64 – DORIS NORTH INFRASTRUCTURE/ NORTH DAM

Prepared by:	John Kurylo Lawrence Borowski	Date:	2012.03.09		
Reviewed by:		Project #:	1CH008.058.0320		
Role	Company	Personnel – Position	On Site		
Client	Hope Bay Mining Limited (HBML)	Angela Holzapfel – ESR Compliance Manager	No		
		David Vokey – ESR Coordinator	Yes		
		Don Ethelston – HSLP Advisor	No		
		Dean Wold - Safety	Yes		
		Jill Turk – ESR Coordinator	No		
		Katsky Venter – ESR Manger	No		
		Michelle Tanquay – ESR Site Manager	Yes		
		Stirling Kelly – HSLP Advisor	Yes		
	JDS	Lloyd Jackson – Mechanical Superintendent	No		
		Doug Fielding – Construction Manager	No		
		Ishan Fechter – Construction Coordinator	Yes		
		Jerry Graham – Construction Manager	Yes		
		Kevin Whieldon – Project Coordinator	No		
		Mark Valeriote – Construction Manager	Yes		
Engineering Design Consultants	SRK Consulting (Canada) Inc.	John Kurylo – Site Engineer	Yes		
		Megan Miller – Site Engineer	No		
		Lawrence Borowski – Site Engineer	Yes

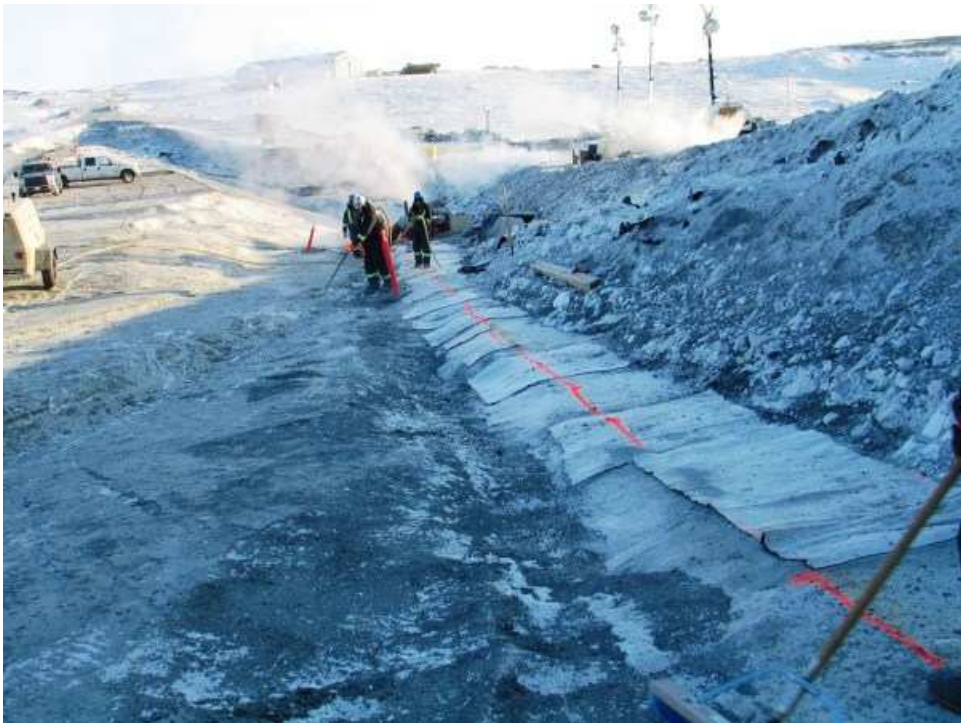
- Nuna started the day shift working in the SE corner.
- SRK inspected patches and cleaning at the corner. A thorough job of patching was evident
- Load of FCM was dumped at ~ Sta 0+40. The excavator was used to fill the hollow at the inflection point starting at Sta 0+60 and heading up to Sta 0+20. At the top end, the available space for placing widened

Photo 4: Patches along inflexion line

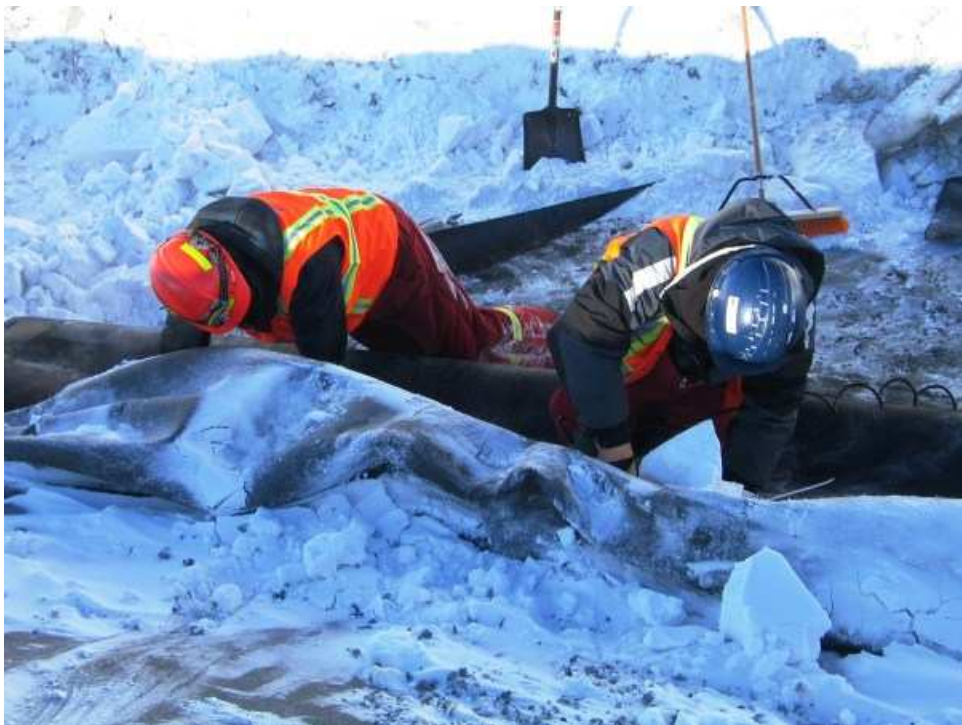
- Layfield repaired HDPE Liner at ~ Sta 5+00
- HDPE liner and geotextile is placed to Sta 4+45. The section from Sta 4+45 to Sta 5+80 filled in partly with snow before the upper layer of bentonite was placed. This section must now be cleared by hand. It is in this section that attempts to clear snow with the excavator resulted with a cut HDPE Liner
- It was decided to leave this section for now.
- Snow clearing was carried out between Sta 3+80 and 4+45. This section already has underliner crush and bentonite placed. This section was inspected and approved for geotextile placement.
- Geotextile placement started ~ 3:30 pm. The area cleared of snow will be covered with geotextile by the end of shift.

Photo 12: Layfield patching HDPE liner

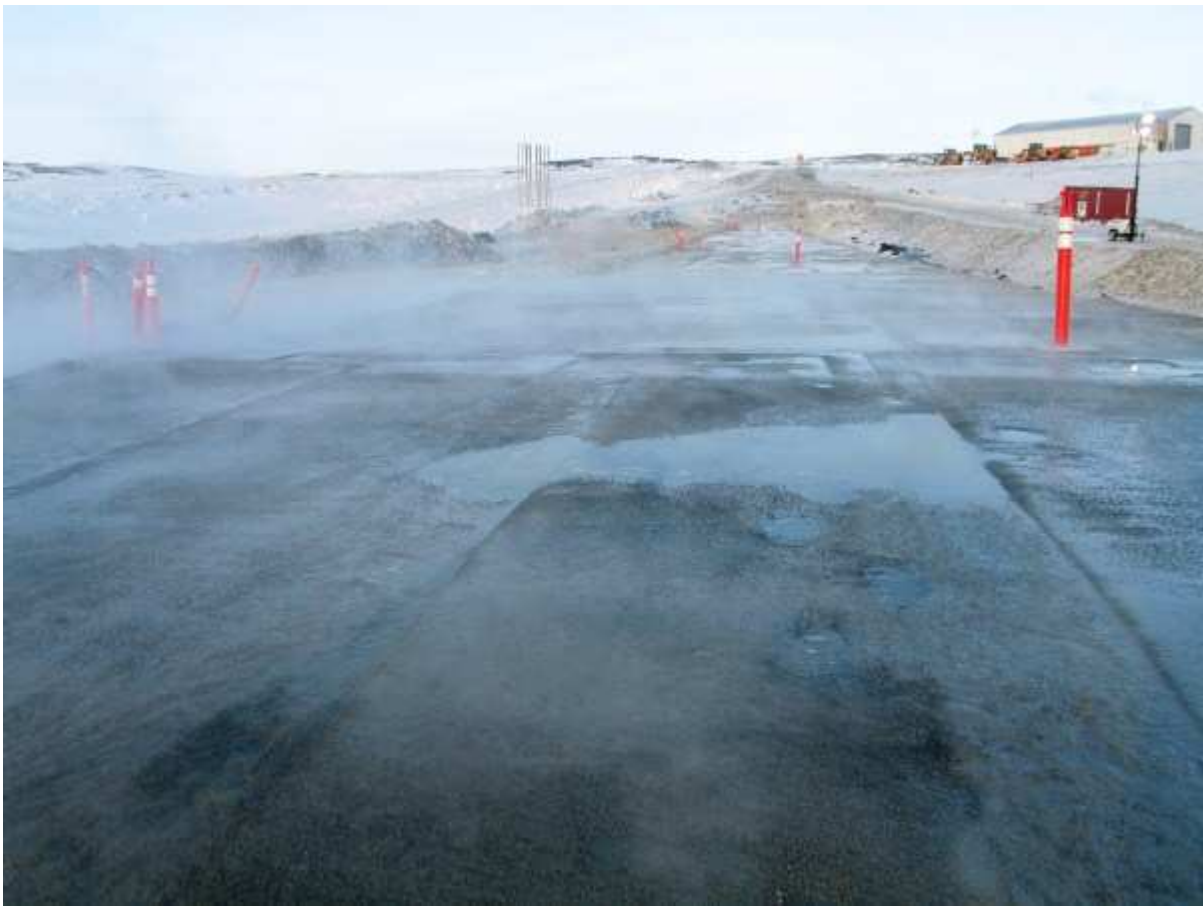
- Frost fighters were moved and additional patching carried out late in the afternoon.
- Small ponds of water were evident after the FCM was placed.

Photo 14: puddles of water on final product.

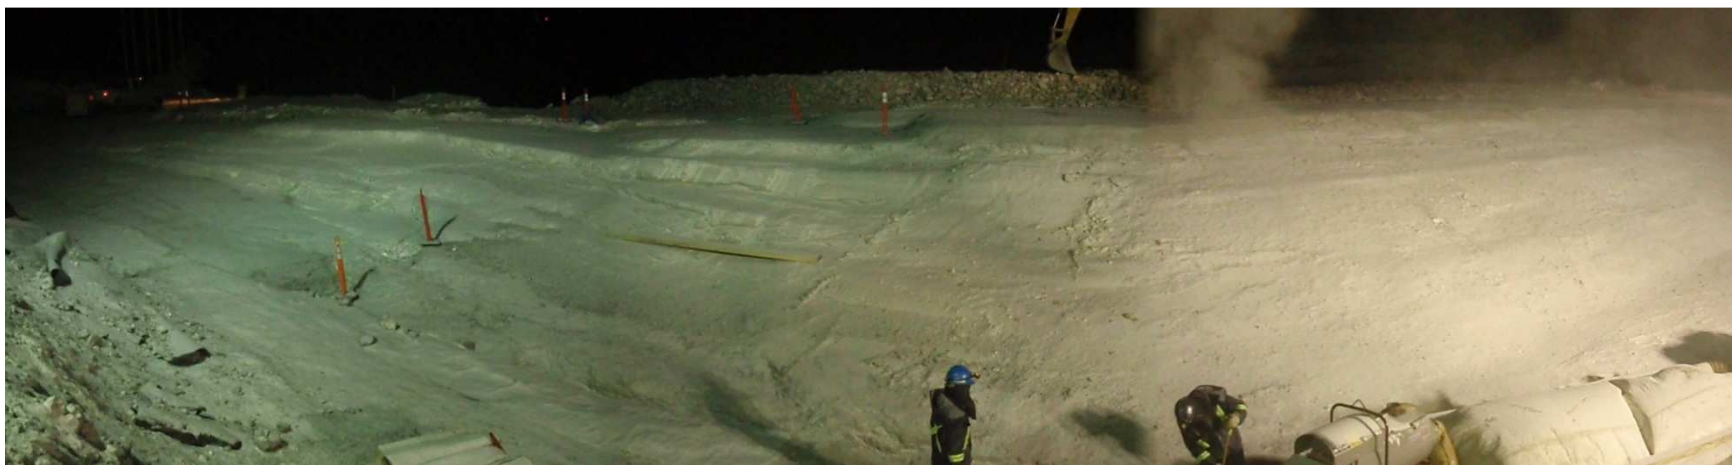
**Photo 15:** ~NW view of SW corner of the North Dam. Taken before GCL patches place around the fillet expansion at 0+60 to 0+70.

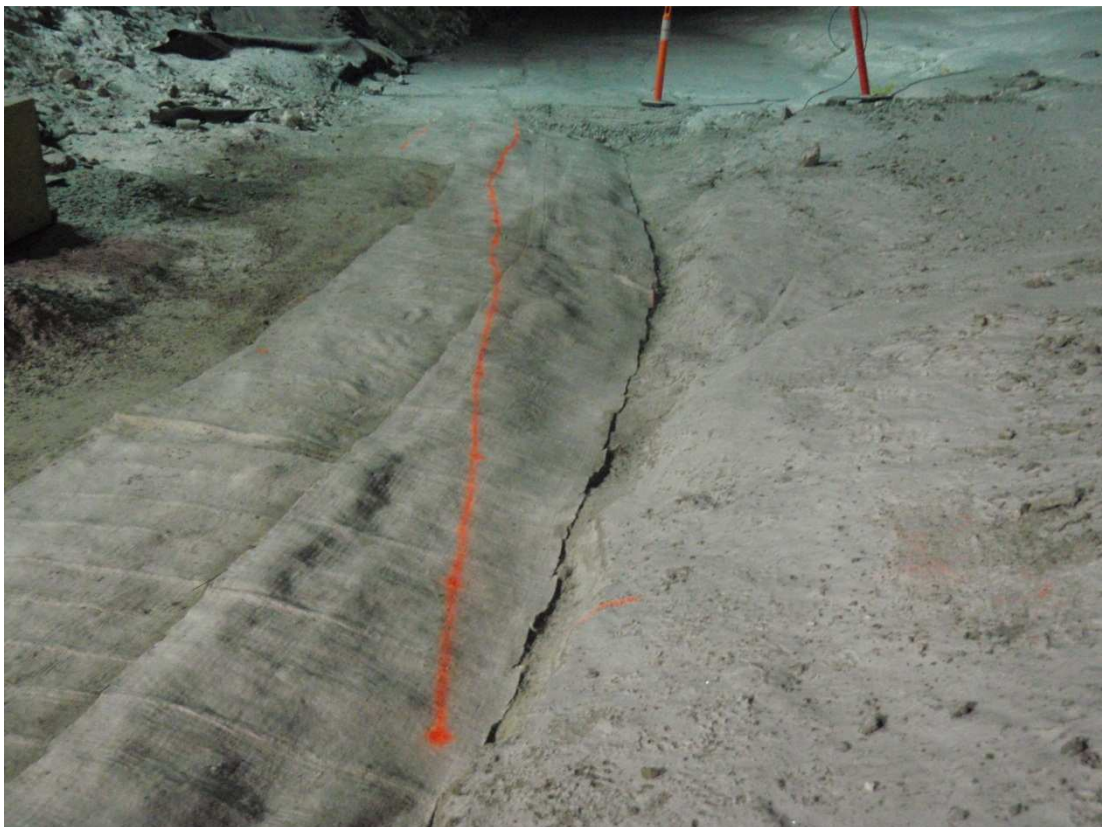
- Hording and heating with frost fighters continued over the GCL around station 0+70 to 0+85 areas.
- From ~ 0+60 to 0+70 the GCL by the hinge of the fillet expansion was cleaned (i.e. the small exposed portion of the slope before the horizontal fort part of the core). GCL patches were placed in this section in areas where the liner had been previously ripped or damaged. Powder bentonite beads were placed around the edges, as appropriate / needed.

**Photo 16:** ~WSW view of GCL repairs around the fillet expansion at station 0+60 to 0+70.

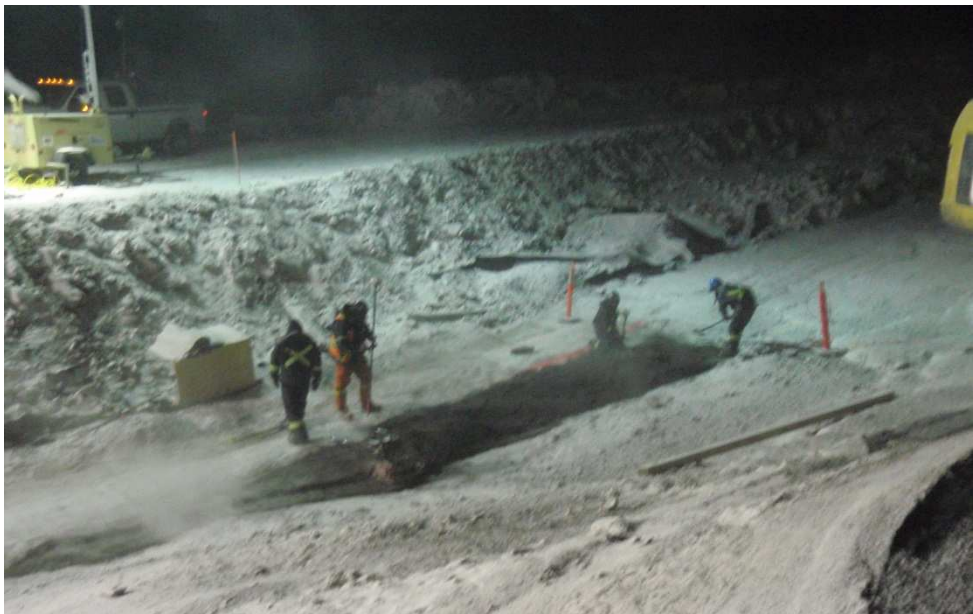
- FCM was placed at the area where GCL was repaired around the hinge of the fillet expansion at 0+60 to 0+70. The 330 excavator moved some material to the toe of the existing slope in this area. This FCM was then spread with shovels and rakes and was packed with the plate tamper. See Photo 16 and 17 for additional details of this area.

**Photo 17:** Placing and spreading FCM by hand around the fillet expansion at station 0+60 to 0+70, ~ SW view.

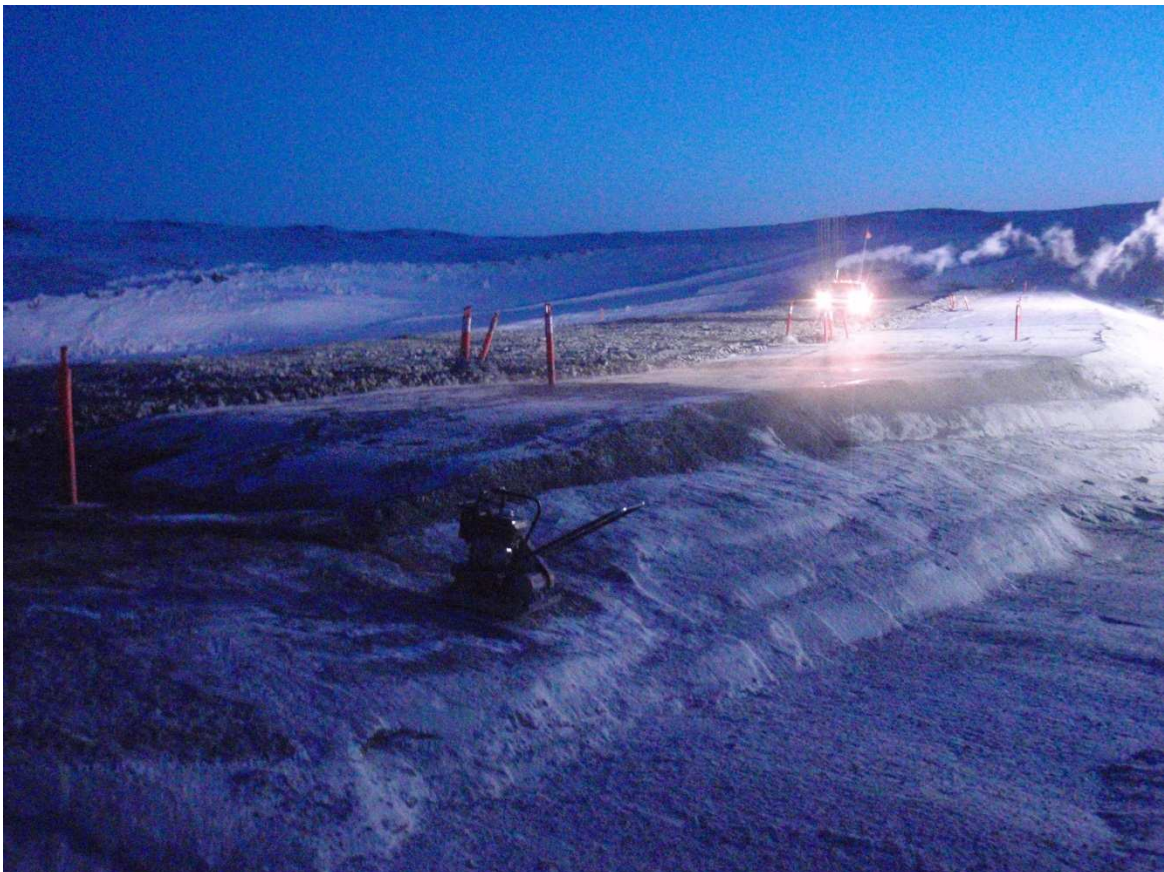
- Material was placed on the top of the dam areas from ~ 0+70 to 0+47. One small bench was filled in this SW area. The upstream side of the lift was unable to be pack by the 10 ton packer, due to the neighbouring slope drop, so the hand tamper was used to achieve compaction.

**Photo 20:** ~N view of core placement around station 0+47 to 0+65. Note plate tamper in foreground that was used to pack the upstream edge.
