DAILY REPORT #65 – DORIS NORTH INFRASTRUCTURE/ NORTH DAM

Prepared by:	John Kurylo Lawrence Borowski	Date:	2012.03.10		
Reviewed by:		Project #:	1CH008.058.0320		
Role	Company	Personnel – Position	On Site		
Client	Hope Bay Mining Limited (HBML)	Angela Holzapfel – ESR Compliance Manager	No		
		David Vokey – ESR Coordinator	Yes		
		Don Ethelston – HSLP Advisor	No		
		Dean Wold - Safety	Yes		
		Jill Turk – ESR Coordinator	No		
		Katsky Venter – ESR Manger	No		
		Michelle Tanquay – ESR Site Manager	Yes		
		Stirling Kelly – HSLP Advisor	Yes		
	JDS	Lloyd Jackson – Mechanical Superintendent	No		
		Doug Fielding – Construction Manager	No		
		Ishan Fechter – Construction Coordinator	Yes		
		Jerry Graham – Construction Manager	Yes		
		Kevin Whieldon – Project Coordinator	No		
		Mark Valeriote – Construction Manager	Yes		
Engineering Design Consultants	SRK Consulting (Canada) Inc.	John Kurylo – Site Engineer	Yes		
		Megan Miller – Site Engineer	No		
		Lawrence Borowski – Site Engineer	Yes

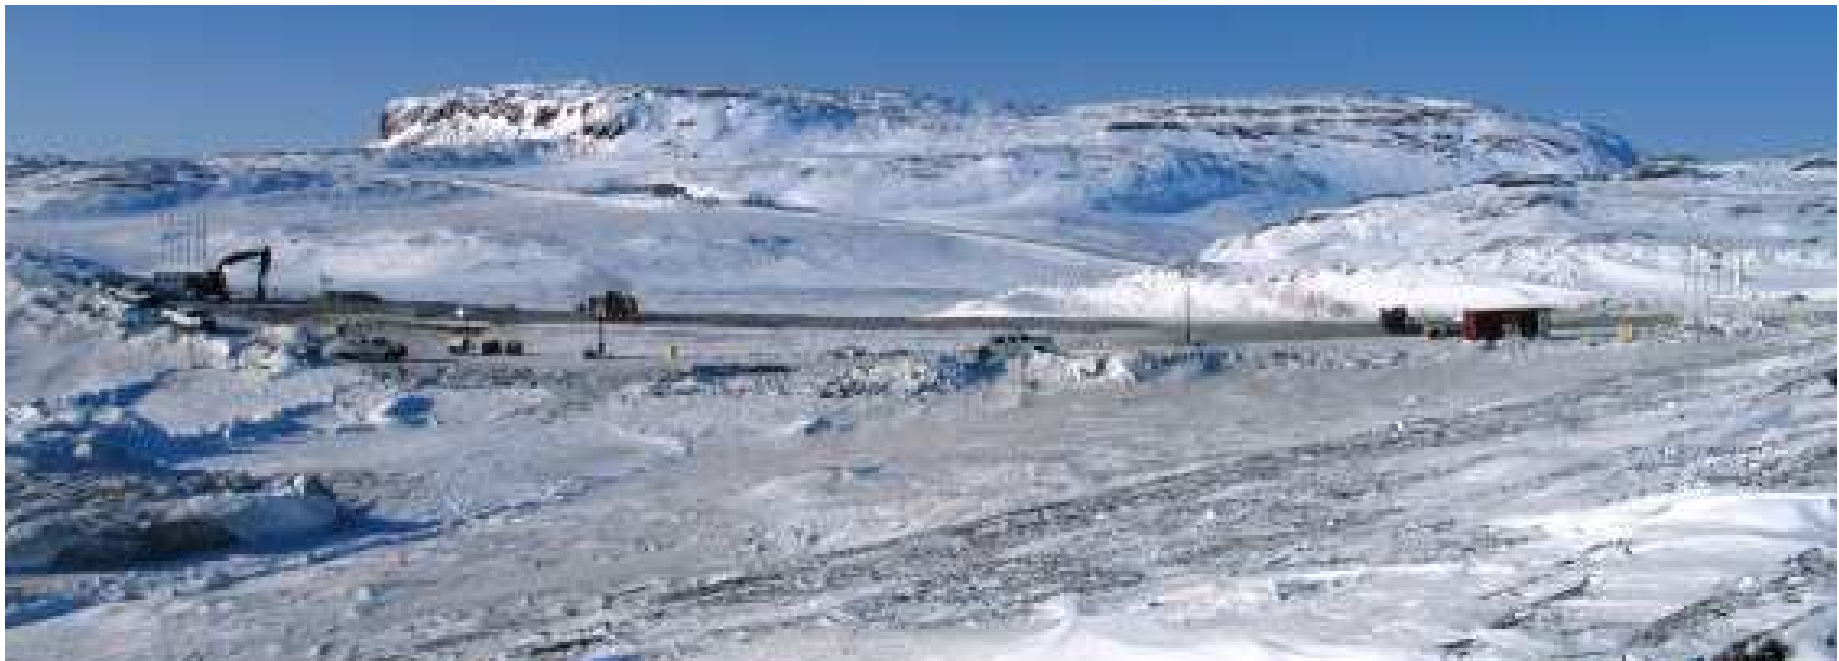
Photo 1: Progress photo from photo point 2, facing NNW

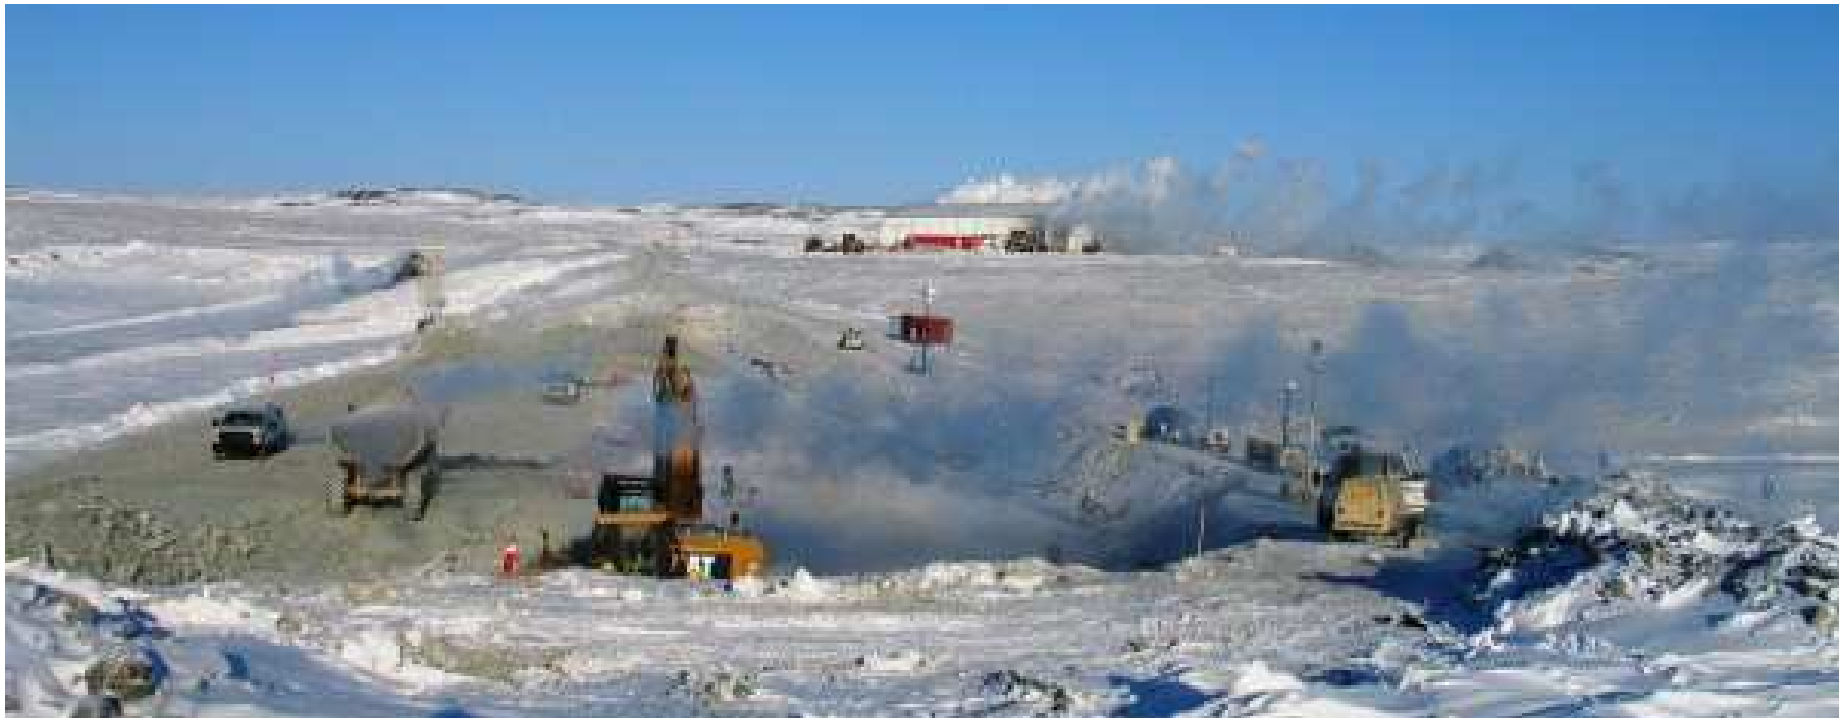
Photo 2: Progress photo from point 3 , facing NNE

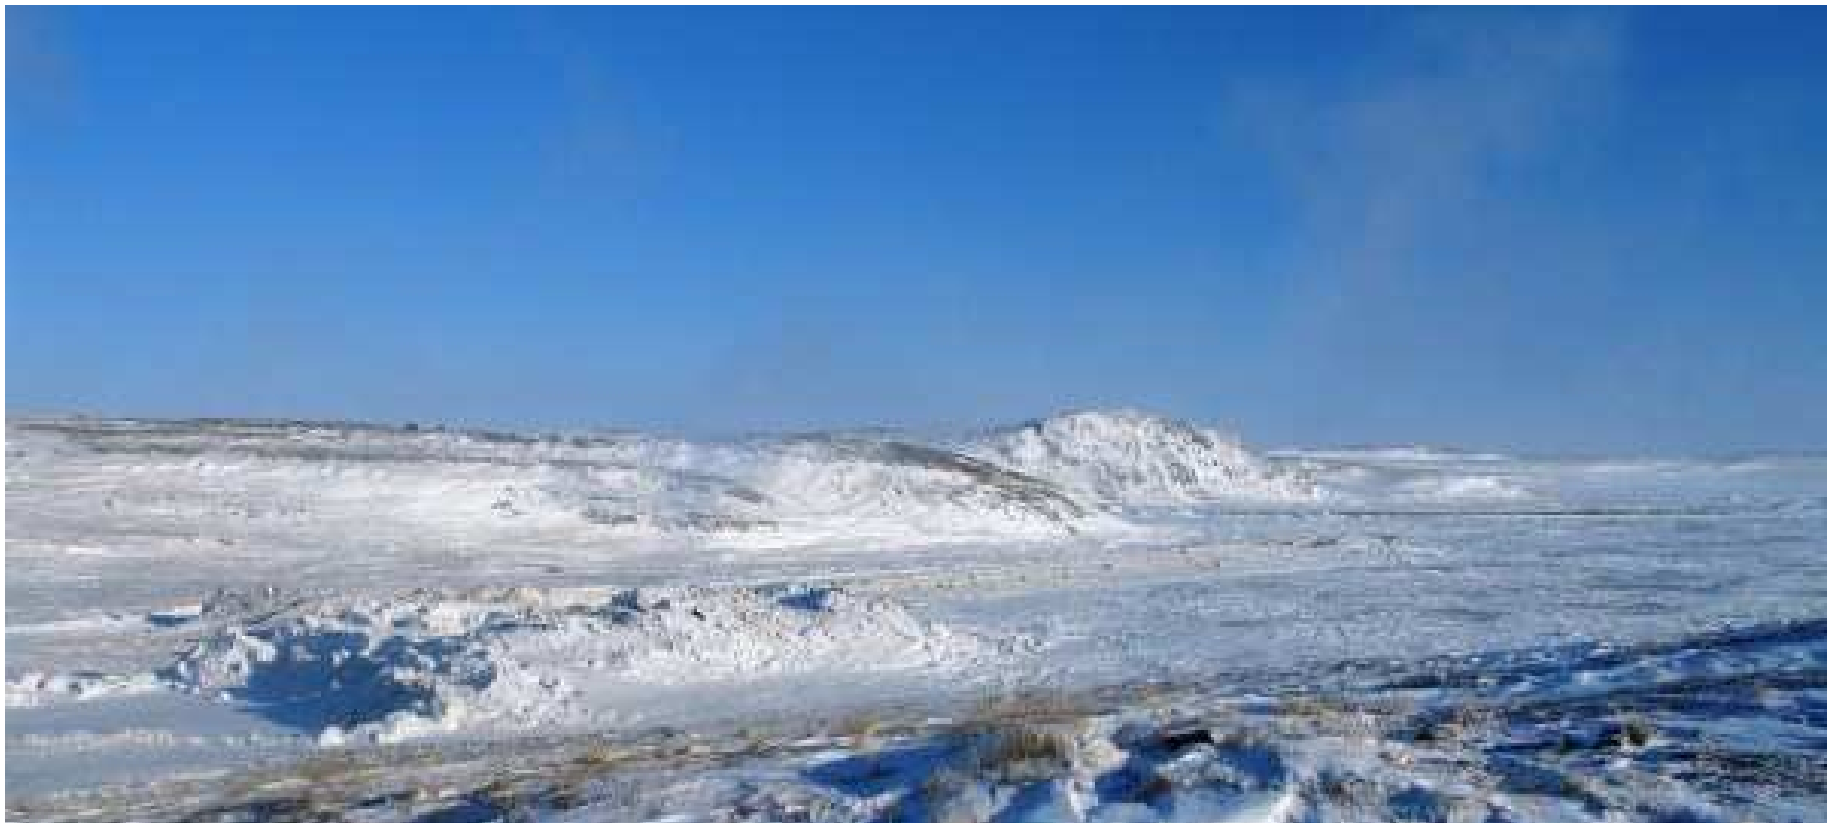
Photo 3: Snow dump at Tail Lake. Nuna has started spreading the snow.

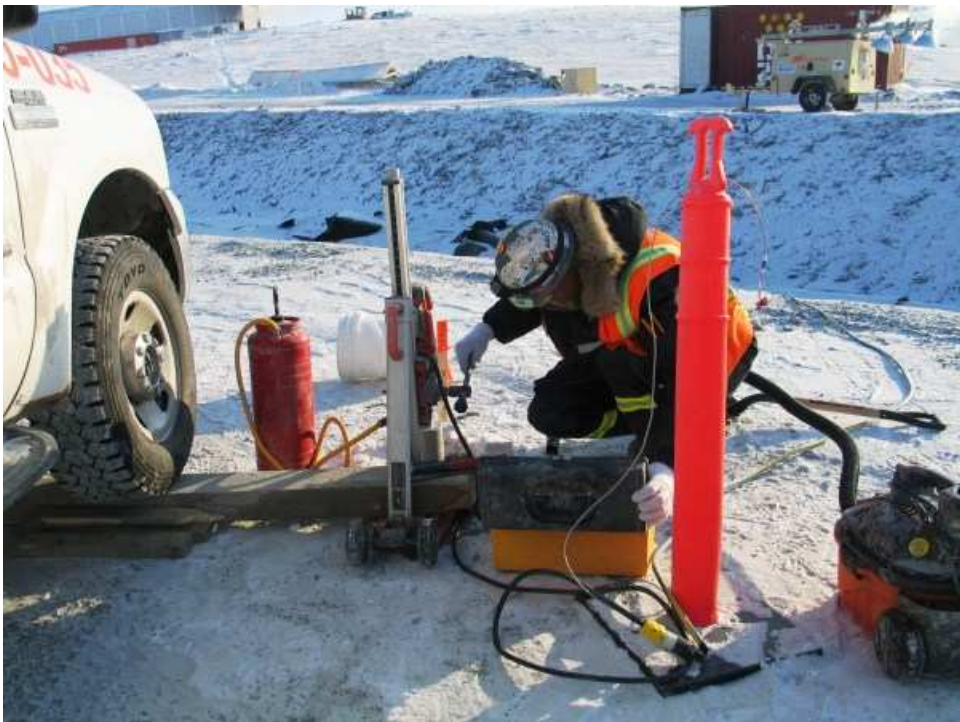
Photo 4: Coring previously placed FCM

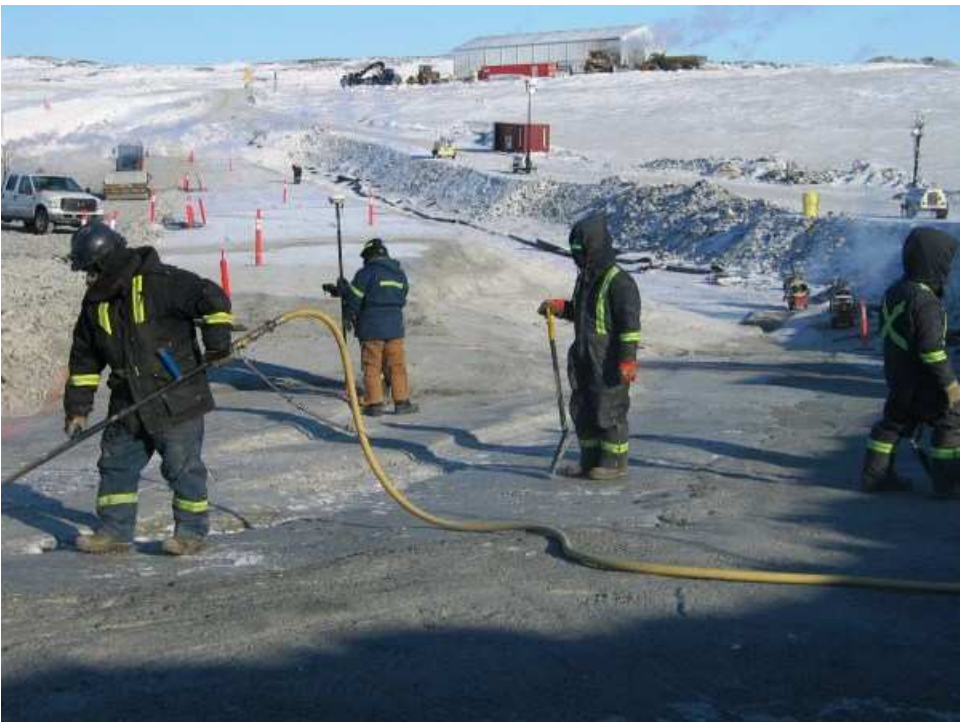
Photo 5: Preparing surfaces with compressed air.

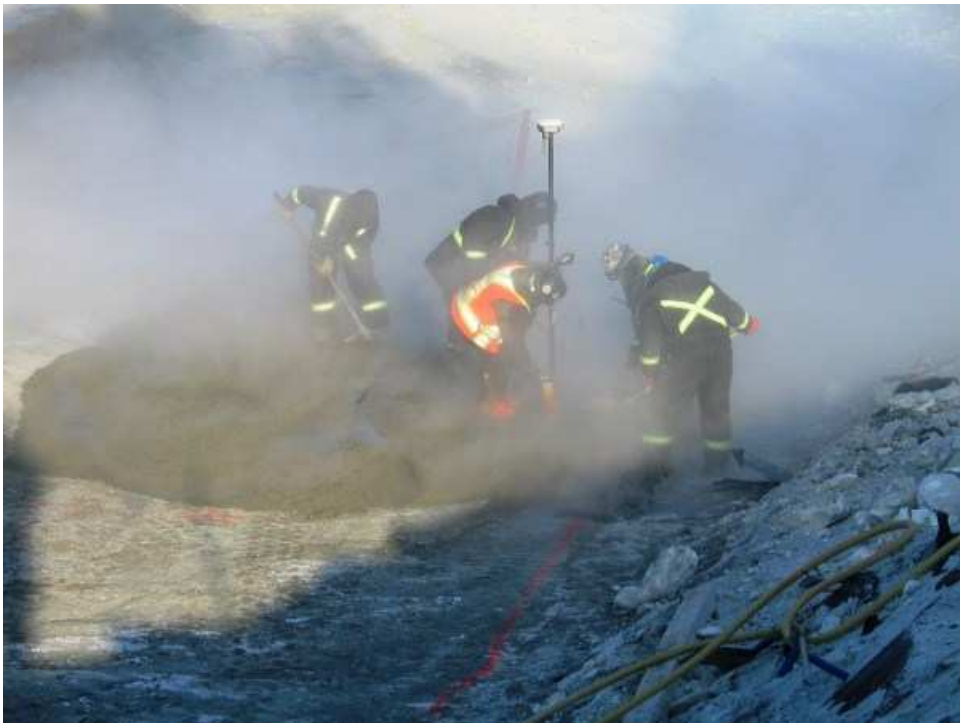
Photo 6: Survey control; workers raking slope. Steam on a very cold day

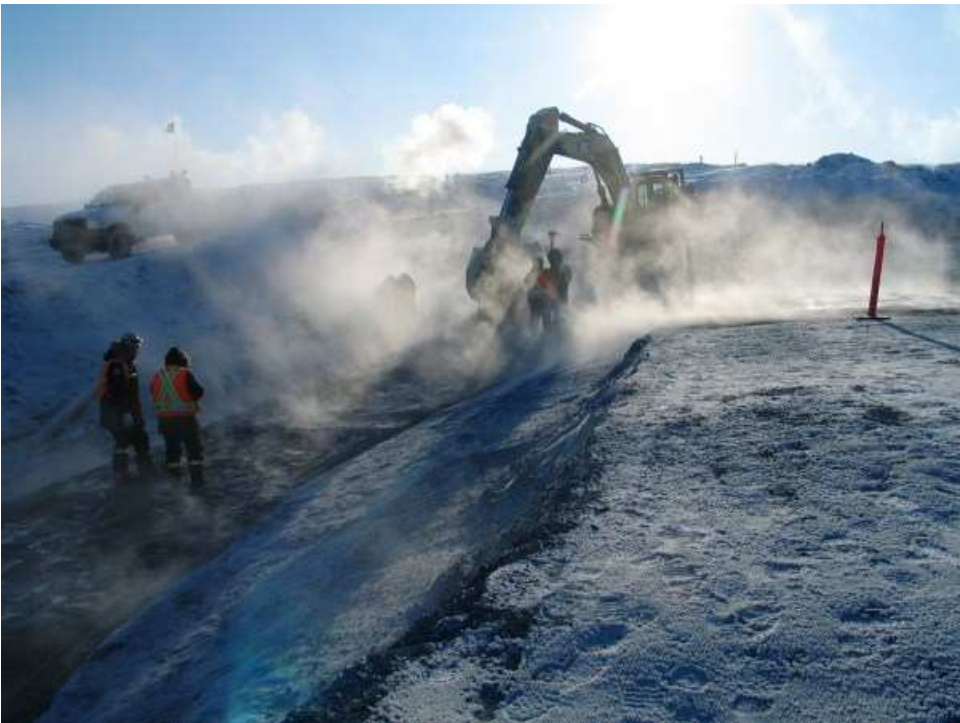
Photo 7: Placing FCM in the SE corner.

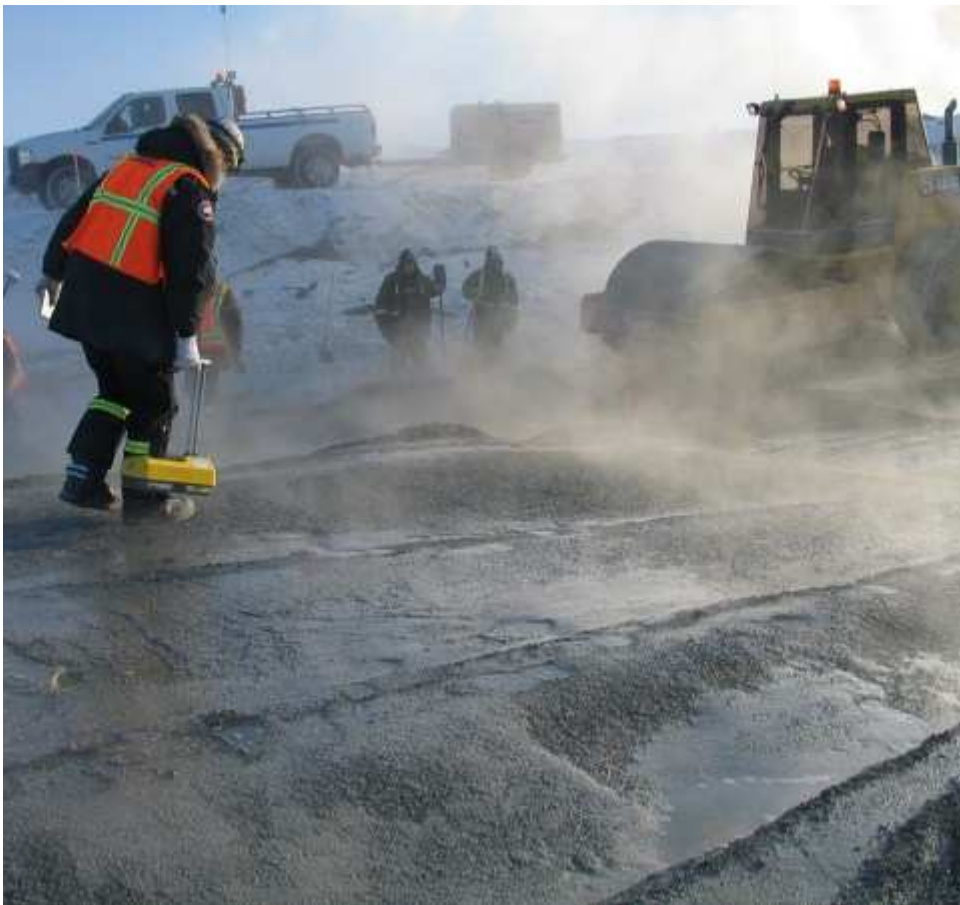
Photo 8: Preparing for density tests

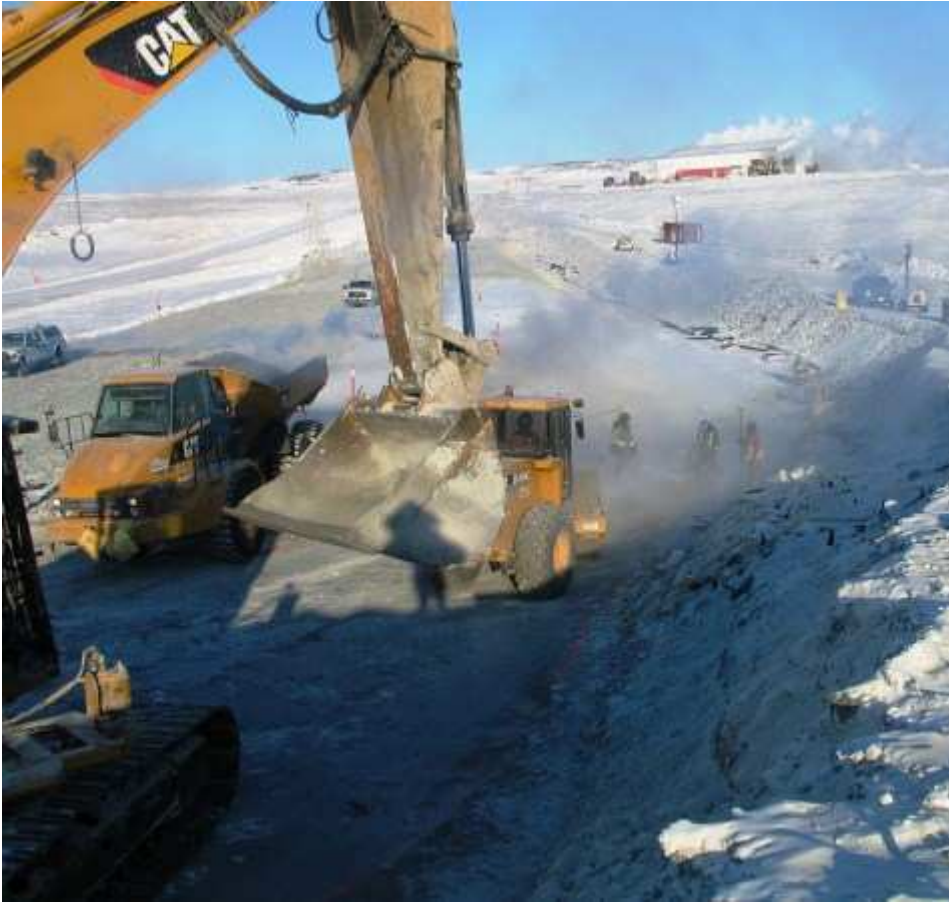
Photo 9: Congested work space.

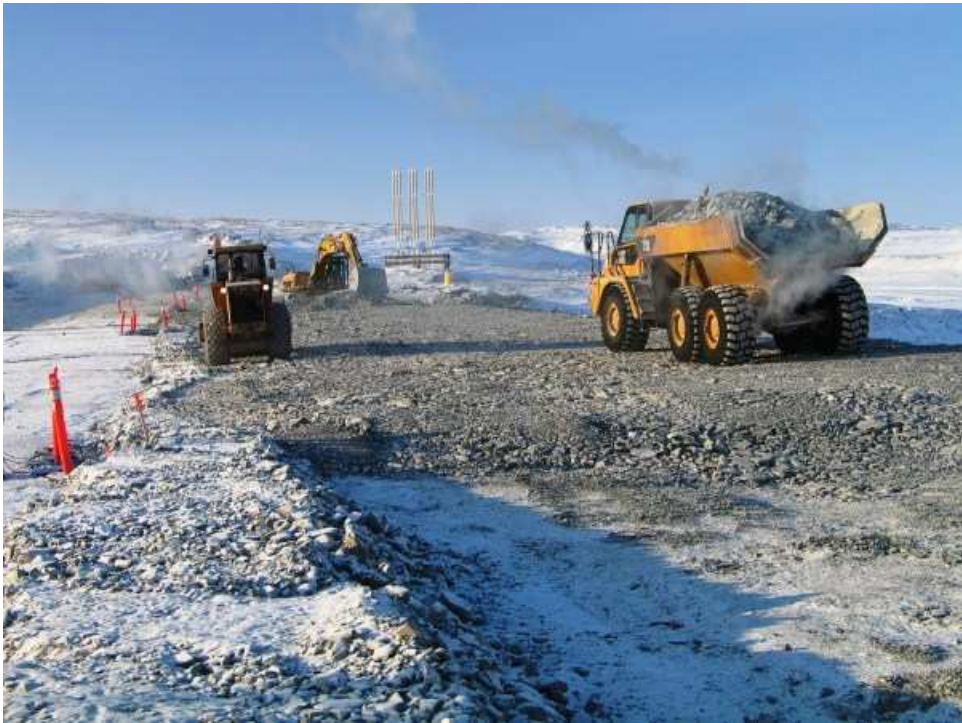
Photo 10: Placing ROQ on downstream side.

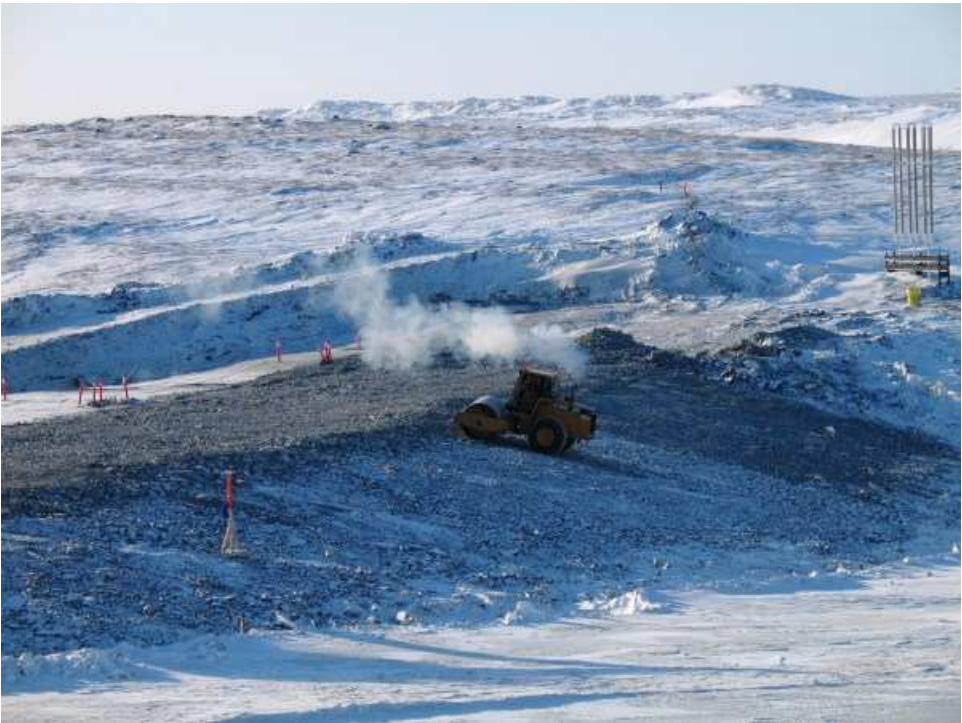
Photo 11: 10 ton packer working on sideslopes

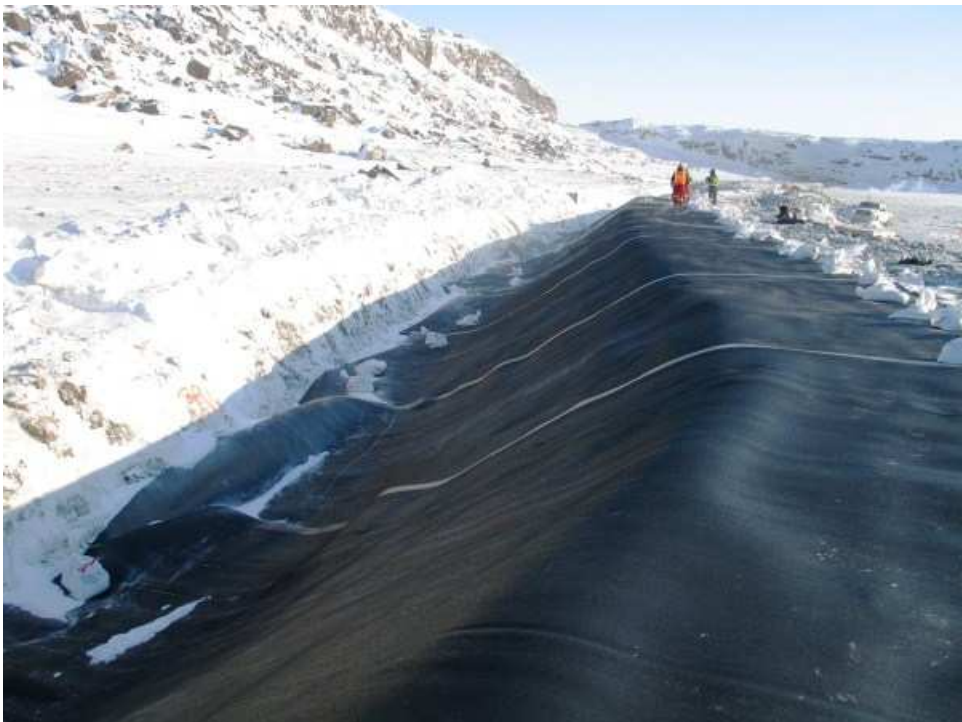
Photo 12: HDPE . Layfield in the background welding seams.

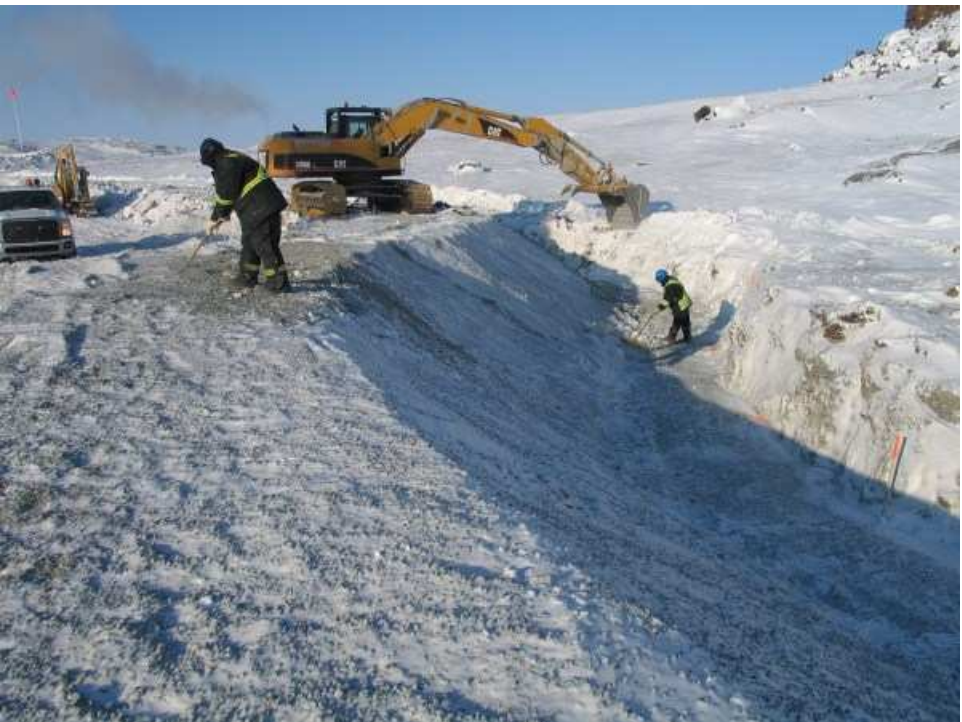
Photo 13: Snow clearing ~ Sta 350

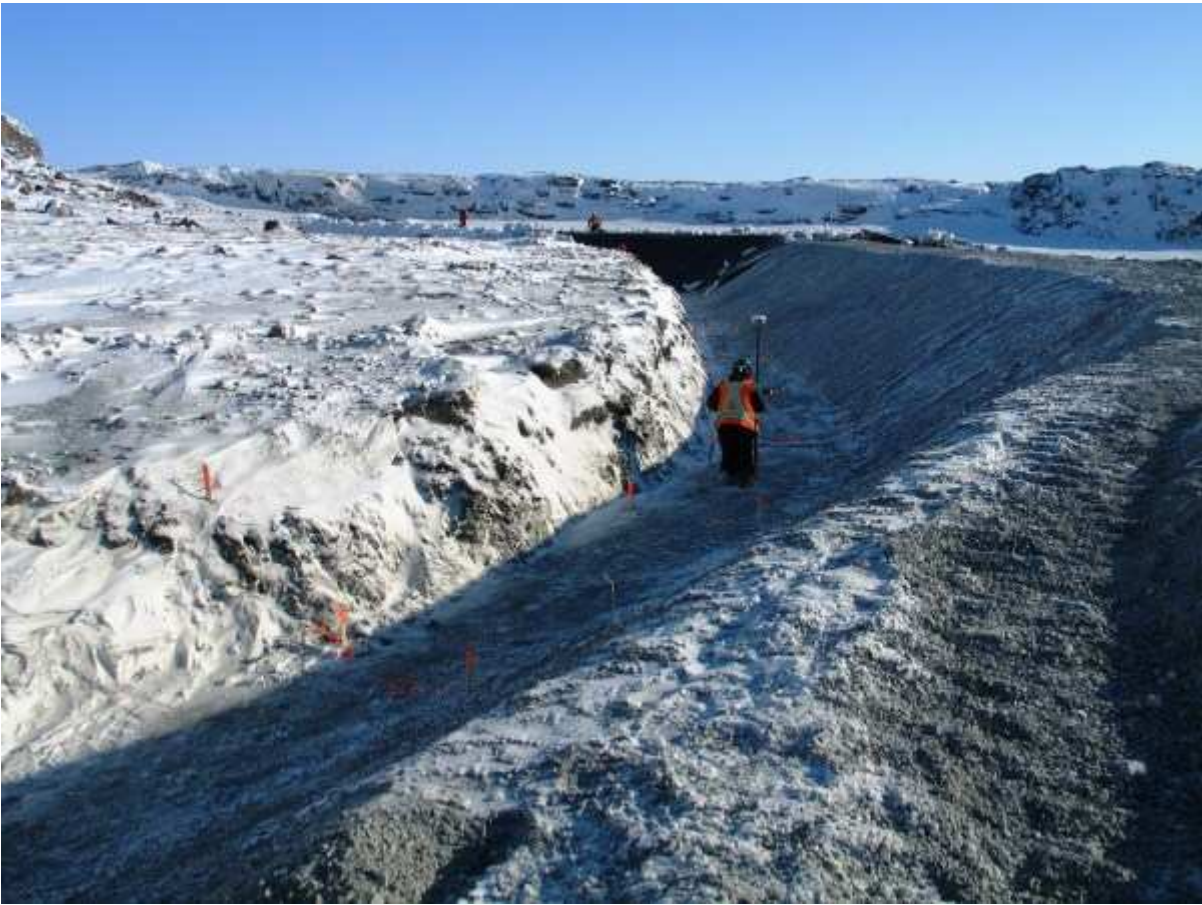
Photo 14: Surveying. Setting grades for bentonite

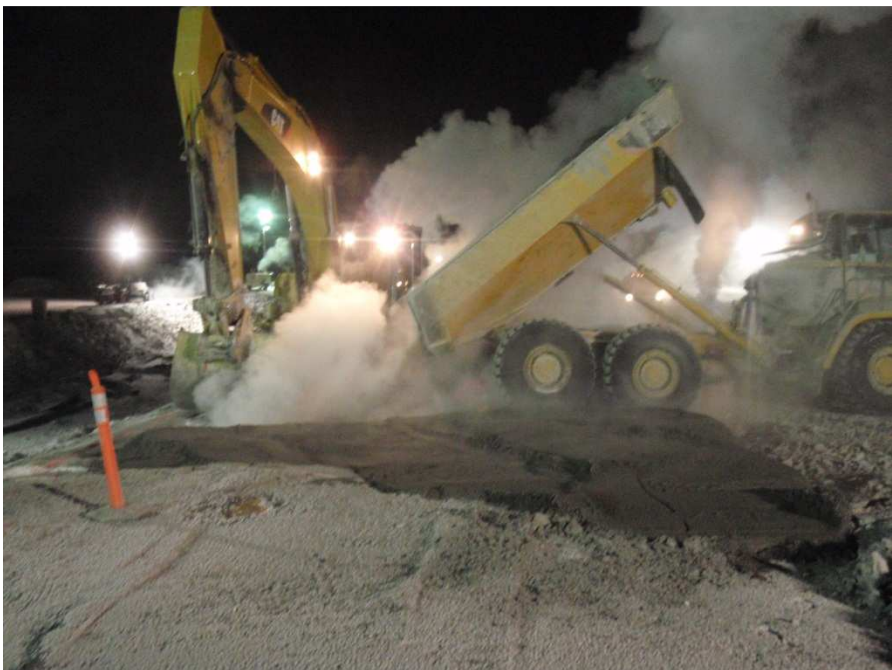
Photo 15: ~SSW view of start of nightshift FCM placement.

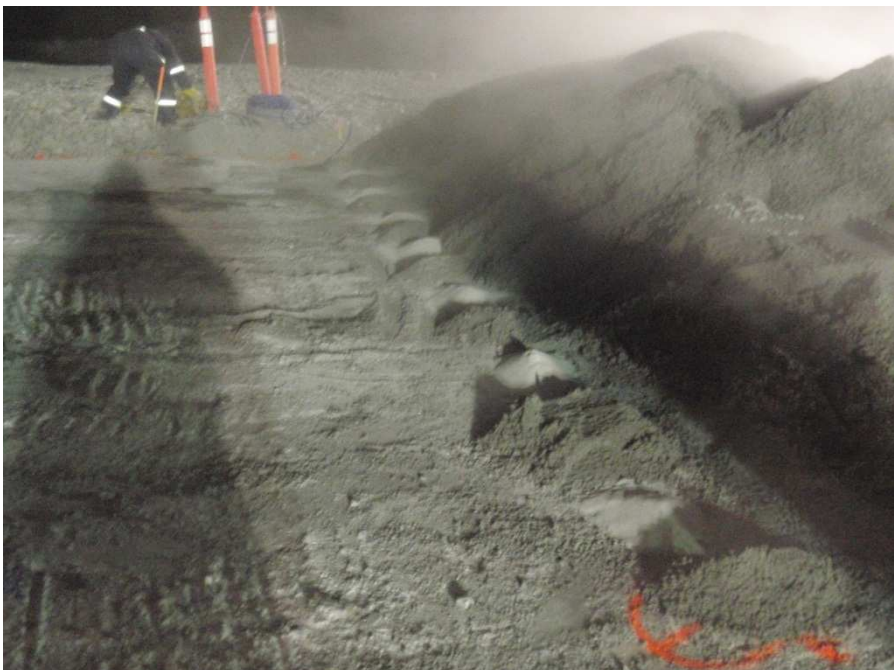
Photo 16: Multi bead thermistor strings installed at station 1+30 at elevation 33.5m today.

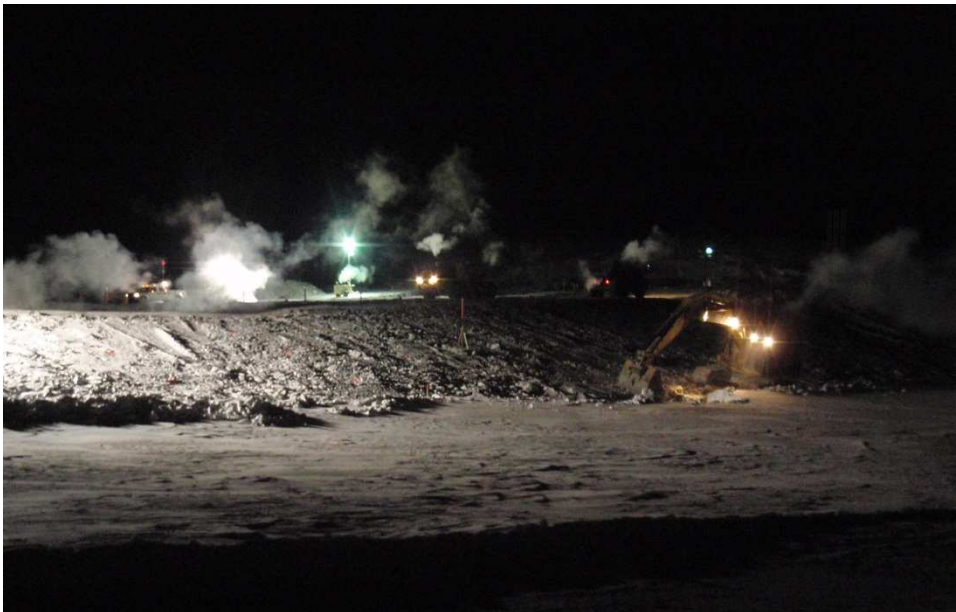
Photo 17: 330 Excavator placing ROA and shaping 4H:1V downstream slope.

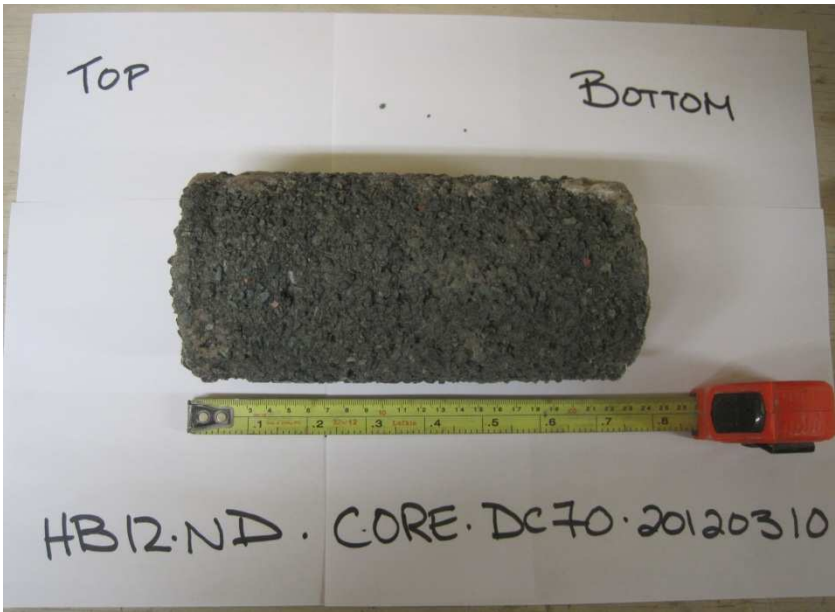
Photo 18: HB12-ND-CORE-DC70-20120310 drilled on dayshift.

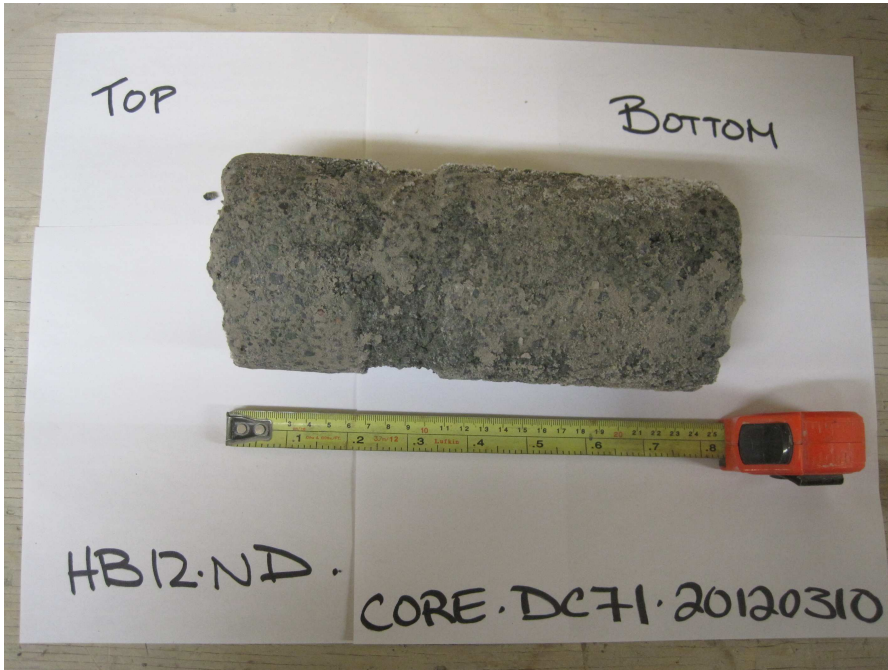
Photo 19: HB12-ND-CORE-DC71-20120310 drilled on dayshift around the time of freeze back in area.

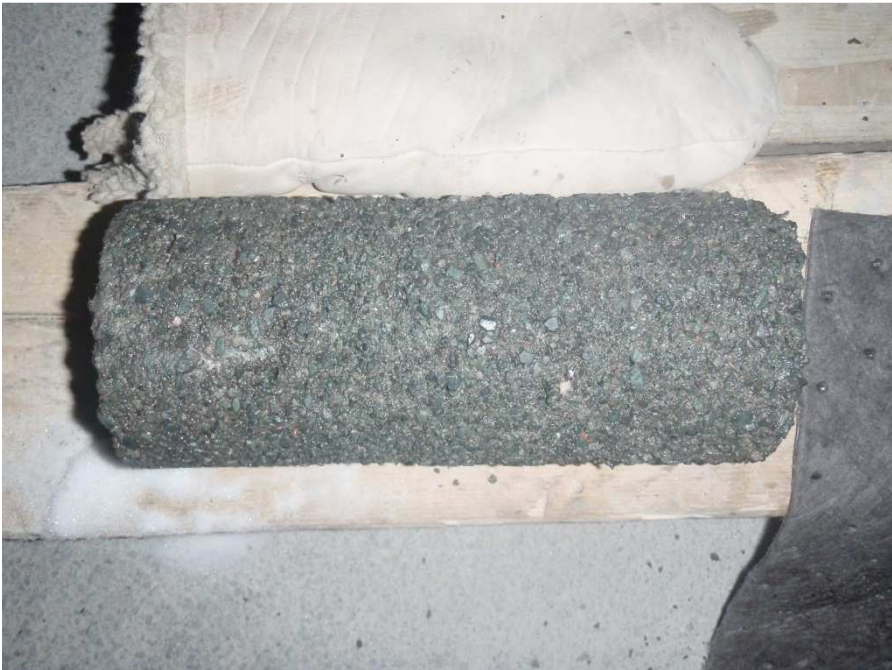
Photo 20: HB12-ND-CORE-DC72-20120310 drilled on Nightshift around 0+90 CL, immediately after freeze back in this area.
