DAILY REPORT #66 – DORIS NORTH INFRASTRUCTURE/ NORTH DAM

Prepared by:	John Kurylo Lawrence Borowski	Date:	2012.03.11		
Reviewed by:		Project #:	1CH008.058.0320		
Role	Company	Personnel – Position	On Site		
Client	Hope Bay Mining Limited (HBML)	Angela Holzapfel – ESR Compliance Manager	No		
		David Vokey – ESR Coordinator	Yes		
		Don Ethelston – HSLP Advisor	No		
		Dean Wold - Safety	Yes		
		Jill Turk – ESR Coordinator	No		
		Katsky Venter – ESR Manger	No		
		Michelle Tanquay – ESR Site Manager	Yes		
		Stirling Kelly – HSLP Advisor	Yes		
	JDS	Lloyd Jackson – Mechanical Superintendent	No		
		Doug Fielding – Construction Manager	No		
		Ishan Fechter – Construction Coordinator	Yes		
		Jerry Graham – Construction Manager	Yes		
		Kevin Whieldon – Project Coordinator	No		
		Mark Valeriote – Construction Manager	Yes		
Engineering Design Consultants	SRK Consulting (Canada) Inc.	John Kurylo – Site Engineer	Yes		
		Megan Miller – Site Engineer	No		
		Lawrence Borowski – Site Engineer	Yes

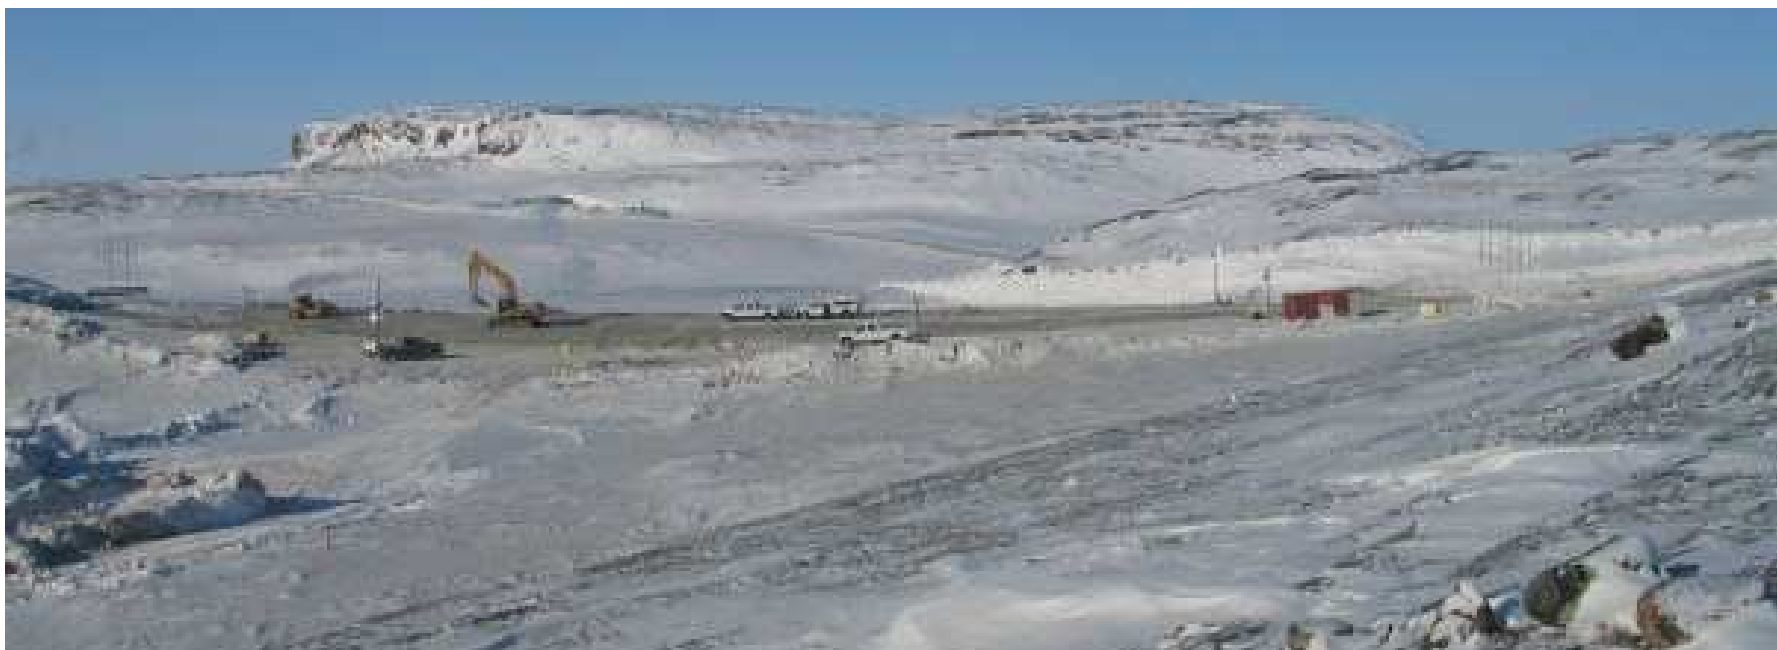
Photo 1: Progress photo from photo point 2, facing NNW

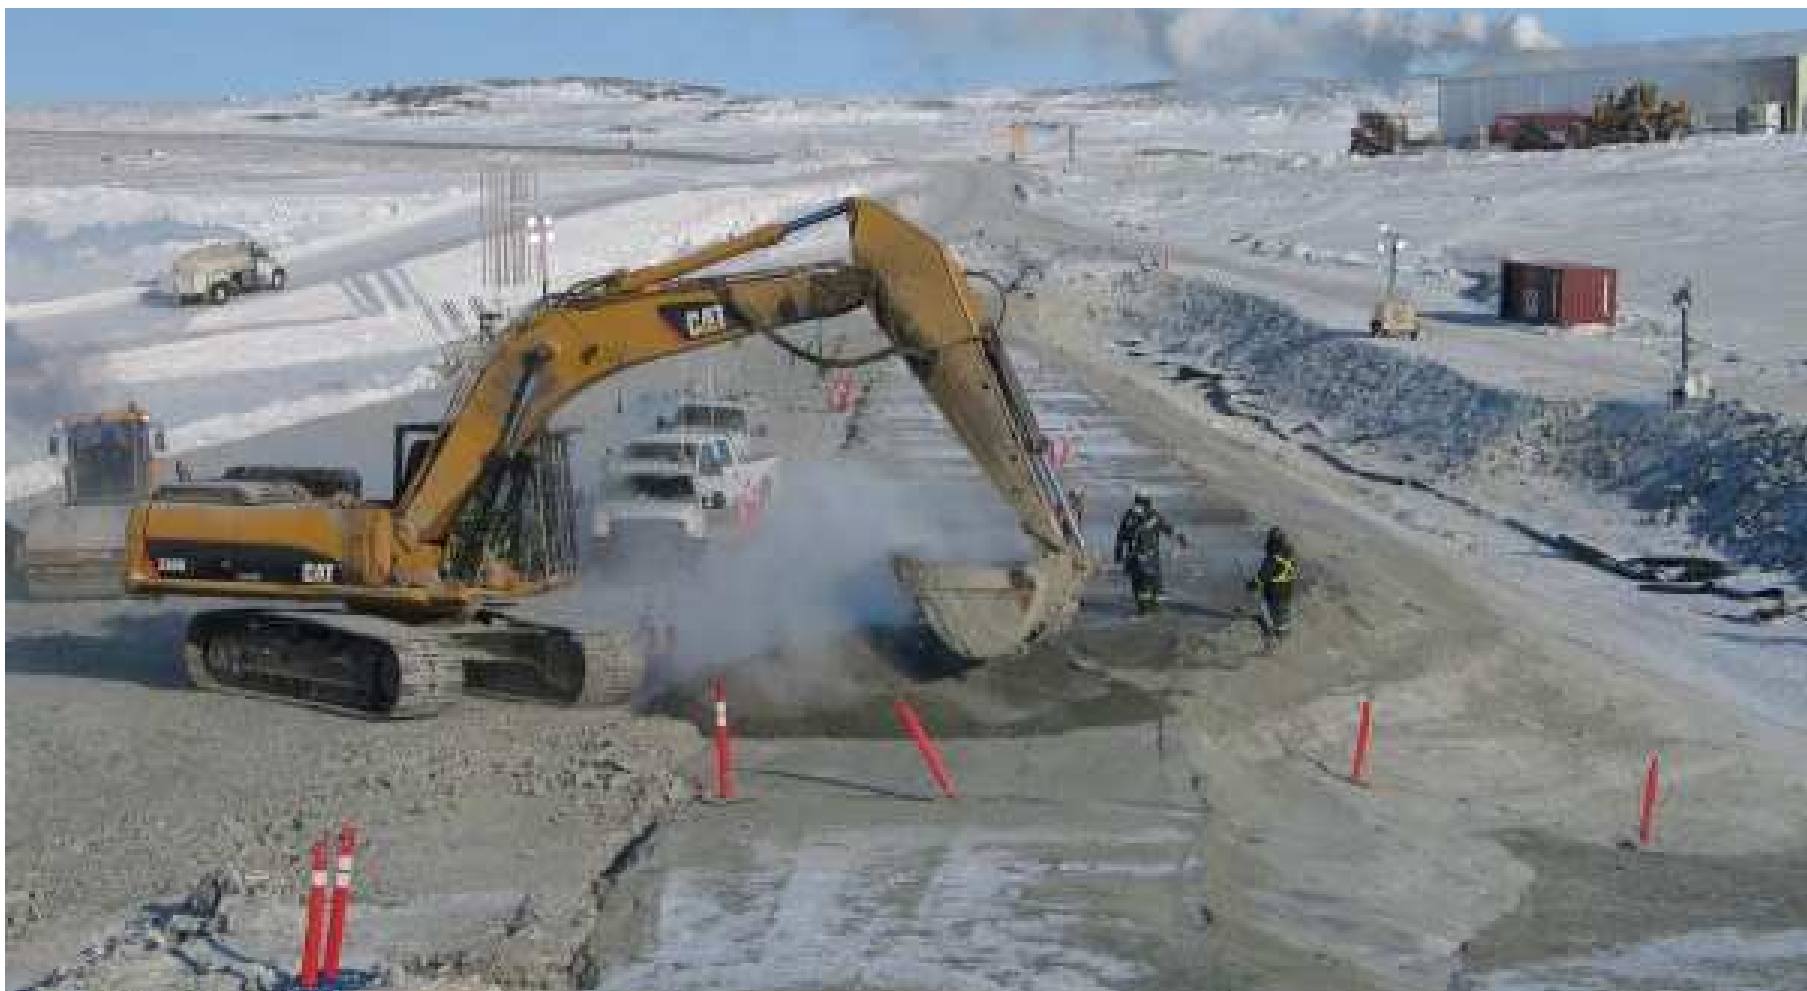
Photo 2: Progress photo from point 3 , facing NNE

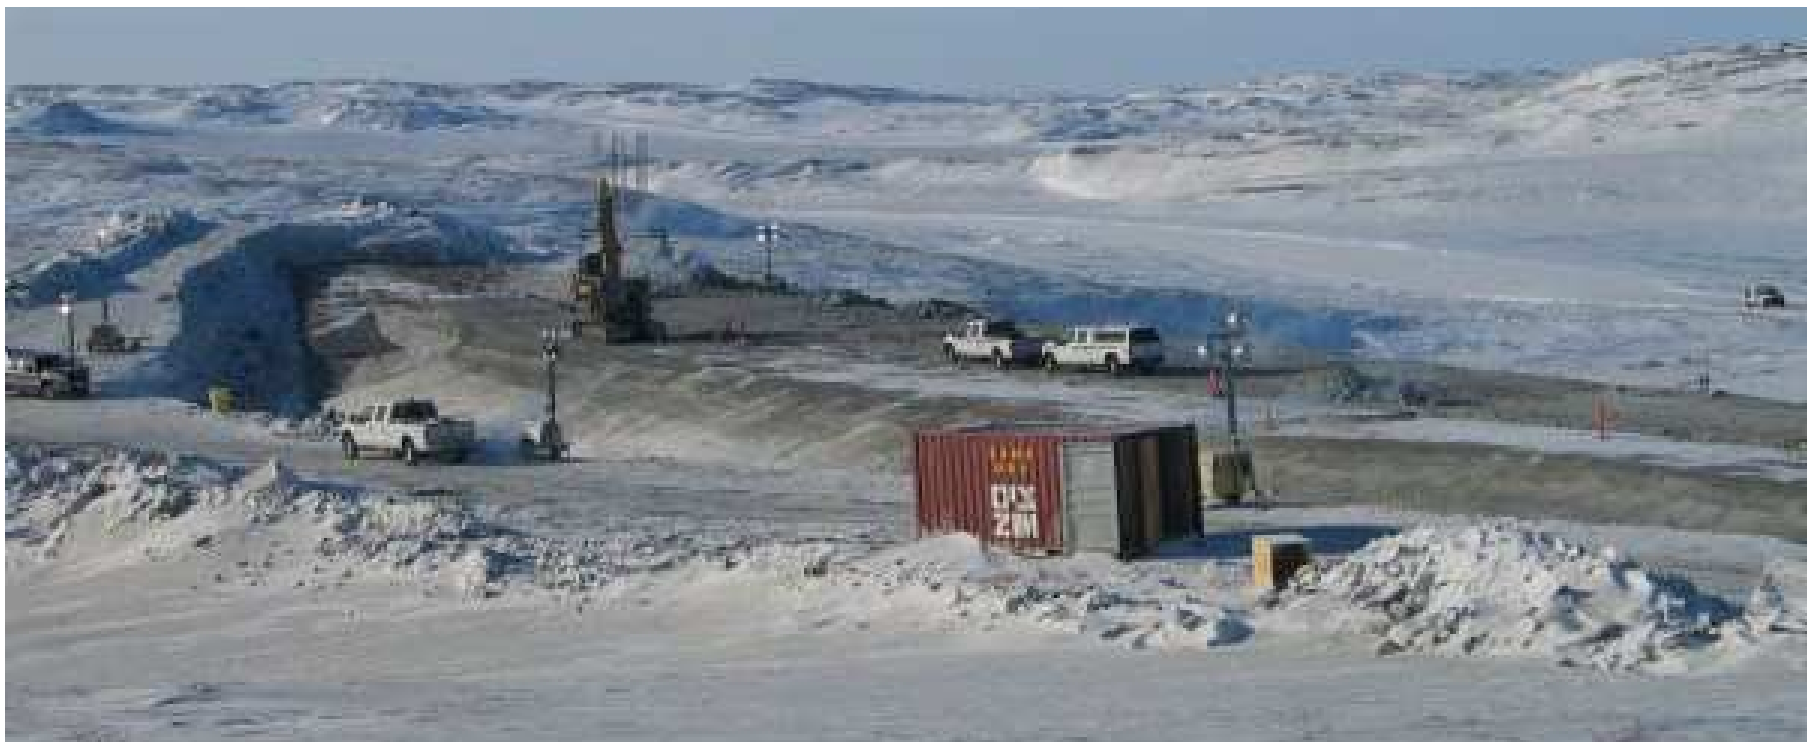
Photo 3: Progress photo showing east side of core.

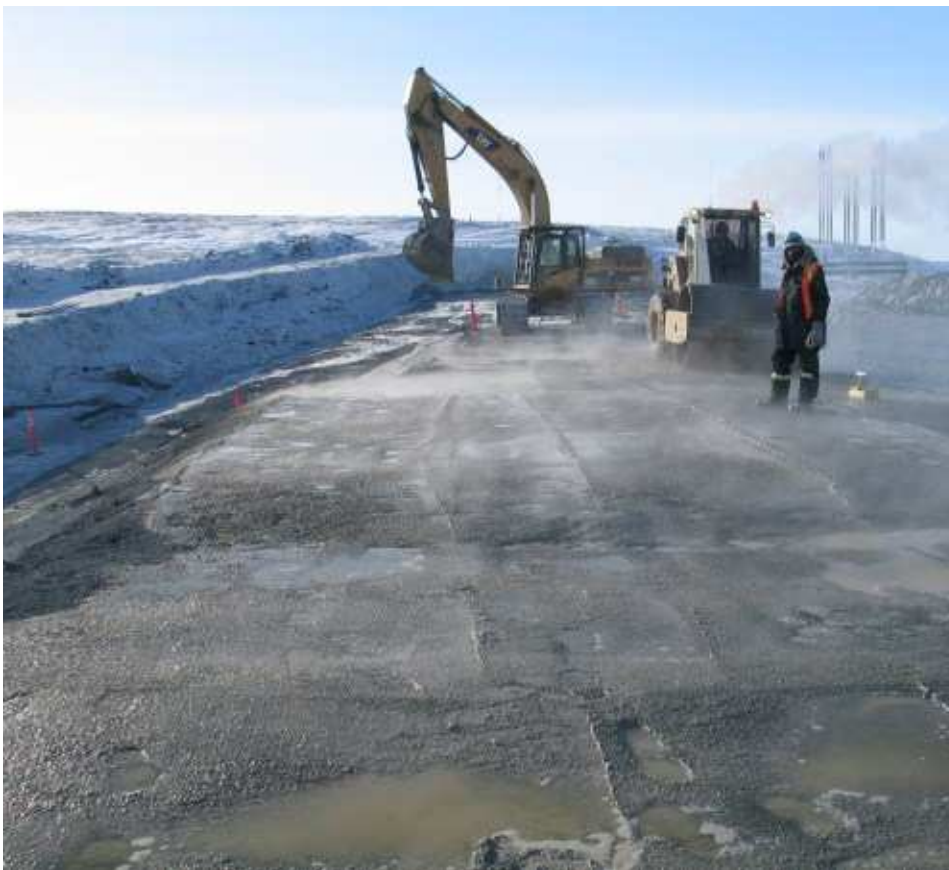
Photo 4: Placing FCM Sta 0+90 facing south

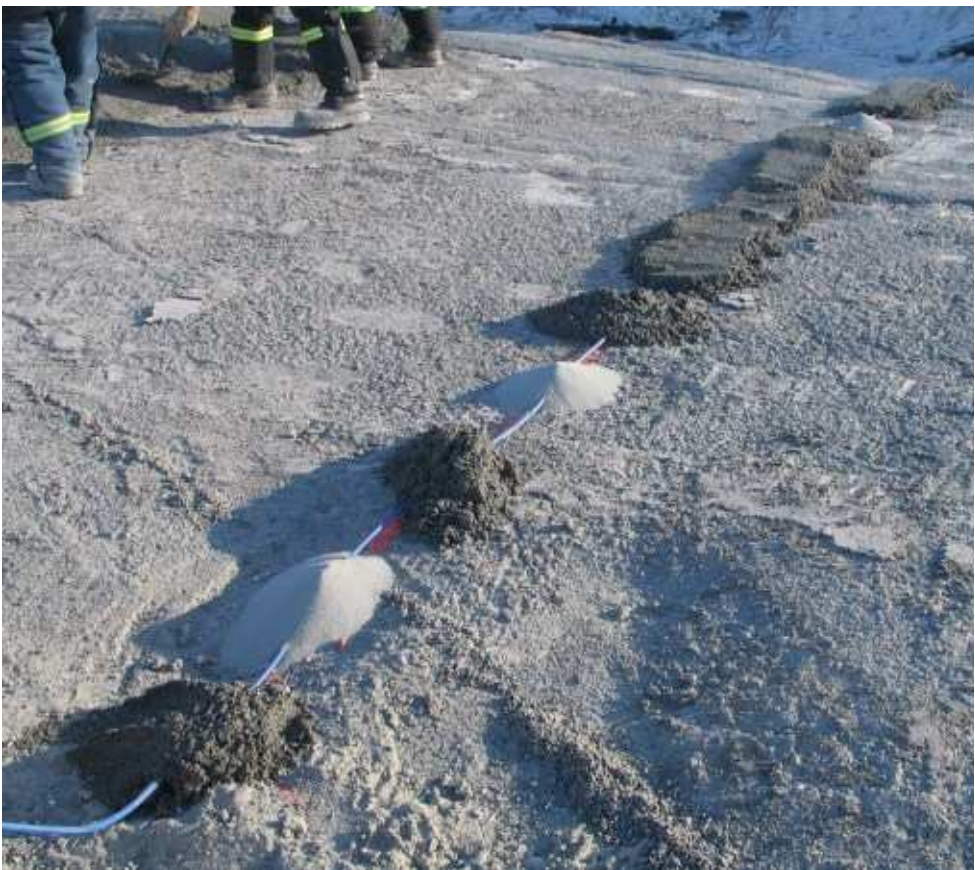
Photo 5: Bead ND-HTS-060-33.5 partially covered.

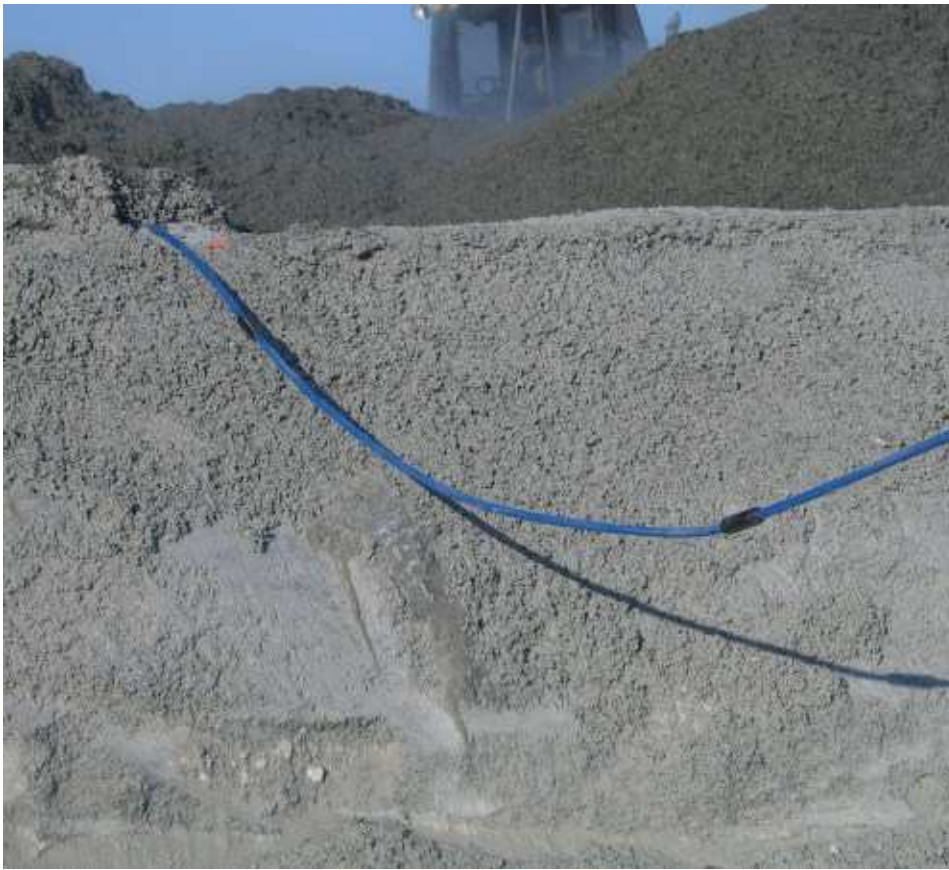
Photo 6: Bead suspended beyond the edge of FCM

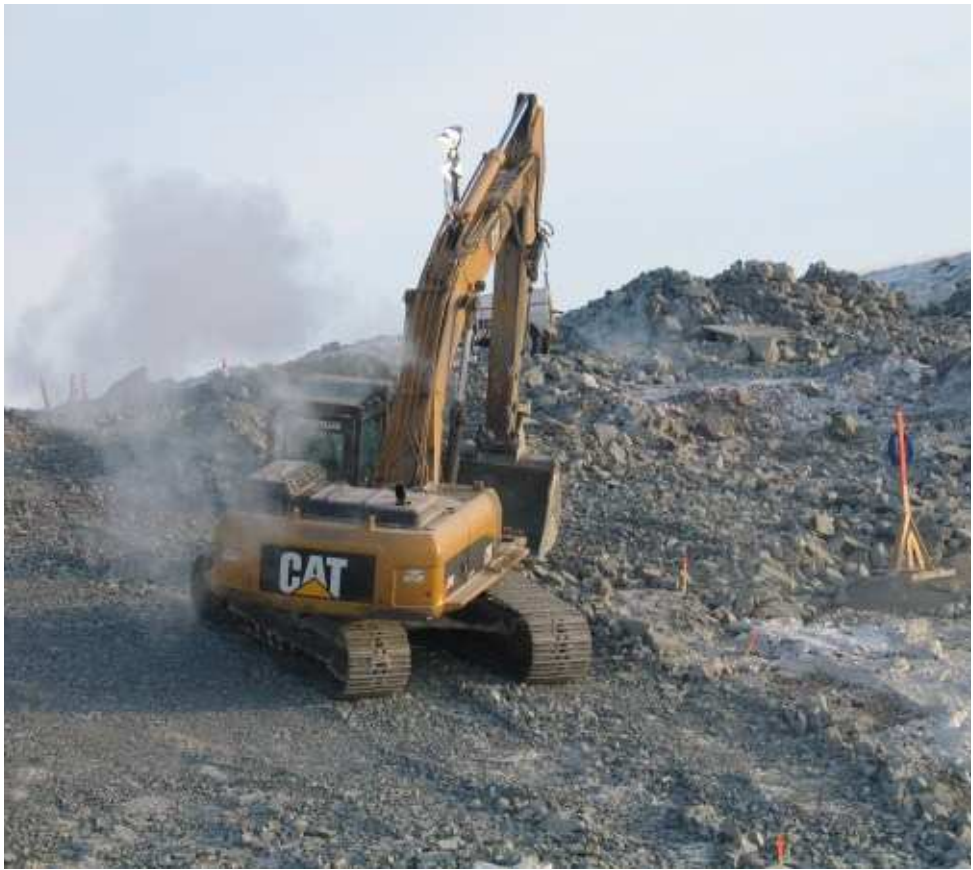
- The upstream slope continues to be sloped to 2.5H:1V grade as construction progresses. Due to access issues the Excavator spread the FCM but was unable to cut back the upstream slope to design limits. A notable about of hand shovelling and raking was required to cut back and smooth the slope. This was done under the guidance of Nuna survey.

Photo 7: Excavator backsloping at Stn 0+40

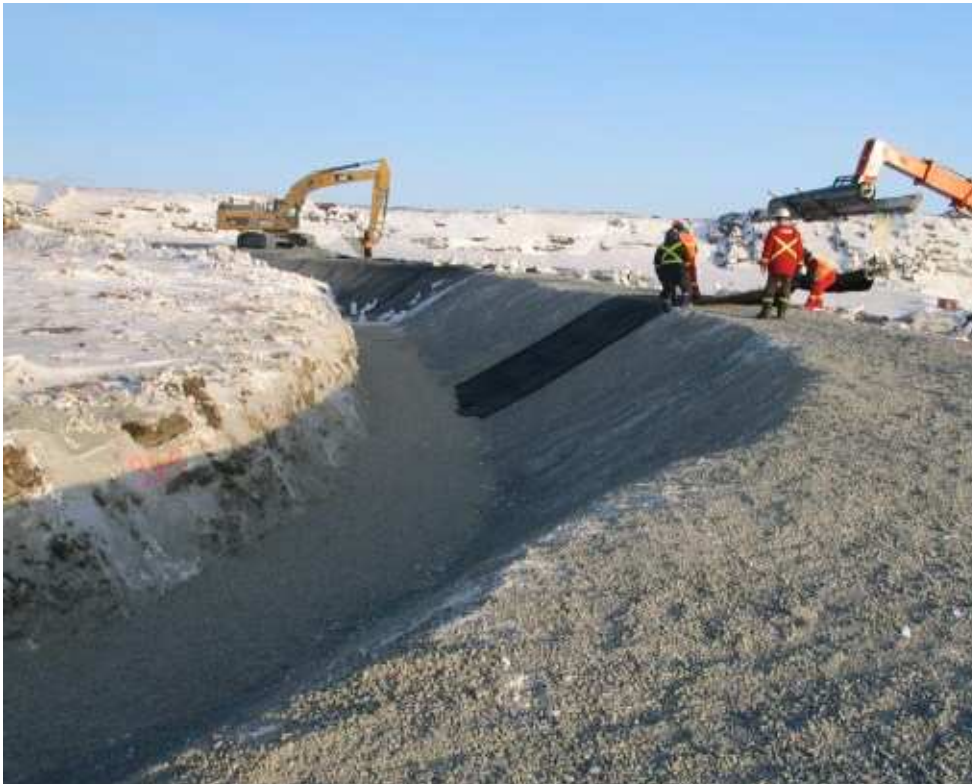
Photo 8: Layfield placing underliner from Sta 3+30 to Sta 3+80

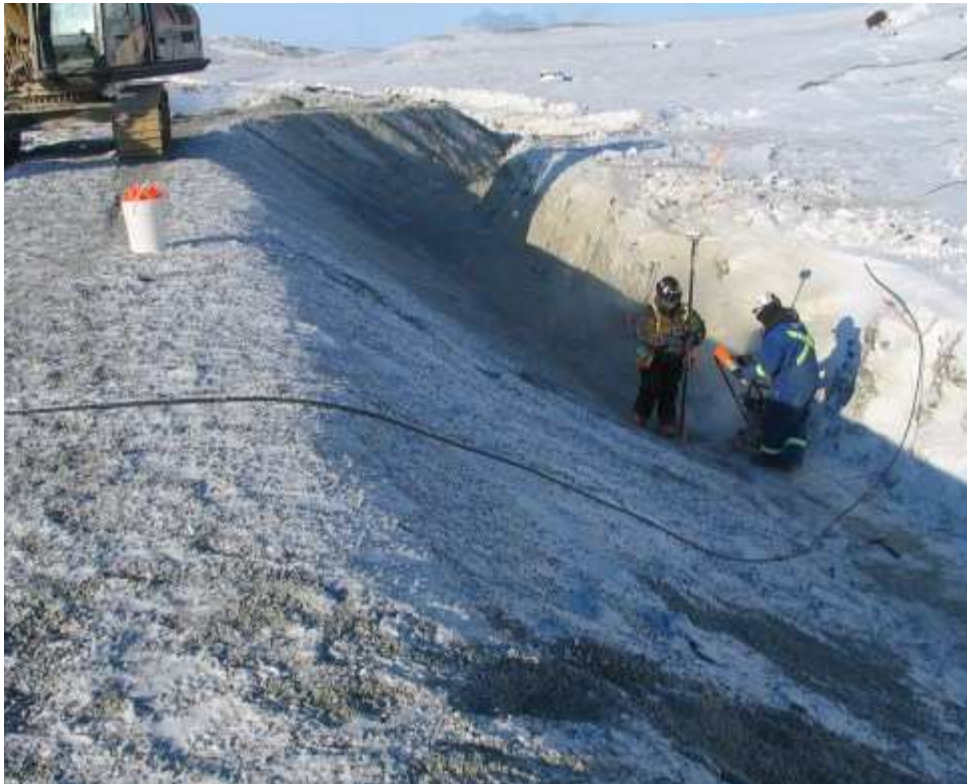
Photo 9: Surveying top of crush at Sta 3+30

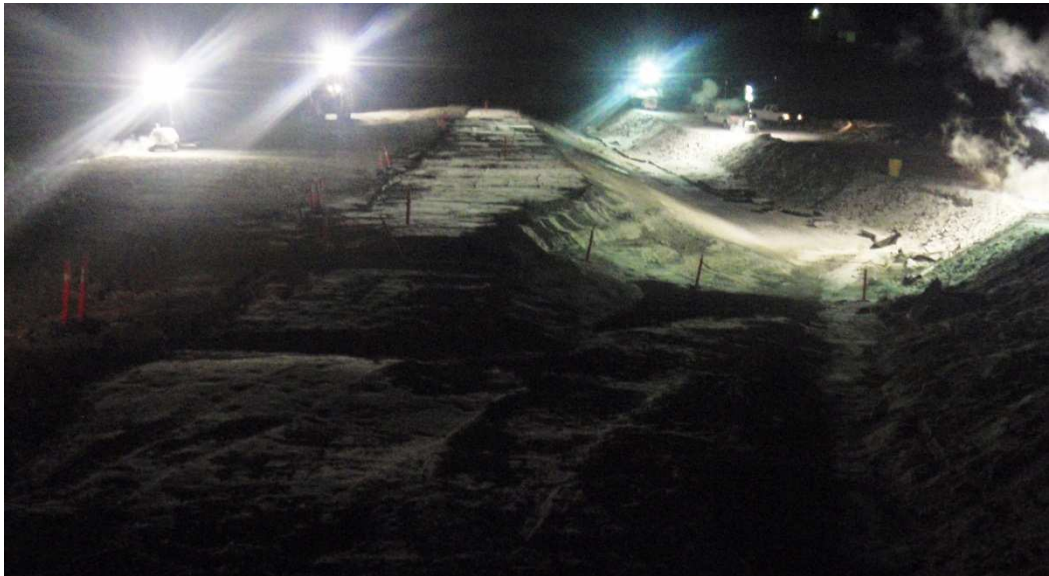
Photo 10: ~NE view down the Dam CL of construction progress

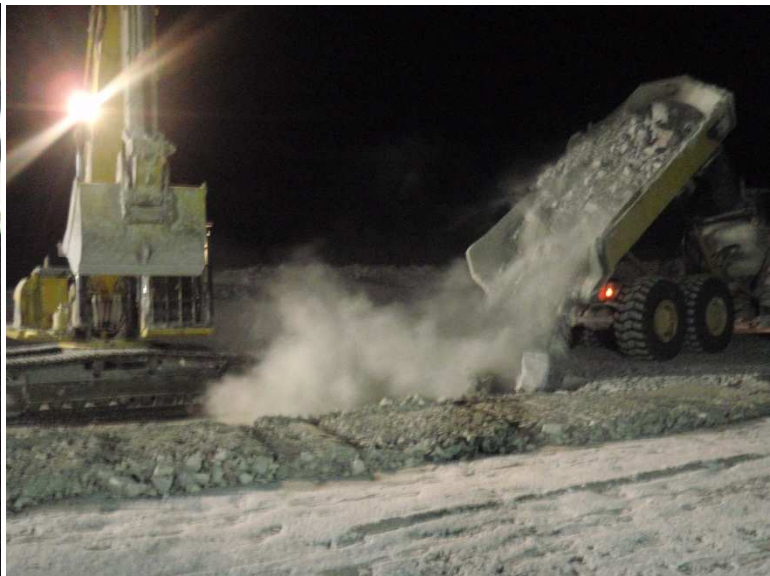
Photo 11: Excavator placing ROQ on downstream slope

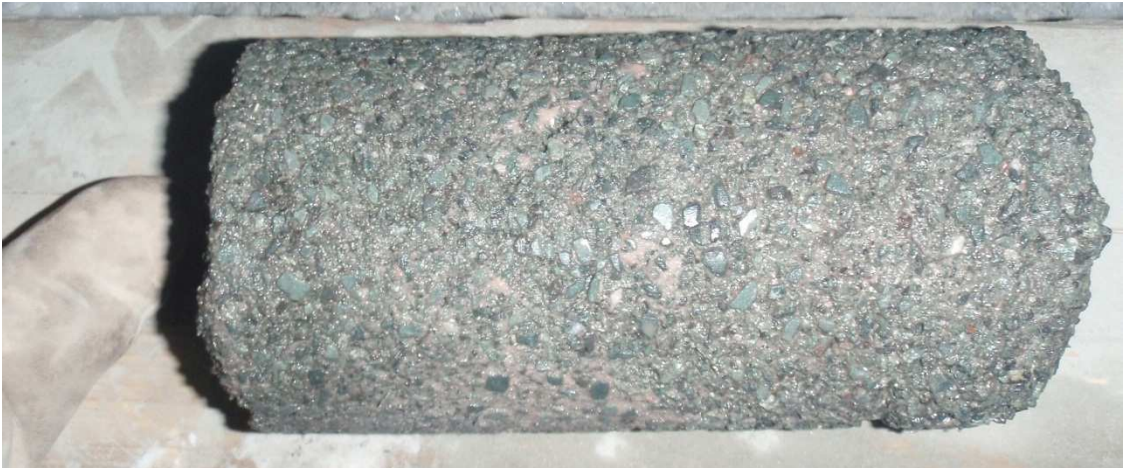
- One drilled core was taken around station 1+60 on the downstream (HB12-ND-CORE-DC73-20120311). Issues with the shop vac continue. Snow and spill pads were utilized to clean up around the drilled core location. A new vacuum is being sourced out.

Photo 10: Drilled core was taken around station 1+60 on the downstream (HB12-ND-CORE-DC73-20120311). Note that the very bottom of the core was noted to slightly melt when cored. This is expected to have resulted as the core was taken immediately after a -2C reading was obtained. This north area is expected to be placed on during dayshift tomorrow.

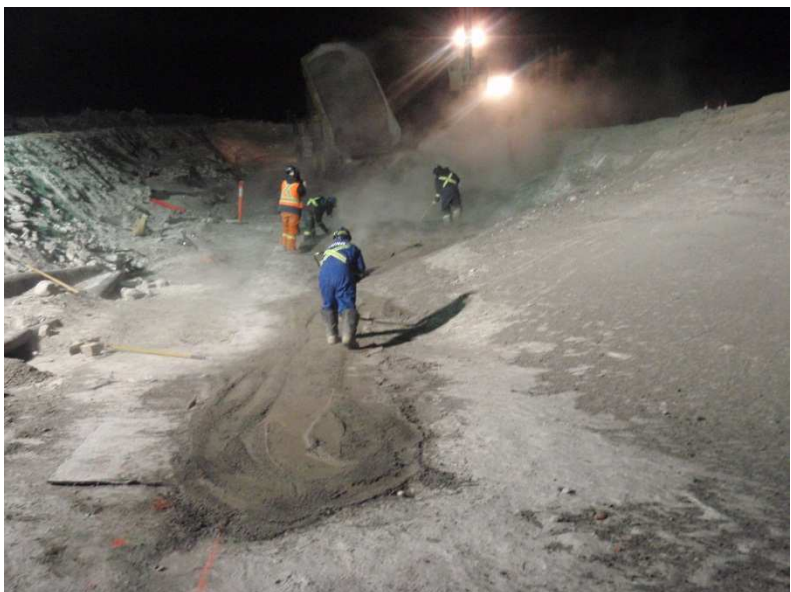
- Difficult to access areas were packed with the hand / plate tamper.
 - The above area was cleared of snow through the use the skid steer, and shovelling.

Photo 10: Labourers smoothing FCM in SE core area after packing with hand tamper

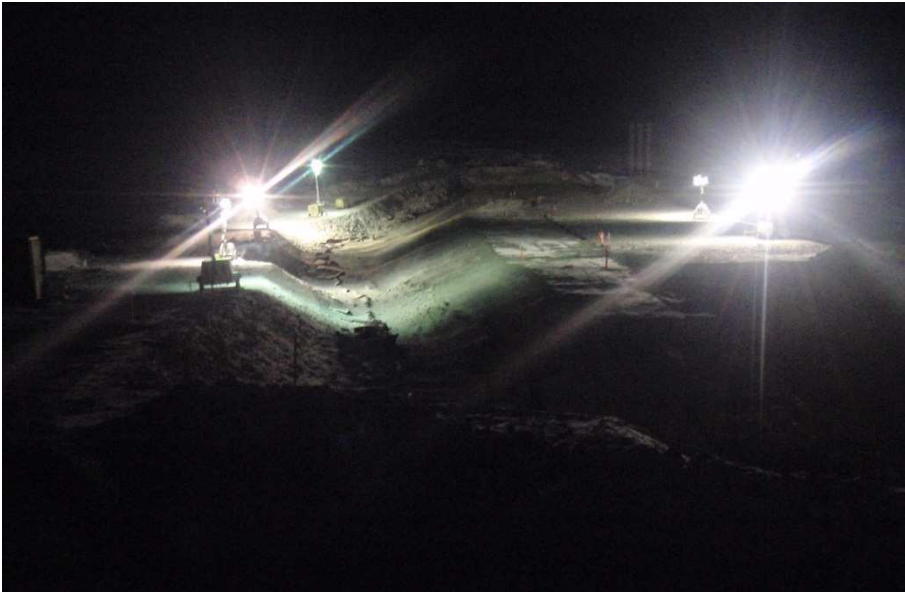
Photo 11: ~SW view down the Dam CL of construction progress

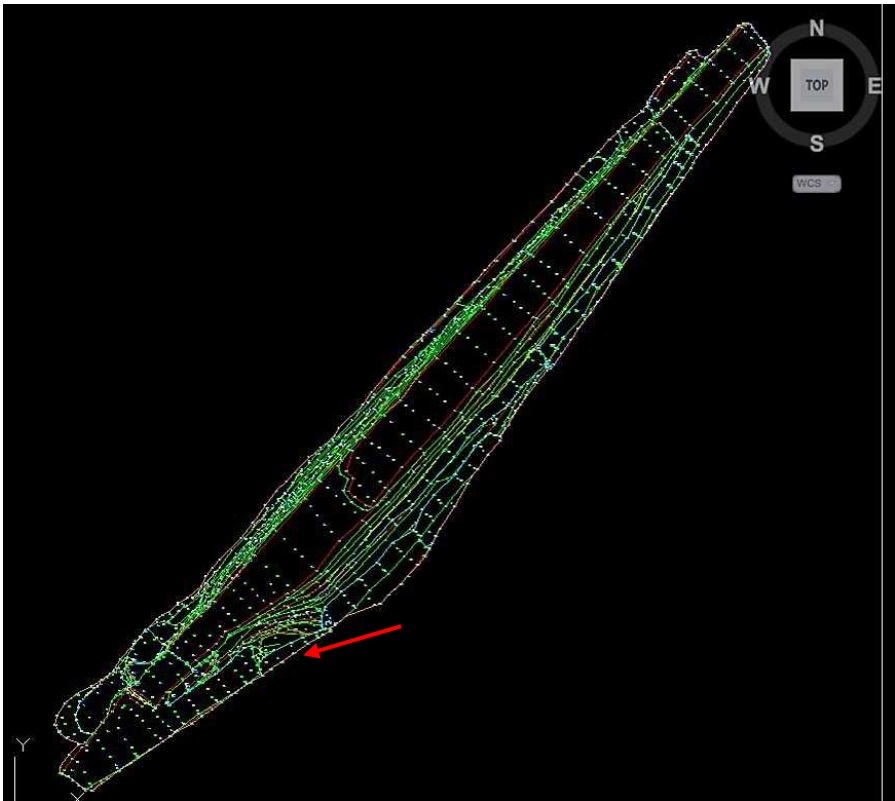
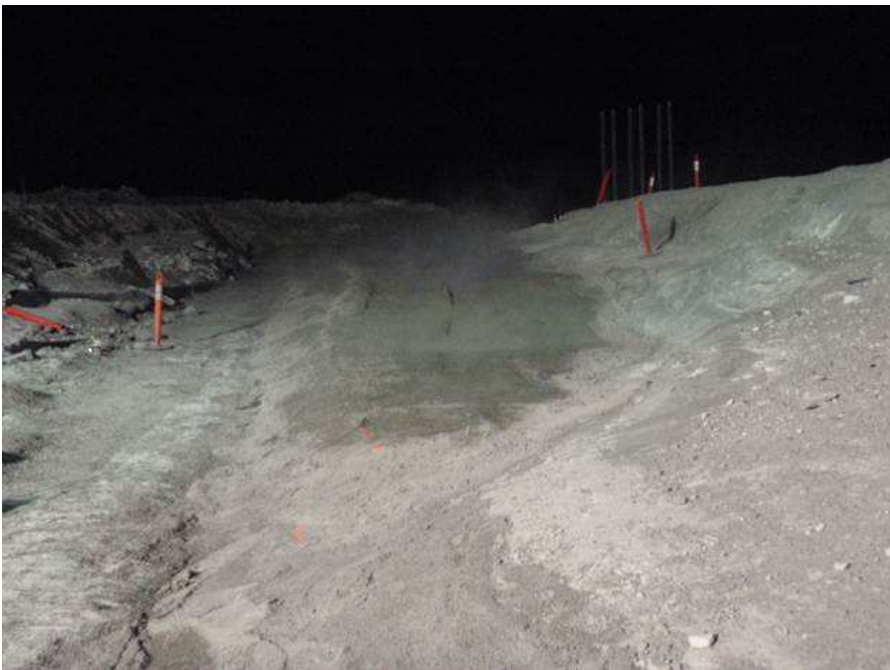
- FCM was placed from ~0+70 to 0+0+40 on the upstream of the dam.
 - Approximately 4 loads were placed on nightshift.
 - Material was placed along the most SE extents of the downstream slope, in the underbuilt SSE area. See Photo section for additional details on exact location / notable underbuilt SE slope area.

Photo 10 (with Acad Screenshot): ~ SW view of the area where placement along the SSE dam slope was completed on night shift. For reference a screenshot showing the as-built breaklines (as of March 10th) is provided. Note the indented almost 'U' shape underbuilt area of the SSE slope. This was the area of focus on tonight's nightshift.
