DAILY REPORT #67 – DORIS NORTH INFRASTRUCTURE/ NORTH DAM

Prepared by:	John Kurylo Lawrence Borowski	Date:	2012.03.12
Reviewed by:		Project #:	1CH008.058.0320
Role	Company	Personnel – Position	On Site
Client	Hope Bay Mining Limited (HBML)	Angela Holzapfel – ESR Compliance Manager David Vokey – ESR Coordinator Don Ethelston – HSLP Advisor Dean Wold - Safety Jill Turk – ESR Coordinator Katsky Venter – ESR Manger Michelle Tanquay – ESR Site Manager Stirling Kelly – HSLP Advisor	In Yes No Yes No No Yes Yes
	JDS	Lloyd Jackson – Mechanical Superintendent Doug Fielding – Construction Manager Ishan Fechter – Construction Coordinator Jerry Graham – Construction Manager Kevin Whieldon – Project Coordinator Mark Valeriote – Construction Manager	No No Yes Yes No Yes
Engineering Design Consultants	SRK Consulting (Canada) Inc.	John Kurylo – Site Engineer Megan Miller – Site Engineer Lawrence Borowski – Site Engineer Murray McGregor – Site Engineer Iozsef Miskolczi – Site Engineer Lowell Wade – Senior Engineer	Yes No Yes No No No

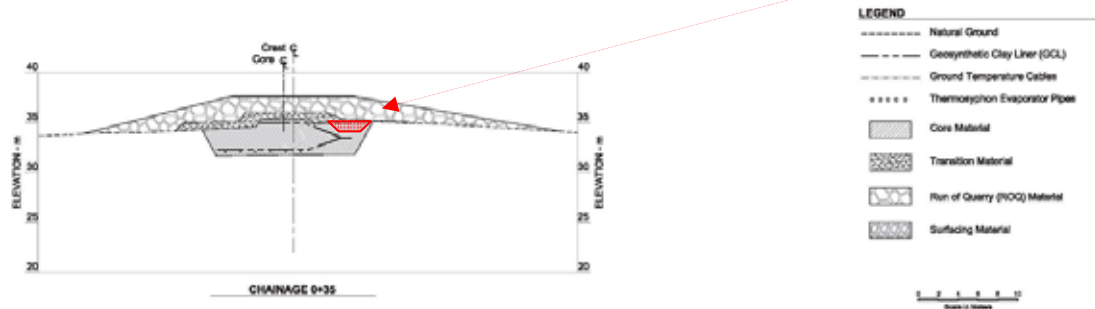
- Based on the 3D geometry of the key trench and dam core there are some areas around the north and south end where the GCL hinge (the joint between the lower and upper GCL panels) is somewhat below the elevation of the original ground (i.e. in the original key trench). JDS inquired if the area in excess of 0.3m above the upper GCL liner cover, but below the original ground elevation, was required to be filled with FCM. See notes on area in red on section below.

From section ~ 0+40 South and from section ~ 1+80 North this is most apparent.

This aforementioned area is required to be backfilled with 'cover material/ however the approved (fillet zone) construction variance method used in 2011 can be utilized. This variance would be slightly different in that the cover material gradation is expected to be slightly different than what has been observed to be used for the saturated core material. Overall the following requirements are expected to be met as the over liner material is filled up the original ground elevation at the ends.

- Using blended core material that meets the original (tech spec) gradation limits (i.e. similar to the material processed between mid-January and early March 2011). As noted in Daily #66 this is expected to be a material that is a mix of ¾" crush with the newer 5mm minus product.
- Ensure minimum Standard Proctor Density requirements are met for the cover material.
- Moisture content no less than optimum Moisture Content (OMC), but no requirement to meet the 85% saturation
- No freeze back wait period between lifts

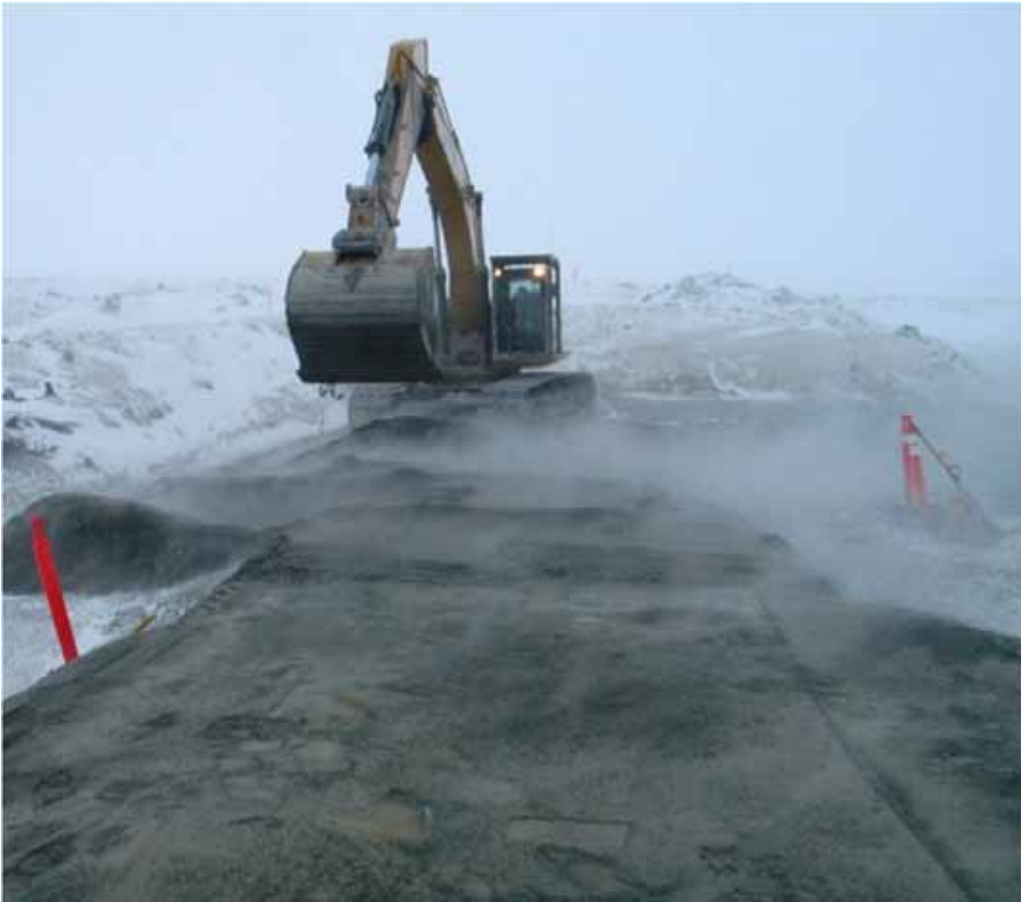
Photo 3: FCM dryer than FCM placed yesterday

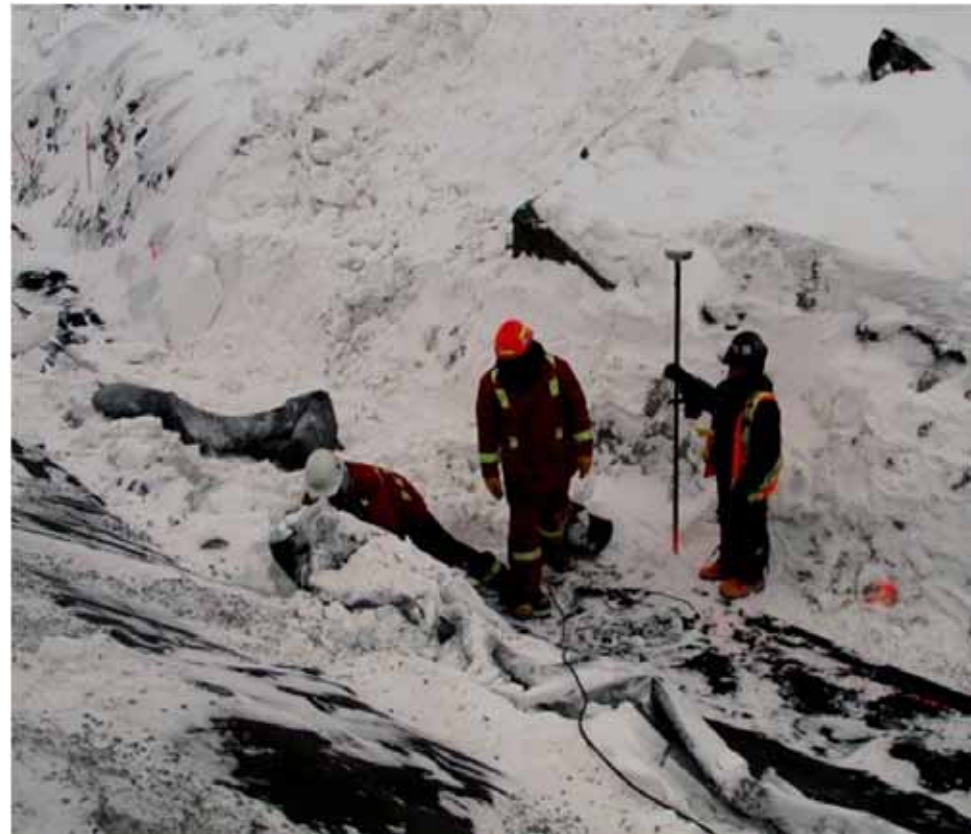
- Bentonite placement over liner between Sta 5+30 and 5+85 completed, surveyed , inspected and approved. Crush surface placement over the geotextile started. To be followed with ROQ.
- Bentonite placement over liner between Sta 3+85 and 4+45 completed and inspected.
- Layfield laying out HDPE liner between Sta 3+35 and Sta 3+85.
- Another cut in the liner was identified at Sta 5+24. Layfield [atched.

Photo 11: Layfield repairing HDPE liner at Sta 5+24

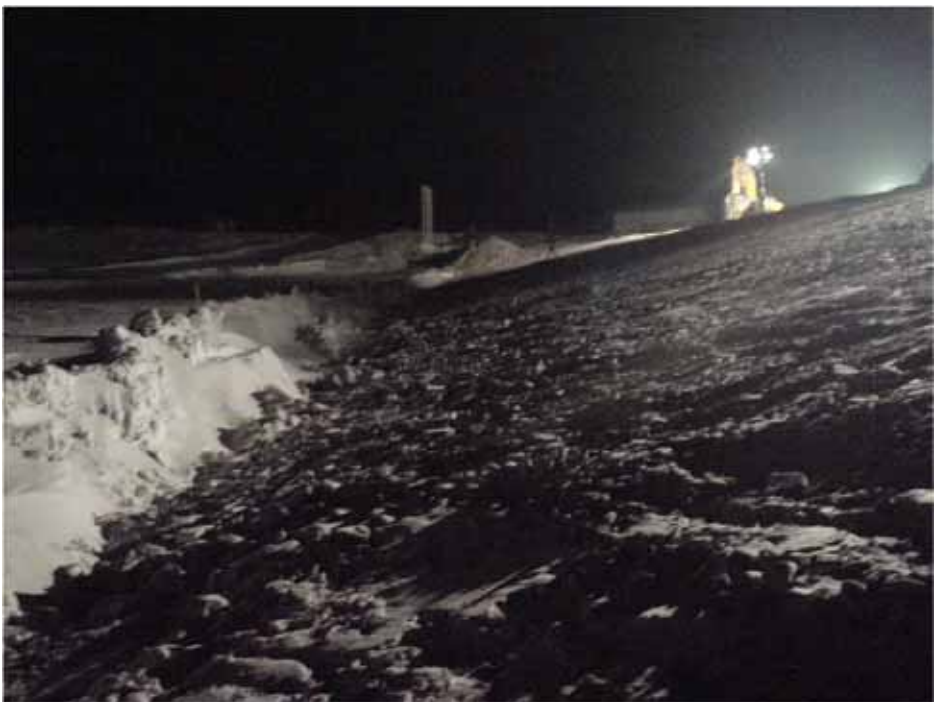
Photo 14: ~NEE view of downstream 4H:1V dam shell; taken from ~ station 0+60

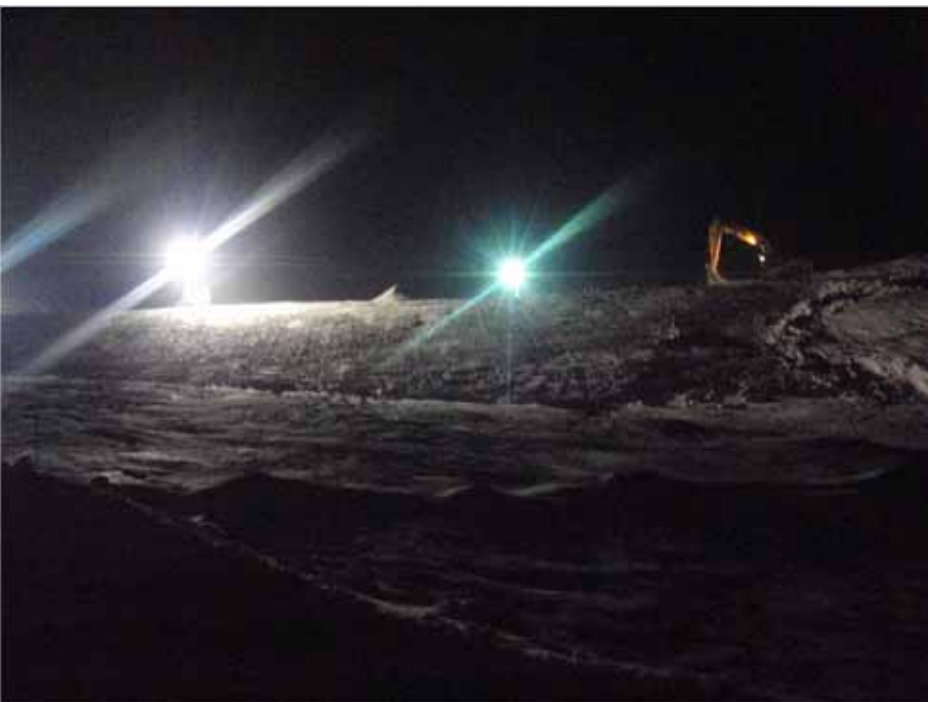
Photo 15: ~SE view of downstream dam shell after 4H:1V sloping.

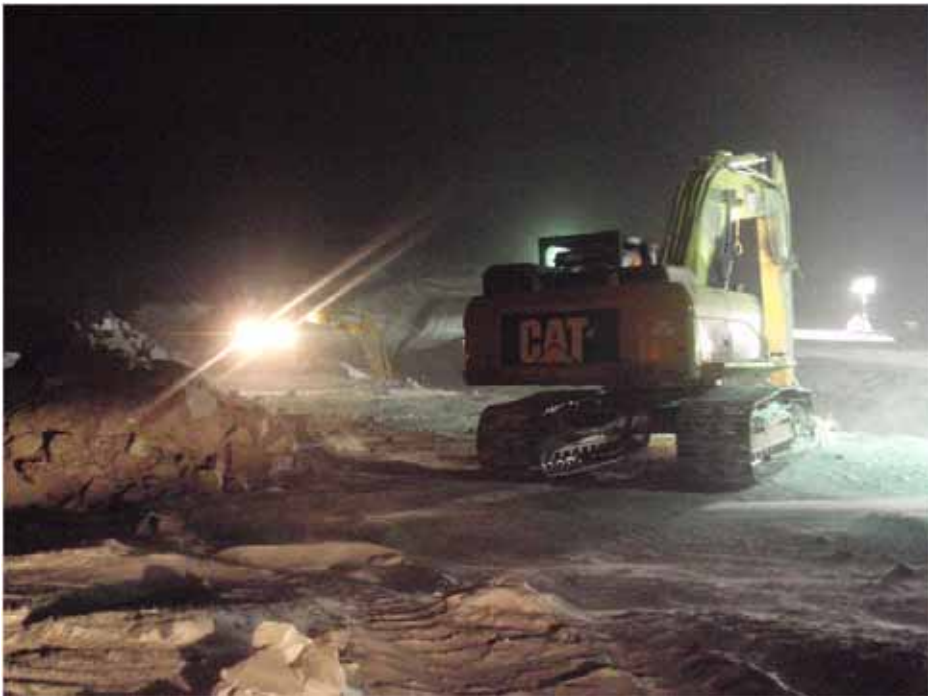
- Some of the upstream slope around was removed around the north end (~ 1+60 to 1+95 area) were scraped down.
- Some ROQ was pulled back from the upstream inside slope (i.e. slope adjacent to the fillet hinge area) around 0+40 to 1+60

- SRK held discussions with the Nuna foreman about the current inside upstream slope of the ROQ.
 - It is expected, at this time, that this inside upstream slope may be pulled back to something around 3H:1V to better allow for equipment access and working space when the upper GCL paned and cover material is placed.

- Due to the steep 2.5HL1V grade of the upstream core slope it is expected that the packer may not be able to travel upslope. At this time it is expected that the packer will either go down from the top then up the sloped upstream ROQ and around or will be tied to a excavator that will assist / guide when the packer is required to travel back up slope.

Photo 17: ~WSW view of excavators working on removing HDPE liner and pulling back ROQ on upstream slope.

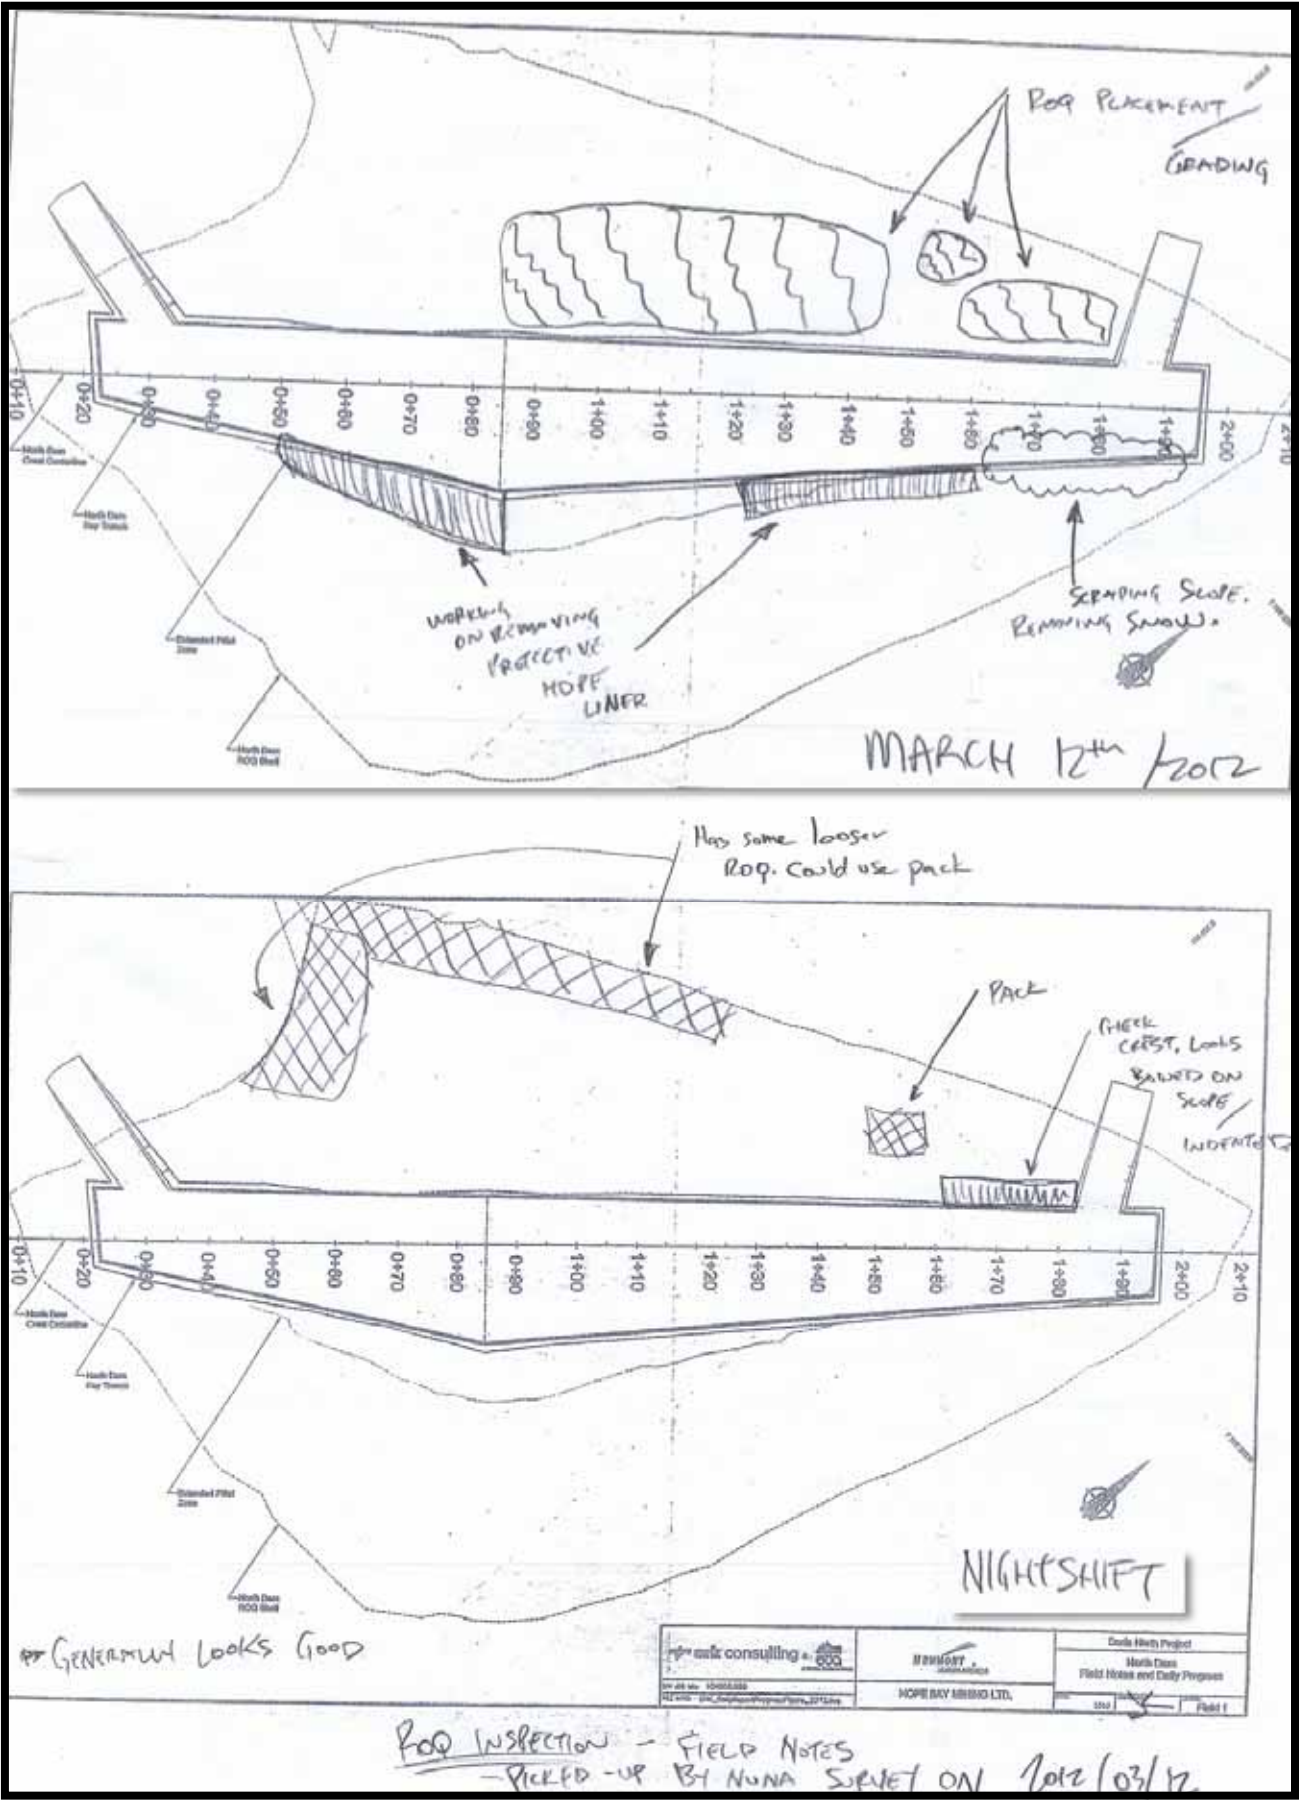
Figure 2 – North Dam Progress – Nightshift

- ROQ material was placed in areas of the downstream from ~0+80 to 1+80. See Figure 2 for additional details.
 - Two vibrator packers worked on packing the downstream crest and slope of ROQ.

- Material was spread with the 330 excavator.
- SRK and Nuna survey completed some field sloping and grade checks of the downstream dam shell. Additional notes on this inspection are provided in Figure 2.

- There is a portion along the bottom / edge of the ROQ toe that is still rough looking and could use some additional compaction. At times the packers are having difficulties with traction at the bottom of the slope (due to the angles and existing light dusting of snow over some area. If this area blows in the final compaction of the slope around the toe would result at a later date (closer to summer). Overall the slopes look good from station ~0+60 to 1+35.

- Around station 1+60 to 1+80 there appears to be an indent around the existing crest location where some additional ROQ may be required to reach the 4H:1V slope grades (to be confirmed by survey in the coming days).

- Nuna survey will provided SRK with the recent downstream ROQ slope survey in the coming week. A preliminary as-built review will be completed at that time. Based on the field inspection grades typically looked to be within -5cm to +10cms.
