## +DAILY REPORT #68 – DORIS NORTH INFRASTRUCTURE/ NORTH DAM

Prepared by:	John Kurylo Lawrence Borowski	Date:	2012.03.13		
Reviewed by:		Project #:	1CH008.058.0320		
Role	Company	Personnel – Position	On Site		
Client	Hope Bay Mining Limited (HBML)	Angela Holzapfel – ESR Compliance Manager	Yes		
		David Vokey – ESR Coordinator	Yes		
		Don Ethelston – HSLP Advisor	No		
		Dean Wold - Safety	Yes		
		Jill Turk – ESR Coordinator	No		
		Katsky Venter – ESR Manger	No		
		Michelle Tanquay – ESR Site Manager	Yes		
		Stirling Kelly – HSLP Advisor	Yes		
	JDS	Lloyd Jackson – Mechanical Superintendent	No		
		Doug Fielding – Construction Manager	No		
		Ishan Fechter – Construction Coordinator	Yes		
		Jerry Graham – Construction Manager	Yes		
		Kevin Whieldon – Project Coordinator	No		
		Mark Valeriote – Construction Manager	Yes		
Engineering Design Consultants	SRK Consulting (Canada) Inc.	John Kurylo – Site Engineer	Yes		
		Megan Miller – Site Engineer	No		
		Lawrence Borowski – Site Engineer	Yes

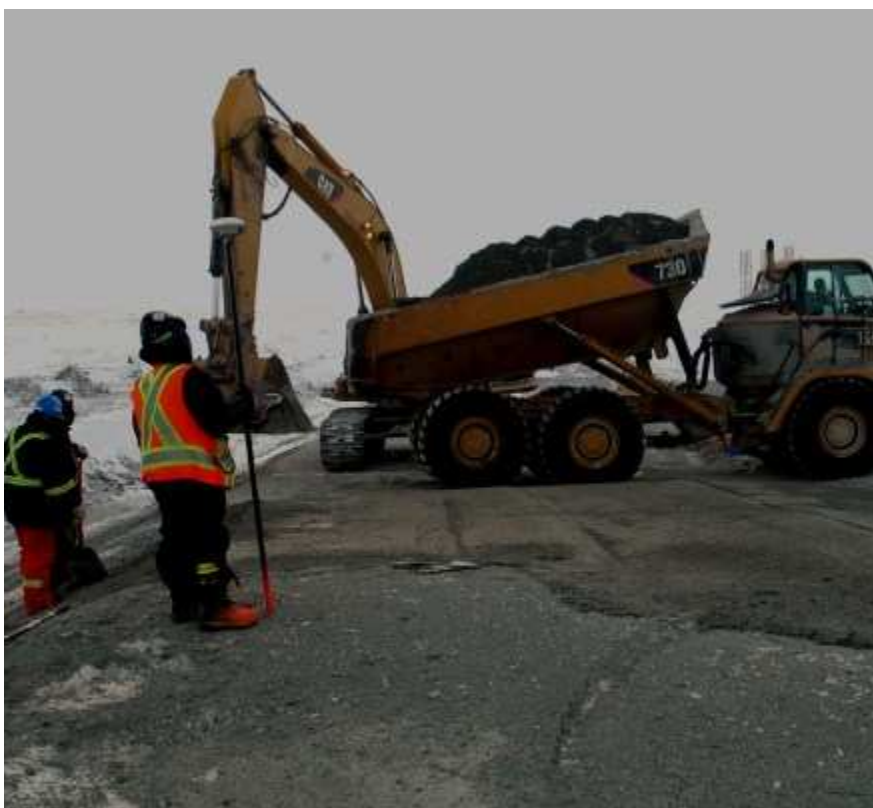
Photo 3: Placing FCM ~ Sta 1+05

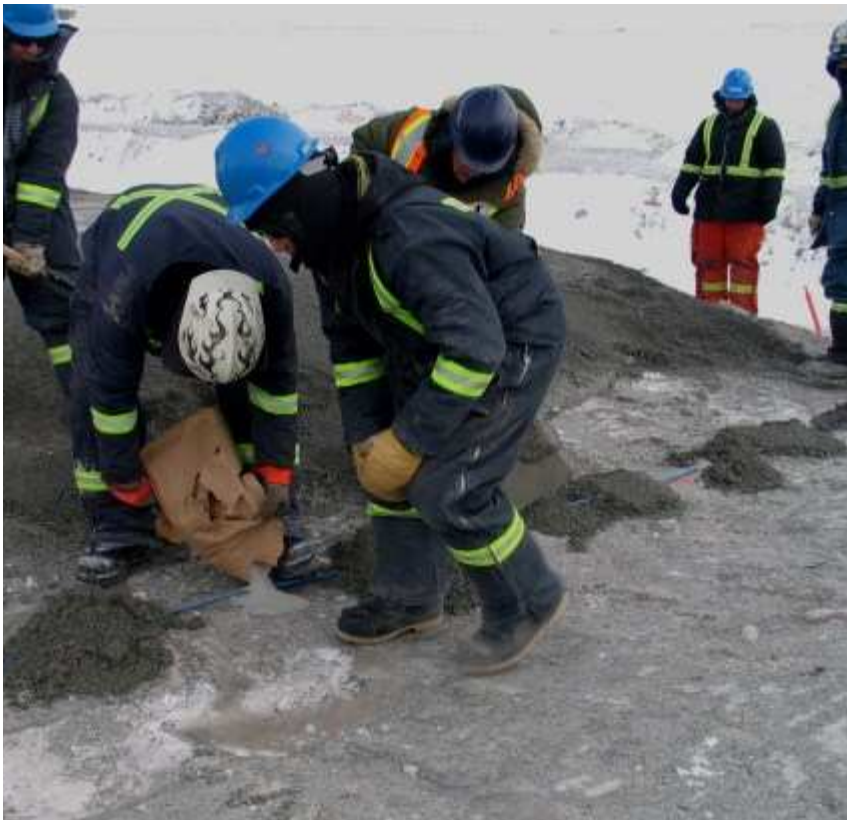
- All installed multi-beads were read:
  - ND-HTS-040-31.5, ND-HTS-040-33.5, ND-VTS-040-KT
  - ND-HTS-060-28.8, ND-HTS-060-31.0, ND-HTS-060-33.5, ND-VTS-060-KT
  - ND-HTS-085-25.3, ND-HTS-085-29.4, ND-HTS-085-33.5, ND-VTS-085-KT
    - Note: the last bead on thermistor string ND-HTS-085-33.5 was noted to not be working. This will be further examined in the coming days. On first inspection no notable damage to the cable could be determined.
  - ND-HTS-130-28.8, ND-HTS-130-31.0, ND-VTS-130-33.5, ND-VTS-130-KT
  - ND-HTS-175-32.5, ND-HTS-175-33.5, ND-VTS-175-KT

Photo 5: Installing thermistor ND-HTS-085-33.5

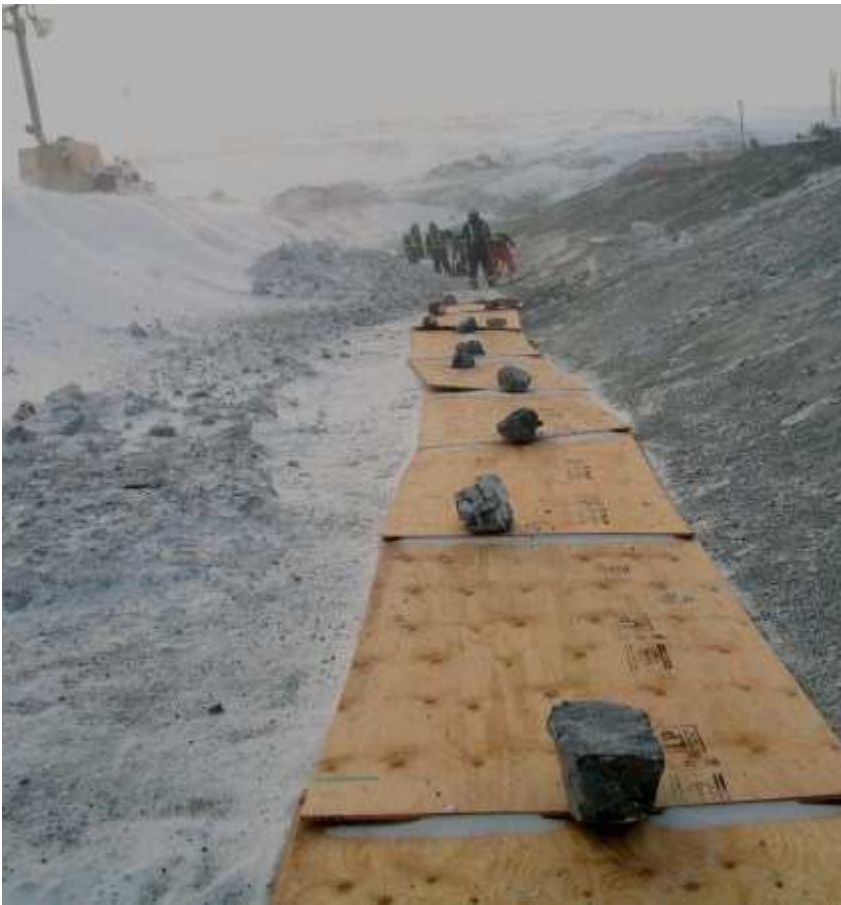
- Placed FCM between Sta 1+00 and Sta 0+55.
- All surfaces were swept with the skid steer before any placement took place.
- Dial for water was set at 53 and remained unchanged all day. Temperature was set in the +26vto +31 range. Test results within specifications were achieved.
- Thermistor ND-HTS-085-33.5 was installed during the day shift. Nodes were surveyed.
- A total of 10 loads were placed
- Labour crew cleared snow off GCL and placed plywood over cleared areas for protection from drifting

snow. No patching on the GCL was undertaken. Patching, if required, will be undertaken when the top GCL is placed.

Photo 7: Plywood placed over cleaned GCL

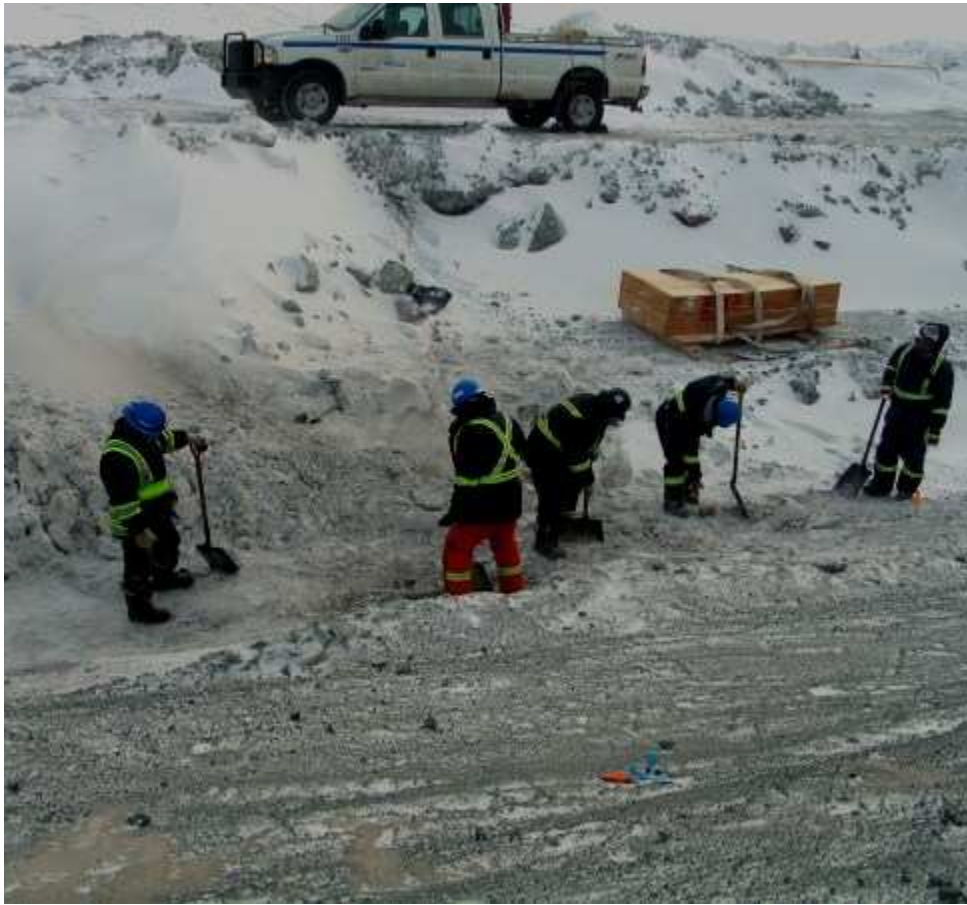
Photo 8: Cleaning crew on GCL.

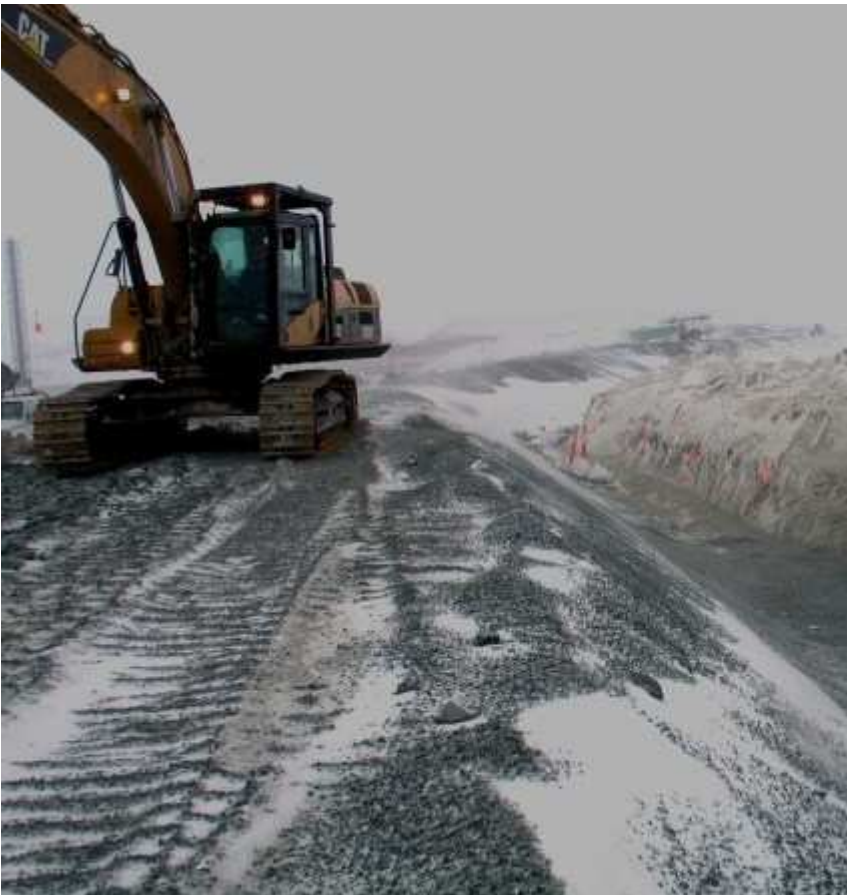
- Between Sta 3+95 and Sta 4+45 crush was placed in the bottom of the trench and on the bank. Crush was surveyed and inspected. For the balance of the day ROQ was placed in this section. By the end of the dayshift the bottom half was filled and work had started on the top half.

Photo 9: Finished crush between Sta 3+95 and Sta 4+45

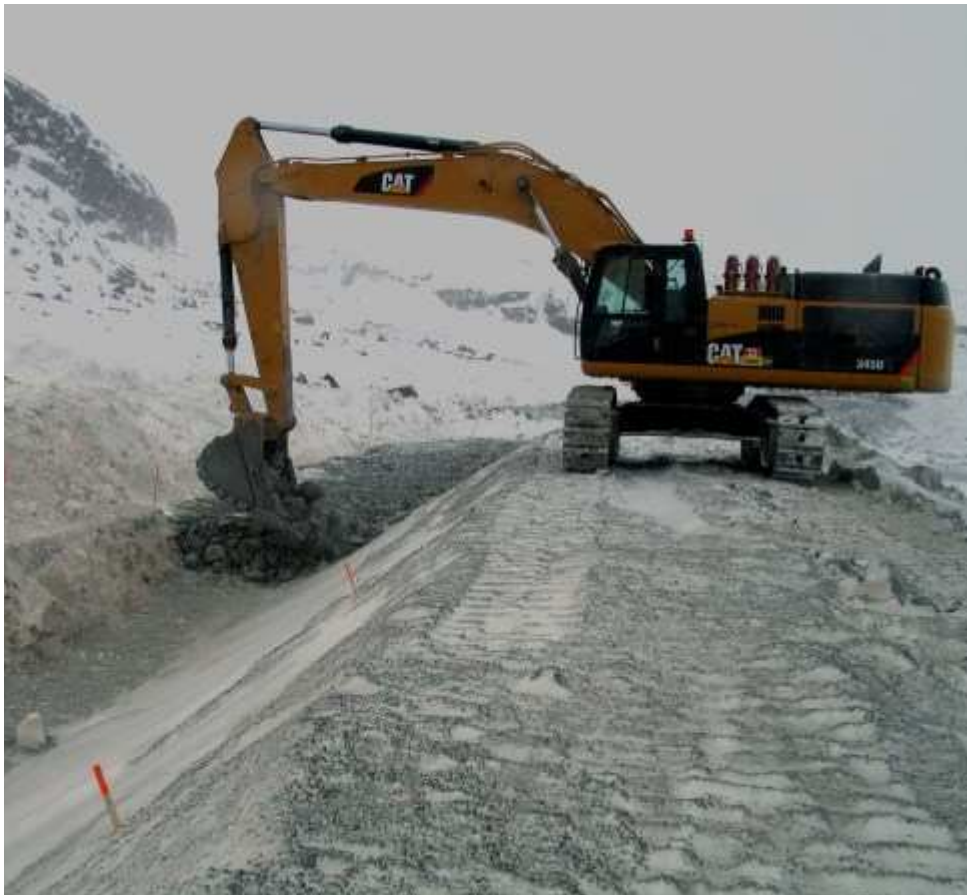
- Excavation operators had been instructed to remove snow drifts as the work progressed.
- At the east end, ROQ was placed between Sta 5+35 and 5+85. To cover as much of the key trench as possible and to keep progressing only the bottom half of the trench was filled. The top will be filled at a later date.

Photo 10: Excavator placing ROQ between Stn 5+35 and Stn 5+85

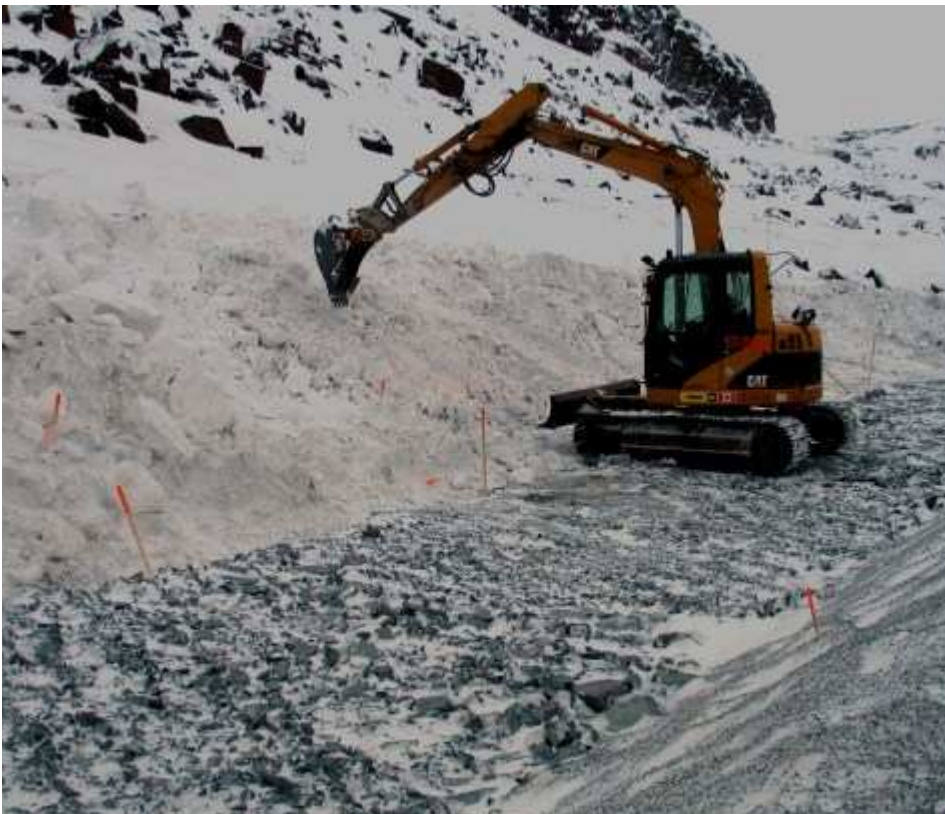
- The small excavator was working ~ Stn 5+75 pushing snow from the top of the bank.
- Today was a weather day for Layfield.
- Because of the storm no new areas were opened.

**Photo 13:** Small excavator pushing snow from back of trench

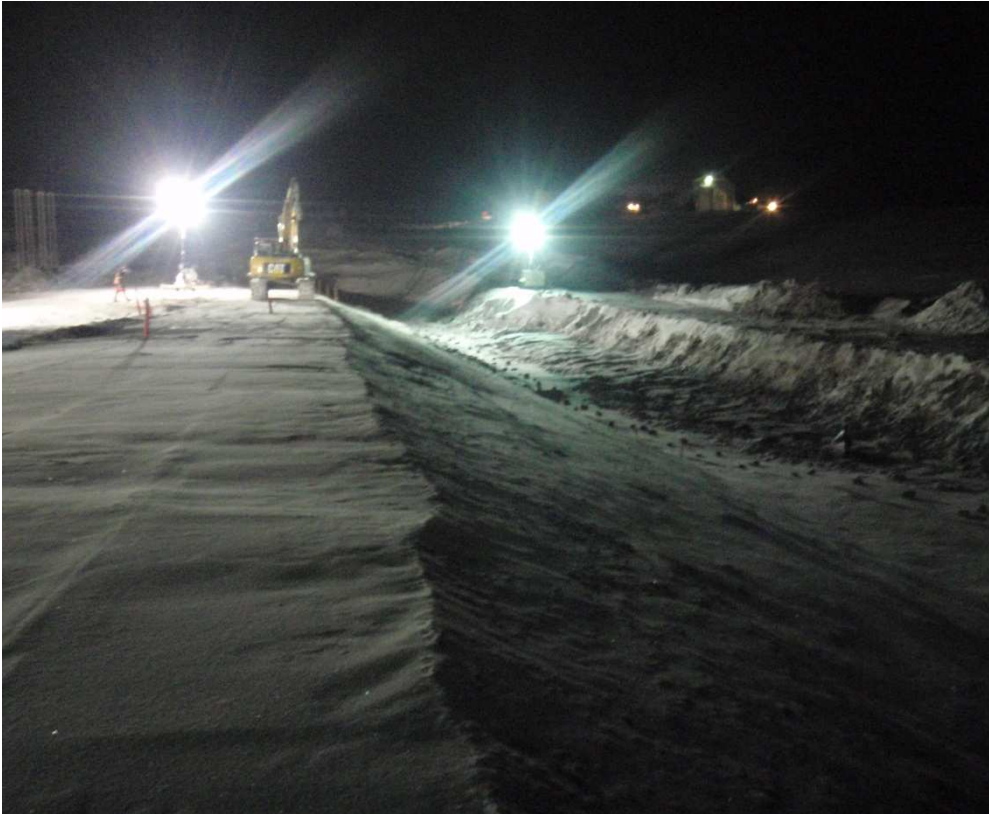
**Photo 14:** ~NE view down upstream crest of dam. Note the 330 in the background scraping down the areas where nightshift placement started.

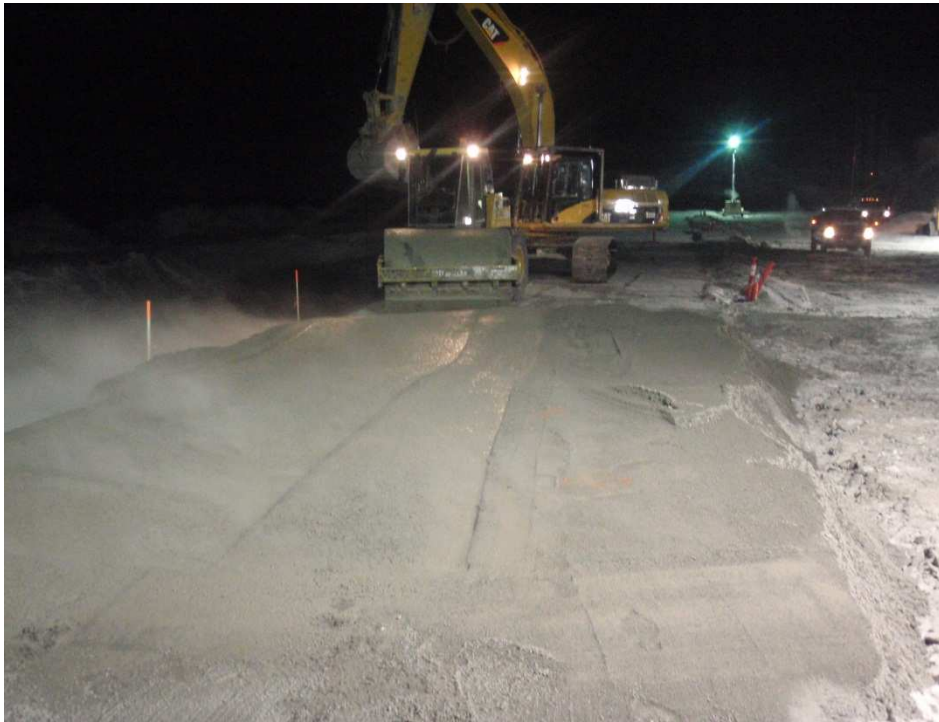
**Photo 16:** Packing completing static passes on FCM around station 1+40. Note that later / after vibrator compaction effort was also used.

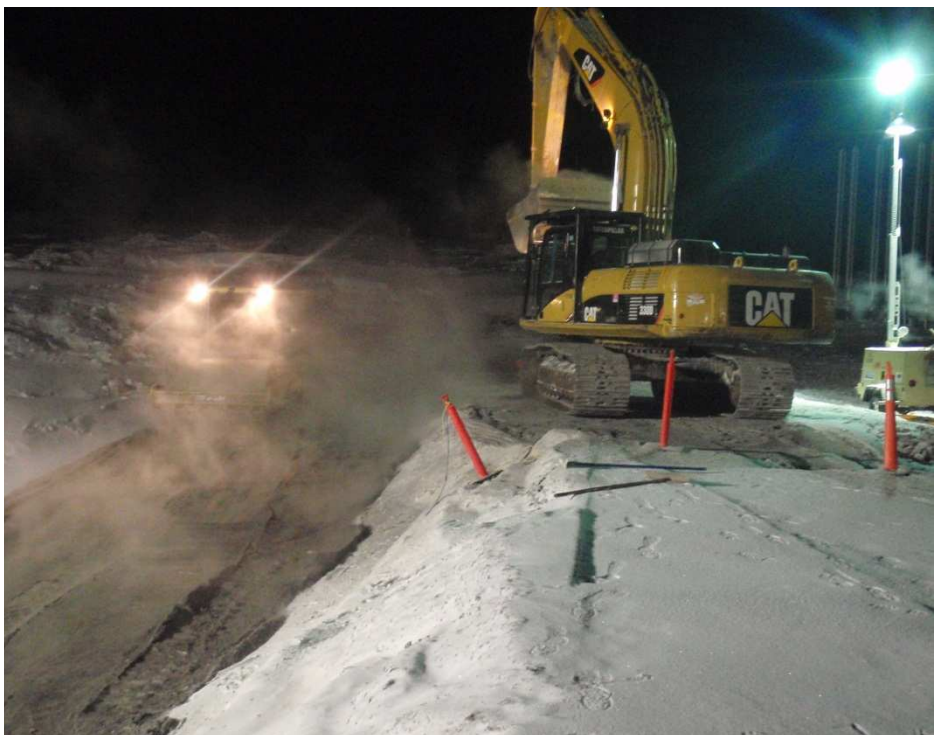
- A lift was placed in the far SSE area where the slope remains notable underbuilt. The single bead was installed around this area.
  - Compaction and saturation tests met specifications.

**Photo 18:** 330 excavator and packer working in SSE corner of dam

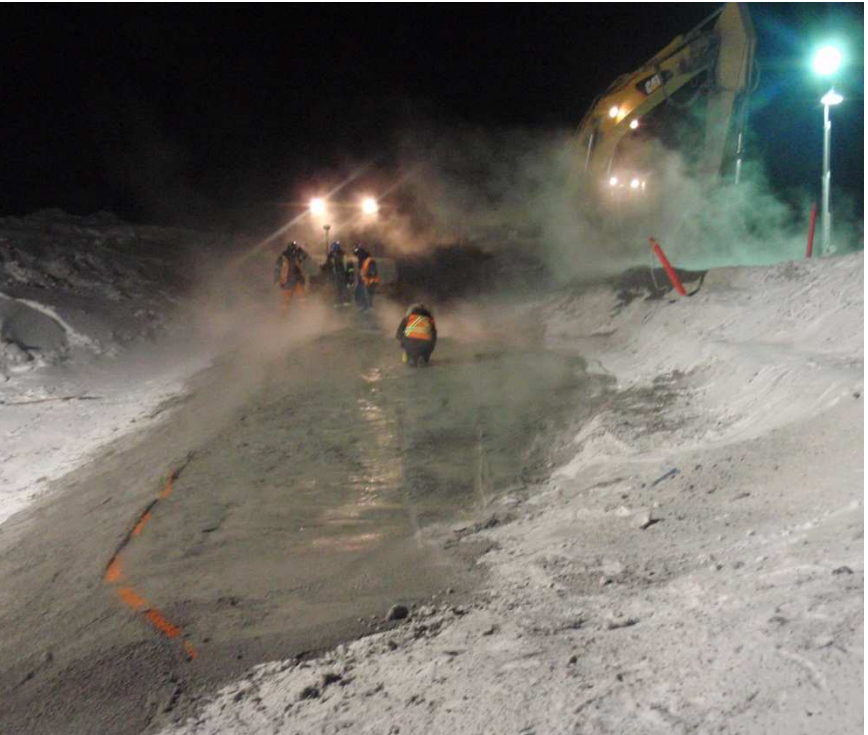
**Photo 19:** EBA doing field checks of FCM around the underbuilt SSE area (~ around 0+60 upstream area)

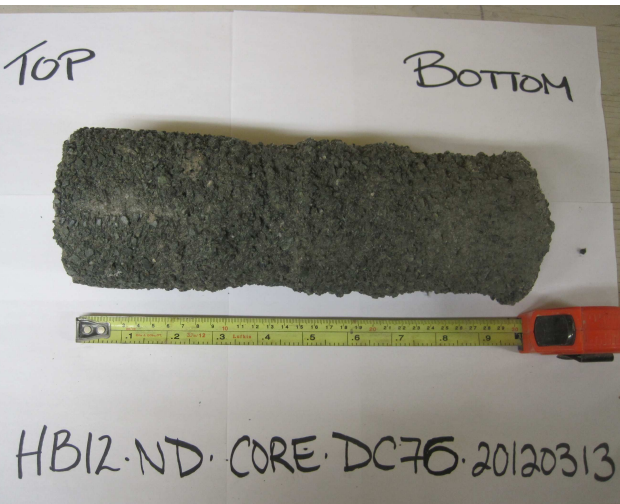
**Photo 22:** Drilled core 75

- Drilled core HB12-ND-CORE-DC76-20120313 was taken from ~ 1+57 on the upstream. This core was taken when the single bead in this area was around -2.7C.

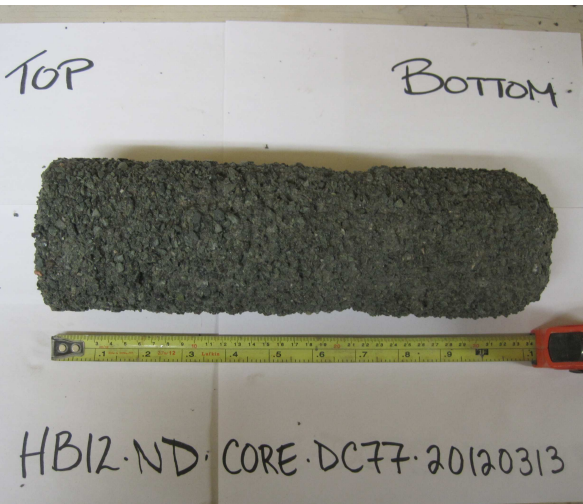
**Photo 23:** Drilled core 76

- Drilled core HB12-ND-CORE-DC77-20120313 was taken from ~ 0+47 on the centerline. This core was taken when the single bead in this area was around -1.9C to allow for FCM placement in this area shortly after coring.
