DAILY REPORT #69 – DORIS NORTH INFRASTRUCTURE/ NORTH DAM

Prepared by:	John Kurylo Lawrence Borowski	Date:	2012.03.14		
Reviewed by:		Project #:	1CH008.058.0320		
Role	Company	Personnel – Position	On Site		
Client	Hope Bay Mining Limited (HBML)	Angela Holzapfel – ESR Compliance Manager	Yes		
		David Vokey – ESR Coordinator	Yes		
		Don Ethelston – HSLP Advisor	No		
		Dean Wold - Safety	Yes		
		Jill Turk – ESR Coordinator	No		
		Katsky Venter – ESR Manger	No		
		Michelle Tanquay – ESR Site Manager	Yes		
		Stirling Kelly – HSLP Advisor	Yes		
	JDS	Lloyd Jackson – Mechanical Superintendent	No		
		Doug Fielding – Construction Manager	No		
		Ishan Fechter – Construction Coordinator	Yes		
		Jerry Graham – Construction Manager	Yes		
		Kevin Whieldon – Project Coordinator	No		
		Mark Valeriote – Construction Manager	Yes		
Engineering Design Consultants	SRK Consulting (Canada) Inc.	John Kurylo – Site Engineer	Yes		
		Megan Miller – Site Engineer	No		
		Lawrence Borowski – Site Engineer	Yes

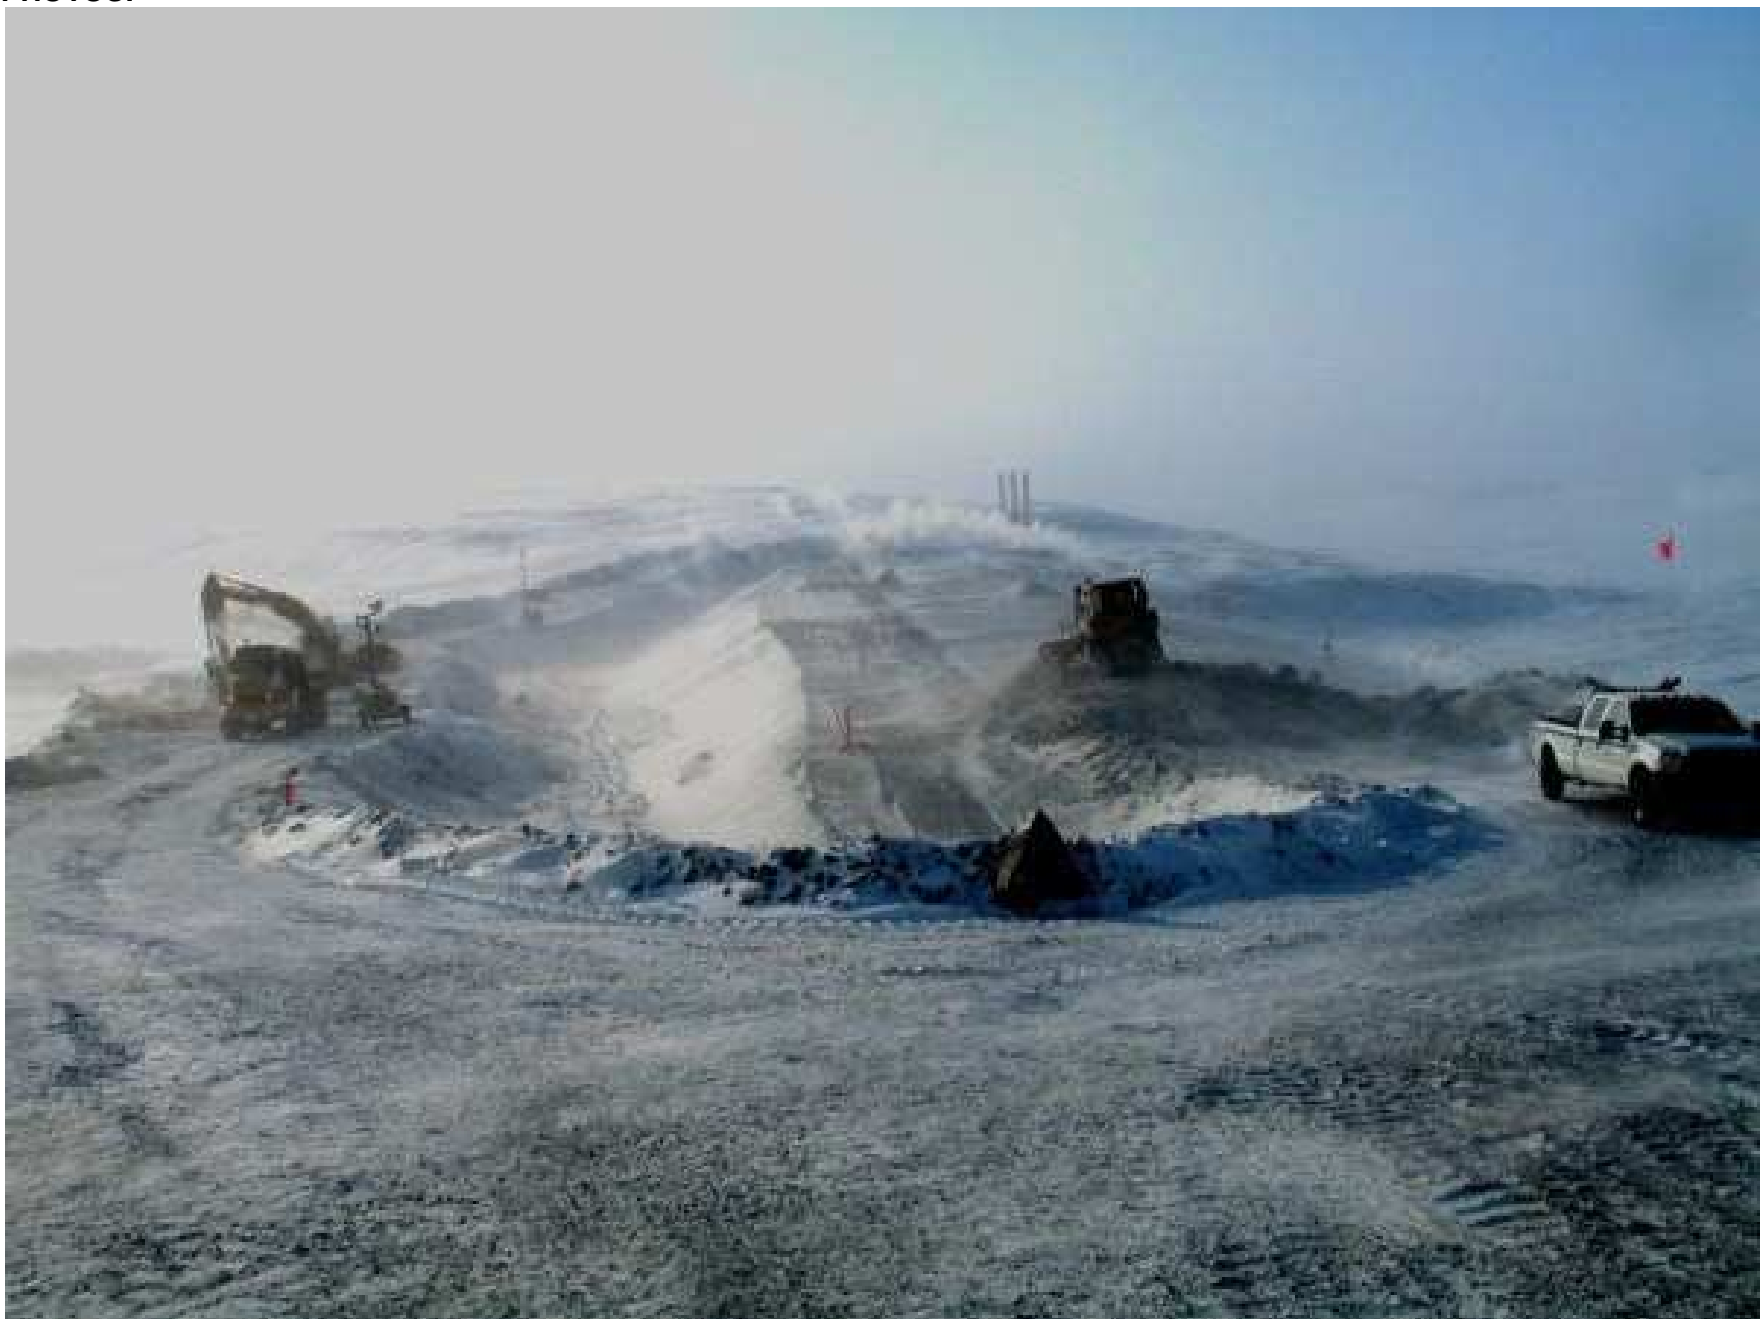
Photo 1: Progress photo, looking SSEE down centerline.

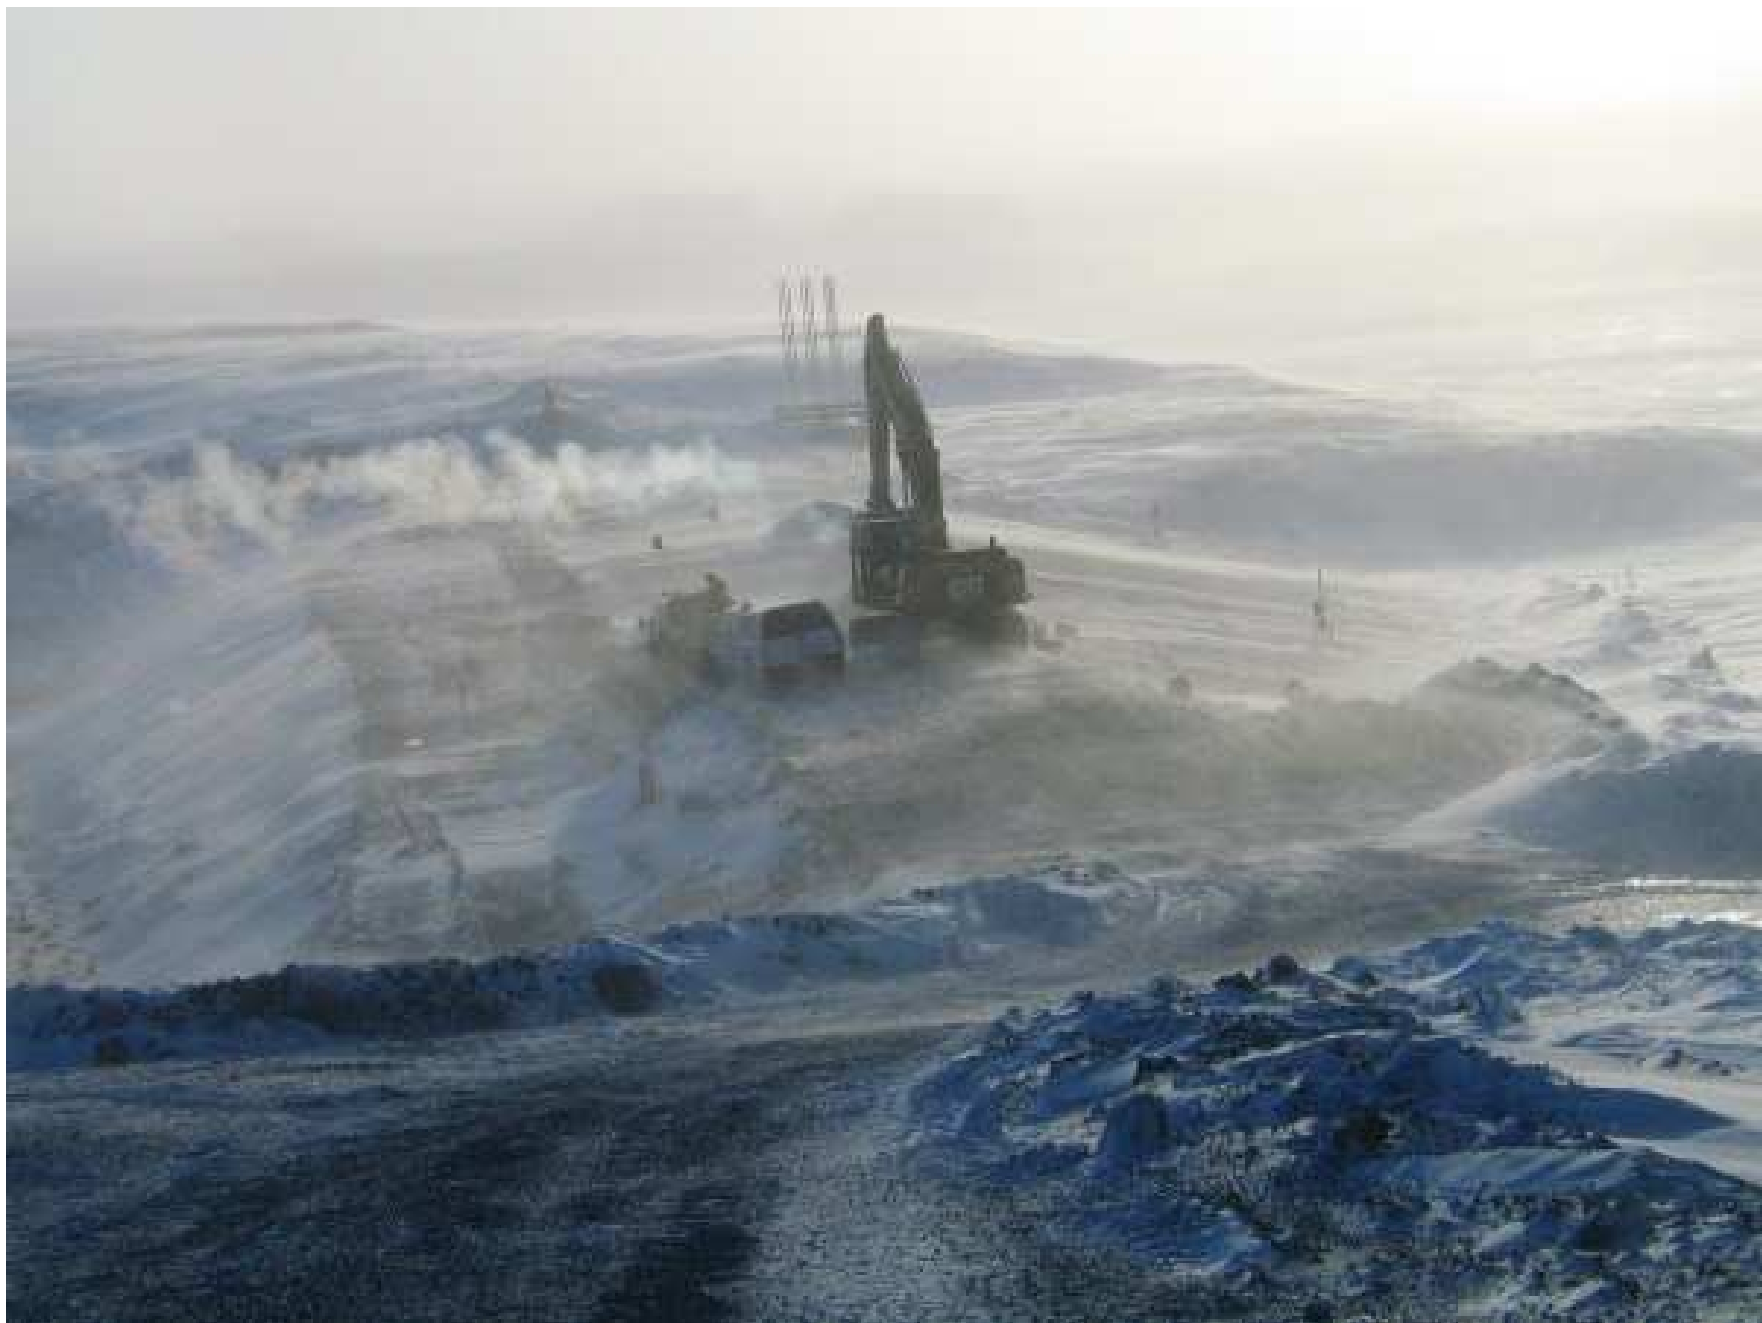
Photo 2: North dam facing south, closer view.

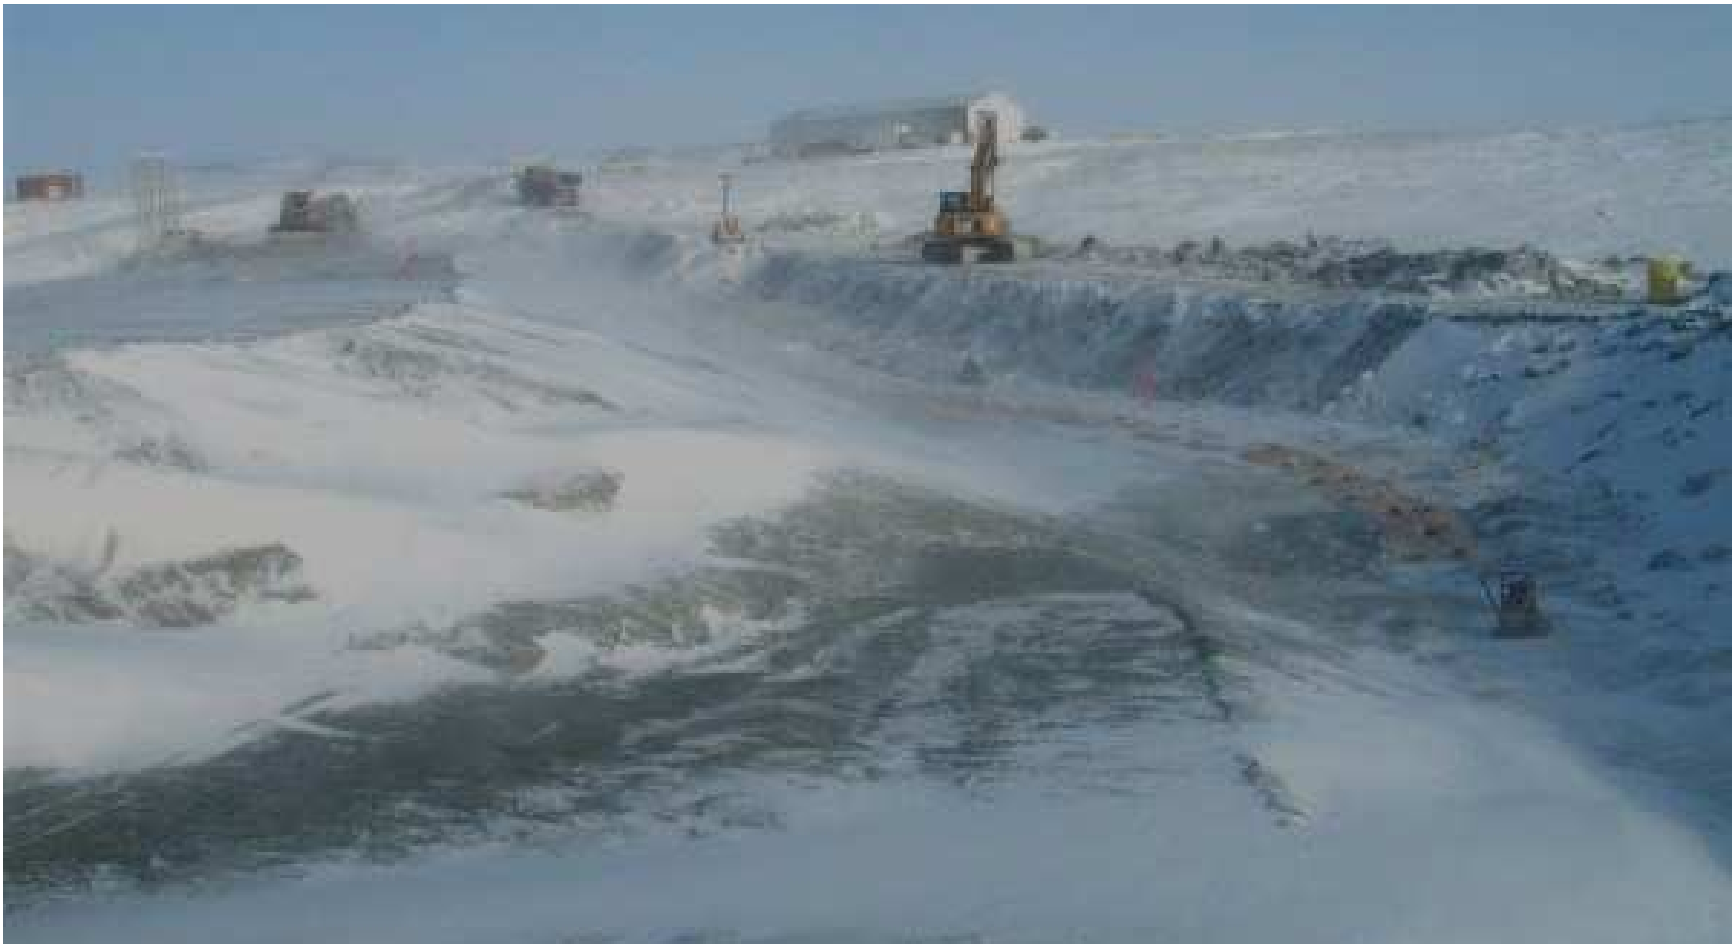
Photo 3: Drifting in the south east corner on dayshift.

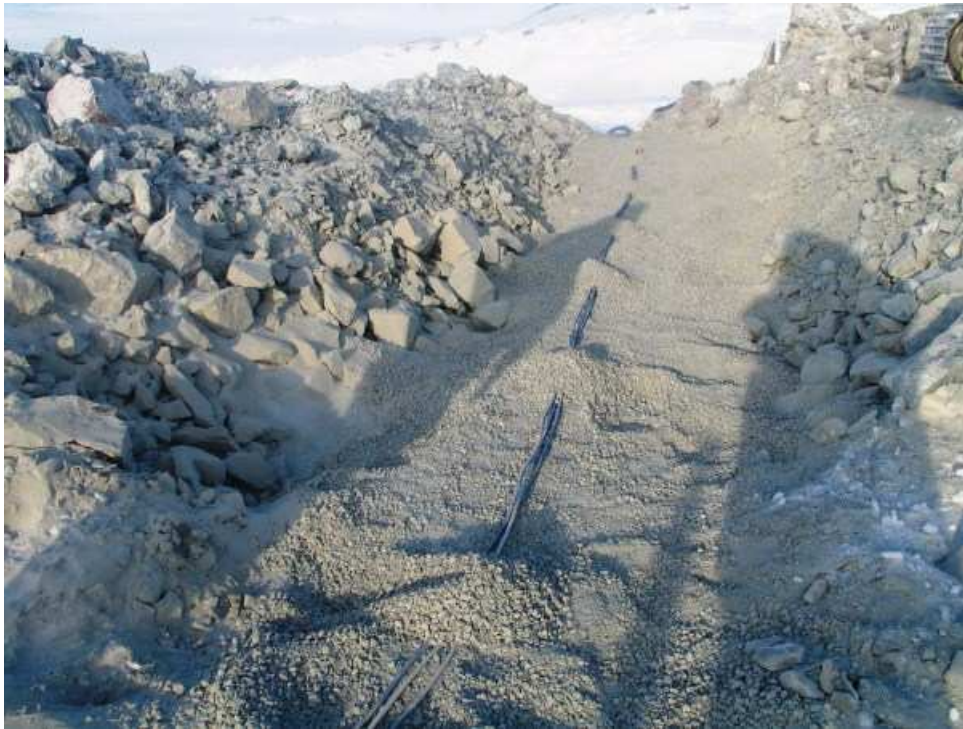
Photo 4: Bedding cables at Sta 1+75. Trench was cut in ramp

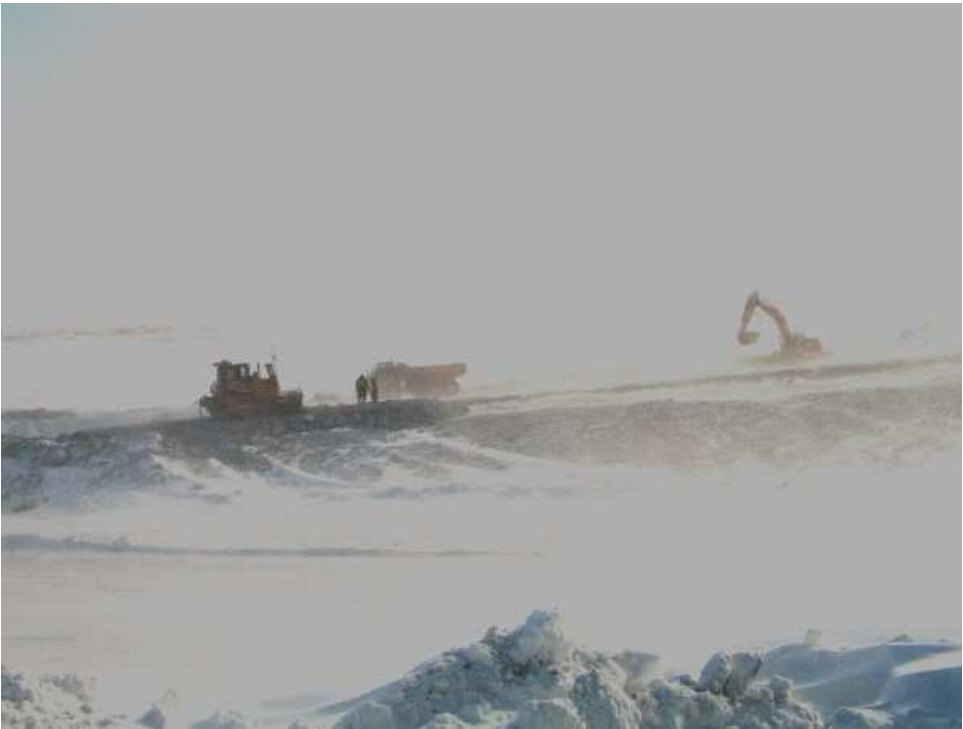
Photo 5: Photo from the secondary road facing east

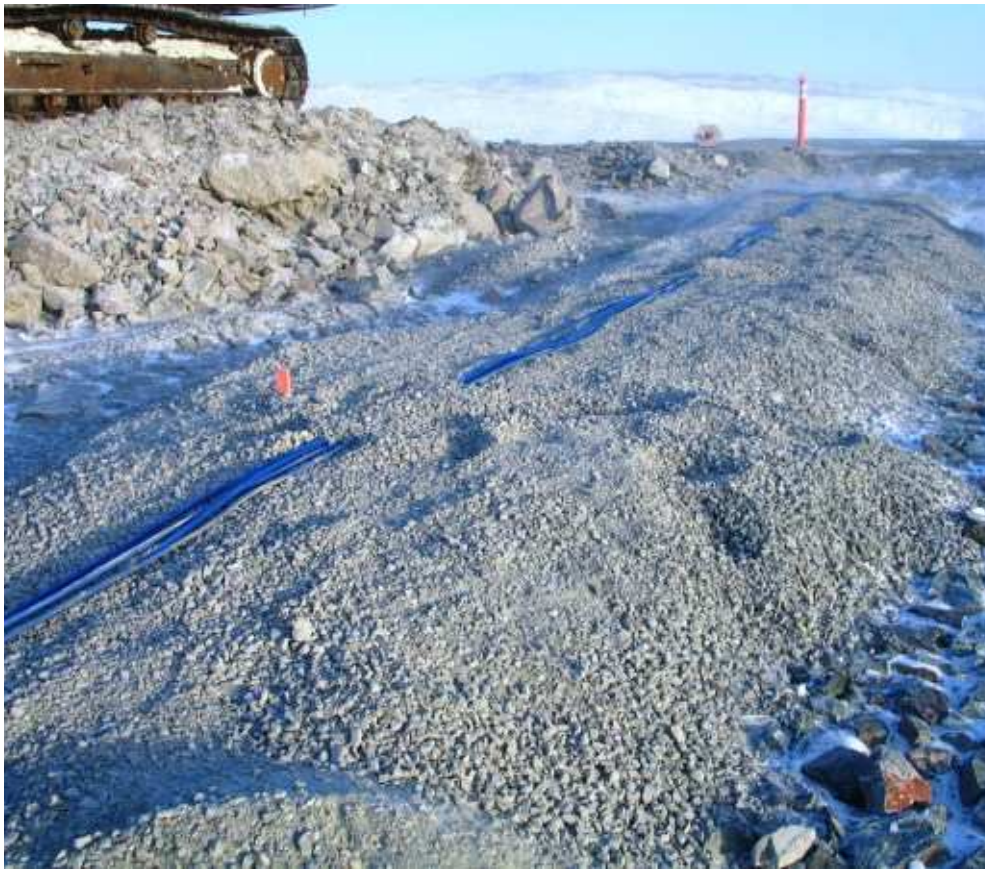
Photo 6: Cables at Sta 1+35

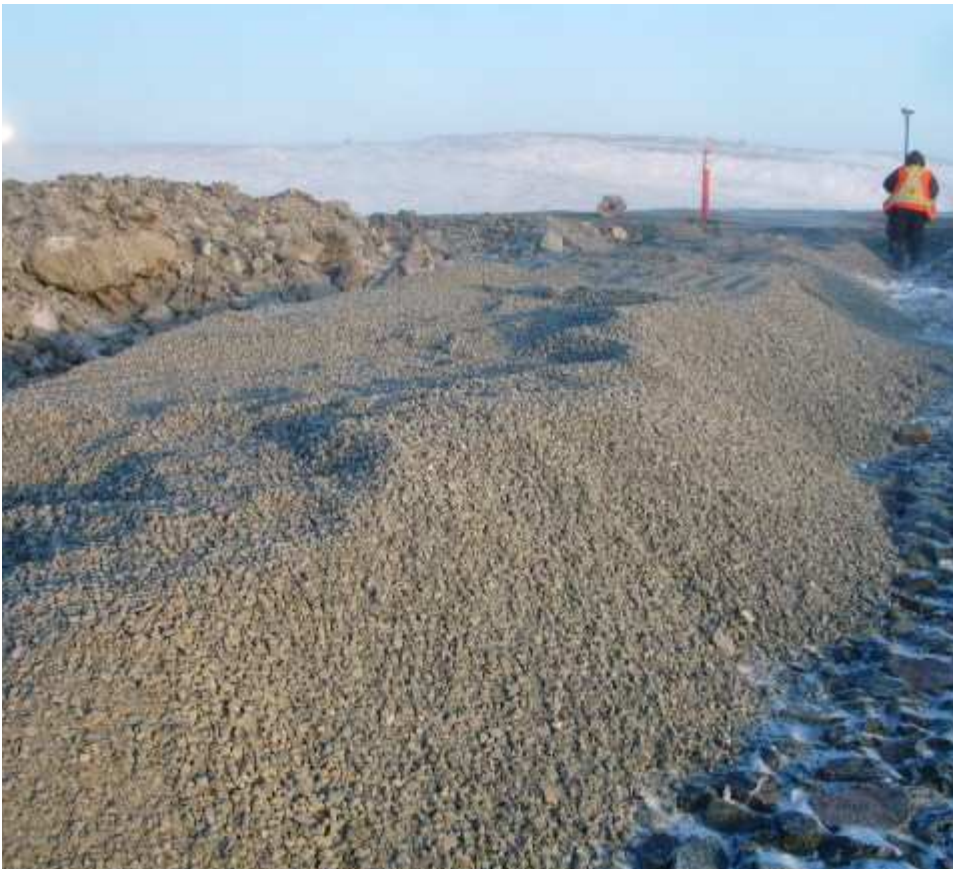
Photo 7: Final cover over cables at Sta 1+35

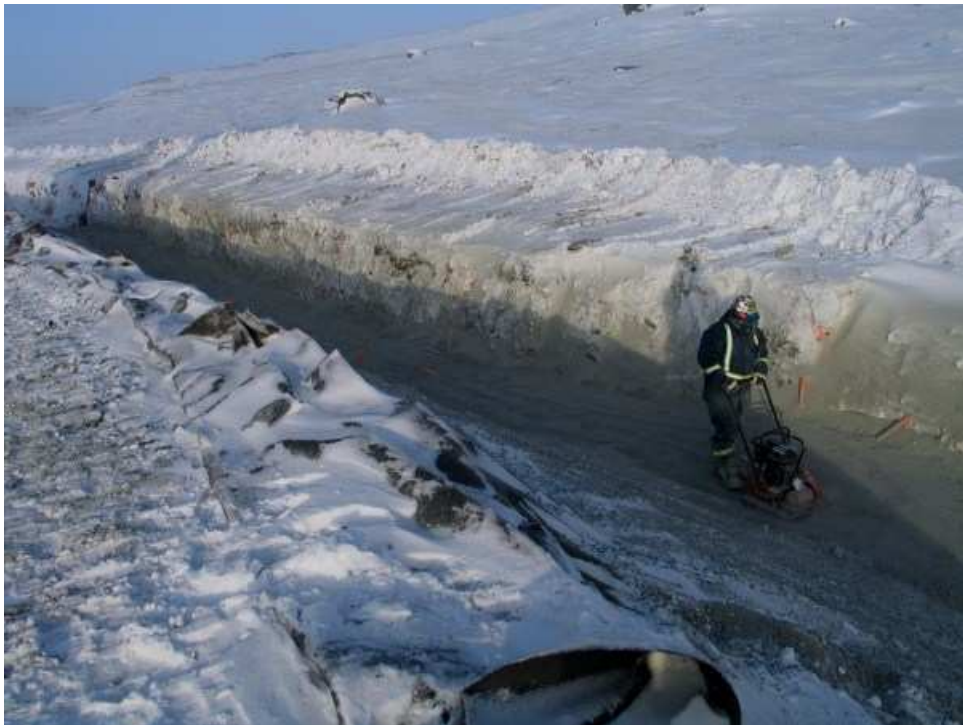
Photo 8: Packing bentonite between Sta 3+00 to Sta 3+35

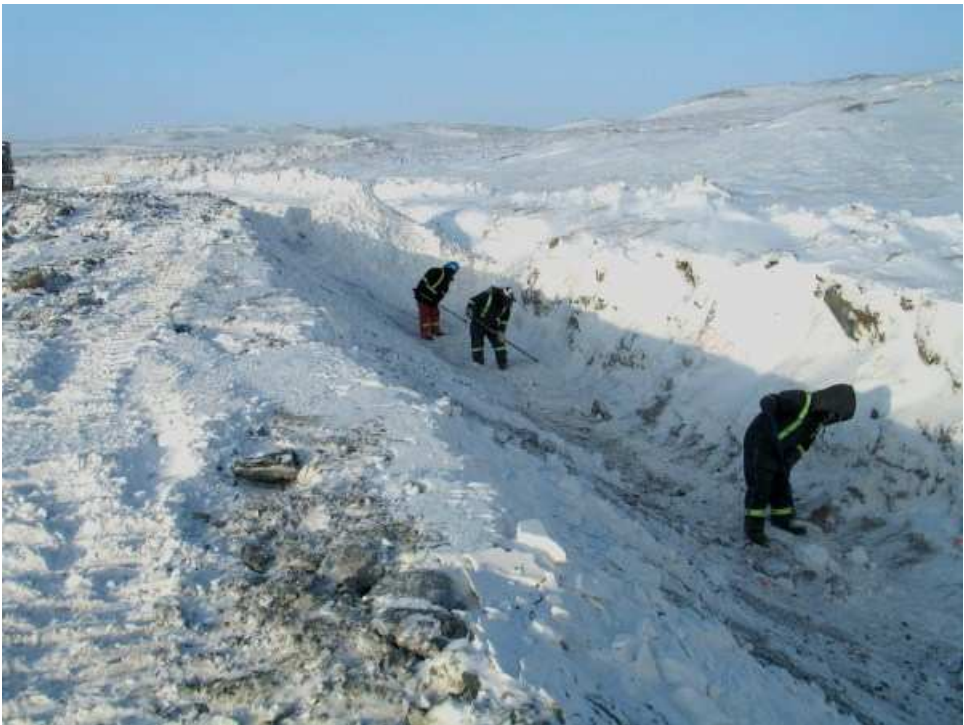
Photo 9: Cleaning bottom of key trench Sta 2+50 to 3+00

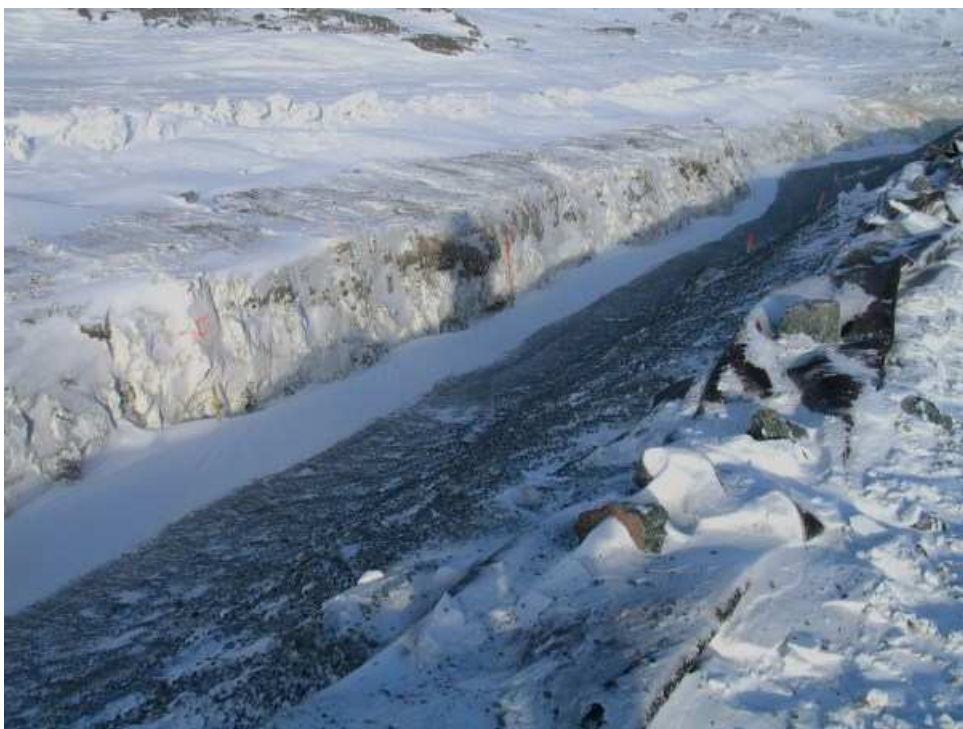
Photo 10: Drifting by mid afternoon Sta 3+00 to Sta 3+35

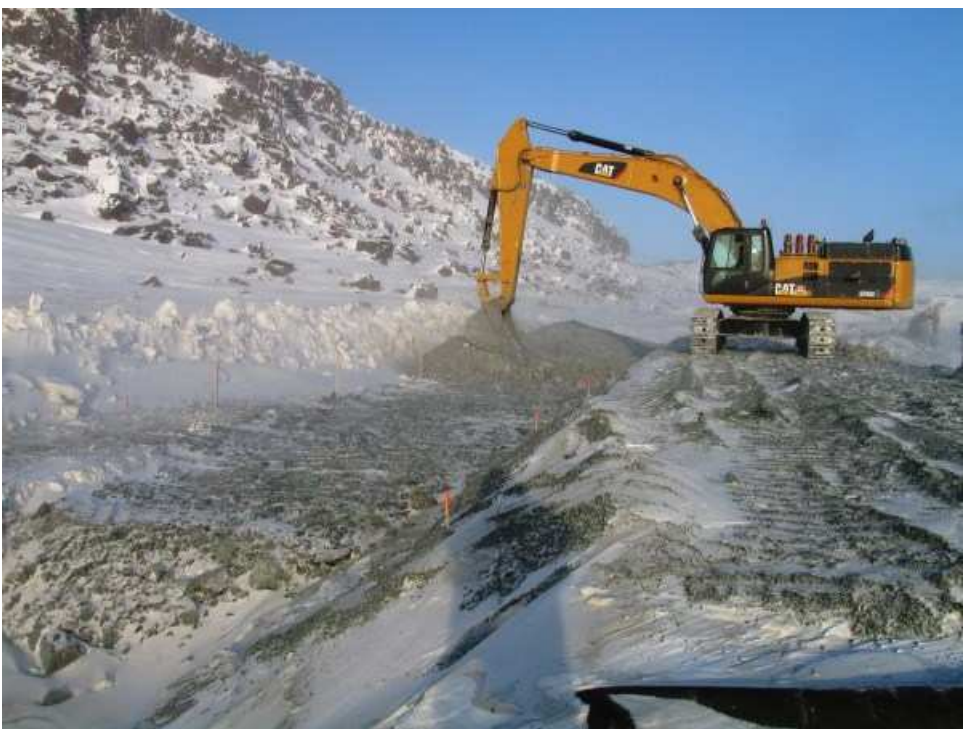
Photo 11: Placing second lift of ROQ ~ Sta 4+60

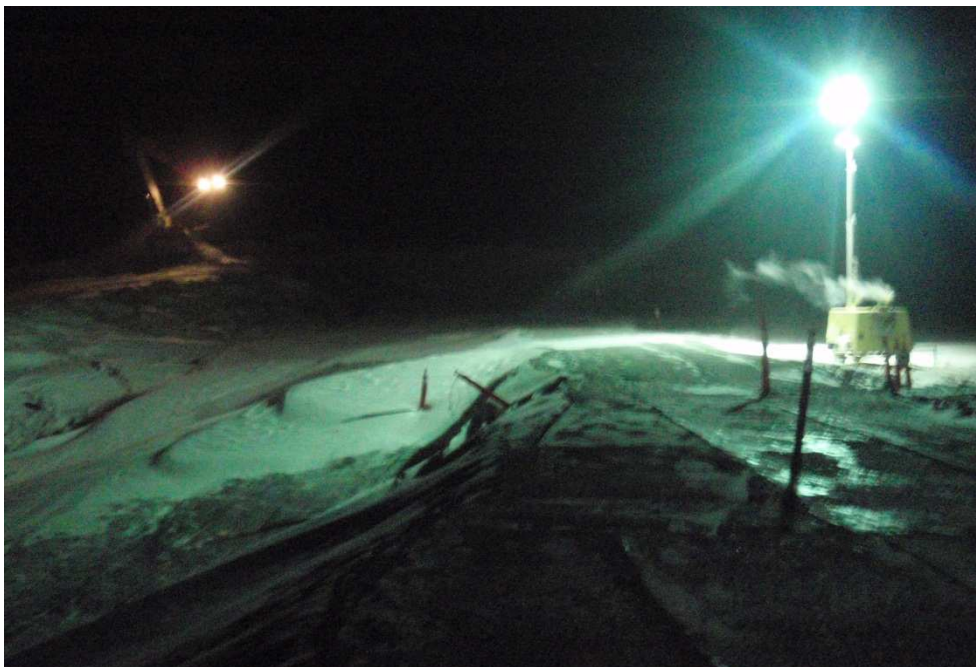
- Single bead thermistors were monitored.
 - The section from ~ 1+00 to 0+60 was noted as being -1.8C at the end of nightshift.
 - The SSE around station 0+55 to 0+20 has had a lot of snow drifted over this location. The single bead reading for this nightshift placement is currently around +1.5C. It is expected that the snow is also slightly insulating this area and the corresponding single bead.

Photo 12: View of snow drifting into the underbuilt SSE upstream portion of the dam.

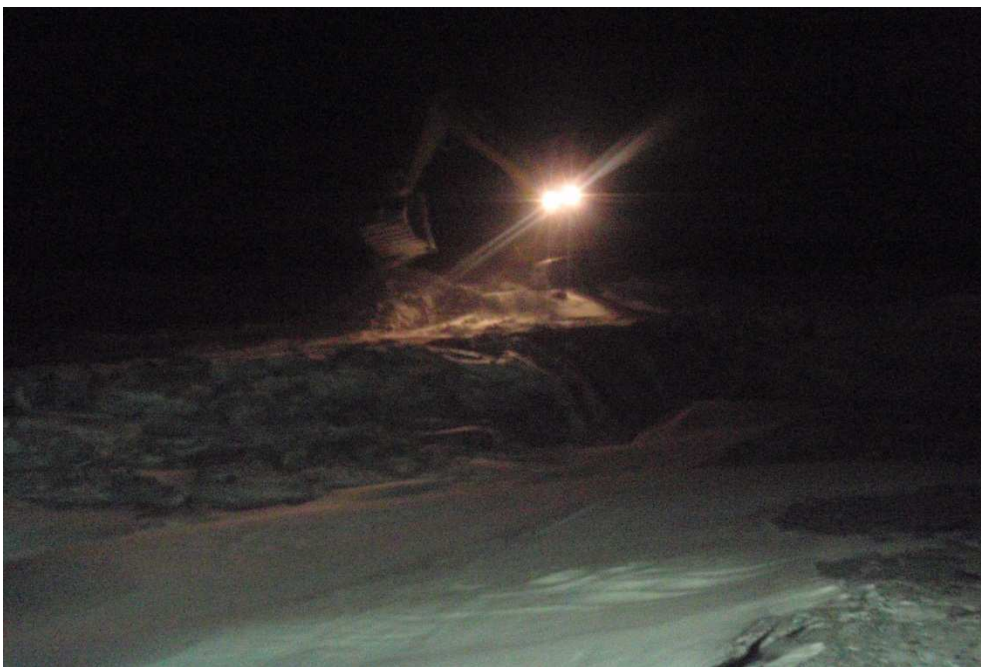
- Some snow was removed on the upstream around the south end (~ 0+40 to 0+10 areas). The excavator worked in this area to create additional access. Some of the ROQ was shaped in this area.

Photo 13: Excavator working on upstream S potion of dam.

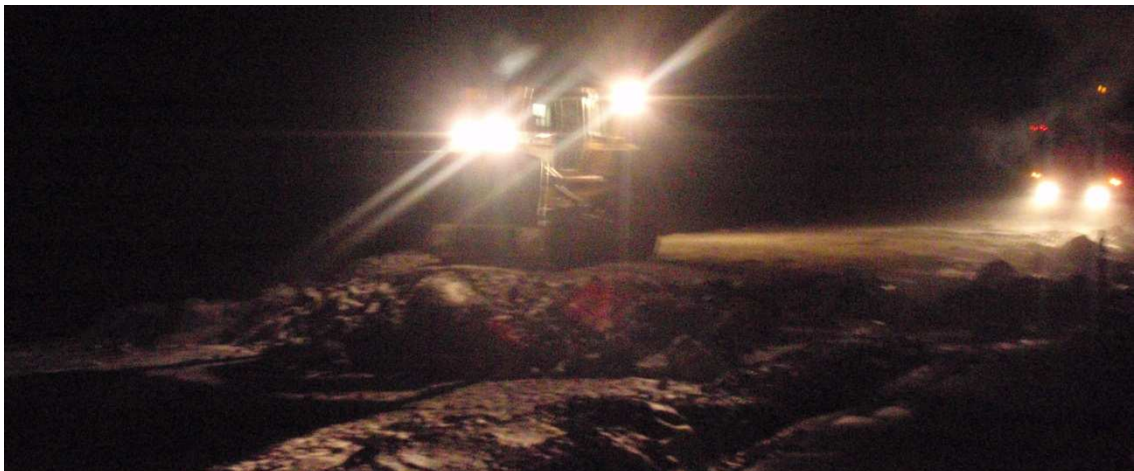
- ROQ material was placed with a D6.
- Some stockpiles of material, that were generated as the upstream slope was pulled back and the areas over the fillet expansion was cleaned (i.e. the inside adjacent core slope pulled back), were short hauled to the downstream and dumped.

Photo 13: D6 spreading ROQ on the downstream dam shell.

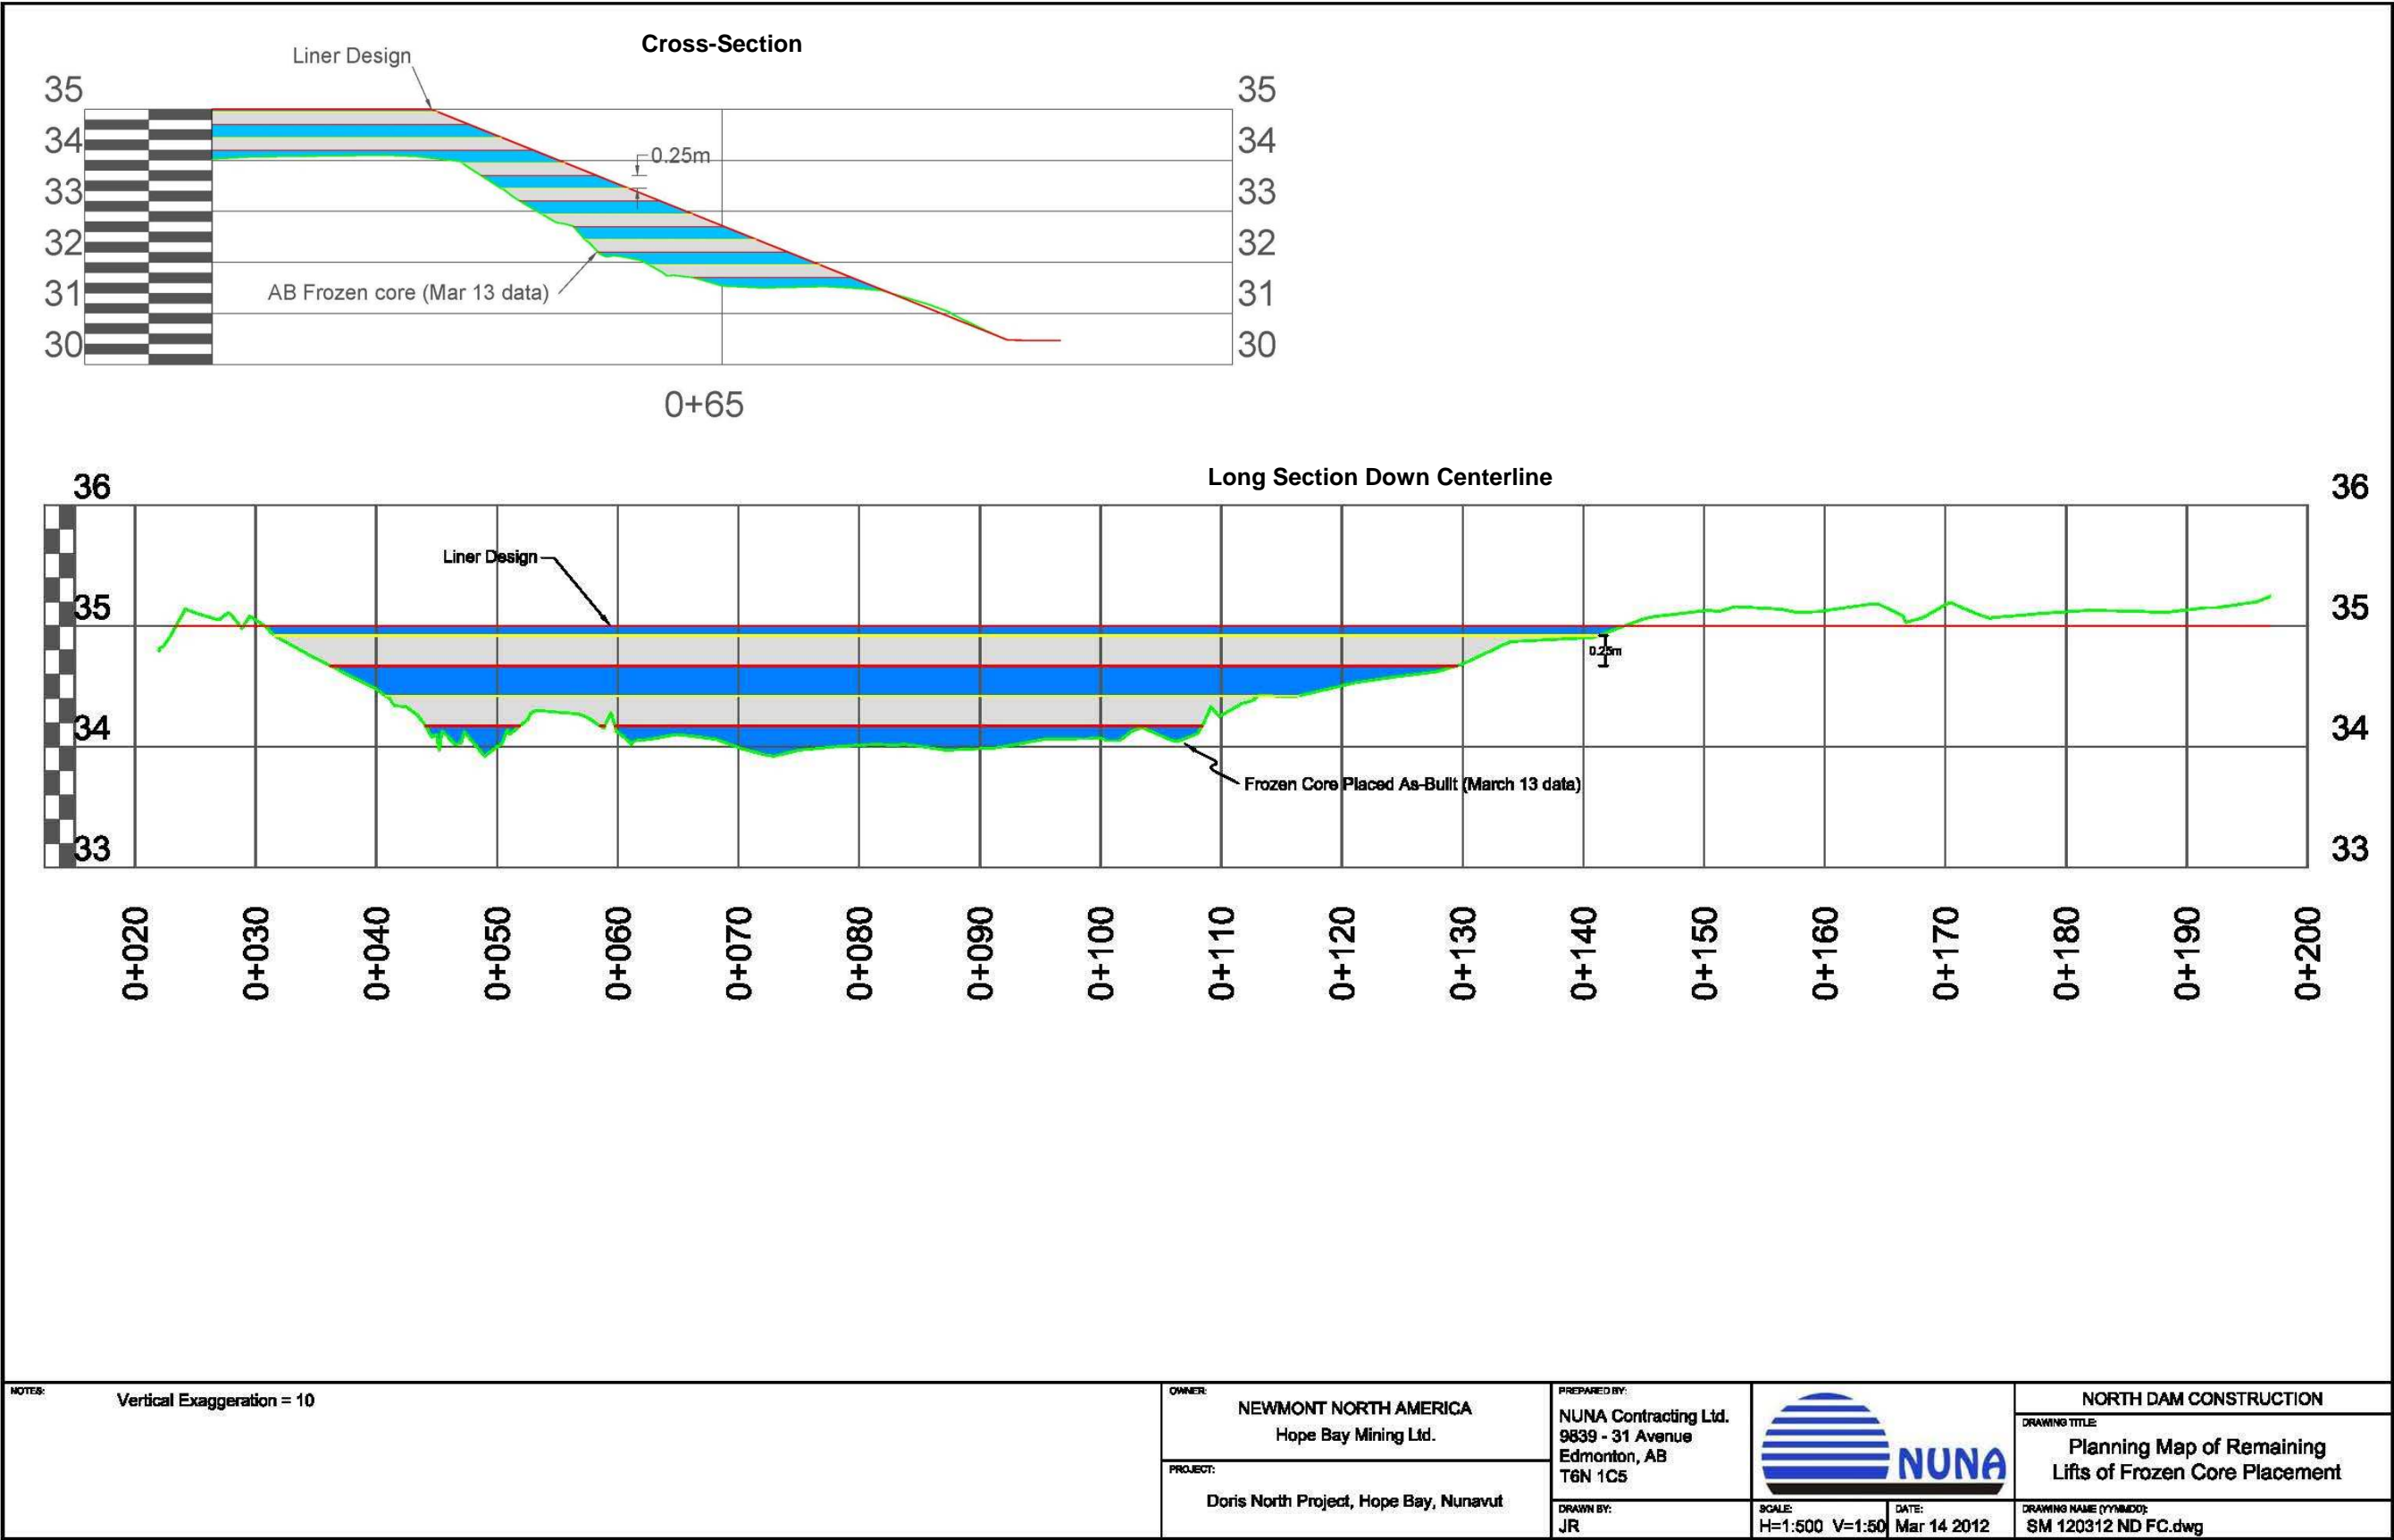
Figure 3 – North Dam, Remaining FCM Lifts to GCL Grade

- No FCM placement resulted today. As of March 14th 9,897 m³ of FCM have been placed at the dam in 2012.
- Sections, provided by Nuna survey, showing the remaining planned lifts at the North Dam are provided as Figure 3 at the end of this report. Based on review of these sections it can be seen that the SSE upstream slope area is expected to be last area to be completed.

- At this time it is planned that GCL placement will start from the North end and progress to the South as the FCM in the aforementioned SSE upstream slope area is brought up to grade in small lifts.
