DAILY REPORT #70 – DORIS NORTH INFRASTRUCTURE/ NORTH DAM

Prepared by:	John Kurylo Lawrence Borowski	Date:	2012.03.15
Reviewed by:		Project #:	1CH008.058.0320
Role	Company	Personnel – Position	On Site
Client	Hope Bay Mining Limited (HBML)	Angela Holzapfel – ESR Compliance Manager David Vokey – ESR Coordinator Don Ethelston – HSLP Advisor Dean Wold - Safety Jill Turk – ESR Coordinator Katsky Venter – ESR Manger Michelle Tanquay – ESR Site Manager Stirling Kelly – HSLP Advisor	Yes Yes No Yes No No Yes Yes
	JDS	Lloyd Jackson – Mechanical Superintendent Doug Fielding – Construction Manager Ishan Fechter – Construction Coordinator Jerry Graham – Construction Manager Kevin Whieldon – Project Coordinator Mark Valeriote – Construction Manager	No No Yes Yes No Yes
Engineering Design Consultants	SRK Consulting (Canada) Inc.	John Kurylo – Site Engineer Megan Miller – Site Engineer Lawrence Borowski – Site Engineer Murray McGregor – Site Engineer Iozsef Miskolczi – Site Engineer Lowell Wade – Senior Engineer	Yes No Yes No No No

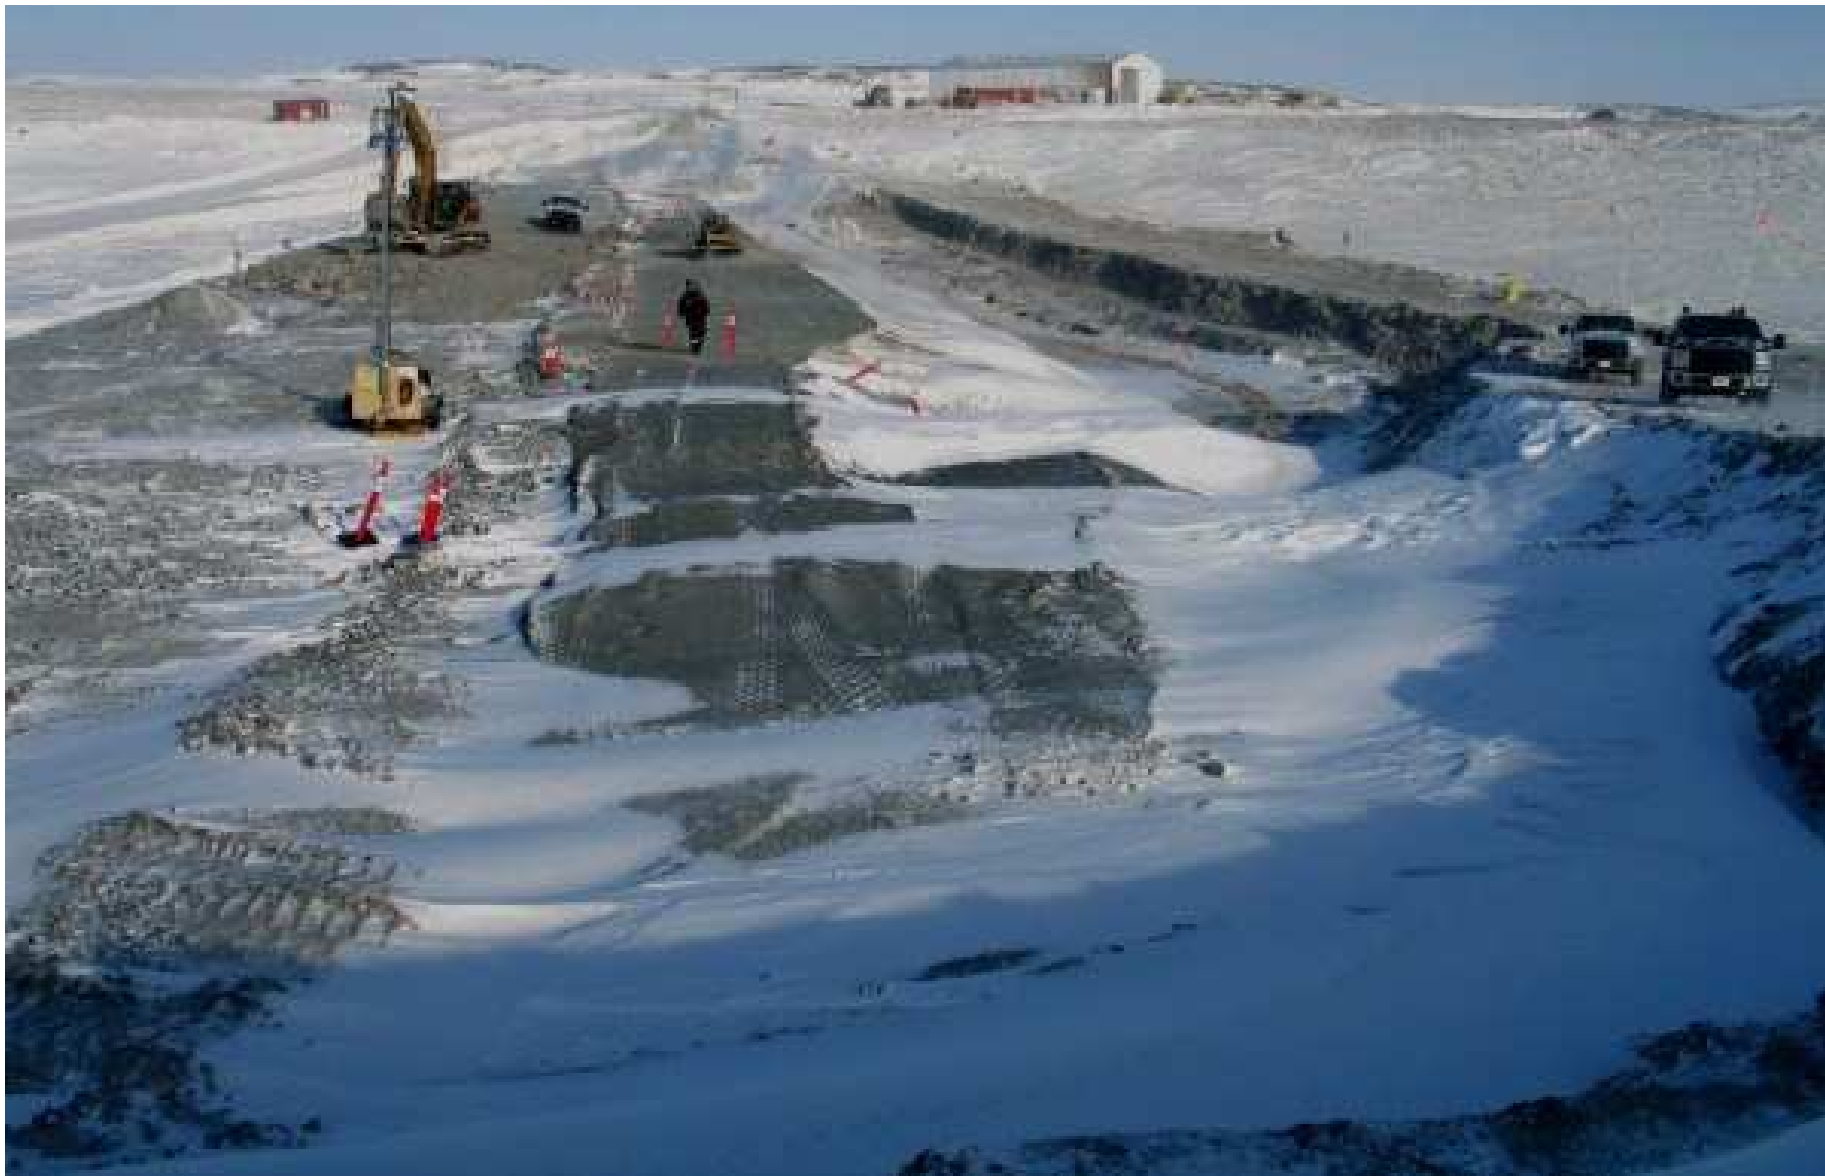
Photo 1: Progress photo from photo point 3. Note snow in SE corner.

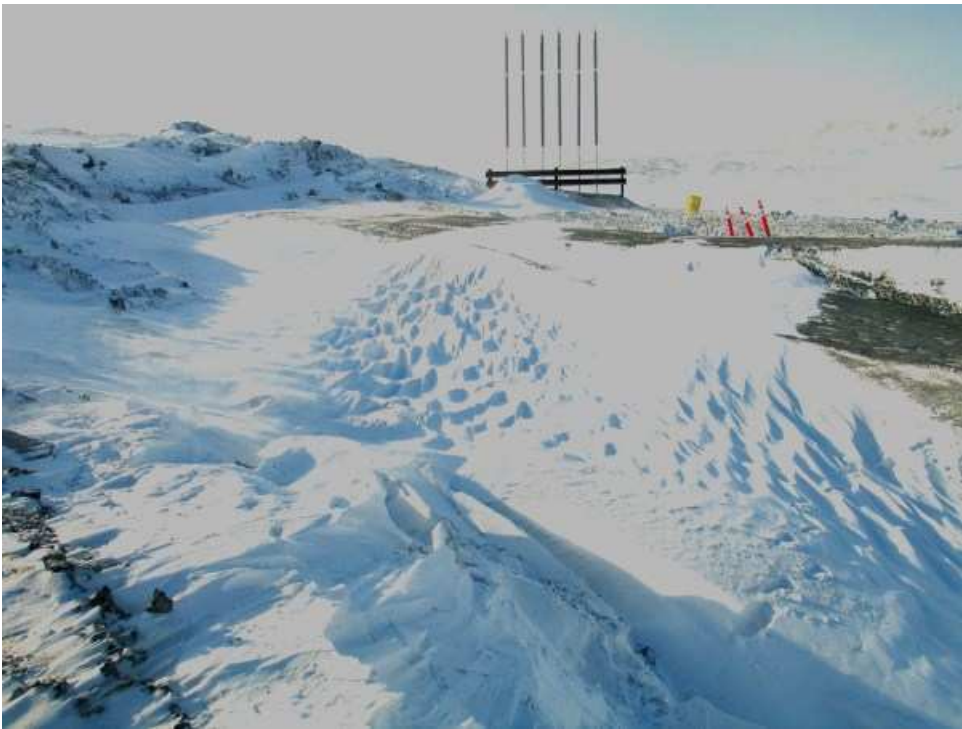
- Single bead thermistors were monitored.
- Snow is accumulating at the SE corner and along the entire length of the frozen core east slope.
- Today was planned shift change day. Some ROQ hauling and placing in the morning. After the plane failed to land there was the period of confusion where the decision had to be made whether to try again or abort. When the decision was made to abort, the site decision was made to pour FCM.
- Snow had blown off the pour area, and little effort was required to sweep it clean.
- FCM was placed between Sta 1+10 and Sta 0+64
- Due to strong winds and low temperatures (-33C) temperature at the plant was set at +40C
- Water dial started at 53, but was raised 3 times to 54.5.
- Nine loads were hauled. Plant operating time was 2.5 hours
- All test results met specifications.

Photo 4: SE corner facing south

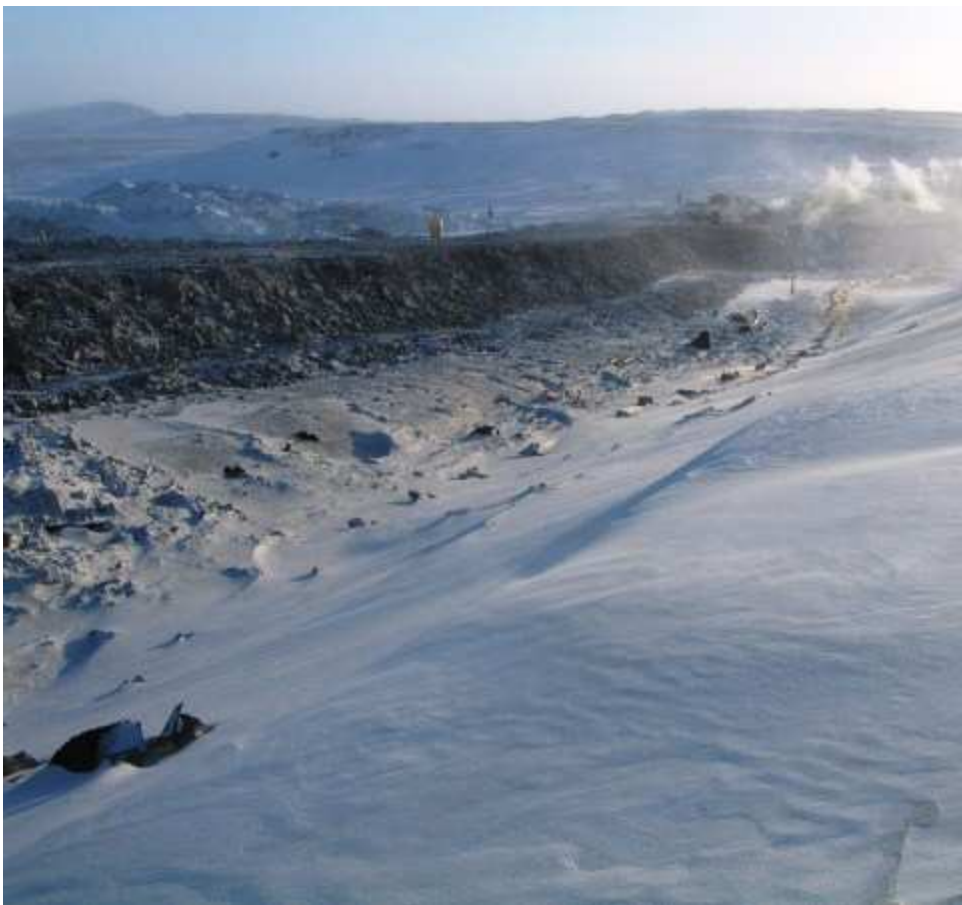
Photo 5: East bank excavation down to separation material.

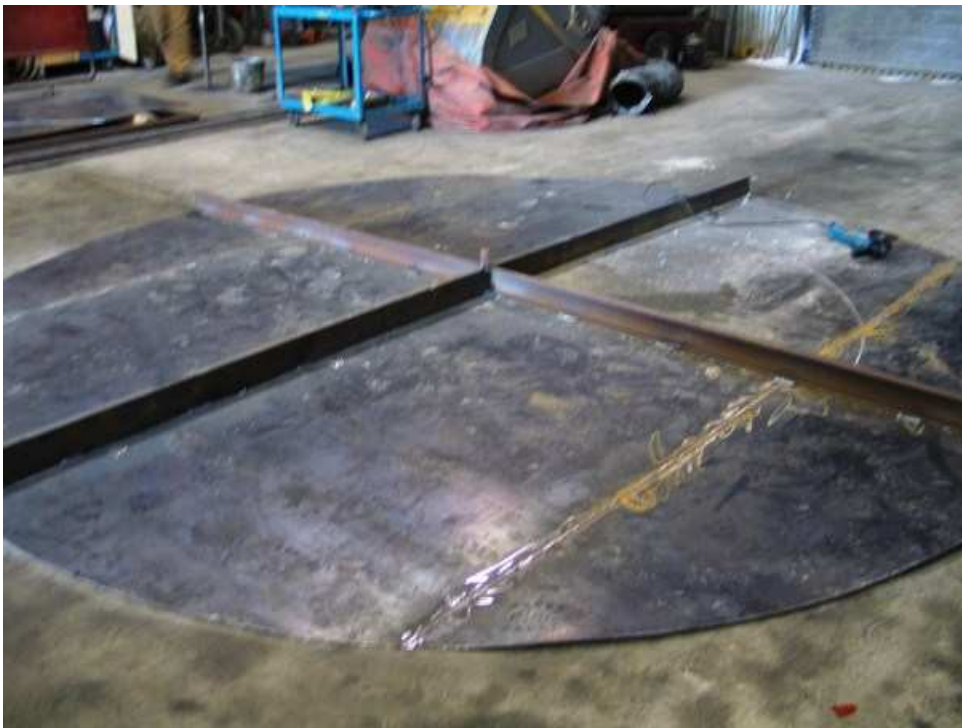
- Plates for the second lid have been welded together. The circle has not been cut out.

Photo 9: Progress on the second Sump lid

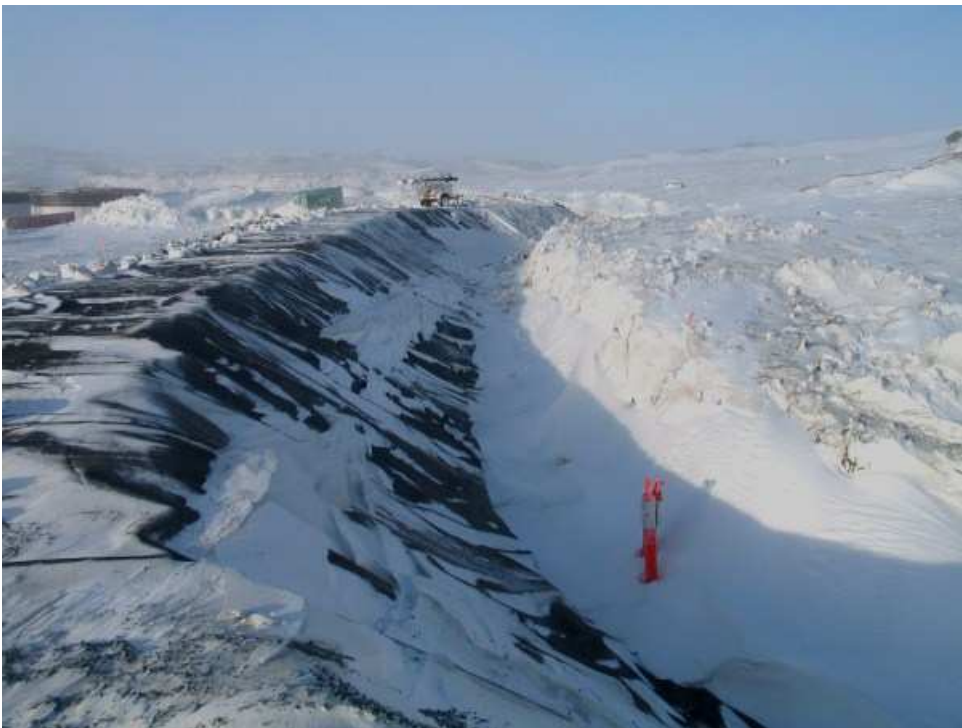
Photo 10: Snow blown in key trench Sta 4+45 facing west.

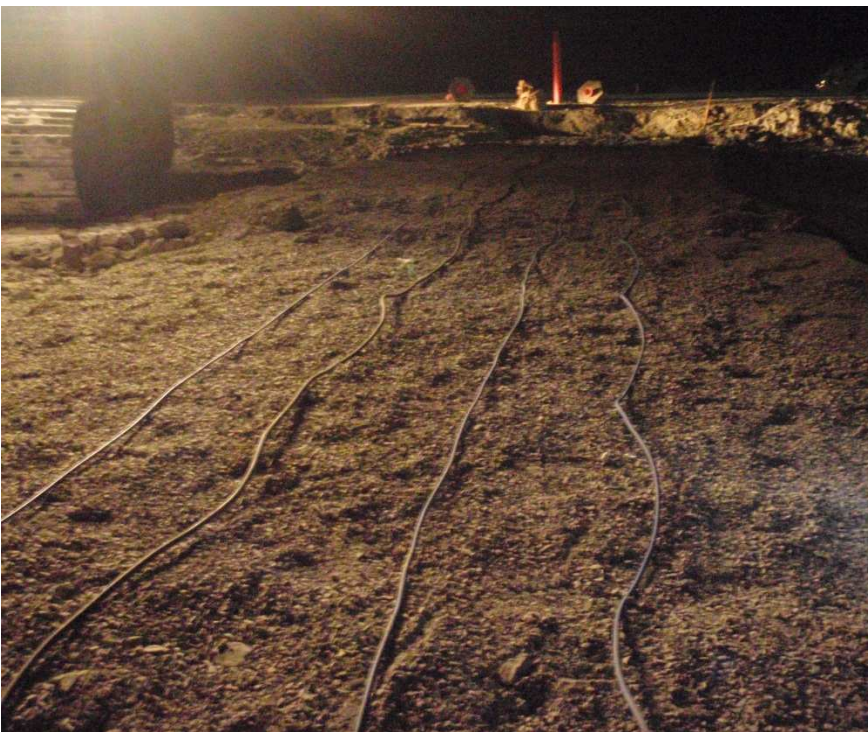
- On well graded compacted ROQ material a bed / pad of crush (dimensions as per original IFC design guidelines, i.e., ~ 0.3m thickness of crush below cables) was constructed at station 0+85. The multibead thermistors at station 0+85 were untangled and spread across the crush bedding pad (see Photo 12). After the multibead cables were strung to the downstream the excavator placed ~0.4m of crush material over the cables for protection. Once the cables were encased in core the excavator continued to bucket tamp the crush. See Photos 13 and 14. Crush to cover the cables was sourced from Quarry #2.

Photo 12: Thermistor cables being laid out around 0+85 in preparation for burring covering cables with additional crush.

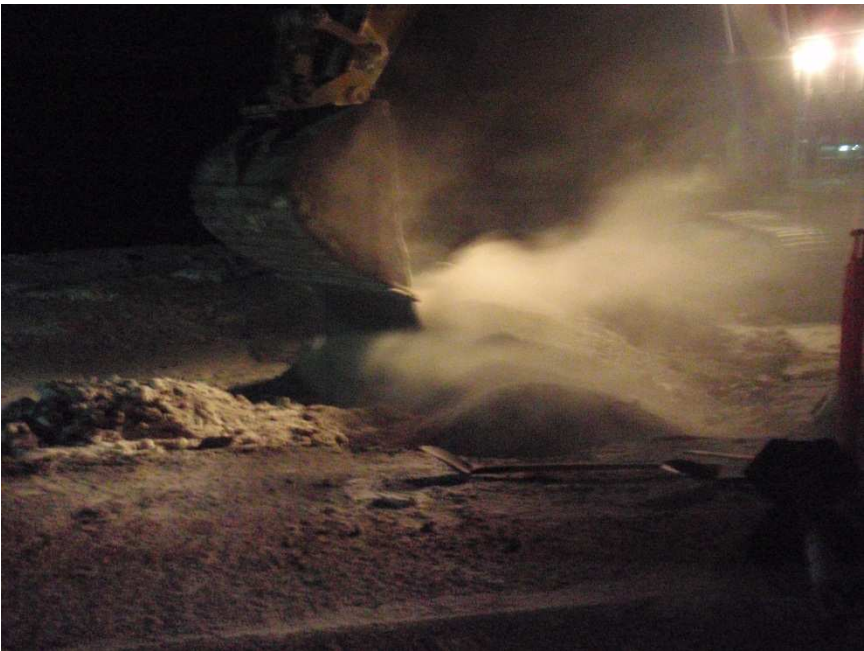
Photo 13: Excavator starting to place ¾" crush around sta 0+85.

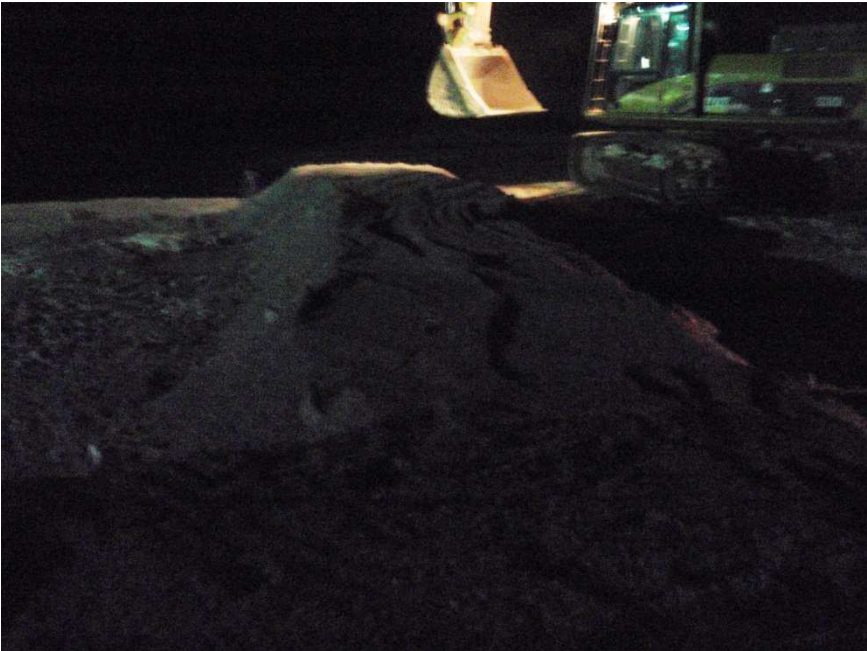
Photo 14: Excavator placing crush material over multi-bead. multi-bead thermistor strings.

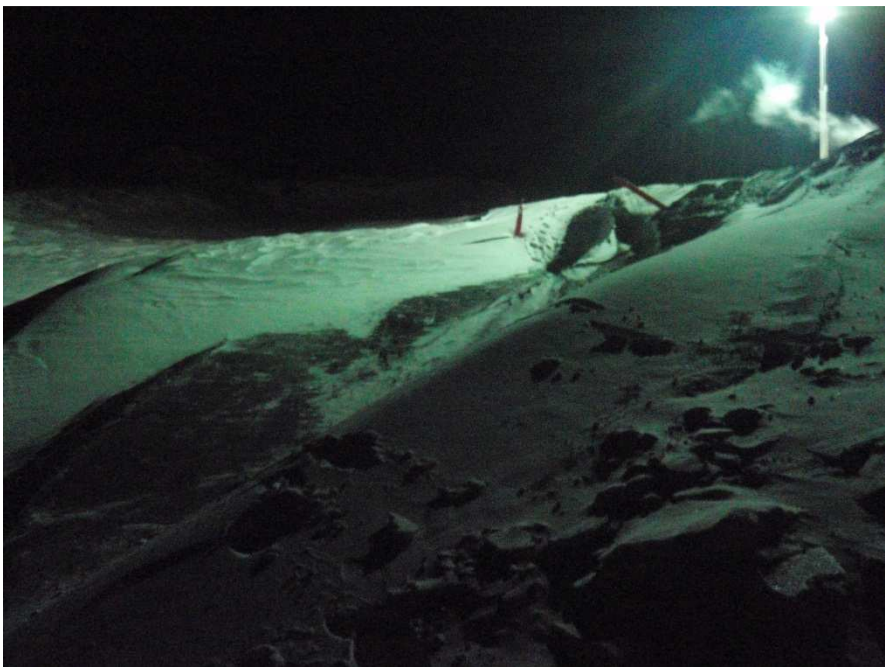
- The section from 0+55 to the south end (around 0+20) was noted as being +0C at the end of nightshift. Large snow drifts have accumulated over the area of the single bead (> 1m thick in areas).

Photo 15: Blown in snow over the SSE area. Note the cone in the

- The area from ~ 0+55 to 0+25 has not reached freezeback. As the top area of this lift has been left exposed and is not covered in snow, SRK has allowed for a one time allowance for the excavator to travel on the top portion of the slope so that it can remove the snow insulating the lower portion of the slope. See Photos 3, 4 and 15 for visuals of the area in question. Placement over this entire area will not result until freezeback has been reached at the single bead location.

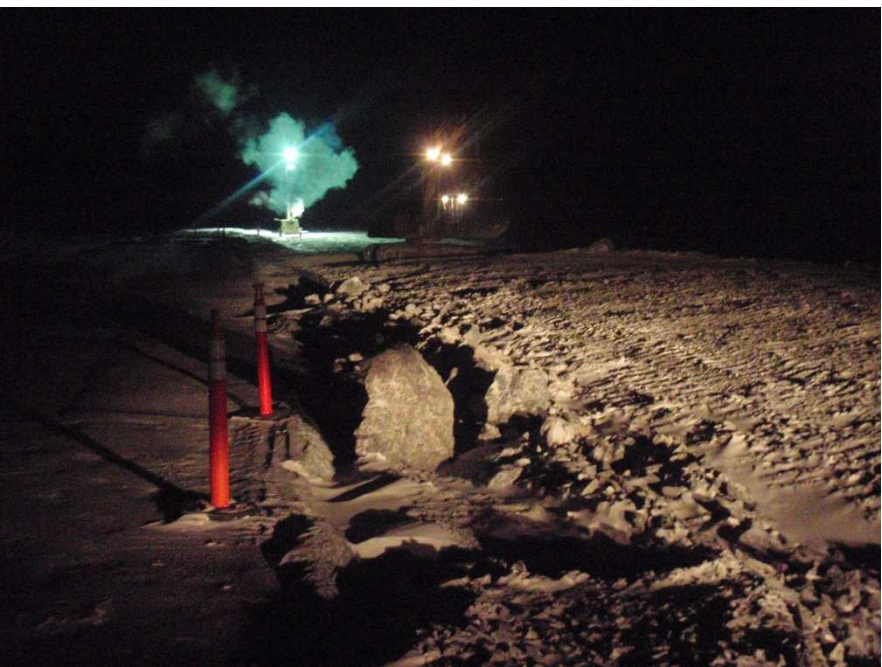
- Select ROQ material was placed over the protective crush placed over the multibeads at 0+85.
- Some snow and some boulders were cleared from within the downstream Transition material footprint. The boulders in this area were there as they were previously bladed to the side by the

dozer. See Photo 16. After the snow and oversized material was removed then Transition material was placed in areas from ~ 1+35 to 0+65 along the downstream edge (adjacent to the core). No compaction was observed to result on this material on nightshift.

Photo 16: View of a few larger boulders that were bladed to the side as ROQ placement progressed. These were removed from the Transition material footprint on the downstream before additional Transition material placement occurred on nightshift. background shows the location of single bead 27.

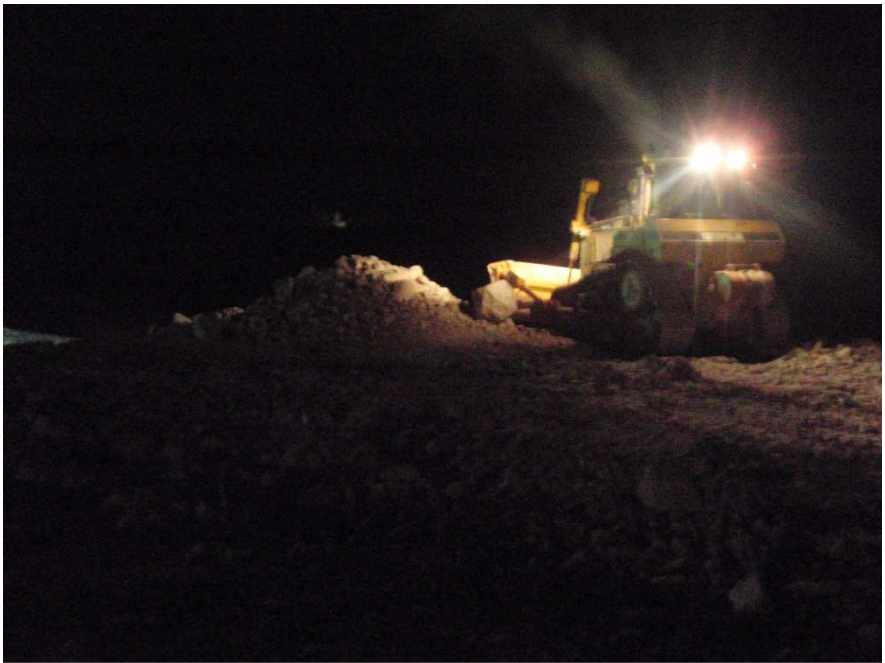
- ROQ material was placed on the downstream from ~0+95 to 0+75.
 - No compaction was observed on this material (packer was not working on nightshift).
 - ROQ material was placed with a D6.

Photo 17: View of D6 spreading ROQ material along downstream

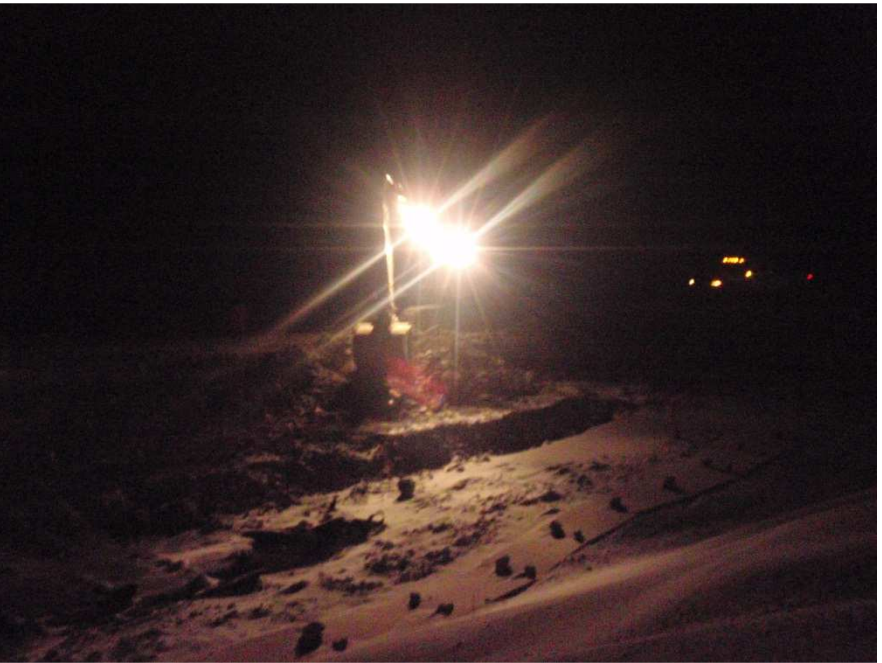
- Reject material was removed in areas from the upstream dam shell. Minor work with the excavator clearing buried 5/8 and HDPE material continued on the south end of the dam, primarily around the most southern end and around station 0+95.

Photo 18: Excavator removing ROQ from upstream inside slope to expose Transition material placed in 2011.

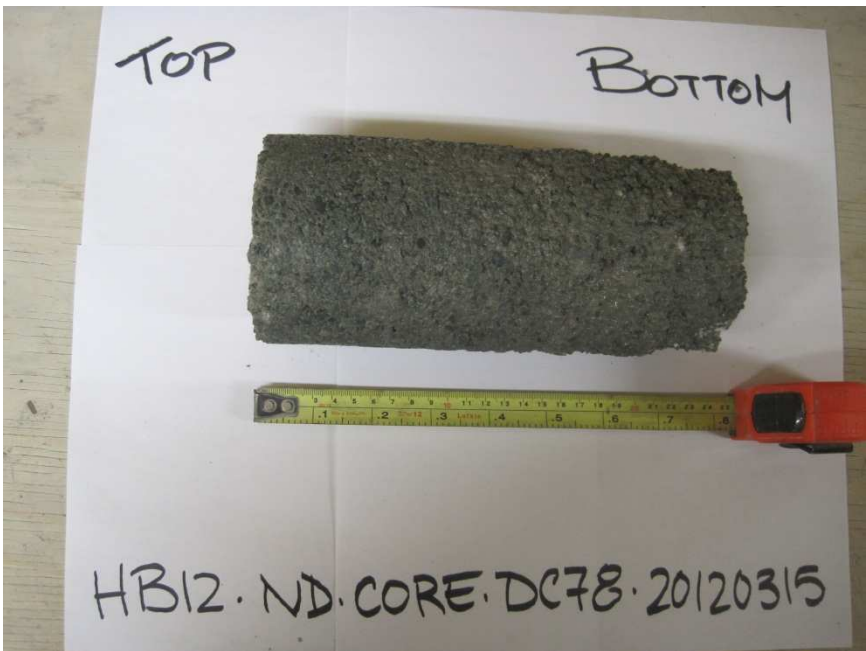
- Drilled core HB12-ND-CORE-DC78-20120315 was drilled today around station 0+65 CL. This was from the lift placed on March 13th dayshift.
- Drilled core HB12-ND-CORE-DC79-20120315 was drilled today around station 1+15 DS. This was from the lift placed on March 13th nightshift.

Photo 19: Drilled Core 78. Taken from ~ station 0+65 CL.

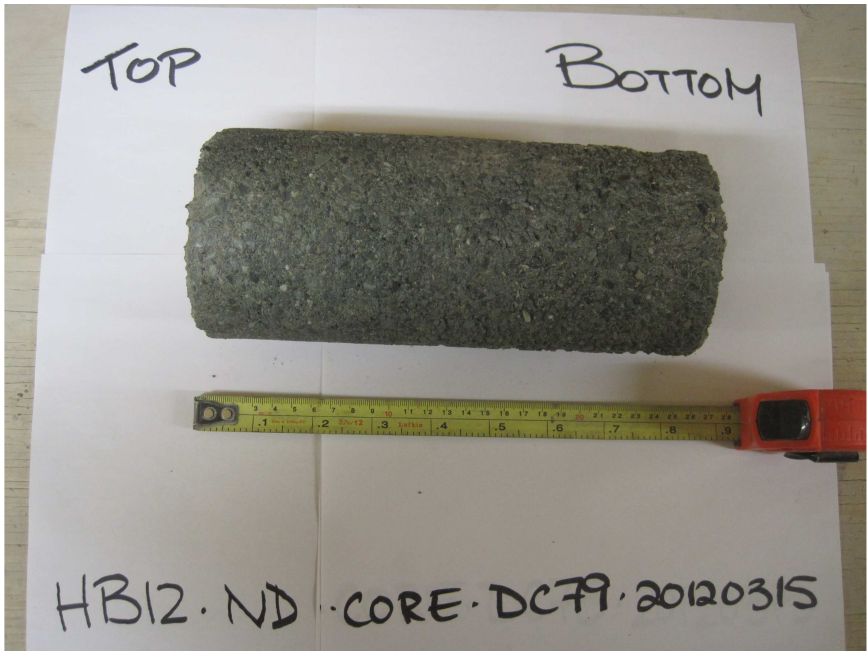
Photo 20: Drilled Core 79. Taken form ~ 1+15 DS.
