DAILY REPORT #71 – DORIS NORTH INFRASTRUCTURE/ NORTH DAM

Prepared by:	John Kurylo Lawrence Borowski	Date:	2012.03.16
Reviewed by:		Project #:	1CH008.058.0320
Role	Company	Personnel – Position	On Site
Client	Hope Bay Mining Limited (HBML)	Angela Holzapfel – ESR Compliance Manager David Vokey – ESR Coordinator Don Ethelston – HSLP Advisor Dean Wold - Safety Jill Turk – ESR Coordinator Katsky Venter – ESR Manger Michelle Tanquay – ESR Site Manager Stirling Kelly – HSLP Advisor	Yes Yes In Out In No Out Out
	JDS	Lloyd Jackson – Mechanical Superintendent Doug Fielding – Construction Manager Ishan Fechter – Construction Coordinator Jerry Graham – Construction Manager Kevin Whieldon – Project Coordinator Mark Valeriote – Construction Manager	No In yes Out No Yes
Engineering Design Consultants	SRK Consulting (Canada) Inc.	John Kurylo – Site Engineer Megan Miller – Site Engineer Lawrence Borowski – Site Engineer Murray McGregor – Site Engineer Iozsef Miskolczi – Site Engineer Lowell Wade – Senior Engineer	Yes No Yes No No No

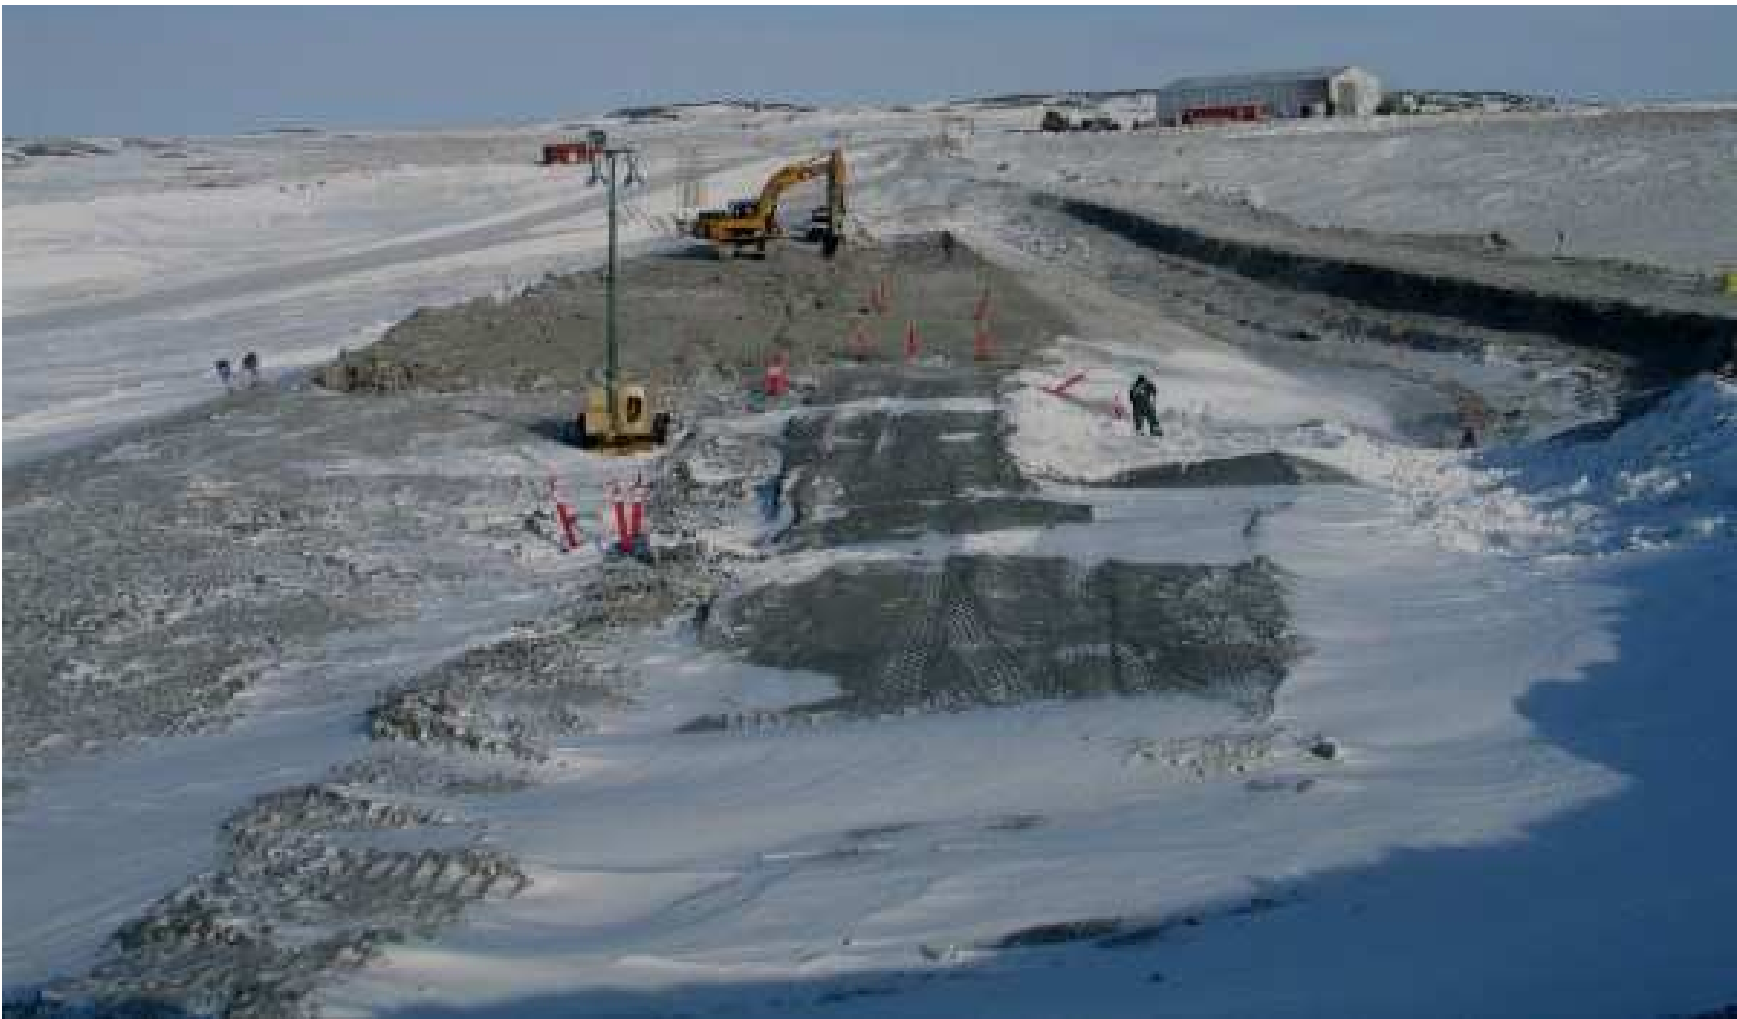
Photo 1: Construction progress. Photo taken from Point 3, Facing NNE

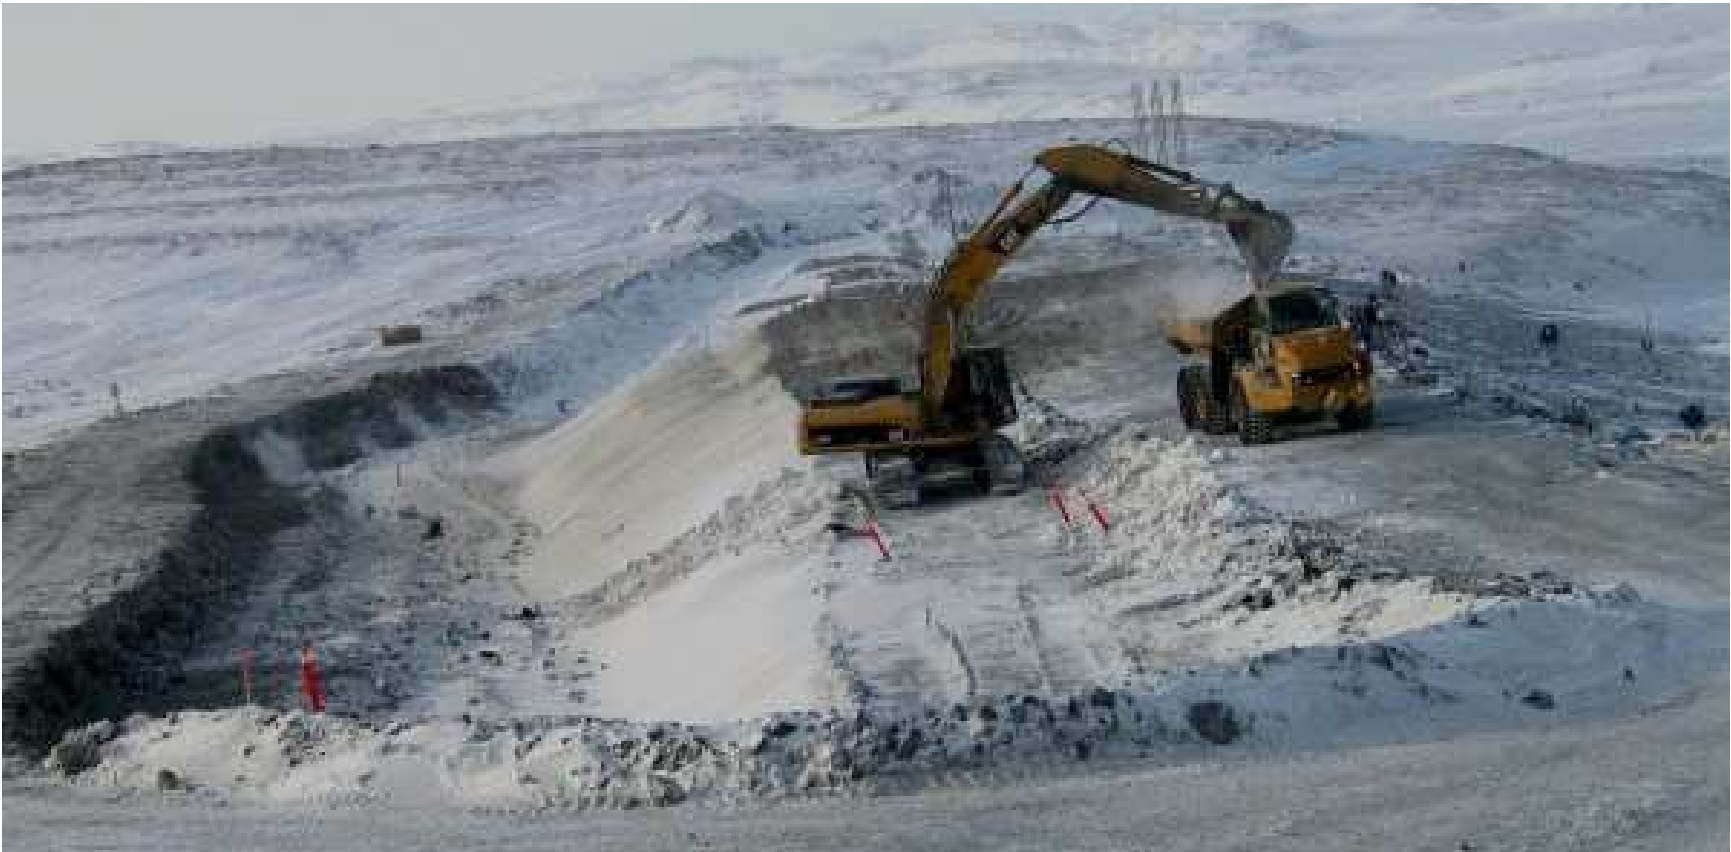
Photo 2: View of construction progress at the North Dam, looking down the centerline facing south

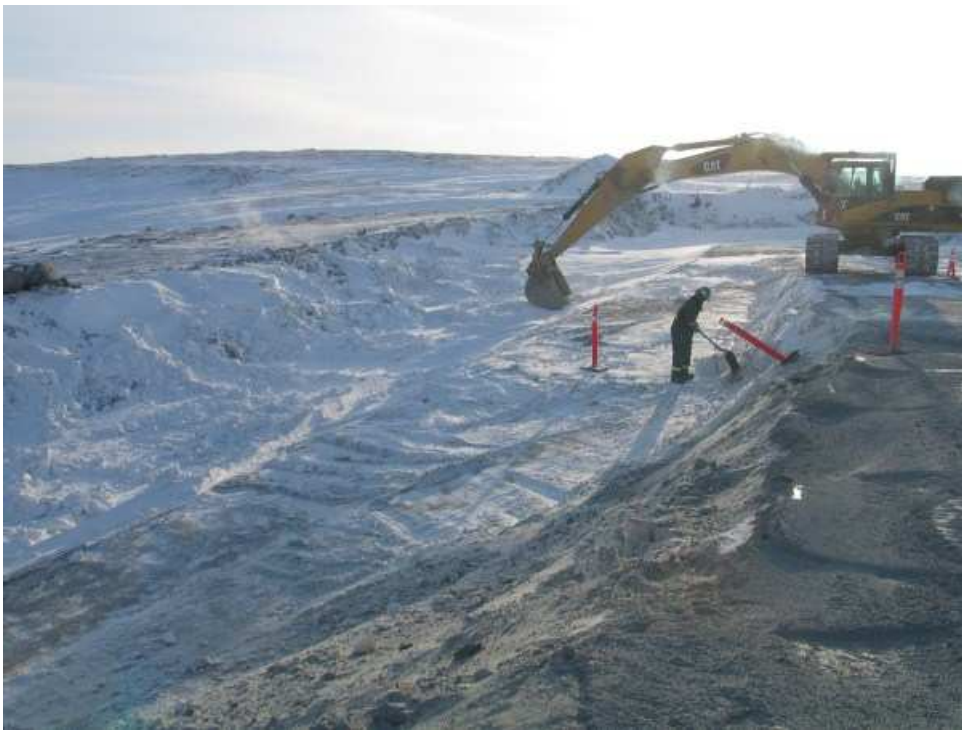
Photo 3: Clearing ramp at SE corner of dam

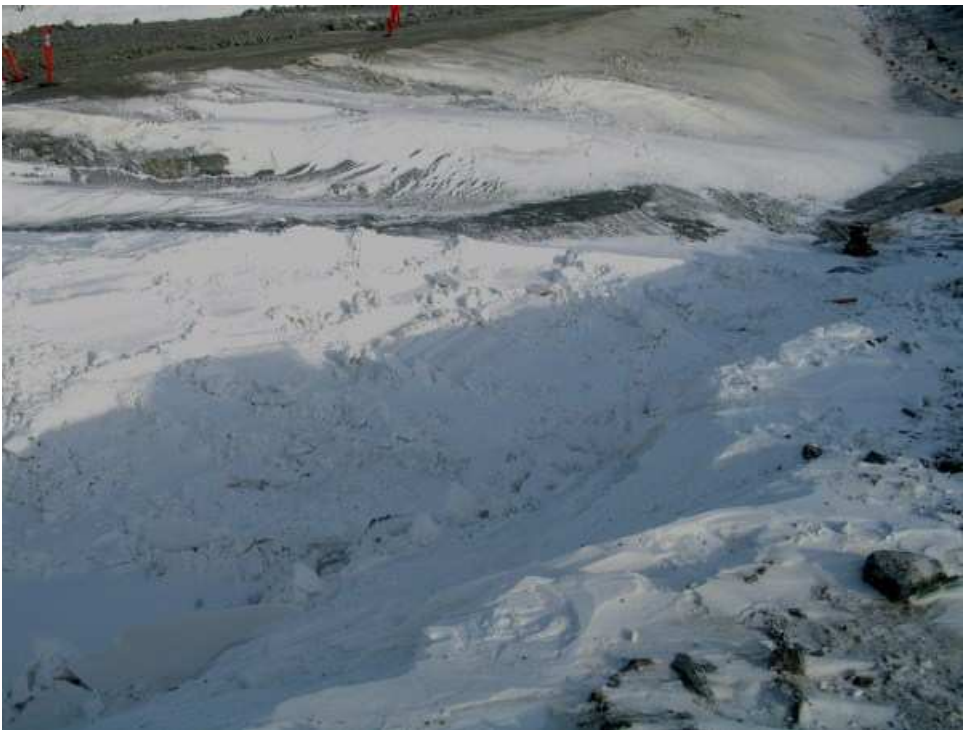
Photo 4: Some snow clearing over GCL at south end of core.

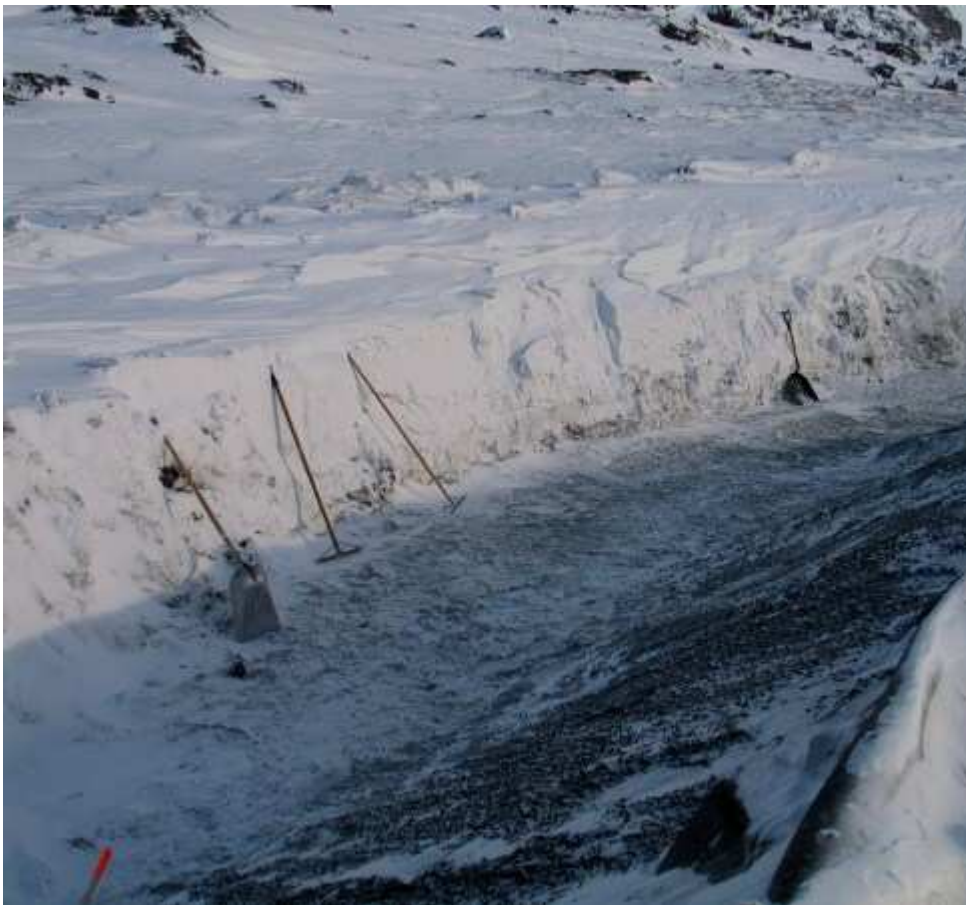
Photo 5; Cleaning Sta 2+95 to Sta 3+30 at the DN Diversion Berm

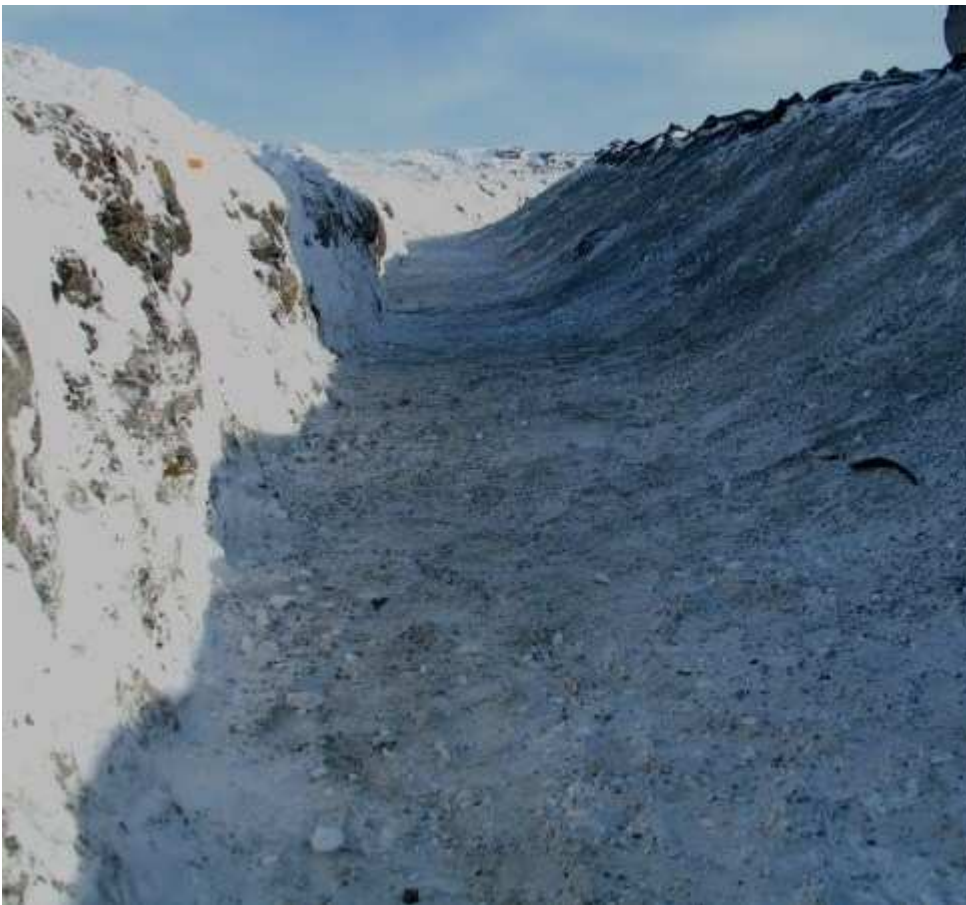
Photo 6: Sta 2+95 to Sta 3+3 cleaned at the Diversion Berm

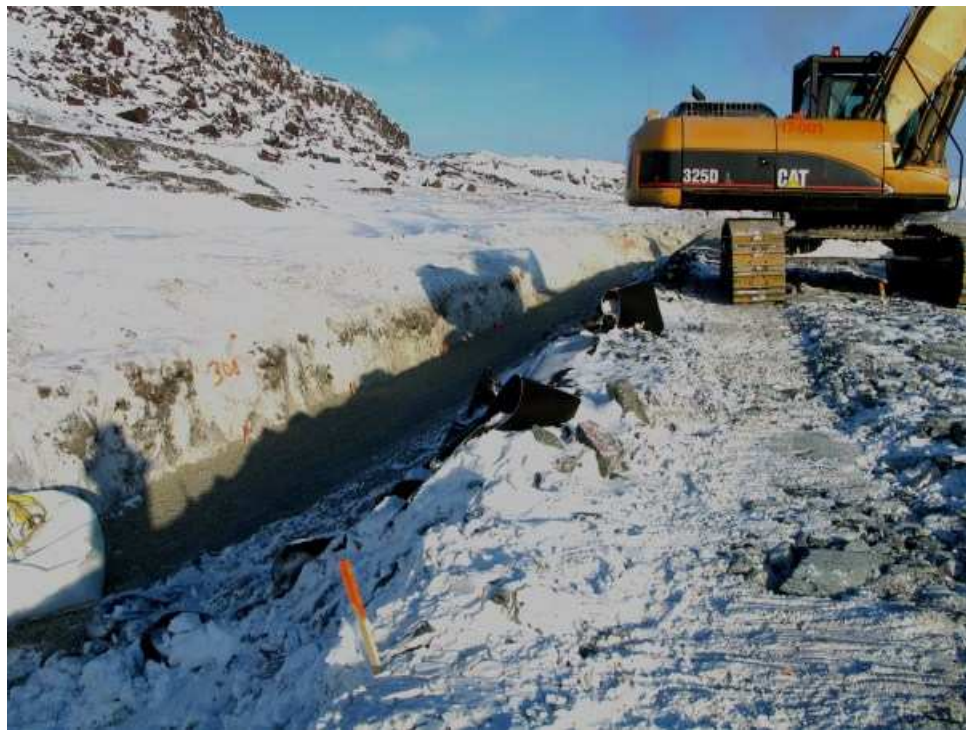
Photo 7: Bentonite placed Sta 2+95 to Sta 3+30 at the berm

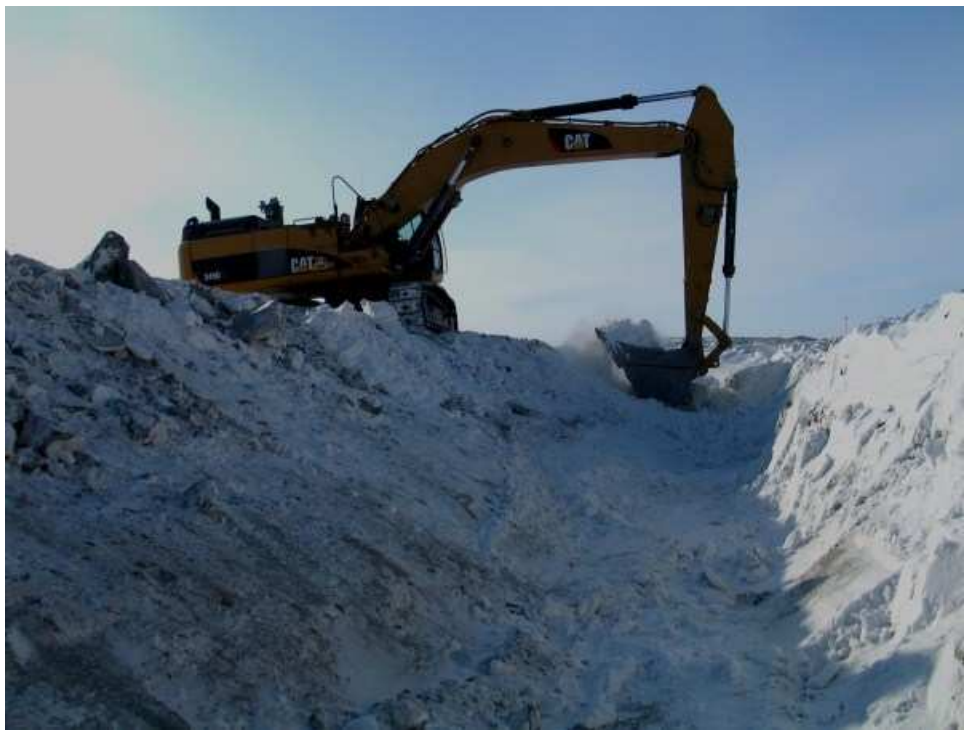
Photo 8: Moving forward. Over 1 m snow in trench of berm at ~ Sta 2+50

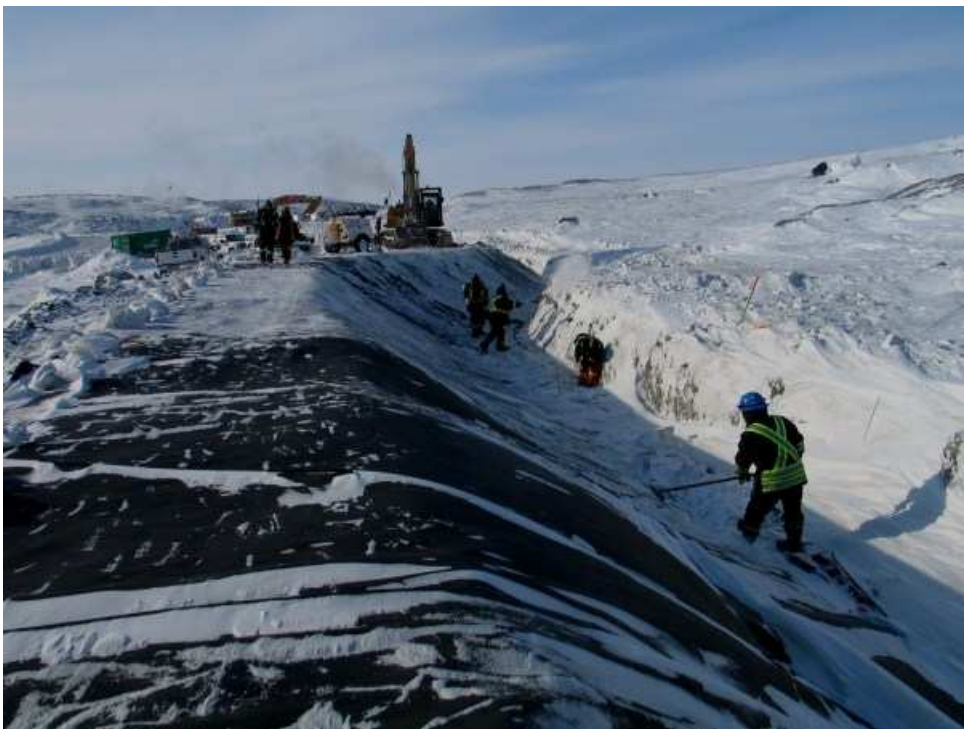
Photo 9: Cleaning snow off geotextile Stn 3+30 to Stn 4+45 at the berm

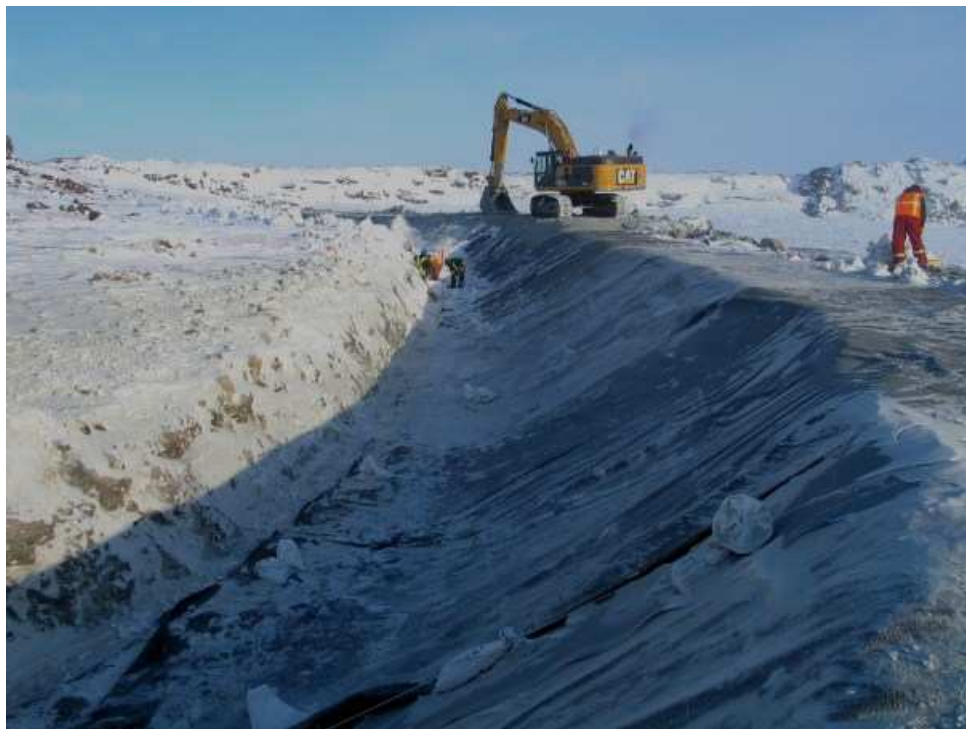
Photo 10: Preparing for overliner bentonite around Stn 3+30 to Stn 4+45 at the berm

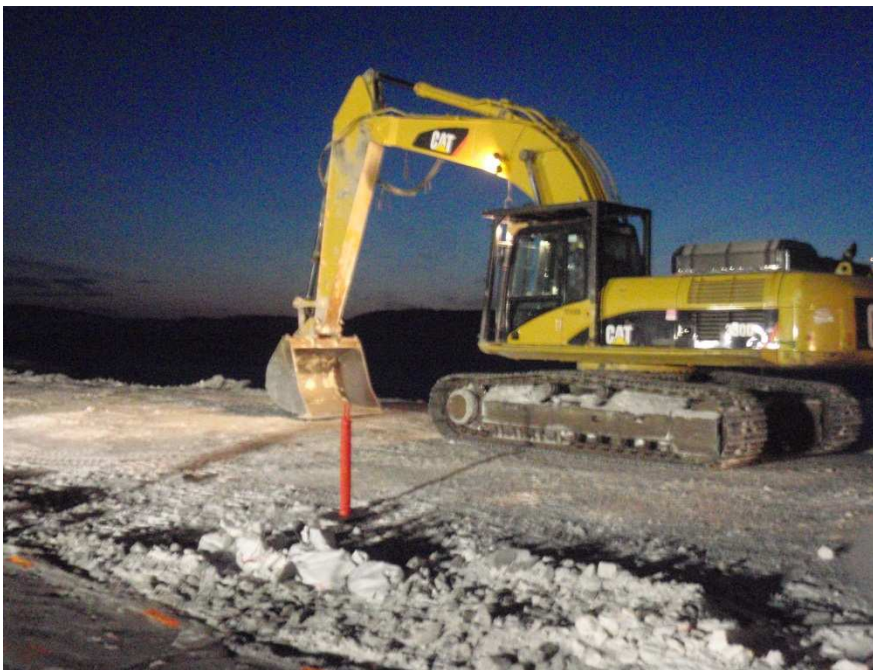
Photo 11: Excavator working on spreading and smoothing ROQ on the upstream

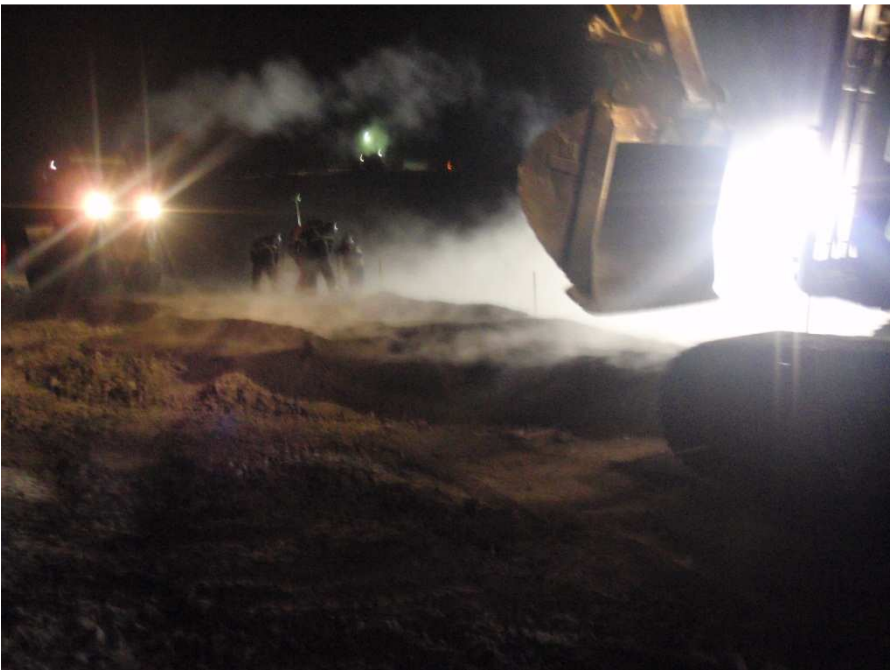
Photo 12: Excavator spreading FCM and labourers sloping side slope.

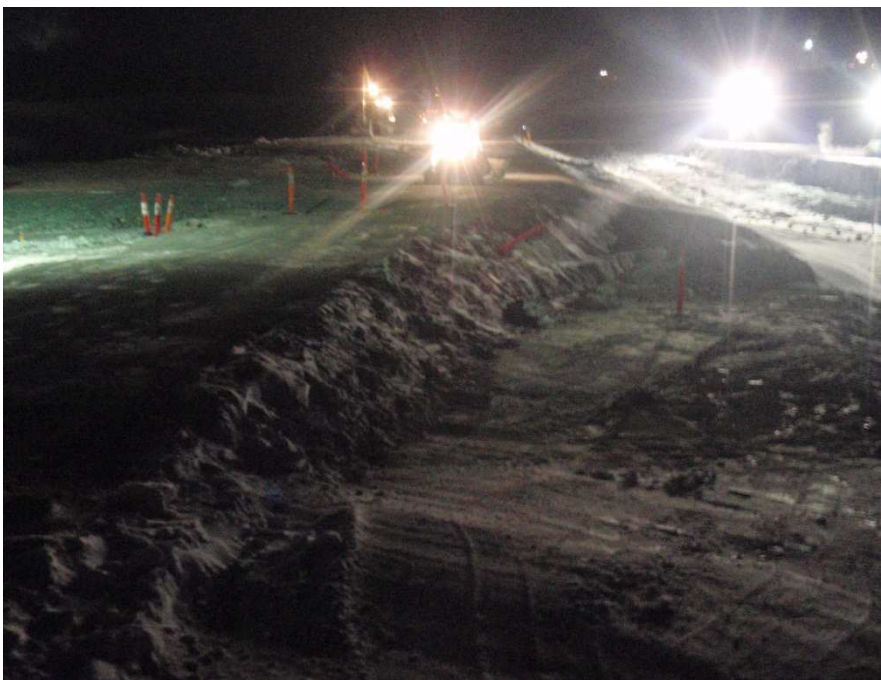
- Single bead thermistors were monitored.
 - The section from 0+55 to the south end (around 0+20) was noted as being ~-0.5C at the end of nightshift. The large snow drifts that were previously over this area have now been mostly removed.

- As noted in Daily #70, due to the slow freezeback being noted in the area of the single bead (see notes above) it was decided by SRK that, as the area has been left for over 48 hours that the skid steer would be allowed onto the surface to clean off more of snow that is insulating this area.

Photo 13 (mid left): SSE underbuilt corner after some snow cleaning (still waiting for freeze back).

- Placement over this entire area will not result until freezeback has been reached at the single bead location. This is due to the fact that the heat in the lift placed in this SSE area is required to dissipate before it is trapped in by an overlying lift.

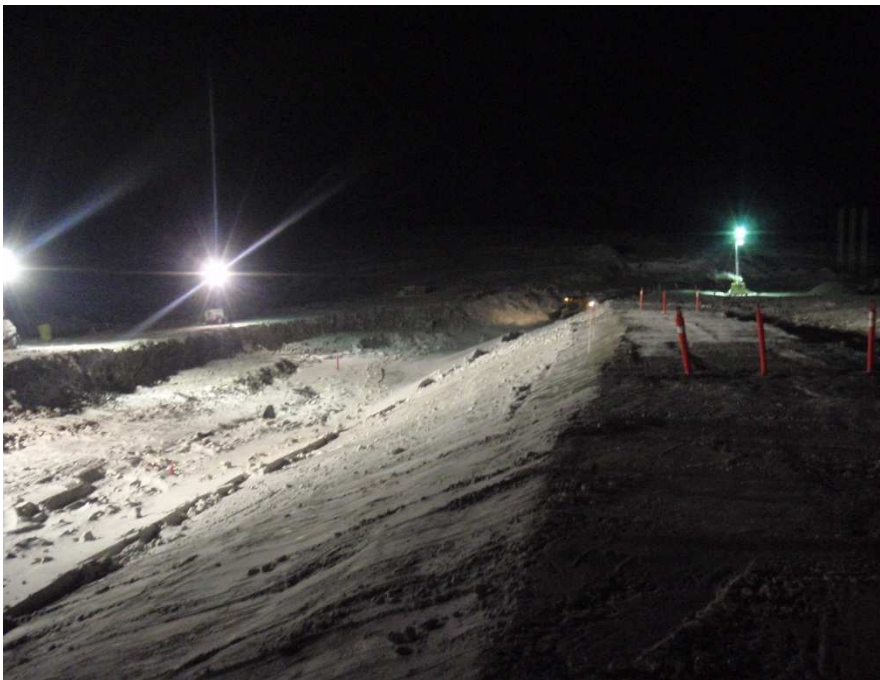
Photo 14 (mid right): ~SW view down dam core. Looking at upstream slope. Additional snow clearing on the upstream slope is still required in the coming days.

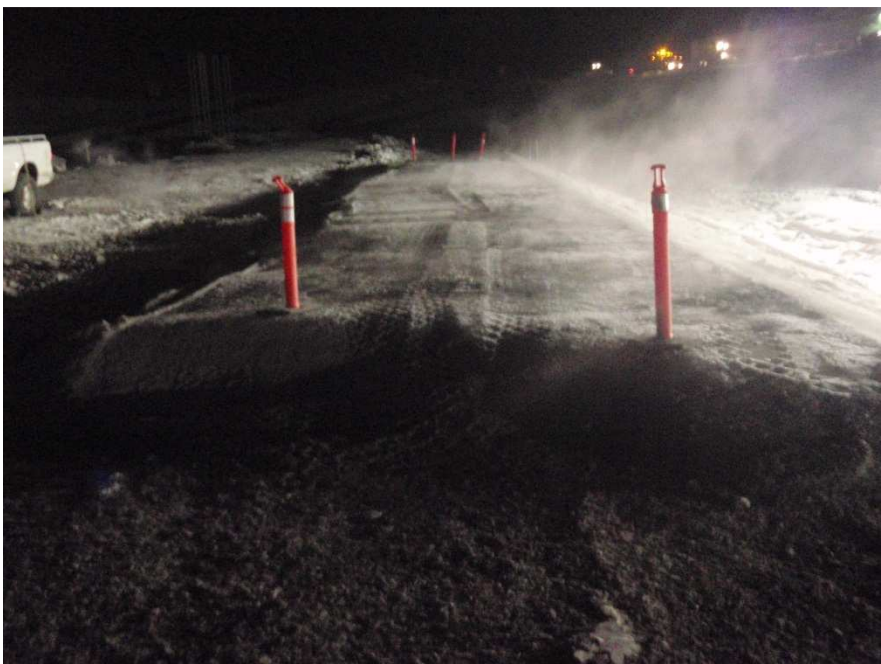
- FCM was placed from station ~1+45 to 1+10. Note that ~ from section 1+95 TO 1+30 is now at final grade.
- As of March 16th **10,039 m³** of FCM have been placed at the North Dam in 2012. On March 16th, 47.8 m³ of material was placed.

Photo 13: ~NE view of FCM placed on nightshift around 1+45 to 1+10

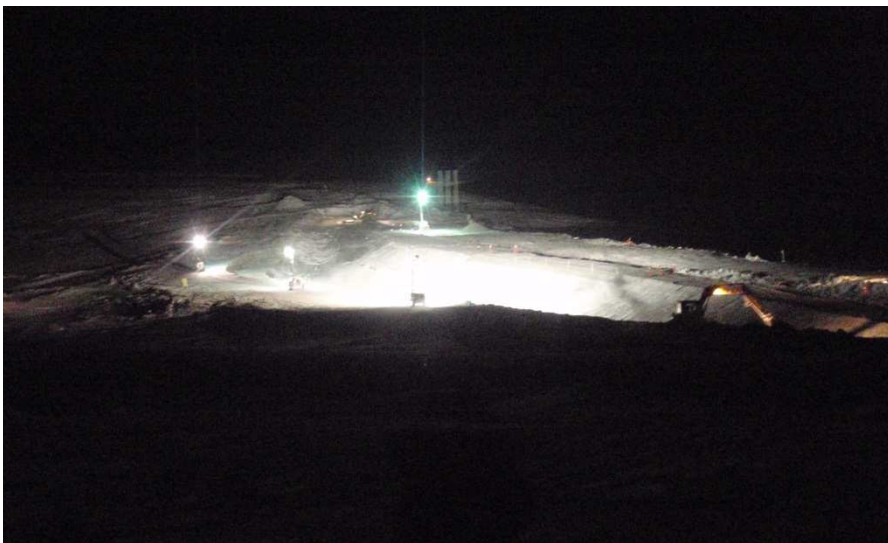
Photo 14: ~ E view of North Dam area. Taken from outside the FCP Pad.

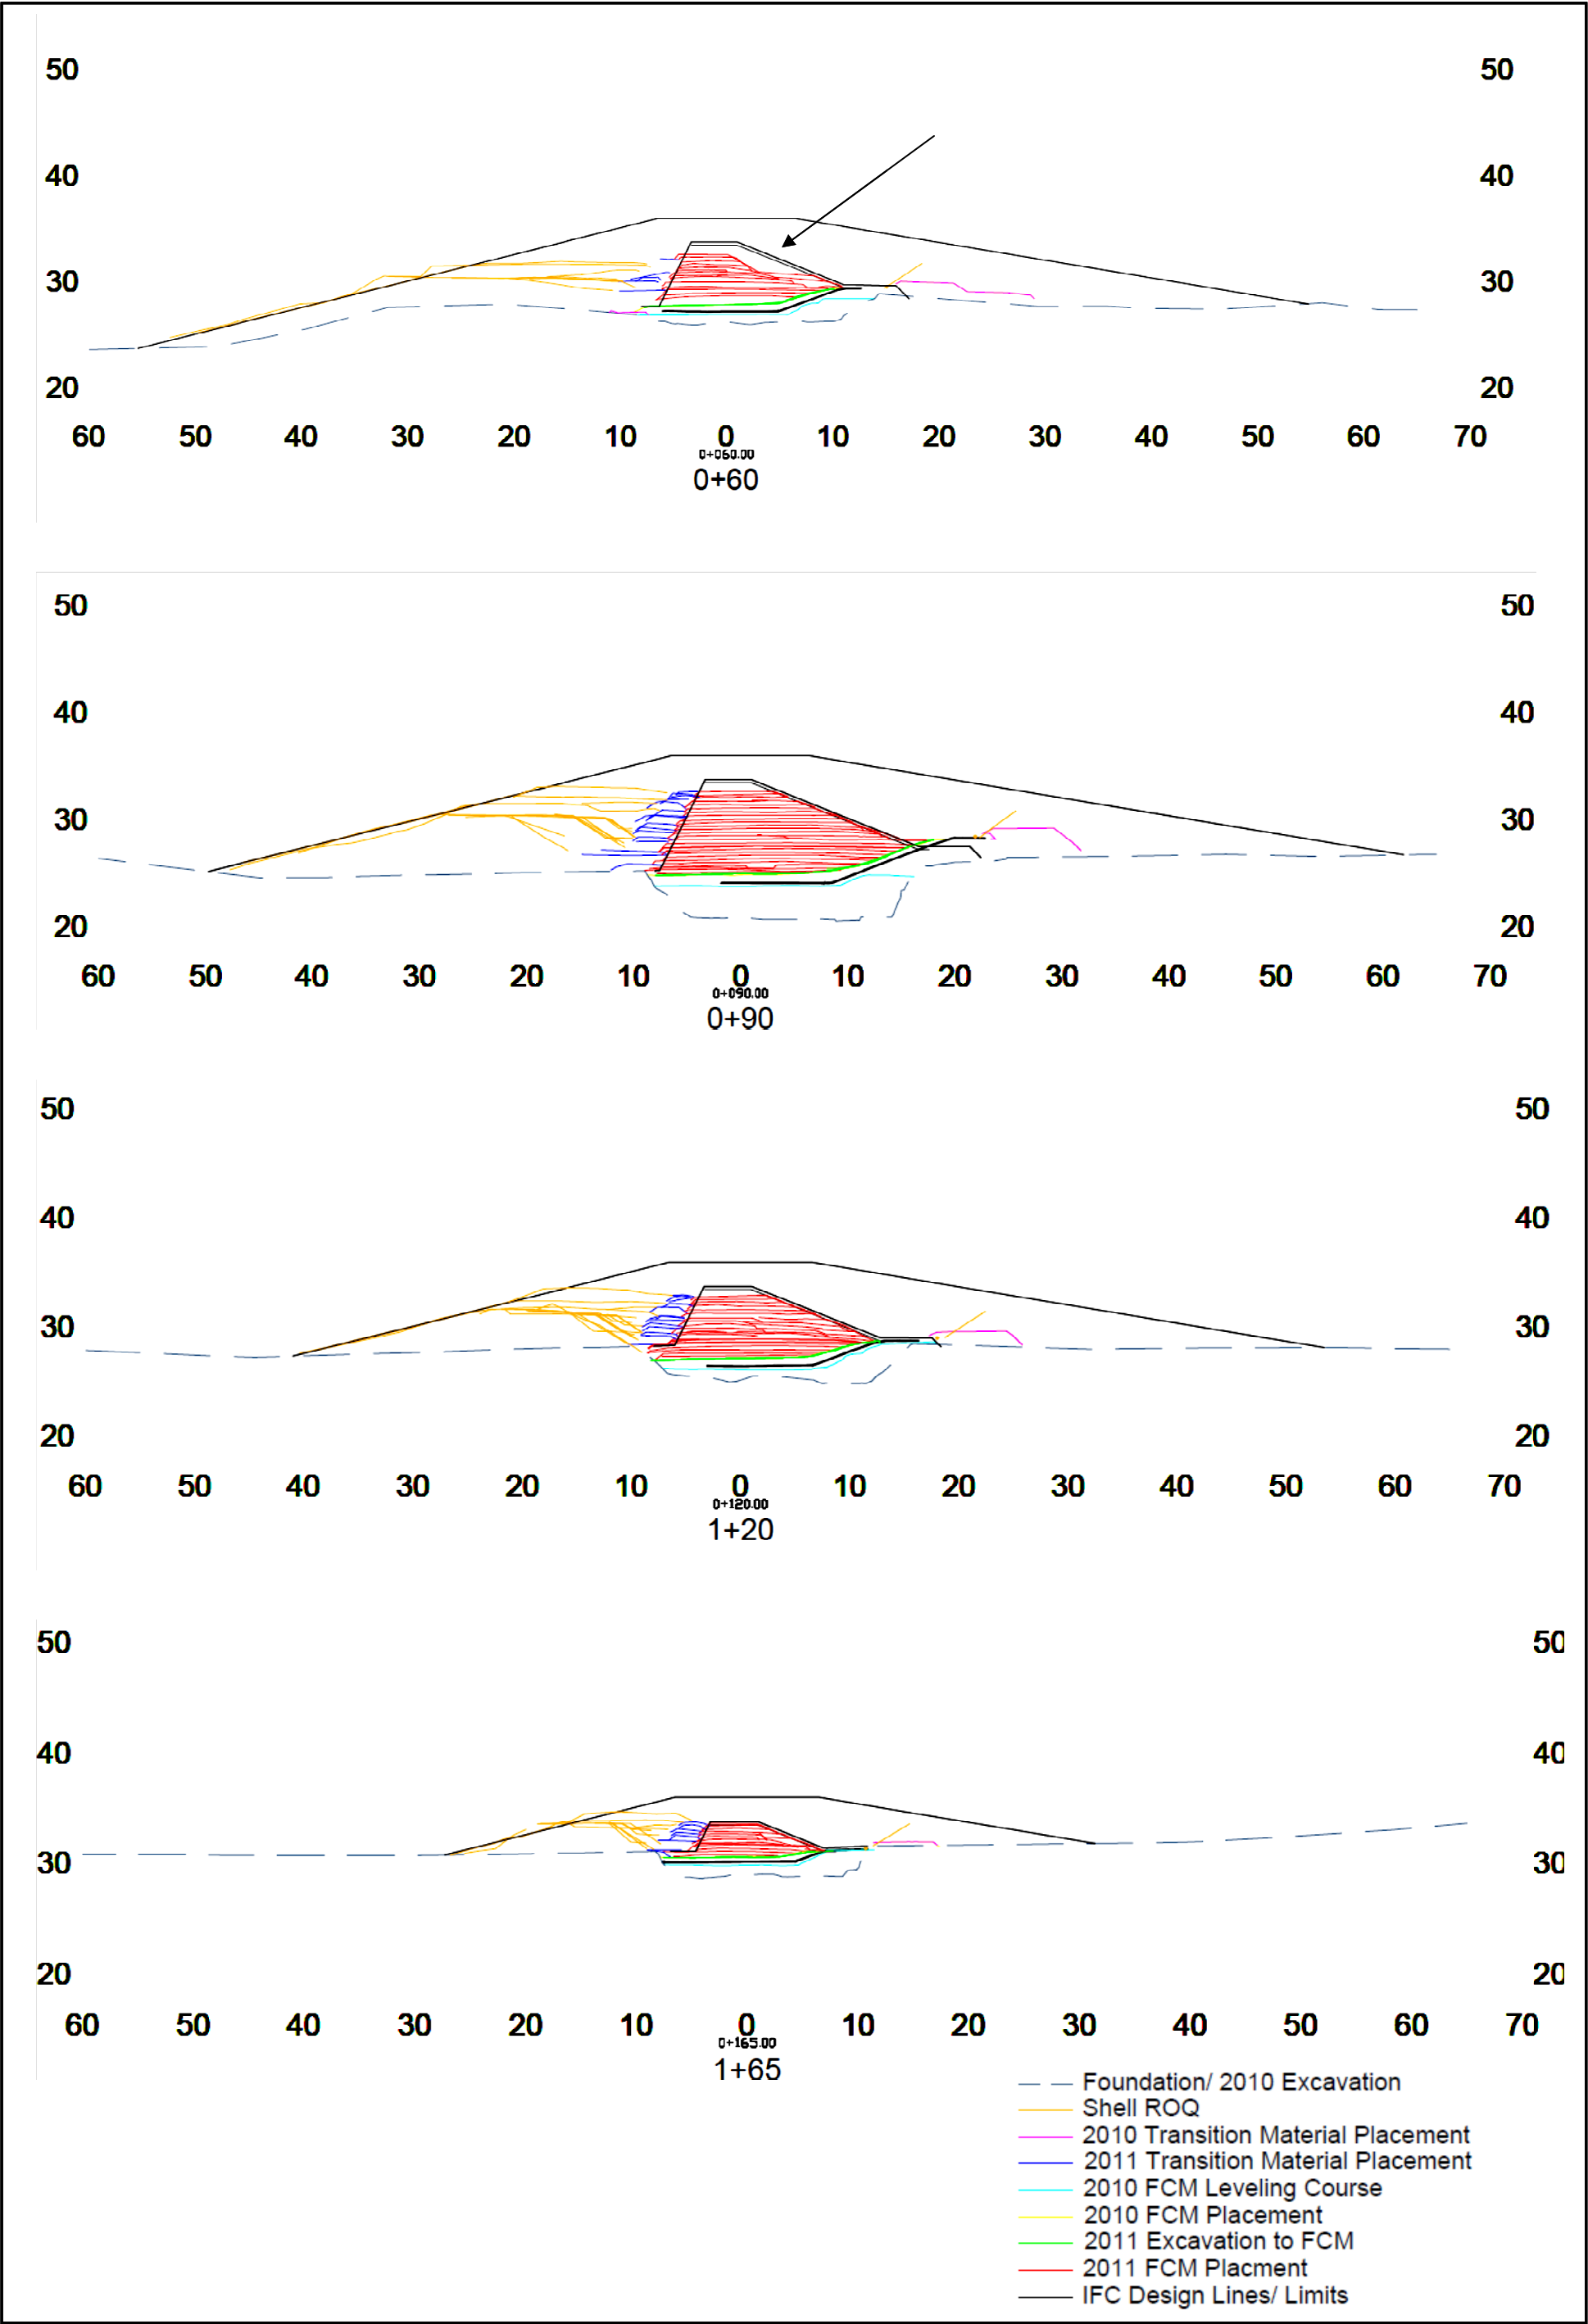
Figure 3 – Select North Dam As-Built Sections (sections for placement up to 2012/03/15)

- SRK completed a preliminary review of the recent North Dam as-built sections. See a few example sections in Figure 3. Note that the North end of the core is at final GCL core grade and with every lift progressing other S additional areas come to grade. The most significant work still left at the dam is to fill in the underbuilt upstream slope around the SSE end of the da. Specifically from Station 0+50 to 0+70 the underbuilt slope is currently the most notable.
