DAILY REPORT #72 – DORIS NORTH INFRASTRUCTURE/ NORTH DAM

Prepared by:	John Kurylo Lawrence Borowski	Date:	2012.03.17
Reviewed by:		Project #:	1CH008.058.0320
Role	Company	Personnel – Position	On Site
Client	Hope Bay Mining Limited (HBML)	Angela Holzapfel – ESR Compliance Manager David Vokey – ESR Coordinator Don Ethelston – HSLP Advisor Dean Wold - Safety Jill Turk – ESR Coordinator Katsky Venter – ESR Manger Michelle Tanquay – ESR Site Manager Stirling Kelly – HSLP Advisor	Yes Yes Yes No Yes No No No
	JDS	Lloyd Jackson – Mechanical Superintendent Doug Fielding – Construction Manager Ishan Fechter – Construction Coordinator Jerry Graham – Construction Manager Kevin Whieldon – Project Coordinator Mark Valeriote – Construction Manager	No Yes yes No No Yes
Engineering Design Consultants	SRK Consulting (Canada) Inc.	John Kurylo – Site Engineer Megan Miller – Site Engineer Lawrence Borowski – Site Engineer Murray McGregor – Site Engineer Iozsef Miskolczi – Site Engineer Lowell Wade – Senior Engineer	Yes No Yes No No No

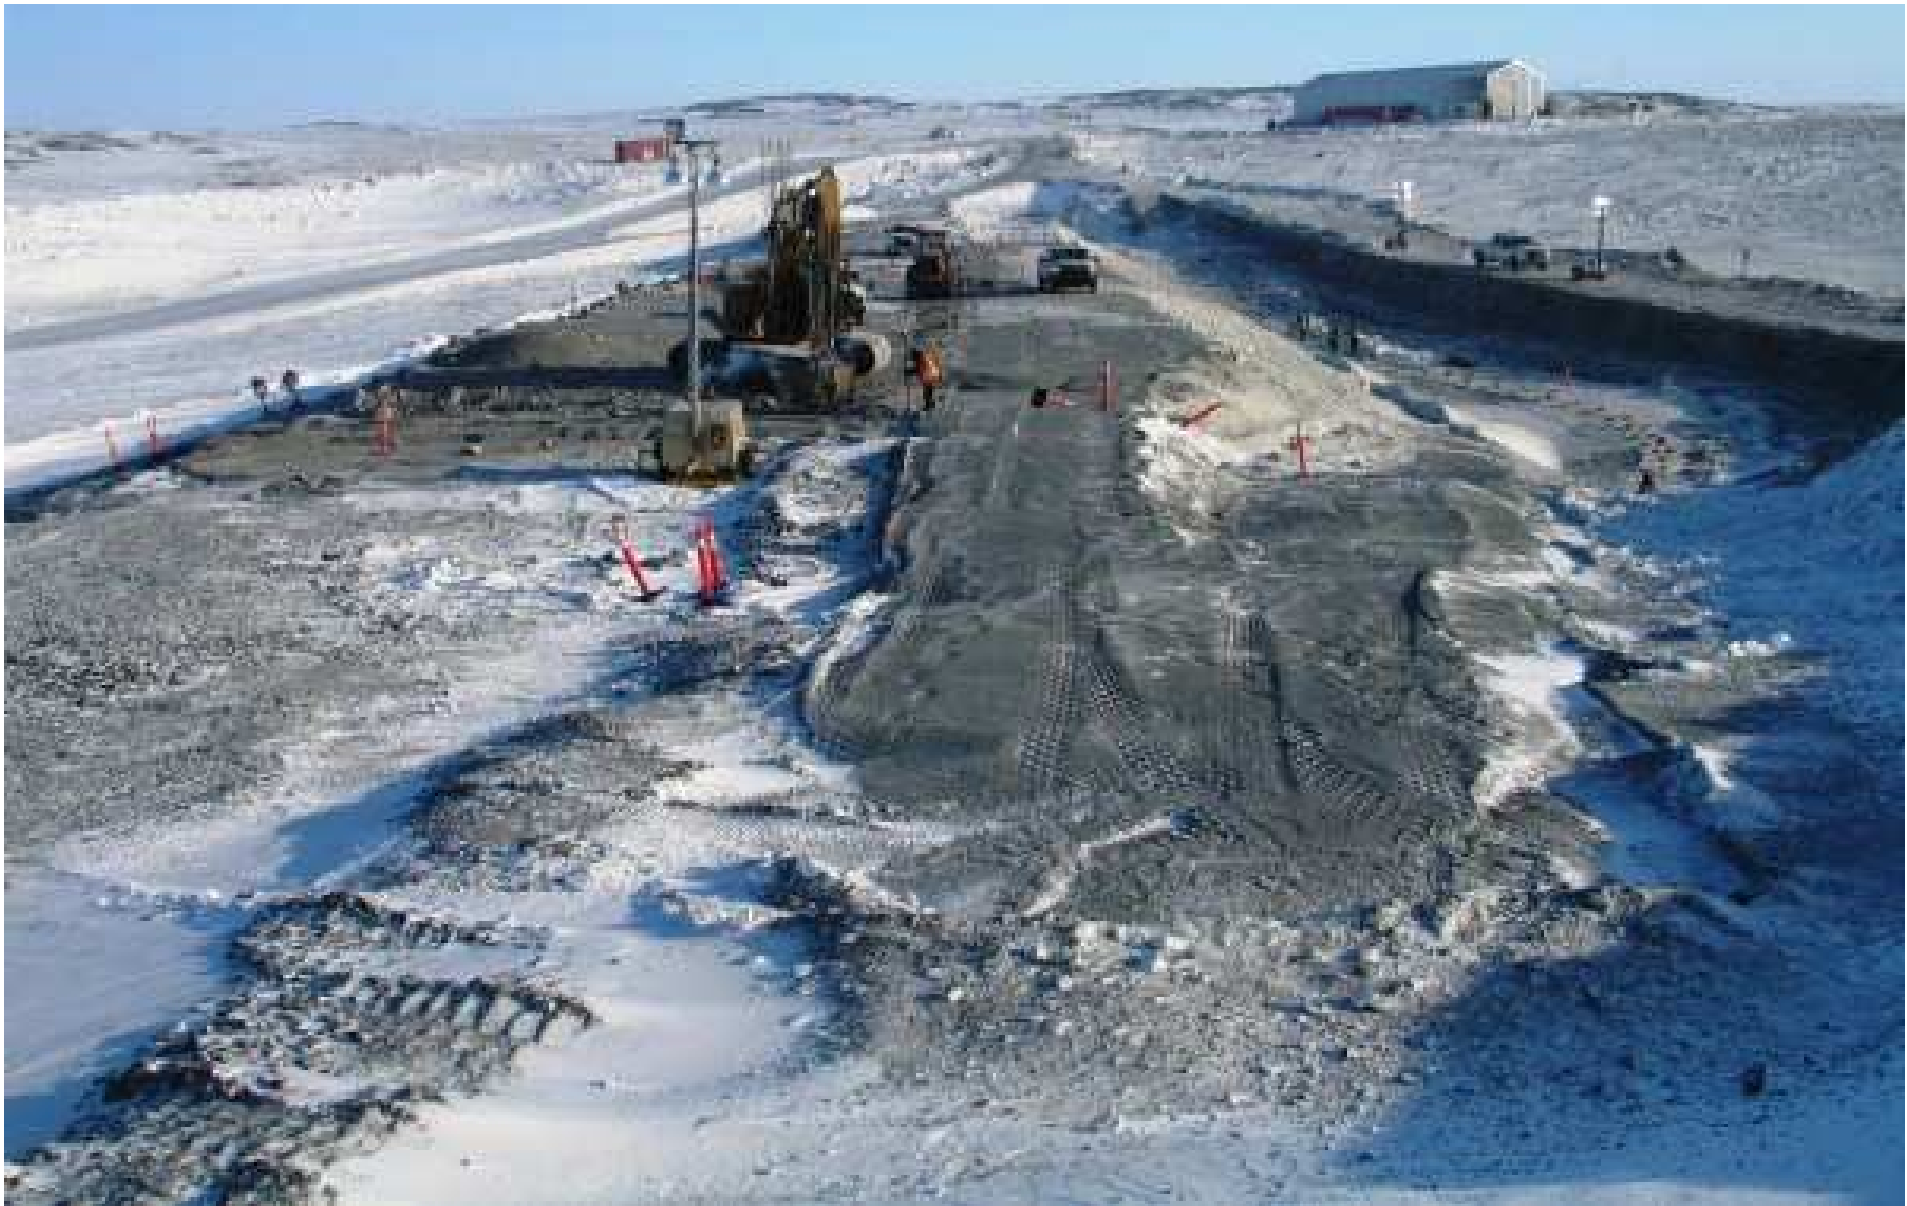
Photo 1: Photo point 3, facing NNE. Photo taken at 10:20 am

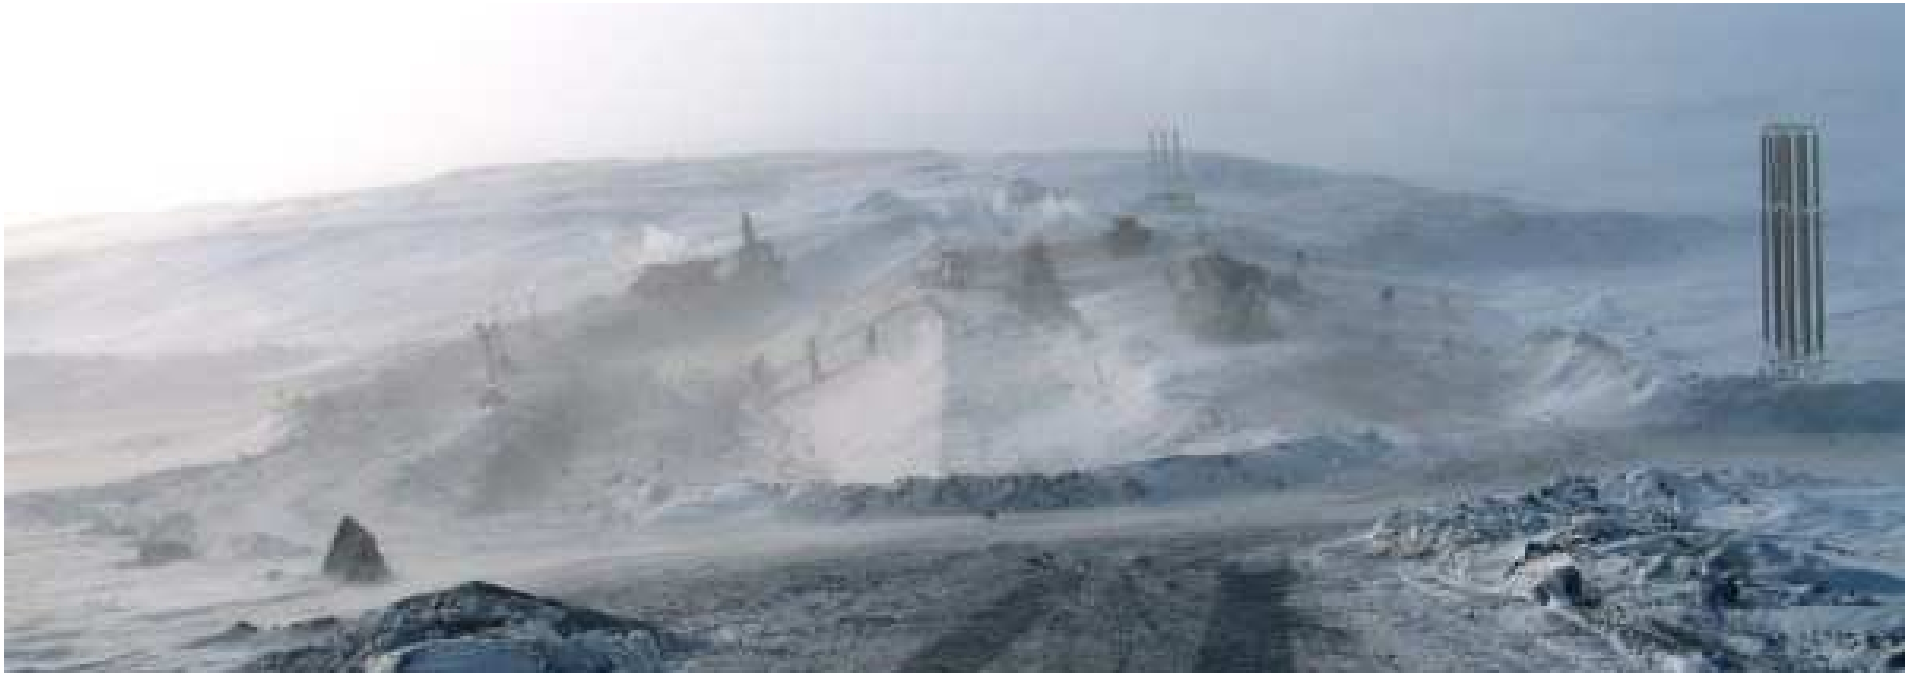
Photo 2: Facing SSW. Photo taken ~ 1:30 pm

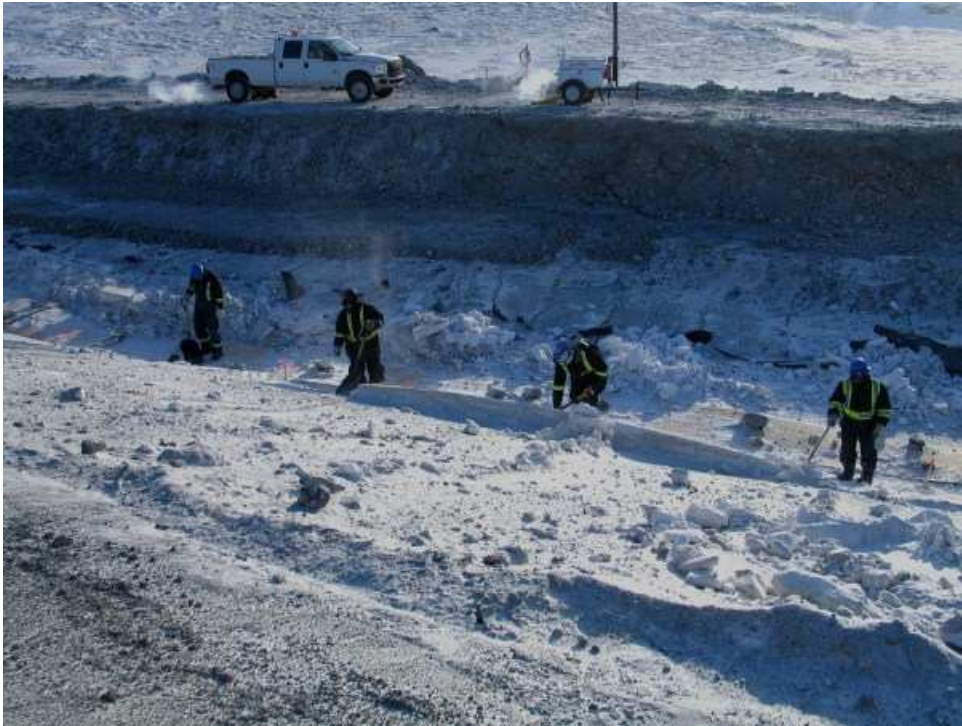
- Thermistors were read ~ 1:30 pm. The section from 0+55 to the south end was noted as being -2.12C. The section between Sta 1+50 and Sta 1+10 was noted as being -1.79C.
- By 17:30 section from 0+55 to the south was -4.77C, and the section between Sta 1+50 and 1+10 was -3.54C
- Four labourers cleared snow by hand off the FC bank in areas that were out of reach by the excavator.

Photo 3: Removal of snow by hand beyond reach of excavator,

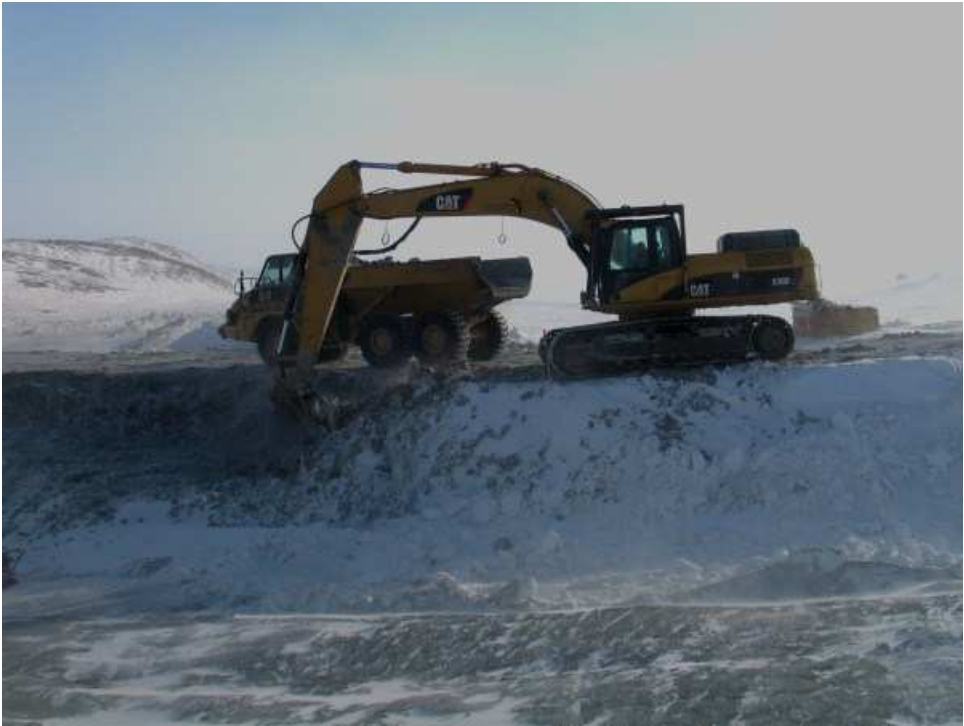
- Continued excavating ROQ and 5/8 in material over separation material on the east bank ~ Sta 0+60. Material hauled to the west bank and end dumped ~ Sta 0+70. By end of shift the excavation of ROQ over separation material was nearing completion.
- Multi bead thermistor cables at Sta 0+60 were strung across the west dam shell. ¾ in crush was hauled and dumped near Sta 0+65. A pad was prepared and packed with the excavator. Labourers strung out the cables. Surveyor surveyed the bedding material and location of the cables. Cables were covered with 300 mm and packed with the excavator

Photo 4: Excavating upstream side to top of separation material.

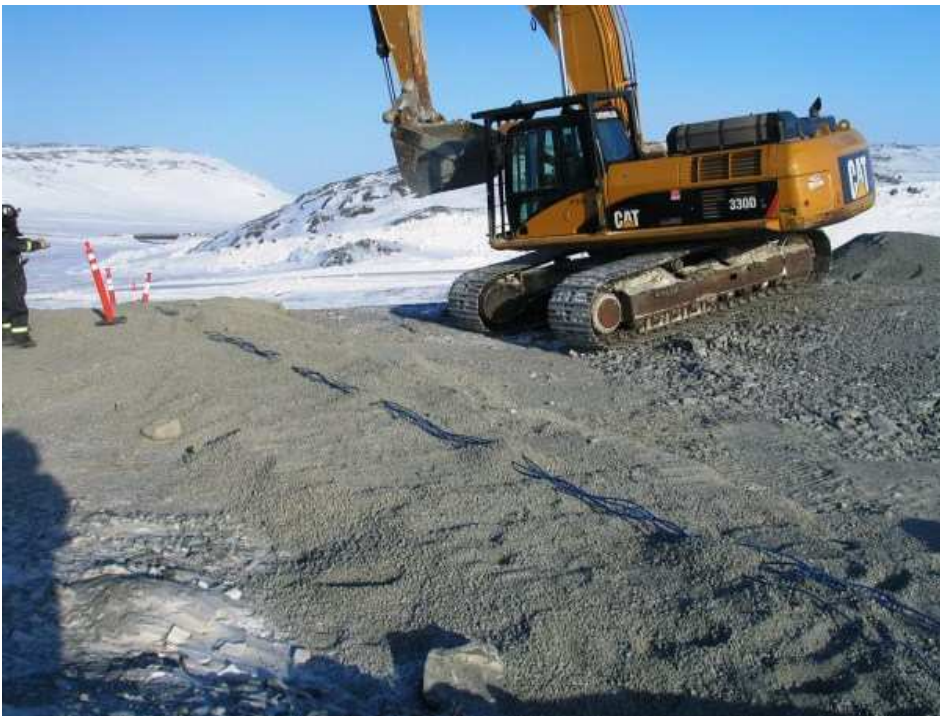
Photo 5: Multi bead cluster laid out at Sta 0+60

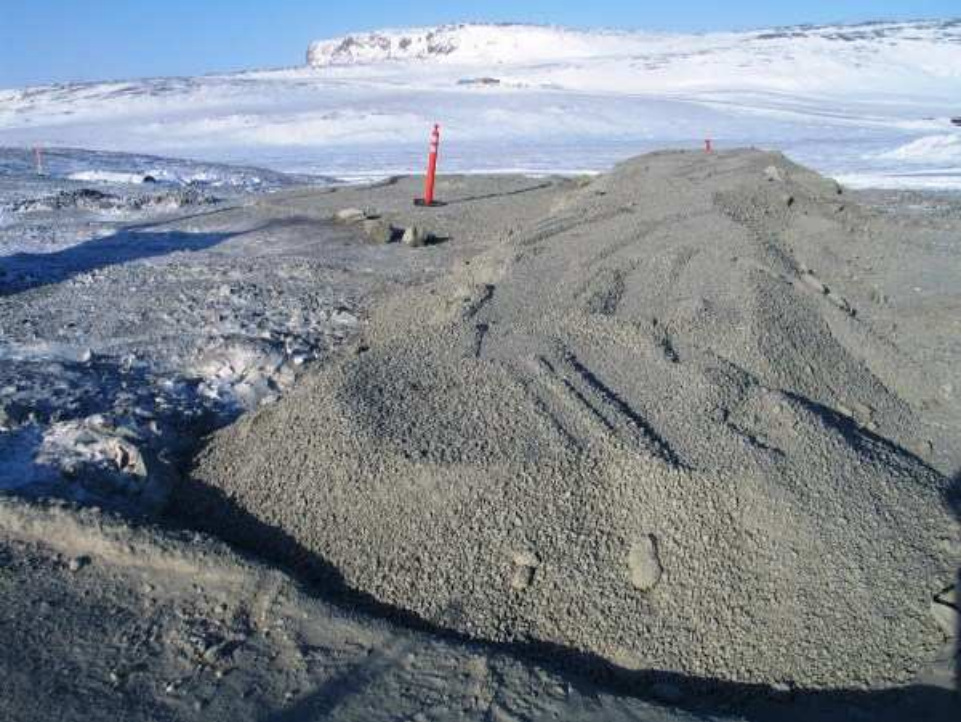
Photo 6: Thermister cables back filled

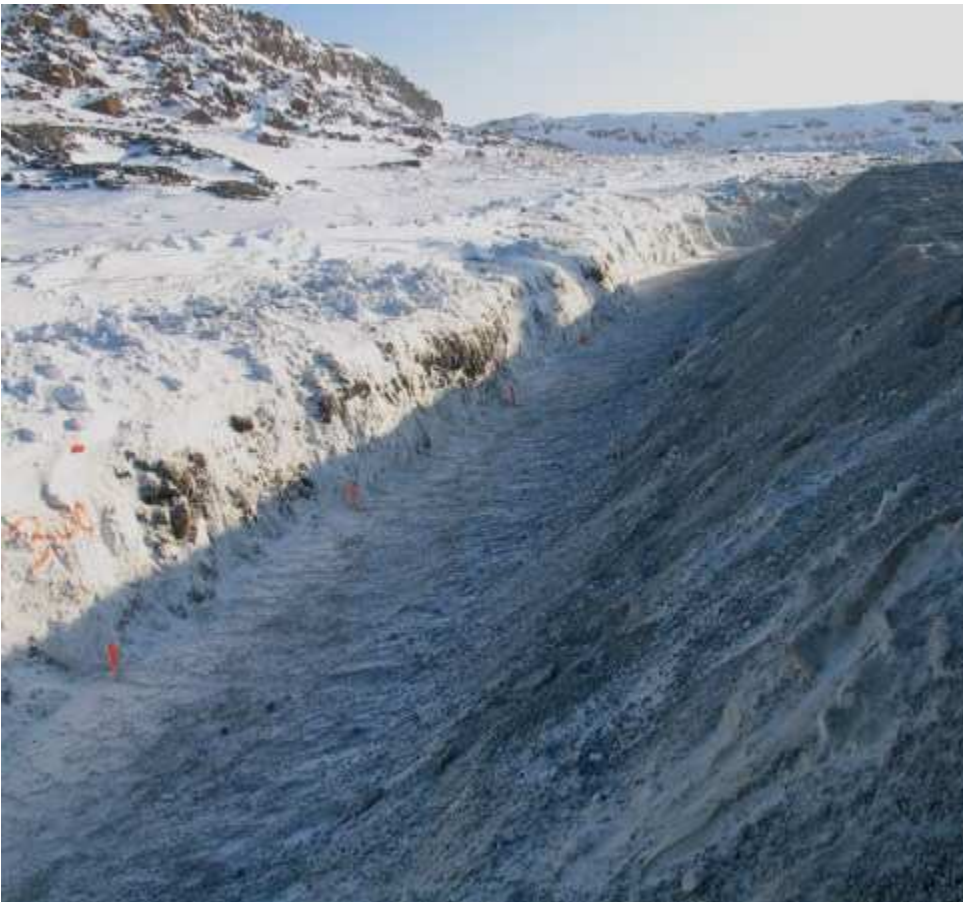
Photo 7: Trench cleaned Sta 2+95 to Sta 3+30

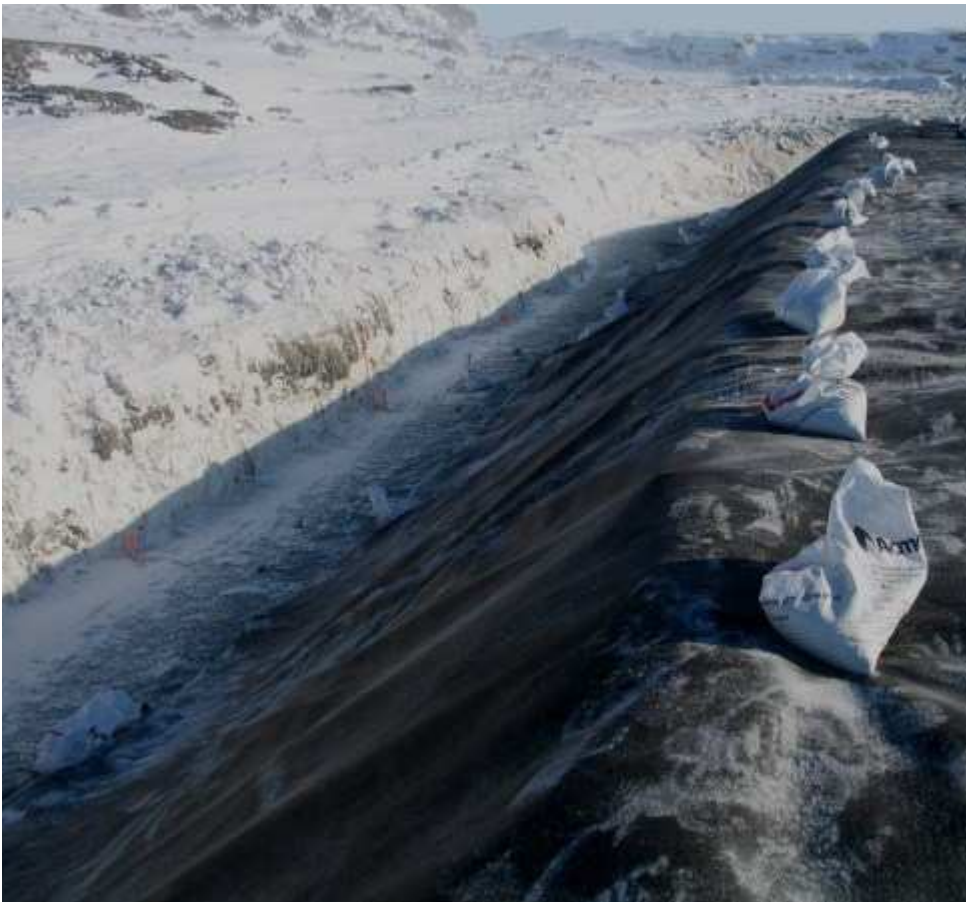
Photo 8: Geotextile placed Sta 2+95 to Sta 3+30

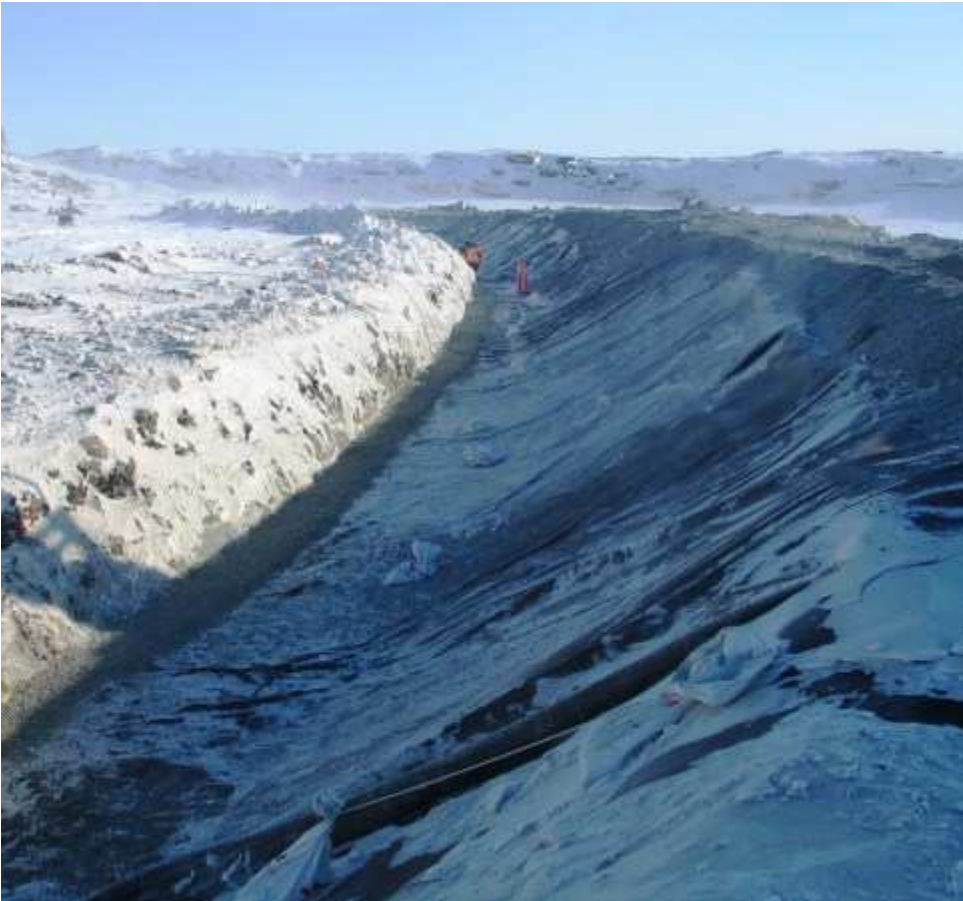
Photo 9: Bentonite placed over liner Sta 3+30 to Sta 3+90

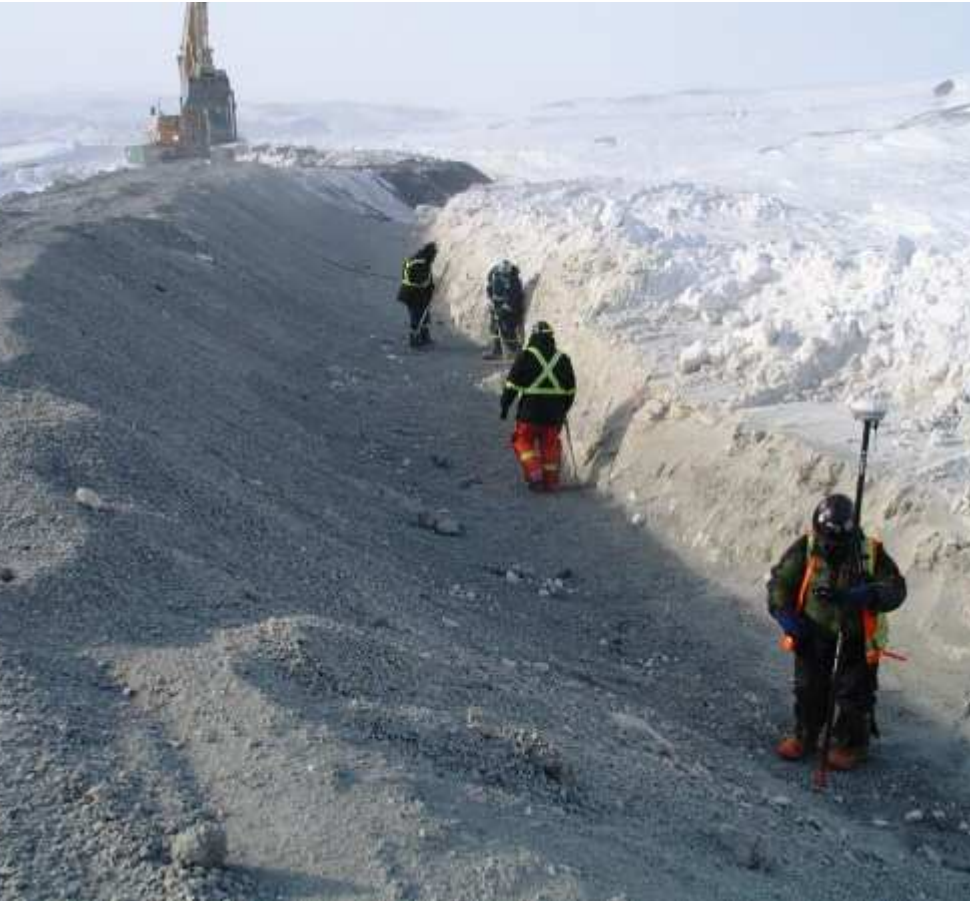
Photo 10: ¾ in crush placed over liner Sta. 3+30 to 3+90

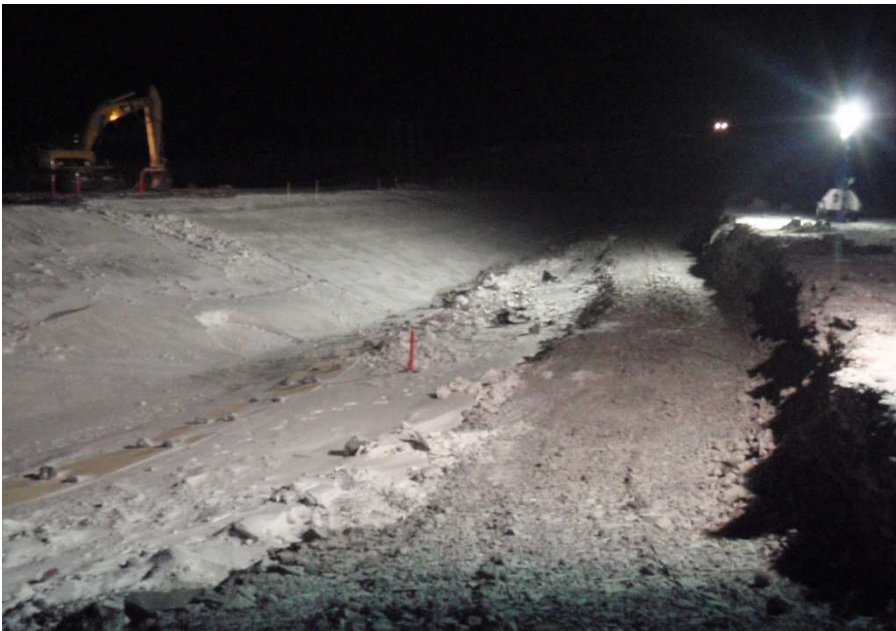
- ROQ material was briefly packed on the downstream from ~1+10 to 0+30.
- ROQ material was removed in areas over the Transition from the upstream dam shell. A small bench of Transition material can be observed on the upstream. Access down onto this material has been

Photo 11: ~NE view down US dam slope, taken from ~ 0+70

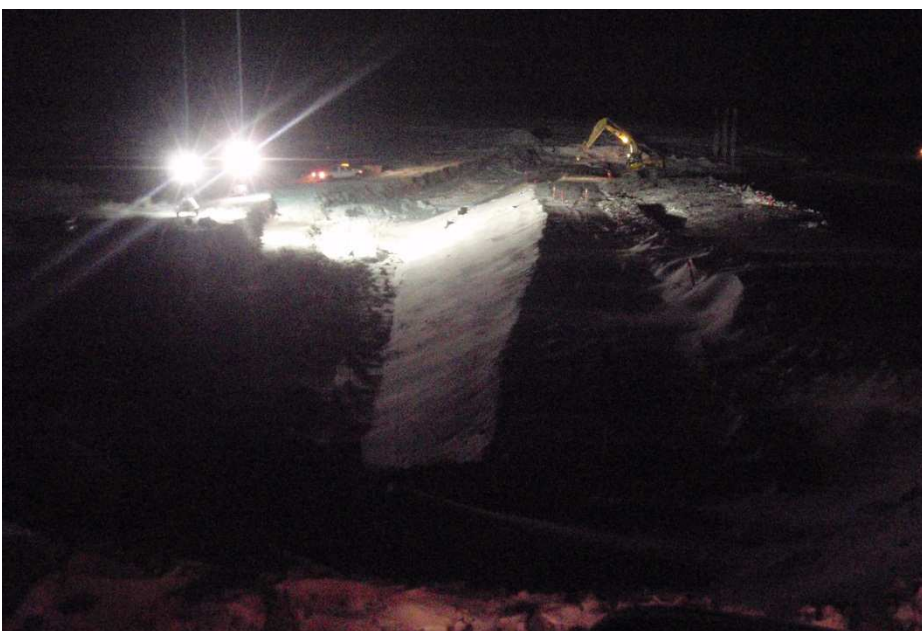
Photo 12: ~SW view of progress, looking down centerline of core.

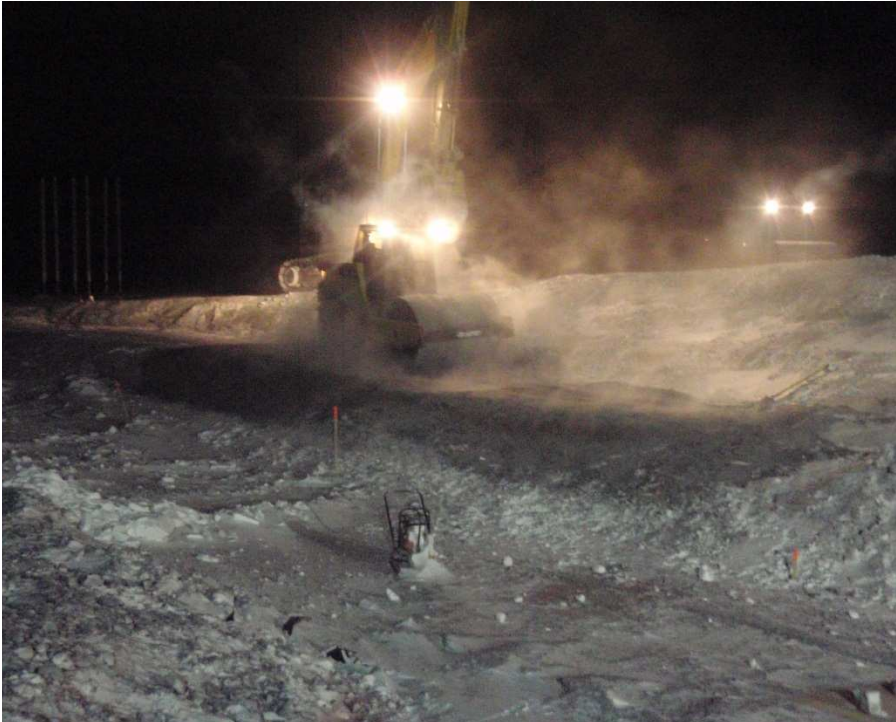
- The 345 placed in the underbuilt SSE corner around station 0+70 to 0+40
 - Typically lift thickness on the order of ~ 0.2m were observed. In the SSE area the lift was noted to be slightly thicker.

Photo 13: Excavator and packer working on underbuilt SSE corner

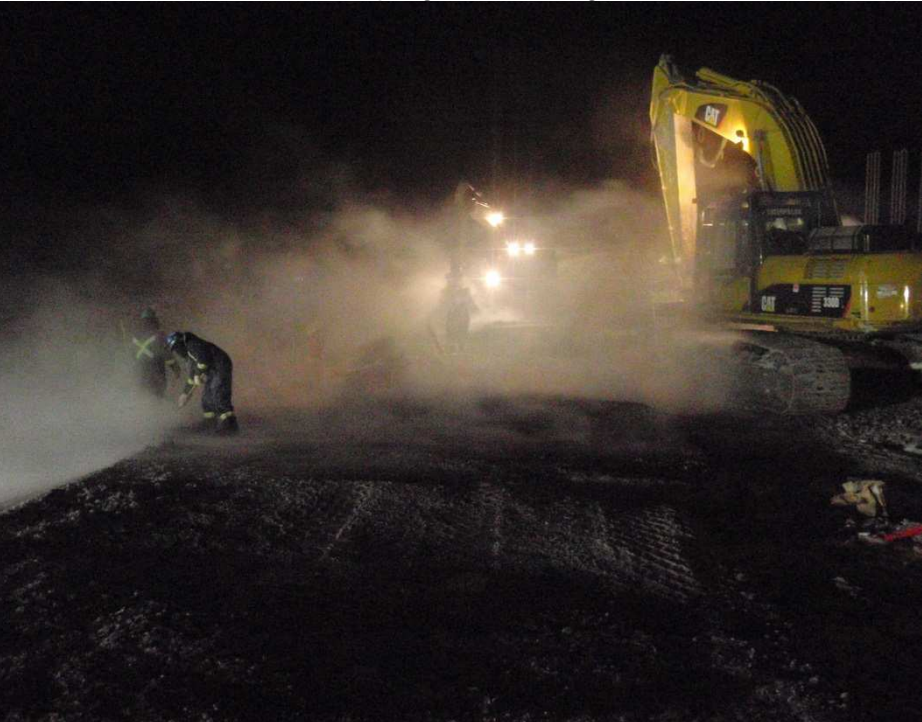
- The labour crew on night shift was limited. Typically the upstream sloping was completed with an excavator and then raked to smooth.
 - In the SSE corner snow was noted to be blowing in against the intermediate slope around the centerline at ~ 0+65 to 0+55. Some hand shovelling was required / completed in this area as the FCM placement proceeded.

Photo 14: Excavator and labours working on sloping US around 0+90

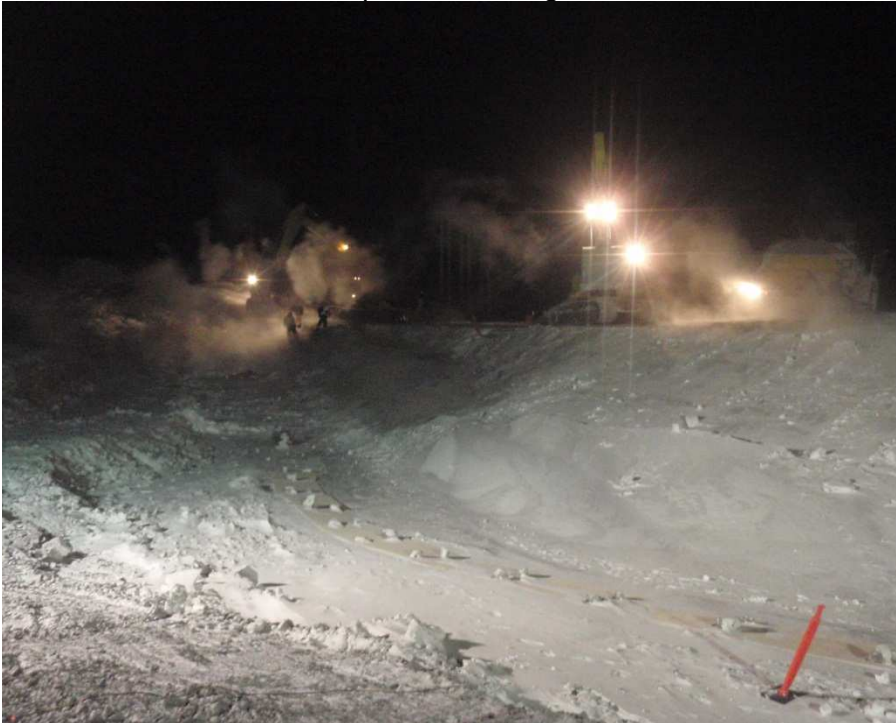
Photo 15: ~WNW view of construction progress around S end of Dam

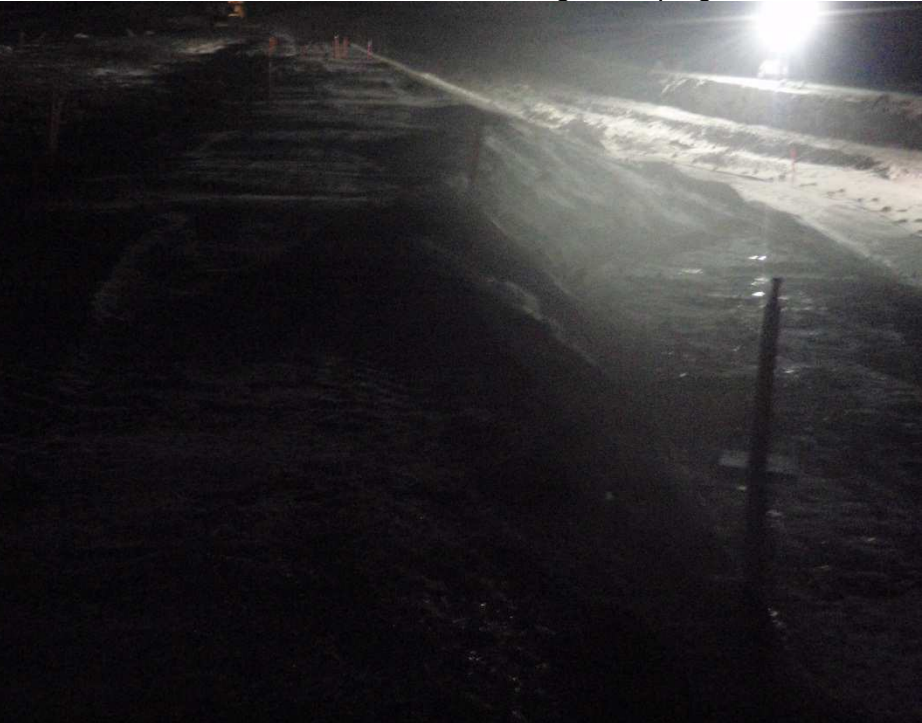
- In the SSE corner, snow was removed on the most upstream area and on the top centerline to downstream area in preparation for placement. However, there is a intermediate slope in this area where snow was not fully removed from. As the excavator placed core on the top downstream area, around 0+60 to 0+45, some FCM was noted to travel over / onto this intermediate snow covered slope.

Photo 16: Underbuilt SSE US area after tonight's lift (~0+50 to 0+70)

- This intermediate slope will be required to be scraped down to hard ground (i.e. snow removed) before subsequent lifts in this area tie into the slope. The excavator attempted to do some of this scraping in the field as placement progressed however, its success was somewhat limited and will have to be revisited after freezeback.

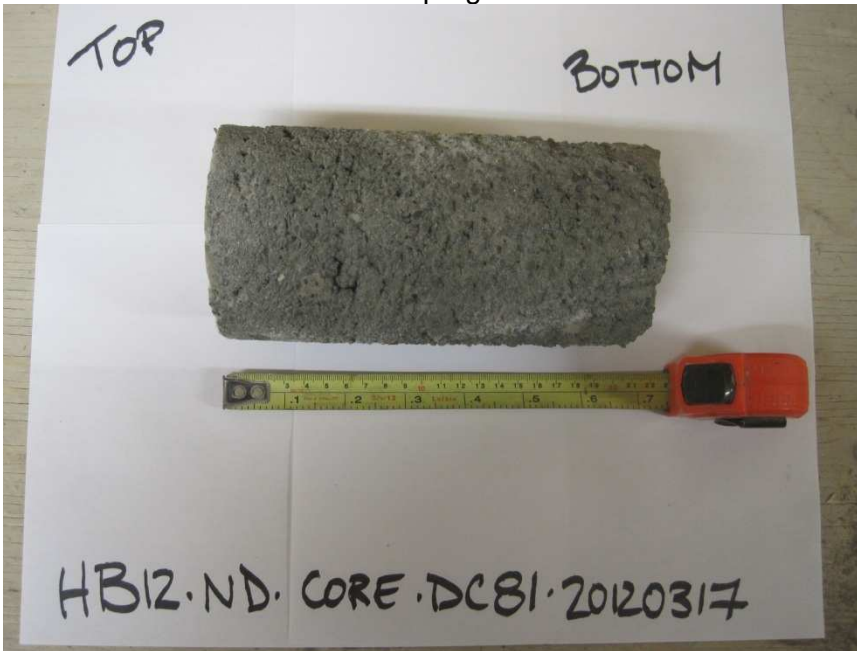
- Two drilled cores were taken on nightshift:
 - HB12-ND-CORE-DC81-20120317 was taken from ~ 0+55 upstream. This was in the SSE corner from the material placed on March 13th nightshift.

Photo 17: Drilled Core 81. Taken from ~ 0+55 US.

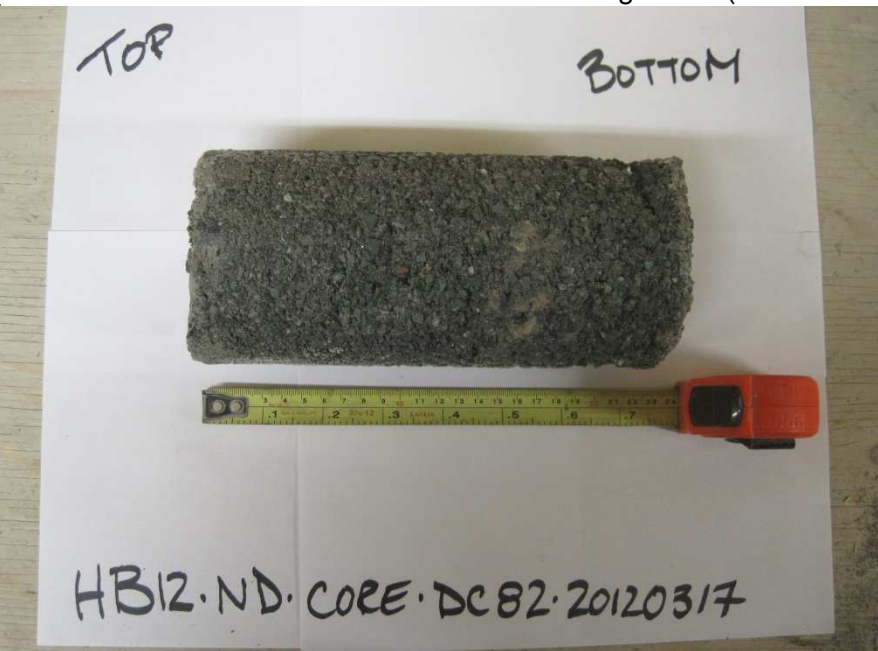
- HB12-ND-CORE-DC82-20120317 was taken from ~1+20 centerline. This was taken from the material placed on March 16th nightshift.
 - Some difficulties were had finding a suitable power source for the drill. Eventually, after multiple attempts with multiple light plants, a power source was found. The breaker for this light plant consistently was tripped and somewhat limited the depth of core drilling that could be completed. The issues with the drill power source will be further examined in the coming days.

Photo 18: Drilled Core 82. Taken from ~ 1+20 CL
