DAILY REPORT #73 – DORIS NORTH INFRASTRUCTURE/ NORTH DAM

Prepared by:	John Kurylo Lawrence Borowski	Date:	2012.03.18
Reviewed by:		Project #:	1CH008.058.0320
Role	Company	Personnel – Position	On Site
Client	Hope Bay Mining Limited (HBML)	Angela Holzapfel – ESR Compliance Manager David Vokey – ESR Coordinator Don Ethelston – HSLP Advisor Dean Wold - Safety Jill Turk – ESR Coordinator Katsky Venter – ESR Manger Michelle Tanquay – ESR Site Manager Stirling Kelly – HSLP Advisor	No No Yes No Yes No No No
	JDS	Lloyd Jackson – Mechanical Superintendent Doug Fielding – Construction Manager Ishan Fechter – Construction Coordinator Jerry Graham – Construction Manager Kevin Whieldon – Project Coordinator Mark Valeriote – Construction Manager	No Yes yes No No Yes
Engineering Design Consultants	SRK Consulting (Canada) Inc.	John Kurylo – Site Engineer Megan Miller – Site Engineer Lawrence Borowski – Site Engineer Murray McGregor – Site Engineer Iozsef Miskolczi – Site Engineer Lowell Wade – Senior Engineer	Yes No Yes No No No

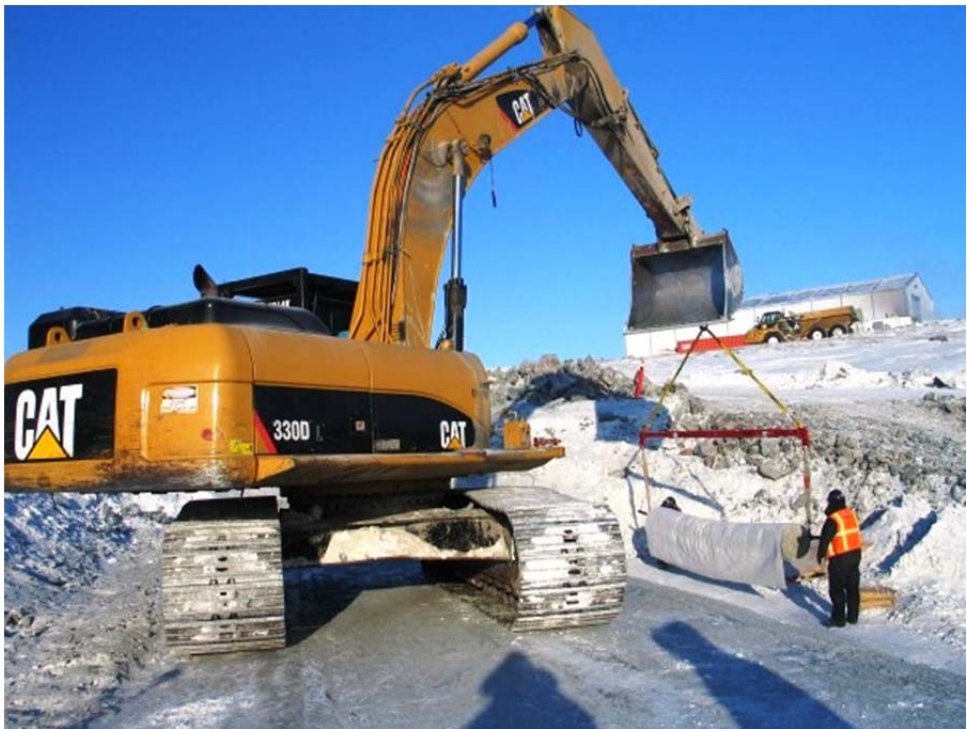
- A 'Trial' placement of GCL was completed on dayshift.
 - Spreading the GCL was fraught with issues.
 - Firstly, an excavator was used as the primary piece of equipment.

- The excavator could not reach far enough.
 - The roll came out of a sea can, so was frozen. Manpower alone could not unroll it. To unroll it they eventually had to hold it in place by running the skid steer over the end.

Photo 4 (right): Excavator was used to handle GCL roll. In this photo it is on top. In the end it was positioned at the bottom.

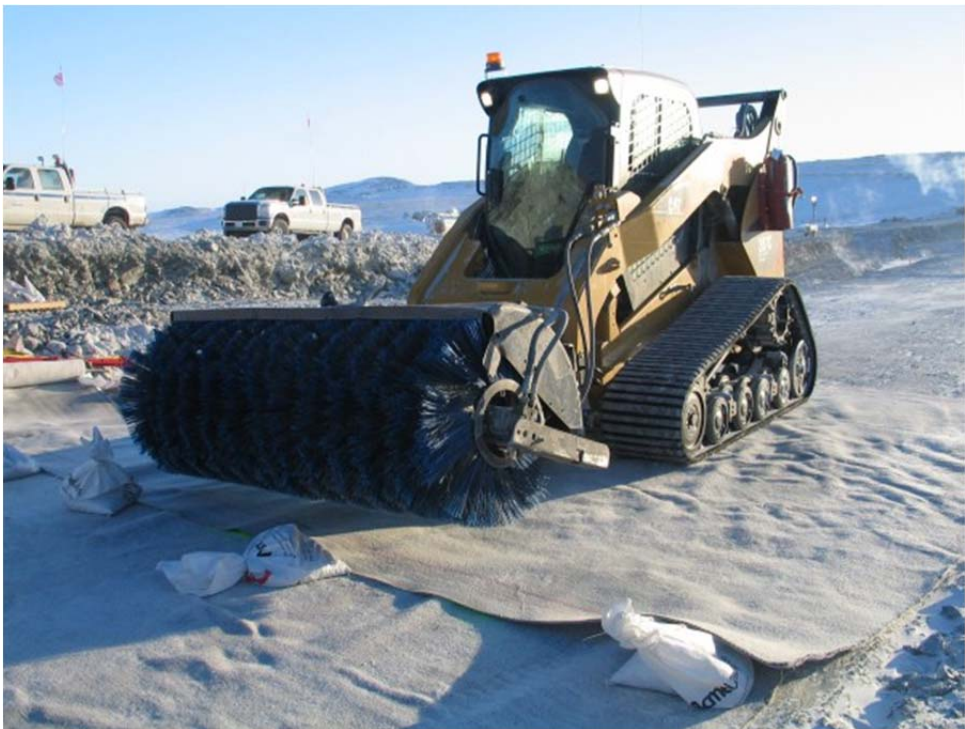
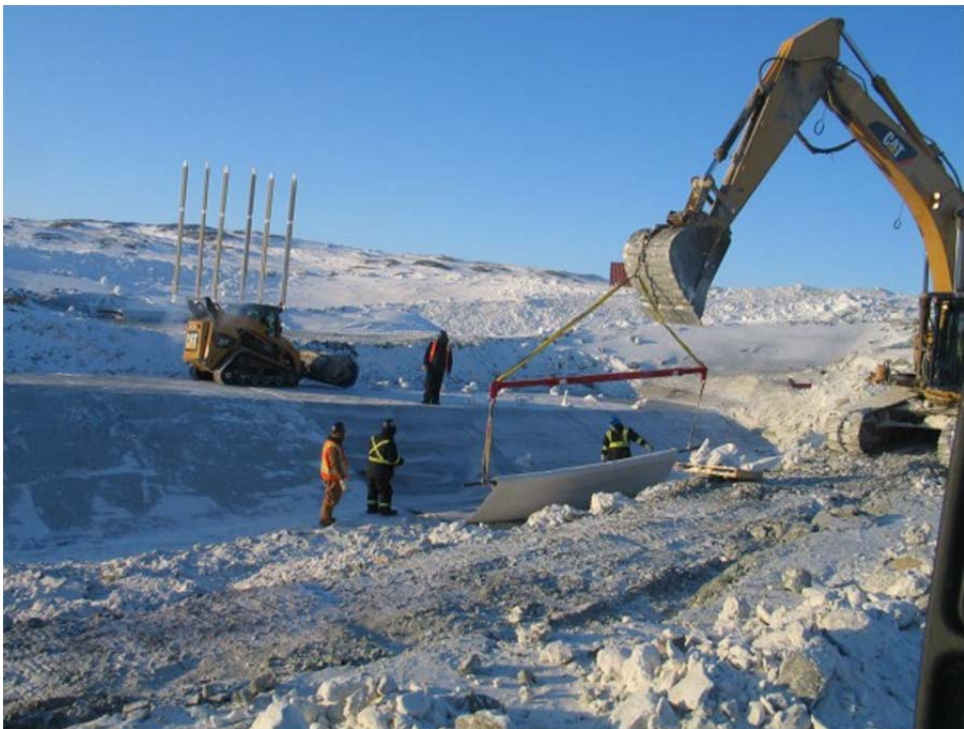
- There was also an issue with the spreader bar which bent under the weight of a roll making it even more difficult to unroll.
 - Rolls were overlapped by ½ meter.

Photo 5 (left): Skid Steer was used to anchor the GCL
Photo 6 (right): Set up. Skid Steer holding down GCL. Excavator pulling and unrolling the GCL.

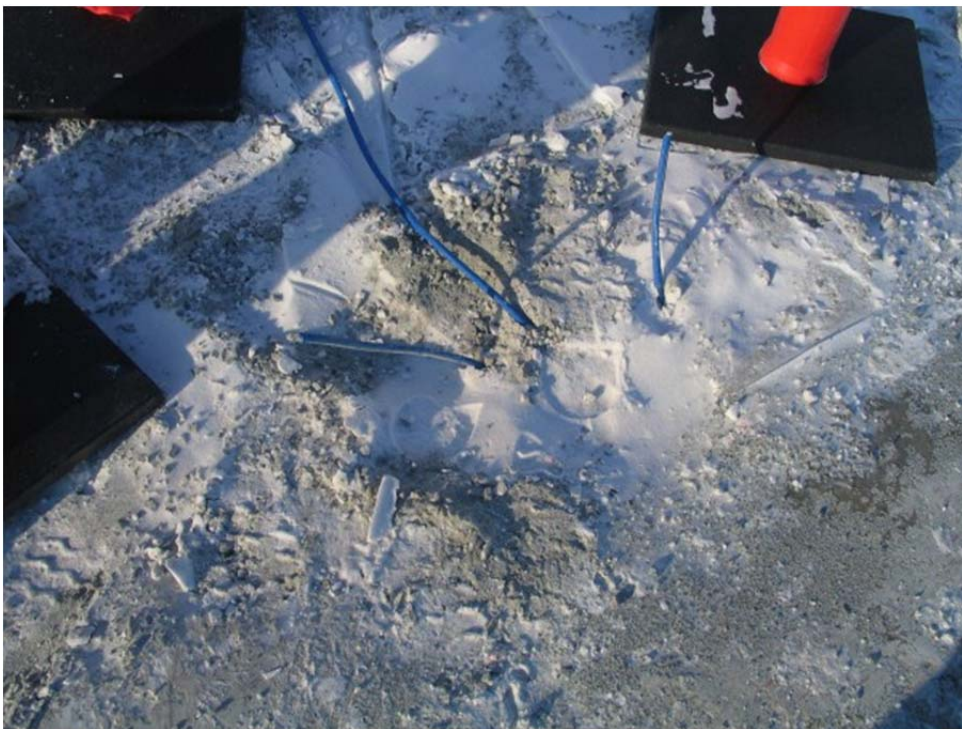
- The following multi-bead thermistors were read:
 - ND-HTS-040-31.5, ND-HTS-040-33.5, ND-VTS-040-KT
 - ND-HTS-175-32.5
 - See notes in 'Key Trench / Central Core' section below. Two thermistor strings were cut today and will be required to be repaired (location of damage is immediately apparent).

- The multibead cables at 1+75 were checked. Cable ND-HTS-175-32.5 was found to still be working. Cables ND-HTS-175-33.5 and ND-VTS-175-KT were identified as being the cables that were cut on dayshift.

Photo 7 (left): Thermister wires severed at Sta 1+75
Photo 8 (right): Layfield welding seams in HDPE Liner

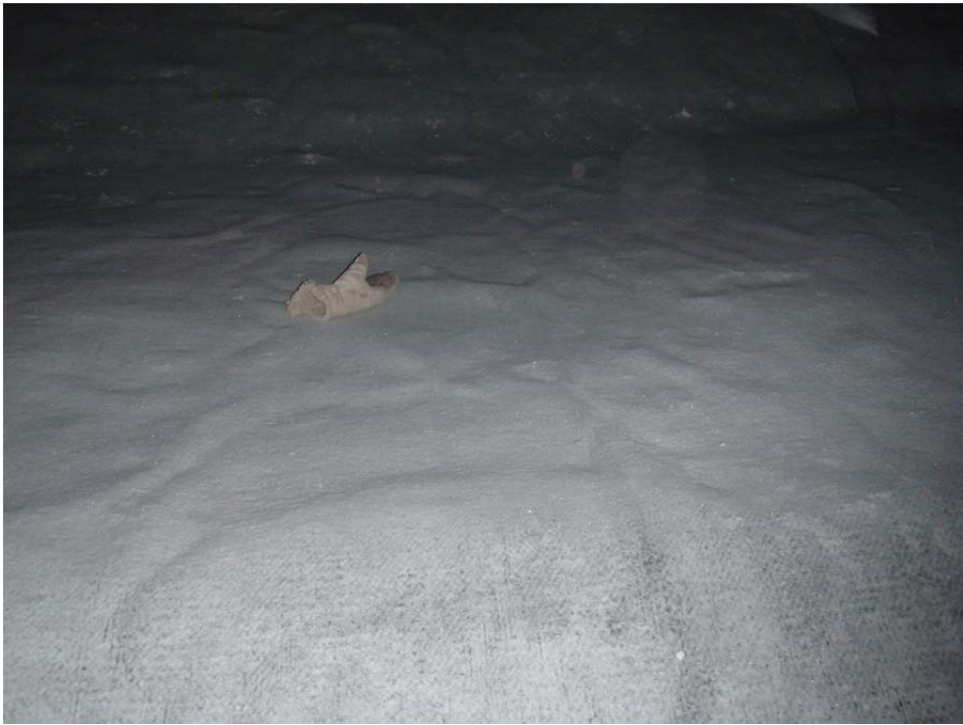
- The GCL appeared to be stiff and slightly frozen in area which resulted in some minor waves/undulations in the GCL surface.
 - Some track marks (from the skid steer) were observable at the top of the liner. Although no liner damage was readily apparent (such as tears or rips) no vehicle equipment should travel on the liner areas that are within the IFC GCL design limits.

Photo 12 (left): View of some minor wrinkles observed in the stiff (partially frozen) GCL.

- Additional discussions on the noted GCL liner placement items will result tomorrow.
 - See Photos 12, 13, 14, 16 and 17 for additional details.
 - In the SSE corner the intermediate slope, between the top area and lower underbuilt downstream area, was still required to be scraped down to hard ground (i.e. snow removed) at the end of shift. This work is expected to result tomorrow.

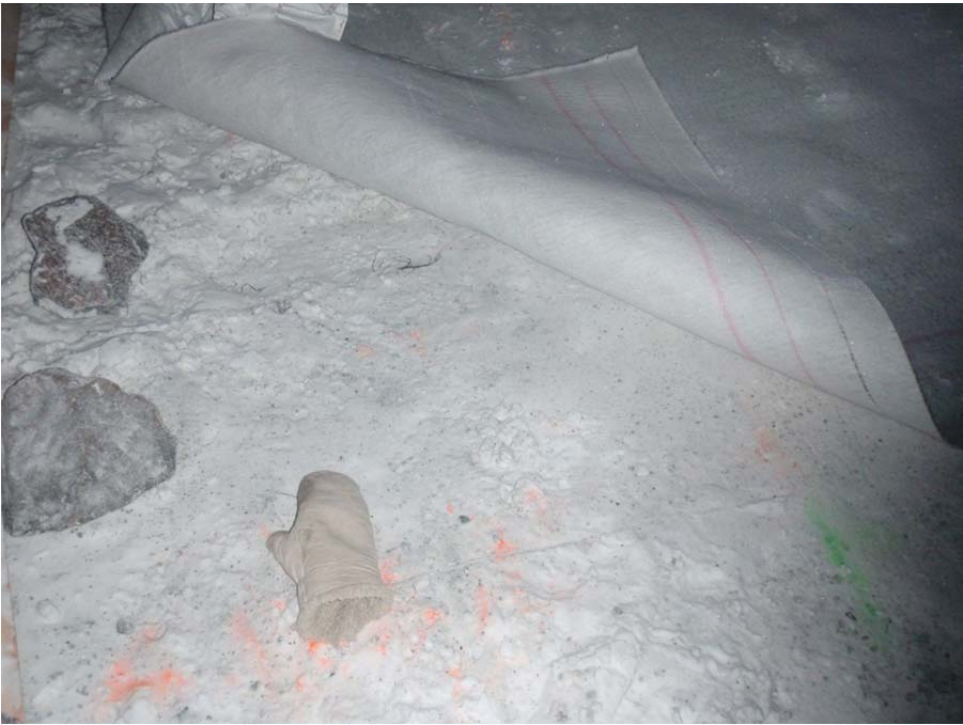
- Only ~ 1m from the upstream toe of the slope (on the horizontal fillet hinge area) was cleaned of snow and debris. Before overliner material placement result the entire area where overliner material will be placed is required to be cleaned (i.e. the horizontal fillet area beyond 1m of the toe where GCL will be placed is required to be cleaned).

Photo 13 (right): View of E upstream end of liner placed, note additional snow removal will be required beyond the 1m past the toe that was cleaned for 'trial' GCL placement.

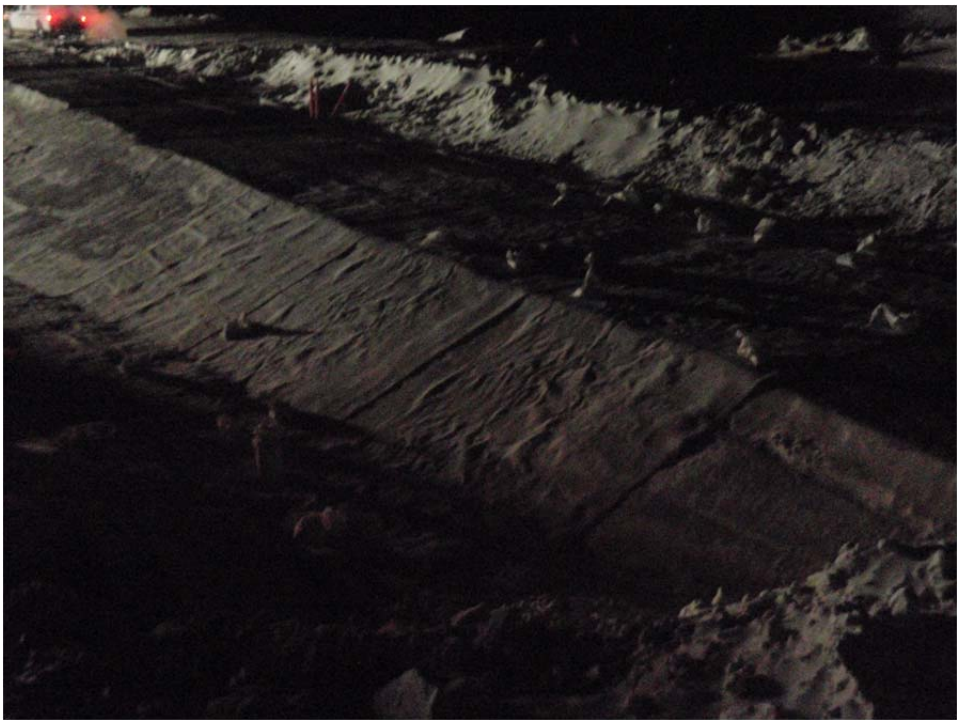
- An offset from the North end of the core (~ a panel width) has been left before the first panel of GCL was placed. Additional GCL in this area is expected to be required. Nuna survey to go in field and provide SRK with location of elevation 35.0m on the OG (to be formally requested tomorrow).

- The overlaps for the liner were noted to all be the wrong way / backwards. Similar to roof shingles the GCL panels on the slopes are required to be placed so that the higher elevation panel overlaps the lower elevation panel.

Photo 14: View of three 'trial' GCL panels placed on dayshift.

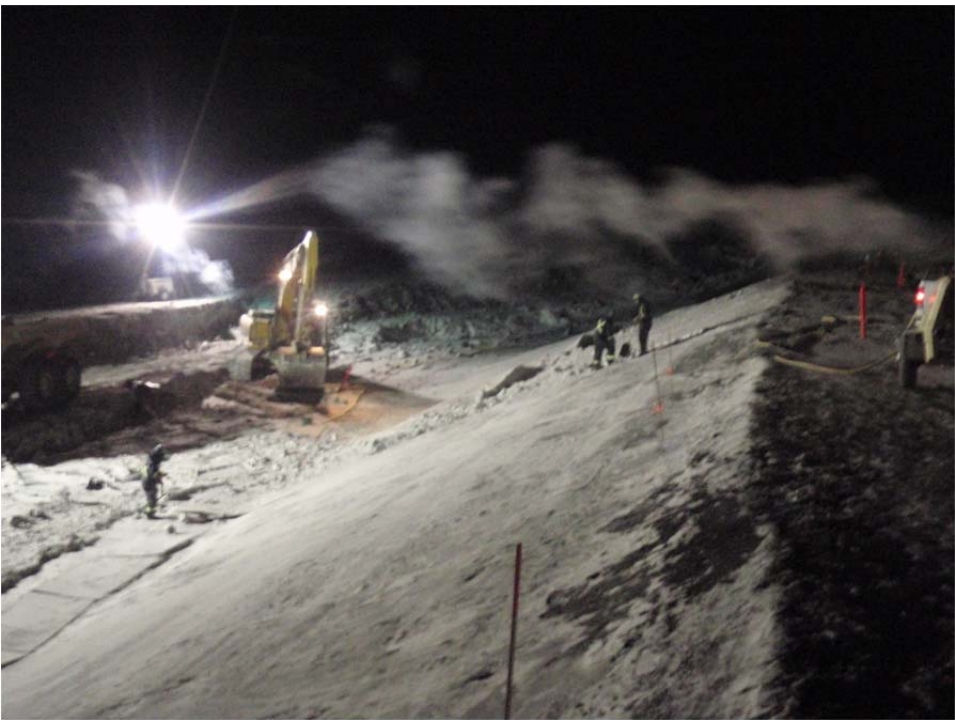
- Labourers worked on cleaning the bottom portion of the upstream slope and the fillet hinge area around station 0+90 to 1+95. For a brief portion of the shift an excavator was used to assist with the cleanup. See Photo 15.

Photo 15: ~WSW view of labourers and 330 cleaning DS slope.

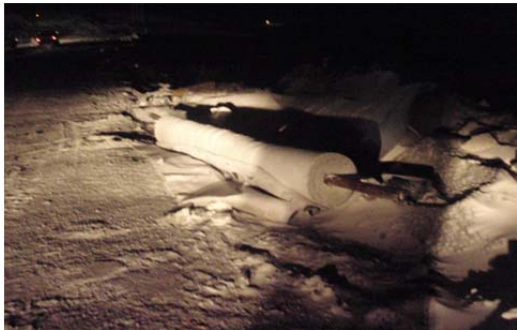
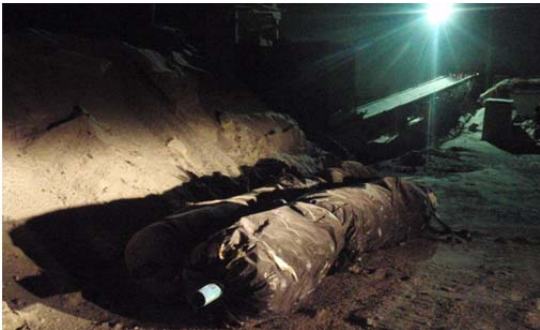
- GCL rolls were noted to have been left outside in various places around the FCP pad and downstream dam shell area. Better handling and storage of the GCL rolls is suggested to be looked at to minimize the creation of unneeded liner damage / waste.

Photo 16 & 17: GCL rolls left outside at the DS dam shell and by the FCP hopper

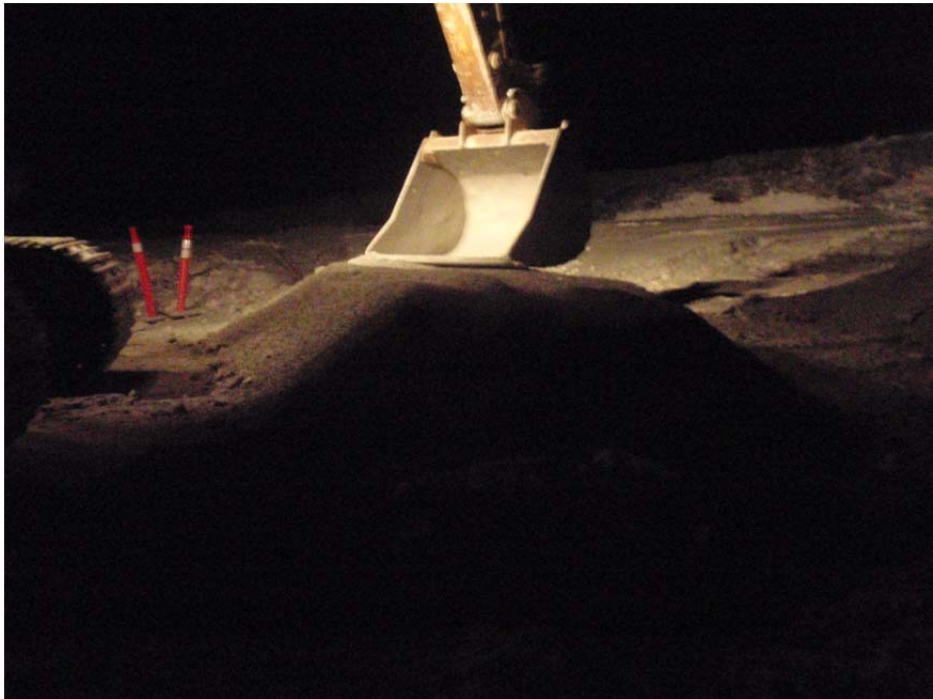
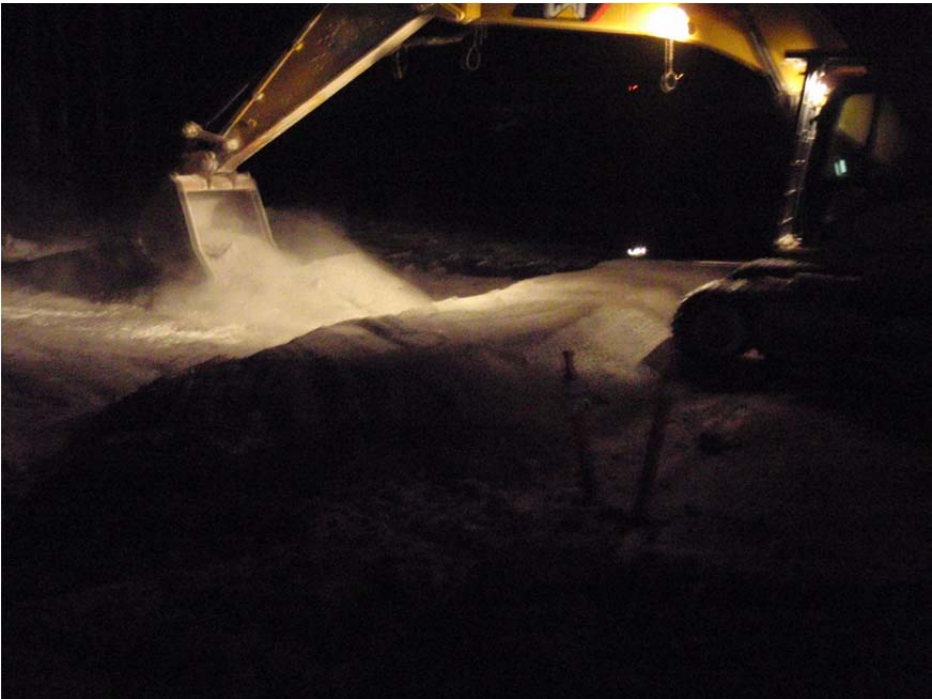
- The multibead cables at 0+40 were strung across to the downstream toe of the dam. Crush material was placed under and above these cables (typically a min of at least 0.3m of crush above and below was observed to be placed. See Photo 20 and 21.

- The multibead cables as 0+40 were all checked and found to be working after they were covered. A small scrape on the plastic of one of the cable at 0+40 was noted (closer to the area where the cable runs alongside the core). This cable was found to be fully operational. As a preventative measure electrical tape was wrapped around this scraped plastic portion of the cable.

Photo 20 and 21: ~ ESE and SW view respectively of the 330 excavator spreading crush over multibead cables at 0+40.

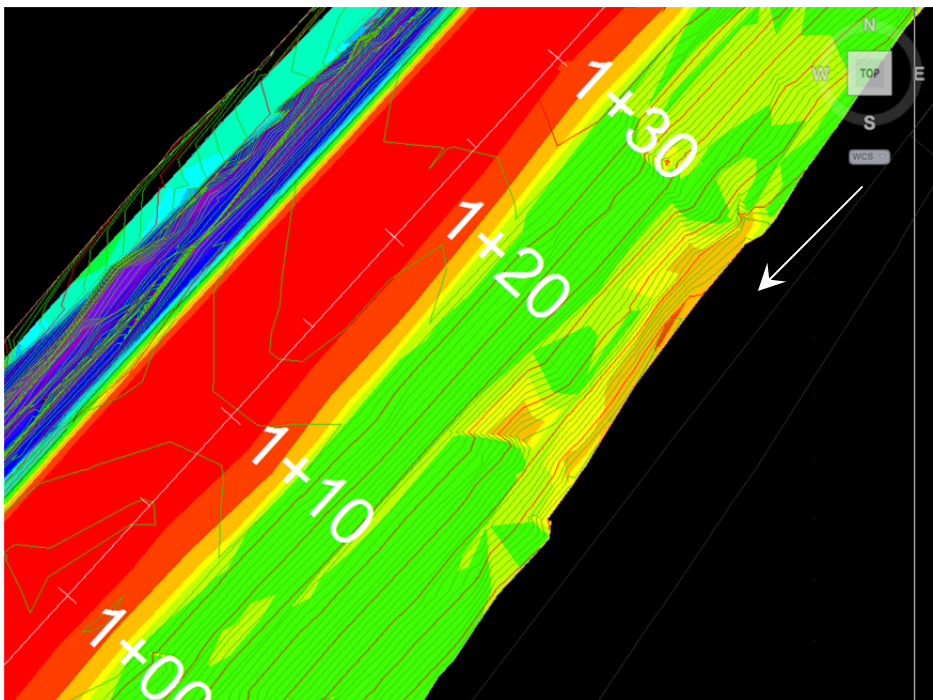
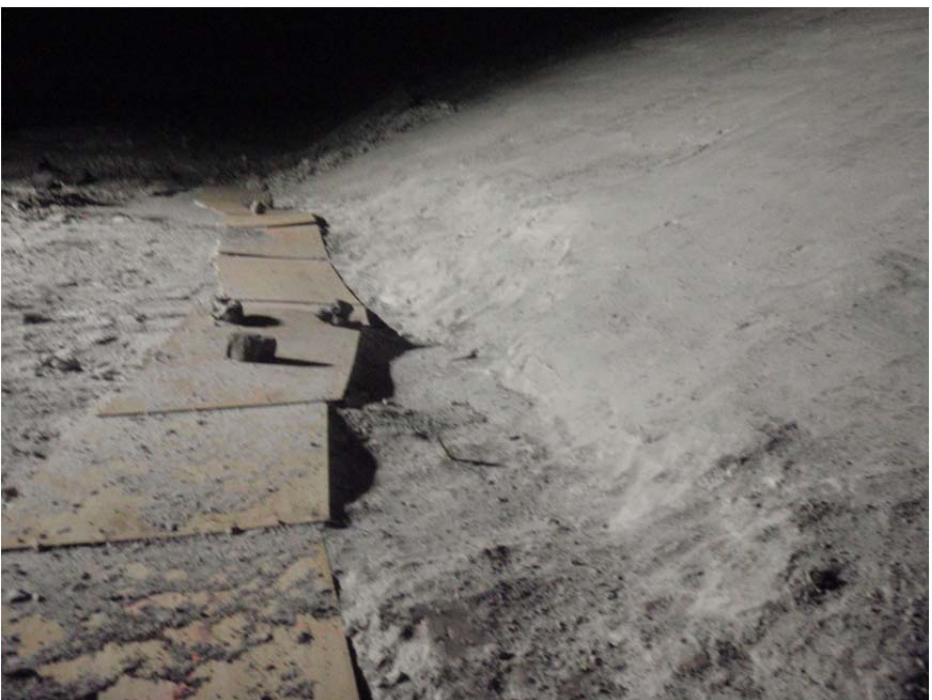
- After cleaning it the underbuilt area at the toe of the upstream slope around 1+20 became visible. This area will required one last small lift of material to bring this area up to grade. See Photo 22 for additional details. FCM placement in this area is expected to result in the coming days.

Photo 22: ~SW view of underbuilt US toe slope around station 1+20. A screenshot of the as-built isopach (from 2012/0313) is included to better highlight this slightly underbuilt area. This area is planned to be built up to grade in the coming days.

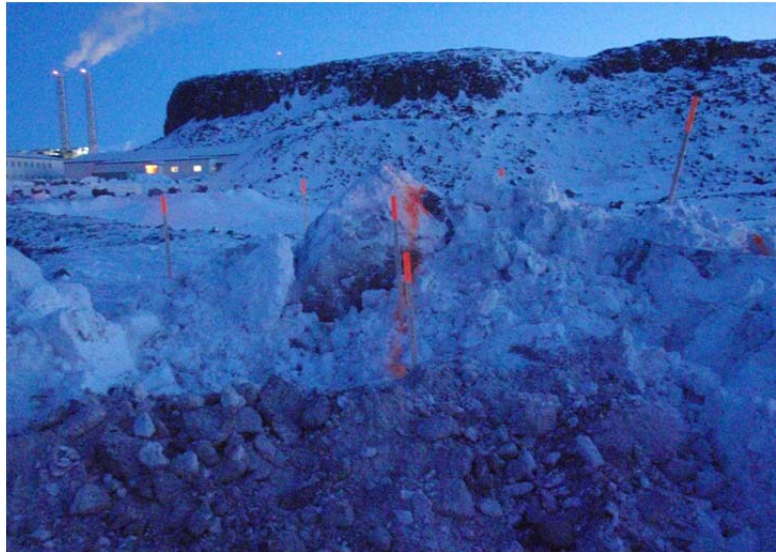
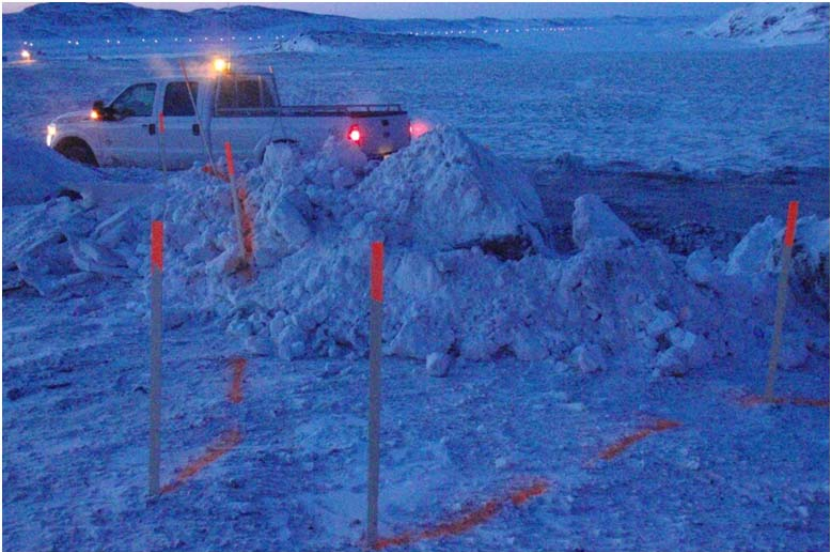
- Nuna survey loaded up the survey files for the as-built liners. The liner limits as well as what was last known to be the planned location for this culvert excavations centerline were marked out. See Photos 23 and 24 for additional details.

- The excavation was note to be very close and arguably impeding inwards onto the pond liners in areas (around the SE corner of the Sediment Pond and SW corner of the Pollution Pond).

Photo 23 & 24: ~N and ~ SSE view respectively of the location where the Sediment and Pollution Pond liners meet around the Separation berm at the pond area. Note the stakes in the center of Photo 23 show the old culvert location which was decided to be slightly revised / offset to be further from the liner key trench areas.

- Details of the events and concerns from the nightshift were outlined to JDS.
 - It was decided that the culvert locations would be slightly moved to the WSW to provide a larger offset from the Pond liners.

- Limits to show the exact extents of planned ripping will be laid out tomorrow for this location.
 - A member of JDS's water management team is planned to watch the ripping in this location to ensure that it does not progress too close to the pond liners.
