DAILY REPORT #74 – DORIS NORTH INFRASTRUCTURE/ NORTH DAM

Prepared by:	John Kurylo Lawrence Borowski	Date:	2012.03.19
Reviewed by:		Project #:	1CH008.058.0320
Role	Company	Personnel – Position	On Site
Client	Hope Bay Mining Limited (HBML)	Angela Holzapfel – ESR Compliance Manager David Vokey – ESR Coordinator Don Ethelston – HSLP Advisor Dean Wold - Safety Jill Turk – ESR Coordinator Katsky Venter – ESR Manger Michelle Tanquay – ESR Site Manager Stirling Kelly – HSLP Advisor	No No Yes No Yes No No No
	JDS	Lloyd Jackson – Mechanical Superintendent Doug Fielding – Construction Manager Ishan Fechter – Construction Coordinator Jerry Graham – Construction Manager Kevin Whieldon – Project Coordinator Mark Valeriote – Construction Manager	No Yes yes No No Yes
Engineering Design Consultants	SRK Consulting (Canada) Inc.	John Kurylo – Site Engineer Megan Miller – Site Engineer Lawrence Borowski – Site Engineer Murray McGregor – Site Engineer Iozsef Miskolczi – Site Engineer Lowell Wade – Senior Engineer	Yes No Yes No No No

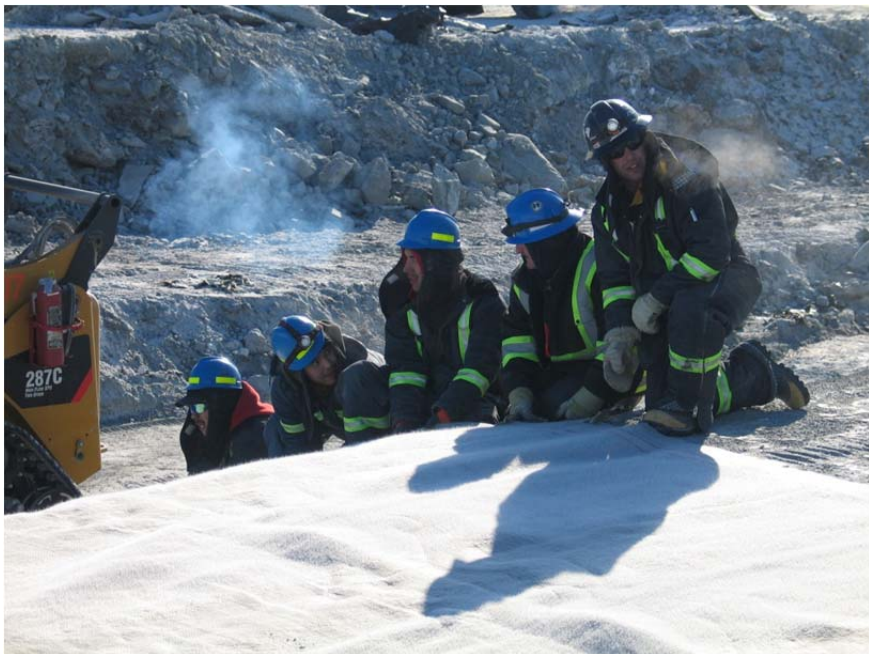
Photo 3: Workers lining up GCL panels.

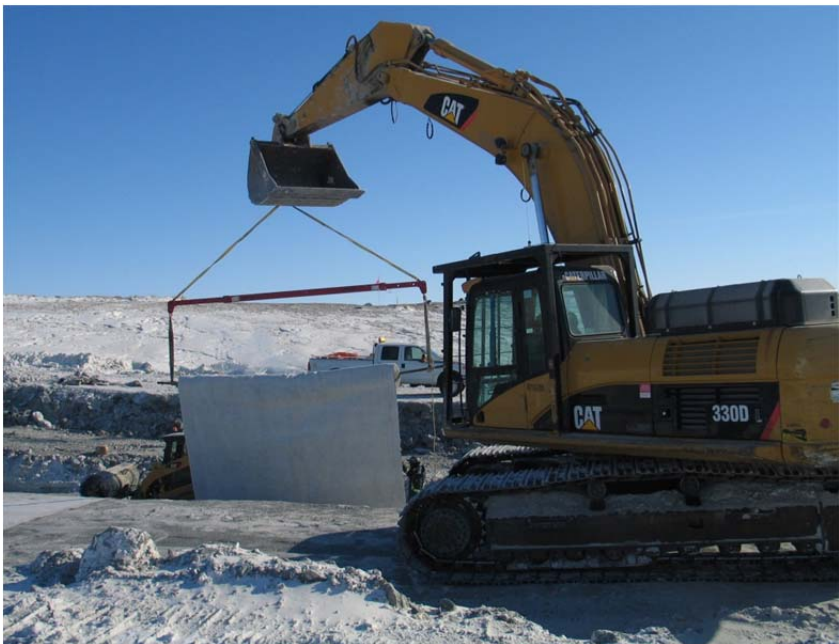
- Excavator was positioned at the top of the slope rather than the bottom. The skid steer was still required to hold the liner in place as it was deployed. The system used was to extend the liner about ½ meter beyond the cut-off line at the bottom of the slope. One skid steer track was positioned over the edge of the liner. After the liner was deployed the ½ meter that was under the skid steer was cut off and discarded.

Photo 4: Cat 330 deploying GCL

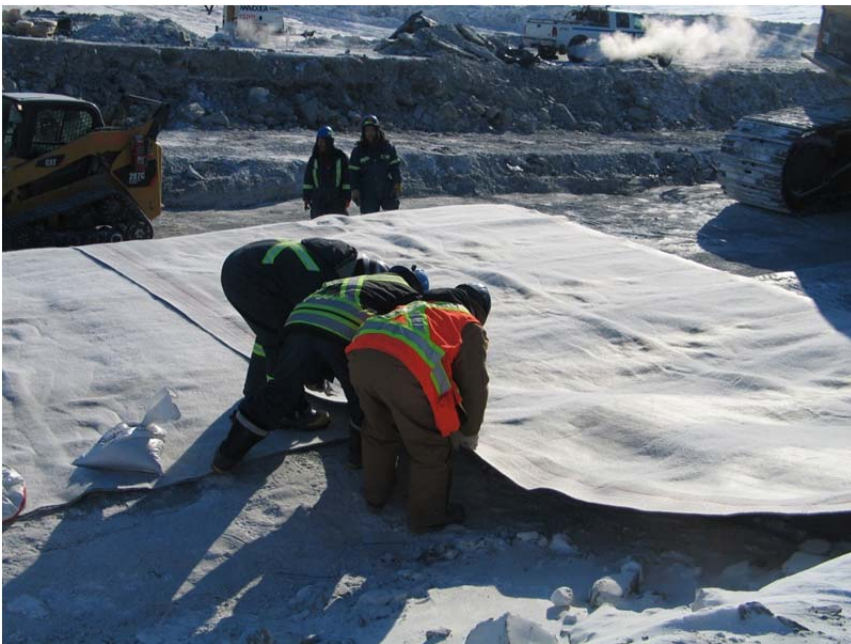
Photo 5: Workers positioning GCL after it has been rolled out.

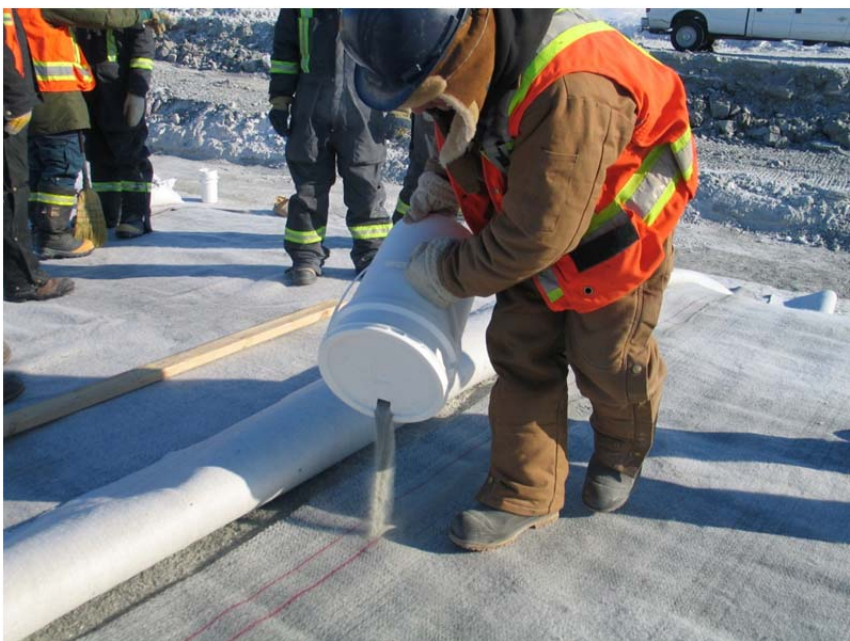
- Discussions were held in the field regarding the correct amount of bentonite to be placed at the seams. There is a vast difference between the manufacturers' recommendations and the IFC drawings (on the order of 14 bags versus 2 per roll). An RFI was issued last year that outlined that the manufacturers' recommendation of 400 grams/meter would be followed.

- As a demonstration JDS measured 400 grams so that workers would know what the correct amount looked like. Bentonite was deployed in a bead from a pail with a hole cut in the lid. The 400 grams/meter was used on the lapped joints and at the bottom.

Photo 6; GCL rolled back. Placing bentonite along seam.

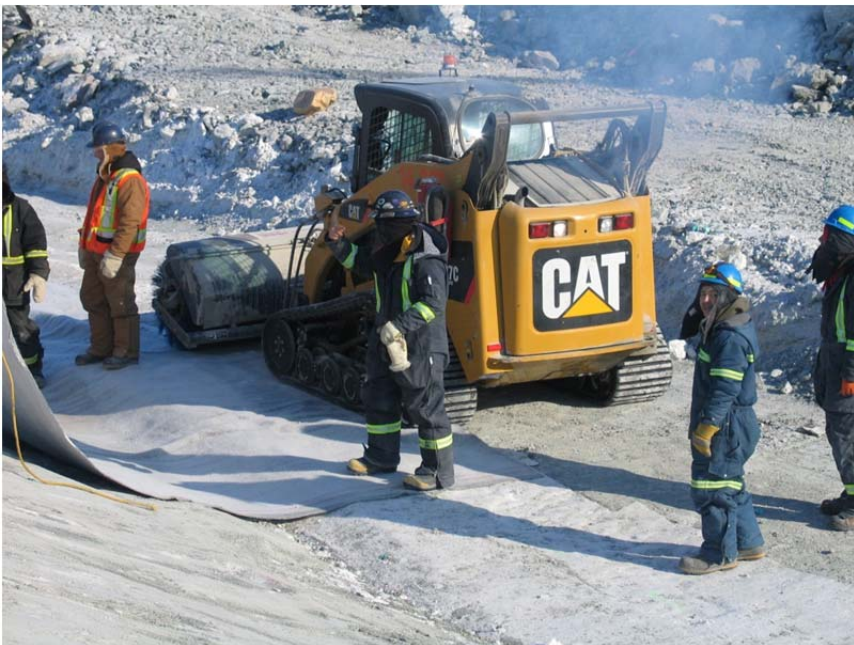
Photo 7: Skid Steer used as anchor. Note the bottom area was trimmed off after the skid steer was moved.

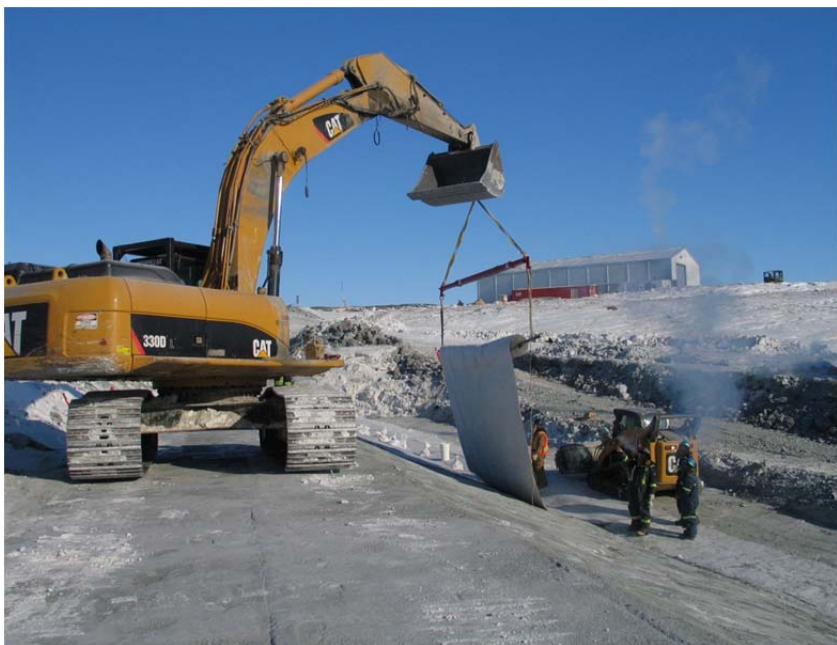
Photo 8: Labour crew and 330 spreading GCL

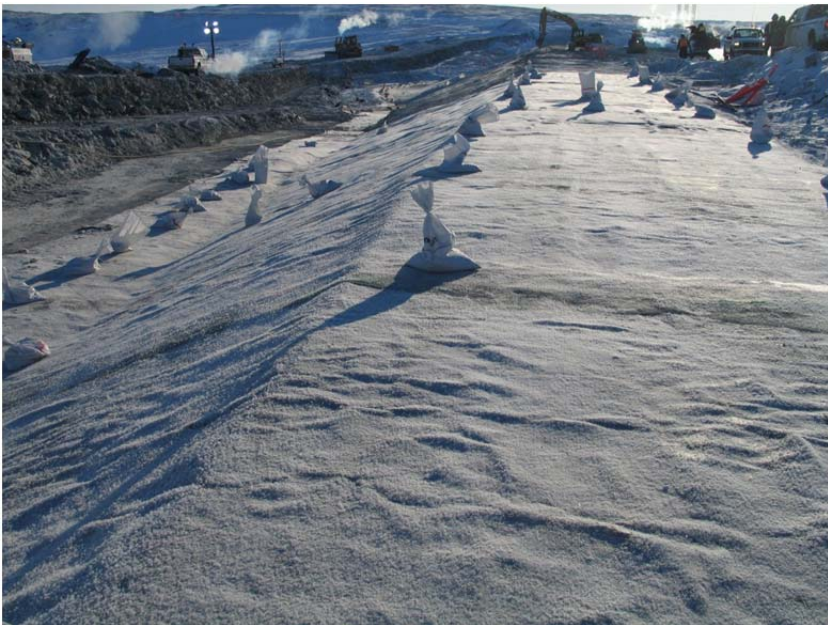
Photo 9: Liner progress to ~Sta 1+60 at the North Dam.

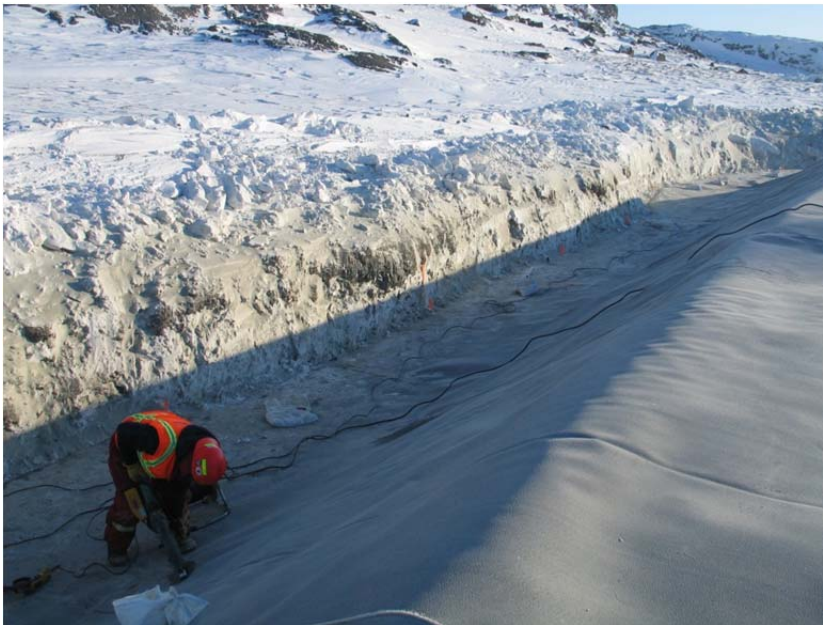
- Work at the berm continues to be well organized. Every phase was inspected before the next phase commenced.
 - Trench cleared between Sta 1+80 and 2+45. Ready for placing crush.
 - Placed bentonite and crush between Sta, 2+45 to 3+00
 - Over liner geotextile placed between Sta 3+00 and 3+45. Final bentonite placed between Sta 3+00 and 3+45

Photo 10: Geotextile Sta 3+00 to 3+45, at the DN Diversion Berm

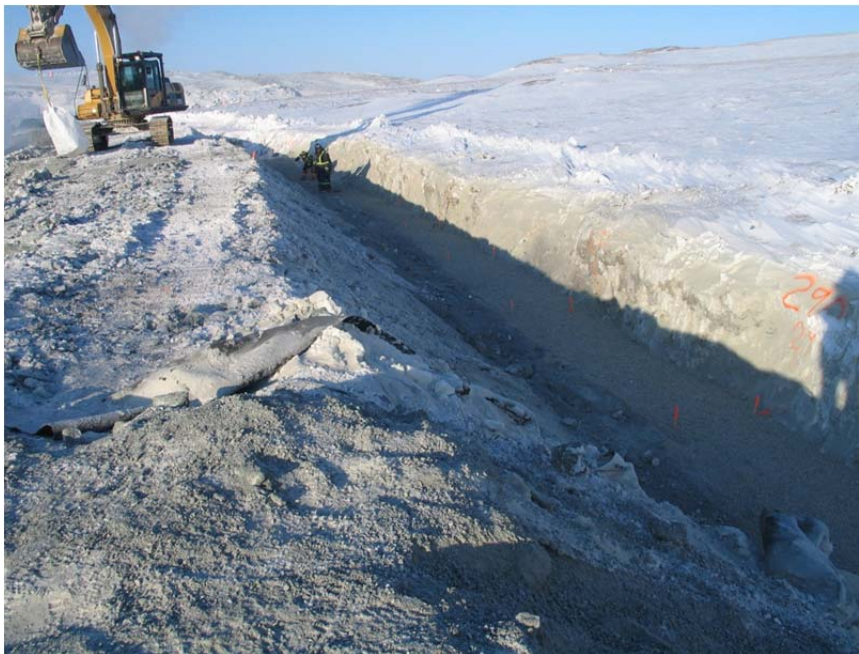
Photo 11: Bentonite Sta 2+45 to Sta 3+00 at the Doris North Diversion Berm.

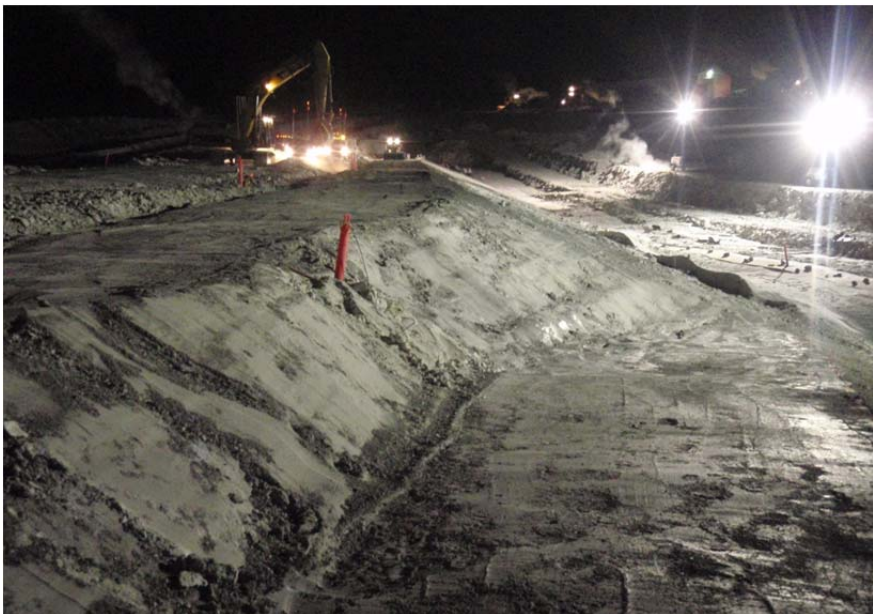
- Near the start of shift the underbuilt SSE corner of the dam was re-inspected. Dayshift had completed some scraping of this slope however loose material, ice and pockets of snow remained on this slope. The intermediate slope, between the top area and lower underbuilt downstream area, was further scraped down to hard ground by hand shovelling / picking and with the excavator. See Photos 13 to 16 for additional details. The nightshift crew did a good job of cleaning this slope.

Photo 13: ~NE view of intermediate slope around 0+50 to 0+70 . at the start of dayshift. Additional cleaning of this slope was required on nightshift to remove pockets of snow, ice and loose material

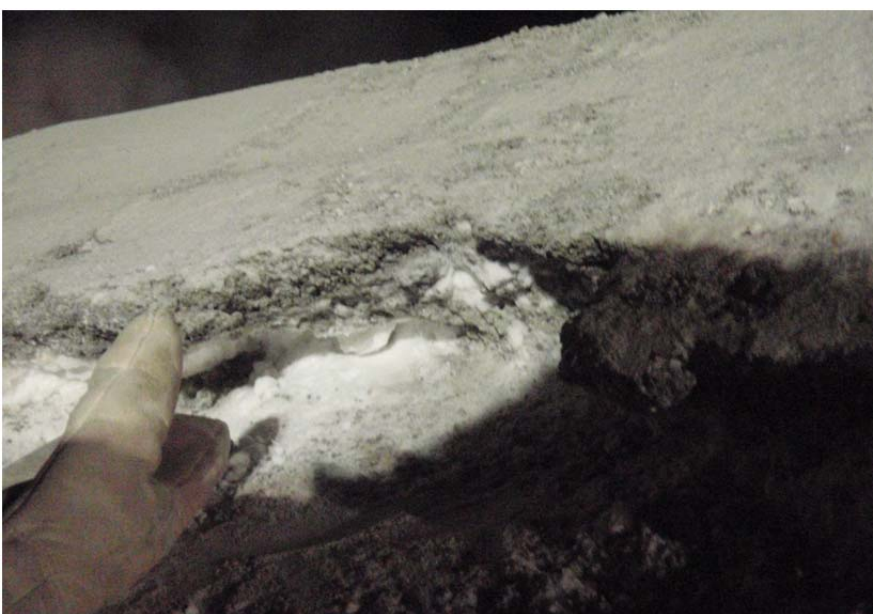
Photo 14: Example of snow pocket under FCM that fell over the side slope during the last placement. Note that this material was ripped out by the excavator

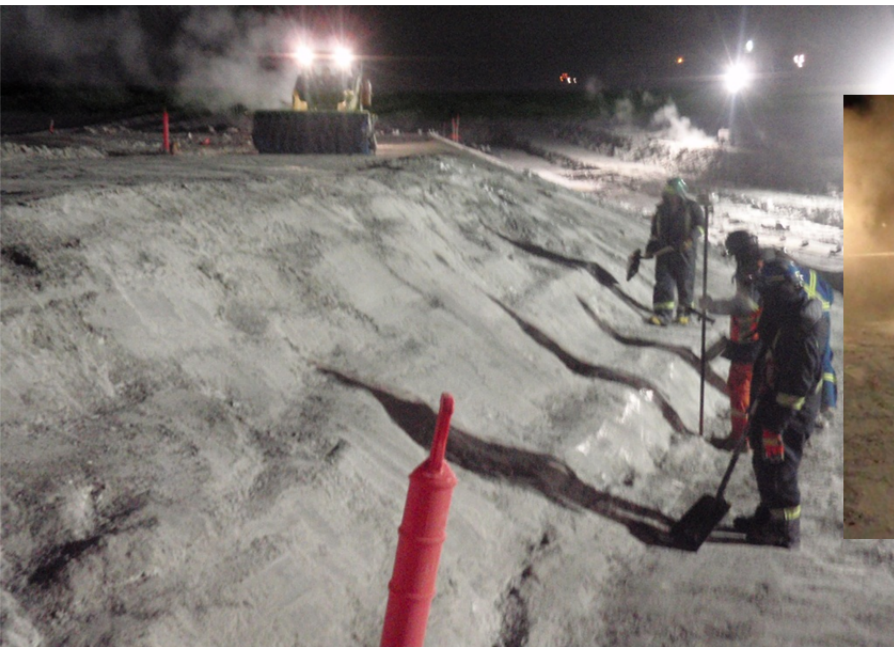
Photo 15: View of intermediate SSE slope (around 0+60) after cleaning.

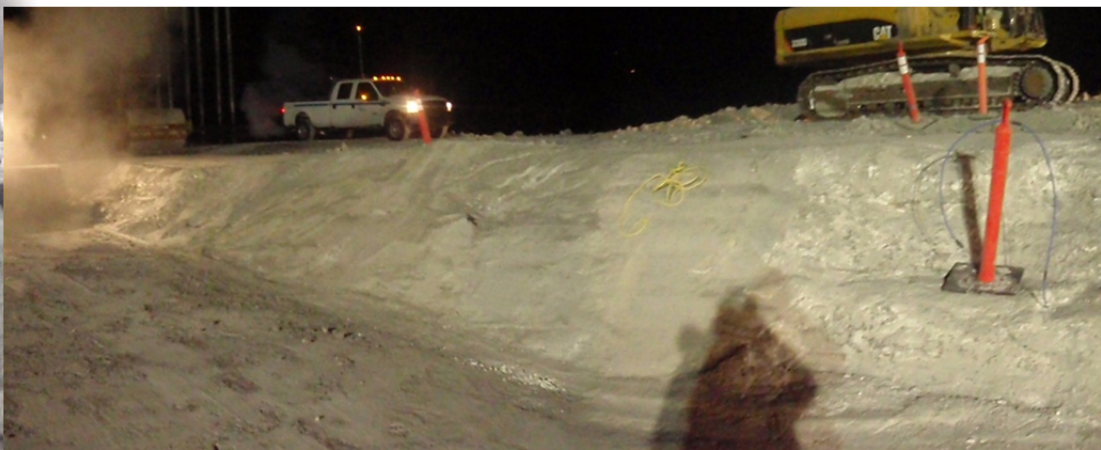
Photo 16: ~WNW view of intermediate slope from ~ 0+40 to 0+60 after cleaning

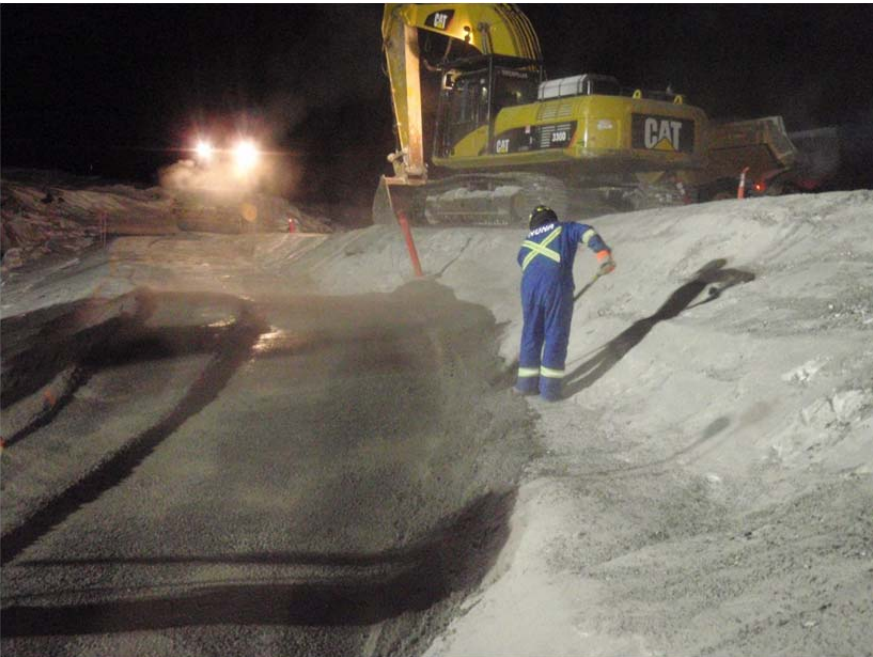
Photo 17: ~W view of FCM placement in underbuilt SSE corner (around 0+70 to 0+4))

- To avoid the need for further extensive cleaning of this intermediate slope area it was decided that saturated FCM would be placed on this slope to remove pockets and undulations. See Photo 17 and 18. FCM was placed on this area with the excavator and tamped with the bucket. Additional water was added to the material placed on this slope area to assist with achieving saturation requirement.

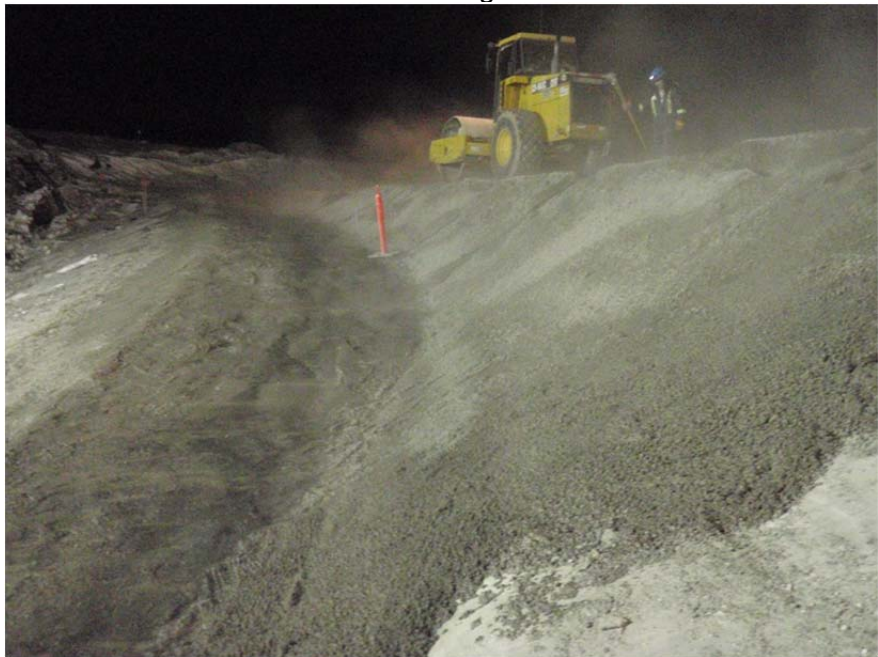
Photo 18: ~W view of SSE corner after FCM placed on side slopes to remove undulations and limit future cleaning activities.

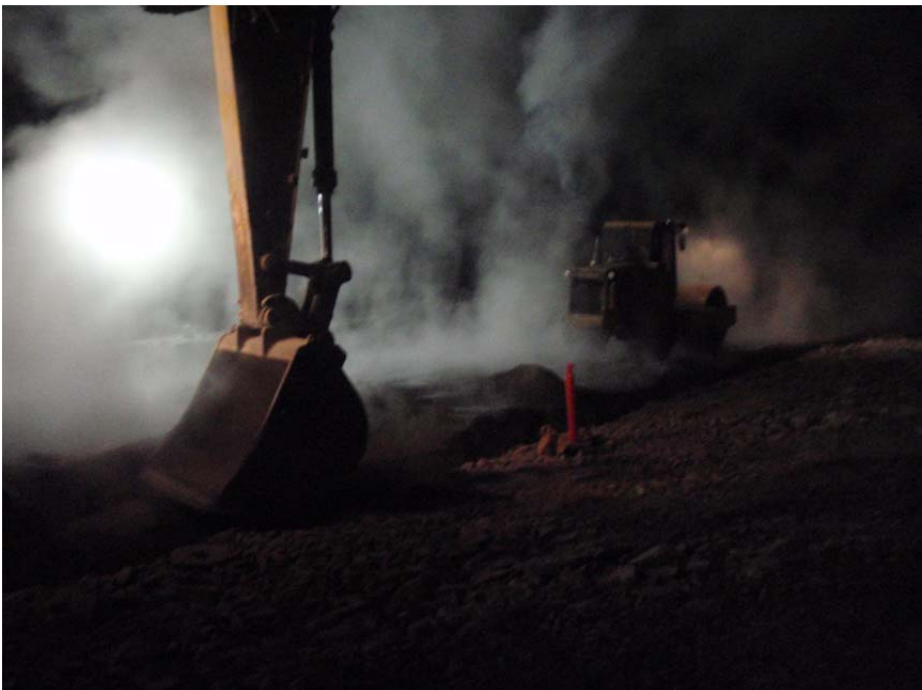
Photo 19: ~SSW view of FCM placement around 0+75
