## DAILY REPORT #75 – DORIS NORTH INFRASTRUCTURE/ NORTH DAM

Prepared by:	John Kurylo Megan Miller	Date:	2012.03.20
Reviewed by:		Project #:	1CH008.058.0320
Role	Company	Personnel – Position	On Site
Client	Hope Bay Mining Limited (HBML)	Angela Holzapfel – ESR Compliance Manager David Vokey – ESR Coordinator Don Ethelston – HSLP Advisor Dean Wold - Safety Jill Turk – ESR Coordinator Katsky Venter – ESR Manger Michelle Tanquay – ESR Site Manager Stirling Kelly – HSLP Advisor	In No Yes No Yes No No No
	JDS	Lloyd Jackson – Mechanical Superintendent Doug Fielding – Construction Manager Ishan Fechter – Construction Coordinator Jerry Graham – Construction Manager Kevin Whieldon – Project Coordinator Mark Valeriote – Construction Manager	No Yes Yes No No Yes
Engineering Design Consultants	SRK Consulting (Canada) Inc.	John Kurylo – Site Engineer Megan Miller – Site Engineer Lawrence Borowski – Site Engineer Murray McGregor – Site Engineer Iozsef Miskolczi – Site Engineer Lowell Wade – Senior Engineer	Yes In Out No No No

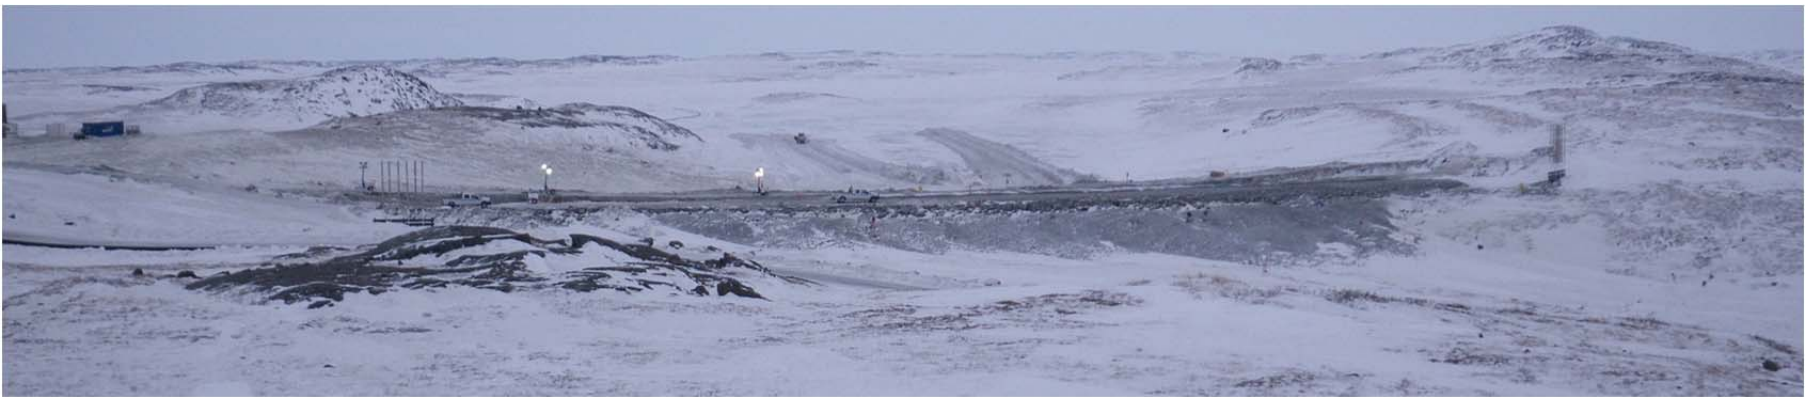
**Photo 1:** Daily progress figure from photo point 1, photo looking south.

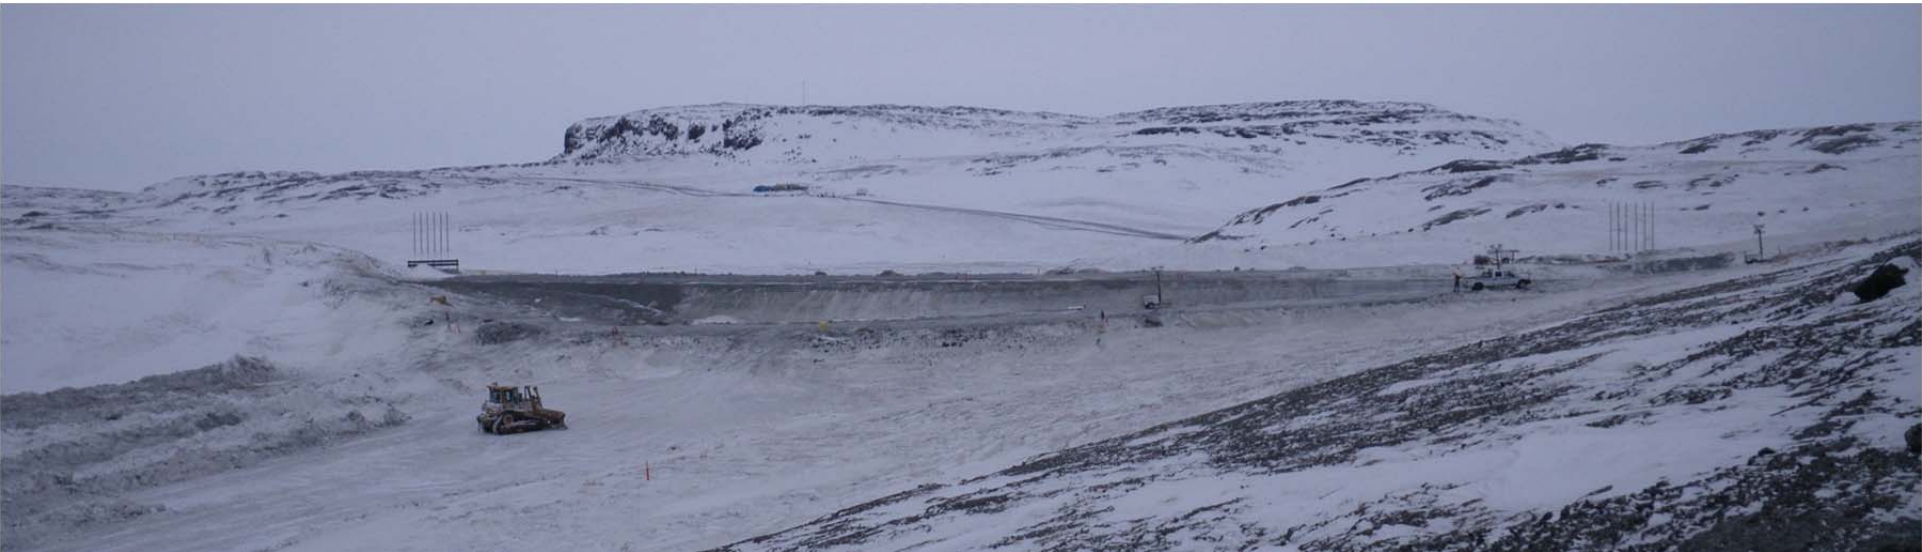
**Photo 2:** Daily progress figure from photo point 2m photo looking north west.

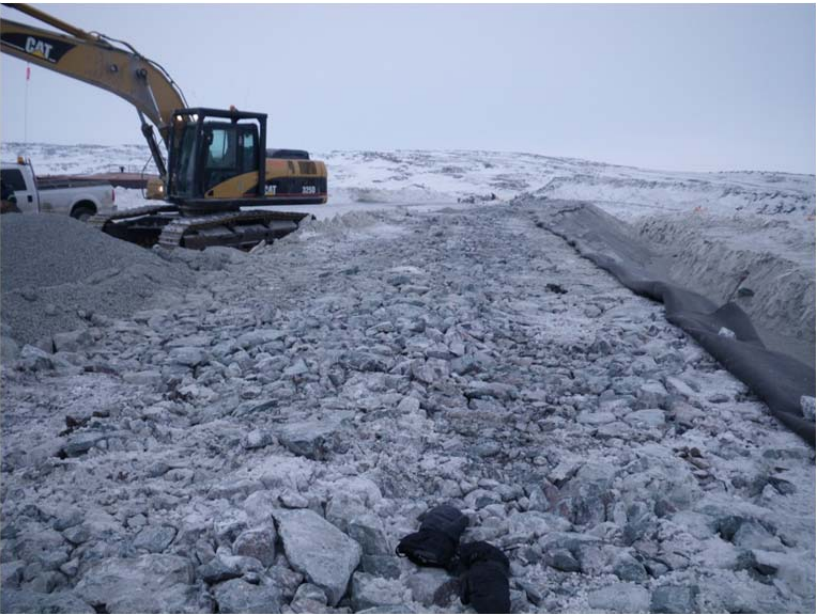
**Photo 3:** Looking south west at the ROQ along the top of the diversion berm. The ROQ surface does not appear packed; however this could be due to the excavator running on the packed surface.

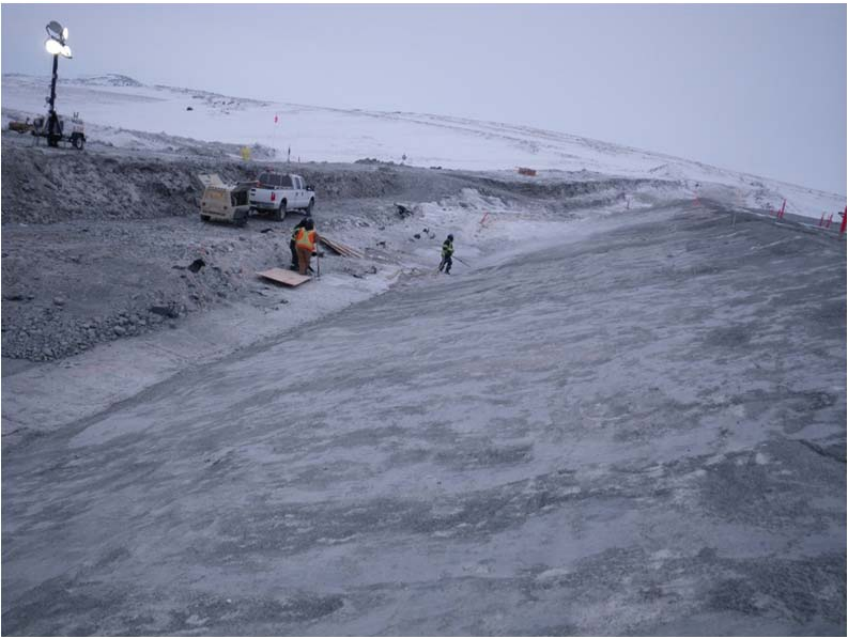
**Photo 4:** Looking south west along the upstream slope of the core. Labourers using air compressor to clean the slope.

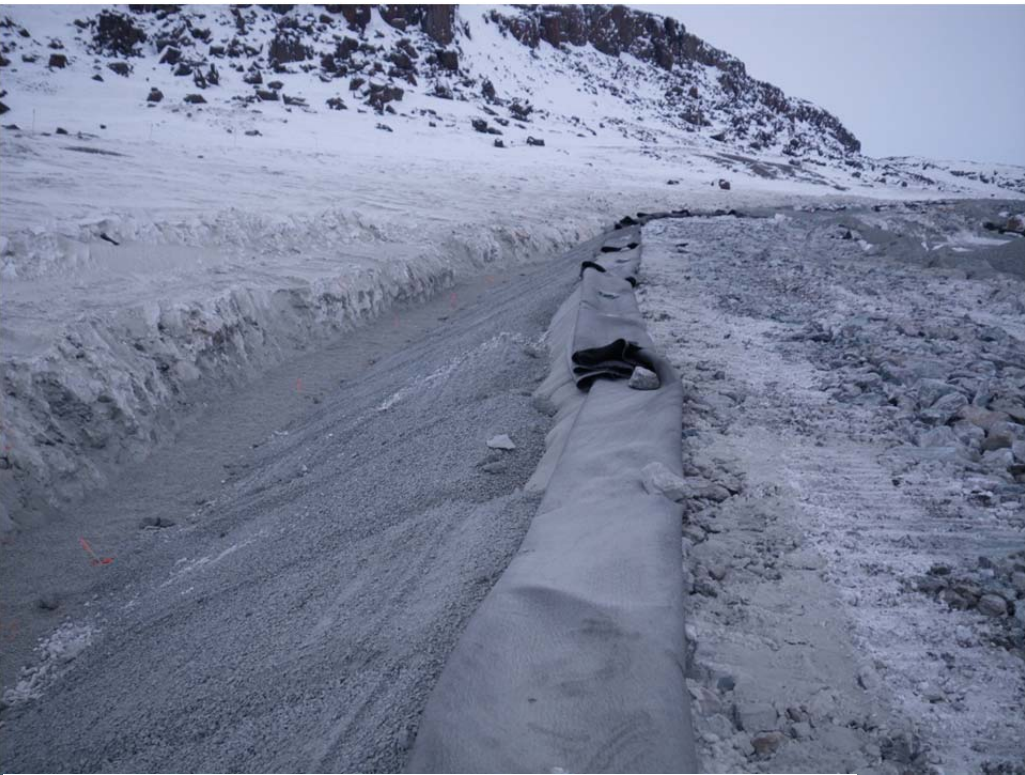
- Placement of ROQ, geotextile and crush continued on dayshift.
- Some snow was removed from the key trench area west of the power cable crossing.
- Crush placed on slope appeared rough. Additional bucket tamping of the crush is expected to be completed with the excavator before additional geotextile deployment.

**Photo 5:** Underliner crush placed on diversion berm. Photo looking east.

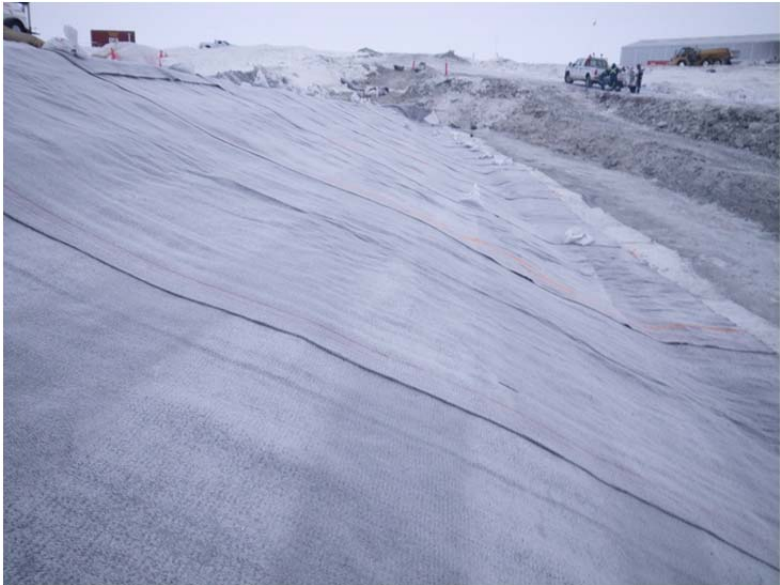
**Photo 6:** View of GCL placed along upstream slope of core. Photo looking north east along dam.

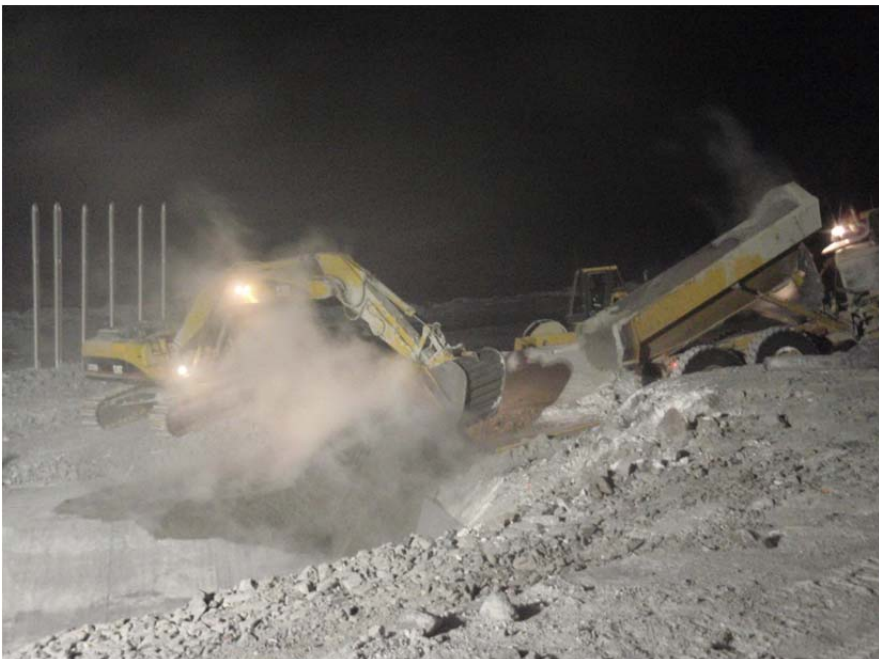
**Photo 7:** The start of Overliner GCL material placement (at ~ 1+95)

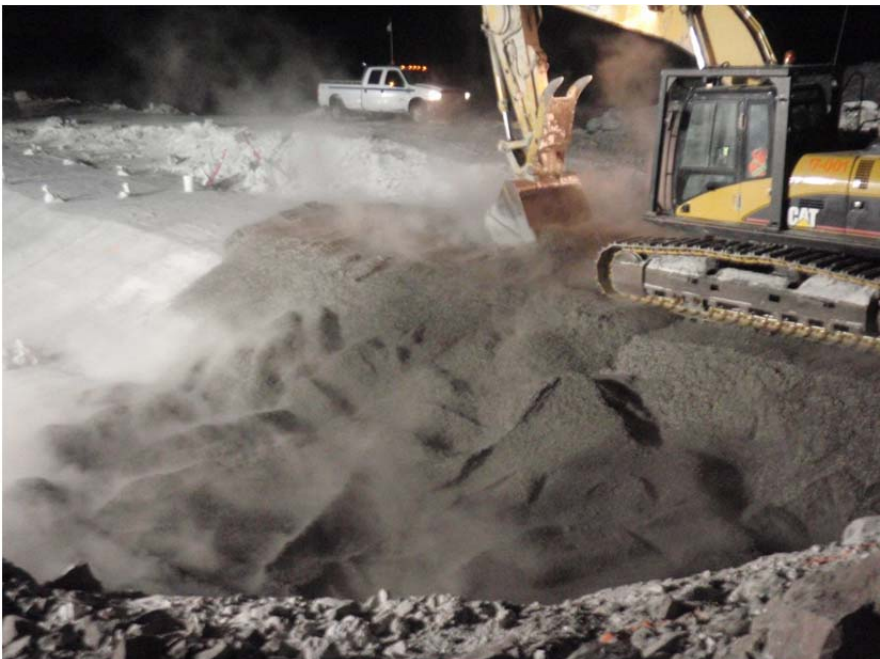
**Photo 8:** Excavator spreading first few loads of Overliner material on the N end of the core.

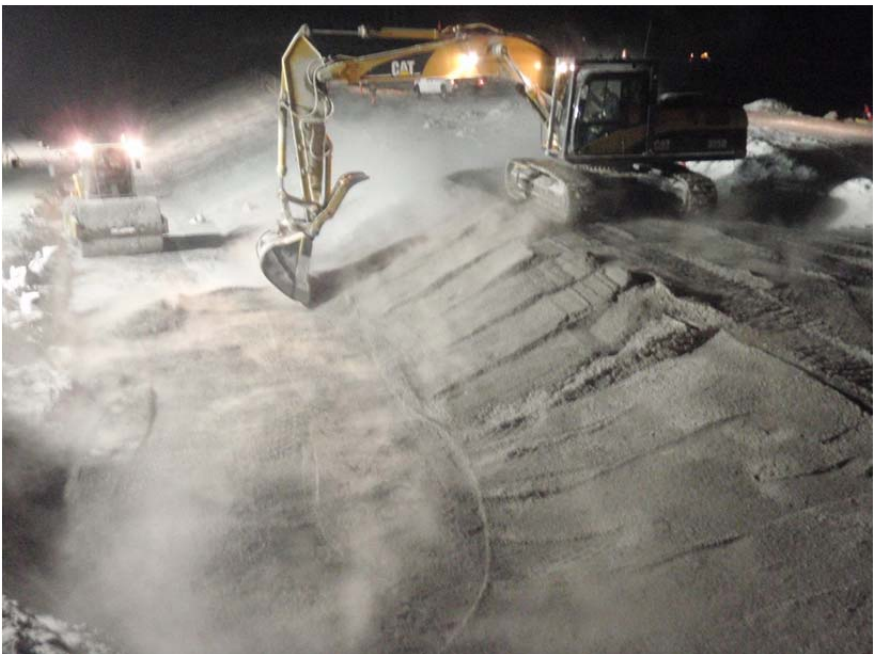
**Photo 9:** ~SWW view of overliner material construction progress (taken around mid shift)

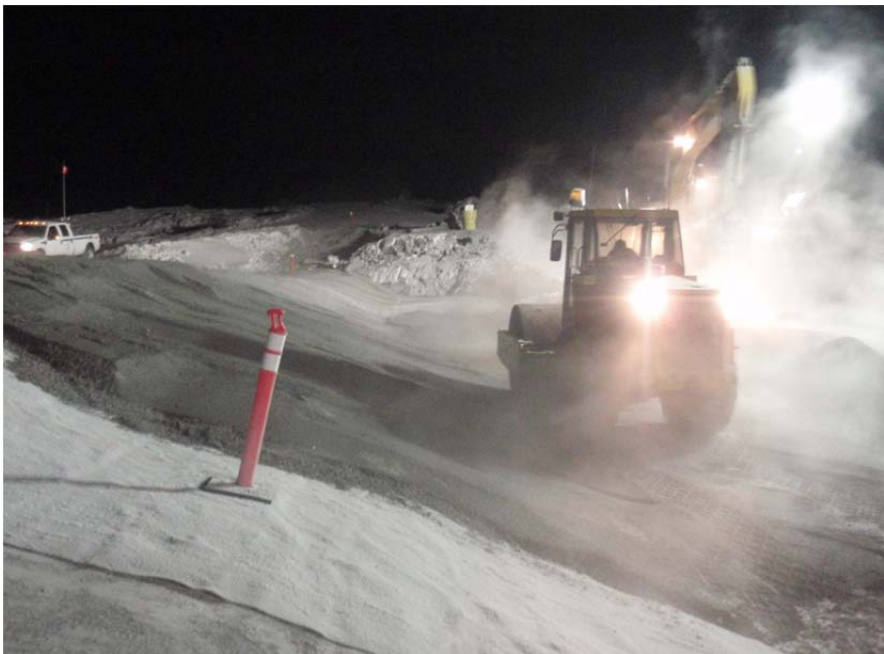
**Photo 10:** ~NEE view of Overliner material placement.

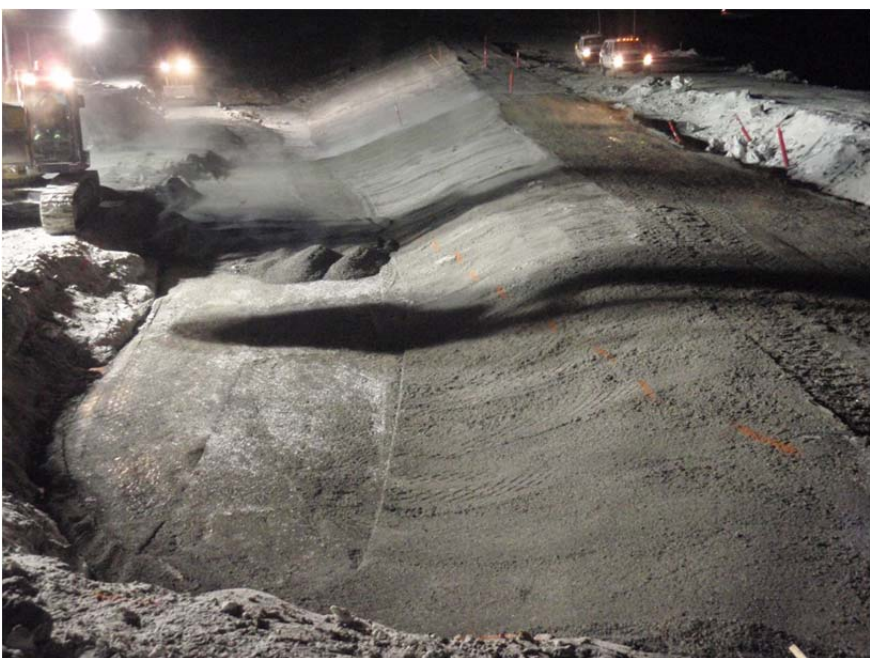
- A first lift of material was placed over the liner and along the base horizontal fillet extension area. After this first lift was placed a second lift was placed at the NE end of the dam core around 1+65 to 1+95.

**Photo 11:** View of second lift of Overliner material starting to be placed at the N end of the core.

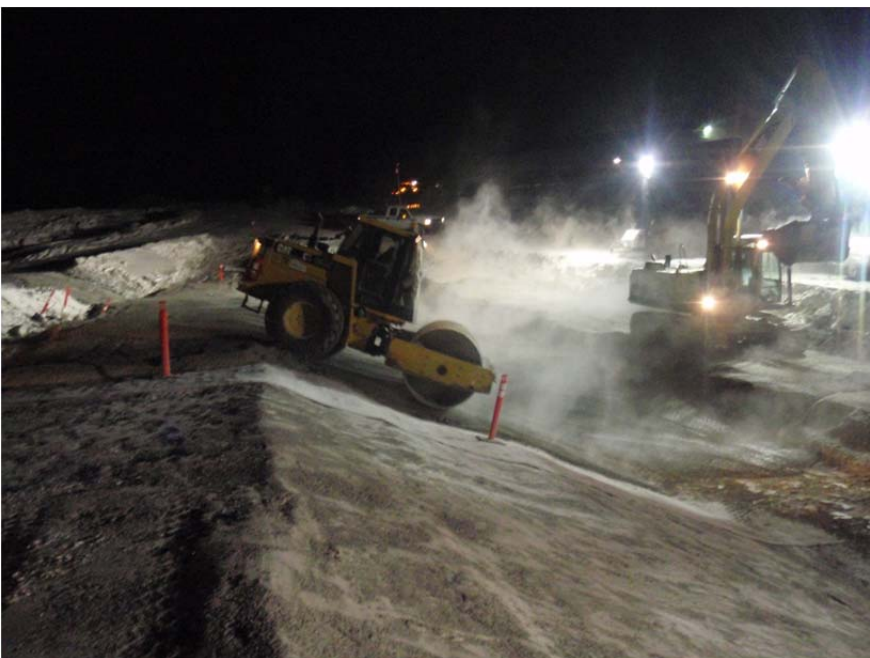
- The overliner material was packed with a 10 ton vibrator compactor. Compaction >90% was achieved.
    - From ~ station 1+70 to 1+95 the packer could travel fully up the side slopes. From ~1+70 S the packer could only make it partly up the slope (~ ½ to ¾ of the way up). The packer worked the bottom area first and then did loops by travelling down the

- slope from the top of the core then going around from the bottom back to the top.
- At the base of the liner at the end of placement the packer ran over a small portion of the outside of the upstream liner (at the toe). SRK will further inspect this area on dayshift to determine if any damage resulted to the liner. On a quick inspection no large or notable damage could be observed.

**Photo 12:** Packer working from the top to the bottom of the slope during Overliner placement.
