DAILY REPORT #76 – DORIS NORTH INFRASTRUCTURE/ NORTH DAM

Prepared by:	John Kurylo Megan Miller	Date:	2012.03.21
Reviewed by:		Project #:	1CH008.058.0320
Role	Company	Personnel – Position	On Site
Client	Hope Bay Mining Limited (HBML)	Angela Holzapfel – ESR Compliance Manager David Vokey – ESR Coordinator Don Ethelston – HSLP Advisor Dean Wold - Safety Jill Turk – ESR Coordinator Katsky Venter – ESR Manger Michelle Tanquay – ESR Site Manager Stirling Kelly – HSLP Advisor	Yes No Yes No Yes No No No
	JDS	Lloyd Jackson – Mechanical Superintendent Doug Fielding – Construction Manager Ishan Fechter – Construction Coordinator Jerry Graham – Construction Manager Kevin Whieldon – Project Coordinator Mark Valeriote – Construction Manager	No Yes Yes No No Yes
Engineering Design Consultants	SRK Consulting (Canada) Inc.	John Kurylo – Site Engineer Megan Miller – Site Engineer Lawrence Borowski – Site Engineer Murray McGregor – Site Engineer Iozsef Miskolczi – Site Engineer Lowell Wade – Senior Engineer	Yes Yes No No No No

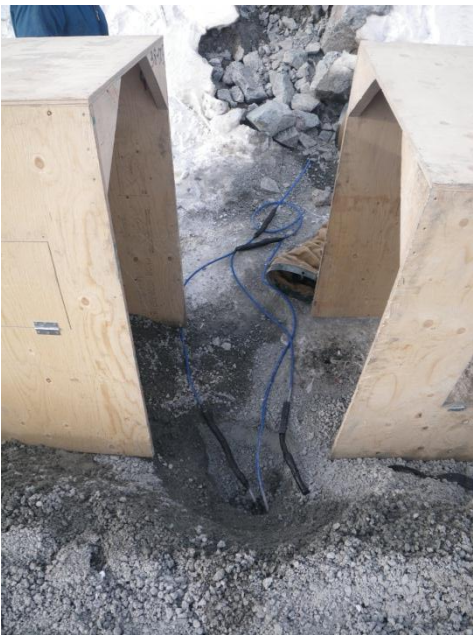
- Electricians completed splicing cables ND-HTS-175-33.5 and ND-VTS-175-KT at station 1+75.
 - During the splicing process the thermistor leads got crossed over; therefore the cable marked ND-HTS-175-33.5 is really reading the vertical key trench thermistor.

- As the wires were mixed up it appeared as though the last three beads on ND-VTS-175-KT were not working. However this is due to the fact that the two thermistors do not have the same number of pins. The electrician has the Thermistor Connector Fixing Kit and will add additional pins tomorrow.

Photo 4: Thermistor cables at 1+75 after splicing.

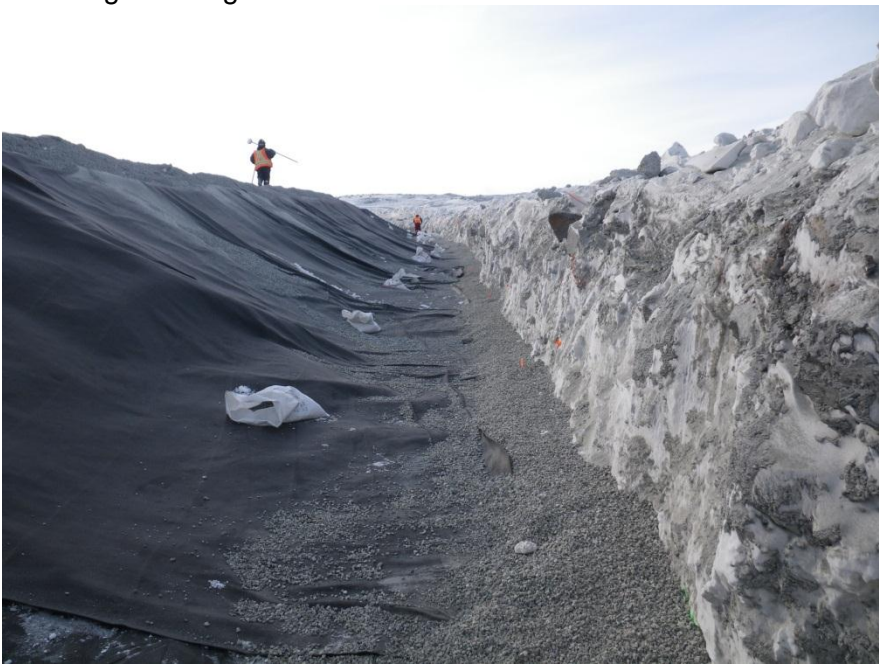
Photo 5: Looking west along diversion berm key trench. Bentonite 'plug' on right side of photo.

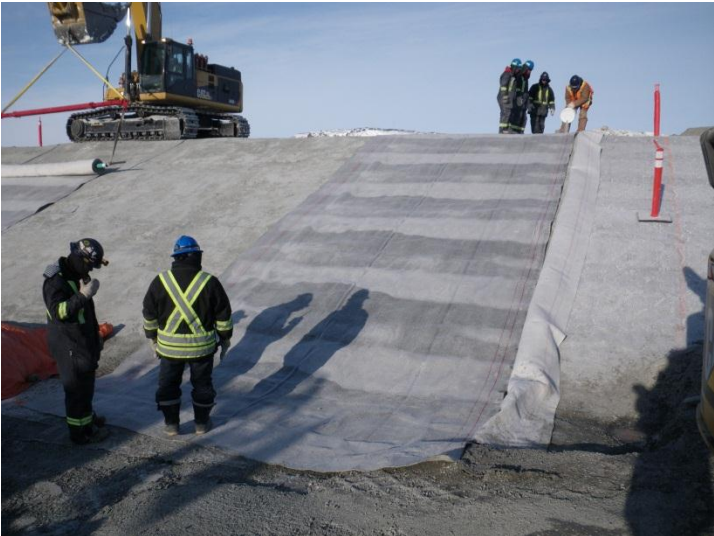
Photo 6: Placing bentonite on GCL seam. Note the striped colouration of the GCL.

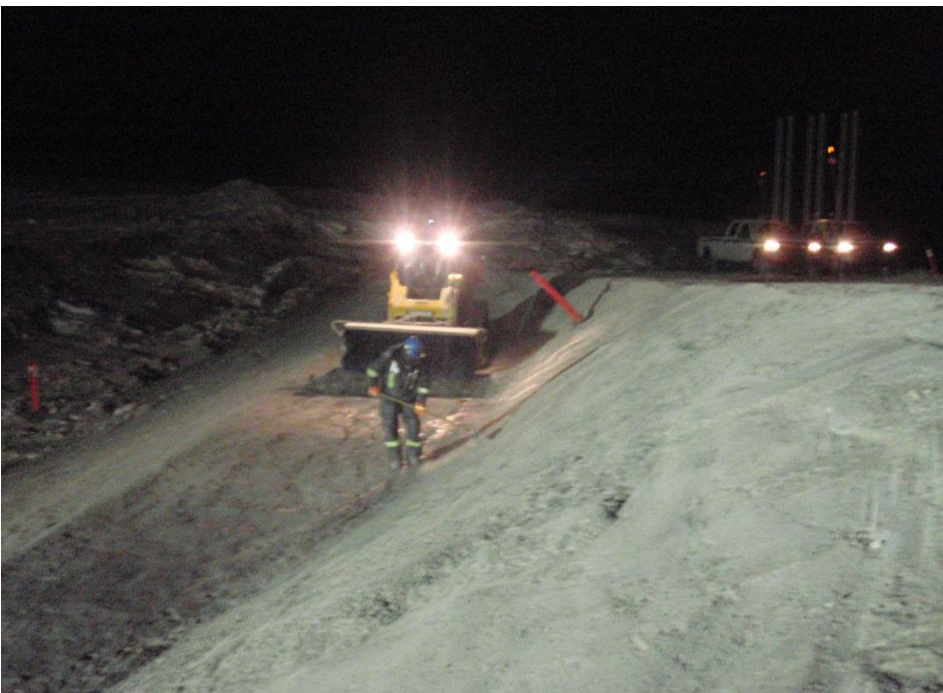
- The underbuilt upstream SSE slope (around 0+40 to 0+70) was cleaned by the excavator, skid steer and labourers.
 - The excavator assisted by scraping off loose material from the intermediate slope around this area.

Photo 8: ~WSW view of cleaning activities in the SSE underbuilt core slope area (Station 0+40 to 0+70)

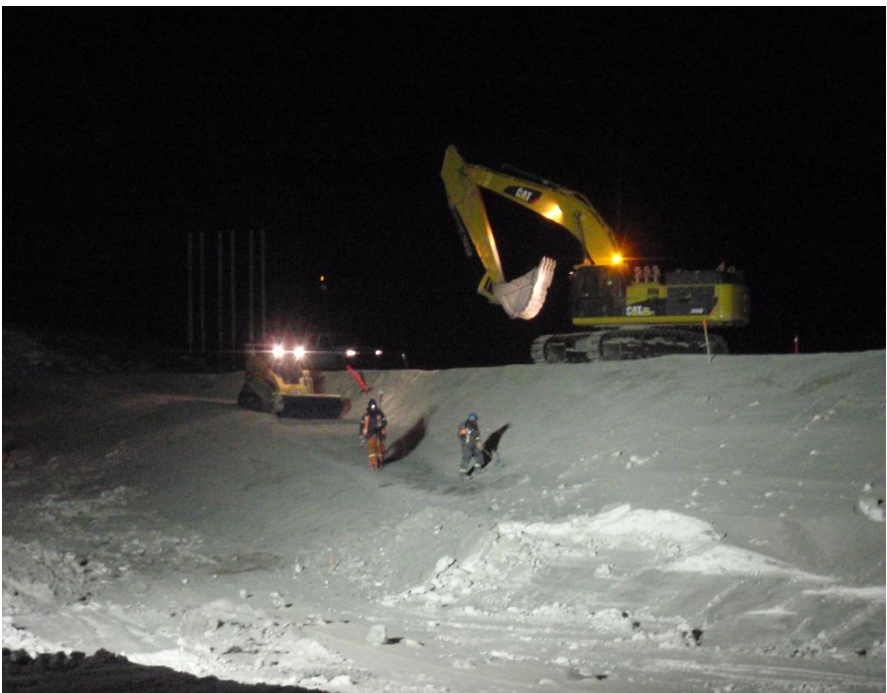
- See Photos 8 and 9.
- The small underbuilt area around the toe of 1+20 was cleaned and then filled in by the 330 excavator with FCM after the plant started up. Bucket tamping was completed on this material and the thin lift was smoothed by the labourers. See Photos 10 and 11.

Photo 9: ~ NNW view of SSE underbuilt upstream slope area after cleaning activities had resulted.

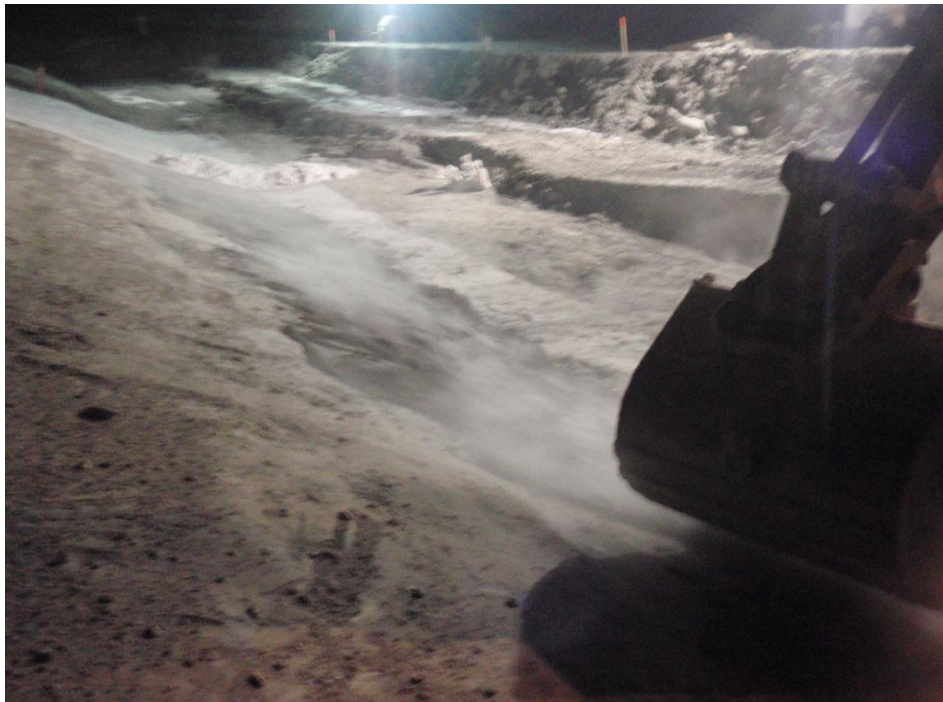
Photo 10: View of 330 bucket spreading FCM in underbuilt upstream slope area around station 1+20.

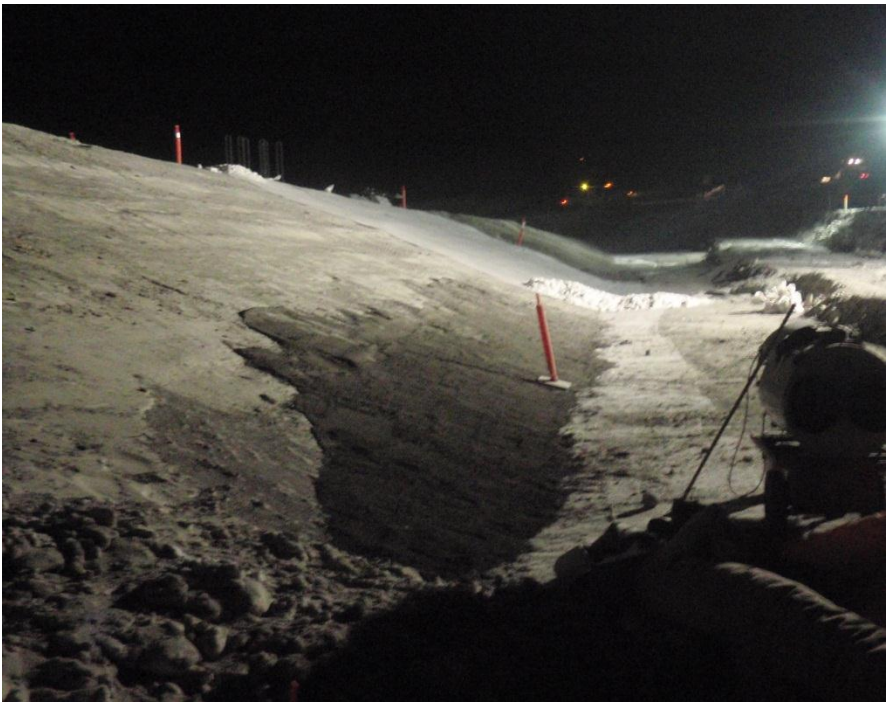
Photo 11: View of completed placement around 1+20. This placement was completed to fill in the previously underbuilt toe. area.

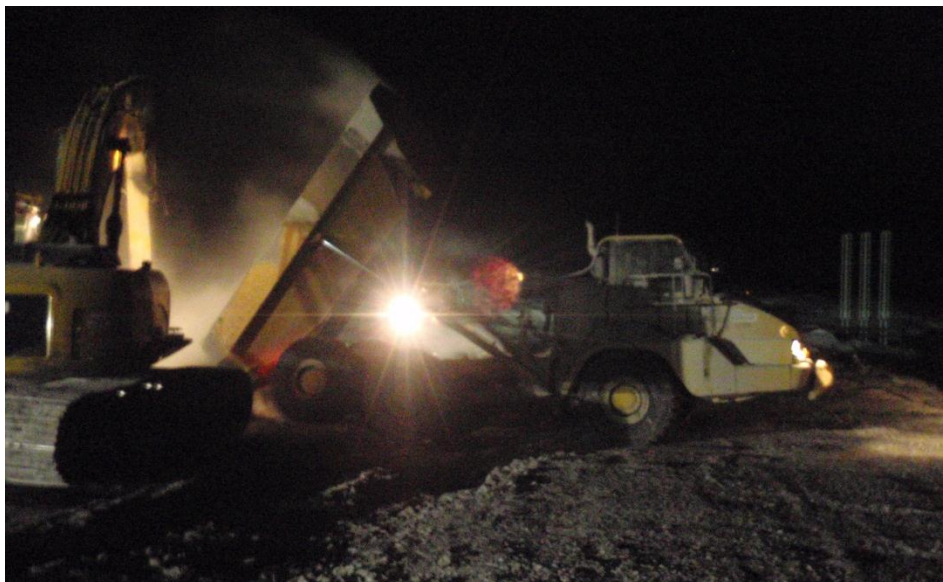
- FCM was placed from ~0+30 to 0+90.
 - FCM was placed first in the underbuilt SSE area of the core slope, and then on the top / crest of the core, progressing from the S to the N. See Photos 12 and 13.

Photo 12: 730 dumping load of FCM around 0+75 for the excavator.

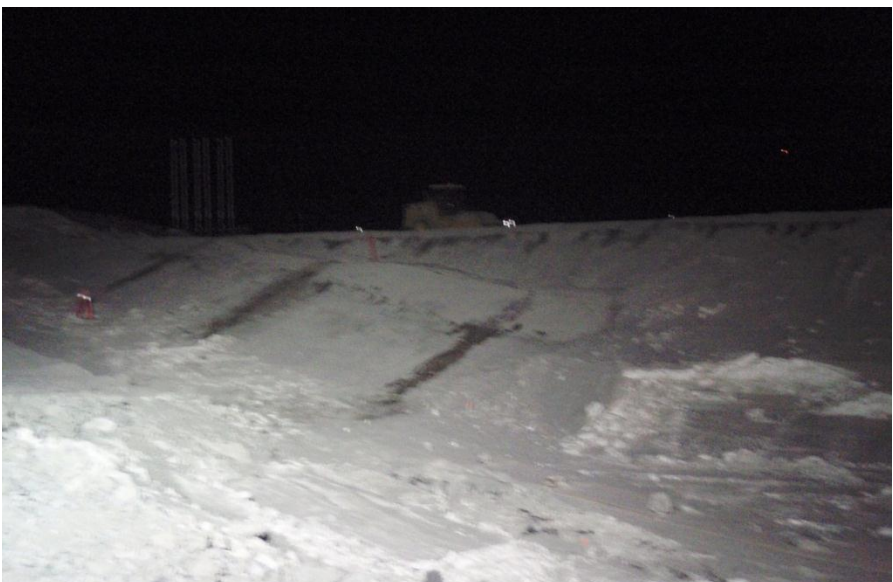
- Due to the inconsistencies noted in the plant / burner setting, see 'Frozen Core Plant' section, some loads of FCM was noted to appear 'wetter' than normal.

- Due to cold weather conditions the top portion of the placed FCM was noted to quickly freeze to create a crust. As the FCM under this crust was still warm and wet this crust was broken in areas by people walking on the core surface or by the packer coming close to previously packed areas. After freezeback the area will be evaluated to see if additional scraping of the top surface is required.

Photo 13: ~ NNW view of SSE underbuilt upstream slope area, after today's placement. Note some water that bled / ran down the side slopes in areas.

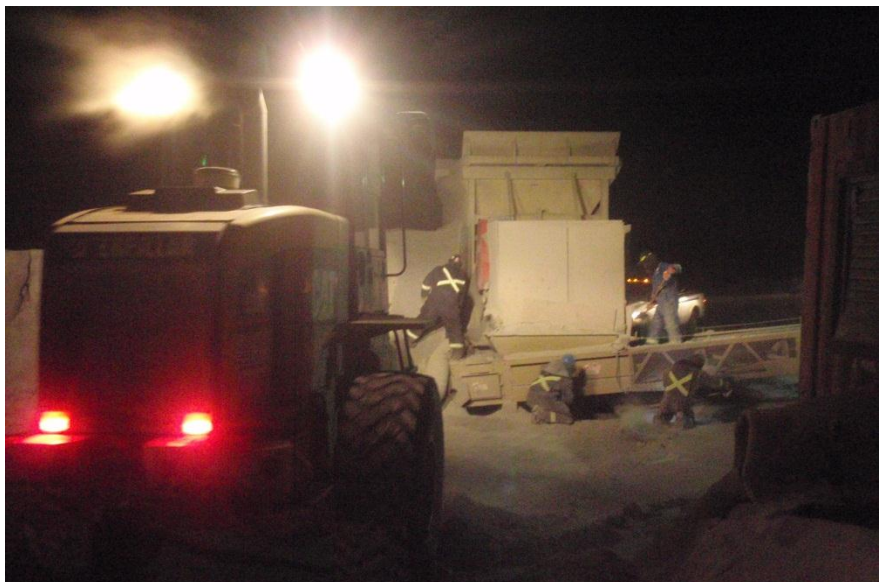
- Issues were had with the feed mill. Material off the hopper / grizzly was found to be spilling

over and clogging up the feed. The plant was stopped around 4:15 - 4:30. Additional cleaning resulted after the plant was stopped. See Photo 14.

Photo 14: Labourers, supported by the loader, digging out feeder and Grizzly at the Frozen Core plant.

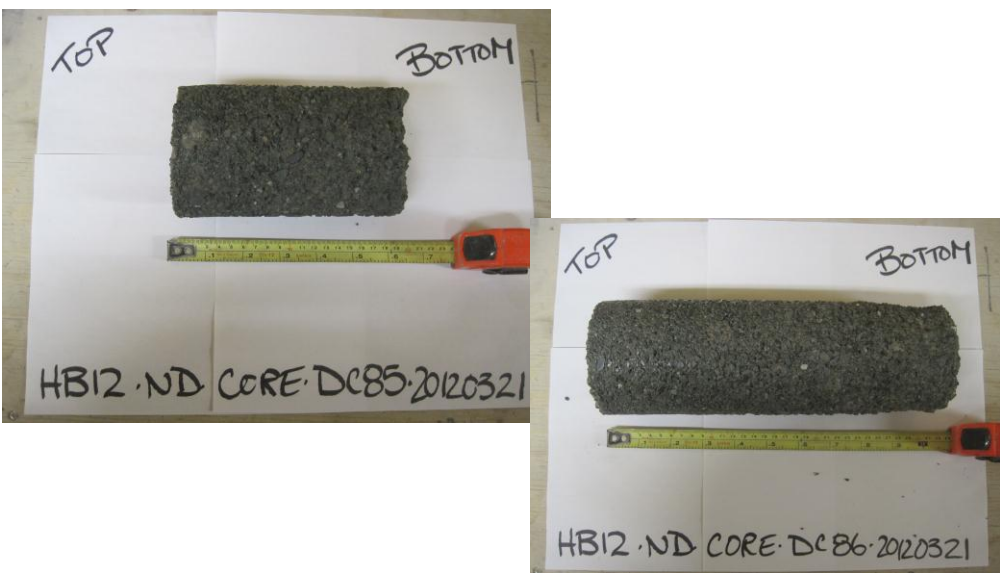
- Two drilled cores were drilled.
 - Drilled core 85 (HB12-ND-CORE-DC85-20120321) was drilled with the use of the small Honda backup generator. The length of the core that could be drilled was limited due to the limited output and easily triggered generator breaker. This core was taken from 0+90 centerline. See Photo 15.
 - Drilled core 86 (HB12-ND-CORE-DC86-20120321) was taken with the use of a Ingersoll Rand light plant. This power supply was moved down to the dam to satisfy SRK's drill power requests. Drilled core 85 (see photo 16) was taken from ~ 1+20, centerline to upstream.

Photo 15 (middle bottom right): Drilled Core 85
Photo 16 (bottom right): Drilled Core 86
