DAILY REPORT #77 – DORIS NORTH INFRASTRUCTURE/ NORTH DAM

Prepared by:	John Kurylo Megan Miller	Date:	2012.03.22
Reviewed by:		Project #:	1CH008.058.0320
Role	Company	Personnel – Position	On Site
Client	Hope Bay Mining Limited (HBML)	Angela Holzapfel – ESR Compliance Manager David Vokey – ESR Coordinator Don Ethelston – HSLP Advisor Dean Wold - Safety Jill Turk – ESR Coordinator Katsky Venter – ESR Manger Michelle Tanquay – ESR Site Manager Stirling Kelly – HSLP Advisor	Out No Yes No Yes In No No
	JDS	Lloyd Jackson – Mechanical Superintendent Doug Fielding – Construction Manager Ishan Fechter – Construction Coordinator Jerry Graham – Construction Manager Kevin Whieldon – Project Coordinator Mark Valeriot – Construction Manager Calvin Goldschmidt – Construction Coordinator	No Yes Out No No Yes In
Engineering Design Consultants	SRK Consulting (Canada) Inc.	John Kurylo – Site Engineer Megan Miller – Site Engineer Lawrence Borowski – Site Engineer Murray McGregor – Site Engineer Iozsef Miskolczi – Site Engineer	Yes Yes No No No

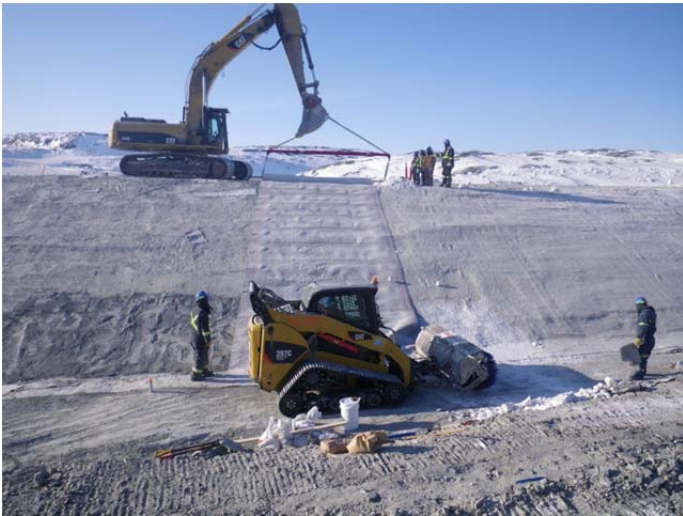
Photo 4: Placing on panel of GCL, skidsteer holding panel at bottom for placement.

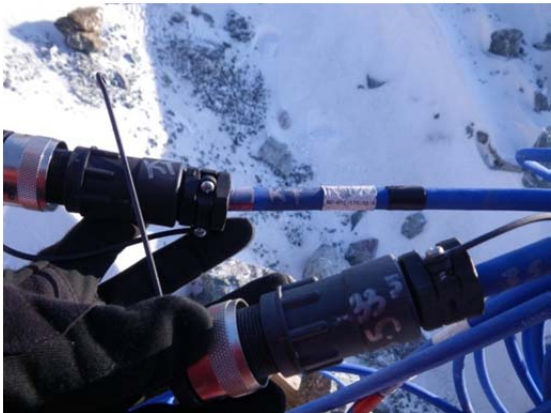
- Readings were taken of all multi-bead thermistors.
- The Nuna electrician replaced the connector on the thermistor string labeled ND-HTS-175-33.5 (which is really ND-VTS-175-KT as the ends were swapped when spliced). All 11 beads on this thermistor are working.
- A silver marker was used to label the two swapped thermistor cables. Photos of this are below.

Photo 5: Silver marker marking the corrected identification for the spliced thermistors at station 1+75.

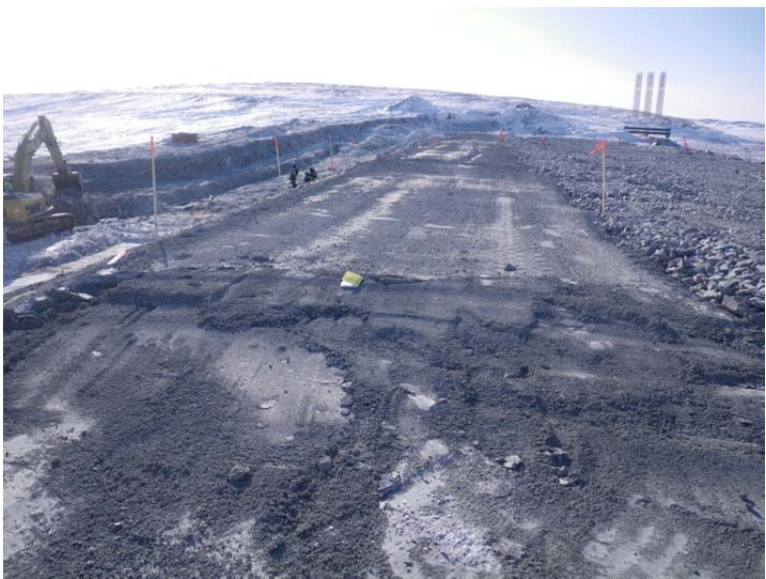
Photo 6: End of FCM placed March 21 nightshift, the end of the placed material was scrapped and removed prior to freeze back.

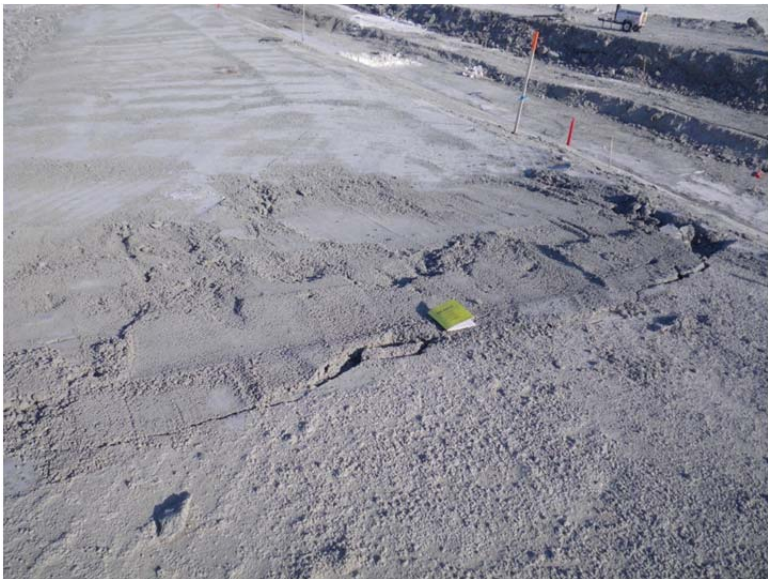
- The CAT 330 excavator scraped/removed the last couple of meters of FCM placed on nightshift, to around 1+05. This material was removed because it was ~20cm higher than the design grade, ended in a straight face and the foreman did not feel that it could be tied in smoothly to the other at-grade core material in the small section (~10m) which remained below grade. The core material was not frozen back when this material was removed so some cracking of the thick frozen core occurred; this cracked material will have to be removed when the area is fully frozen back.

Photo 7: Closer view at the end of the scraped material. As the material was not fully frozen back the surface of the FCM cracked. This cracked material will have to be removed once freeze back is achieved.

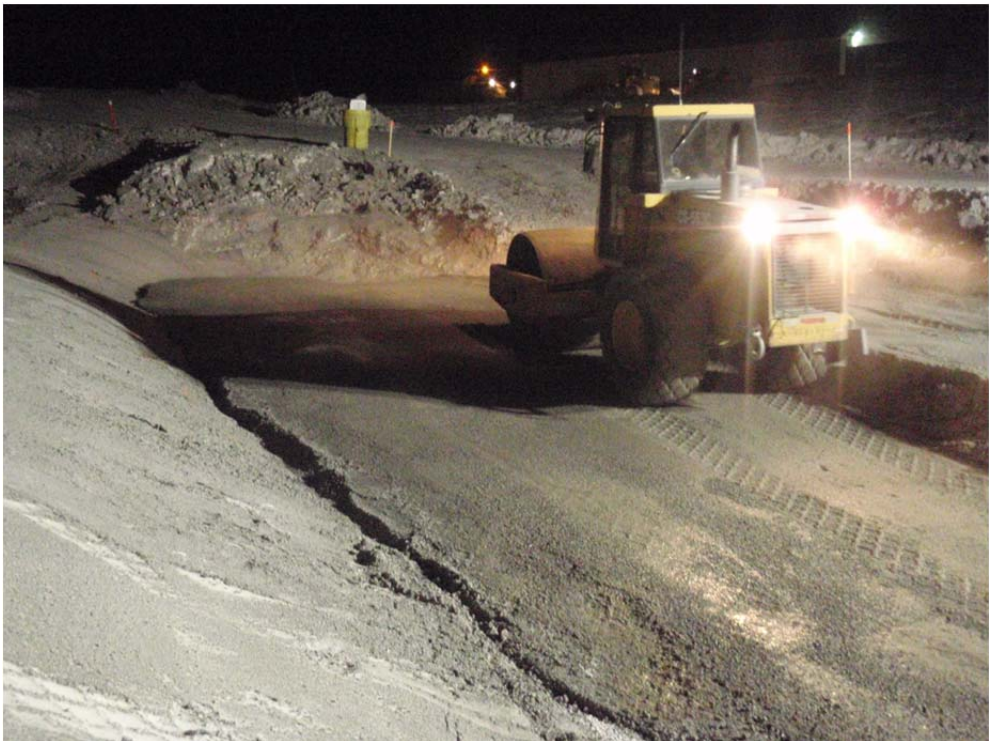
- In some areas the packer was told to stop vibratory packing as in areas the surface was being compacted a large number of times with vibration and water was being brought up through the Overliner material (coarse / more gravel rich than the current FCM being used).

Photo 10: View of vibratory packer on third Overliner lift (1st today) at the North end of the dam alignment.

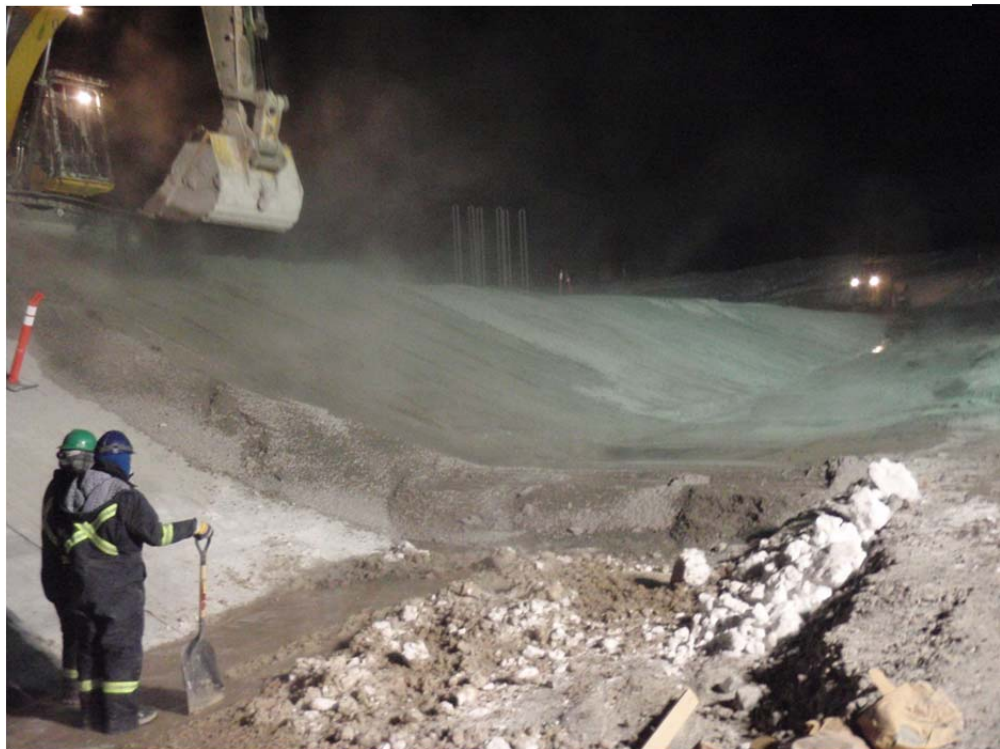
- Material was spread with a 330 excavator.
 - An offset was left from today's overliner placement and the end of the placed GCL.
 - Some bleed water was noted at the toe of the downstream slope (near the fillet area). Some of this bleed water bypassed the snow berm created. Laborers used flat shovels to remove some of the wet snow and partially frozen bleed water off the liner at the toe. See photo 13. Additional hording and heating around this area can be expected. Additional techniques to limit / control the bleed water will be investigated in the coming days. The main factors influencing the bleeding are the coarser gradation of the material (less readily holds water), the near or slightly above optimum moisture contents in the material, and the downwards slope of this area (higher elevation in the N then water travelling down through or on material down to the S).

Photo 13: ~ N view of 330 excavator spreading Overliner material around station 1+60. Note bleed water and snow used to slow / trap some of the bleed water.

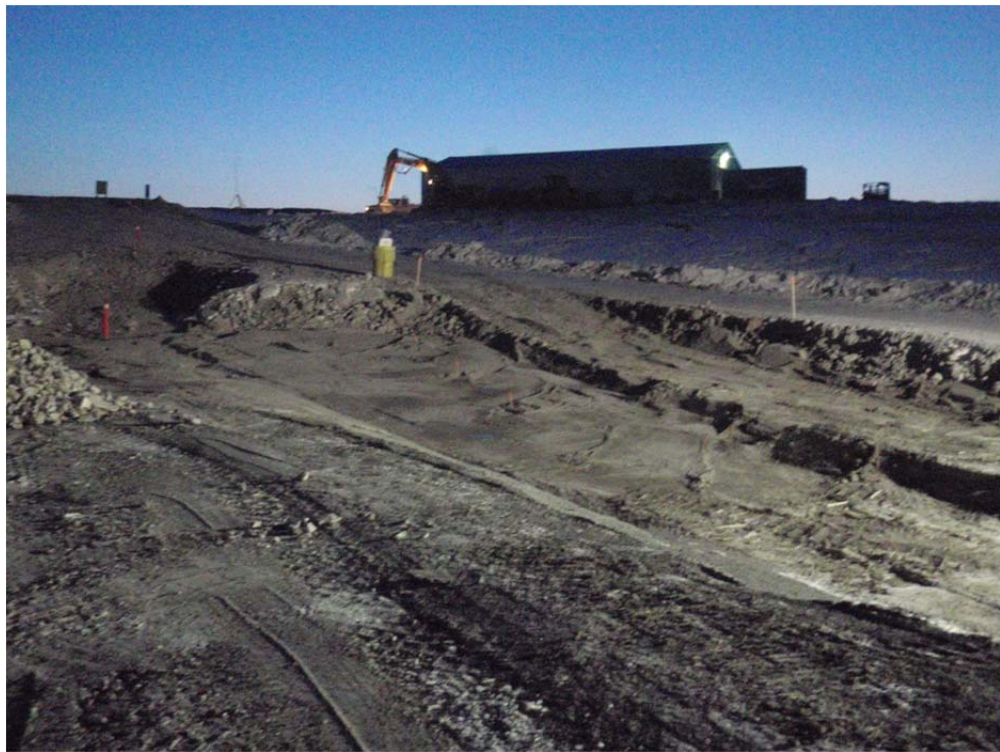
- To allow for Transition placement to progress (and to not have to restart the plant) a one-time allowance was granted by SRK for Nuna to place dry Overliner material in this area to bring it up to the SRK design lines / limits. Note that in the aforementioned area more than 0.3m above the GCL liner was noted everywhere (based on section review). Further, it should be noted that this was the wettest and softest area where four plus lifts of Overliner material from the plant was placed. See Photo 15.

Photo 15: ~NNE view towards the North corner of today's overliner placement. Note that this was the area where a thin skiff of drier crush was placed.

- One load of dry Overliner material was spread over this area.

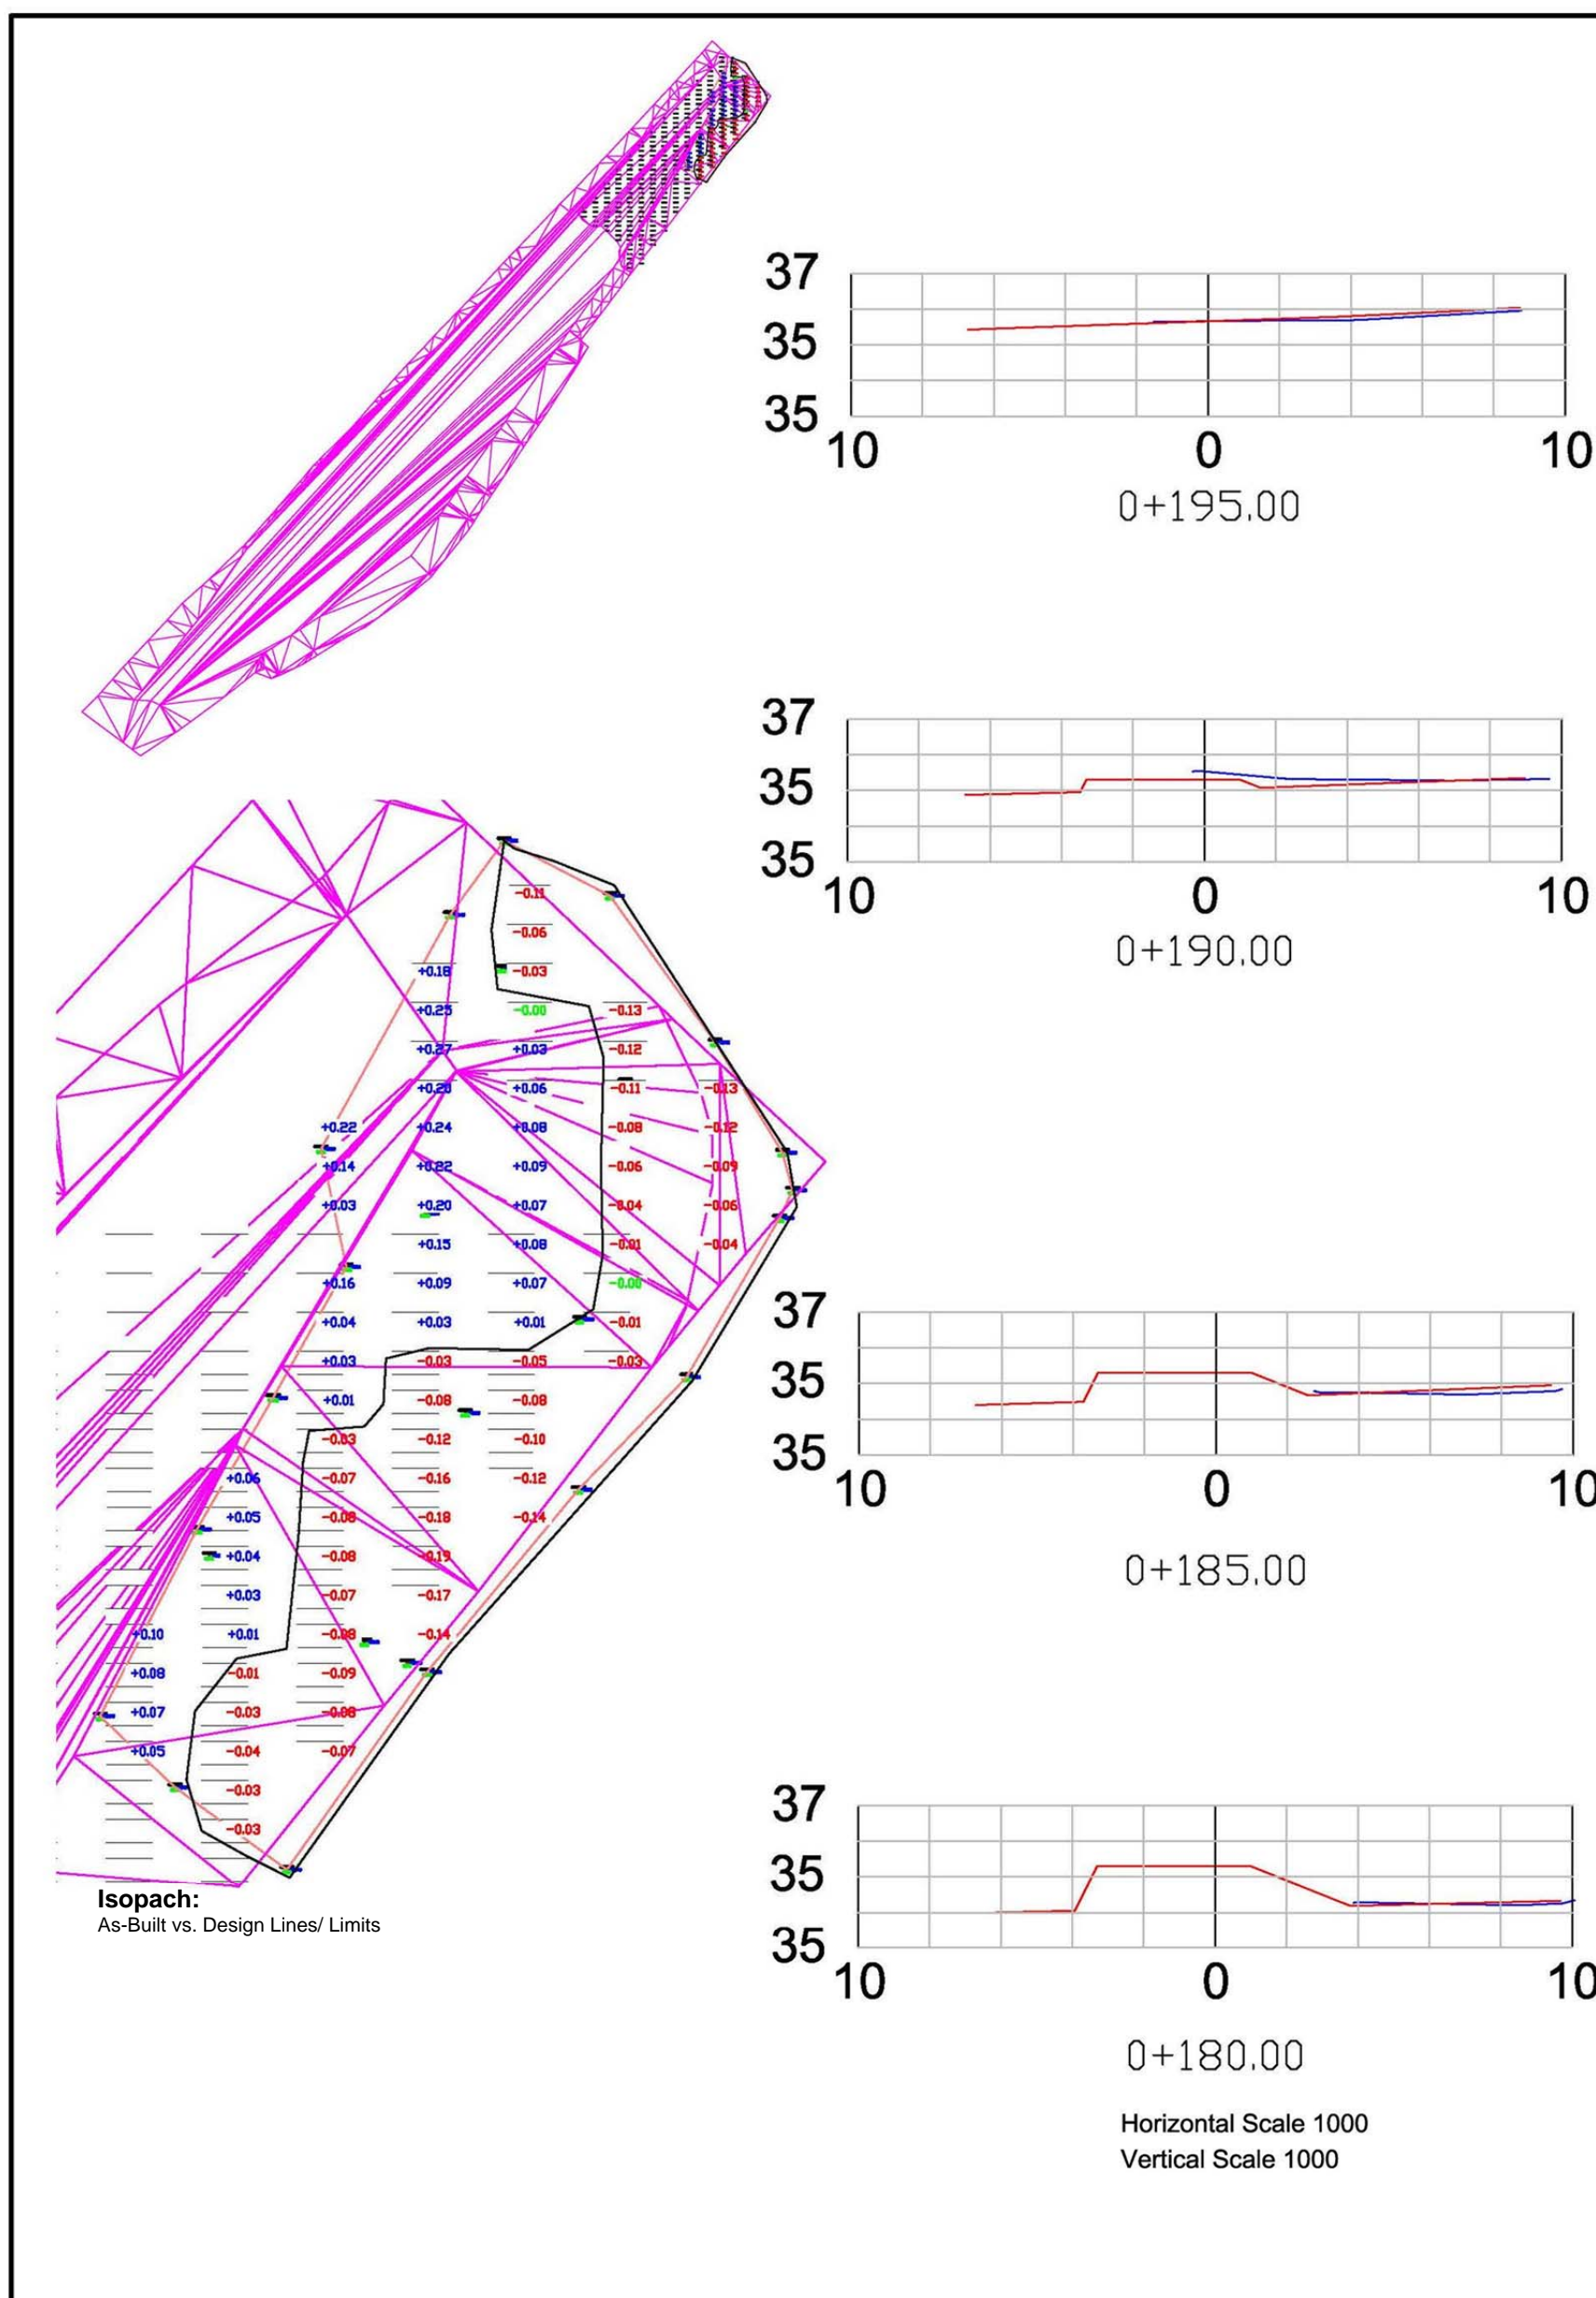
Figure 3 – Preliminary as-built model / review of Overliner material placement at N dam end (model provided by Nuna Survey)

- After the Overliner placement was completed Nuna survey went back to the office and compiled the recent survey data for the Overliner material. Based on the Nuna models / isopach a preliminary as-built review was completed for today's Overliner placement. See Figure 3 for details.

- It was noted that there was an ~ 100 m² area where the Overliner material grades were below the SRK design lines / limits. Typically this area was only 0.1 to 0.12m below the design lines.

- The Nuna foreman indicated that they wanted to proceed with Transition material placement over this aforementioned area (around ~1+75 to 1+95).
 - It is expected that the as-built blasted key trench is slightly inside and below the IFC design lines in this area. This was not further examined due to time constraints and the need for a decision to be made immediately for Transition placement to proceed.

Note: In the sections the red lines show the SRK design lines / limits and the blue lines show the preliminary as-built data review surface. Note that additional Overliner material has now been placed in this area and thus would now raise the elevation of the blue line.
