DAILY REPORT #78 – DORIS NORTH INFRASTRUCTURE/ NORTH DAM

Prepared by:	John Kurylo Megan Miller	Date:	2012.03.23
Reviewed by:		Project #:	1CH008.058.0320
Role	Company	Personnel – Position	On Site
Client	Hope Bay Mining Limited (HBML)	Angela Holzapfel – ESR Compliance Manager David Vokey – ESR Coordinator Don Ethelston – HSLP Advisor Dean Wold - Safety Jill Turk – ESR Coordinator Katsky Venter – ESR Manger Michelle Tanquay – ESR Site Manager Stirling Kelly – HSLP Advisor	No No Yes No Yes Yes No No
	JDS	Lloyd Jackson – Mechanical Superintendent Doug Fielding – Construction Manager Ishan Fechter – Construction Coordinator Jerry Graham – Construction Manager Kevin Whieldon – Project Coordinator Mark Valeriot – Construction Manager Calvin Goldschmidt – Construction Coordinator	No Yes No No No Yes Yes
Engineering Design Consultants	SRK Consulting (Canada) Inc.	John Kurylo – Site Engineer Megan Miller – Site Engineer Lawrence Borowski – Site Engineer Murray McGregor – Site Engineer Iozsef Miskolczi – Site Engineer Lowell Wade – Senior Engineer	Yes Yes No No No No

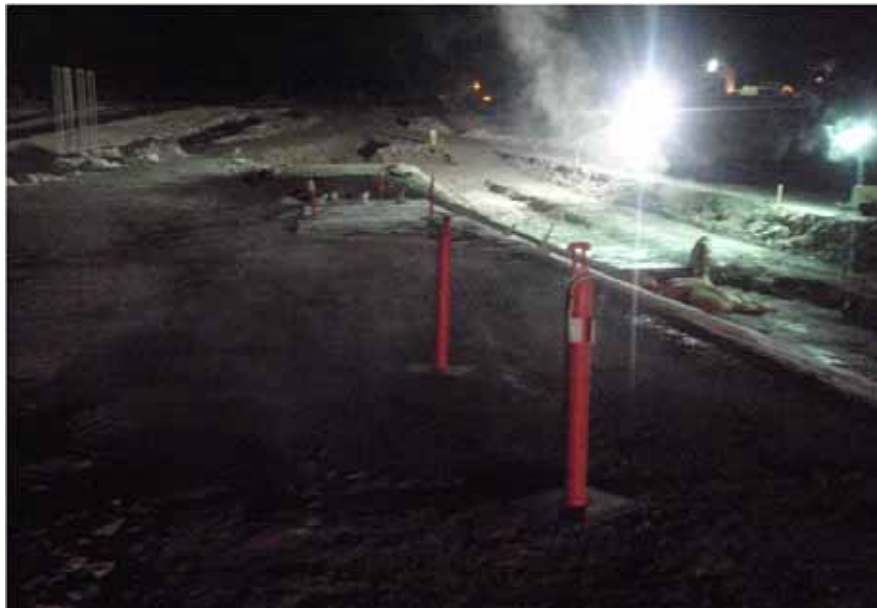
- 1 load of FCM was placed on the slightly underbuilt top crest of the dam (see Figure 3), around 1+05 to 1+20.
 - See Photo 8
- Around station 1+40 to 1+30 the hording and heating over the liner where ice from bleed water had built up was removed. Some of the water / slush was scraped to the side with flat shovels. A few pieces of reject GCL (typically cut off from the end of rolls) was placed around this area near the toe / base of the upstream slope (slightly N of the edge of the min 1m GCL liner overlap).

Photo 8: Area on the top crest of the dam, around 1+05 to 1+20, that was built up on the downstream and upstream crest with a small lift of material (~0.1 to 0.15m left).

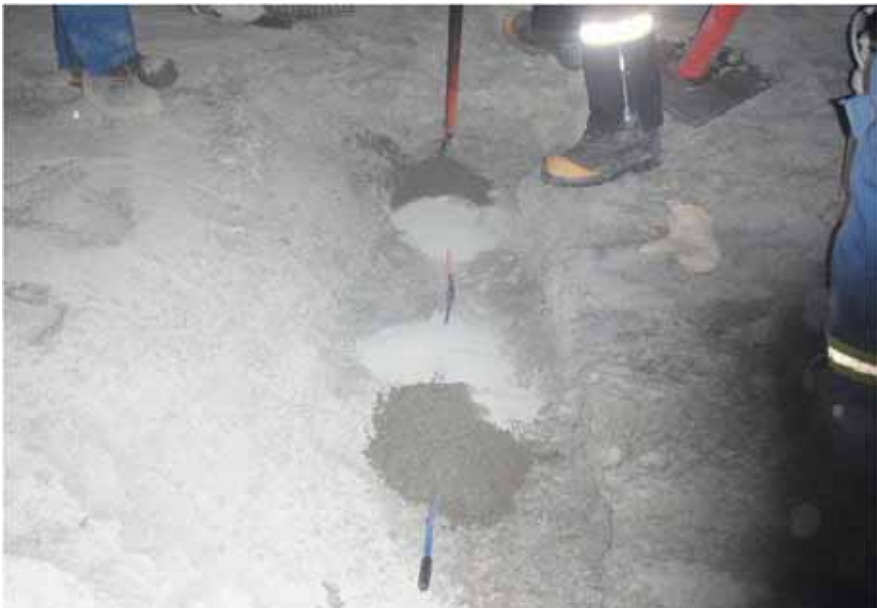
- The last three exposed beads from thermistor string ND-HTS-060-33.5 were installed / covered. All thermistor strings have now been installed in the main dam core. See Photo 9.

Photo 9: The final three exposed beads on thermistor cables ND-HTS-060-33.5 being installed in FCM.

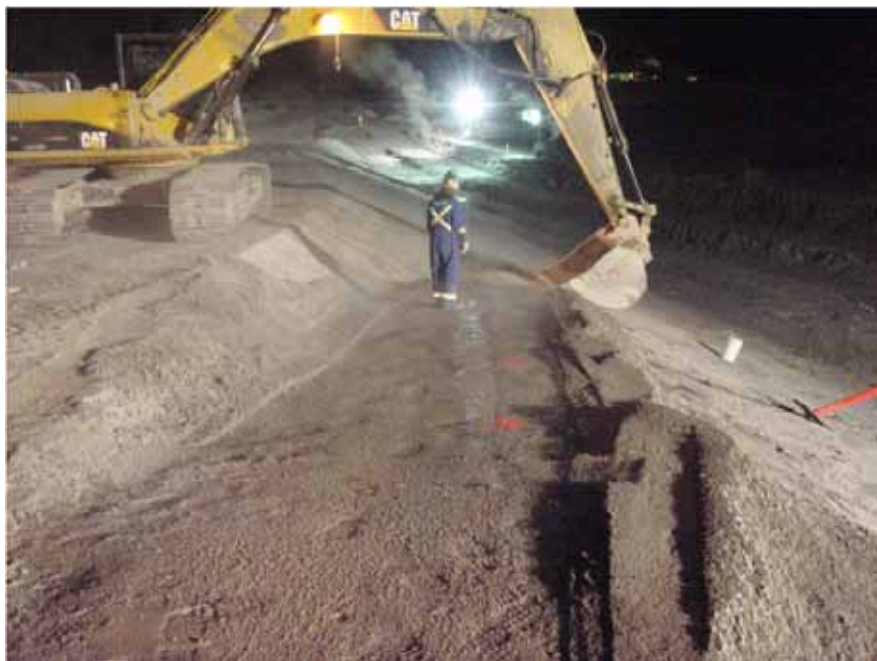
- 3 loads of FCM were placed between 0+40 and 0+70, in the underbuilt SSE corner.
 - This small triangular sliver was overbuilt and packed with the 10 ton vibrator compactor then cut back with the excavator. The side slopes were then smoothed by the labour team with shovels and rakes. See Photo 10 and 11.

Photo 10: View of lift of FCM placed in underbuilt SSE corner of the core. Note the paint marks outlining the crest that this lift was required to be cut back to after being overbuilt and packed.

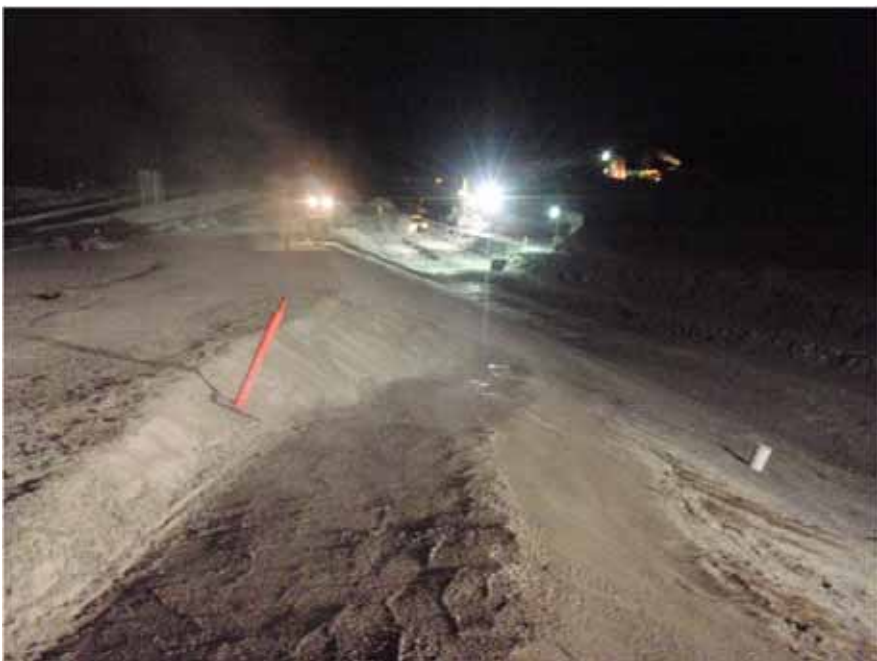
Photo 11: ~NE view of SSE underbuilt corner of the core. Photo taken after final sloping completed. Note that on the order of 3 lifts remain to be placed in this underbuilt sliver.

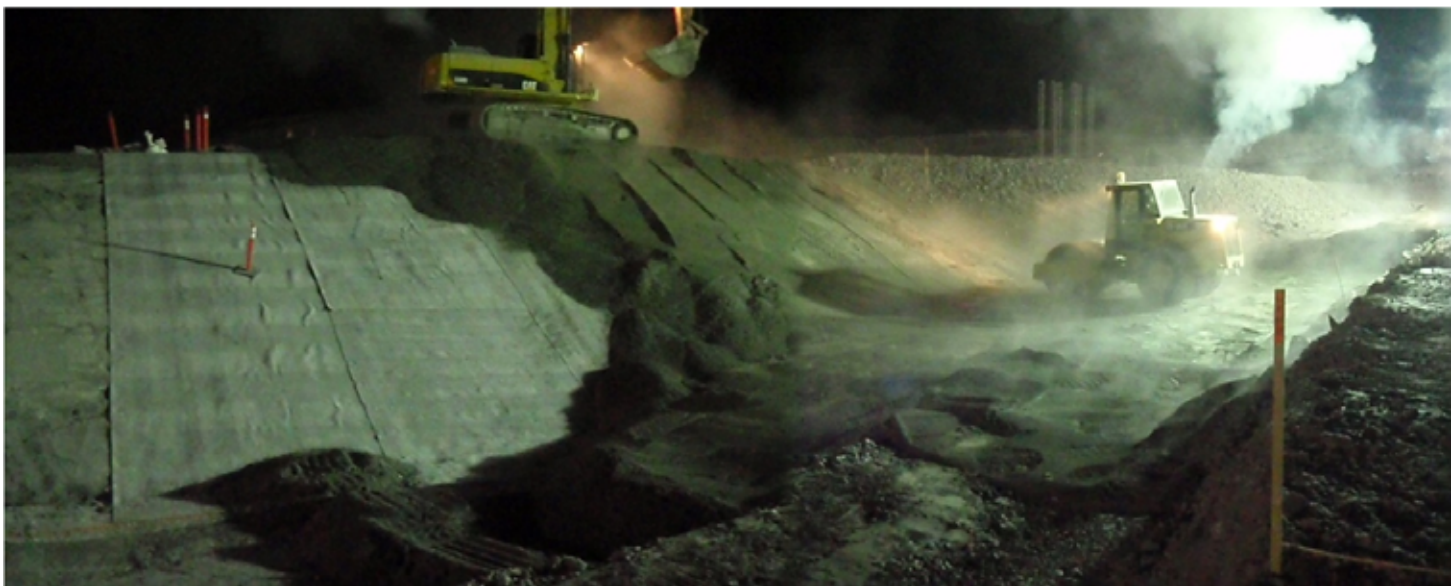
- Two panels of GCL material were placed, approximately station 1+30 to 1+20.
 - The first panel placed was joined on the slope as there was insufficient material on the roll to cover the entire slope. The portion of liner on the upper portion of this slope was patched 4 times as the GCL was punctured.

Photo 13: ~NNW stitched panoramic view of excavator spreading Overliner material. As noted by dayshift one panel row of GCL had a seam that was overlapped on the upstream slope. These GCL panels can be observed in the left of this picture.

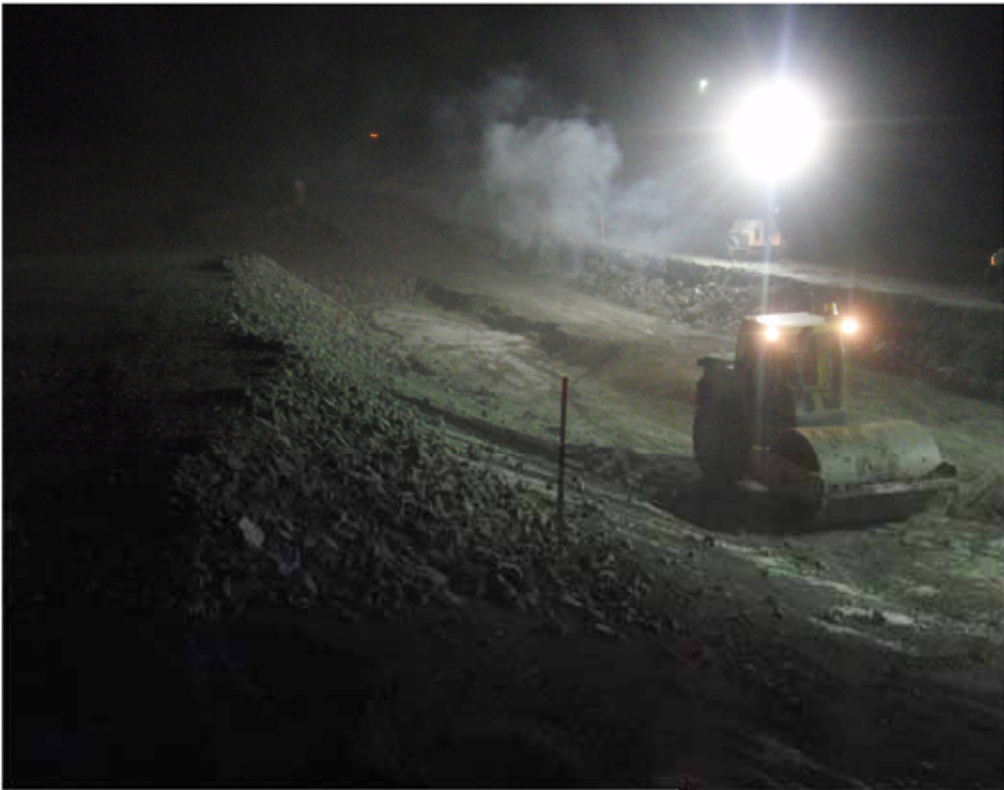
Photo 14:~ NE view from 1+40 of Transition material placed on dayshift. Note that the majority of the placed transition material was placed first on the crest of the dam. Additional material required on the upstream dam slope from ~ 1+95 to 1+60.

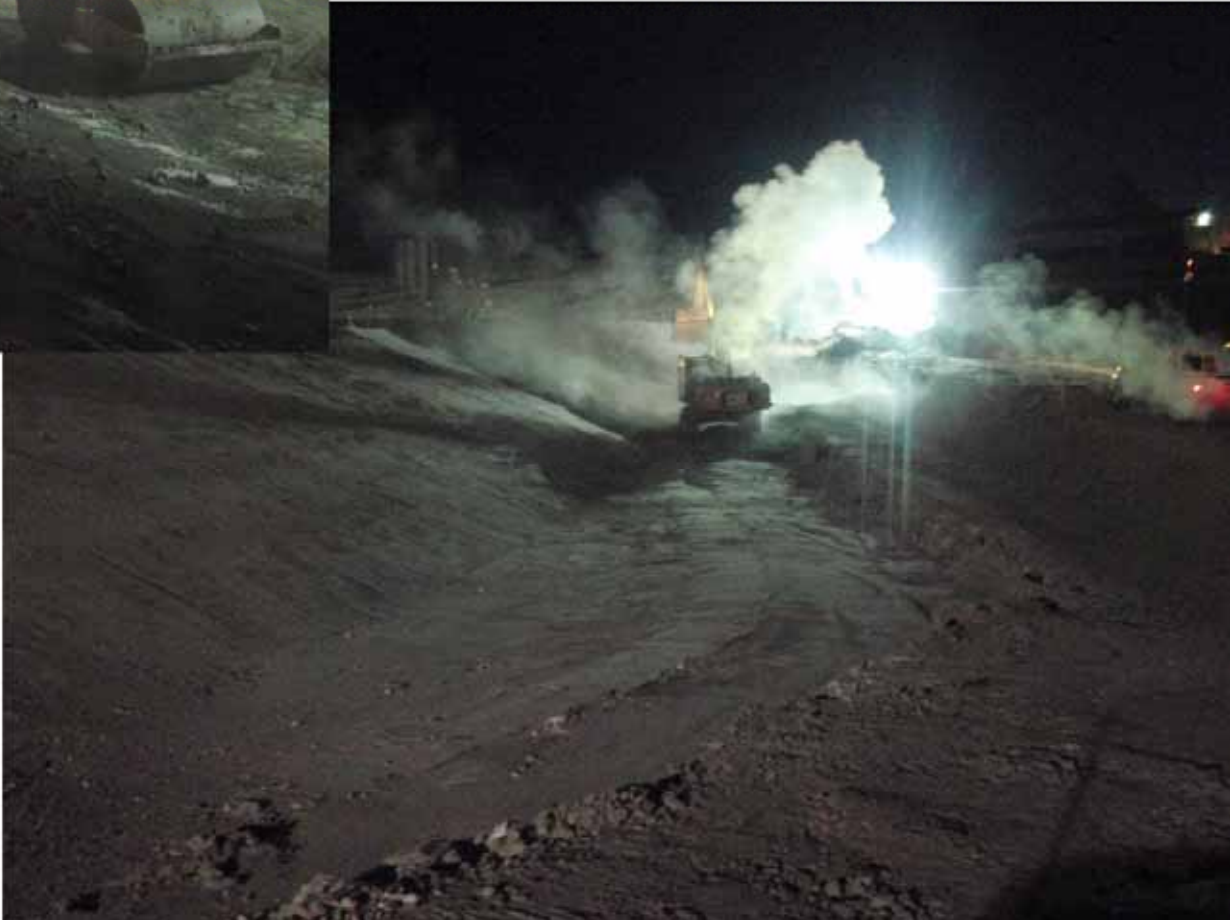
Photo 15: ~NE view down over inflection point of the dam towards the Overliner placement at the N The area show in this picture was cleaned of snow and large debris. The area south of (or behind) this picture still requires notable snow clearing.

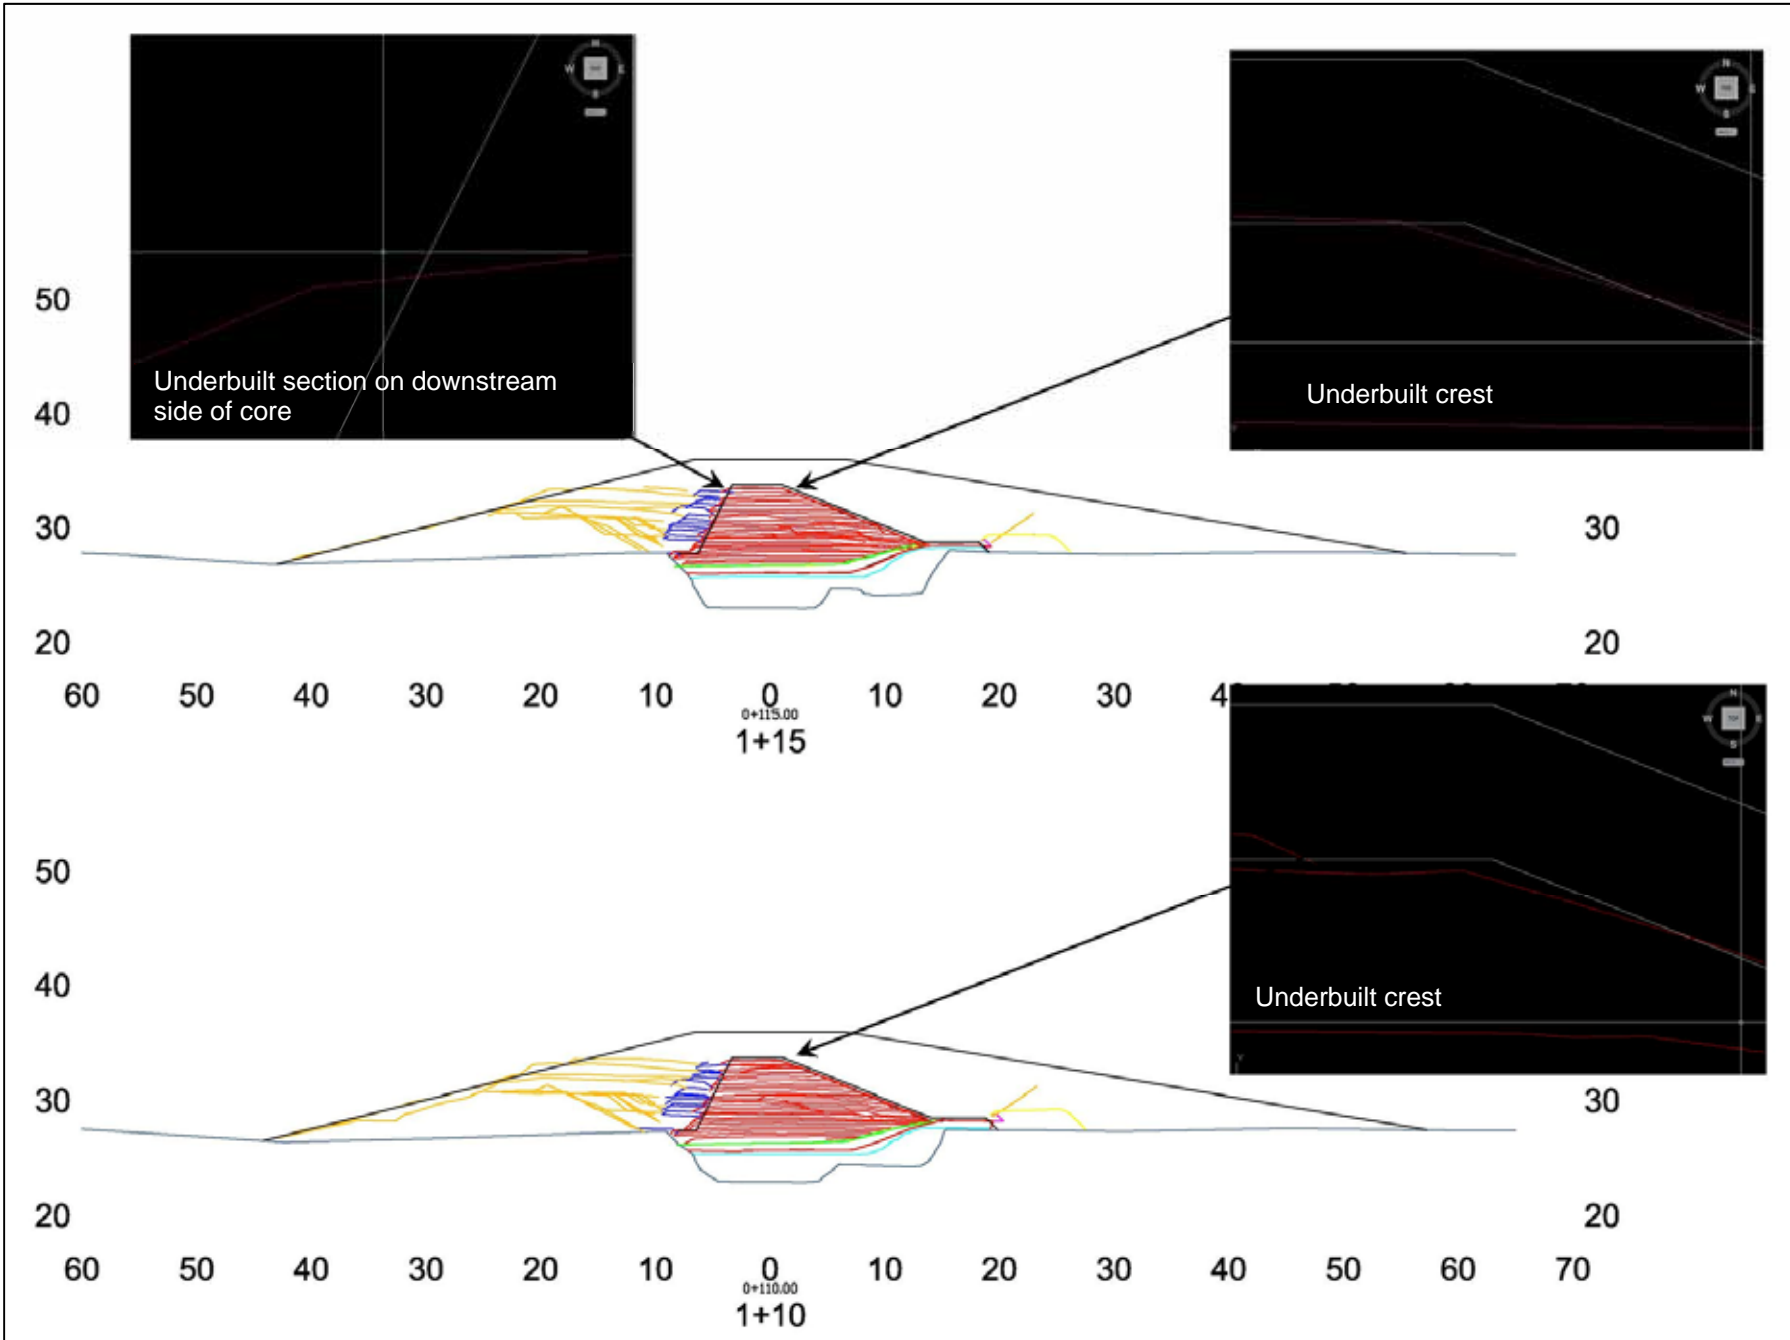
- Discussions were had with Nuna foreman, superintendent and engineer regarding the underbuilt crest slope at station 1+15 and 1+10. As can be seen in Figure 3. Nuna plans on building up these areas when they place FCM on nightshift.

Figure 3: Cross sections of underbuilt crest area at station 1+15 and 1+10 (design lines are in white on the screen shots). Note that material was placed over these areas on nightshift.

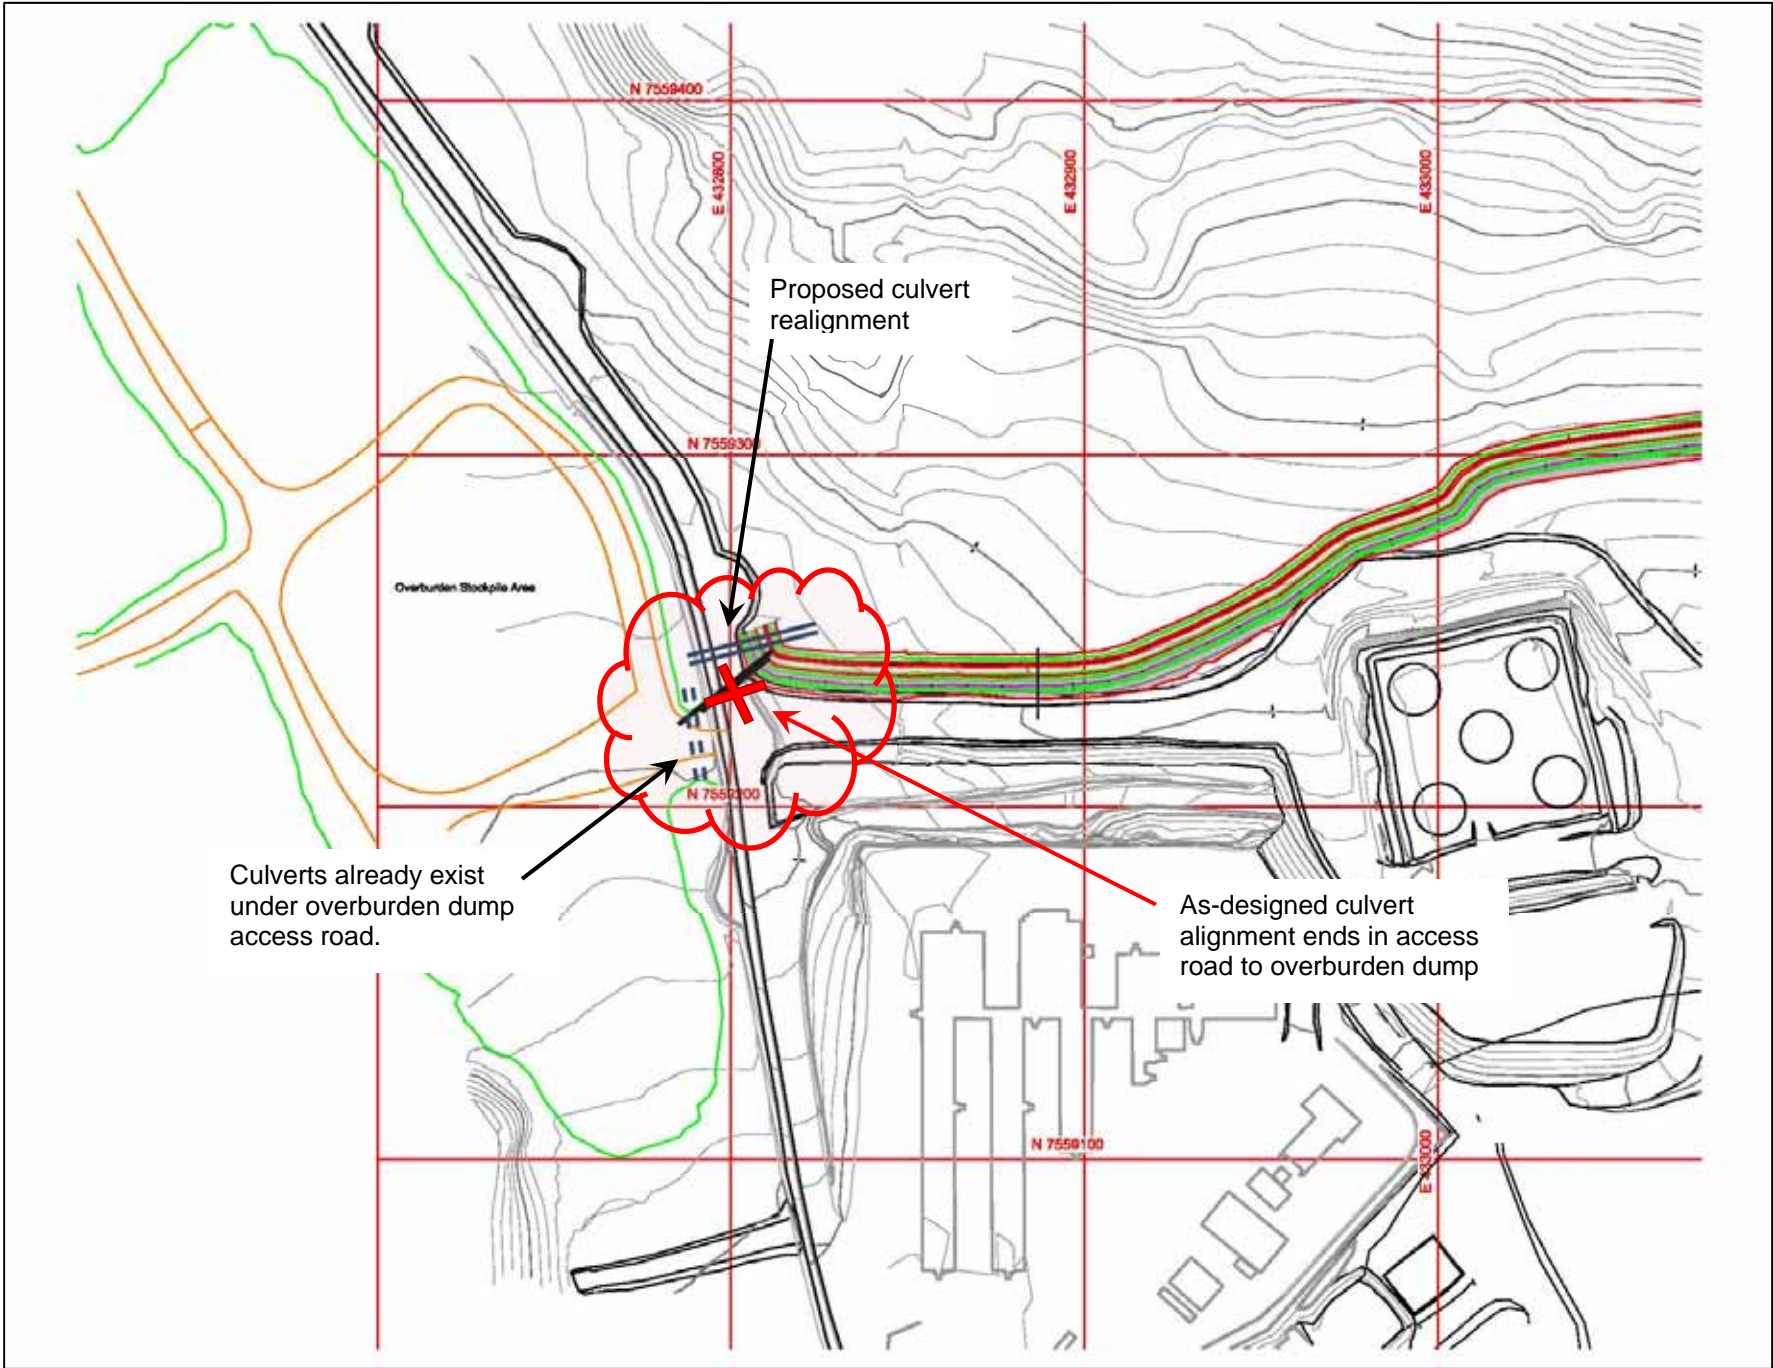
- Placement of overliner crush over this area was started before the end of shift.
- Discussions were had in the field with the Diversion Berm Foreman and the Nuna field engineer regarding the culverts crossing the primary road. Nuna has only ordered the quantity of pipe shown on the design drawings; therefore there is insufficient pipe to diagonally cross the Primary Road coming out on the downstream side of the overburden dump access road. Therefore having the culverts cross the primary road above the access road to the overburden dump (this is the existing culvert alignment) was discussed. Culverts already exist under the overburden dump access road.

Figure 4: Location of IFC culvert alignment in relation to the Overburden dump access roads (light green lines).
