## DAILY REPORT #79 – DORIS NORTH INFRASTRUCTURE/ NORTH DAM

Prepared by:	John Kurylo Megan Miller	Date:	2012.03.24
Reviewed by:		Project #:	1CH008.058.0320
Role	Company	Personnel – Position	On Site
Client	Hope Bay Mining Limited (HBML)	Angela Holzapfel – ESR Compliance Manager David Vokey – ESR Coordinator Don Ethelston – HSLP Advisor Dean Wold - Safety Jill Turk – ESR Coordinator Katsky Venter – ESR Manger Michelle Tanquay – ESR Site Manager Stirling Kelly – HSLP Advisor	No No Yes No Yes Yes No No
	JDS	Lloyd Jackson – Mechanical Superintendent Doug Fielding – Construction Manager Ishan Fechter – Construction Coordinator Jerry Graham – Construction Manager Kevin Whieldon – Project Coordinator Mark Valeriot – Construction Manager Calvin Goldschmidt – Construction Coordinator	No Yes No No No Yes Yes
Engineering Design Consultants	SRK Consulting (Canada) Inc.	John Kurylo – Site Engineer Megan Miller – Site Engineer Lawrence Borowski – Site Engineer Murray McGregor – Site Engineer Iozsef Miskolczi – Site Engineer Lowell Wade – Senior Engineer	Yes Yes No No No No

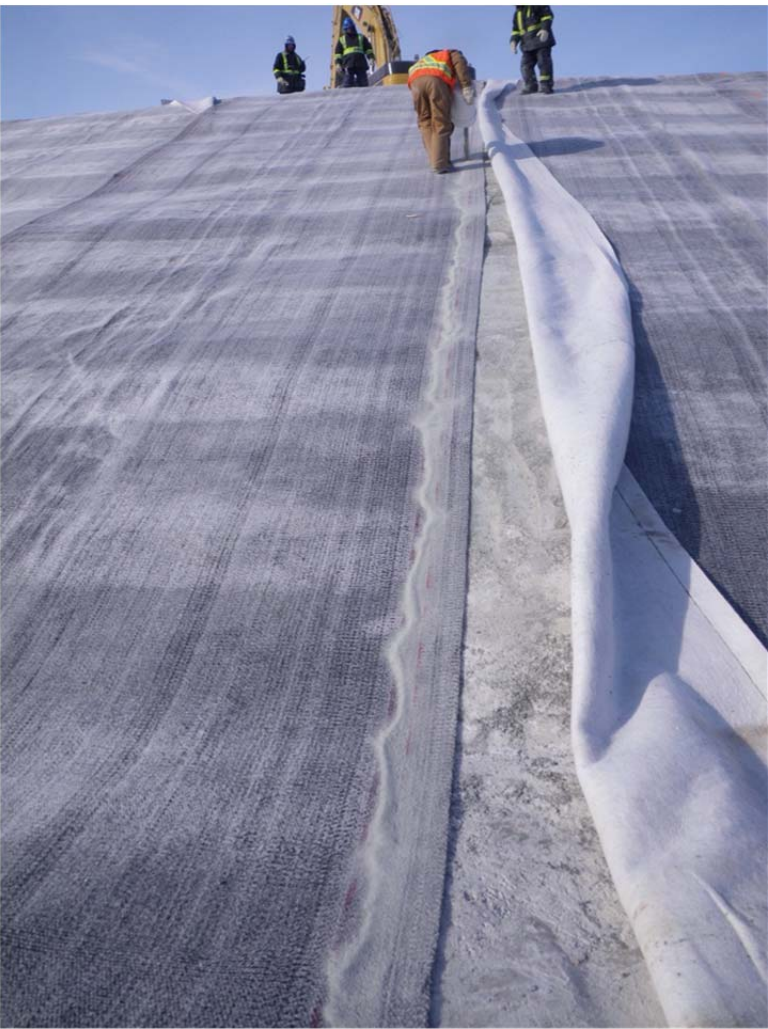
**Photo 4 (above):** Bentonite being placed along overlap between sections of GCL.

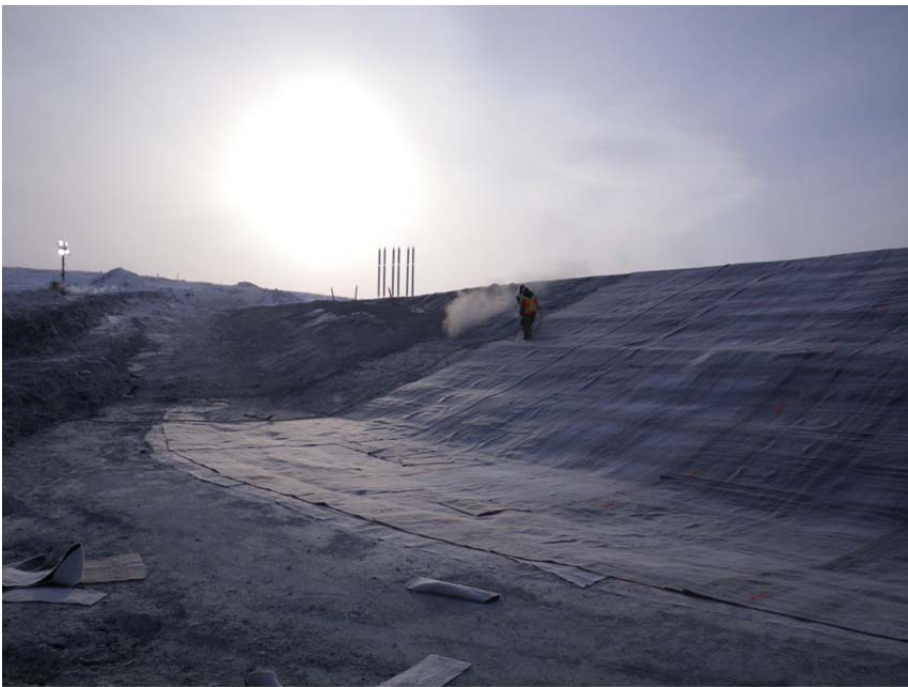
- GCL was placed from approximately station 1+15 to 0+80.
  - A total of 9 GCL panels were placed. An area was cleaned in preparation of placing one additional panel however this was not placed prior to the end of shift.

**Photo 6 (right):** View of GCL after placement looking west. Labourer clearing additional section of slope, GCL did not get placed in that area prior to the end of dayshift.

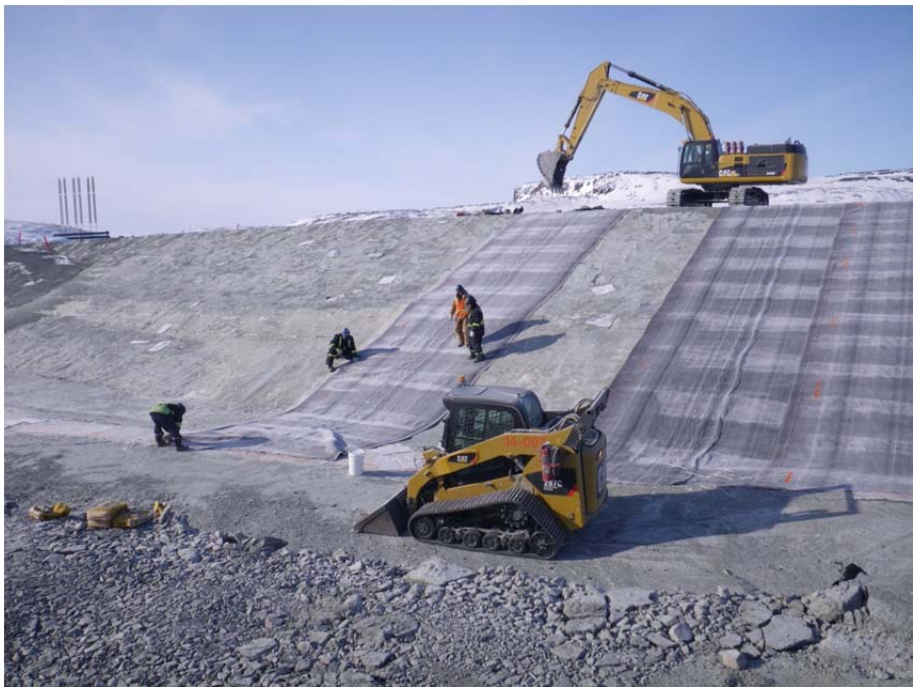
**Photo 7:** Placement of GCL along the slope near station 1+05.

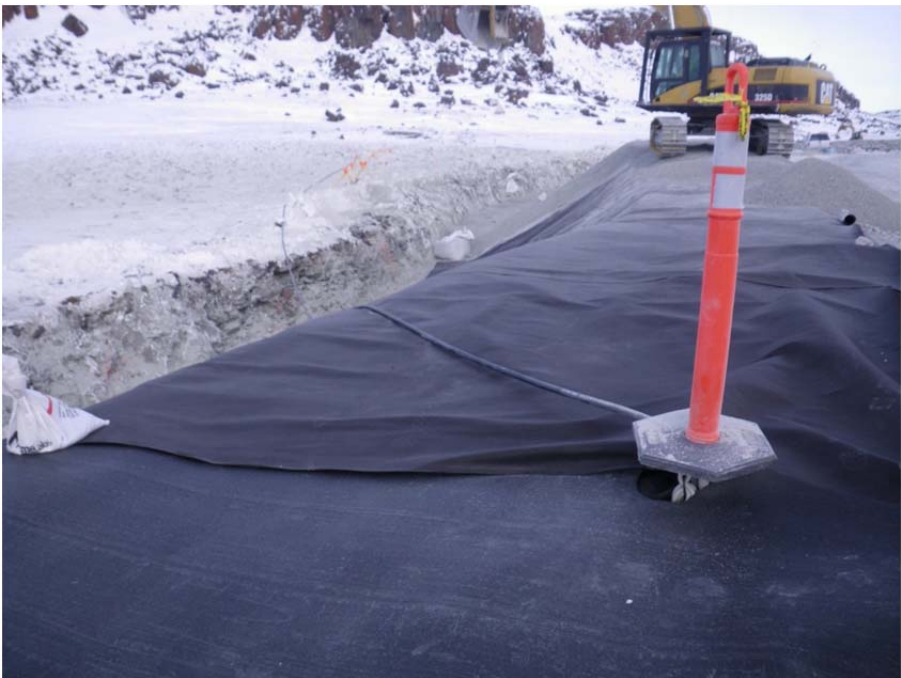
**Photo 9:** Diversion berm. Hole in liner at crest of berm for power cable near station 160.

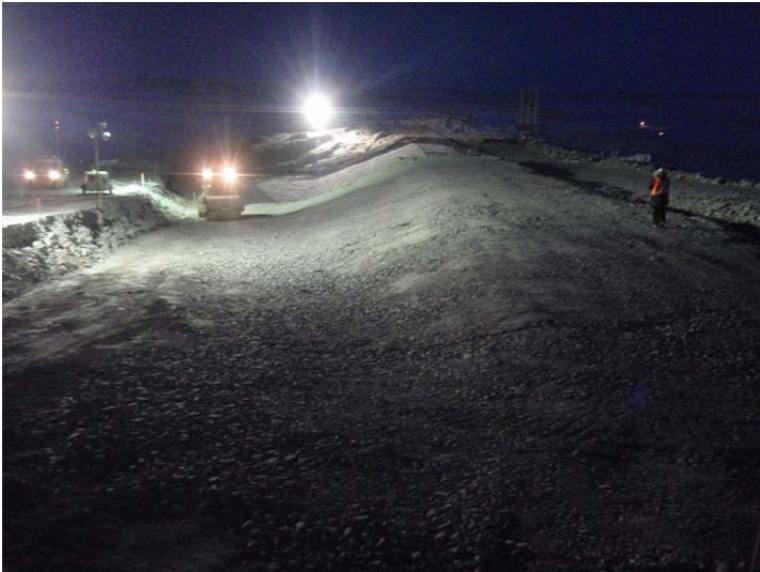
**Photo 14 (right):** ~SWW view down North Dam alignment. Note the Transition material in the foreground that has been placed and compacted on the Overliner (above GCL) material.

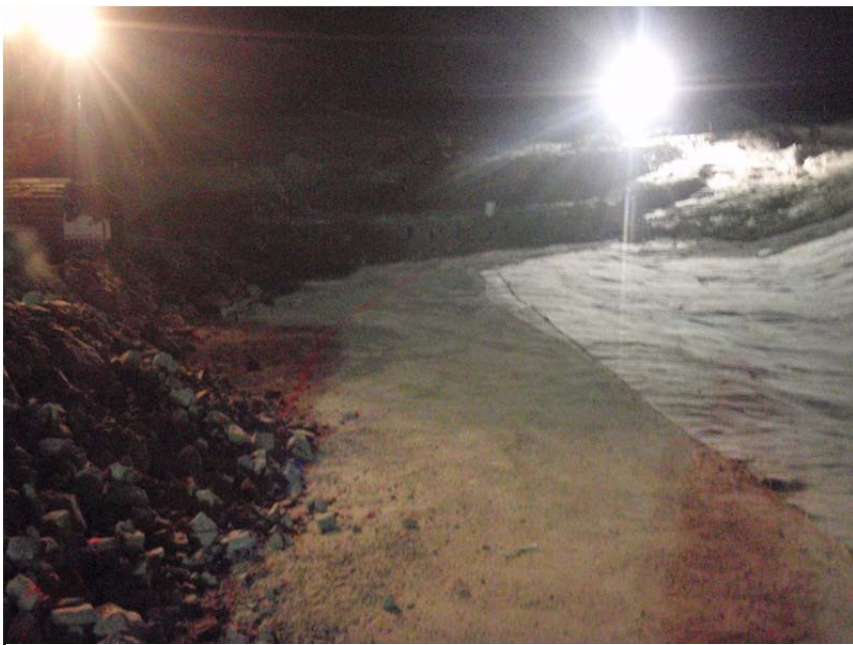
- SRK and Nuna had discussions in the field about the upstream limits of the Overliner (GCL cover) material layer. It was noted that due to the 2011 close out measure of building up the fillet to elevation 29.8m (i.e. extended fillet area). There were areas around 1+35 to 0+50 where the GCL comes up and extends further to the downstream than in the original IFC design. It was noted that in areas the GCL was close to the limits originally laid out for the Overliner material placement by survey.

- Nuna survey original layout was based on a constant offset (based on the IFCs) from the toe of the existing upstream slope.
    - SRK indicated to Nuna that they felt that a minimum ~1.5m offset from the end of the minimum GCL liner tie in (for the upper and lower GCL panels) should be maintained.

**Photo 15:** ~SSW view of the core fillet area. Note the orange liner denoted the x and y (easting and northing) extents of the design IFC fillet limits.

- Upon further discussions and review of the IFC drawings SRK instructed that the layout for the upstream edge of the Overliner material in this area use the same x and y (or

northing and easting) as the IFC design for the Overliner on the fillet however, the elevations should all be brought up to meet the existing core elevation at any respective location.

- This will ensure that the Overliner material will have the same footprint (or slightly larger) than the original IFC design.
- Typically a 2m or greater offset from the IFC x, y coordinates for the fillet toe and the existing GCL were noted.
- See Photos 15 and 16 for additional details.
- A small / thin lift of Transition material was placed with the excavator and packed from ~ 1+40 to 0+70.

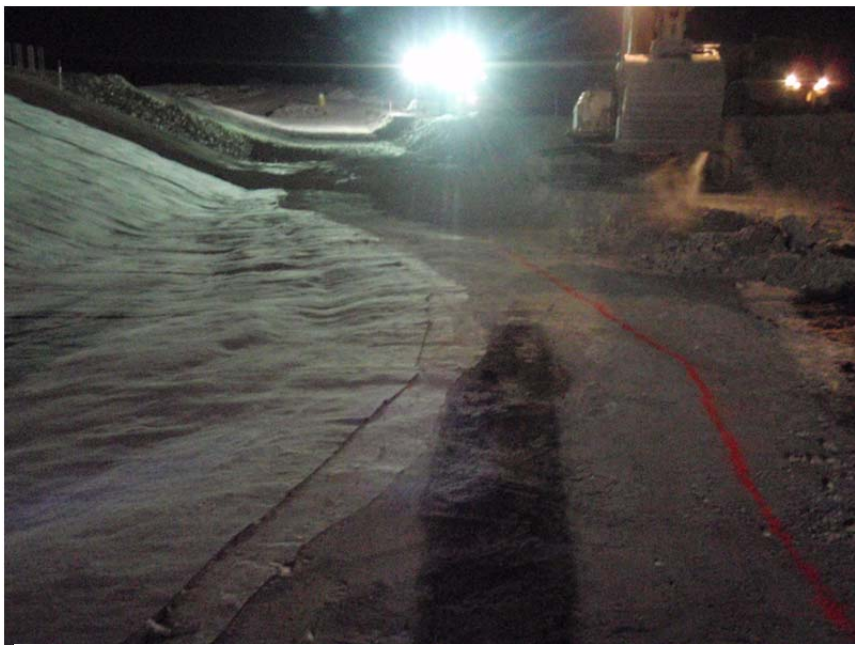
**Photo 16:** ~NNE view of the core fillet area. Note the orange liner denoted the x and y (easting and northing) extents of the design IFC fillet limits.

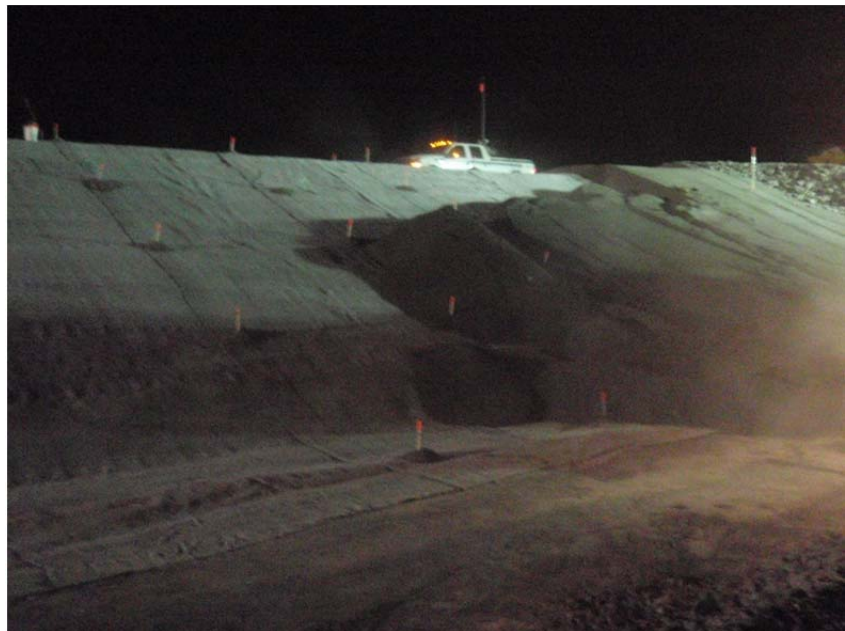
- Grade control was a large focus of today's placement. Nuna survey placed grade stake to assist the excavator operator with spreading and cutting back of the Overliner material, to as close to the design lines as possible.

**Photo 17:** View of survey stakes placed for grade control for today's material placement.

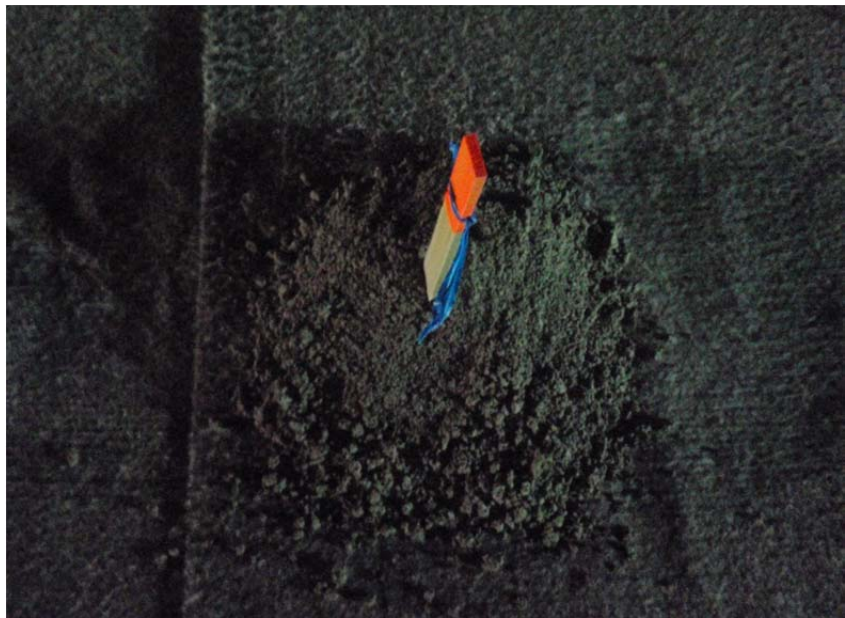
- At the request of SRK grade stakes were only placed on the joints / seams of the GCL. This was done as this was seen as providing a little extra insurance against puncturing of the

- liner, if the stakes are somehow driven or packed into the liner surface. This extra insurance is derived from the fact that two layers of GCL material exists at the joints / seams, thus both would have to be punctured to create a hole.

**Photo 18:** Note that the grade stakes were placed in some Overliner material after it had been hand shoveled onto the area around the GCL seams. Stakes were only placed around the seams as this area has a little more cushioning in case a stake was accidentally pushed through the Overliner fill towards the GCL surface.

- Before an area was packed, the spread Overliner material was walked over on foot and any visible stakes were removed.
  - Small piles of Overliner material were hand shoveled over the seams then stakes were placed or material was pushed around the stakes to anchor them.

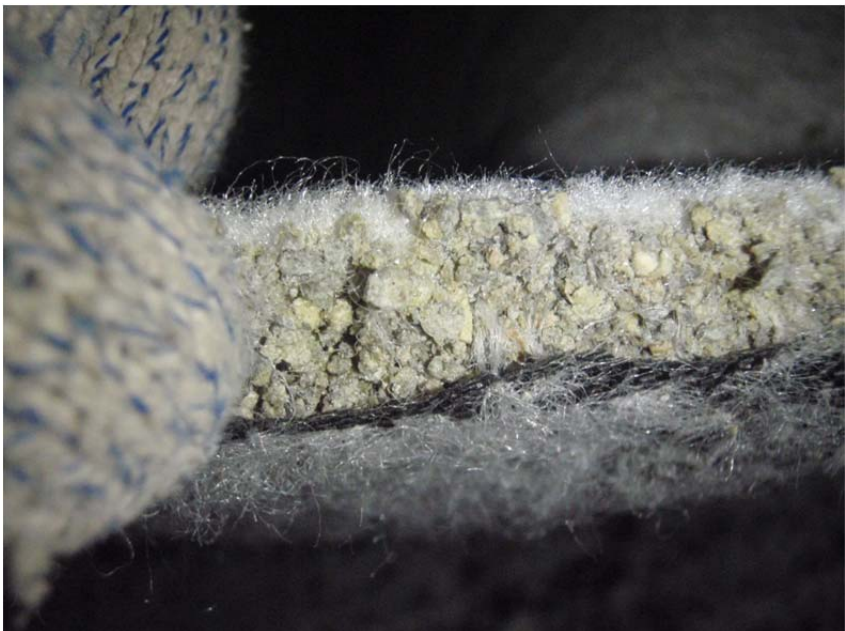
- Around the base of the slope around 1+05 a few scrap pieces of GCL liner (e.g. cut off from the end of damaged rolls) were placed over an area that appeared to have been previously hydrated.

**Photo 19:** Close-up view of bentonite in a discarded cut portion of GCL liner.

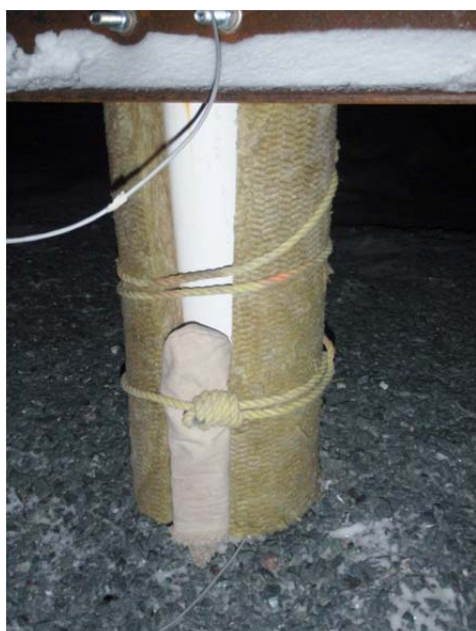
- A single bead thermistor was strapped to the base of the thermosyphon pipes (close to where the thermosyphon exits the existing fill). These single beads were then wrapped in insulation. See Photo 20.

- The insulation used was designed for 3" pipe and was rather long. Due to the larger diameter of the thermosyphons and the limited amount of space available between the ground and the first thermosyphon radiator riser / support, gaps were noted between the pipe and the single bead.

- Due to the poorly established insulation cover over the single beads this trial was abandoned after testing evaporator pipes (thermosyphons) TS-31 and TS-32.

**Photo 20:** View of thermosyphon performance monitoring test trial. Note that 3" pipe diameter insulation was wrapped around the single bead that was attached to the base of the thermosyphon. Additional testing will result in the coming days

- Alternate insulation will be sourced out tomorrow for additional trials on testing the thermosyphons performance, hopefully with less environmental influences resulting on the single beads.

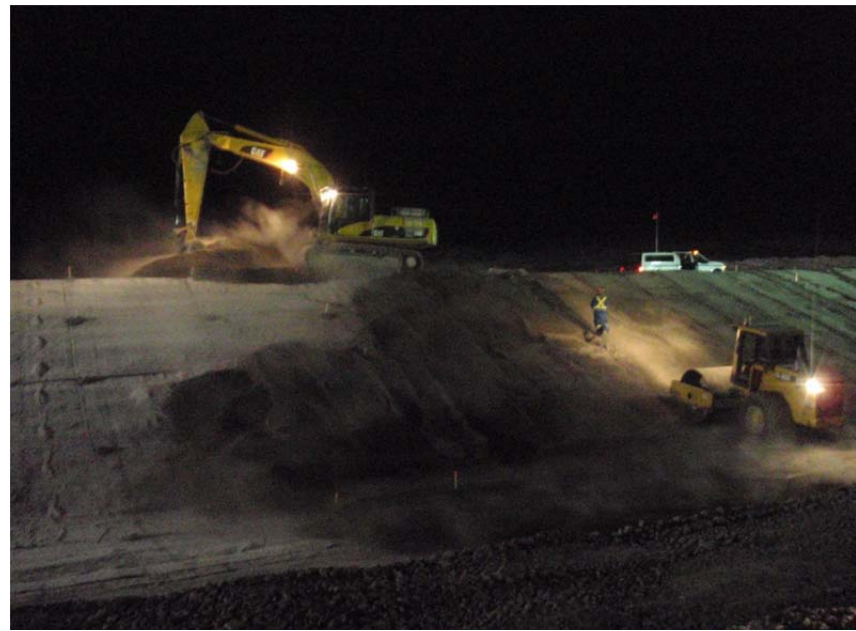
**Photo 23:** ~NWN view of Overliner material placement progress. Note that the survey stakes were attempted to be removed from a given area before the packer traveled over the Overliner material surface.

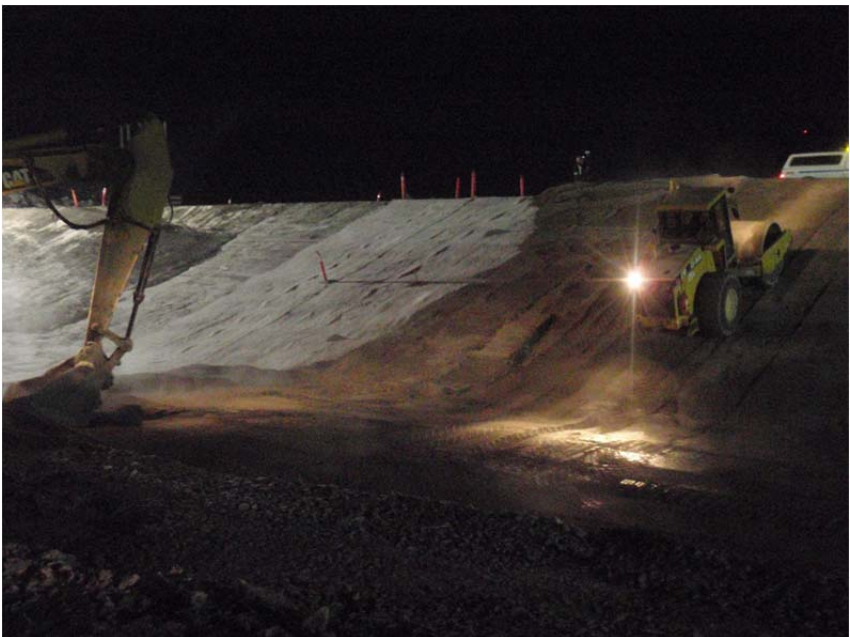
**Photo 24:** ~ NE view of the end of today's Overliner placement. Note ~15m of CL still remained exposed at the end of the shift.
