DAILY REPORT #80 – DORIS NORTH INFRASTRUCTURE/ NORTH DAM

| Prepared by: | John Kurylo Megan Miller | Date: | 2012.03.25 |
| Reviewed by: | | Project #: | 1CH008.058.0320 |

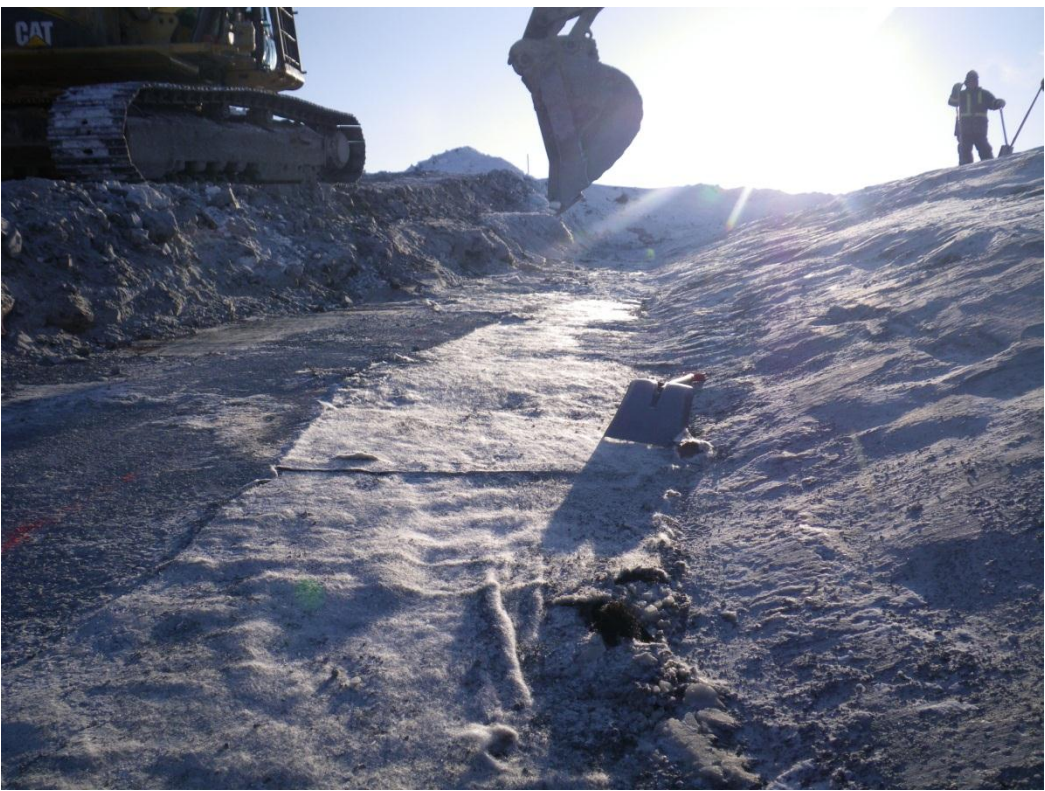
- A single panel of GCL was placed at ~station 1+80 to 1+75.
- Labourers and the CAT 330 excavator cleaned snow and ice from along the lower GCL south of station 0+75.0+75. The air compressor was used to
 - There is a lot of damage to the lower liner in this area. At least a few areas will require heating and FCM excavation to allow for patching, as the damage is right at the toe of the

FCM.

Photo 5: Holes in lower GCL near station 0+50. The hole in the foreground is right where the FCM slope meets the GCL.

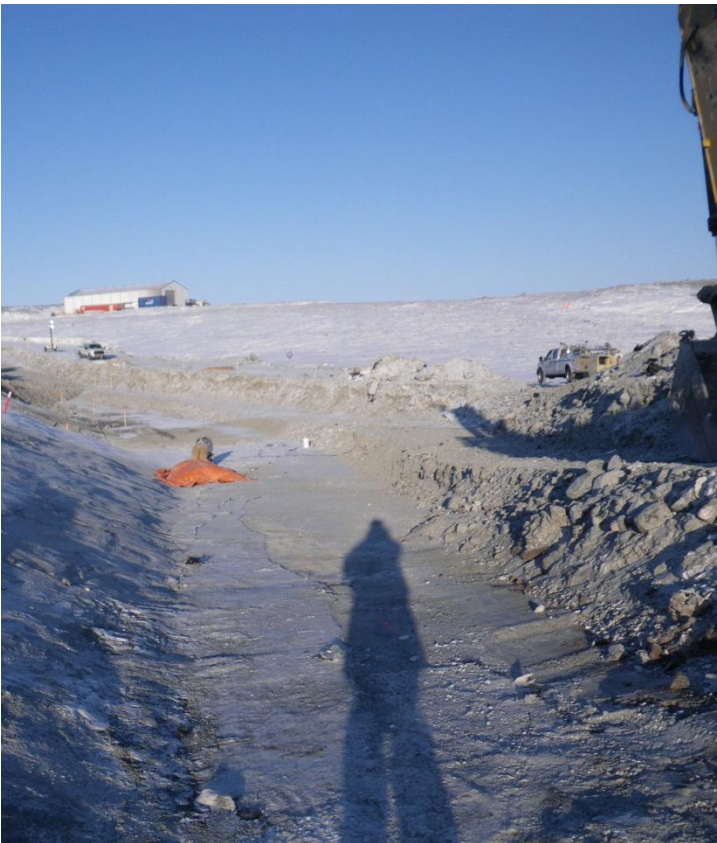
- Heating and hoarding were placed on one area of liner covered in ice which required patching around 1+75.
- The FCM placed in the small wedge was not frozen back by the end of dayshift.

Photo 6: Looking east along the lower GCL. The frost fighter and tarp are located at approximately station 0+70.

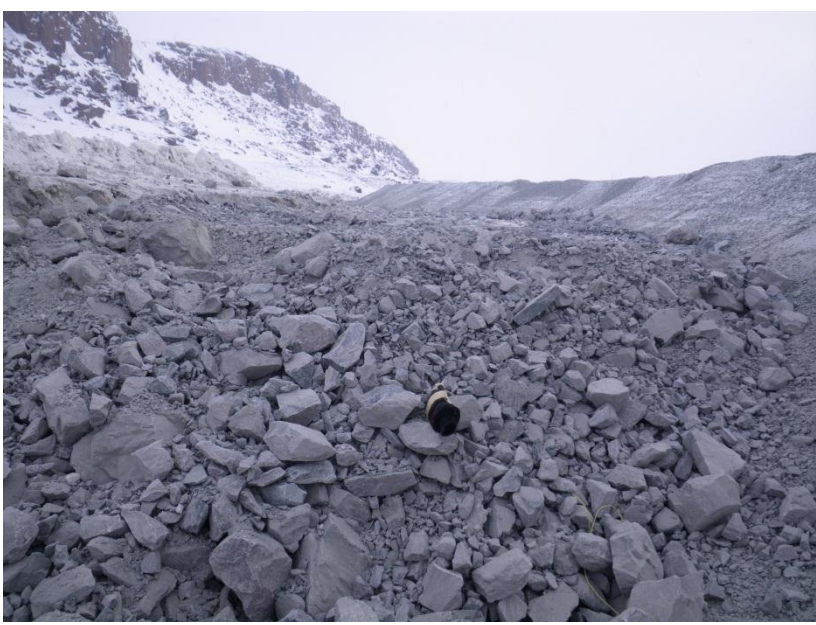
Photo 8: First lift of ROQ placed in diversion berm. The ROQ is of good quality and very fine.

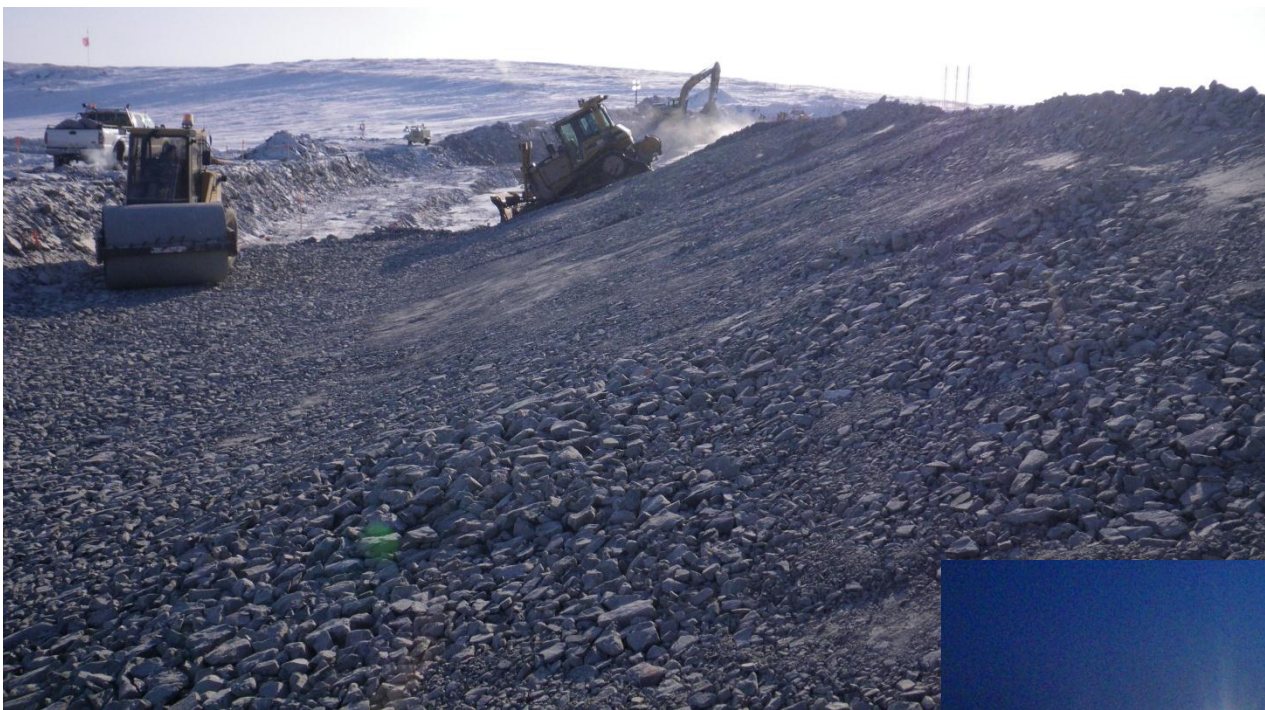
- Transition material was placed over the GCL overliner material working south west from the end of placement yesterday.
 - A second lift was placed over the material from 1+60 to 1+30 and the transition material was placed to 1+10.
 - The packer had some difficulty packing the material on the slope; however everything got packed.

Photo 9: Transition material being placed on the slope above the liner. Photo looking south west.

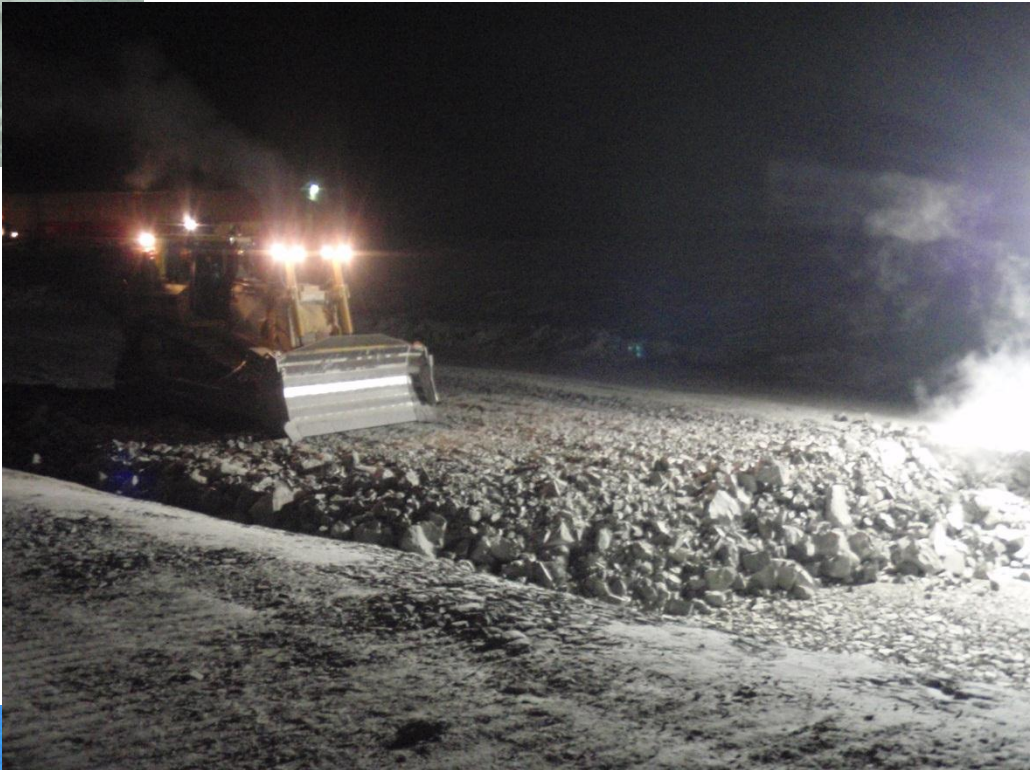
- The 10 ton vibratory compactor compacted all exposed transition material at the dam.
- Later in the shift ROQ was placed by a D8 around 1+95 and 1+75. ROQ was noted to be of good quality. The lift of ROQ was noted to be near the maximum allowable lift thickness of 1.85m. No compaction on this material was observed on nightshift.

Photo 16 (right): D8 spreading ROQ at the North end of the dam (around 1+90).

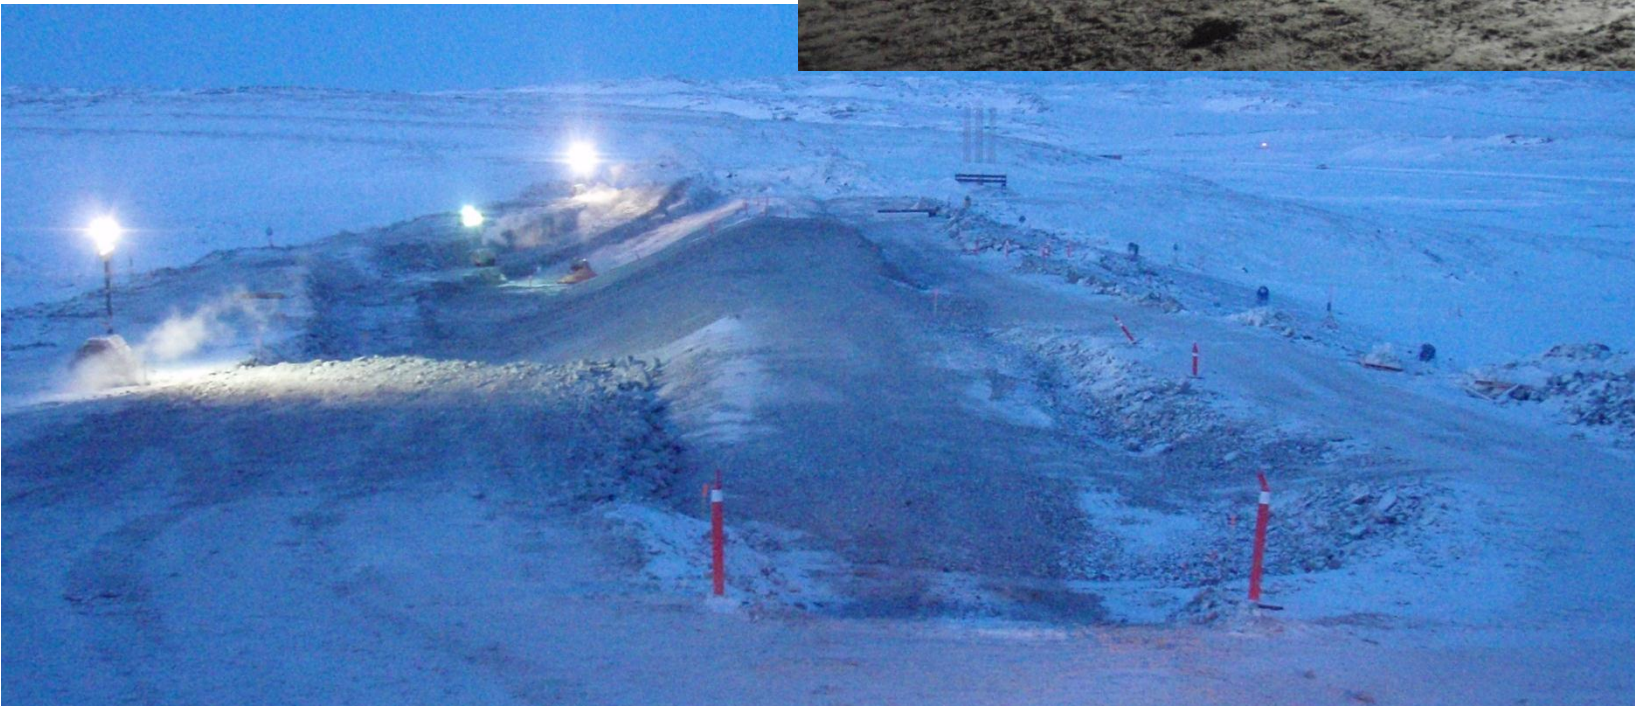
Photo 17: ~ SW view down the center of the dam. Note that the ROQ is on the left, Transition material is over the central area, the packer is working by the area where Overliner material was placed and beyond the packer to the S is the end of the GCL (around station 0+70).
