DAILY REPORT #81 – DORIS NORTH INFRASTRUCTURE/ NORTH DAM

Prepared by:	Iozsef Miskolczi Megan Miller	Date:	2012.03.26
Reviewed by:		Project #:	1CH008.058.0320
Role	Company	Personnel – Position	On Site
Client	Hope Bay Mining Limited (HBML)	Angela Holzapfel – ESR Compliance Manager David Vokey – ESR Coordinator Don Ethelston – HSLP Advisor Dean Wold - Safety Jill Turk – ESR Coordinator Katsky Venter – ESR Manger Michelle Tanquay – ESR Site Manager Stirling Kelly – HSLP Advisor	No No Yes No Yes Yes No No
	JDS	Lloyd Jackson – Mechanical Superintendent Doug Fielding – Construction Manager Ishan Fechter – Construction Coordinator Jerry Graham – Construction Manager Kevin Whieldon – Project Coordinator Mark Valeriote – Construction Manager Calvin Goldschmidt – Construction Coordinator	No Yes No No No Out Yes
Engineering Design Consultants	SRK Consulting (Canada) Inc.	John Kurylo – Site Engineer Megan Miller – Site Engineer Lawrence Borowski – Site Engineer Murray McGregor – Site Engineer Iozsef Miskolczi – Site Engineer Lowell Wade – Senior Engineer	Out Yes No No In No

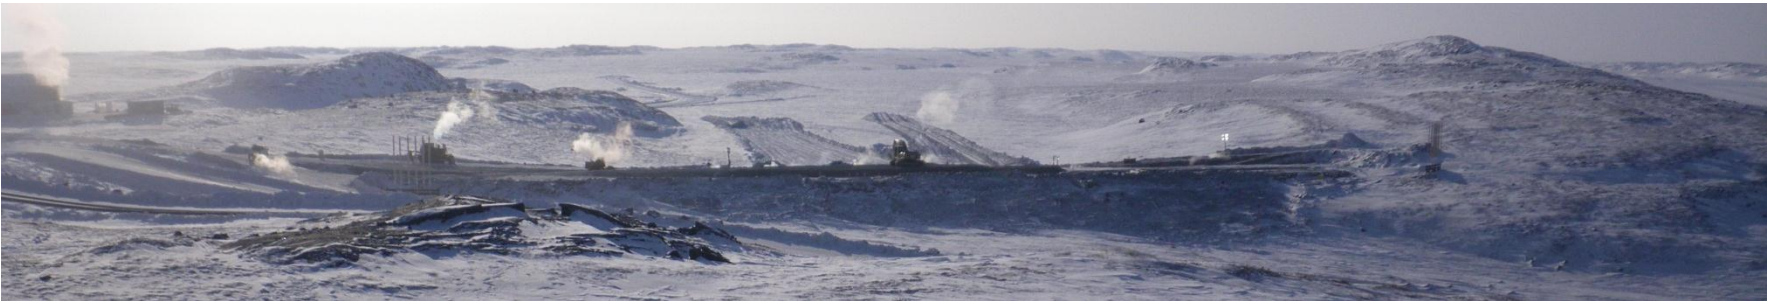
Photo 1: Progress photo of North Dam from photo point 1. Looking south west.

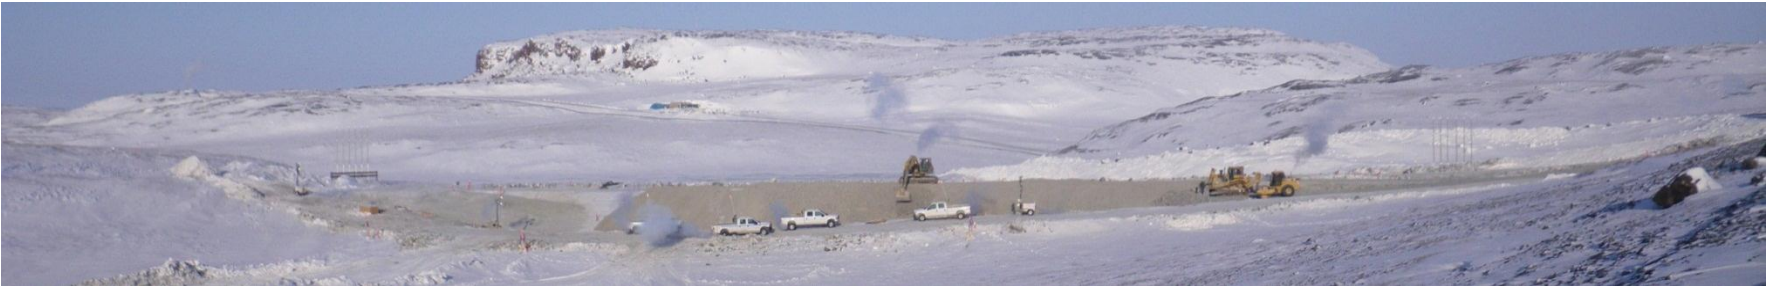
Photo 2: Progress photo of North Dam from photo point 2. Looking north west.

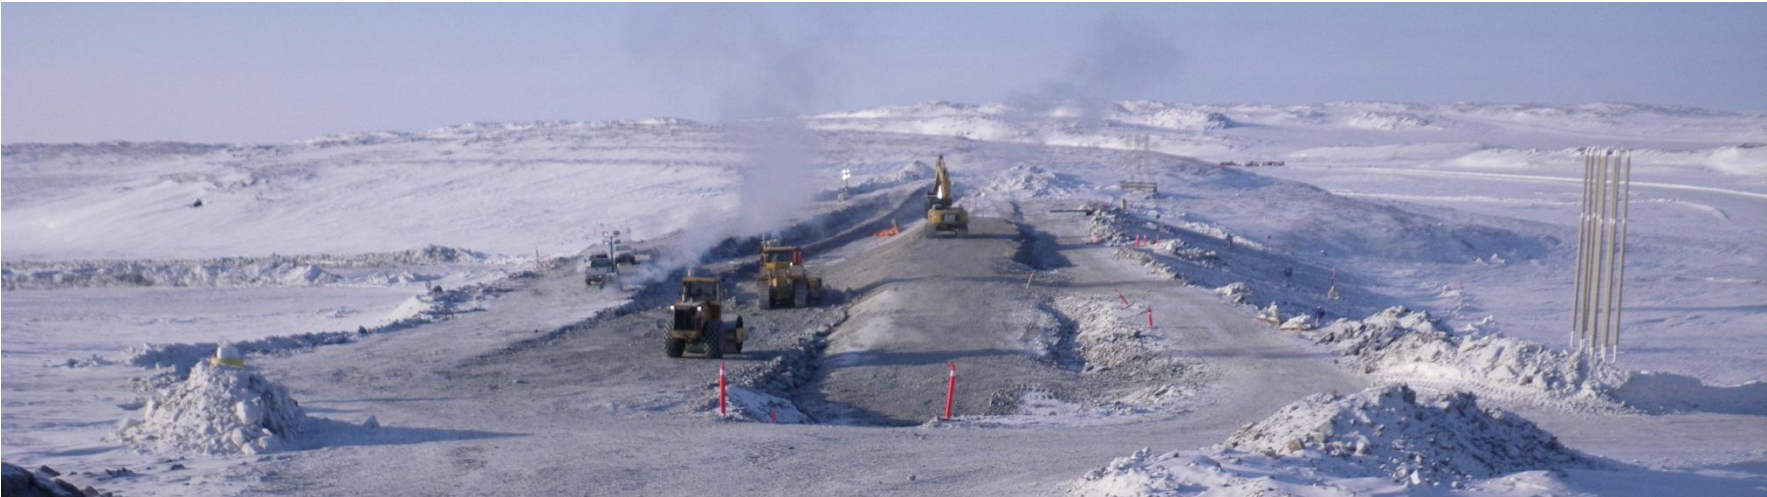
Photo 3: Progress photo of North Dam from photo point 3. Looking north east along the dam.

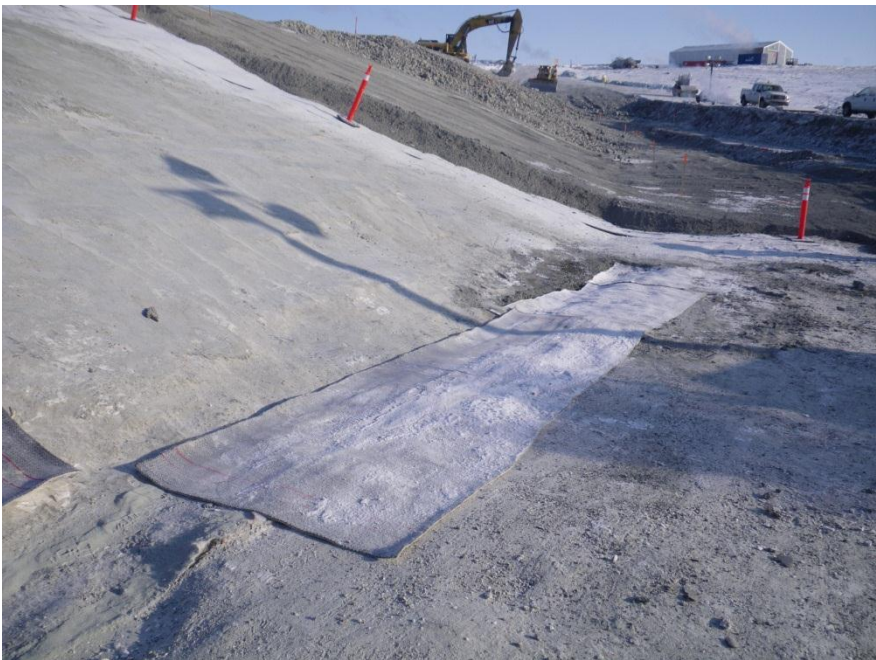
- The small wedge of material placed March 23, 2012 nightshift was not frozen back by the end of dayshift. However, a drilled core samples was collected from a thinner section of this lift when the thermistor bead was reading -1.3°C.
- Labourers continued to clean and patch the lower GCL south of 0+70. Heating and hoarding was used to thaw an area where GCL material was torn right at the bottom of the core material. Large, GCL roll width, patches were placed along the areas where multiples tears occurred.

Photo 4: large patches placed over the GCL liner near station 0+75.

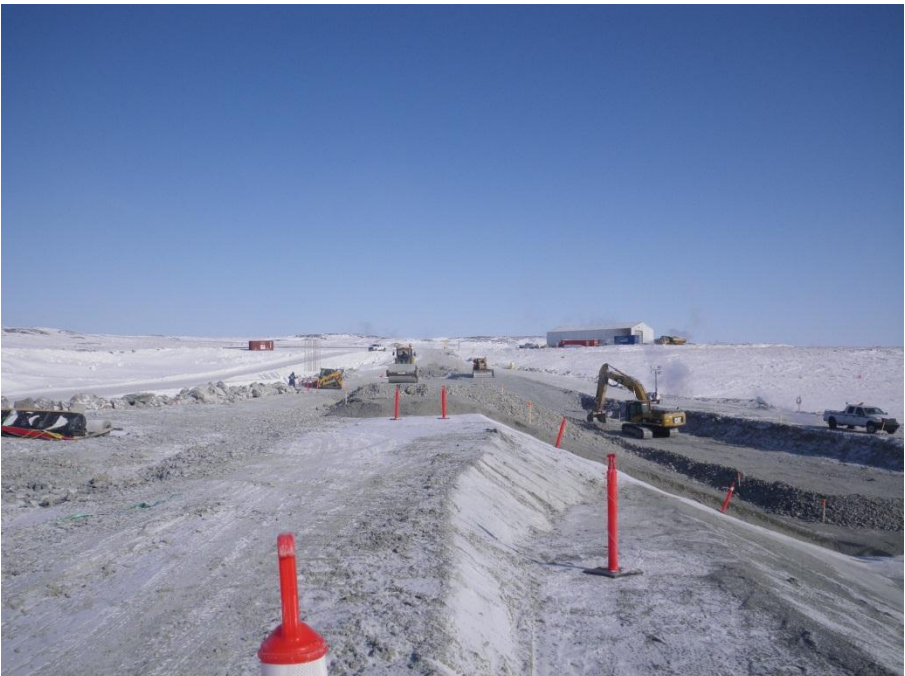
Photo 5: Photo looing north east at the transition and ROQ placement on the North Dam.

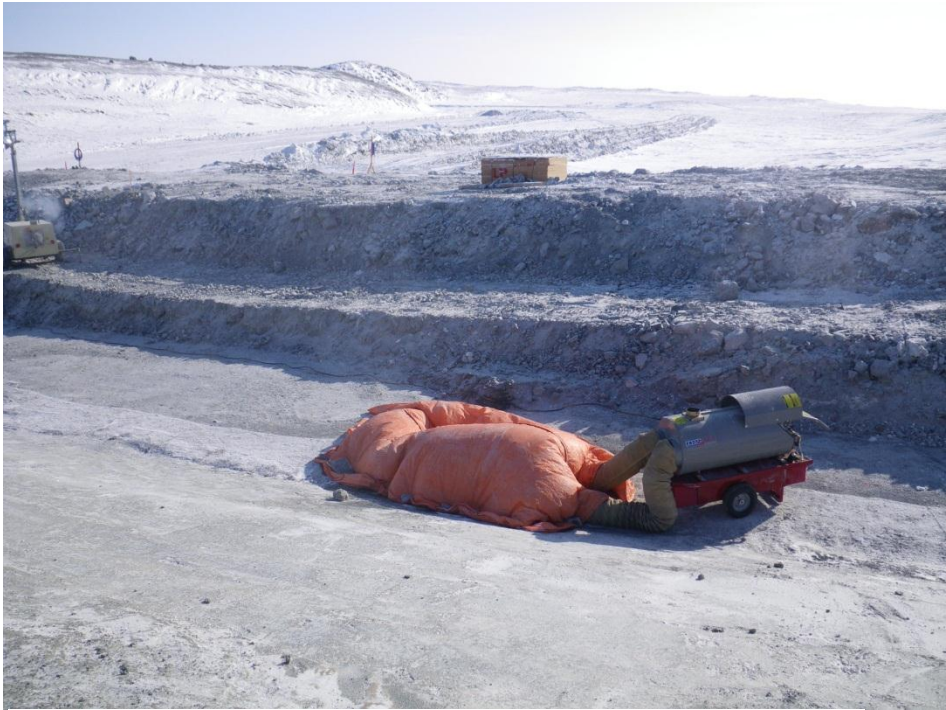
Photo 6: Heating and hoarding on the lower GCL.

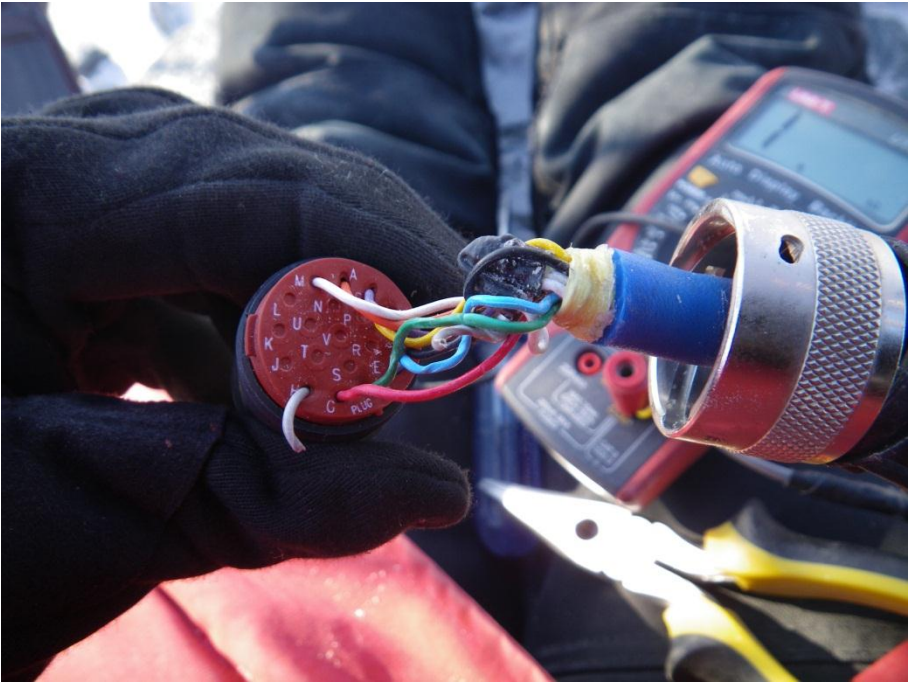
- Readings were taken of the upstream multi-bead thermistors and the thermistors at station 0+40.
- The connector of thermistor string ND-HTS-085-33.5 was opened and examined to determine if it is the reason that the thermistor is not reading. The grey wire, 'H', was broken, which would account for the eighth bead not working when the thermistor was installed; however no other damage to the wires was apparent. The resistance of individual beads were attempted to be tested with the multi-meter however no readings were obtained.
- The connector of thermistor ND-HTS-060-28.8 was checked. All wires were found to be well connected and no physical damage was noted.

Photo 7: Examining thermistor cable ND-HTS-085-33.5 connector to try and determine why it is not working. The grey wire labeled 'H' was found to be broken; but this does not account for the entire cable not working.

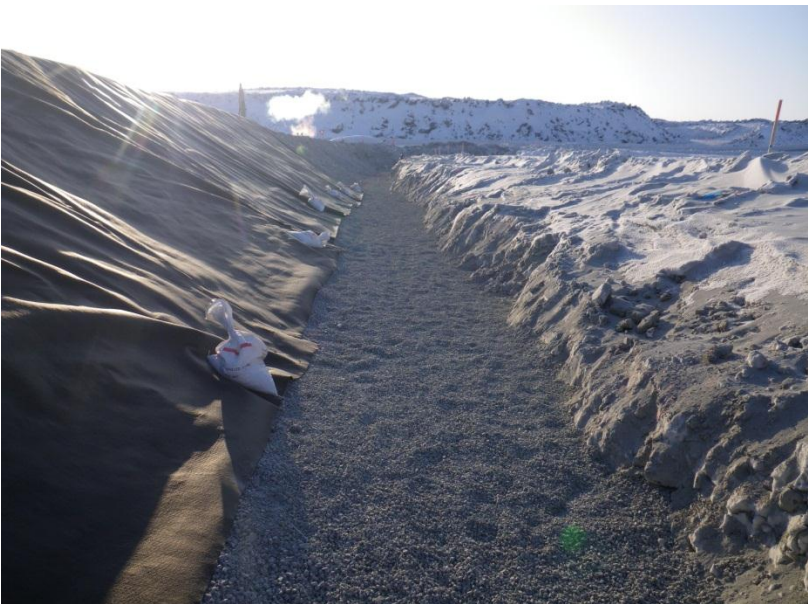
Photo 8: Bentonite placed in base of key trench and under HDPE geotextile.

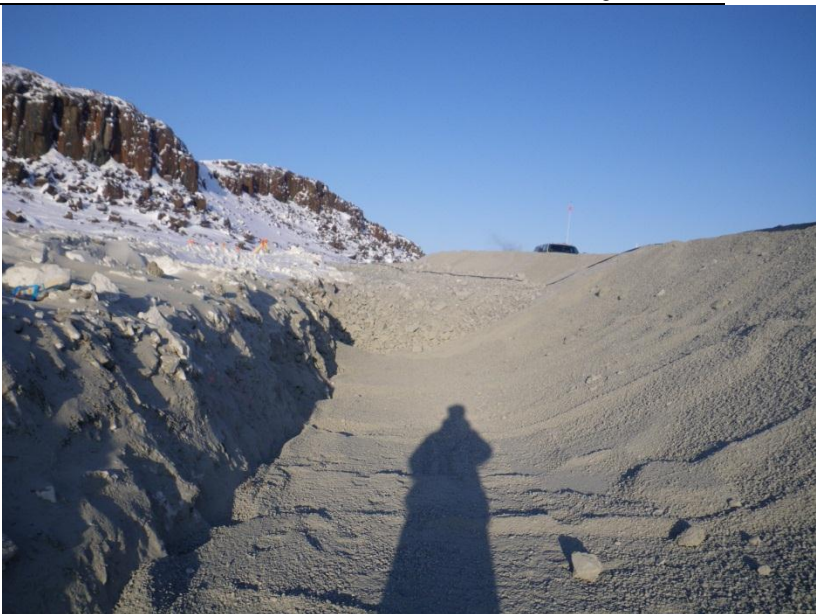
Photo 9: Over liner crush placed from 160 to 100, looking east along berm. Face of ROQ front visible.

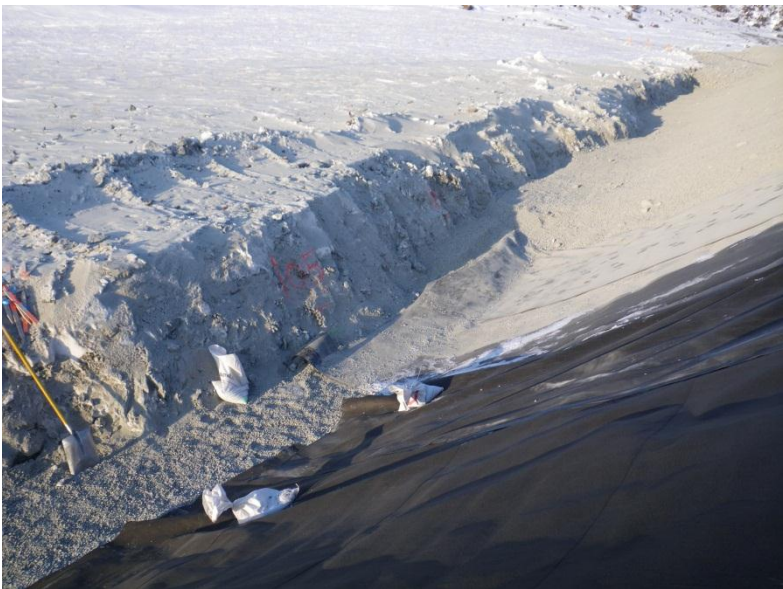
- Upper geotextile, bentonite 'plug' and overliner crush were placed from station 160 to station 100.
 - After the bentonite and overliner crush were placed the very end of the HDPE liner, ~5 m, was noticed to be bent such that the HDPE does not run along the bentonite at the bottom. This was mentioned to the foreman. The foreman plans on fixing this area tomorrow morning.
- Underliner crush and geotextile placed to station 060.
- The bottom bentonite and bottom crush (in the overblasted bottom) were placed from 060 to 020. The slopes of the ROQ in this area were also smoothed.

Photo 10: Wrinkle in HDPE liner at approximately station 100.

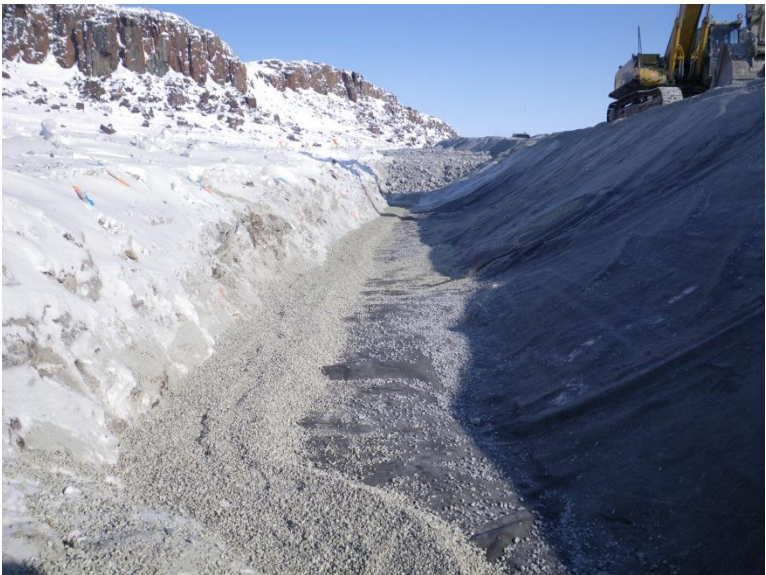
Photo 11: Bentonite 'plug' placed from 100 to 160, photo looking east.

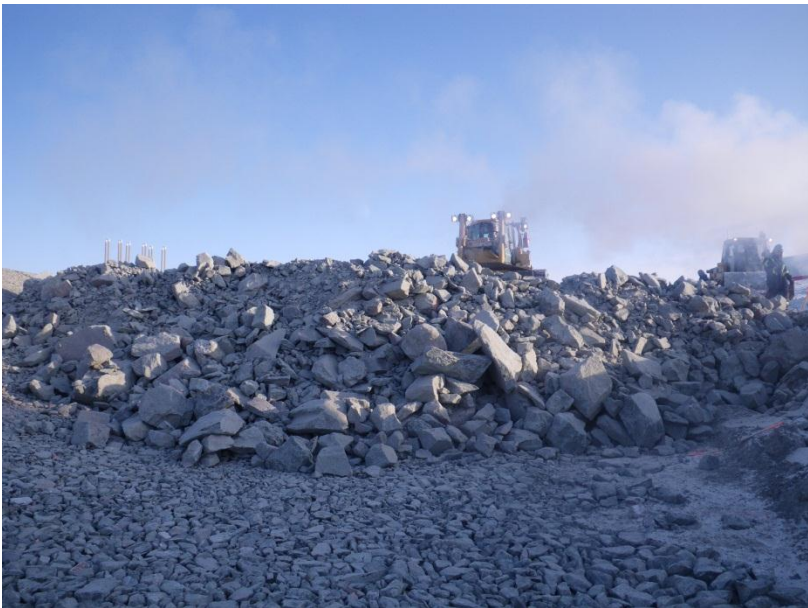
- The ROQ material was very fine and of good quality.
- The CAT 330 excavator was used place the transition material along the slope and the CAT D8 excavator was used to place the transition material along the toe of the core slope and to place ROQ.

Photo 12: ROQ placement at the north dam.

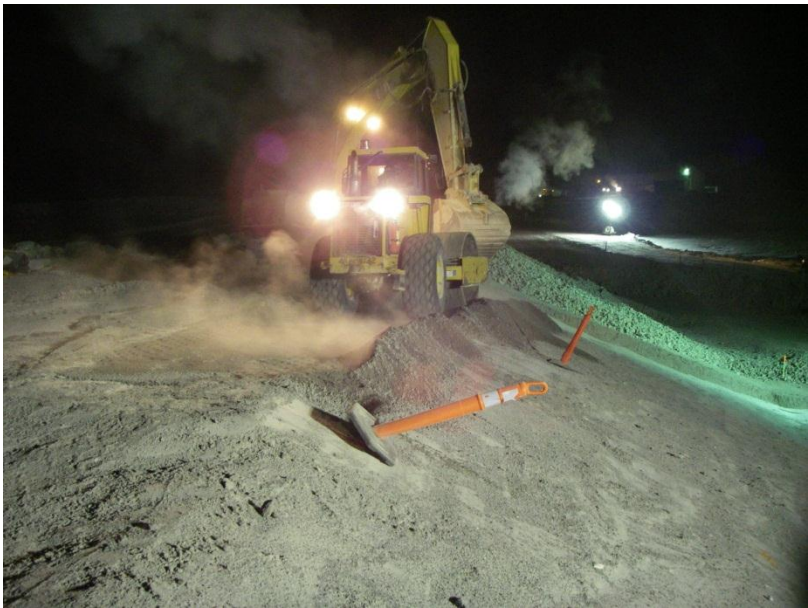
- The remaining volume of FCM in the underbuilt sliver was placed **to complete the frozen core.**
 - The thickness of the FCM was highly variable, requiring two lifts in the wider portion, from Sta. 0+65 to Sta. 0+70

Photo 13: Placing and compacting the last of the FCM at approximately station 0+70.

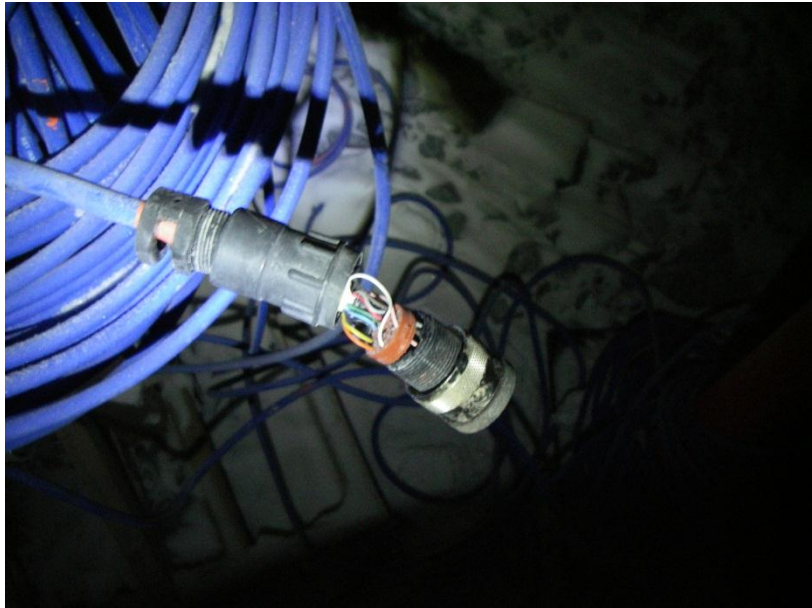
Photo 14: Connector of ND-HTS-060-28.8. No apparent physical damage.

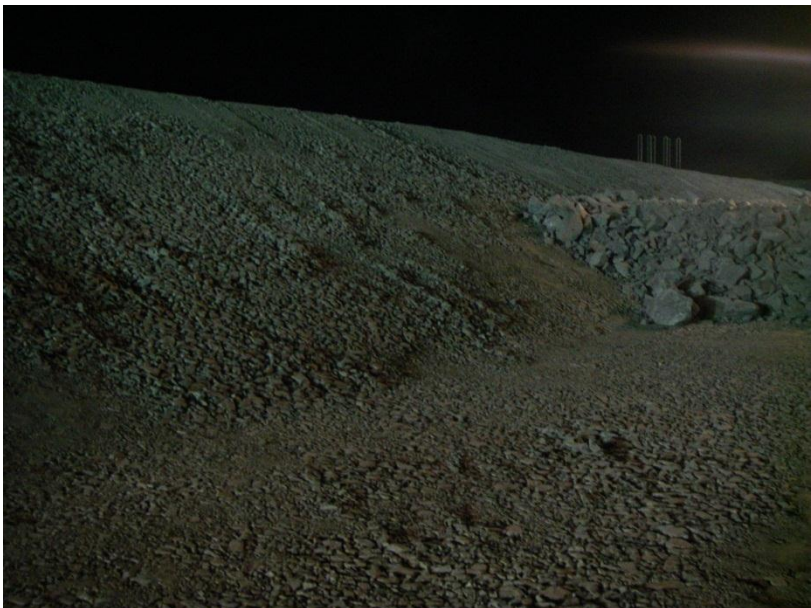
- First lift of transition material from Sta. 1+05 to Sta. 1+25 and the second lift from Sta. 1+20 to Sta. 1+45 were compacted.
 - The surface looked loose in some spots, even after several passes with the compactor, because the wheels of the compactor would spin out as it was powering up the slope. A new technique was tried, whereas only the bottom half of the slope was compacted, the part that was to be covered by the first lift of ROQ. The top part of the transition on the slope will be compacted once the ROQ is in place and access onto the slope becomes easier.
- A second lift of transition was placed from Sta. 1+20 to 1+05, but was not compacted.
- The first lift of ROQ was placed from Sta. 1+20 to 1+40. No compaction of the ROQ was observed.

Photo 15: Compacted .Transition material on the upstream slope. Photo looking north-west from Sta. 1+00. Note the lift of ROQ in the background.
