DAILY REPORT #82 – DORIS NORTH INFRASTRUCTURE/ NORTH DAM

Prepared by:	Iozsef Miskolczi Megan Miller	Date:	2012.03.27
Reviewed by:		Project #:	1CH008.058.0320
Role	Company	Personnel – Position	On Site
Client	Hope Bay Mining Limited (HBML)	Angela Holzapfel – ESR Compliance Manager David Vokey – ESR Coordinator Don Ethelston – HSLP Advisor Dean Wold - Safety Jill Turk – ESR Coordinator Katsky Venter – ESR Manger Michelle Tanquay – ESR Site Manager Stirling Kelly – HSLP Advisor	No No Yes No Yes Yes No No
	JDS	Lloyd Jackson – Mechanical Superintendent Doug Fielding – Construction Manager Ishan Fechter – Construction Coordinator Jerry Graham – Construction Manager Kevin Whieldon – Project Coordinator Mark Valeriote – Construction Manager Calvin Goldschmidt – Construction Coordinator	No Yes No No No Out Yes
Engineering Design Consultants	SRK Consulting (Canada) Inc.	John Kurylo – Site Engineer Megan Miller – Site Engineer Lawrence Borowski – Site Engineer Murray McGregor – Site Engineer Iozsef Miskolczi – Site Engineer Lowell Wade – Senior Engineer	Out Yes No No In No

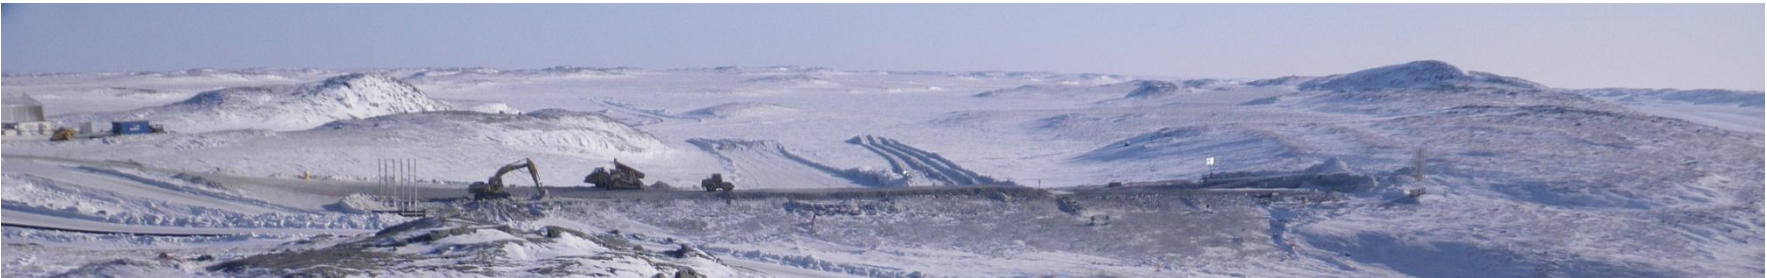
Photo 1: Progress photo of North Dam from photo point 1. Looking south west.

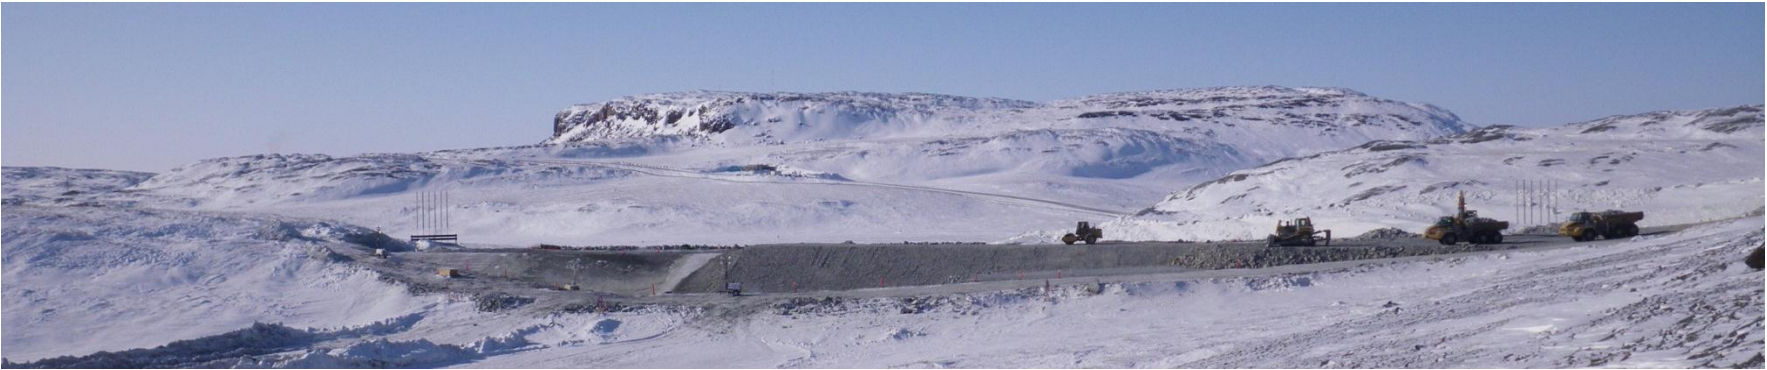
Photo 2: Progress photo of North Dam from photo point 2. Looking north west.

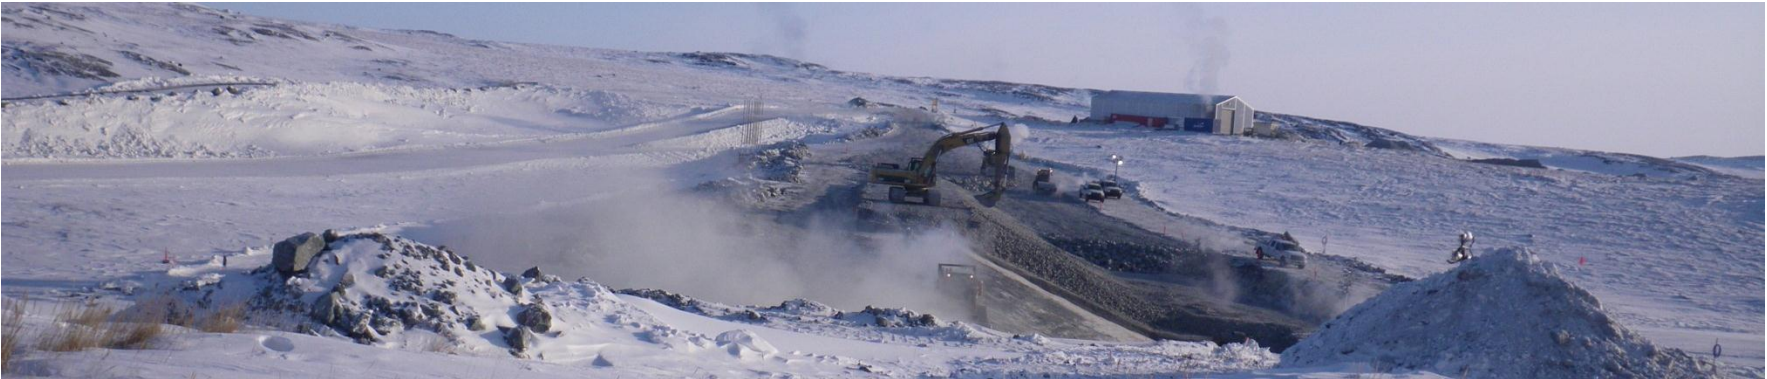
Photo 3: Progress photo of North Dam from photo point 3. Looking north east along the dam.

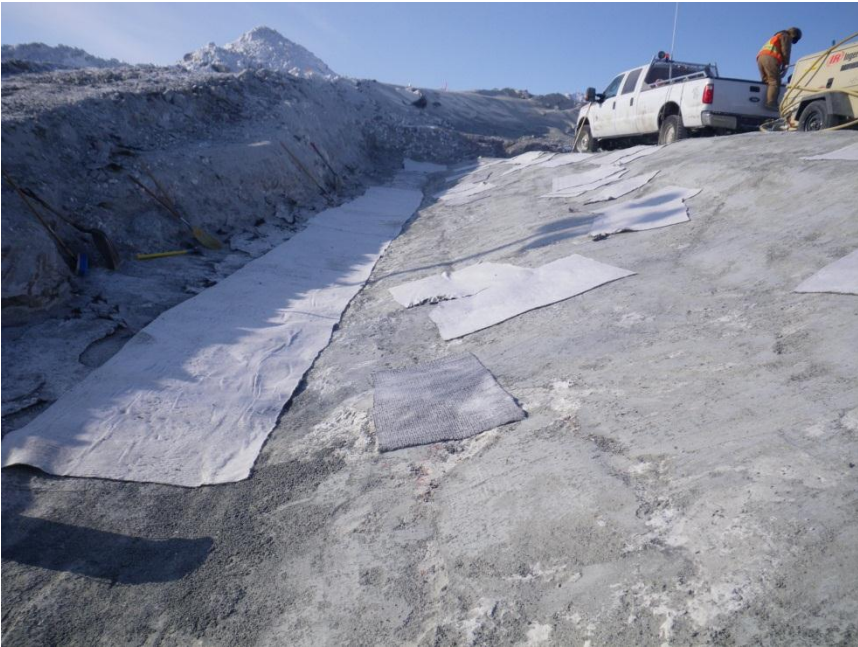
- The remaining holes along the lower GCL were patched with large strips of excess GCL.
- Six panels of GCL were placed along the core material from approximately station 0+30 to 0+50.
 - Prior to GCL placement sacrificial patches of GCL were placed on any sharp looking spot along the core material.
 - After GCL placement the GCL area was walked and any areas where it appeared there was something sharp under the liner and the one hole noted were patched.
 - The CAT 330 excavator was used to place the GCL material.
- The single beads placed in the FCM placed on nightshift March 26th were monitored. Freeze back was not achieved by the end of dayshift.

Photo 4: large patches placed over the GCL liner south west of station 0+50.

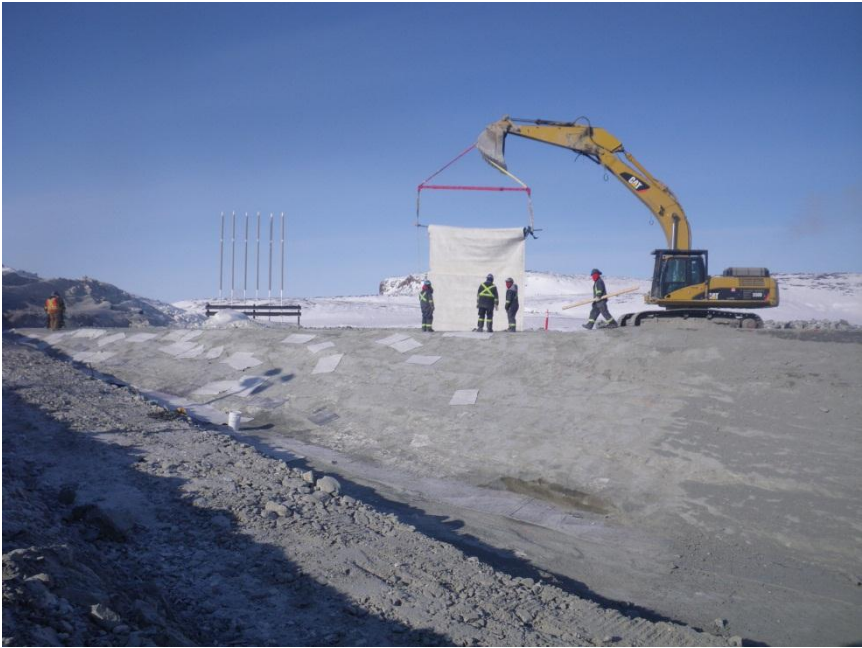
Photo 5: Placement of upper GC south of station 0+50.

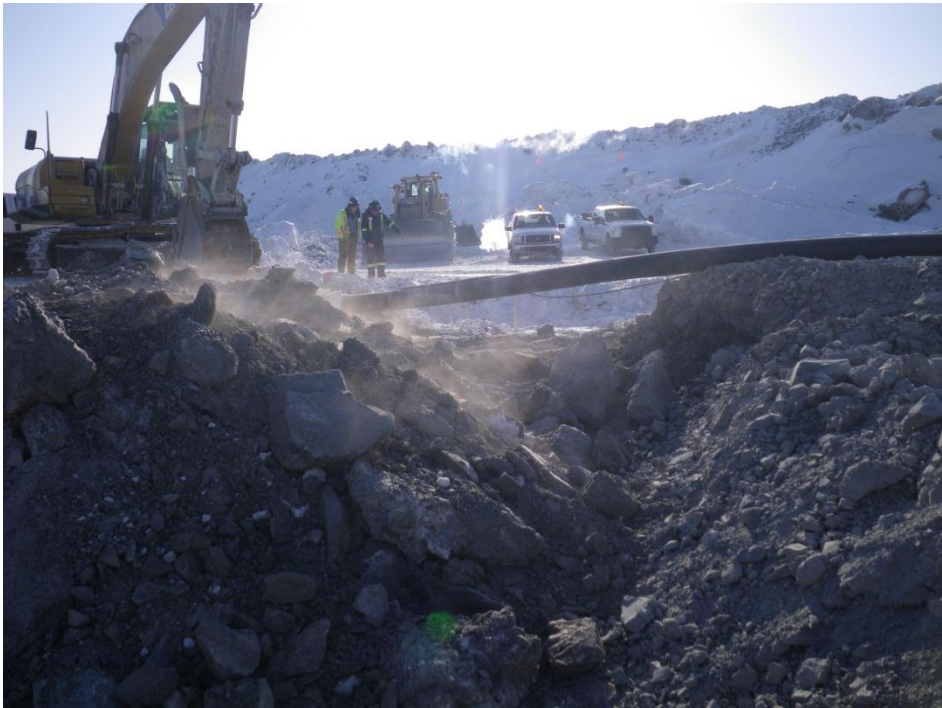
Photo 6: Diversion Berm - Excavation through primary road for culvert installation.

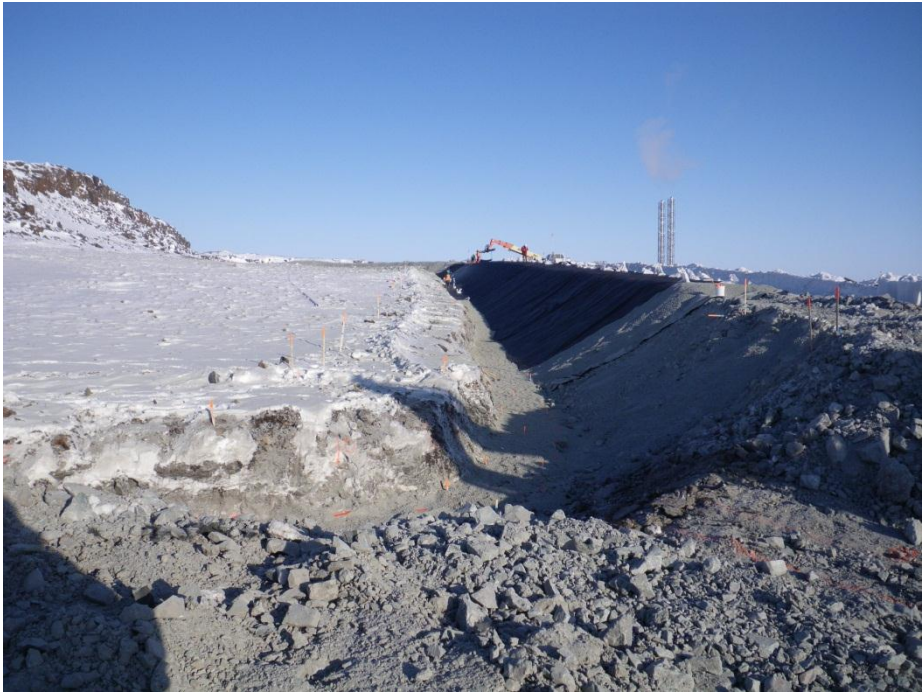
Photo 7: View of diversion berm progress from culvert excavation. Photo looking east.

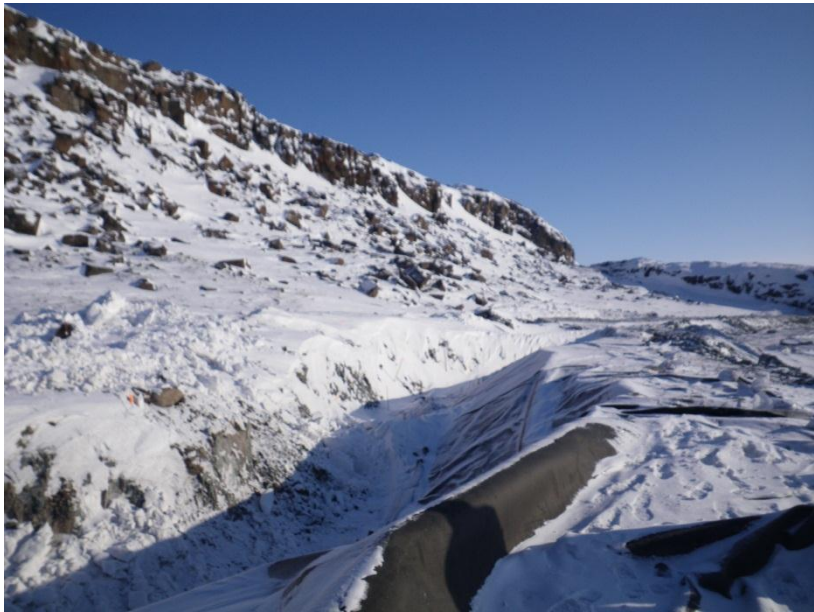
- The primary road crossing for culvert installation was ripped with the dozer and excavated with the CAT 325 excavator. At the end of dayshift this excavation was to grade.
- No work was done on the section from 000 to 027 as this was the area where the culvert excavation was occurring.
- Underliner crush and lower bentonite were inspected to station 025. Underliner geotextile as placed in this area to station 027.
- HDPE liner and overliner geotextile were placed from station 100 to 050.
- The second lift of ROQ was staked from station 395 to 200.
 - A small section of this area (station 260 to 230) had more than 4" of snow within the footprint of the ROQ. This was mentioned to the foreman and he instructed the placing operator to remove the snow prior to ROQ placement.

Photo 8: View of the diversion berm where snow was allowed to accumulate on the exposed geotextile and HDPE liner.

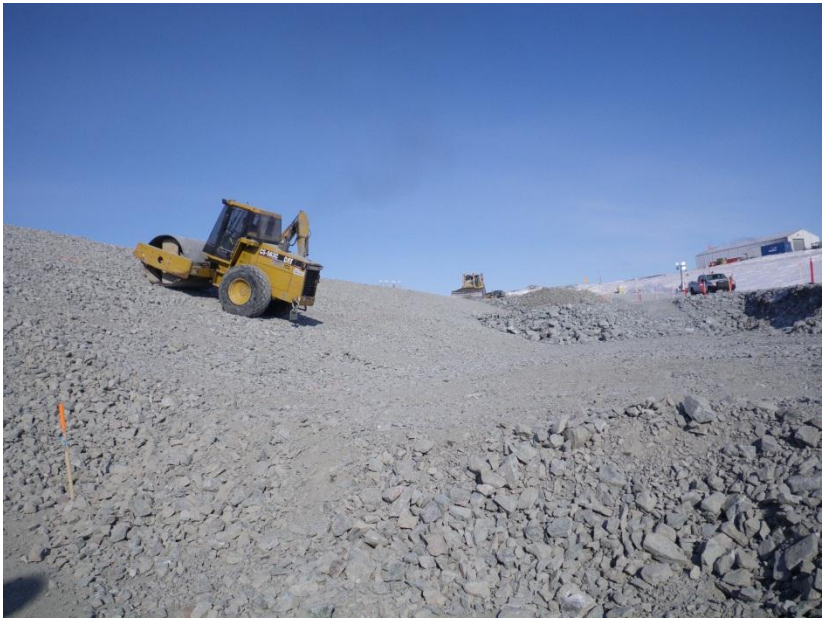
- Transition material was placed in a second lift over the GCL cover material to station 0+85.
 - The compactor had difficulties compacting this material on the slope. At the beginning of shift the compactor operator was compacting the slopes going down, and this was working okay. The compactor used in the morning broke down due to a problem with the roller vibrator, and the other compactor was used. The second compactor used was pulling material down as it backed down the slope as the drum was not rolling as fast as the wheels.

Photo 9: North Dam - Compactor compacting slope of transition material. Photo looking north east along dam alignment.

- The second lift of transition material placed on dayshift received further compaction. The packer operator was instructed to turn off the vibrator on his trip back (downwards) to eliminate the downslope transport of the transition material

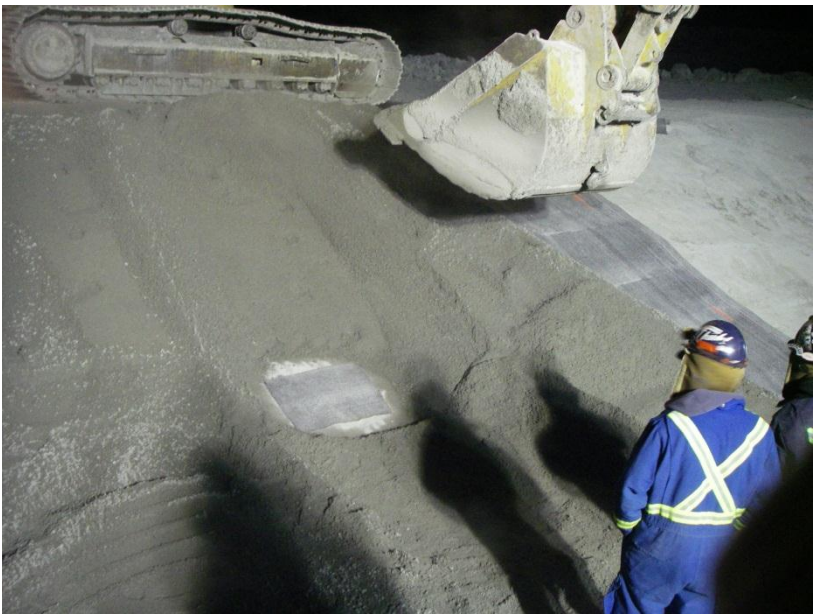
-
- One lift of overliner material was placed from Station 0+20 to Sta. 0+40.
- During placement of the material the excavator grabbed the GCL liner in one spot. A patch was placed over the damaged area and a bentonite seal was applied.

Photo 10: Patch in the GCL liner.

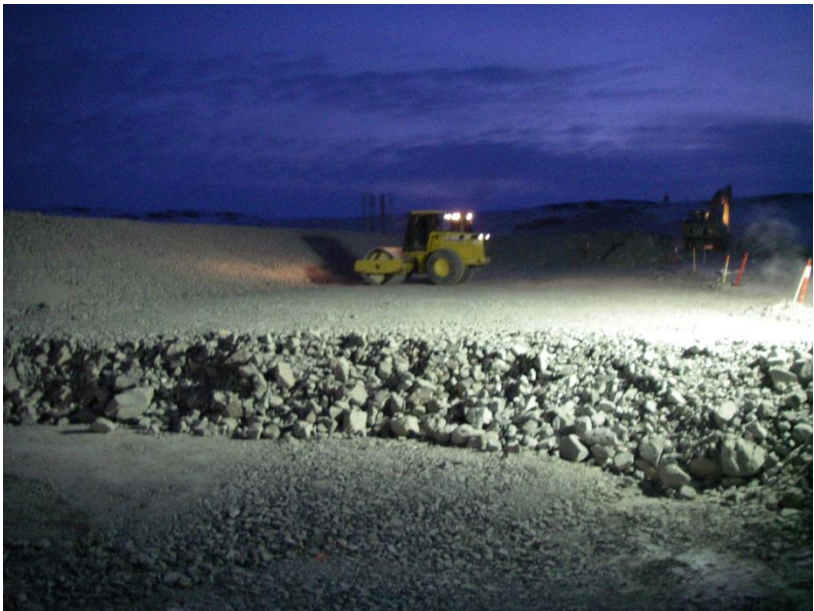
Photo 11: Compactor on the first lift of ROQ on the upstream side.

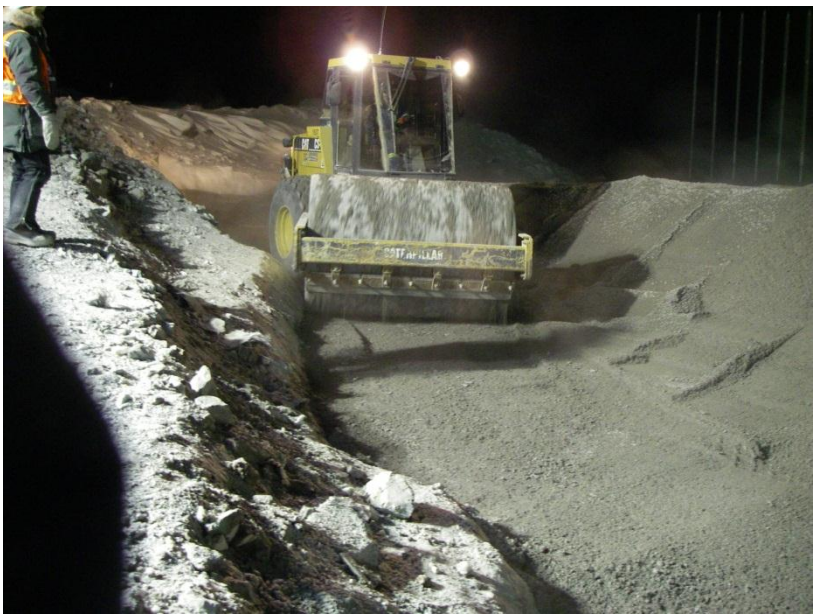
- The flat portion of the toe and the top were compacted in a pattern parallel to the dam centerline.
- Good compaction was achieved both on the flat portions (above 97% Proctor) and on the slope (96% Proctor). One small corner could not be reached by the compactor in the extreme south end. Compaction here was measured at just over 90% Proctor. Moisture contents were dry of optimum for this material (confirmation to follow in the lab reports).

Photo 12: Compactor compacting the toe of the overliner material. Photo looking south.

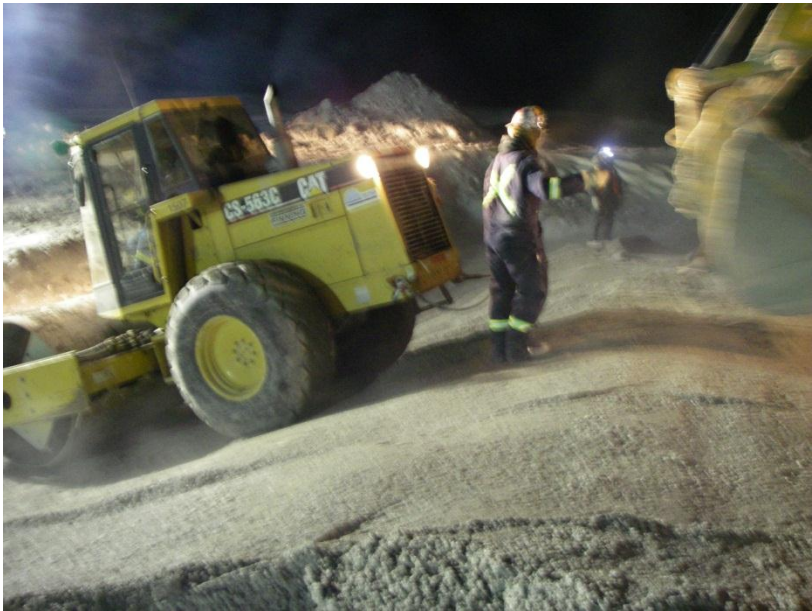
- Compaction of the placed overliner proved to be difficult due to the limited space for maneuvering. Following several attempts, it was decided to tie the compactor to the bucket of the excavator, which would help on the upward trip.

Photo 15: Compactor backing up the slope with the help of the excavator.
