DAILY REPORT #83 – DORIS NORTH INFRASTRUCTURE/ NORTH DAM

Prepared by:	Iozsef Miskolczi Megan Miller	Date:	2012.03.28
Reviewed by:		Project #:	1CH008.058.0320
Role	Company	Personnel – Position	On Site
Client	Hope Bay Mining Limited (HBML)	Angela Holzapfel – ESR Compliance Manager David Vokey – ESR Coordinator Don Ethelston – HSLP Advisor Dean Wold - Safety Jill Turk – ESR Coordinator Katsky Venter – ESR Manger Michelle Tanquay – ESR Site Manager Stirling Kelly – HSLP Advisor	No No Yes No Yes Yes No No
	JDS	Lloyd Jackson – Mechanical Superintendent Doug Fielding – Construction Manager Ishan Fechter – Construction Coordinator Jerry Graham – Construction Manager Kevin Whieldon – Project Coordinator Mark Valeriote – Construction Manager Calvin Goldschmidt – Construction Coordinator	No Yes No No No No Yes
Engineering Design Consultants	SRK Consulting (Canada) Inc.	John Kurylo – Site Engineer Megan Miller – Site Engineer Lawrence Borowski – Site Engineer Murray McGregor – Site Engineer Iozsef Miskolczi – Site Engineer Lowell Wade – Senior Engineer	No Yes No No Yes No

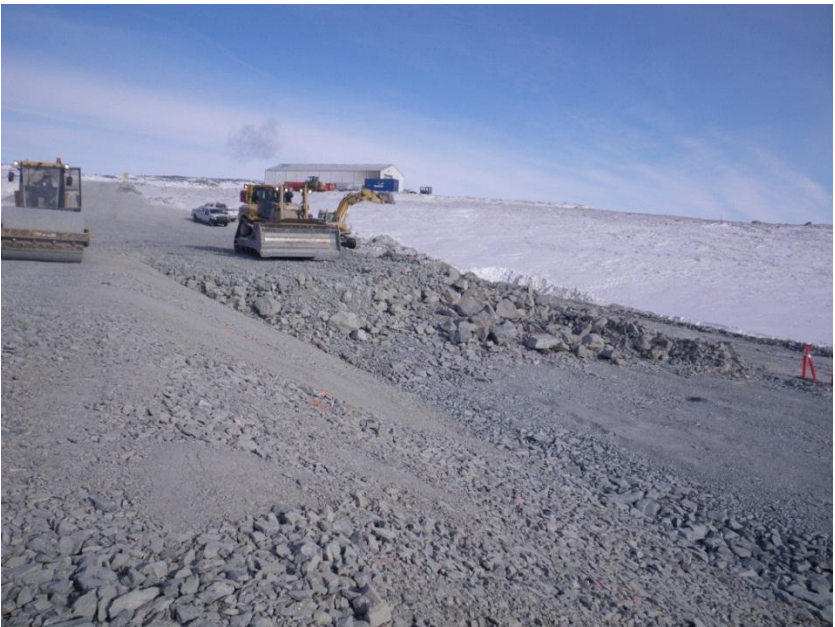
Photo 4: ROQ placement at the north dam. Note the few large pieces in the working face in front of the dozer. These pieces were removed with the CAT 330 excavator.

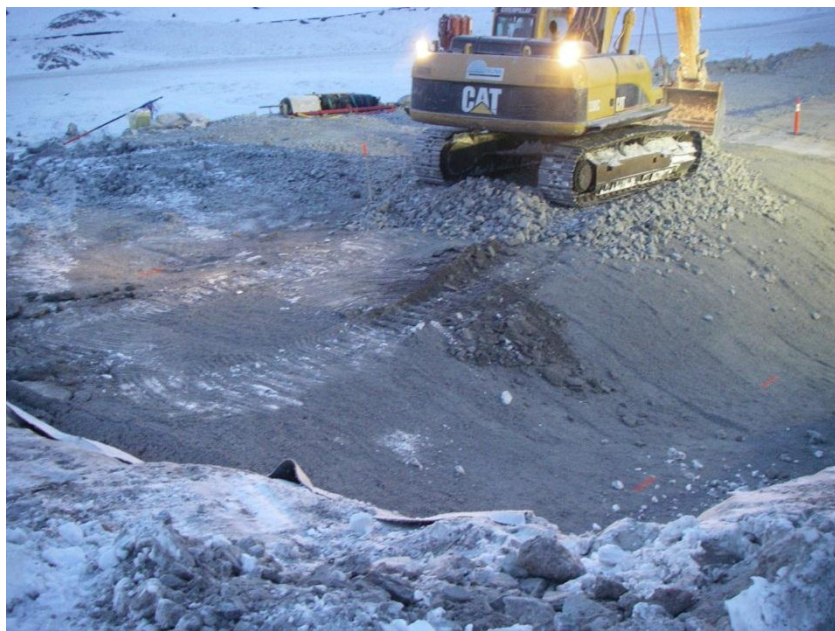
- The material was placed in three lifts, each compacted.
 - The overliner core was scarred in one spot and cracked at the tie-in with the keytrench wall on the south end as a result of excavator movement. See Photo 9 for details.

Photo 9: North Dam – Excavator spreading the transition material placed on top of the overliner core. Note the scarred surface of the overliner as a result of excavator traffic.

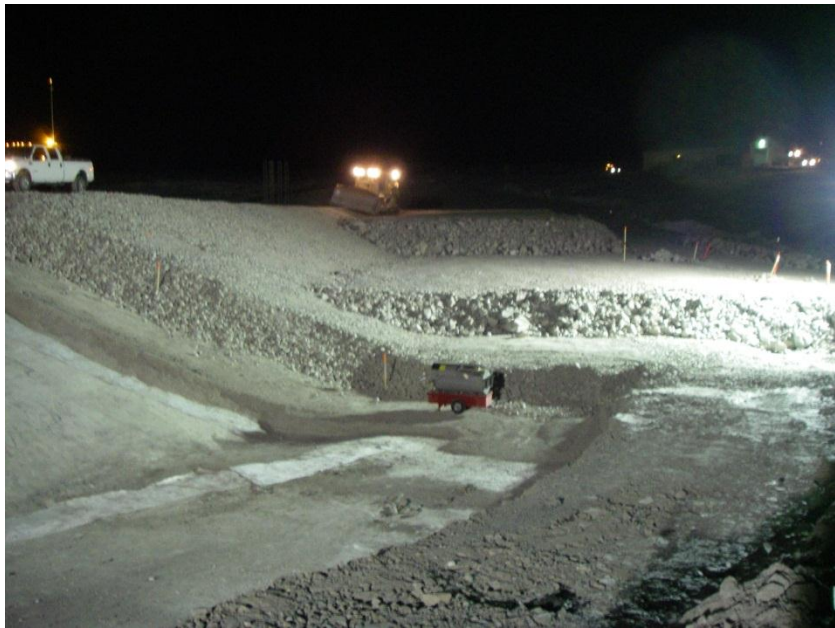
Photo 11: North Dam – progress photo of the second lift of ROQ placed on the upstream side. Note the transition and the first lift of ROQ were stopped around Station 0+90 waiting for completion of the GCL and overliner core placement. Photo looking north from Sta. 0+70
