DAILY REPORT #84 – DORIS NORTH INFRASTRUCTURE/ NORTH DAM

Prepared by:	Iozsef Miskolczi Megan Miller	Date:	2012.03.29
Reviewed by:		Project #:	1CH008.058.0320
Role	Company	Personnel – Position	On Site
Client	Hope Bay Mining Limited (HBML)	Angela Holzapfel – ESR Compliance Manager David Vokey – ESR Coordinator Don Ethelston – HSLP Advisor Dean Wold - Safety Jill Turk – ESR Coordinator Katsky Venter – ESR Manger Michelle Tanquay – ESR Site Manager Stirling Kelly – HSLP Advisor	No No Out No Yes Yes No No
	JDS	Lloyd Jackson – Mechanical Superintendent Doug Fielding – Construction Manager Ishan Fechter – Construction Coordinator Jerry Graham – Construction Manager Kevin Whieldon – Project Coordinator Mark Valeriote – Construction Manager Calvin Goldschmidt – Construction Coordinator	No Out No In No No Yes
Engineering Design Consultants	SRK Consulting (Canada) Inc.	John Kurylo – Site Engineer Megan Miller – Site Engineer Lawrence Borowski – Site Engineer Murray McGregor – Site Engineer Iozsef Miskolczi – Site Engineer Lowell Wade – Senior Engineer	No Yes No No Yes No

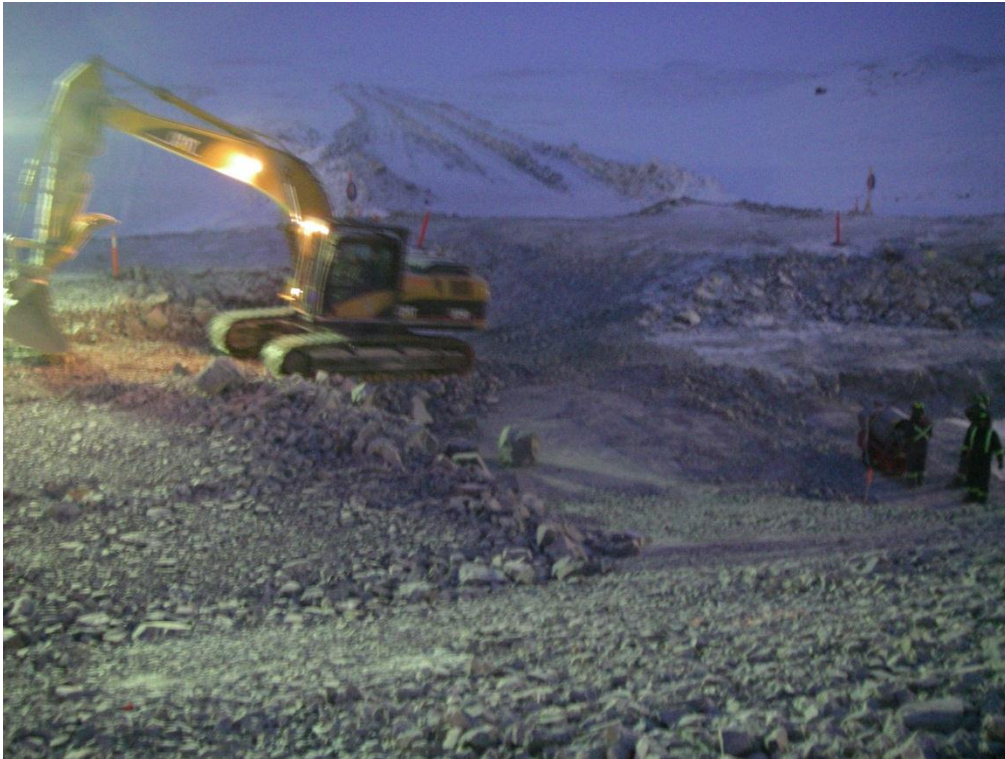
Photo 4: Diversion Berm - Excavator placing ROQ material on diversion berm. Photo looking east along diversion berm.

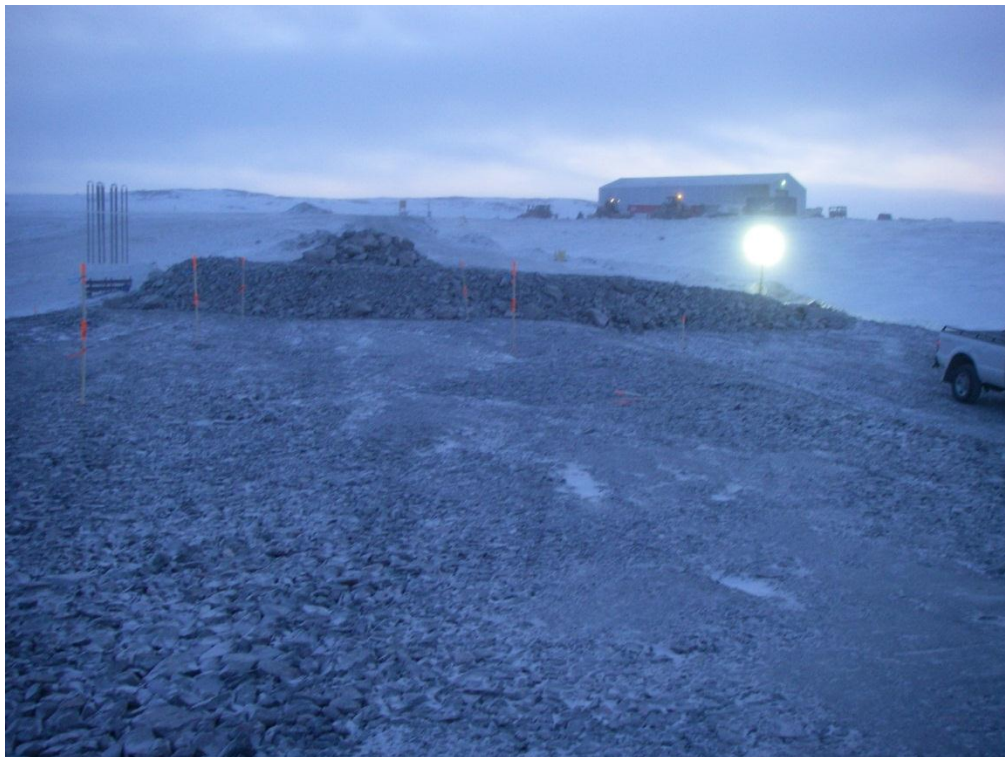
- Placement of the final lift of ROQ continued. This lift reached station 1+20 by end of dayshift.
 - A few oversize were noted in the fill. The issue was discussed with the foreman who reminded the loader operator in the quarry and the dozer operator placing the ROQ that maximum size of rock for this thinner lift is 500 mm opposed to 900 mm specified for the full lift thickness.

Photo 7: North Dam – CAT D8 dozer placing ROQ on the final lift of the dam shell. Photo looking north-east from station 1+00.

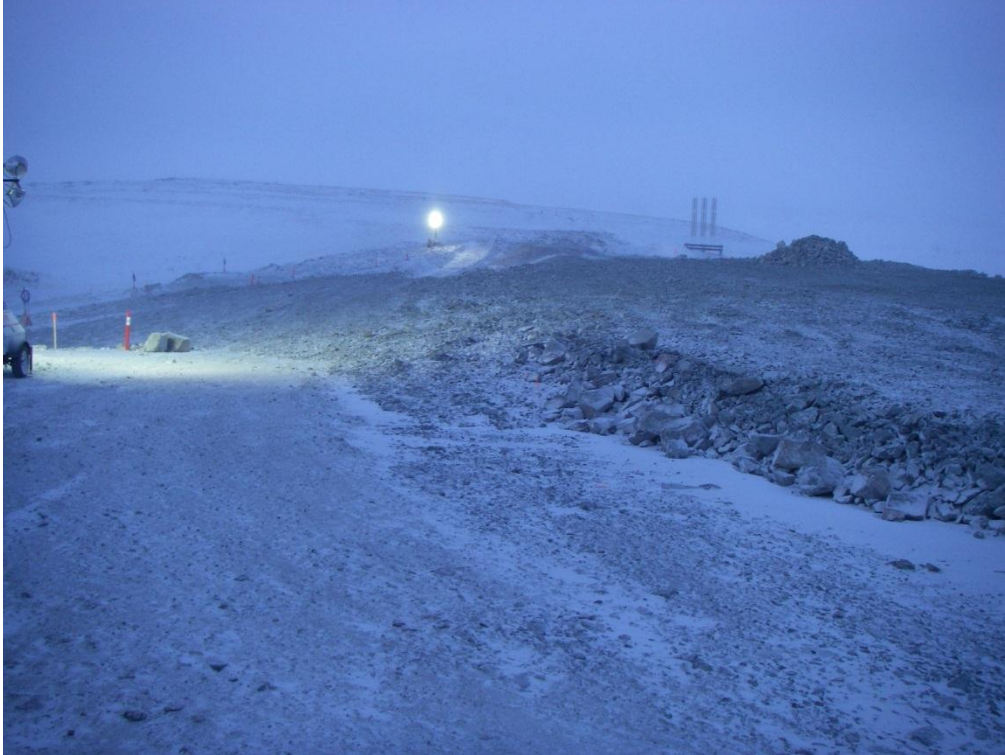
- ROQ was of good quality, with adequate fines and some oversize.
- Compaction of the final lift on the crest of the dam is required.

Photo 8: North Dam – progress photo of final lift of ROQ. Photo looking north-east from station 1+00.

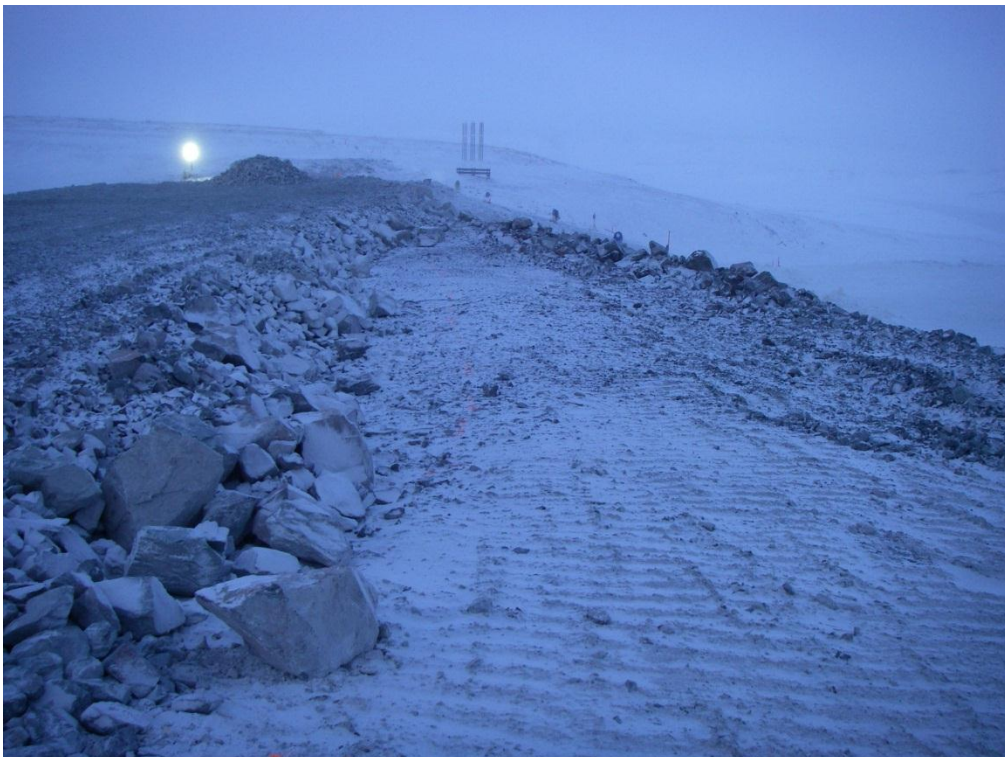
Photo 9: North Dam – progress photo of the final lift of ROQ. Photo looking south-west along the upstream crest of the dam shell from Sta. 1+90.
