## DAILY REPORT #85 – DORIS NORTH INFRASTRUCTURE/ NORTH DAM

Prepared by:	Iozsef Miskolczi Megan Miller	Date:	2012.03.30
Reviewed by:		Project #:	1CH008.058.0320
Role	Company	Personnel – Position	On Site
Client	Hope Bay Mining Limited (HBML)	Angela Holzapfel – ESR Compliance Manager David Vokey – ESR Coordinator Don Ethelston – HSLP Advisor Dean Wold - Safety Jill Turk – ESR Coordinator Katsky Venter – ESR Manger Michelle Tanquay – ESR Site Manager Stirling Kelly – HSLP Advisor	No No No No Yes Yes No No
	JDS	Lloyd Jackson – Mechanical Superintendent Doug Fielding – Construction Manager Ishan Fechter – Construction Coordinator Jerry Graham – Construction Manager Kevin Whieldon – Project Coordinator Mark Valeriote – Construction Manager Calvin Goldschmidt – Construction Coordinator	No No No Yes No No Yes
Engineering Design Consultants	SRK Consulting (Canada) Inc.	John Kurylo – Site Engineer Megan Miller – Site Engineer Lawrence Borowski – Site Engineer Murray McGregor – Site Engineer Iozsef Miskolczi – Site Engineer Lowell Wade – Senior Engineer	No Yes No No Yes No

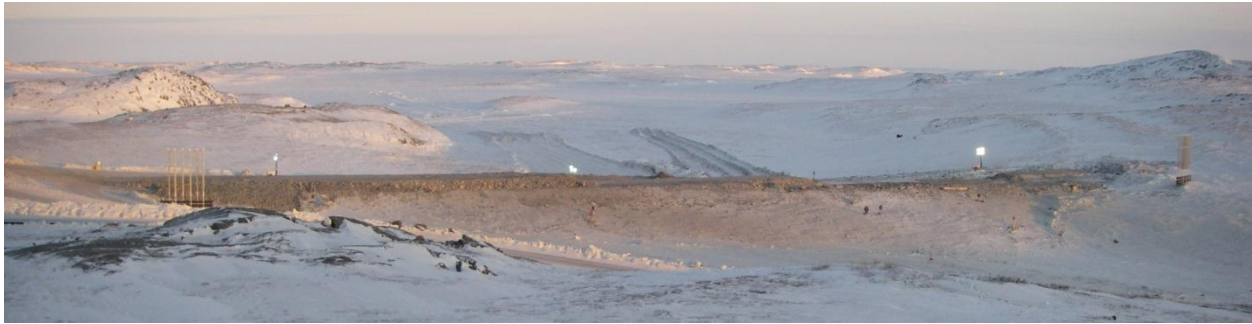
**Photo 1:** Progress photo of North Dam from photo point 1. Looking south west.

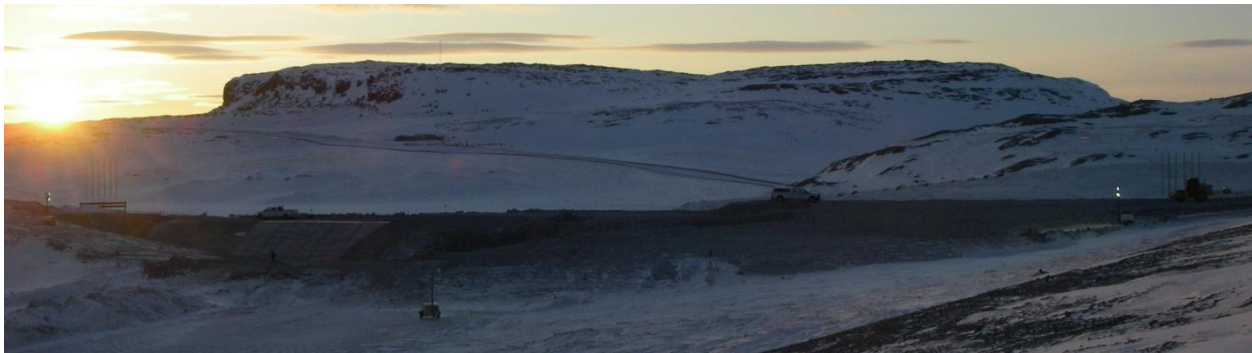
**Photo 2:** Progress photo of North Dam from photo point 2. Looking north west.

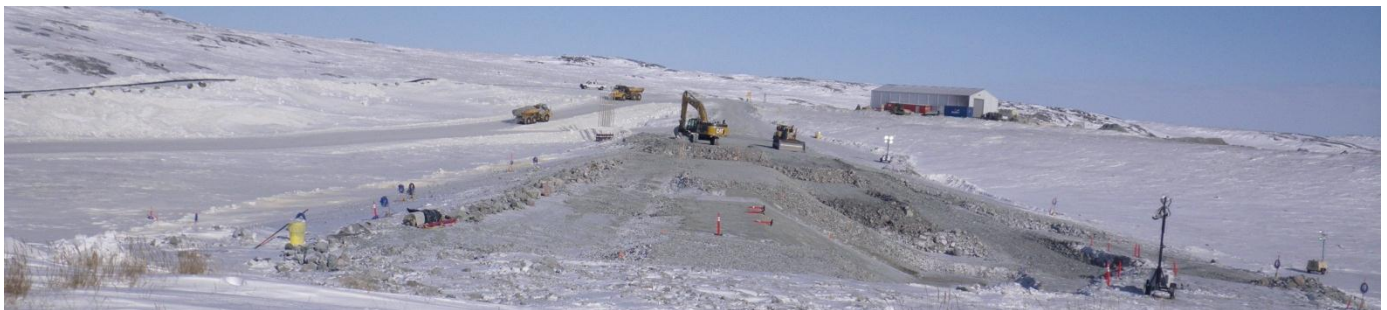
**Photo 3:** Progress photo of North Dam from photo point 3. Looking north east along dam alignment.

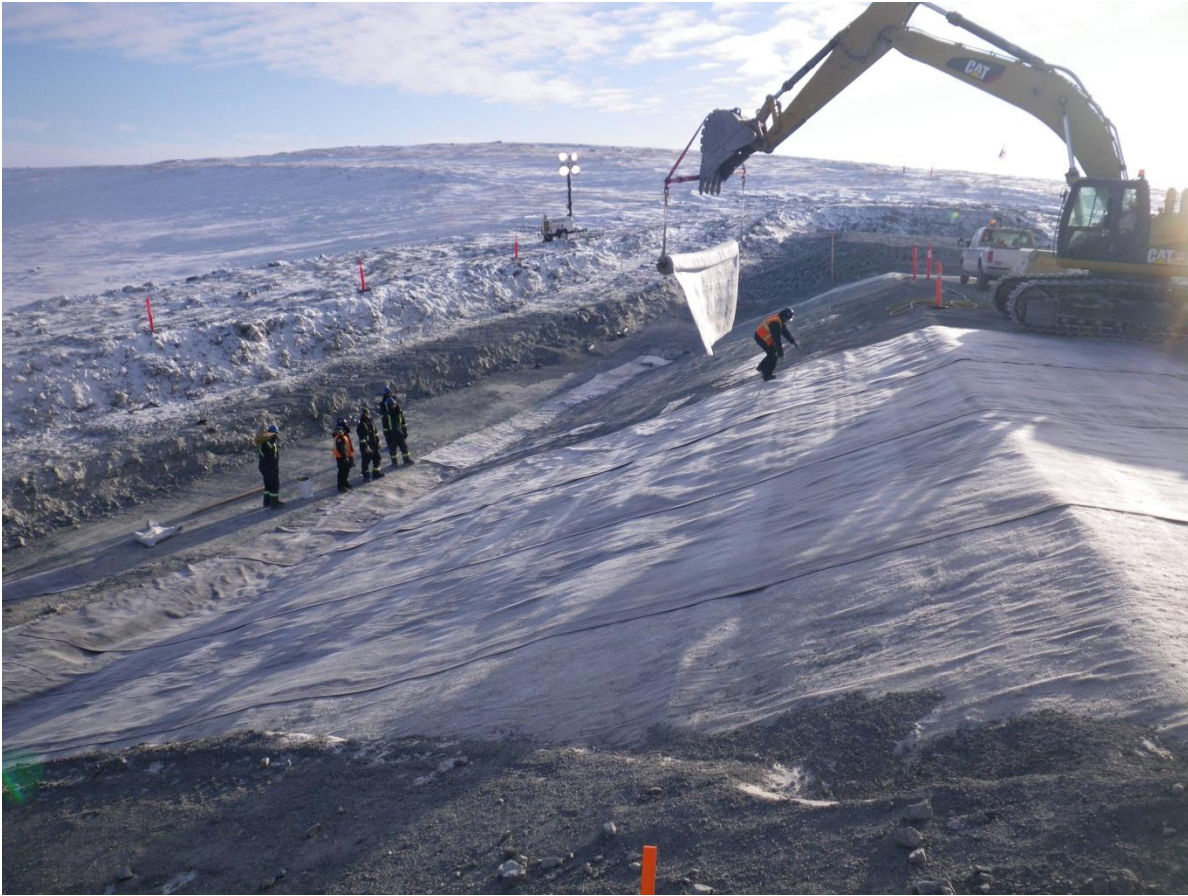
- Freeze back of the single bead thermistors placed in the last lift of core material was monitored. Only one of the beads had not reached freeze back by the end of dayshift.
- Four panels of GCL were placed from approximately station 0+85 to station 0+75.
  - Prior to placement the slope was smoothed with the back of the CAT 345 excavator bucket. The slope was not scraped with the excavator as only the excavator with the toothed bucket was available.
  - Pieces of excess GCL material were placed over any rough or sharp spots as additional padding.
  - The air compressor was used to blow the slopes clean. The air compressor was down for several hours.
  - The GCL was placed directly adjacent to the thermistor bead which was not frozen back. At the time of material placement in this area the thermistor bead was reading -1.3°C.

**Photo 4:** North Dam – GCL being placed along slope.

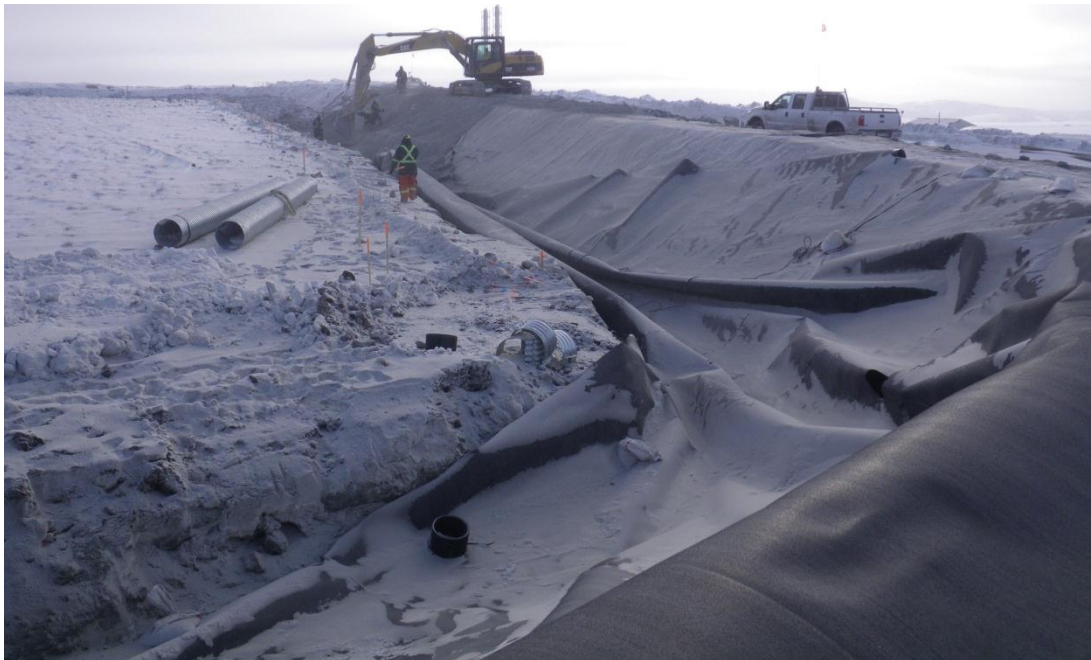
- Overnight the wind caught the liner in the corner near the culverts. The HDPE and geotextile slid down the slope to approximately station 050, this included some liner which was covered with compacted crush material. The crew spent to day shoveling out the crush and fixing the liner. Pictures are provided below.

**Photo 5:** Diversion Berm - Liner and geotextile slid down the slope at the diversion berm near the culvert crossing. Photo looking south east.

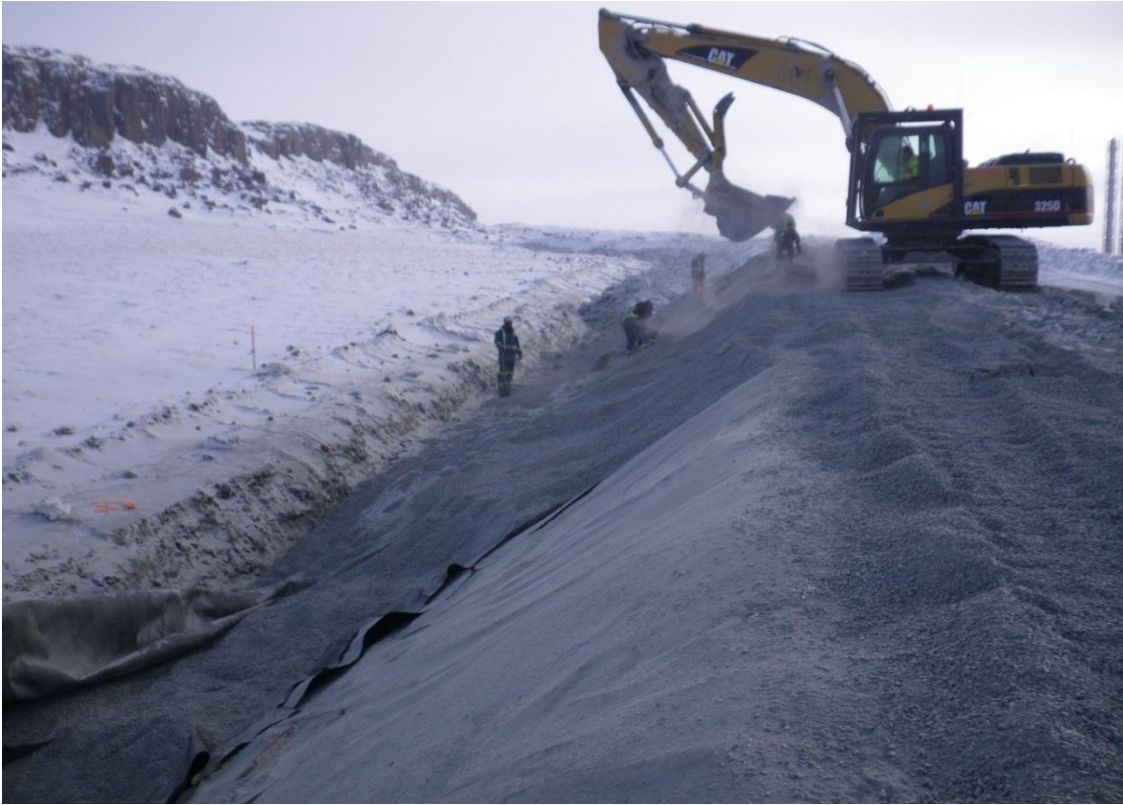
**Photo 6:** Diversion Berm – HDPE liner under the uncompactd crush slid down the slope.

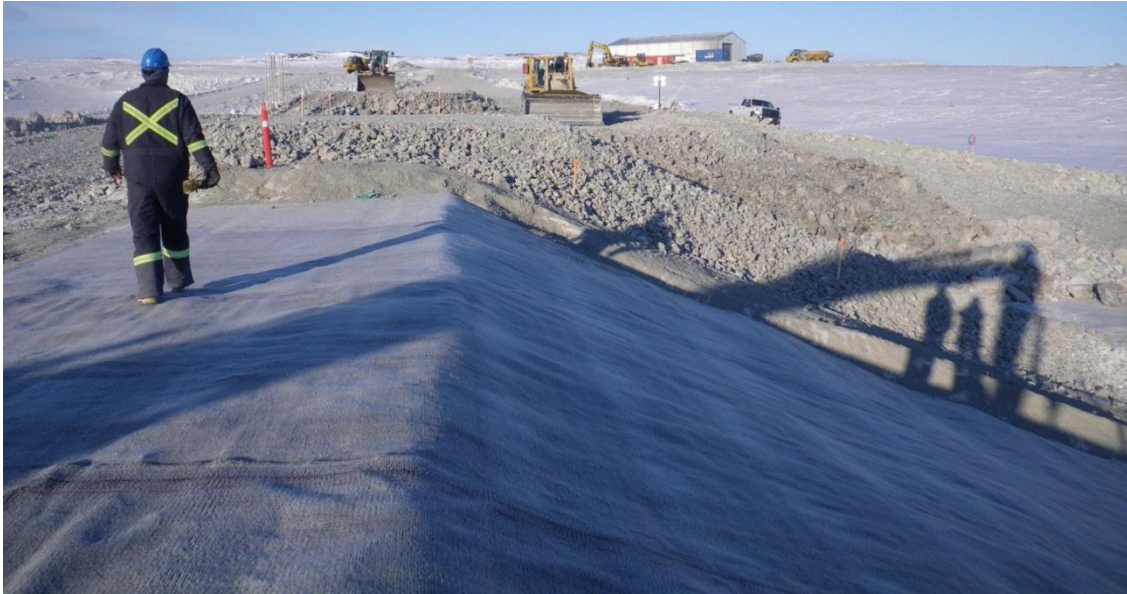
**Photo 8:** North Dam – Progress photo at end of dayshift looking north east along dam alignment from station 0+80..

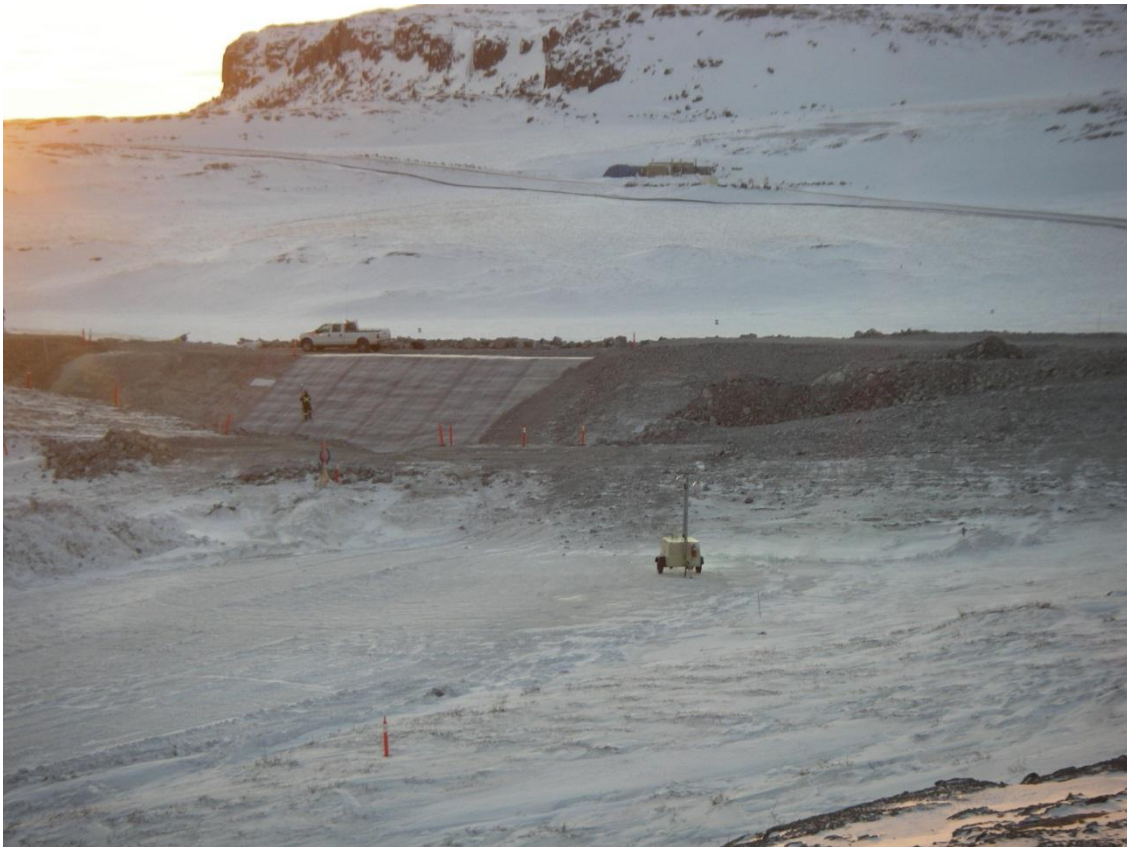
**Photo 9:** North Dam – General view of the North Dam. Note extent of the GCL liner placed on dayshift. Photo looking west.

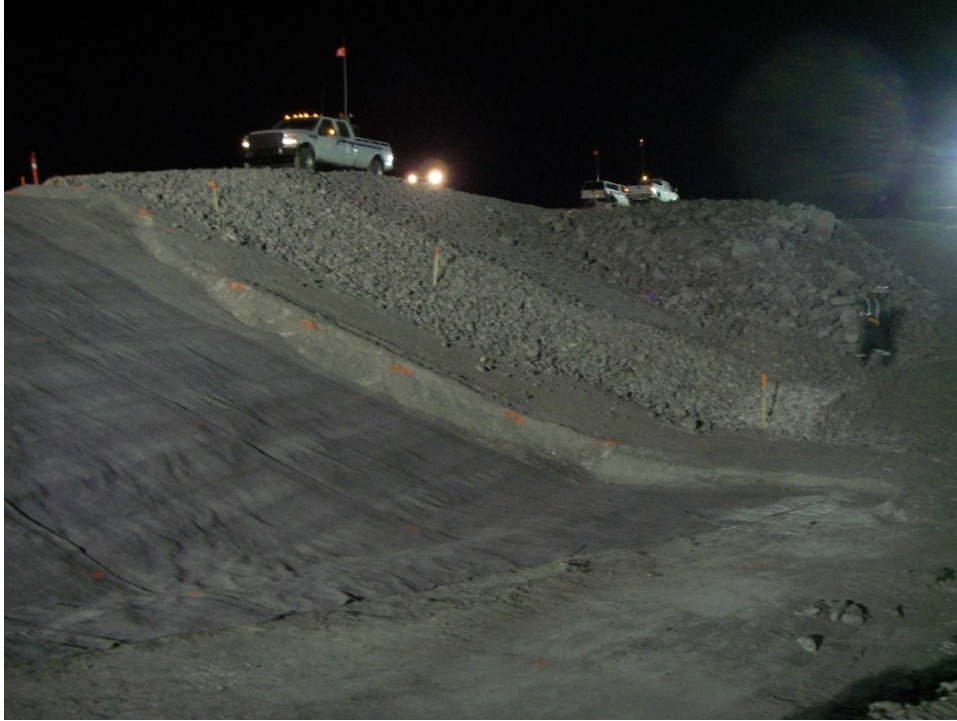
**Photo 10:** North Dam – preparations for placement of overliner core material. Note the grade marks on the crest of the previously placed overliner material. Photo looking north from Sta. 0+40.

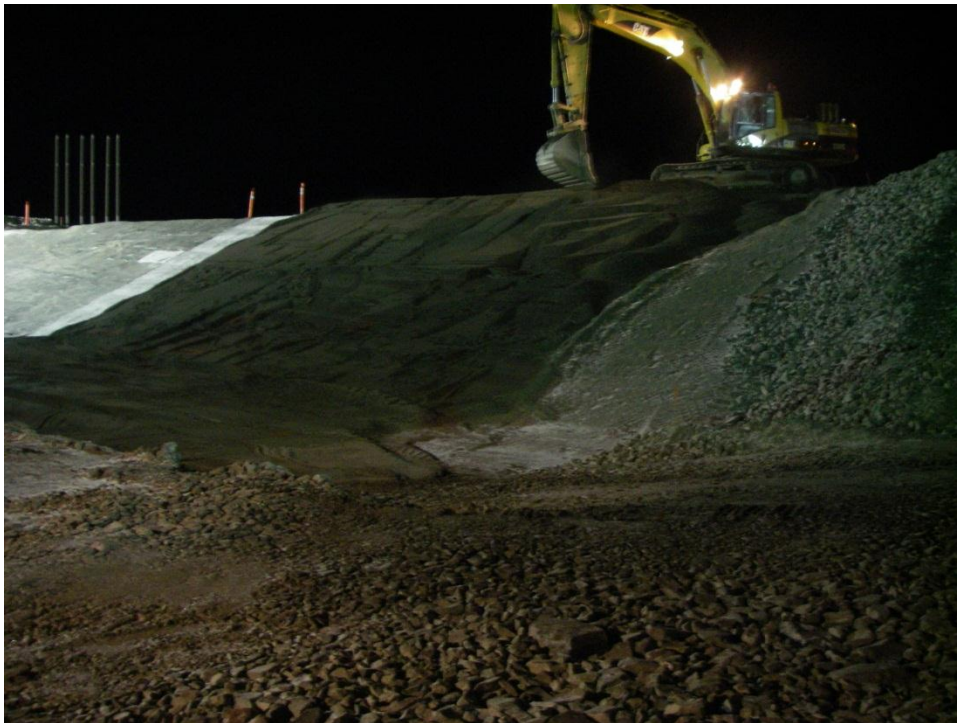
**Photo 11:** North Dam – finishing the surface of the placed overliner core material, before compaction. Photo looking south-west, from Sta. 0+90.

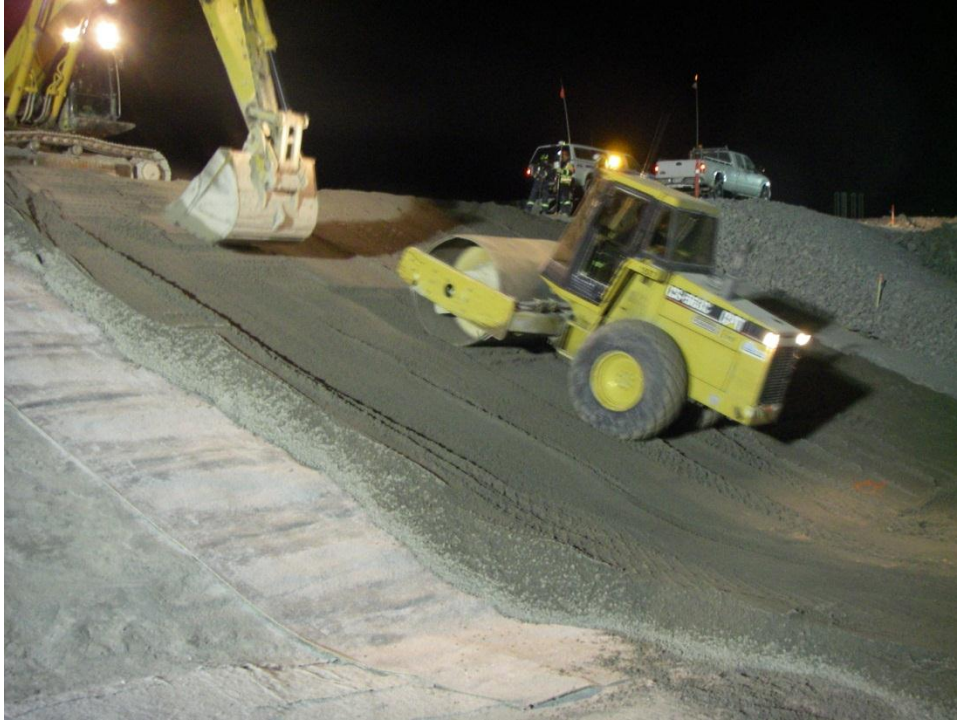
- Overliner core material was placed to cover the CGL liner installed on dayshift.
  - Compaction of the core was initially done by driving the compactor up and backing down the slope on static compaction mode. This method proved to be inefficient, as significant amount of material would be carried down-slope when the compactor would travel down. A variation of this method was to drive the compactor up onto the crest of the core; the downside of this method was that the wheels would spin out and dig into the already compacted material on the top third of the slope. Finally, at the foreman's instruction the compactor would run up the slope on vibration mode as far as it could without spinning out, and then roll back on static mode. By repeating this cycle the core material would eventually become dense enough to allow travel all the way up to the crest of the core. Some small amount of material would still be displaced downslope when the compactor would back down the slope.

**Photo 12:** North Dam – compacting the placed overliner core material. Photo looking north from Sta. 0+50

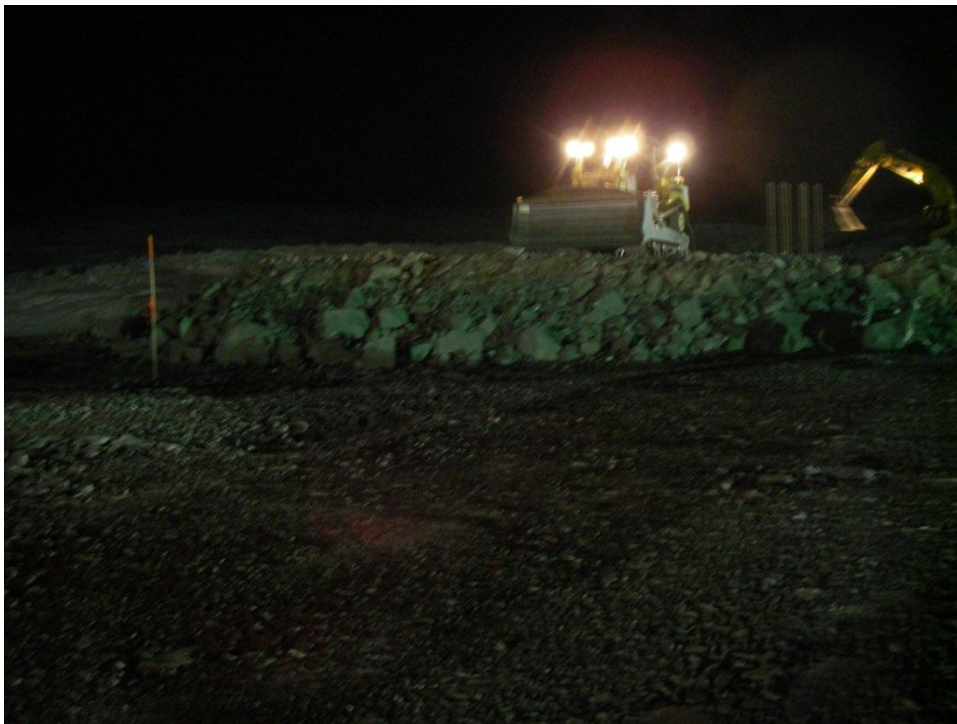
**Photo 13:** North Dam – progress photo of final ROQ lift placement. Photo looking north from Sta. 0+80.

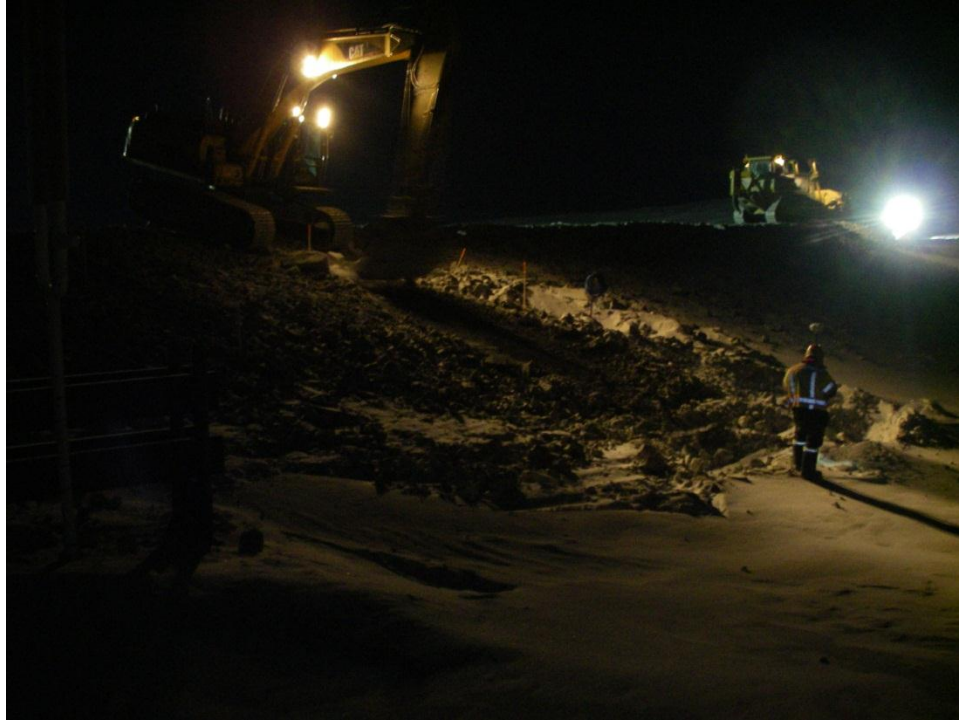
**Photo 14:** North Dam – finishing the downstream slope of the dam around Sta. 1+75. Surveyor is providing grade control support to the excavator operator. Photo looking south from the ice road.
