## DAILY REPORT #86 – DORIS NORTH INFRASTRUCTURE/ NORTH DAM

Prepared by:	Iozsef Miskolczi Megan Miller	Date:	2012.03.31
Reviewed by:		Project #:	1CH008.058.0320
Role	Company	Personnel – Position	On Site
Client	Hope Bay Mining Limited (HBML)	Angela Holzapfel – ESR Compliance Manager David Vokey – ESR Coordinator Don Ethelston – HSLP Advisor Dean Wold - Safety Jill Turk – ESR Coordinator Katsky Venter – ESR Manger Michelle Tanquay – ESR Site Manager Stirling Kelly – HSLP Advisor	No No No No Yes Yes No No
	JDS	Lloyd Jackson – Mechanical Superintendent Doug Fielding – Construction Manager Ishan Fechter – Construction Coordinator Jerry Graham – Construction Manager Kevin Whieldon – Project Coordinator Mark Valeriote – Construction Manager Calvin Goldschmidt – Construction Coordinator	No No No Yes No No Yes
Engineering Design Consultants	SRK Consulting (Canada) Inc.	John Kurylo – Site Engineer Megan Miller – Site Engineer Lawrence Borowski – Site Engineer Murray McGregor – Site Engineer Iozsef Miskolczi – Site Engineer Lowell Wade – Senior Engineer	No Yes No No Yes No

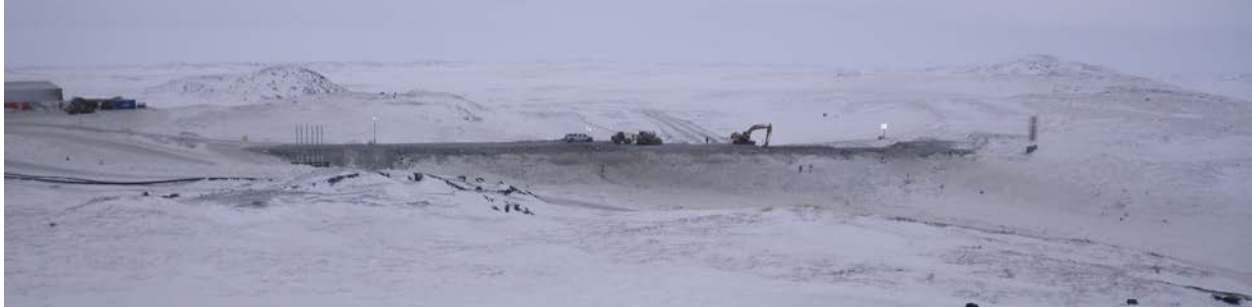
**Photo 1:** Progress photo of North Dam from photo point 1. Looking south west.

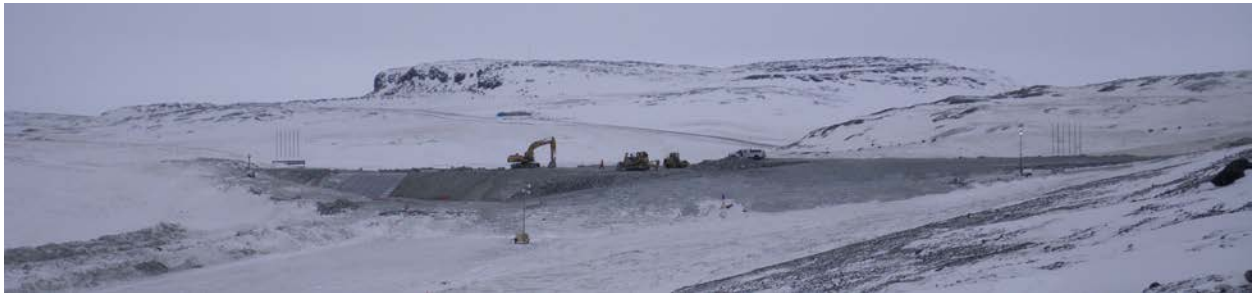
**Photo 2:** Progress photo of North Dam from photo point 2. Looking north west.

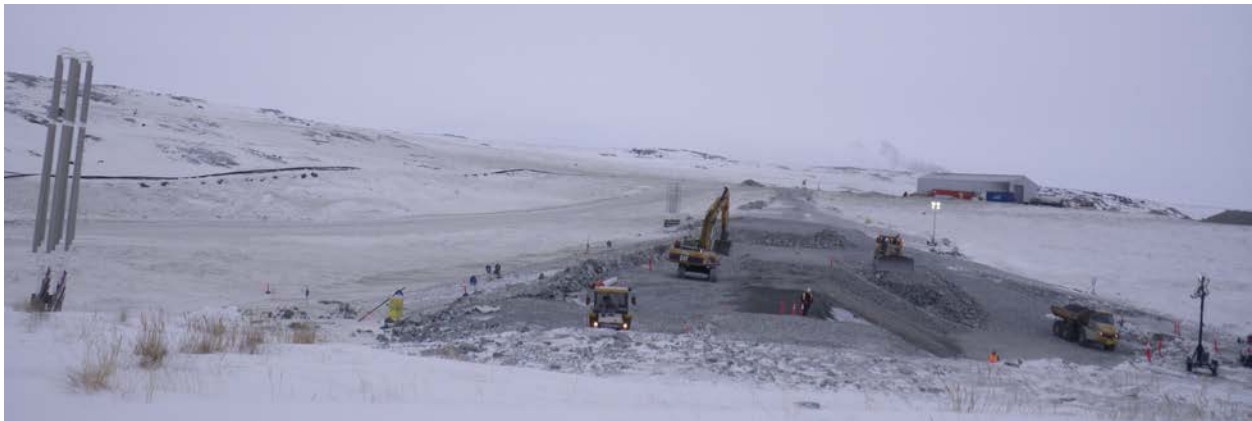
**Photo 3:** Progress photo of North Dam from photo point 3. Looking north east along dam alignment.

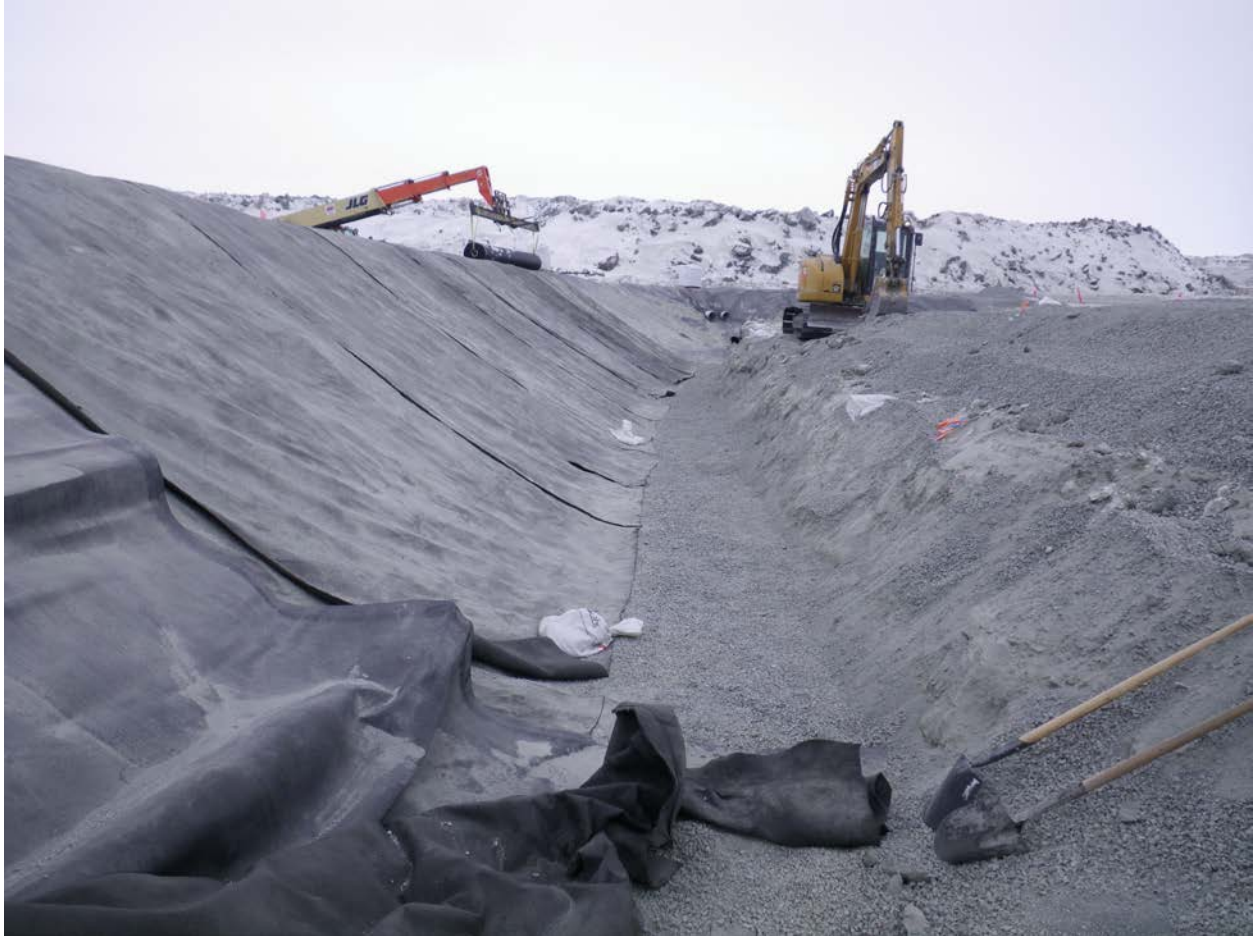
- Work continued on repairing the corner caught by the wind the night of March 30, 2012.
- Layfield decided to cut out the HDPE liner that slid down the slope and replace it with new panels. At the end of the dayshift all the new panels of HDPE were installed, and some patches were being placed.
- The second lift of ROQ was placed in the area behind the tank farm; this material was placed with the CAT 345 excavator.

**Photo 4:** Diversion Berm – View of replaced HDPE liner at approximately station 050 looking west towards the culverts through the Primary Road.

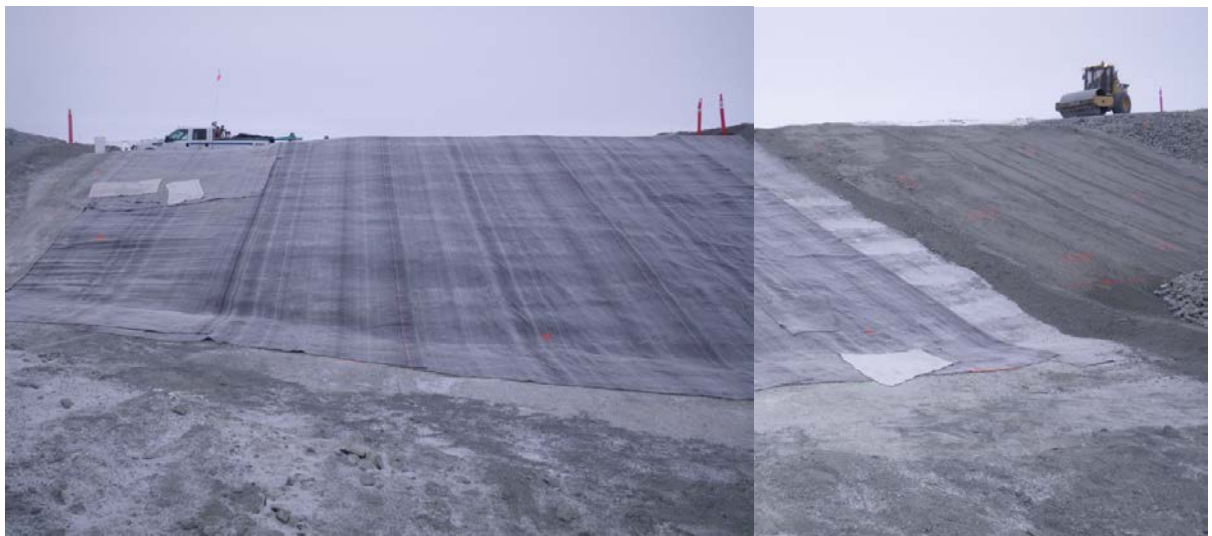
- Three additional panels of GCL were placed from station 0+60 to 0+45.
  - The third panel of GCL which contained the most overlap with the other panels was jointed on the slope. The joint occurred approximately 1 m from the crest (above the full supply level). An ~ 2 m overlap was used at this joint; however the bottom 1 m of this overlap (furthest from the joint) was of ripped/damaged liner from the outside of the roll.

- There were two holes in the first panel of liner installed; these holes are located near the bottom of the panel. Patches were applied over both holes.

**Photo 5:** GCL placed on slope of the remaining exposed core material. Photo looking north west.

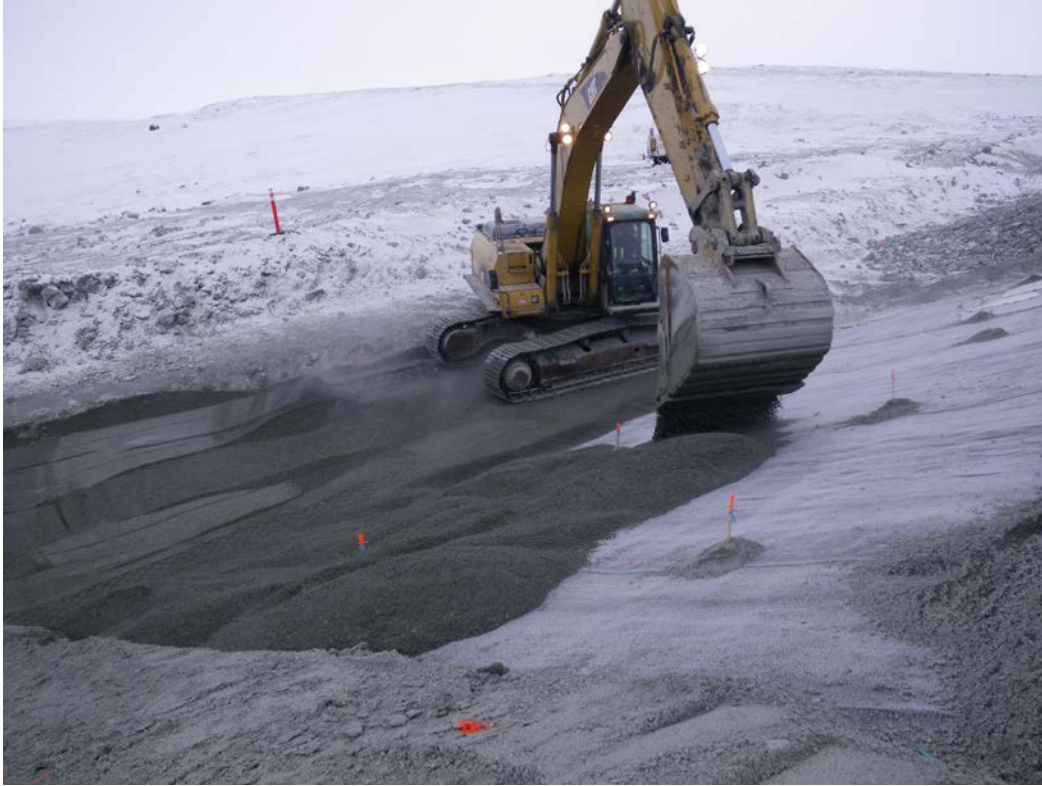
- GCL overliner material was placed over the GCL. This material was placed with CAT 330 excavator and compacted with the 10T roller.
  - During compaction of the slope some of the overliner material was pulled down the slope by the packer drum rounding the crest. The crest was built up with the excavator and the ~0.1 m to

0.2 m thick section of additional material was packed with the back of the excavator bucket.

**Photo 6:** North Dam – Excavator placing overliner material on slope.

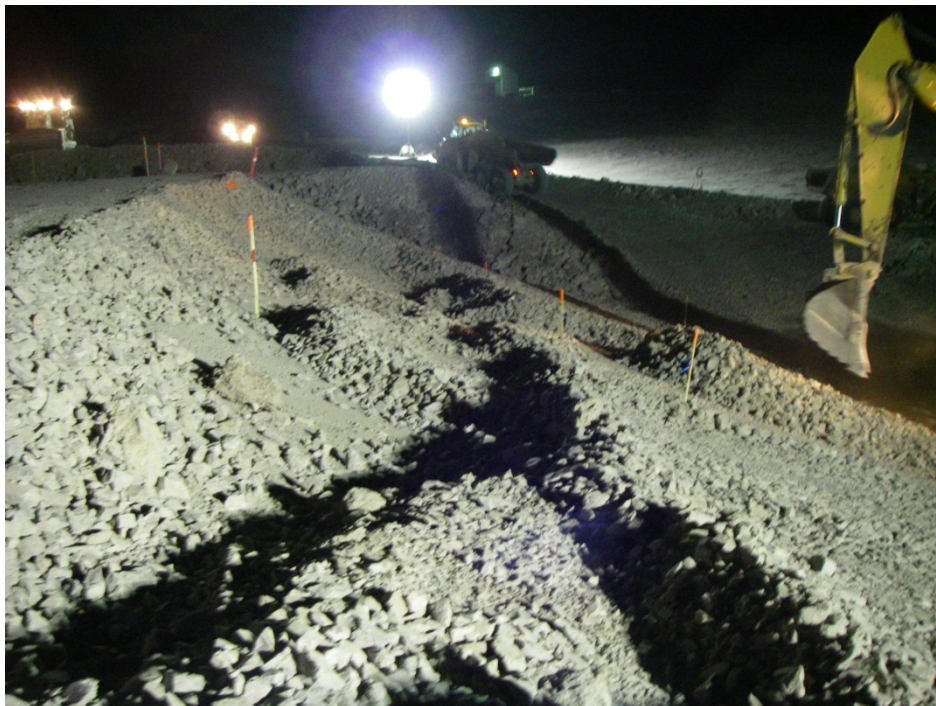
- Transition material was placed starting from the previously placed transition at Station 0+85. The material was placed in three lifts, each compacted, up to the elevation of 32.5 (approximately mid-slope). This was done to allow for proper compaction by vibrating up the slope and backing down on static mode, without the compactor's wheels spinning out.

**Photo 7:** North Dam – Progress photo of transition material placement. The three consecutive lifts are clearly visible. Photo looking north-east from Sta. 0+50.

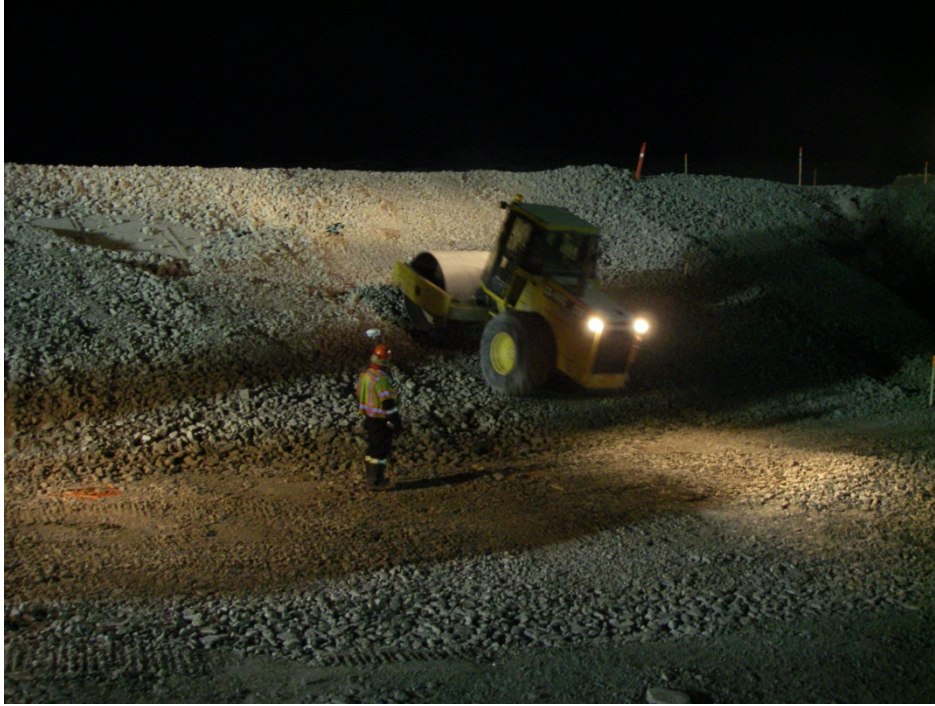
**Photo 9:** North Dam – compacting the second lift of transition material. Photo looking north-west from Sta. 0+60.

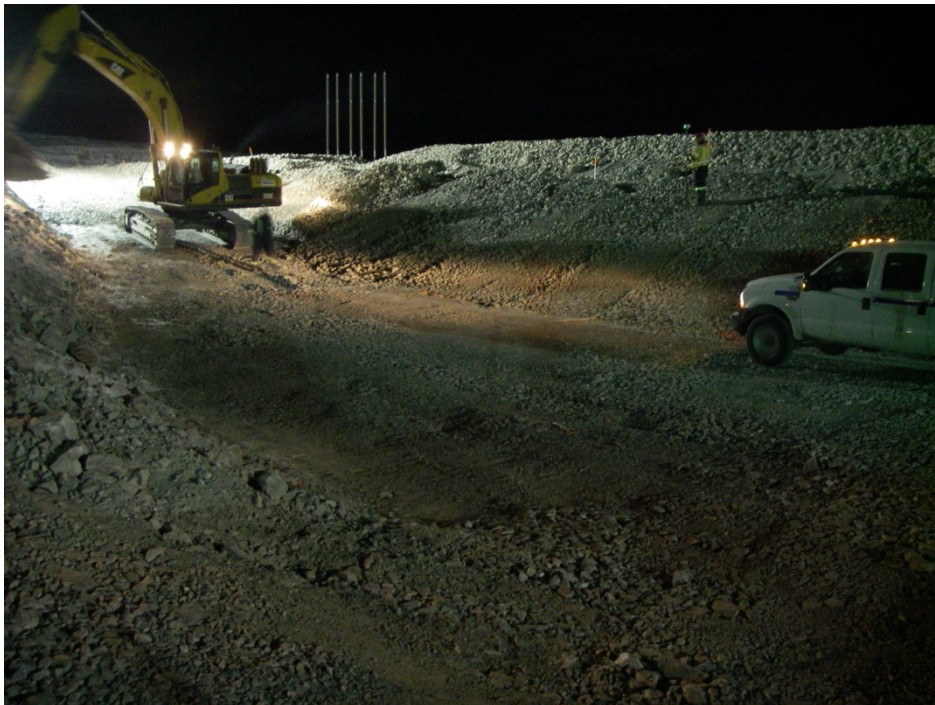
- The placed and compacted transition material was inspected with grade check support from the surveyor and was approved to be covered with ROQ from Station 0+60 to Station 0+85, up to elevation 32.5.

**Photo 10:** North Dam – finished transition material blanket up to elevation 32.5. Note the windrows perpendicular to the slope, indicating that further compaction is required. Photo looking west from Sta. 0+85.

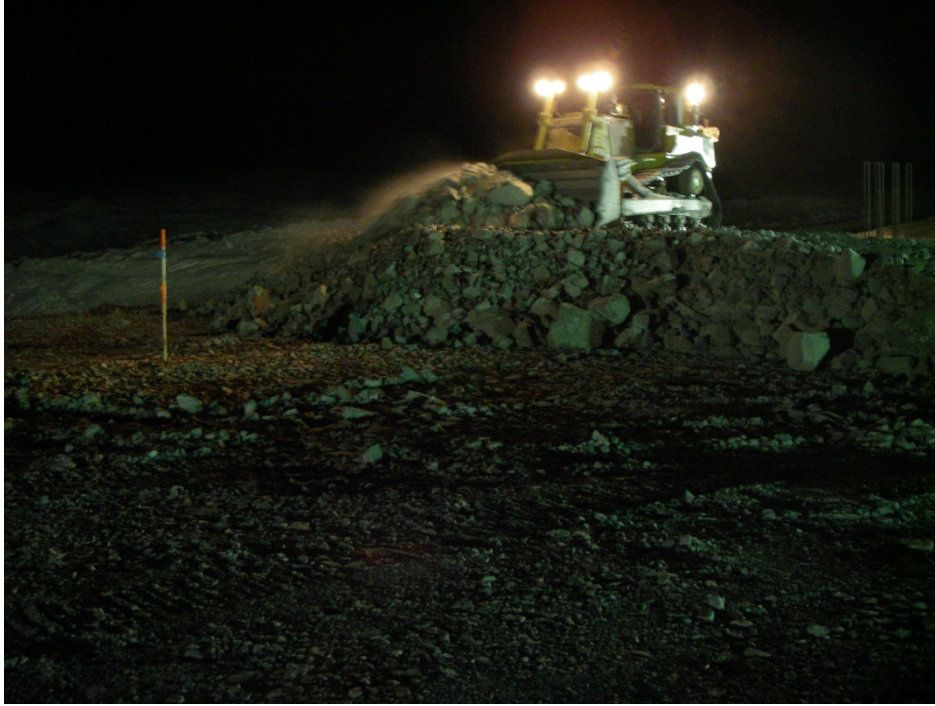
- Placement of the final lift of ROQ continued from Station 1+20 to about Station 1+15. No compaction was observed.
- Placement of the first lift of ROQ was started around Sta. 1+00, aiming to backfill the trench at the toe of the frozen core.

**Photo 11:** North Dam – progress photo of the final lift of ROQ. Photo looking north-west from Sta. 1+00.

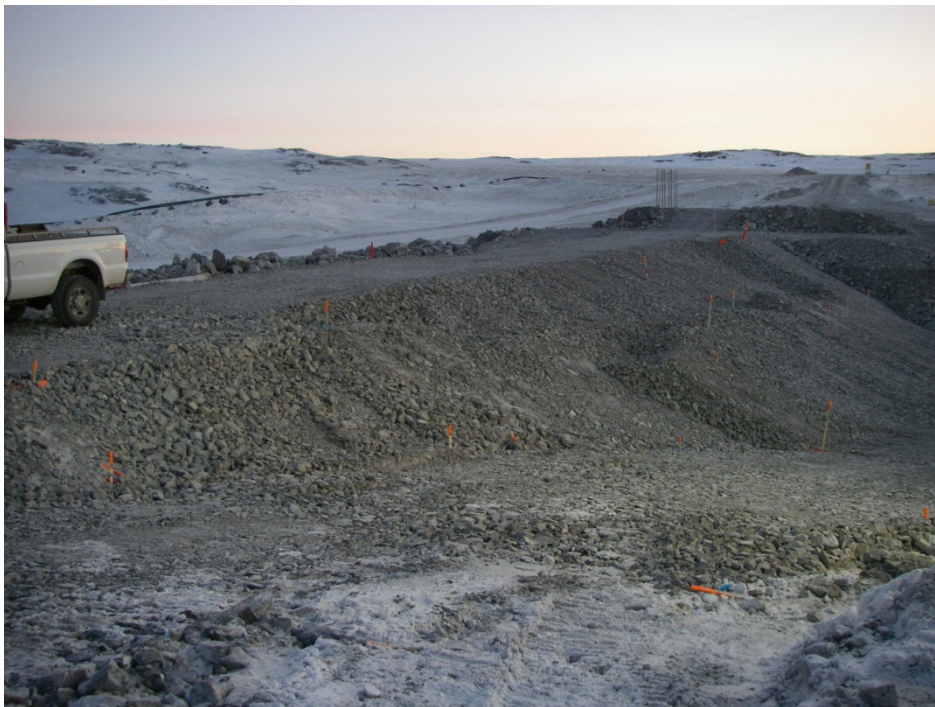
- ROQ material was placed on the upstream side of the core material in a third lift near station 0+90.
- Transition material was placed along the crest of the overliner material placed March 30, 2012 nightshift.
  - The lift of transition material along the crest was looking thick and the foreman was reminded that the maximum lift thickness for transition material is 0.5 m.

**Photo 12:** North Dam – completed transition on the crest of the dam. Photo looking north from Sta. 0+20.

- The thick lift of transition material on the crown of the frozen core was cut down by the excavator to less than 500 mm.

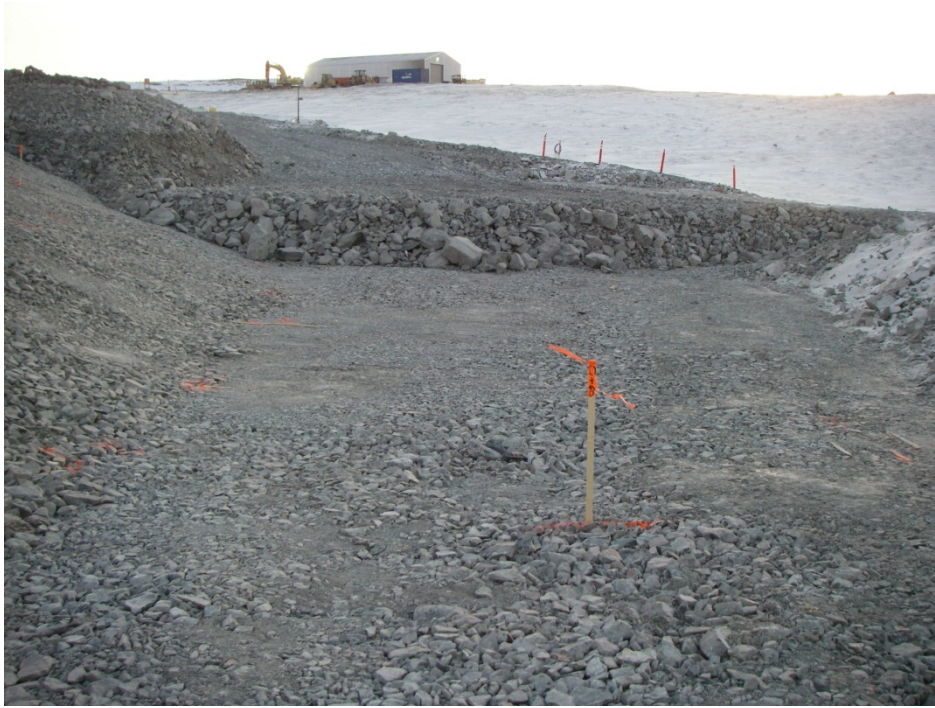
- The thick lift of ROQ to be placed at the toe of the core will create a new work surface at higher elevation, which will allow compaction further up the slope. An additional benefit of the ROQ being placed to fill in the existing trench is elimination of the snow trap in case the winds become stronger.

**Photo 13:** North Dam – progress photo of the first lift of ROQ at the toe of the core. The stake in the foreground is marking the extent of the area approved for covering with ROQ. Photo looking north-east from Sta. 0+55.
