DAILY REPORT #87 – DORIS NORTH INFRASTRUCTURE/ NORTH DAM

Prepared by:	Iozsef Miskolczi Megan Miller	Date:	2012.04.01
Reviewed by:		Project #:	1CH008.058.0320
Role	Company	Personnel – Position	On Site
Client	Hope Bay Mining Limited (HBML)	Angela Holzapfel – ESR Compliance Manager David Vokey – ESR Coordinator Don Ethelston – HSLP Advisor Dean Wold - Safety Jill Turk – ESR Coordinator Katsky Venter – ESR Manger Michelle Tanquay – ESR Site Manager Stirling Kelly – HSLP Advisor	No No No No Yes Yes No No
	JDS	Lloyd Jackson – Mechanical Superintendent Doug Fielding – Construction Manager Ishan Fechter – Construction Coordinator Jerry Graham – Construction Manager Kevin Whieldon – Project Coordinator Mark Valeriote – Construction Manager Calvin Goldschmidt – Construction Coordinator	No No No Yes No No Yes
Engineering Design Consultants	SRK Consulting (Canada) Inc.	John Kurylo – Site Engineer Megan Miller – Site Engineer Lawrence Borowski – Site Engineer Murray McGregor – Site Engineer Iozsef Miskolczi – Site Engineer Lowell Wade – Senior Engineer	No Yes No No Yes No

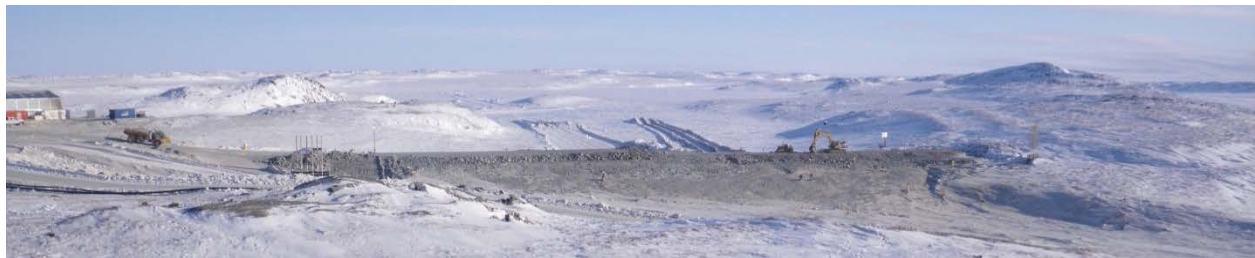
Photo 1: Progress photo of North Dam from photo point 1. Looking south west.

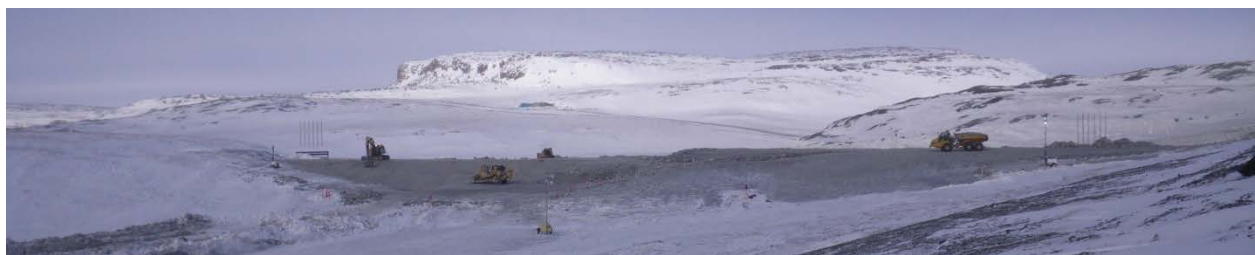
Photo 2: Progress photo of North Dam from photo point 2. Looking north west.

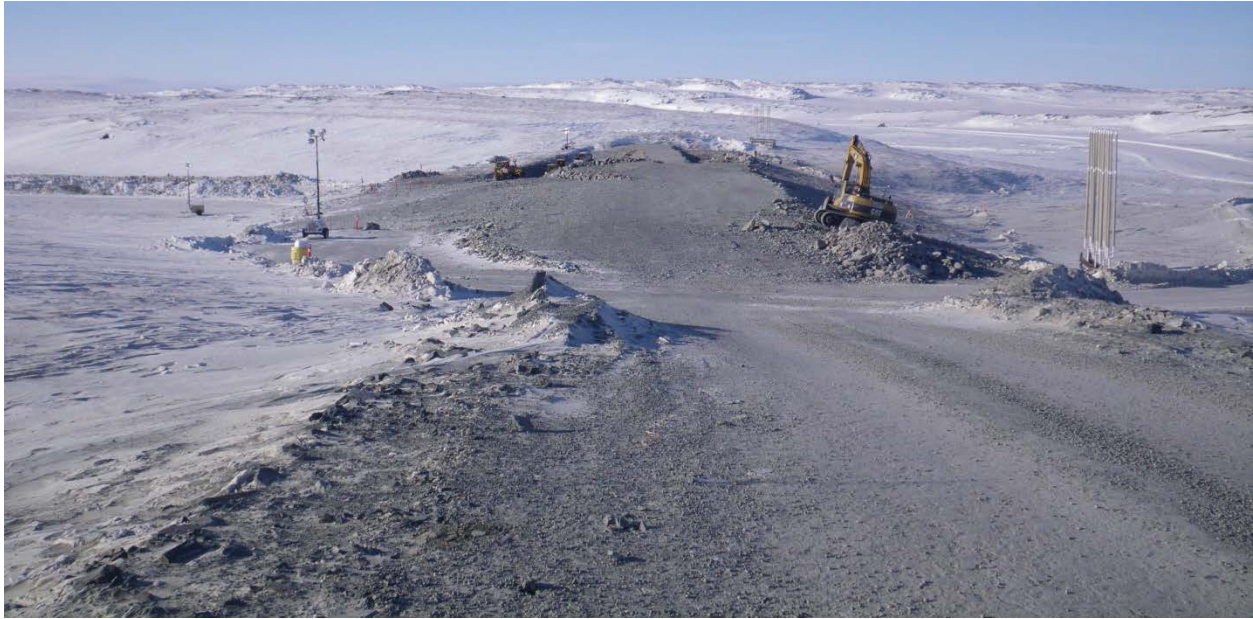
Photo 3: Progress photo of North Dam from road to FCP. Looking south west along dam alignment.

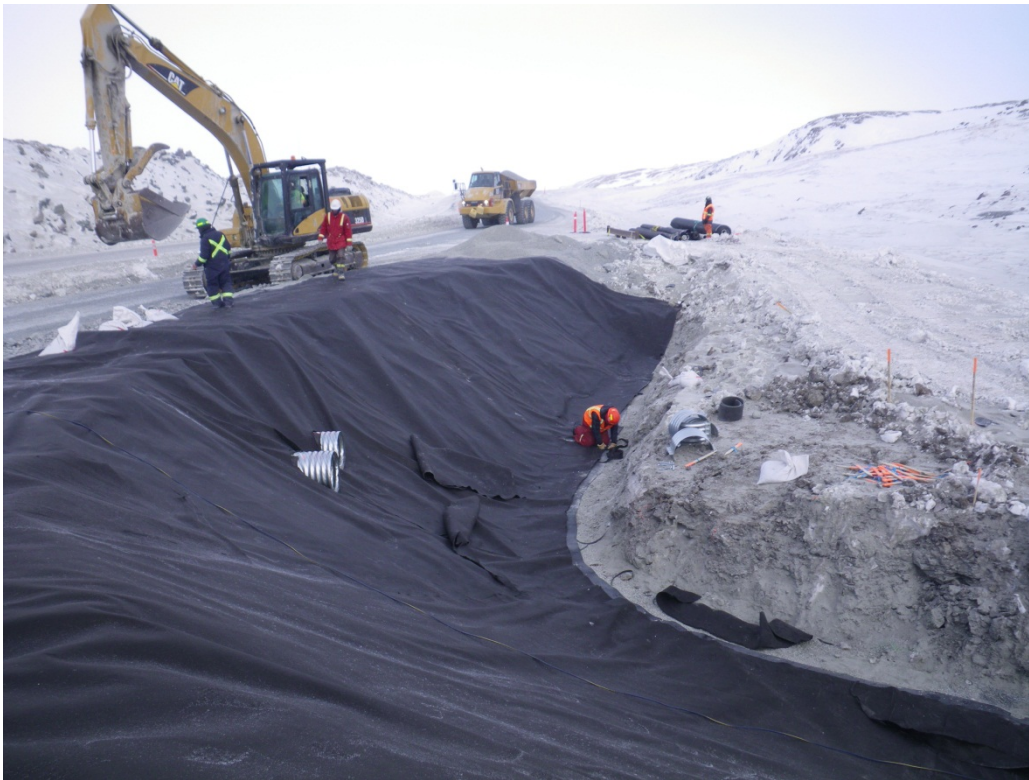
- Geotextile and bentonite 'plug' were placed from the edge of the area where the liner slid to the beginning of the berm alignment. Crush was put on the top of the berm for this section.
- ROQ 'bridges' (piles of ROQ along the slope) were placed to keep the liner from sliding down.
- Labourers started clearing snow from the section of the diversion berm which was blown in. The CAT 325 excavator assisted in removing snow.
- Destructive testing for the HDPE liner was witnessed for destructive test 2 and part of destructive test 5. Destructive test 3 and 4 were also performed but not witnessed by SRK.
- The bulk of the snow from the blown-in portion of the keytrench was removed on nightshift. Some more

Photo 4: Diversion Berm – View of geotextile placed in the corner near the start of the diversion berm alignment.

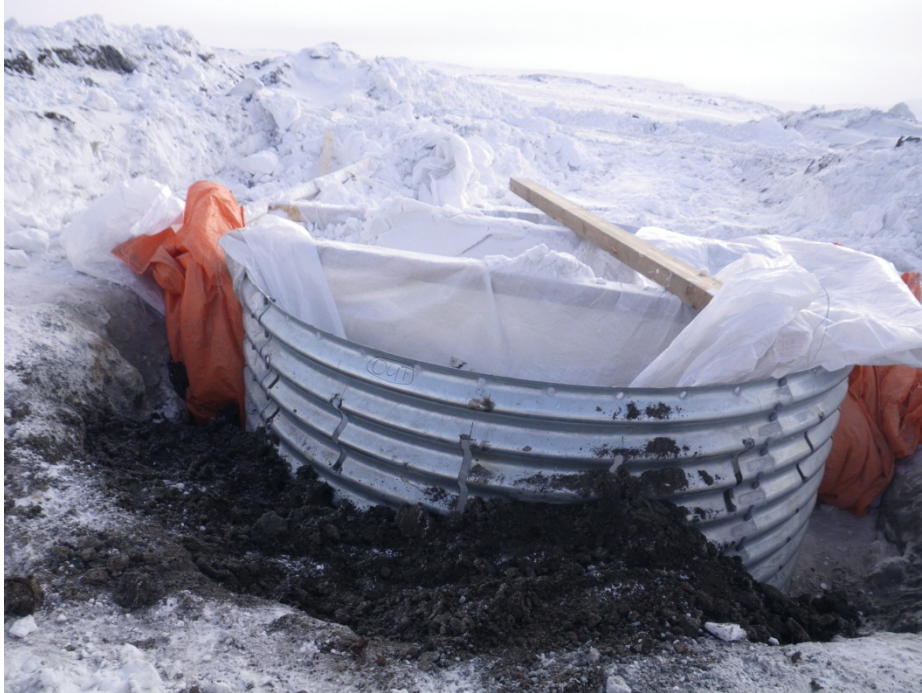
- Sump 1 was backfilled with overburden material; this material did not appear to be compacted.
- Sump 2 was partially backfilled with overburden material.

Photo 5: Sump – Overburden material in the annulus of sump 2.

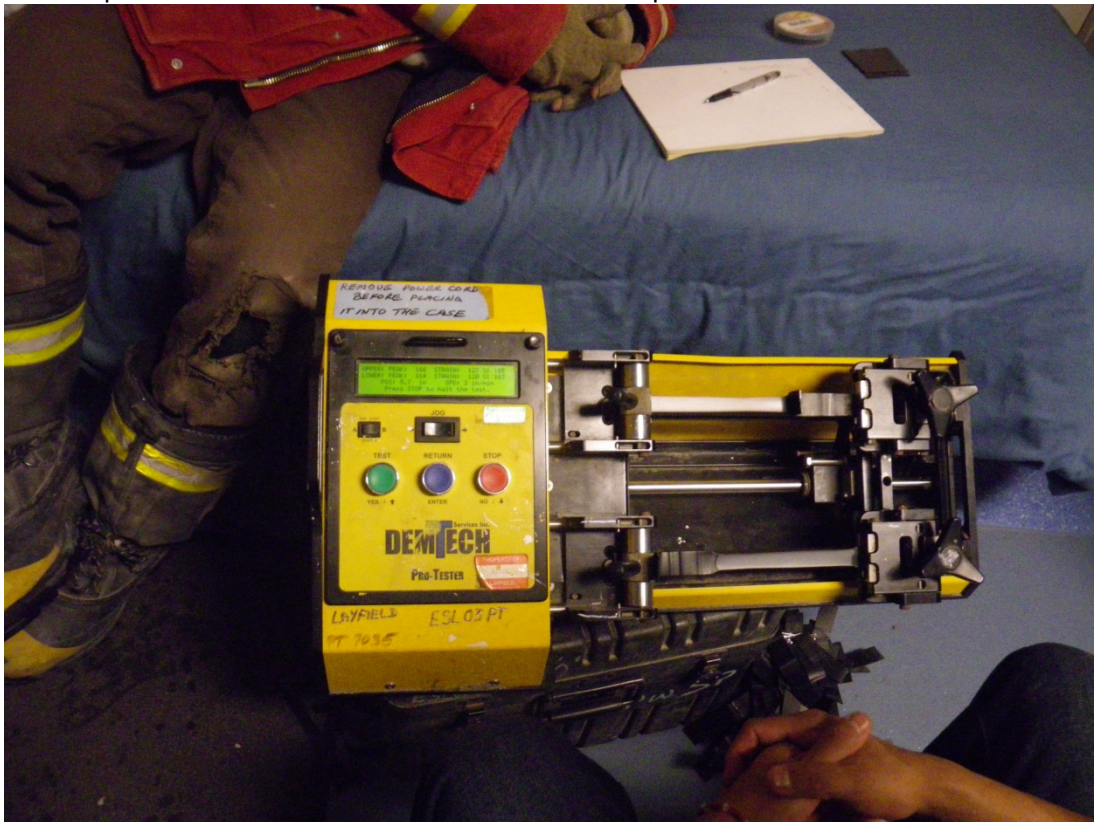
Photo 6: Diversion Berm – Witnessing destructive testing of HDPE liner for the diversion berm.

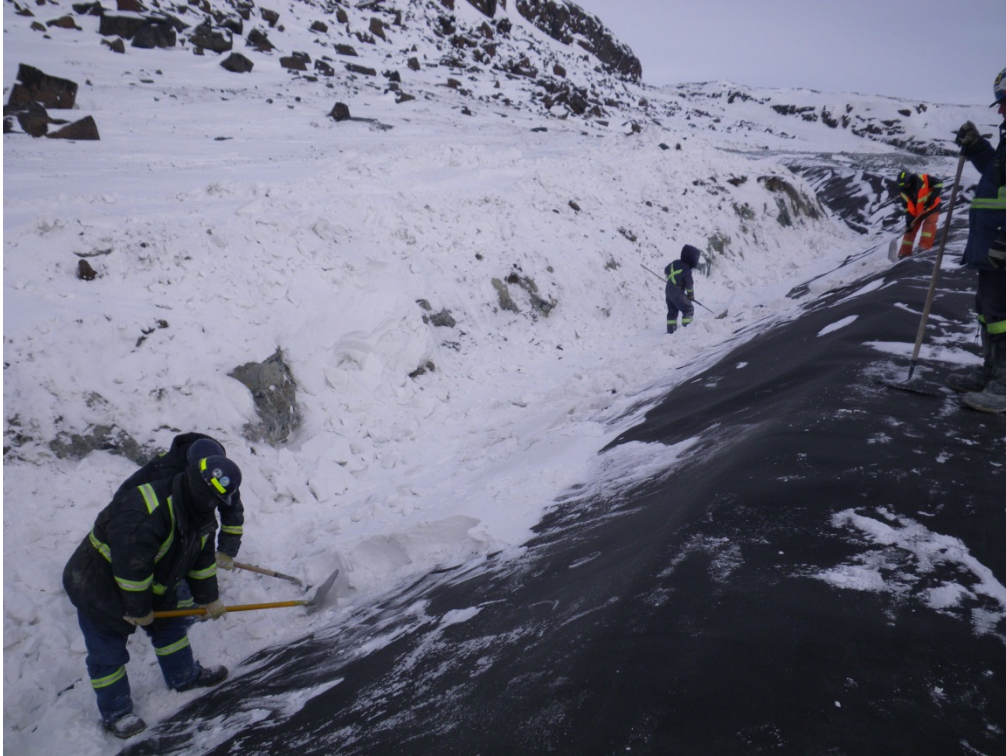
Photo 7: Diversion Berm – Labourers cleaning snow from the geotextile and liner.

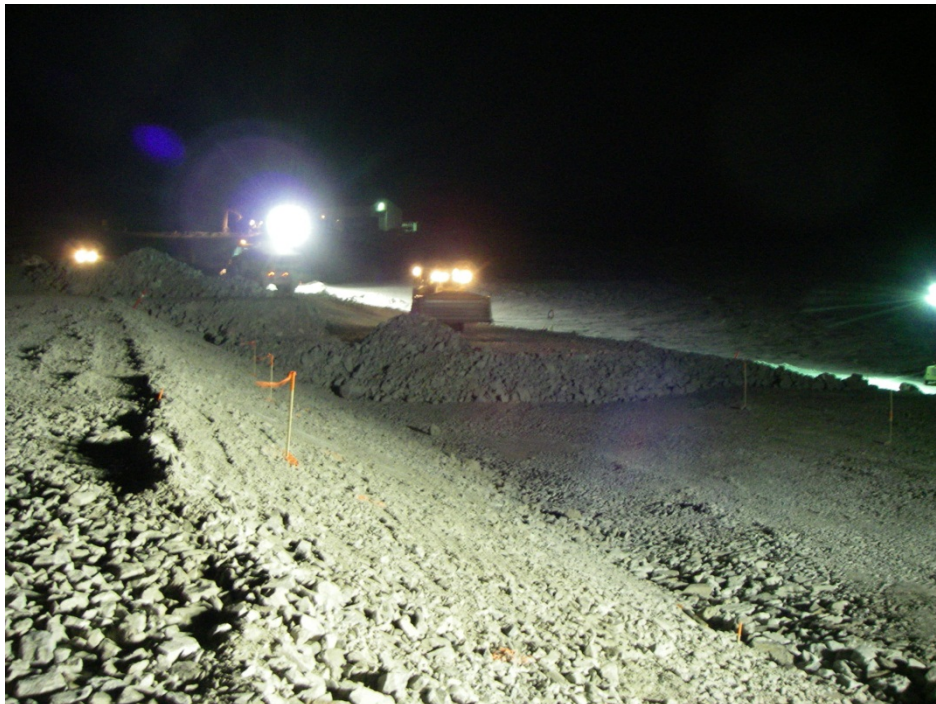
- Placement of the third lift of transition material was completed at the beginning of the nightshift.
 - The placed and partially compacted final lift was inspected, and in general it was found to be conforming to the specs for lift thickness. The final thickness was noted to be thinner by about 20 cm in one localised area. Additional transition material was placed in this area and compacted.
 - More compaction is required on the crest of the transition material.
- Transition material placement around the frozen core is now complete.
- The second lift of ROQ was placed in the upstream side, progressing south from Station 1+00. Lift thickness was 1.8 m; ROQ quality was good, with no oversize.

Photo 9: North Dam – progress photo of ROQ placement. Photo looking north-west from Sta. 0+60.

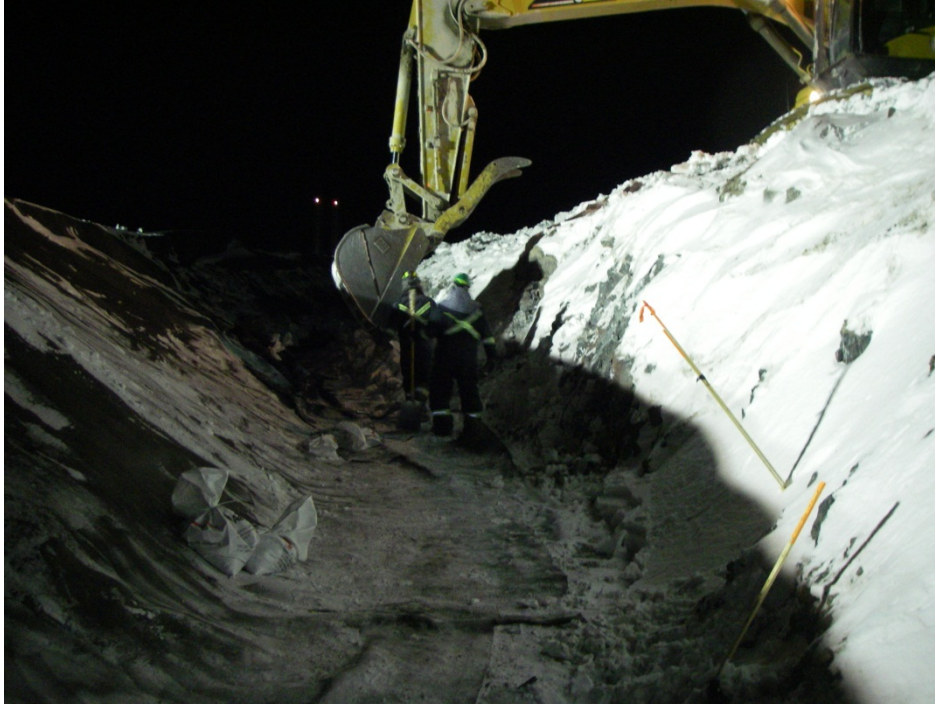
detailed cleaning will be required before the bentonite plug can be completed.

Photo 10: Diversion Berm – workers clearing the snow drifts from the keytrench with support from an excavator. Photo looking west from Sta. 0+520.
