DAILY REPORT #88 – DORIS NORTH INFRASTRUCTURE/ NORTH DAM

Prepared by:	lozsef Miskolczi Megan Miller	Date:	2012.04.02
Reviewed by:		Project #:	1CH008.058.0320
Role	Company	Personnel – Position	On Site
Client	Hope Bay Mining Limited (HBML)	Angela Holzapfel – ESR Compliance Manager David Vokey – ESR Coordinator Don Ethelston – HSLP Advisor Dean Wold - Safety Jill Turk – ESR Coordinator Katsky Venter – ESR Manger Michelle Tanquay – ESR Site Manager Stirling Kelly – HSLP Advisor	No No No No Yes Yes No Yes
	JDS	Lloyd Jackson – Mechanical Superintendent Doug Fielding – Construction Manager Ishan Fechter – Construction Coordinator Jerry Graham – Construction Manager Kevin Whieldon – Project Coordinator Mark Valeriote – Construction Manager Calvin Goldschmidt – Construction Coordinator	No No No Yes No In Yes
Engineering Design Consultants	SRK Consulting (Canada) Inc.	John Kurylo – Site Engineer Megan Miller – Site Engineer Lawrence Borowski – Site Engineer Murray McGregor – Site Engineer lozsef Miskolczi – Site Engineer Lowell Wade – Senior Engineer	No Yes No No Yes No

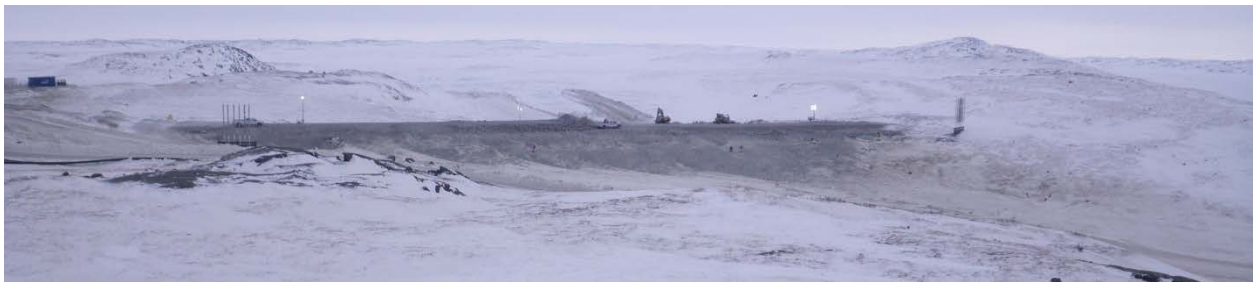
Photo 1: Progress photo of North Dam from photo point 1. Looking south west.

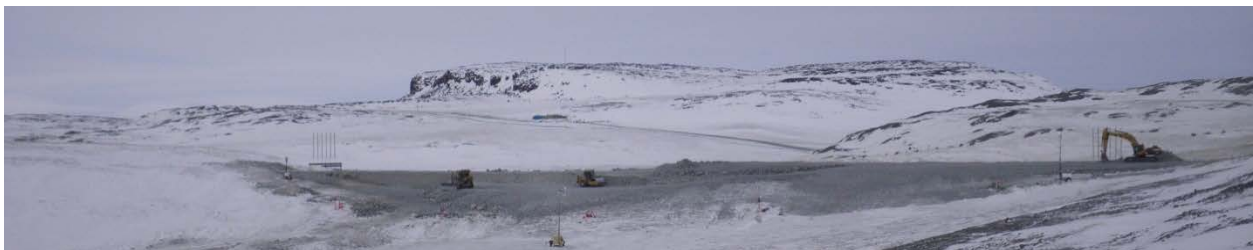
Photo 2: Progress photo of North Dam from photo point 2. Looking north west.

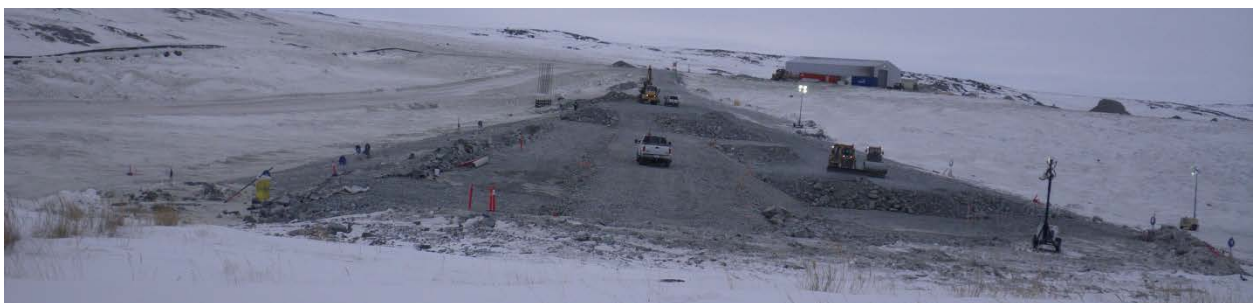
Photo 3: Progress photo of North Dam from photo point 3. Looking north east along dam alignment.

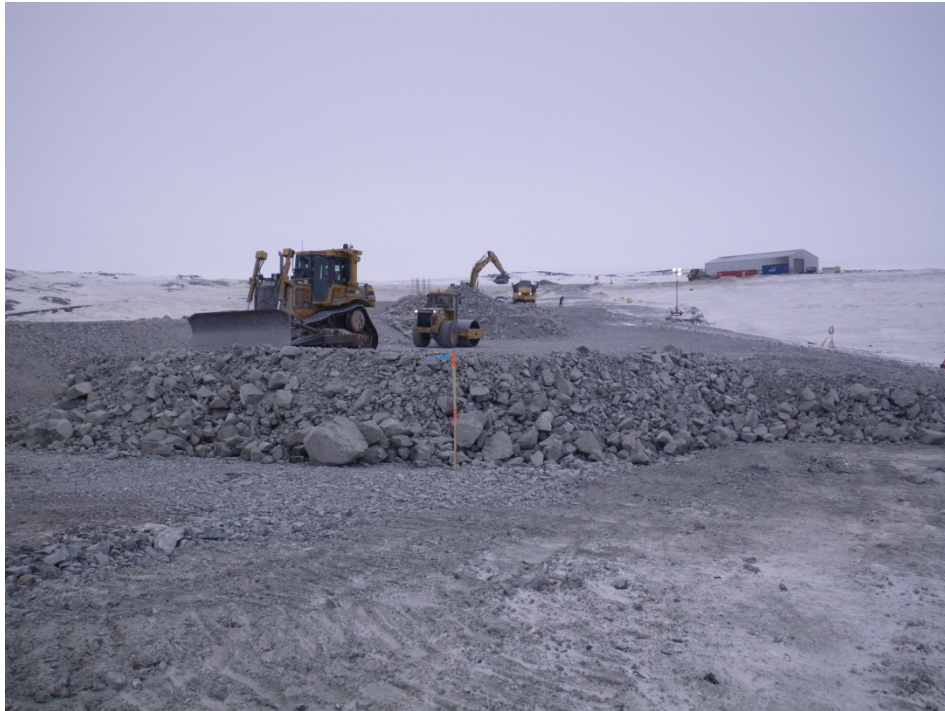
- ROQ placement continued in a second lift above the transition material from station 0+85 southwards on the upstream side of the core. The ROQ was placed with the CAT D6 dozer and compacted as placement occurred with the 10T vibratory roller. The dozer shaped the upstream slope while advancing forward.
- The CAT 330 excavator sloped the final lift of ROQ on the downstream side from approximately 1+75 to 1+50. Excess material from this sloping was hauled to the dozer and incorporated into that fill.
- The CAT 330 excavator was used to remove compacted snow from the portion of the dam fill used as an access road during core construction on the upstream side of the dam.

Photo 4: North Dam – View of progress on north dam. Dozer placing second lift of ROQ material over transition on upstream side of dam.

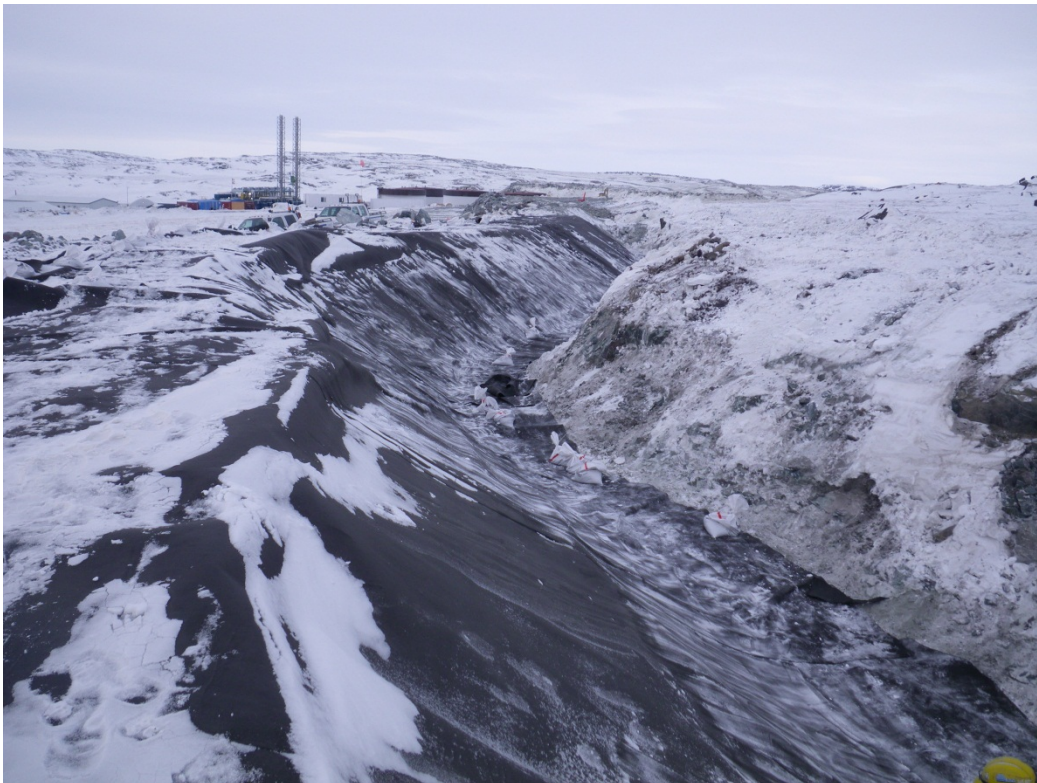
Photo 5: Diversion Berm – View of diversion berm area after snow clearing, photo looking east.

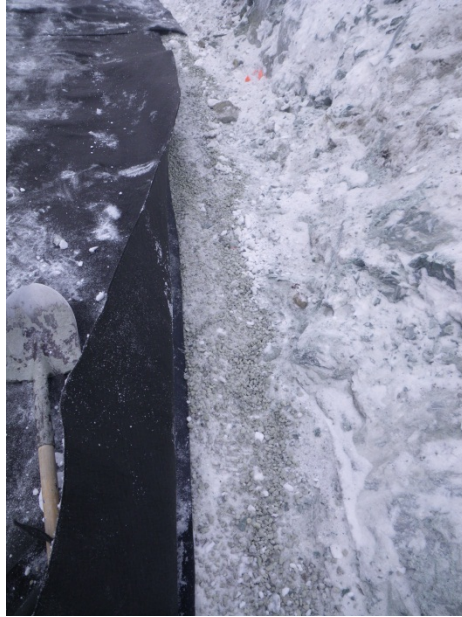
- Laborers continued to clean snow from the blown in section of the diversion berm in the morning.
- The edge of the liner along the bottom bentonite was examined; a few small tears along the edge of the HDPE and one small hole were noticed. As all of this was at the bottom of the berm where the HDPE was lying on the bentonite it was decided that additional welding was not need, as long as the bentonite 'plug' was extended such that it covered ~0.1 m beyond these areas.
- The bentonite 'plug' and ¾" crush overliner material were placed in this area and placement of the first lift of ROQ was started.
- ¾" crush material and the first lift of ROQ were placed from approximately station 000 to 050.

Photo 6: Diversion Berm – Closer view of bottom bentonite after snow cleaning.

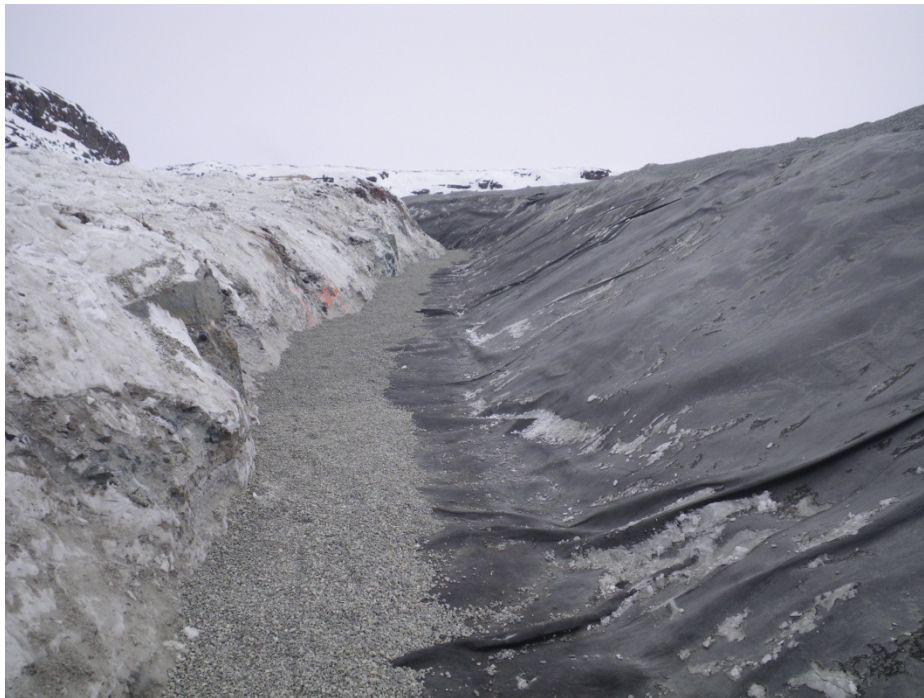
Photo 7: Diversion Berm – Bentonite plug placed in bottom of diversion berm. Photo looking east.

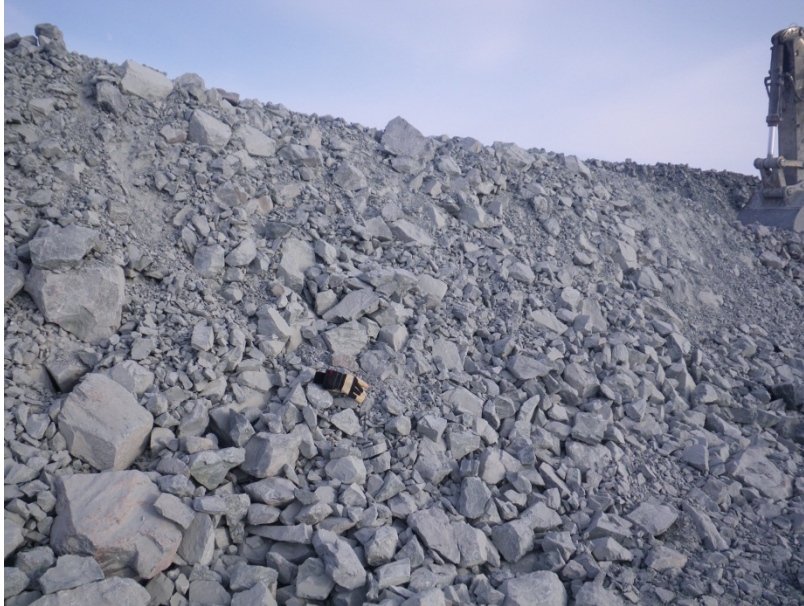
- The CAT 385 excavator loaded ROQ material from the middle bench and the CAT 980 loader loaded ROQ and crush from the floor of the Quarry.
- The ROQ from the blast April 1, 2012 was examined. The ROQ is of good quality with lots of fines and not very many pieces of big rock.

Photo 8: Quarry 2 – ROQ material from blast April 1, 2012. Very fine ROQ material with lots of fines.

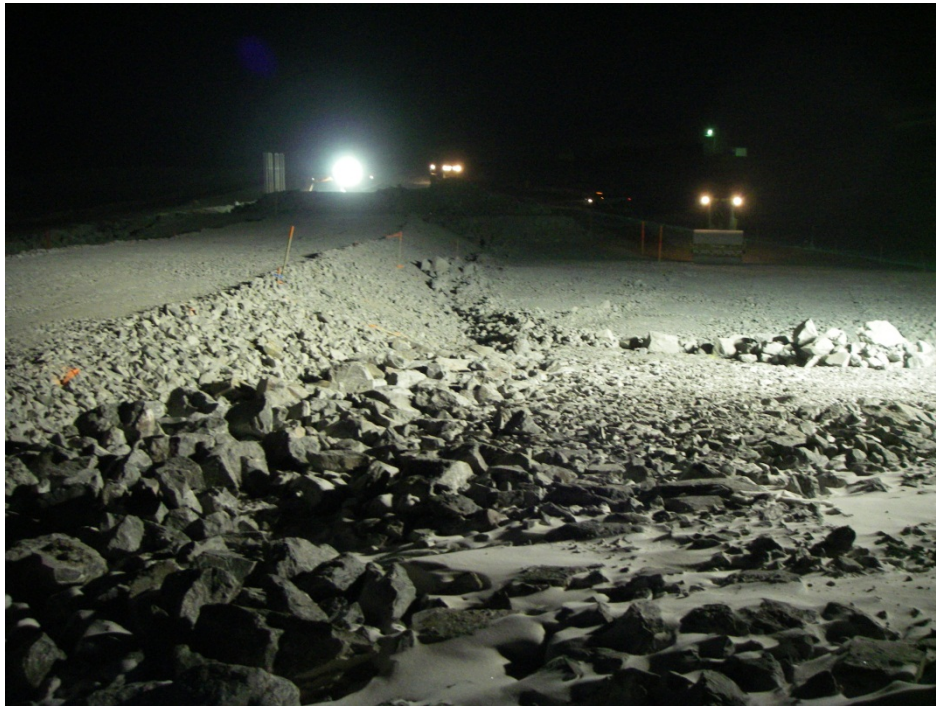
- The second lift of ROQ placed previously was compacted using the 10 tonne compactor in vibration mode.
 - A rubble zone consisting of boulder size rocks and virtually no fines was noted at the interface between the second lift of ROQ and the transition material, near the south end of the placed ROQ. This zone is not very thick, essentially one layer of rocks.

Photo 9: North Dam – rubble zone near the south end of the dam. Photo looking north from Sta. 0+30

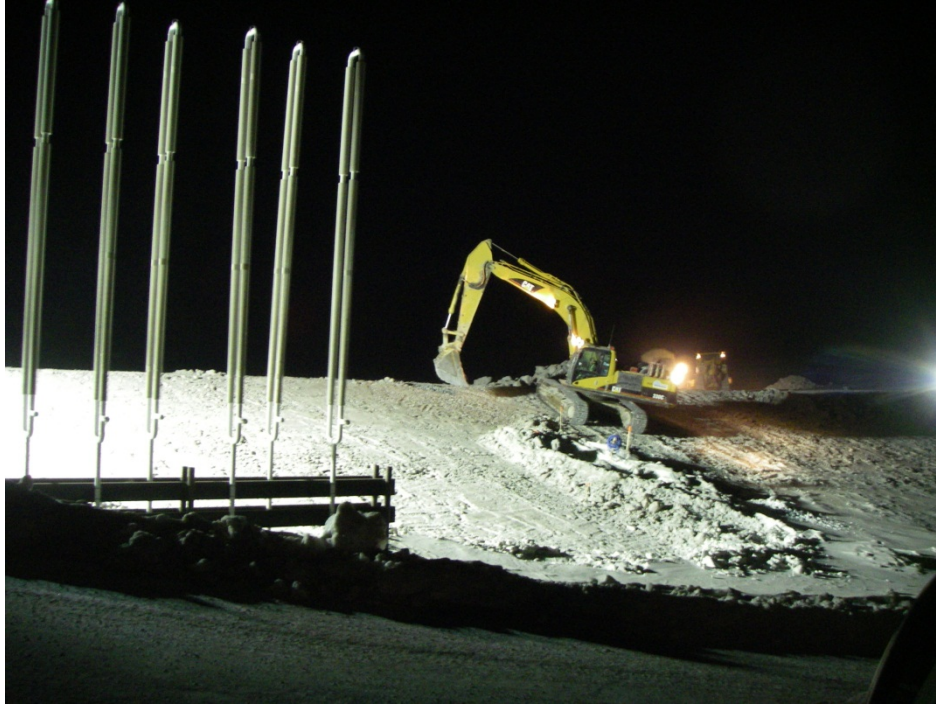
- Finishing of the 4H:1V slope on the upstream side was continued, reaching Station 1+45.
 - A wide swath of snow and rock was left around the thermistor cables at Station 1+75.

Photo 10: North Dam – excavator sloping and finishing the downstream face around Sta. 1+75. Photo taken from ice road, looking south

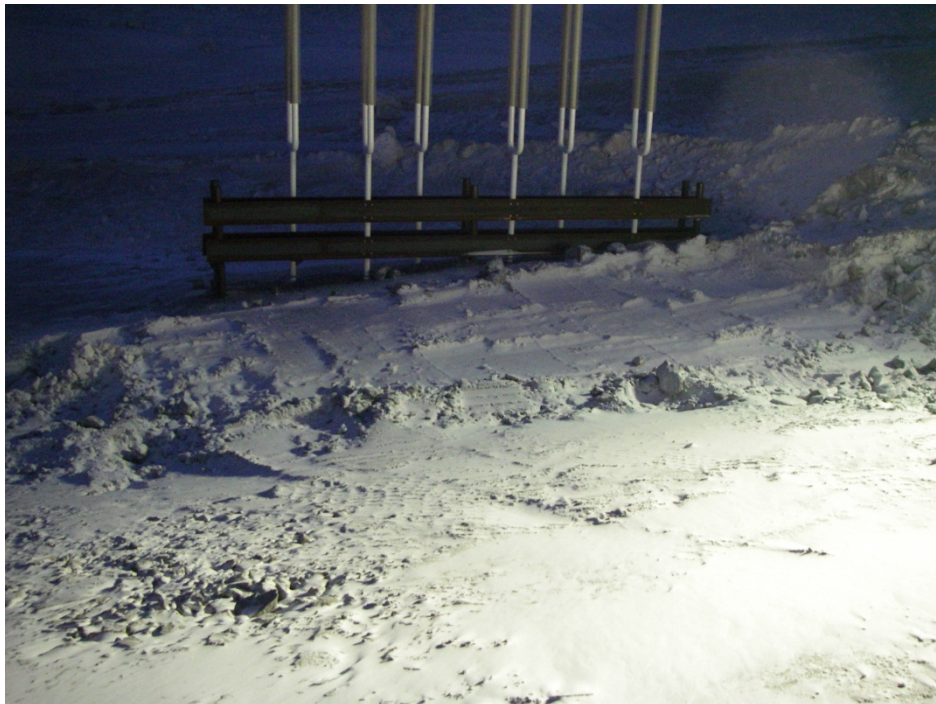
Photo 11: North Dam – snow cleared and crush surface levelled near the north thermosyphon radiators. Photo looking west.

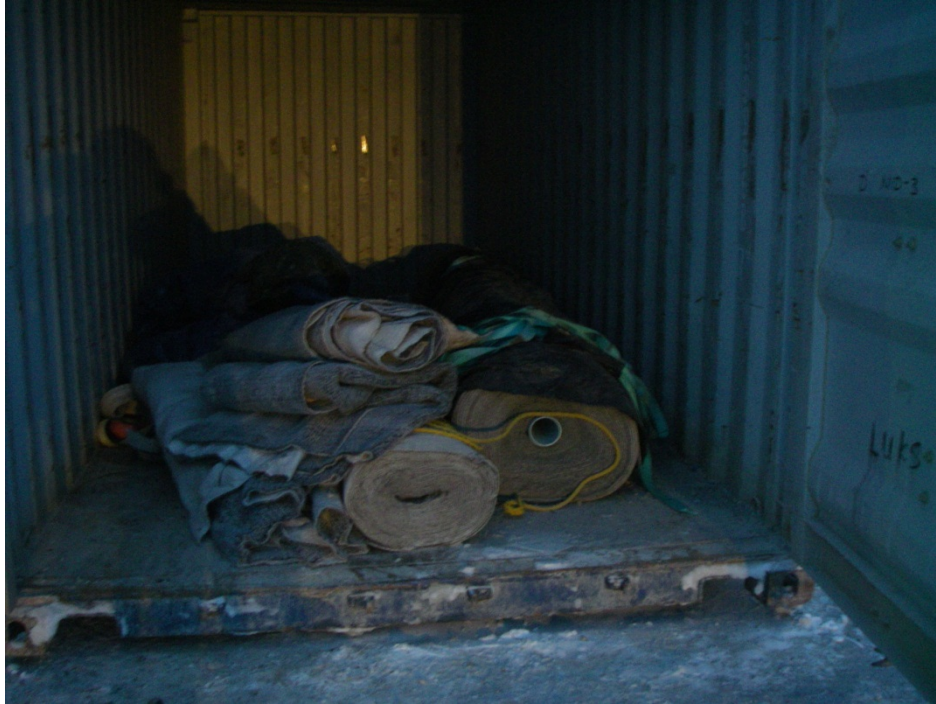
- Cleanup of the leftover GCL liner and the installation implements was done. The remaining GCL was stored in a seacan container at the south-west corner of the FCP.

Photo 12: North Dam – remaining rolls and scraps of GCL liner left at the dam were placed in a seacan container at the FCP.

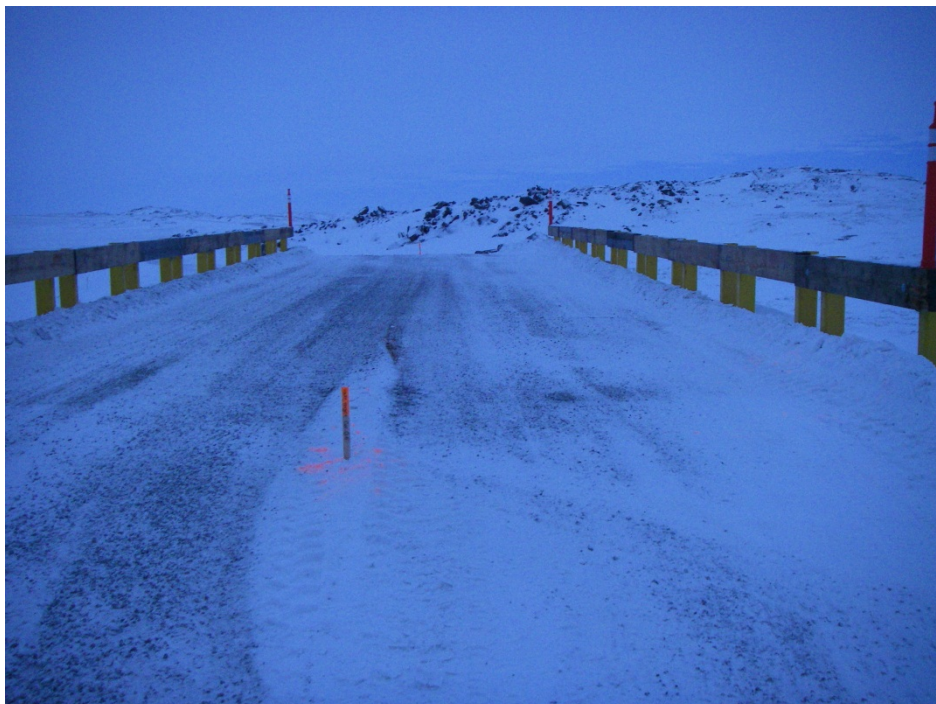
Photo 13: Location of thermistor strings was marked with stakes on the abutments of Bridge #4. Photo looking south.

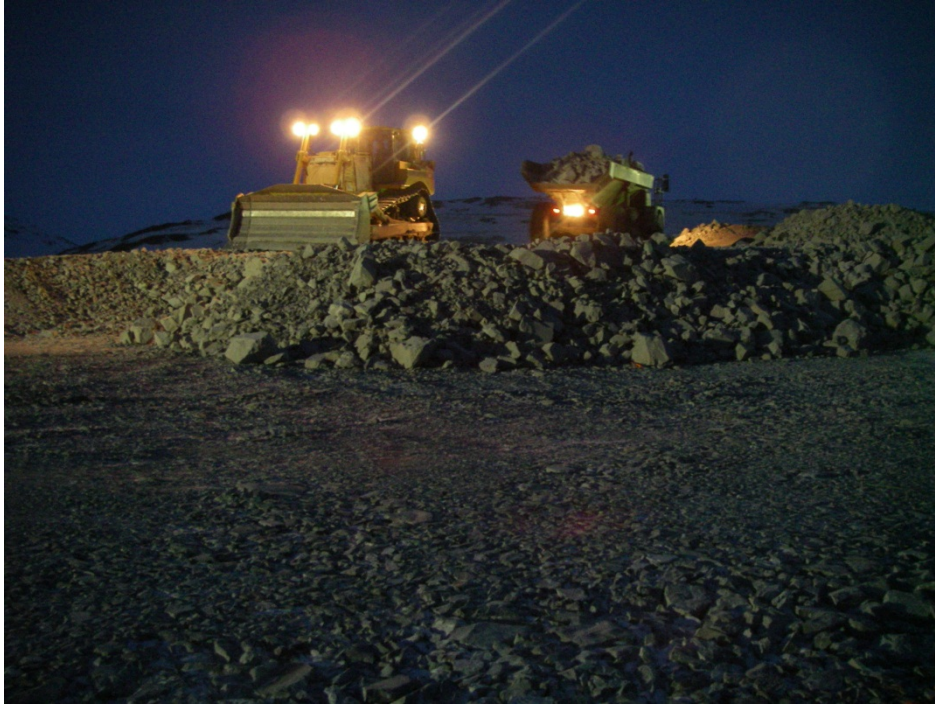
- Placement of ROQ continued. A third lift of ROQ was started around Station 1+30, progressing south to about Station 0+80. This lift is final on the upstream slopes, but it ends flush with the transition material on the centerline side.

Photo 14: North Dam – progress photo of ROQ placement. Photo looking west from Sta. 0+80.
