## DAILY REPORT #93 – DORIS NORTH INFRASTRUCTURE/ NORTH DAM

Prepared by:	Lawrence Borowski Iozsef Miskolczi	Date:	2012.04.07
Reviewed by:		Project #:	1CH008.058.0320
Role	Company	Personnel – Position	On Site
Client	Hope Bay Mining Limited (HBML)	Angela Holzapfel – ESR Compliance Manager David Vokey – ESR Coordinator Dean Wold - Safety Jill Turk – ESR Coordinator Katsky Venter – ESR Manger Michelle Tanquay – ESR Site Manager Stirling Kelly – HSLP Advisor	No Yes Yes No No Yes No
	JDS	Doug Fielding – Construction Manager Ishan Fechter – Construction Coordinator Jerry Graham – Construction Manager Mark Valeriote – Construction Manager Calvin Goldschmidt – Construction Coordinator	No Yes Yes Yes No
Engineering Design Consultants	SRK Consulting (Canada) Inc.	Megan Miller – Site Engineer Lawrence Borowski – Site Engineer Iozsef Miskolczi – Site Engineer	No Yes Yes
Earthworks Contractor	Nuna Logistics	Benny Vostermans – Foreman (Day Shift) Doug Haverland – Area Superintendent Gary Sodhi – Field Engineer Georges Cornelissen – Survey Manager Jeff Roberts - Surveyor Jim Cardinal – Foreman Jordan Gunter – Foreman (Day Shift) Kyle Kuntz – Project Engineer Margaret Caley – Surveyor Mike MacMast

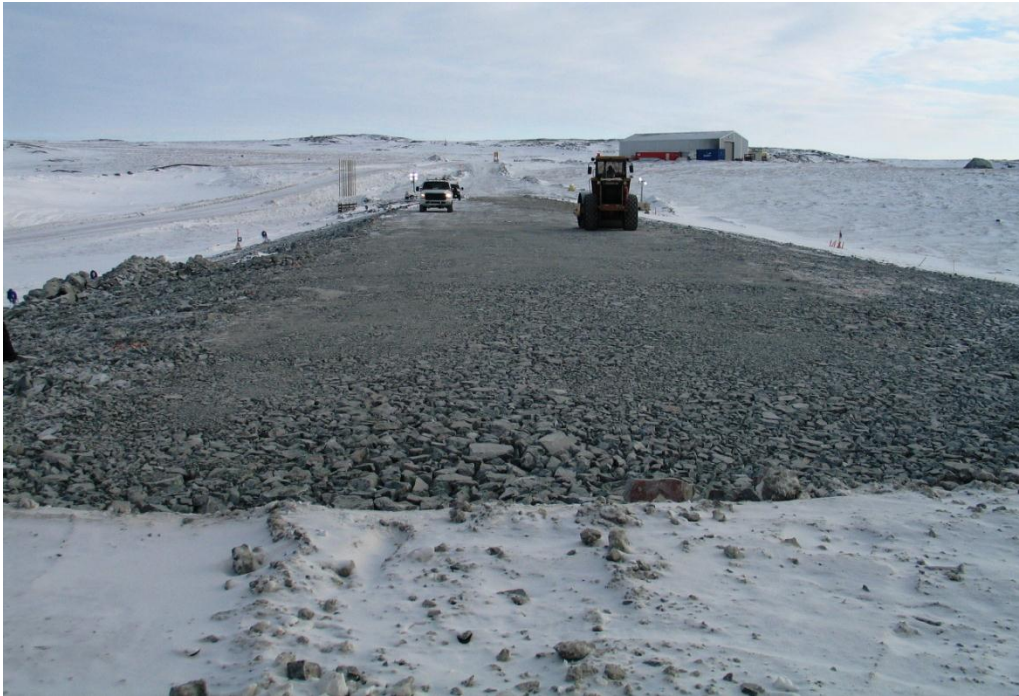
- An inspection of works completed on April 6<sup>th</sup> revealed that the section between station 0+20 and 0+40 is still low, by amounts up to 0.5m at the extreme south end.
- The 10 ton packer worked on the ROQ placed yesterday and the transition material placed during night shift.
- No activity on side slopes between Sta 0+20 and 0+40.

**Photo 1:** Progress photo of North Dam facing north. Photo shows ROQ placed April 6<sup>th</sup>. 10 ton packer is starting to pack.

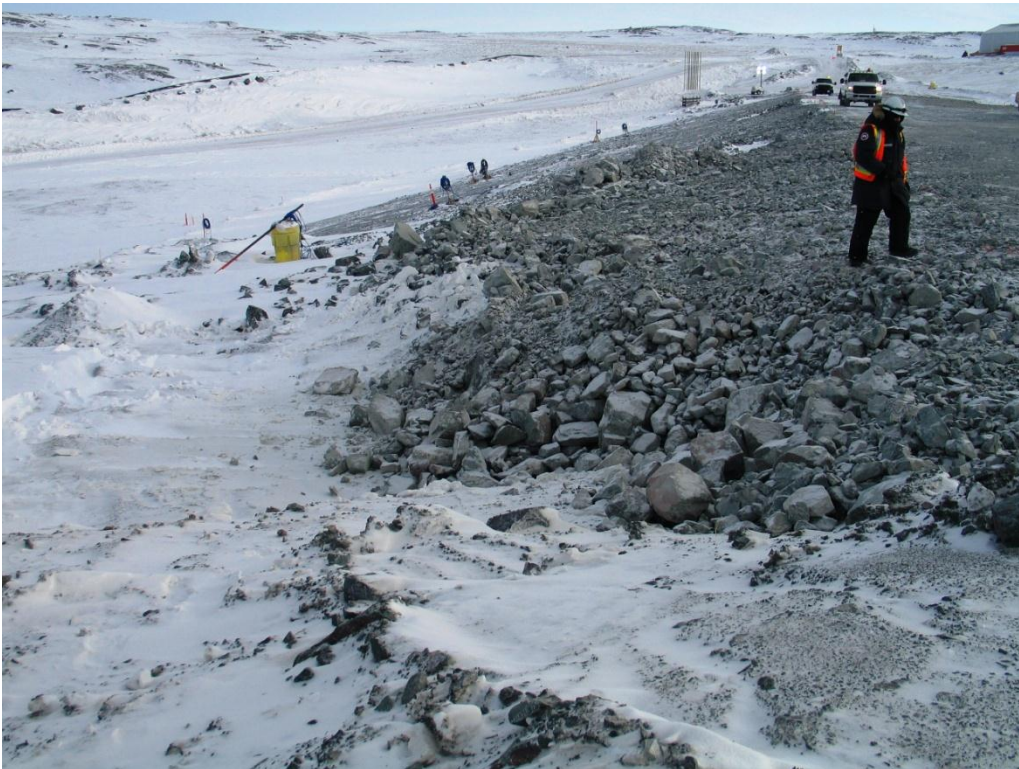
**Photo 2:** Downstream slope between Sta 0+20 and 0+40 still needs to be graded and packed.

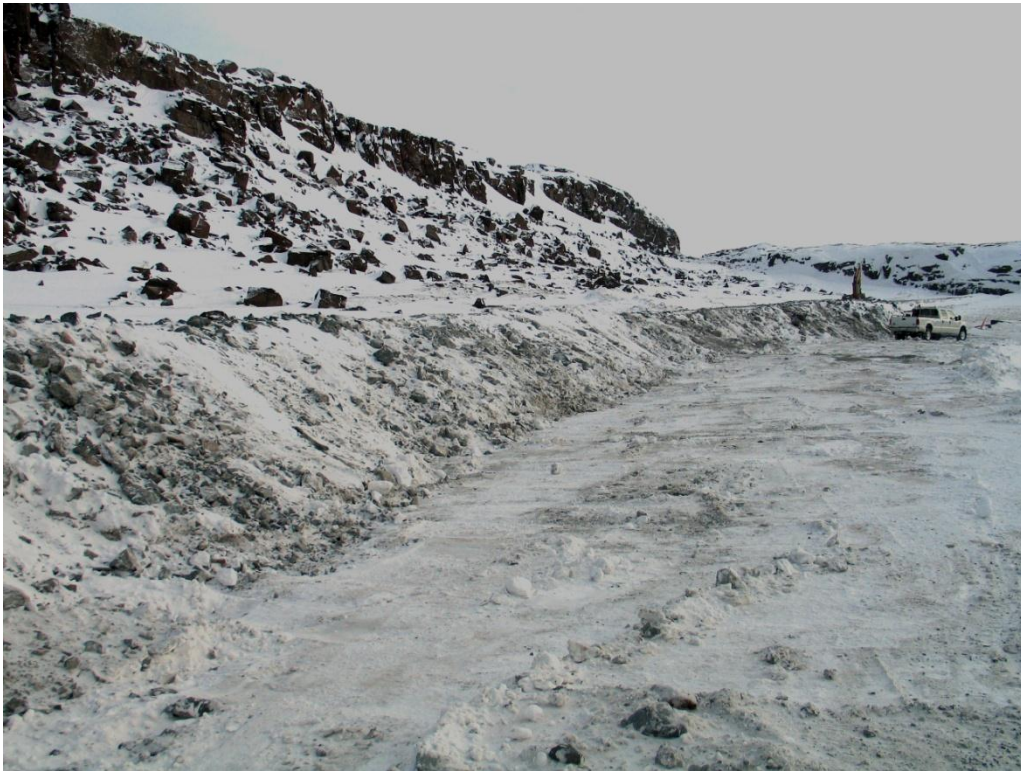
- Snow clearing on the south face of the berm was completed during the day shift. This will permit backsloping on the berm to commence.
- Snow clearing from the key trench commenced about mid afternoon. Approx. 100 meters were cleared from Sta 4+50 to Sta 5+50. Section was approved for placing final ROQ..

**Photo 3:** Snow was cleared from the south side of the North Diversion Berm from ~ Sta 1+50 to Sta 5+50

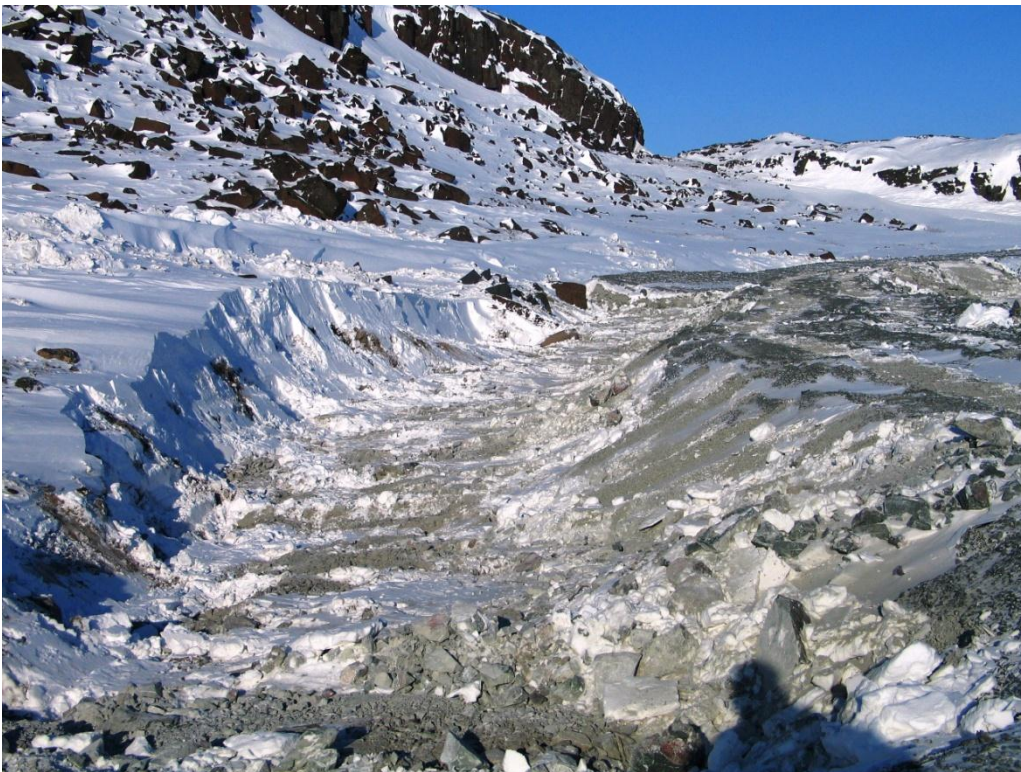
**Photo 4:** Snow cleared from ~ Sta 4+50 to Sta 5+50. Section approved for second lift ROQ.

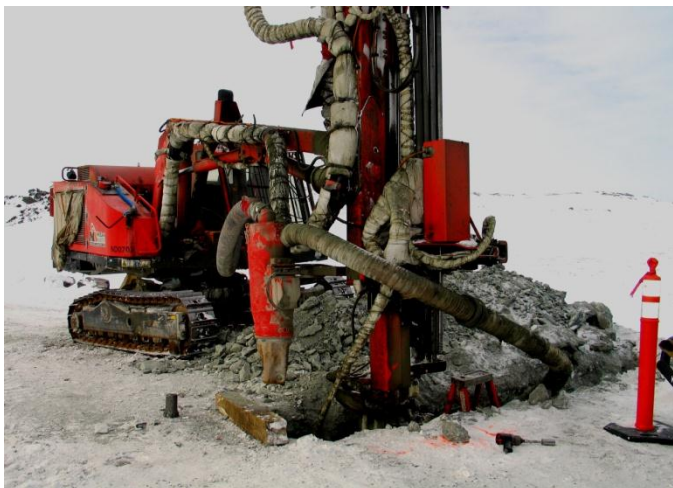
- Hole was drilled to a depth of 10 meters below the bottom of the cable trench.
  - Hole was measured. The cable was then measured, and marked at the 9.4 m mark. This was the distance from bottom of the cable trench to the lowest bead.

**Photo 5:** Drilling for thermister SRK –DWB5

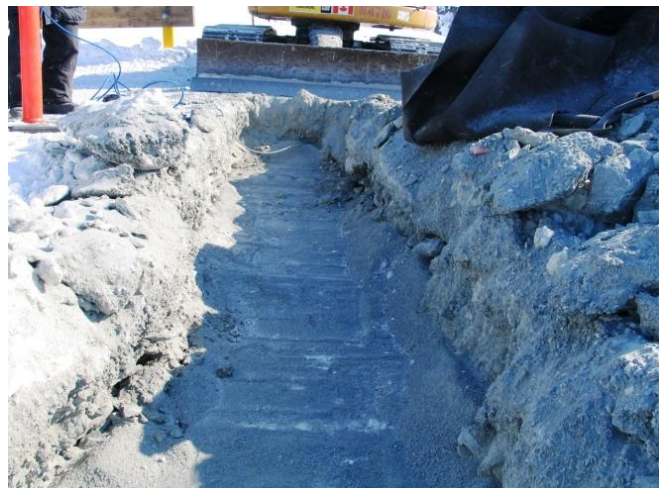
- A piece of rebar was strapped to the end of the thermistor cable and the cable lowered. The hole was then backfilled with fine core material.
  - A bedding lift of fine core material was placed in the cable trench, and packed with the bucket.

**Photo 6:** Bedding for cables...core material

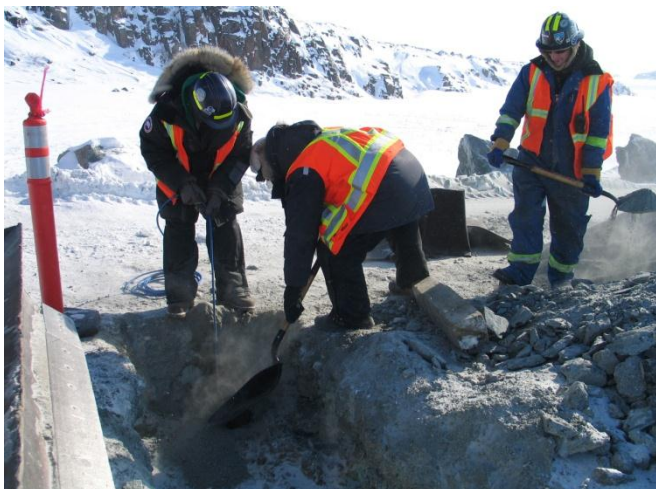
**Photo 7:** Backfilling hole.

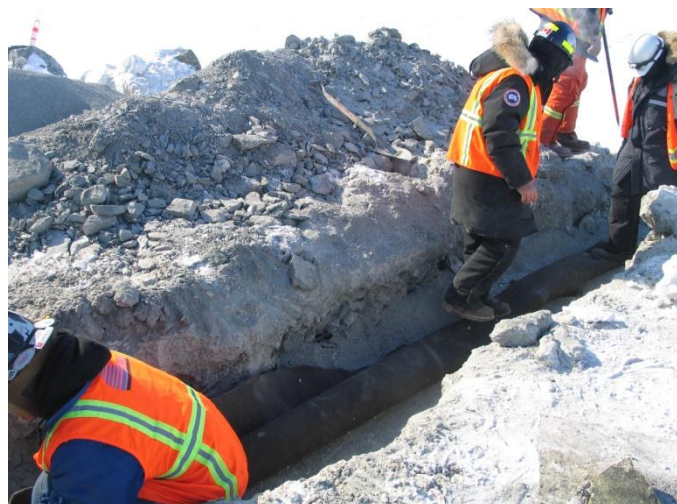
- The thermistor cable was wrapped with geotextile and placed in the cable trench. Location was surveyed.
  - The final backfill of the cable trench consisted of a layer of fine core material followed by a thin layer (~0.15m) of select ROQ, capped with fine core material.

**Photo 8:** Wrapping cable with geotextile.

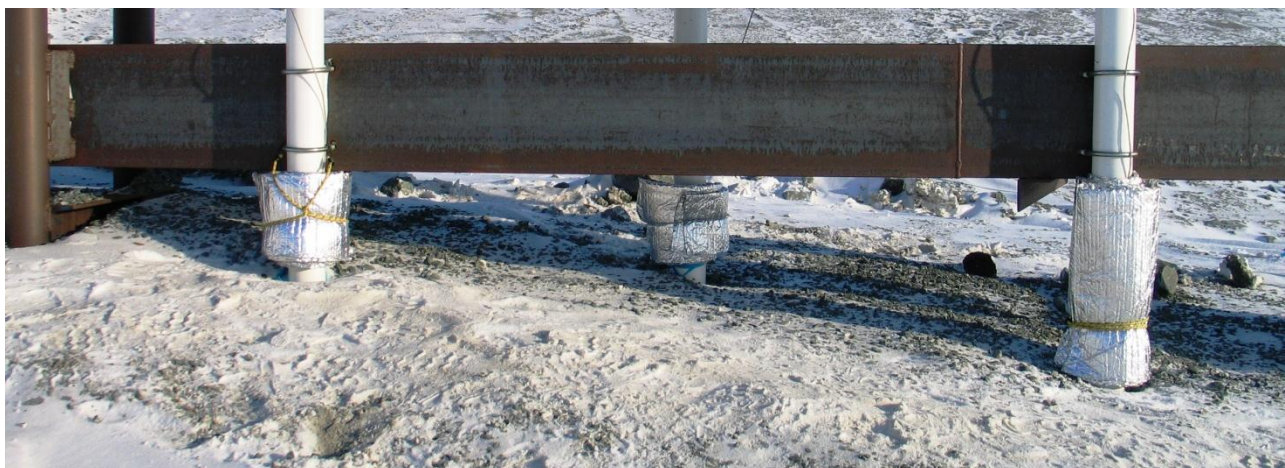
- Tests on the thermosyphons were started. Thermosyphons 4,5 and 6 were selected. Single bead thermistors were fastened to the pipes and wrapped with insulation. These thermosyphons and the remaining nine will be tested tomorrow.

**Photo 9:** Testing thermosyphons 4,5 and 6
