7DAILY REPORT #96 – DORIS NORTH INFRASTRUCTURE/ NORTH DAM

Prepared by:	Lawrence Borowski Iozsef Miskolczi	Date:	2012.04.10
Reviewed by:		Project #:	1CH008.058.0320
Role	Company	Personnel – Position	On Site
Client	Hope Bay Mining Limited (HBML)	Angela Holzapfel – ESR Compliance Manager David Vokey – ESR Coordinator Dean Wold - Safety Jill Turk – ESR Coordinator Katsky Venter – ESR Manger Michelle Tanquay – ESR Site Manager Stirling Kelly – HSLP Advisor	No Yes Yes No No Yes No
	JDS	Doug Fielding – Construction Manager Ishan Fechter – Construction Coordinator Jerry Graham – Construction Manager Mark Valeriot – Construction Manager Calvin Goldschmidt – Construction Coordinator	No Yes Yes No No
Engineering Design Consultants	SRK Consulting (Canada) Inc.	Megan Miller – Site Engineer Lawrence Borowski – Site Engineer Iozsef Miskolczi – Site Engineer	No Yes No
Earthworks Contractor	Nuna Logistics	Doug Haverland – Area Superintendent Gary Sodhi – Field Engineer Georges Cornelissen – Survey Manager Jeff Roberts - Surveyor Jim Cardinal – Foreman Jordan Gunter – Foreman (Day Shift) Kyle Kuntz – Project Engineer Margaret Caley – Surveyor Mike MacMaster – Surveyor Mike Price – Field Engineer Ri

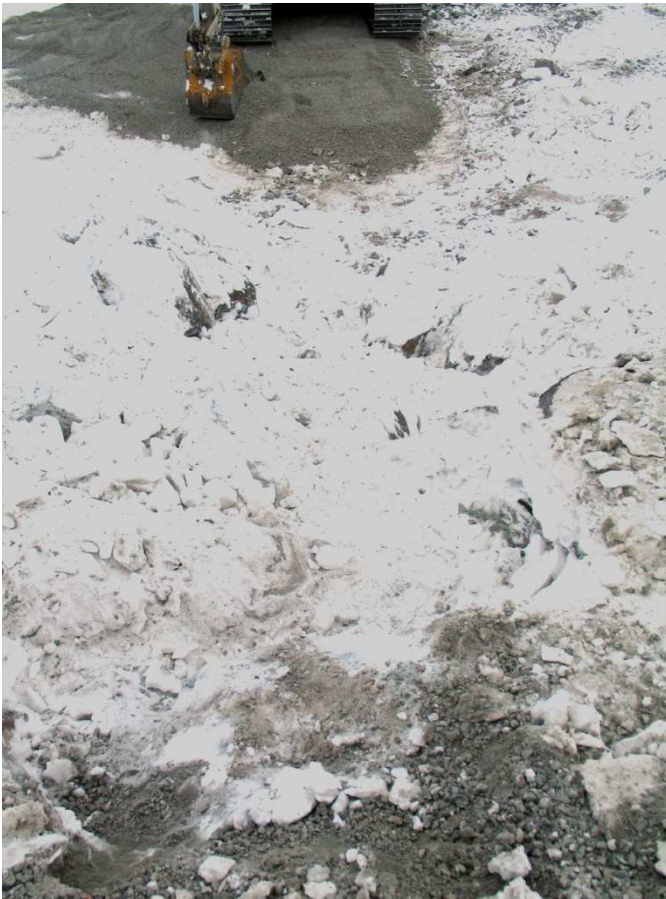
Photo 1: Surface of Pollution Pond bank after snow removal. Cable path between Pollution Pond floor and road.
Photo 2: 6 in material placed to fill voids in rip rap .

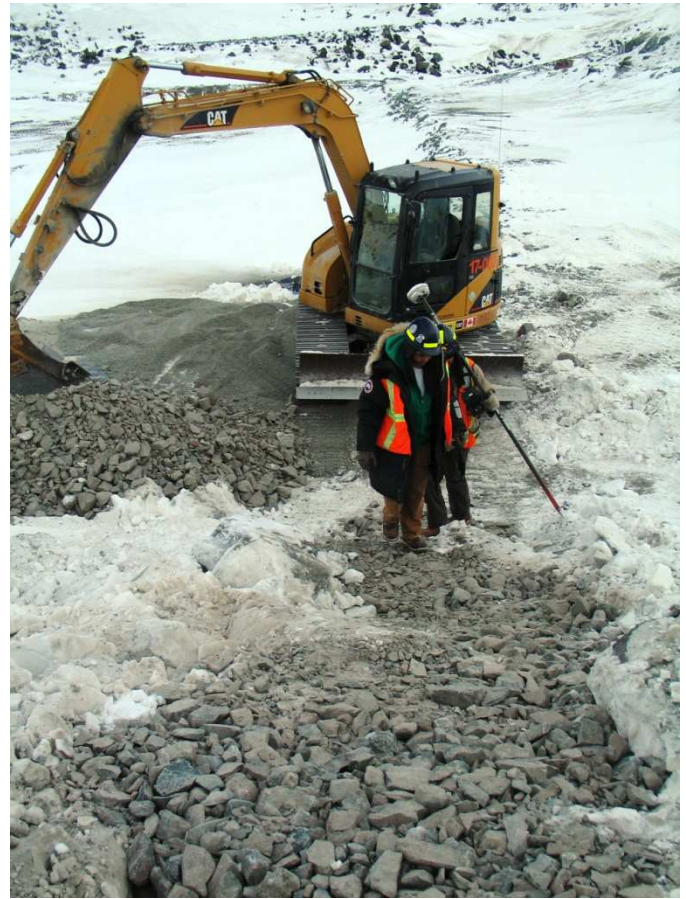
- Cable from thermister SRK-12-GTC-DH03. was run up the side of the Pollution Control berm to a termination point on the float plane dock access road.
- Rip rap had been placed on the berm. Removing the rip rap down to the geotextile below was not considered to be a viable option. In lieu, 6 in material was used to provide a stable platform for placing the cable.

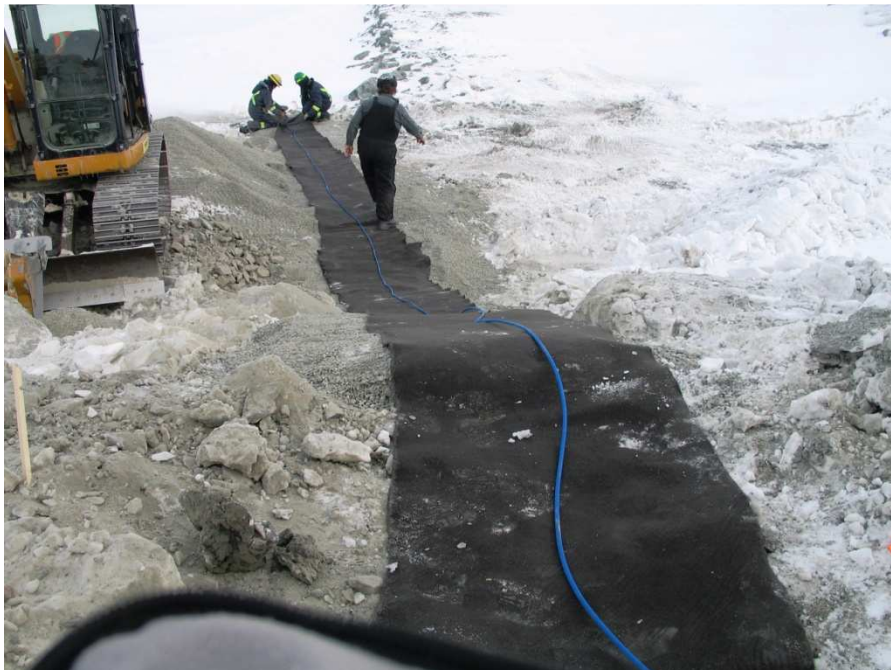
Photo 3: Preparing to wrap cable with geotextile.

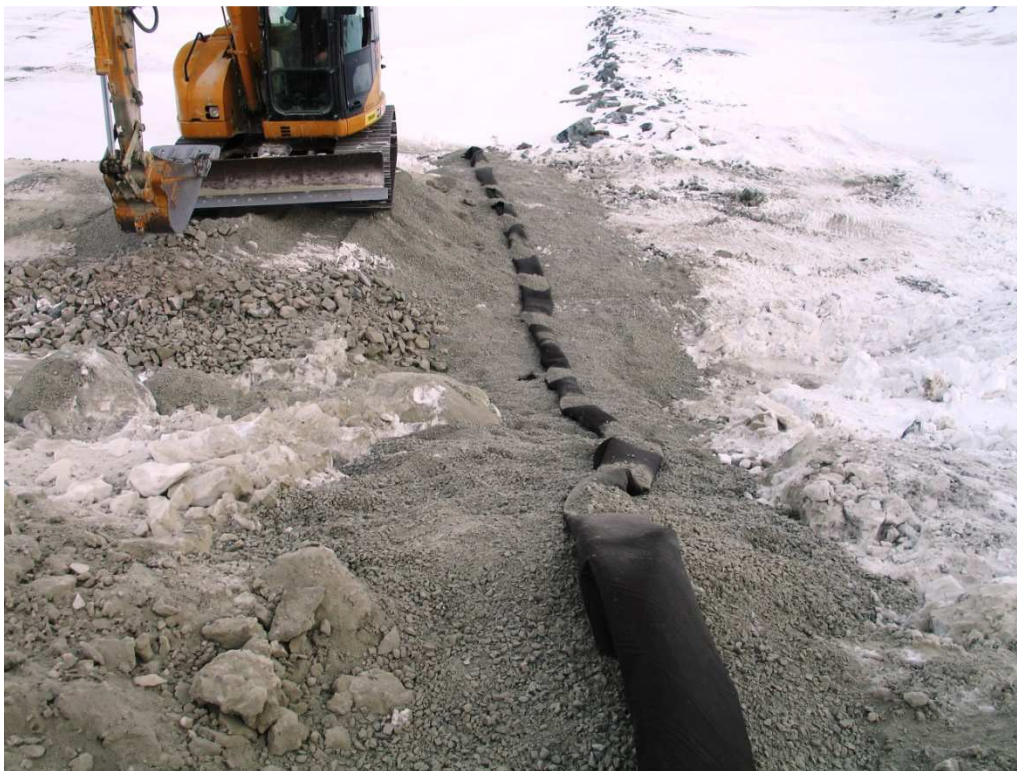
Photo 4: Wrapped cable ready for $\frac{3}{4}$ in crush.

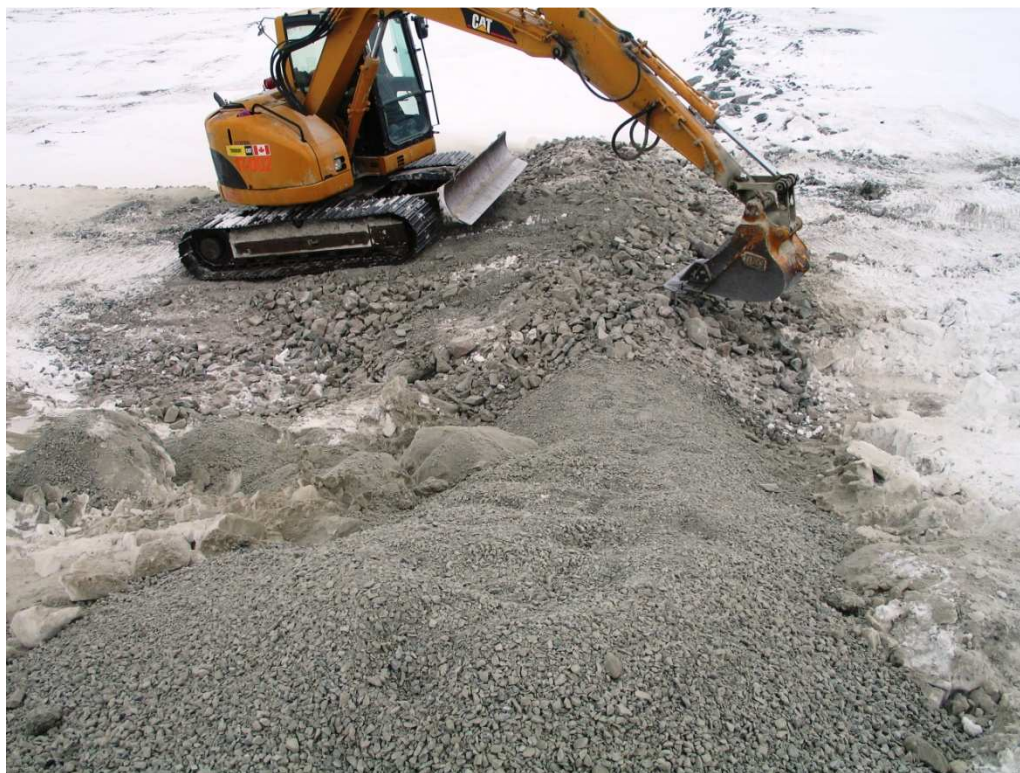
Photo 5: Cable covered with $\frac{3}{4}$ in crush. Final ROQ surfacing underway.

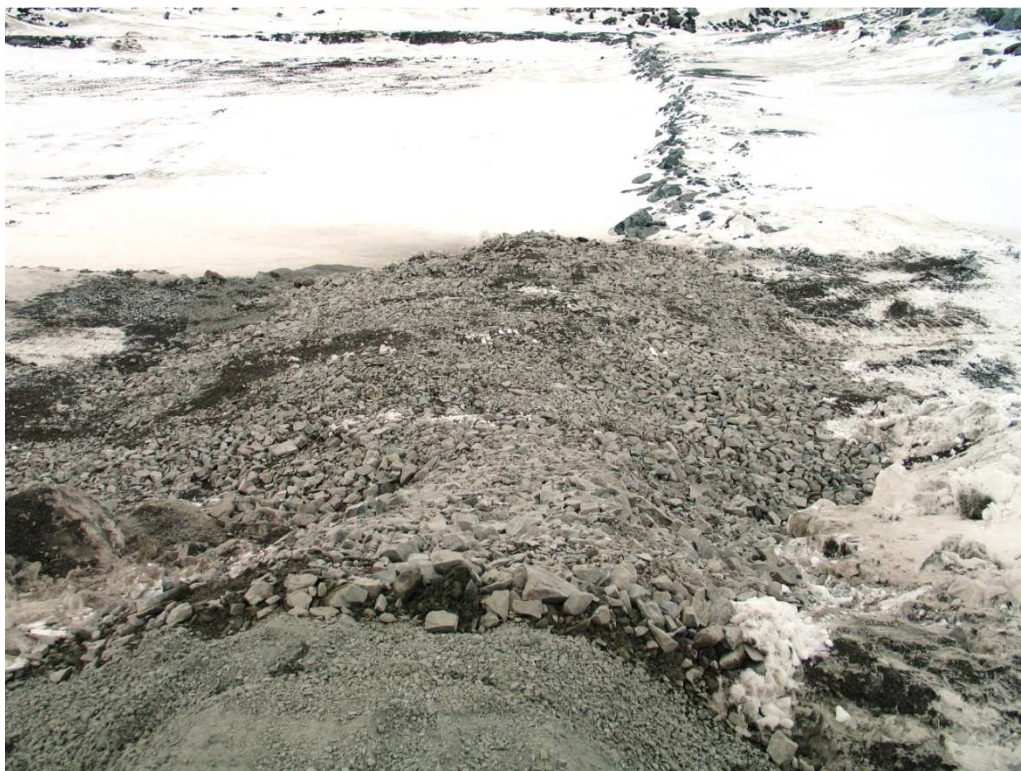
Photo 6: Final product. ROQ terminates at road surface.

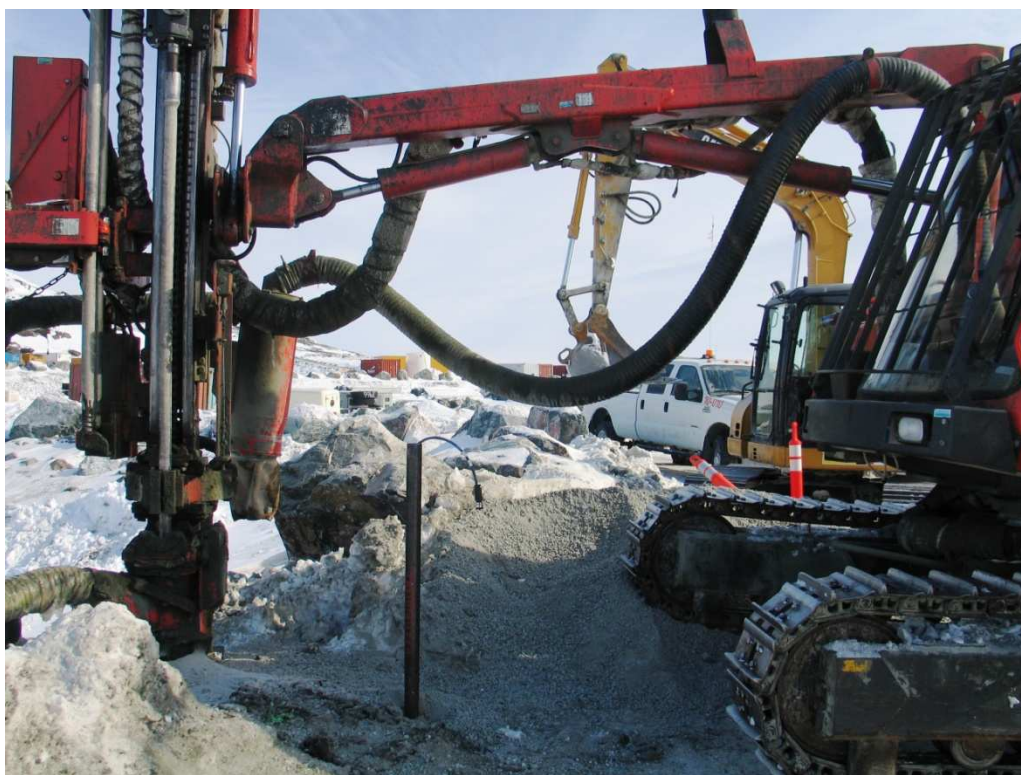
- Cable was bedded in ¾ in material, wrapped with geotextile, and covered with ¾ in material.
- Final cover up the slope was select ROQ.
- The cable was ~ 1 meter short. In lieu of splicing a short section of cable, a second hole was drilled and a second read out location was created.

Photo 7: Drilling a 2 foot hole. Cable was ~ 1 meter short.

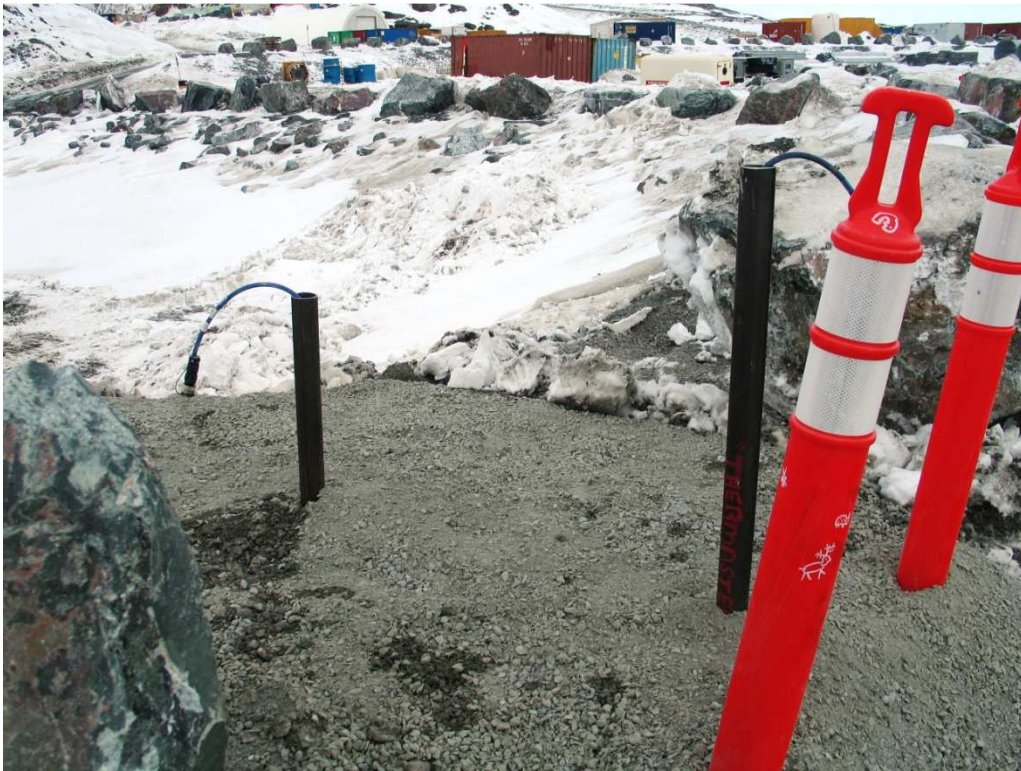
Photo 8: Finished product. The second pipe could have been higher. A wood junction box will be fastened to the pipe to protect the end of the cable.

- Currently, the cable is threaded through a 3 in pipe and excess is draped over the edge. Nuna advises that wood termination boxes will be constructed and fastened to the 3 in pipe at the Pollution Pond locations and at the 5 bridge locations.

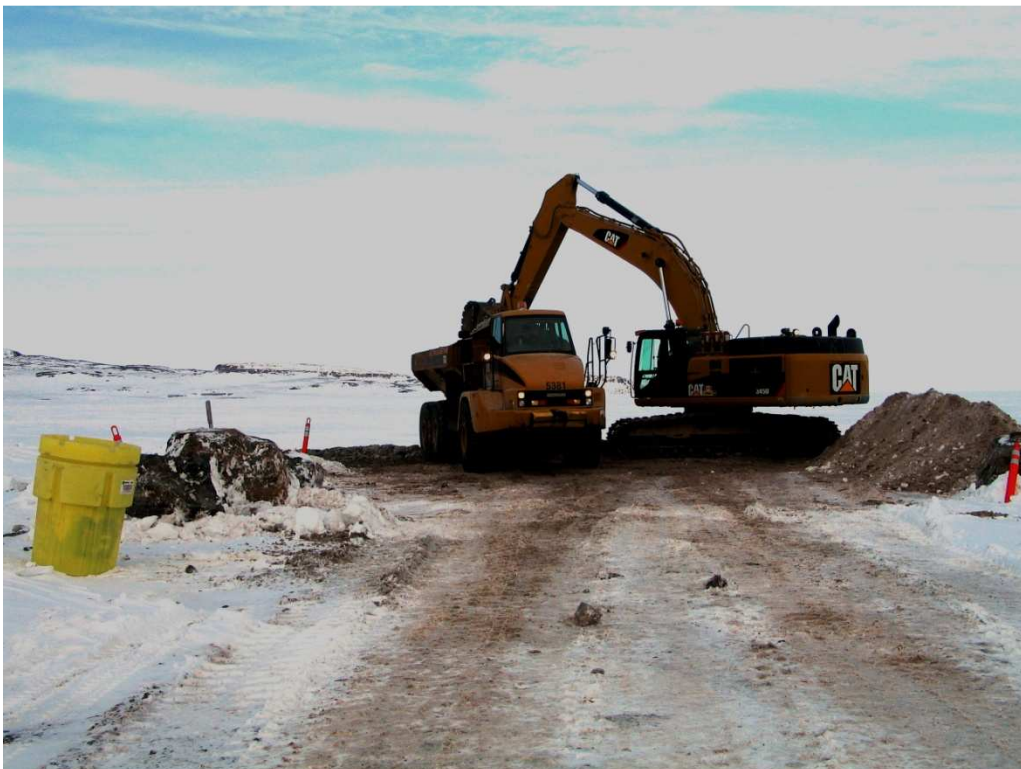
Photo 9: Work at the jetty.

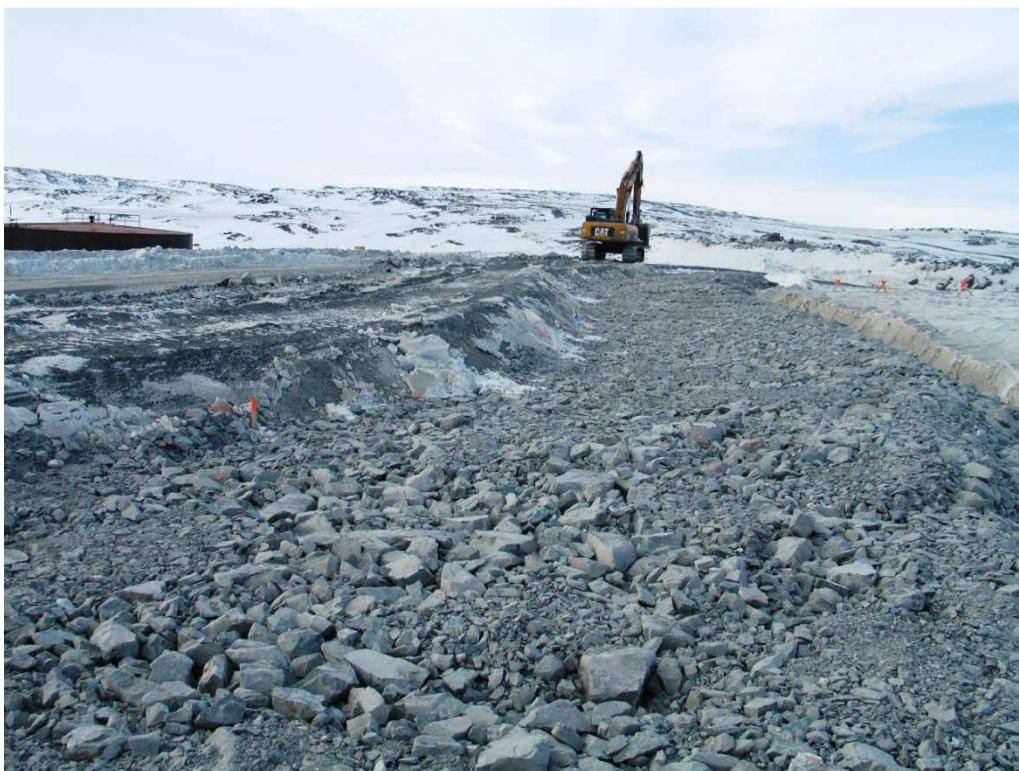
Photo 10: Completed work at the berm, ~ Sta 2+50 facing west.

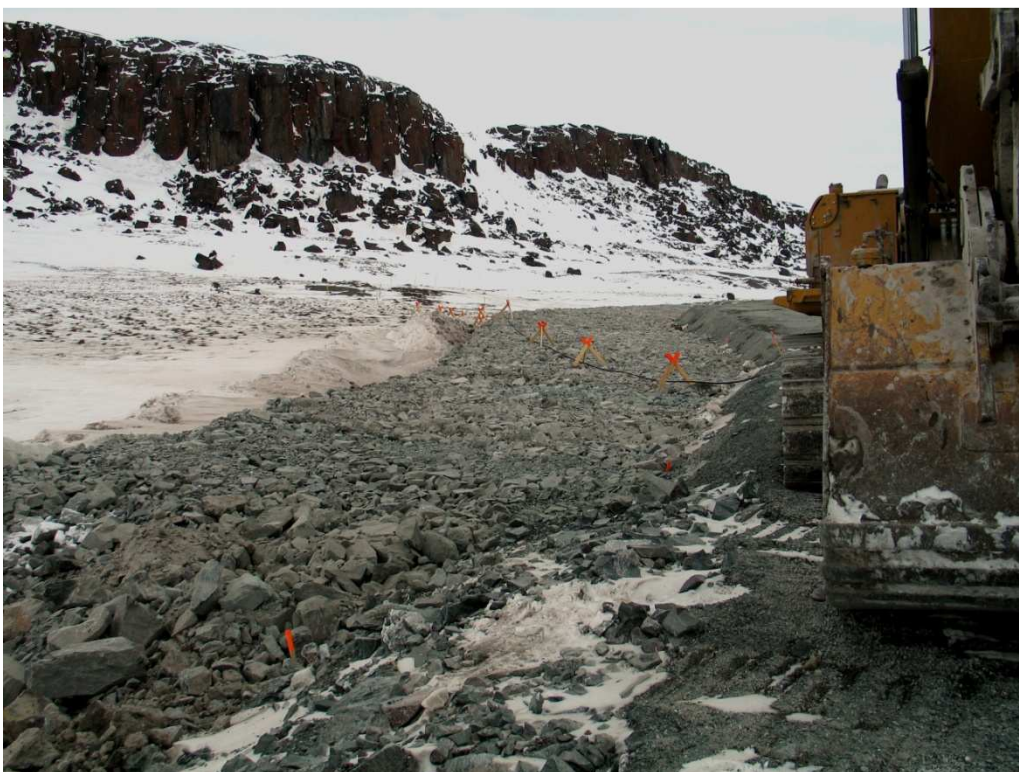
Photo 11: Progress photo – electrical cable in background ~ Sta 1+50 facing east.
